# Interim Reclamation and Stormwater Inspection

Operator: LONGS PEAK RESOURCES LLC- #10611

Location ID: 439459

Inspection Document #: 697504024

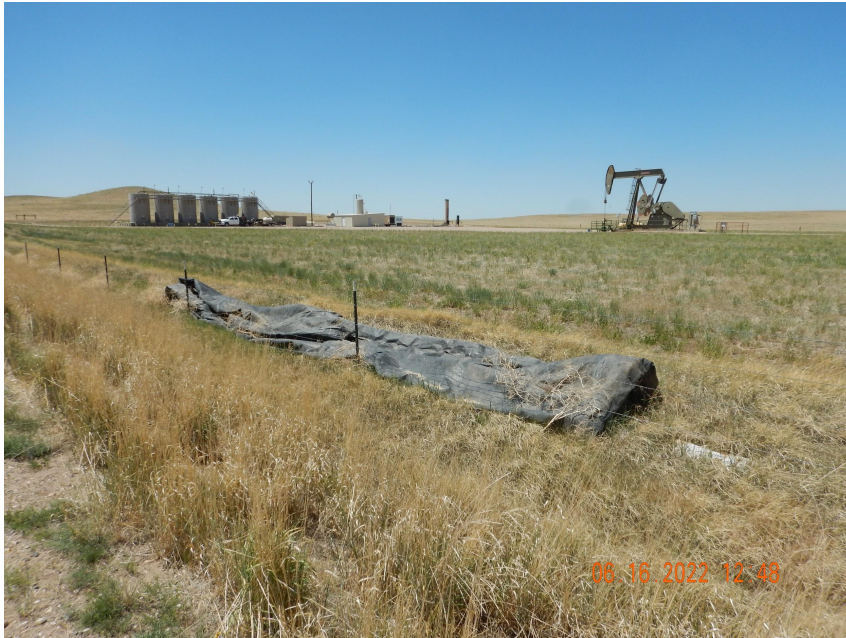
**Photo 1.** Photo taken from the southeastern location, facing Northwest. Photo illustrates debris that needs to be removed.

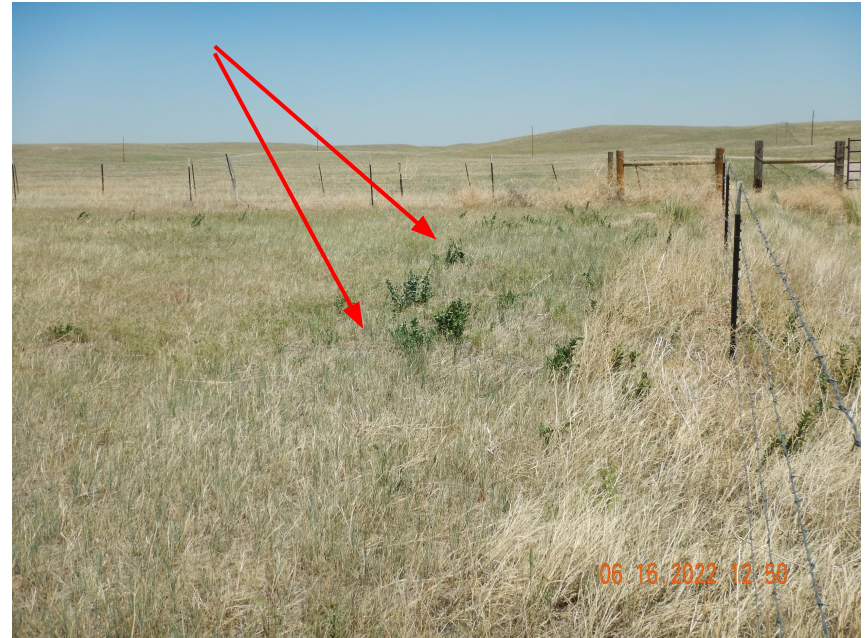
**Photo 2.** Photo taken from the southeastern location, facing East. Photo illustrates a List B Colorado noxious weed, toadflax.

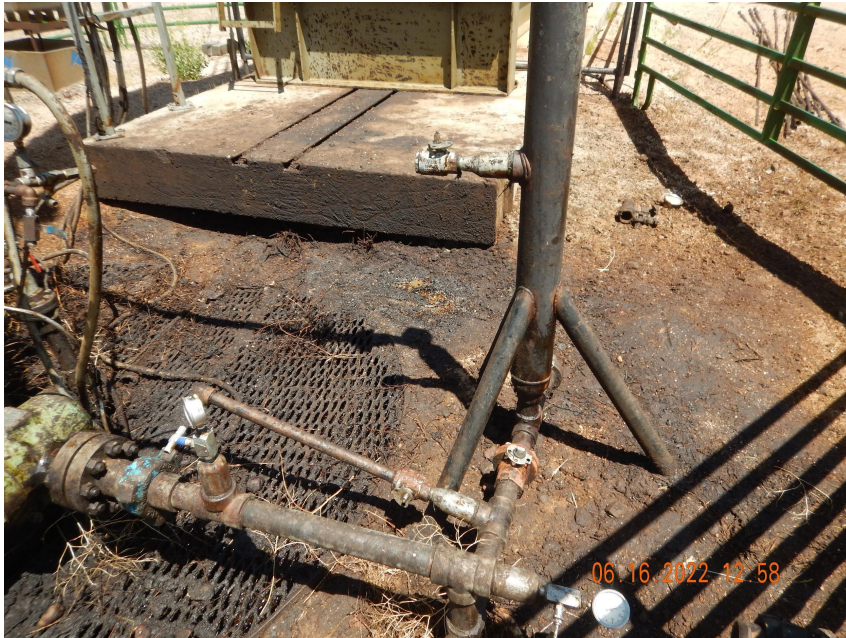
**Photo 3.** Photo taken from the wellhead. Photo illustrates production facility equipment is not in good mechanical condition per Rule 608.e.

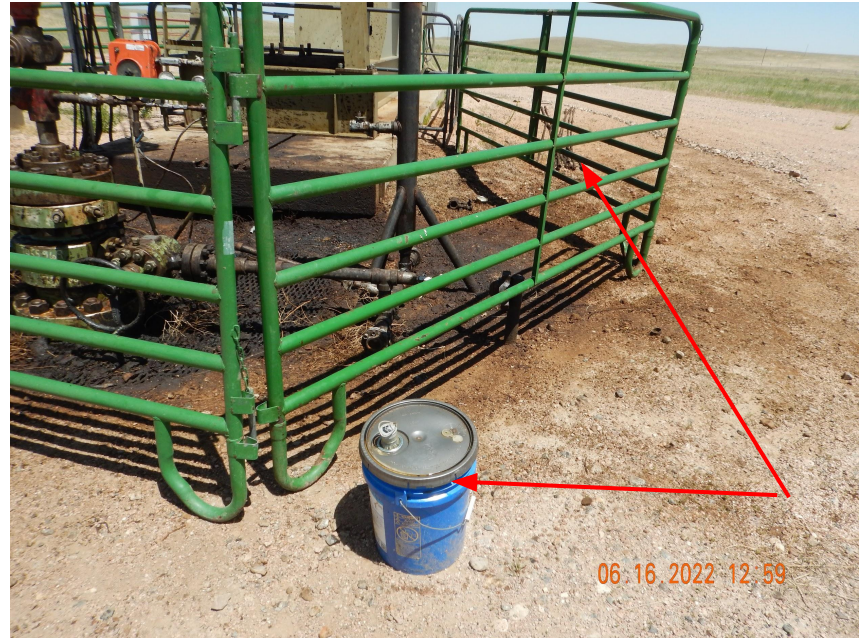
**Photo 4.** Photo taken from the wellhead. Photo illustrates unused equipment.

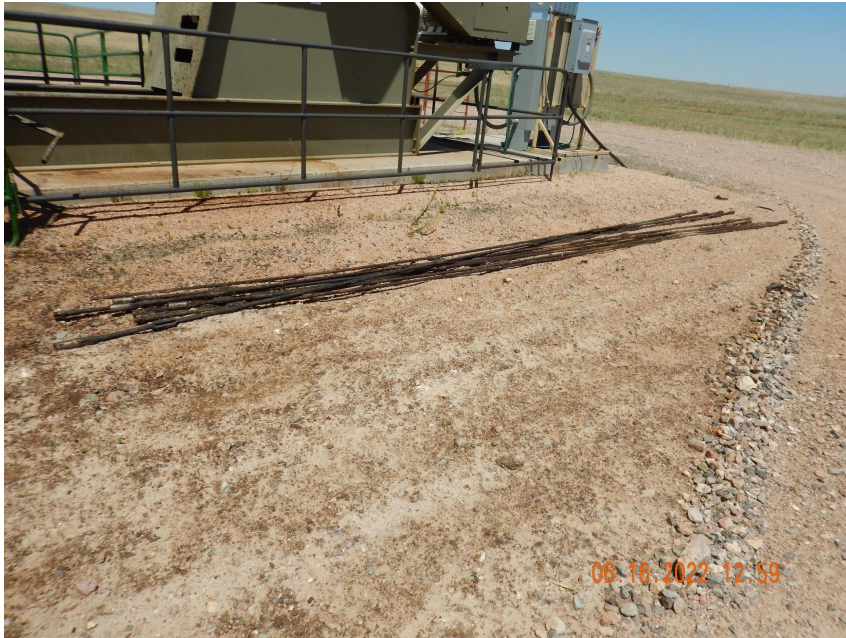
**Photo 5.** Photo taken from the wellhead. Photo illustrates unused equipment.

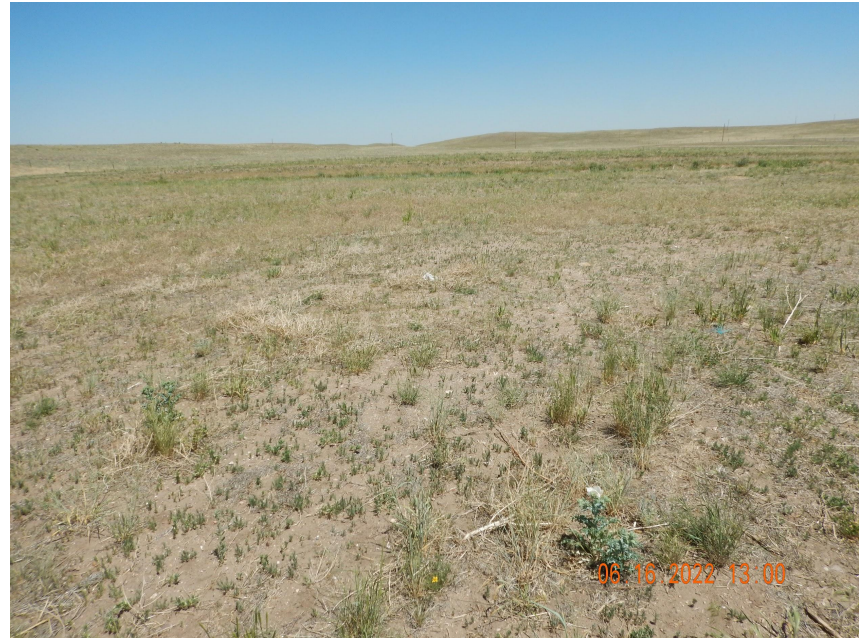
**Photo 6.** Photo taken from the northern interim reclamation area, facing East. Photo illustrates interim reclamation has been performed; however, an introduced seed mix was used which is not reflective of reference area vegetation per Rule 1003.

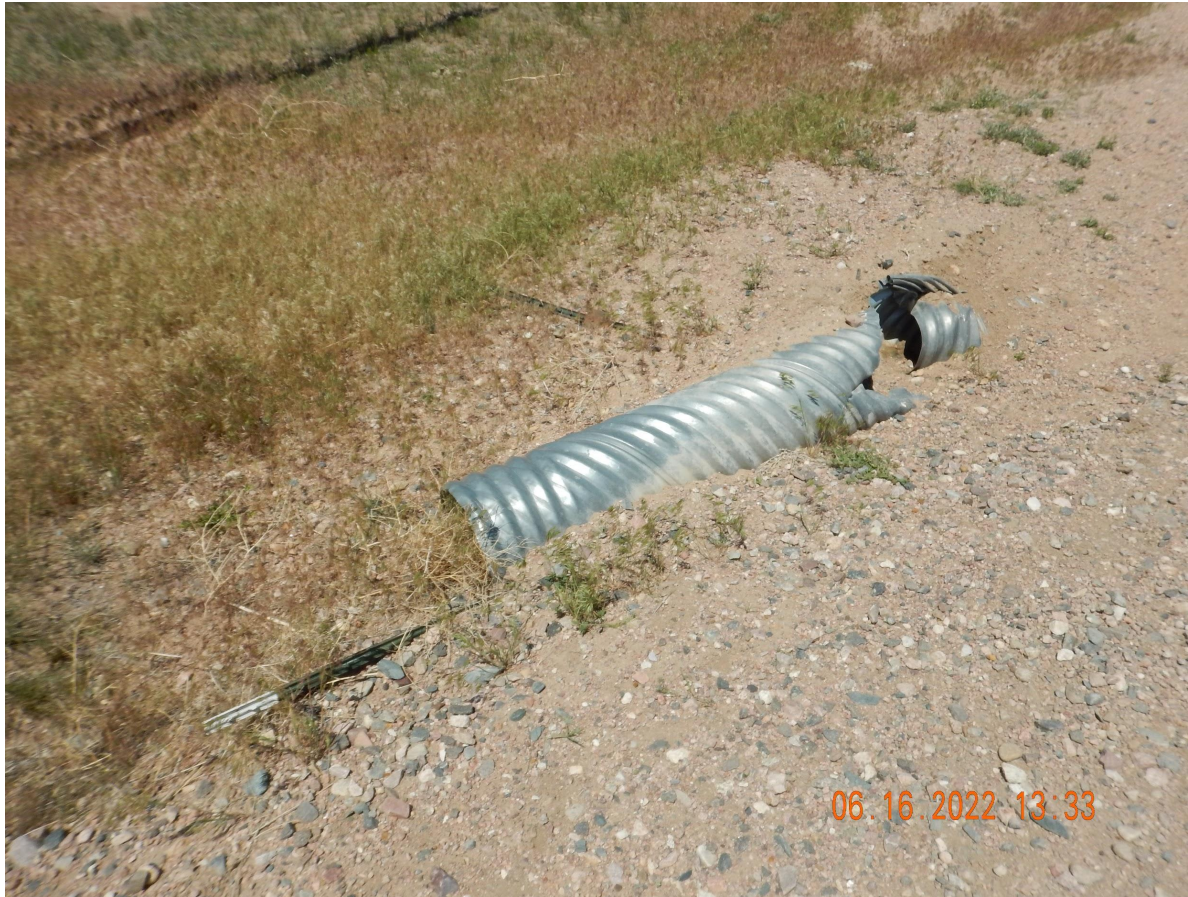
**Photo 7.** Photo taken from the entrance of location off CR 136. Photo illustrates damaged culverts that need to be repaired.
