Inspection Photos  
Location Name: Alva Short A 1  
Location ID: 312075

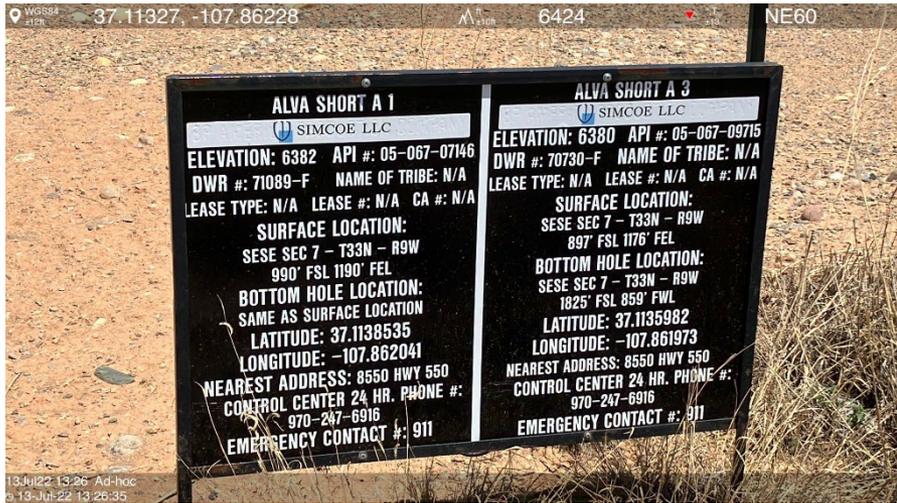
IMG 01  
Well sign

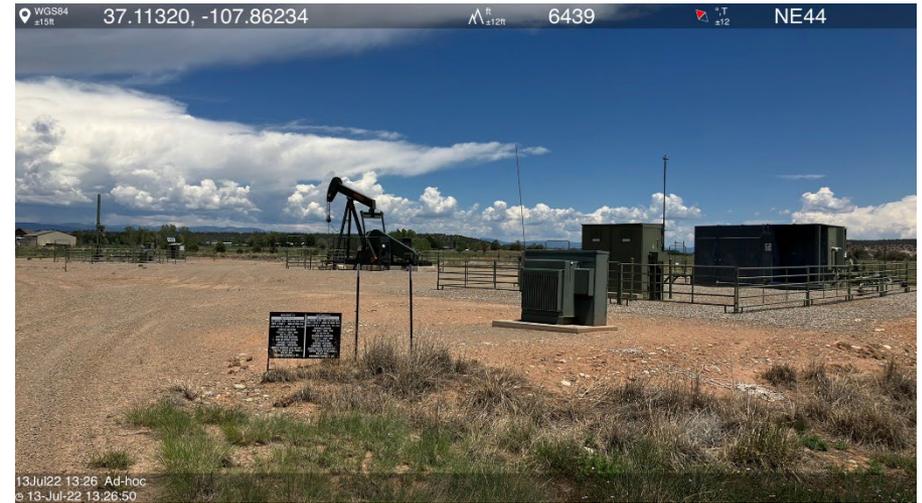
IMG 02  
Location overview

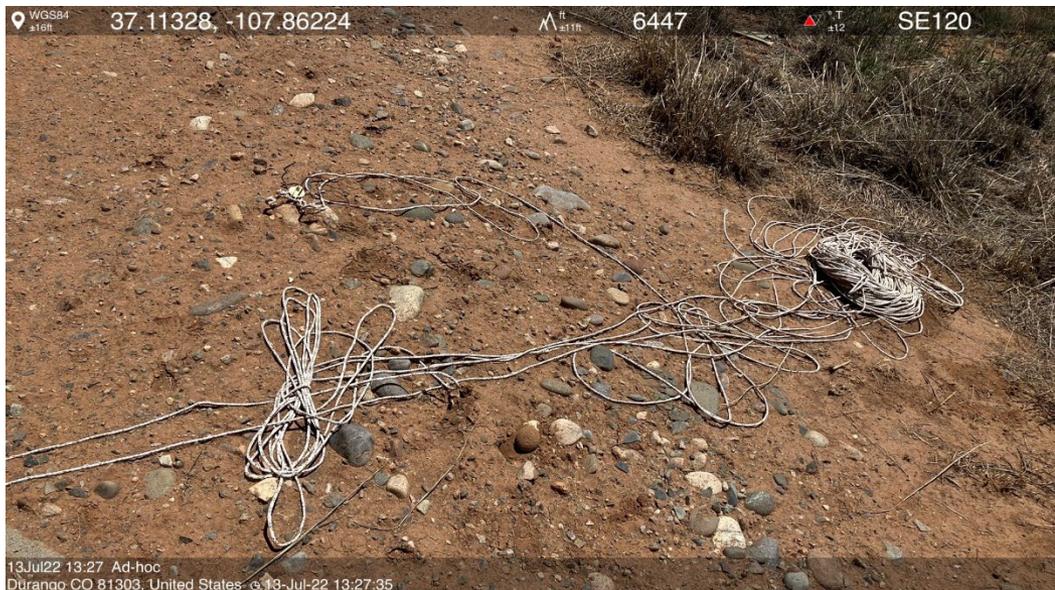
**IMG 03**  
Electric fence cable

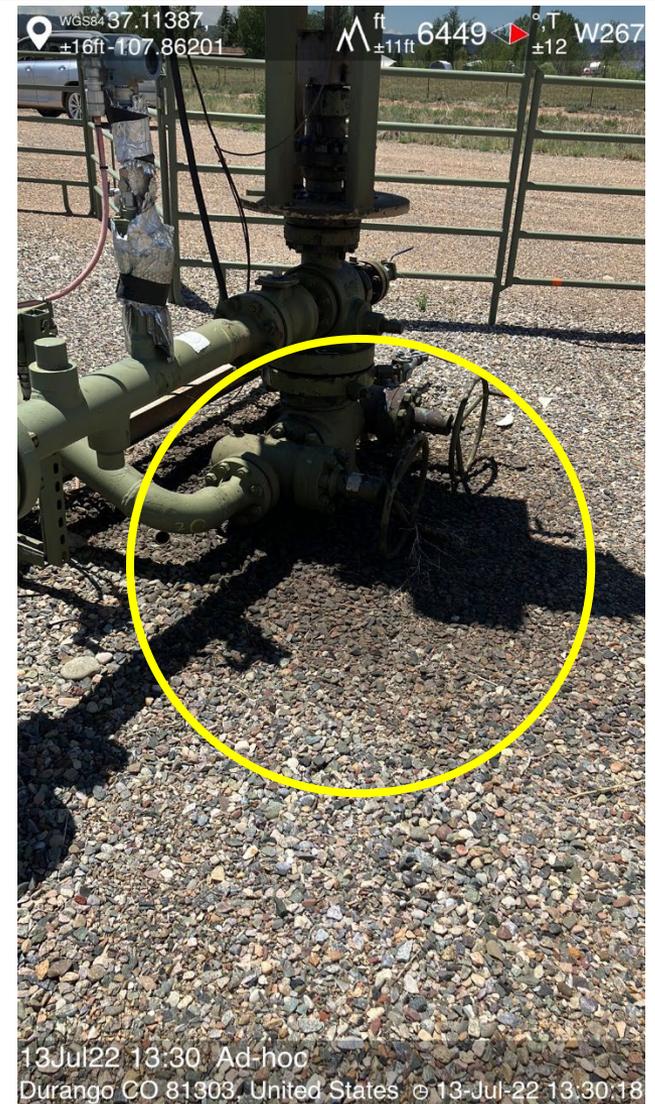
**IMG 04**  
Lube oil has impacted surface material

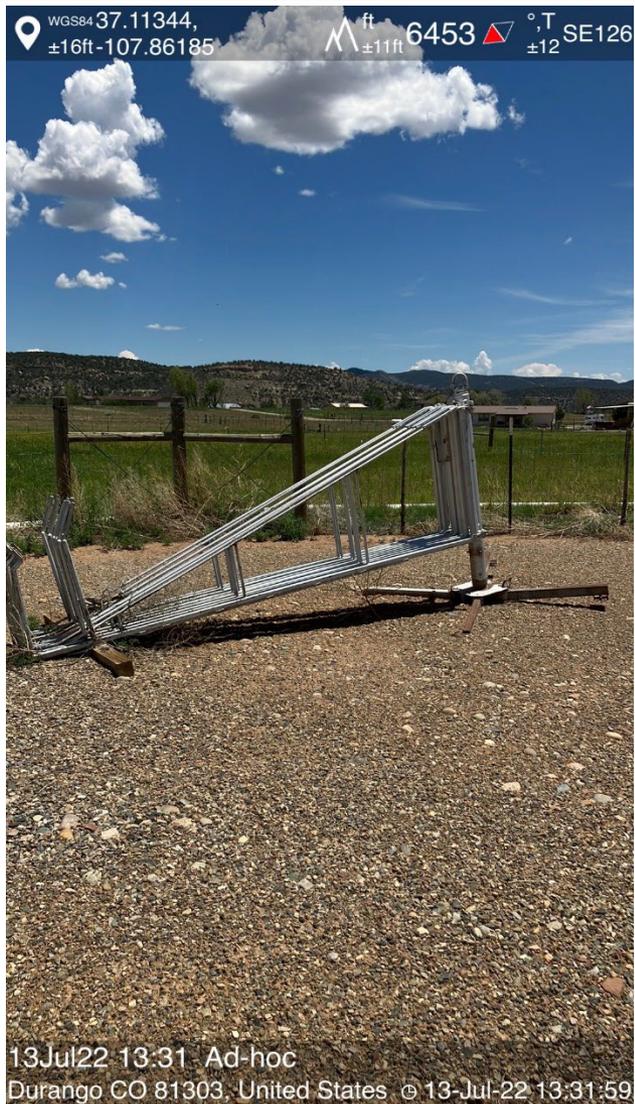
**IMG 05**

**Agriculture equipment on location**

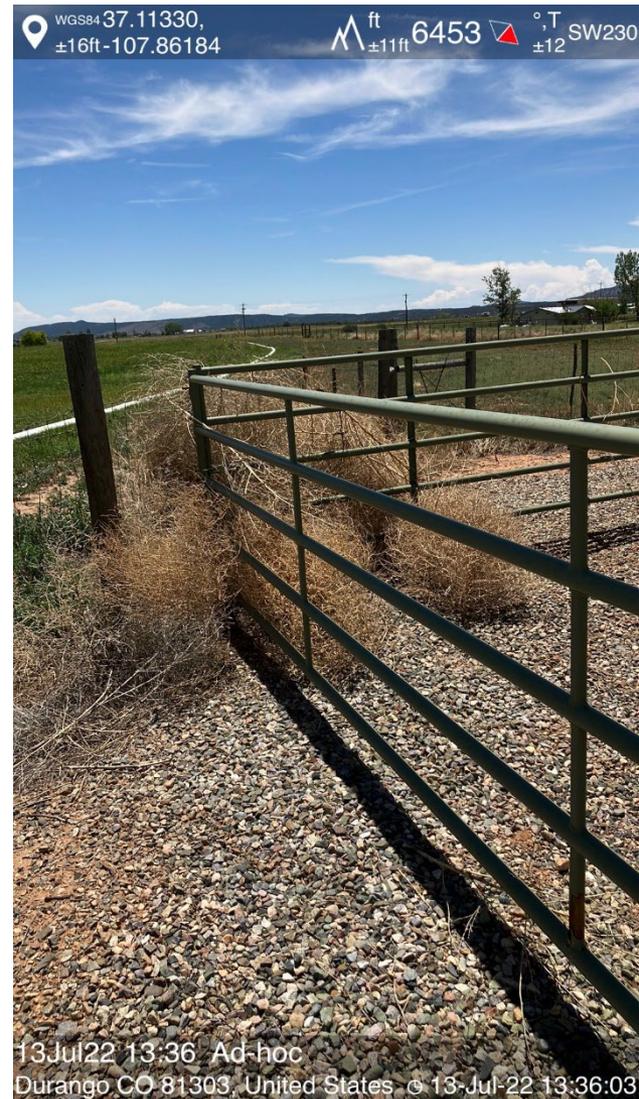
**IMG 06**

**Weeds in southeast corner**
