Inspection Photos  
Location Name: Cory Jack 33-7 11-2  
Location ID: 306898

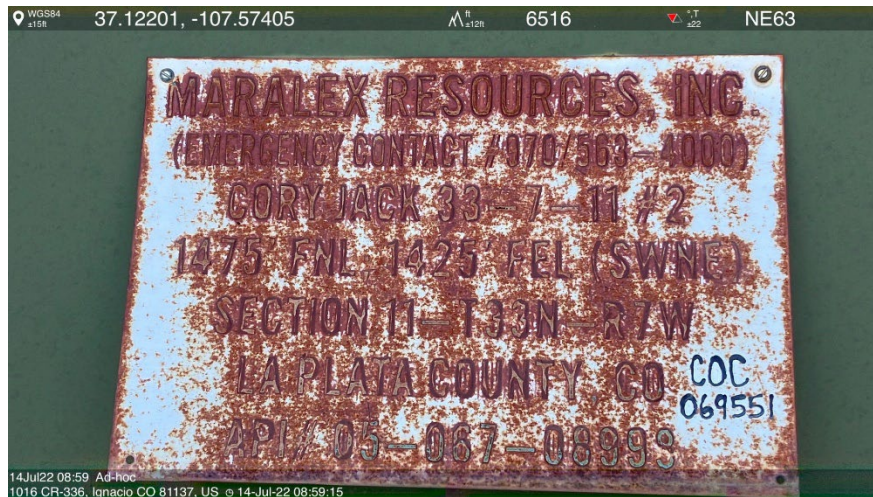
IMG 01

Well sign is deteriorated

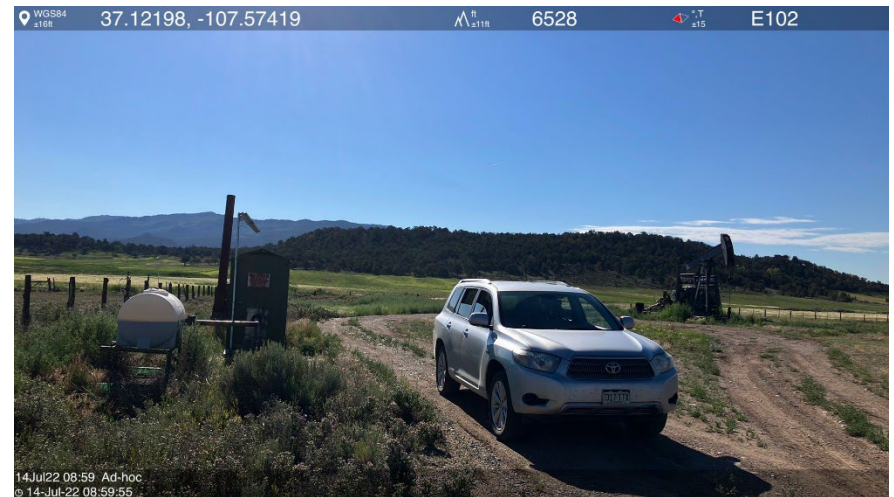
IMG 02

Location overview

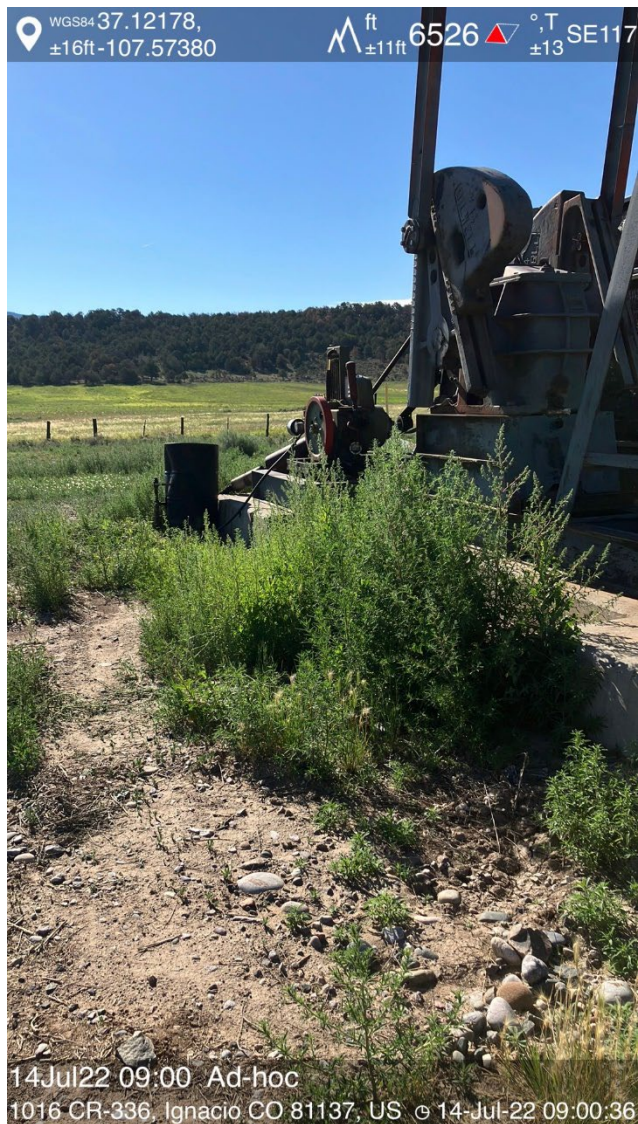
**IMG 03**

**Weeds are established at pump jack and location**

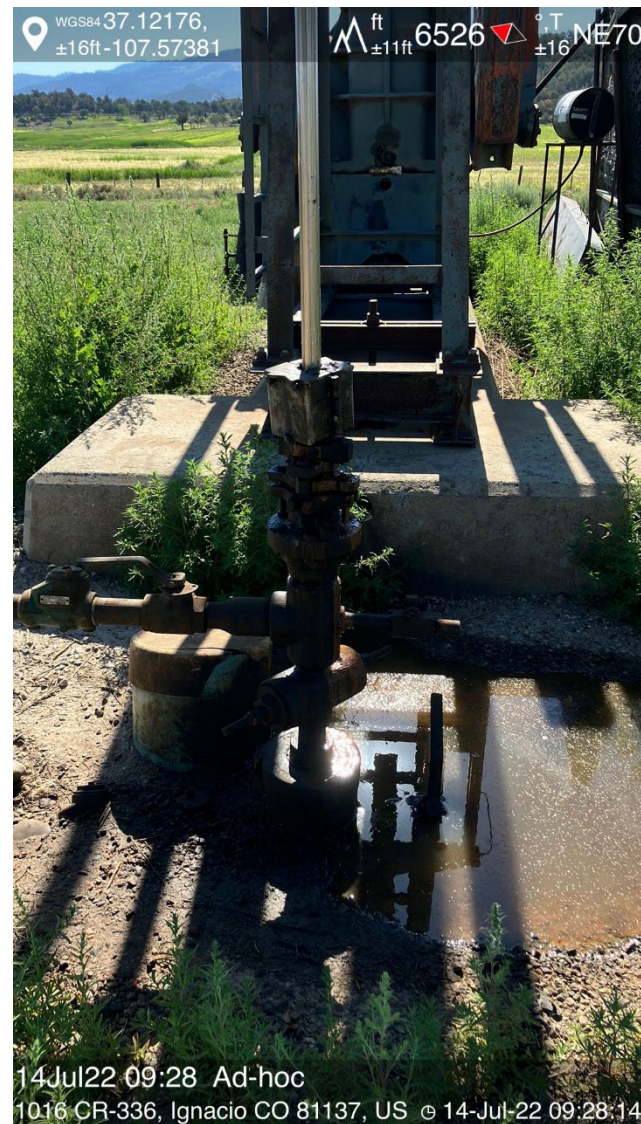
**IMG 04**

**Produced water at wellhead**

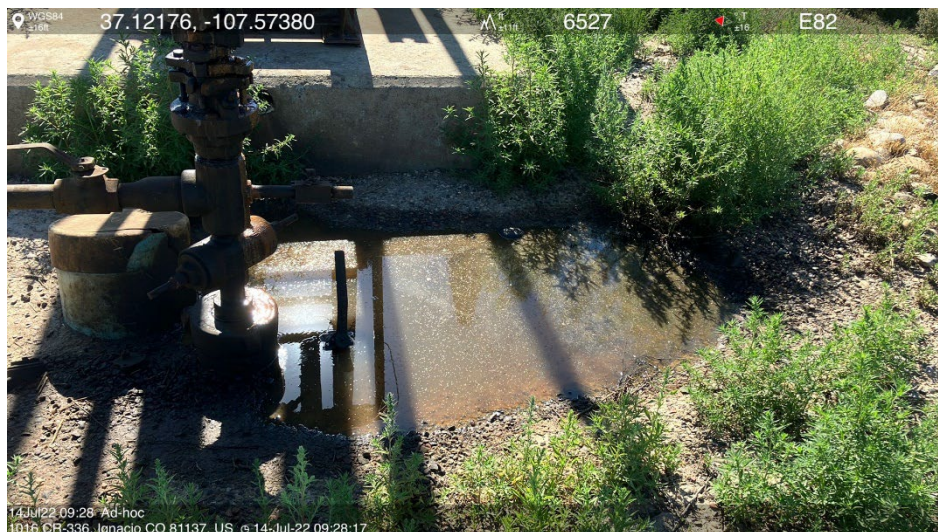
**IMG 05**  
**Produced water at wellhead**
