Inspection Photos

Operator: Beeman Oil & Gas Inc- #7125

Location Name: Bulldog /17-11H-893

Inspection Document #: 702800438

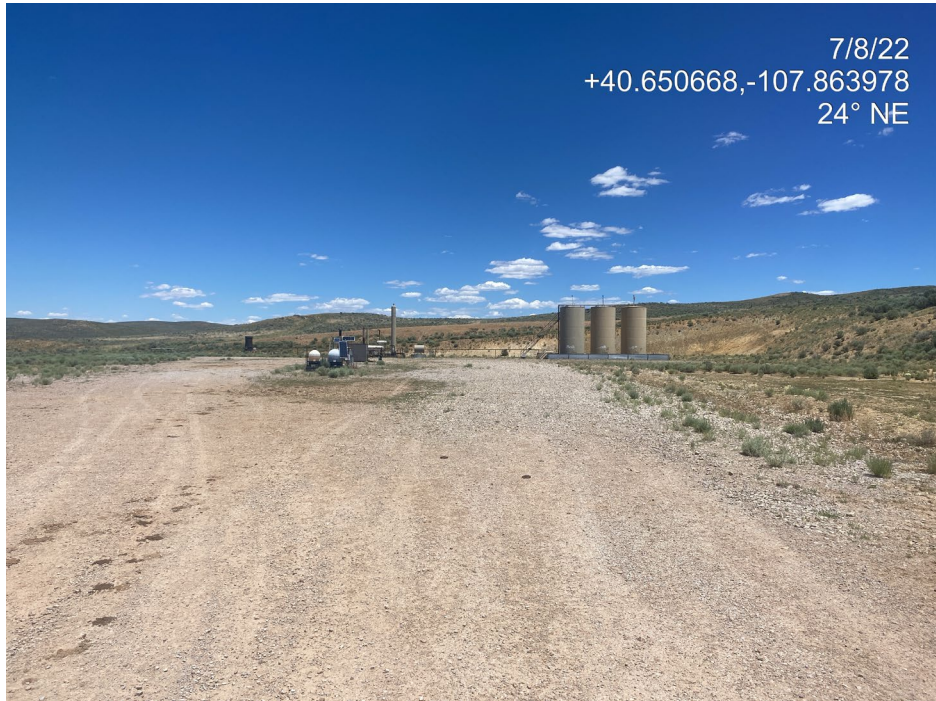
Photo 1. Photo taken from the Location entrance shows an overview of the eastern portion of the Location.

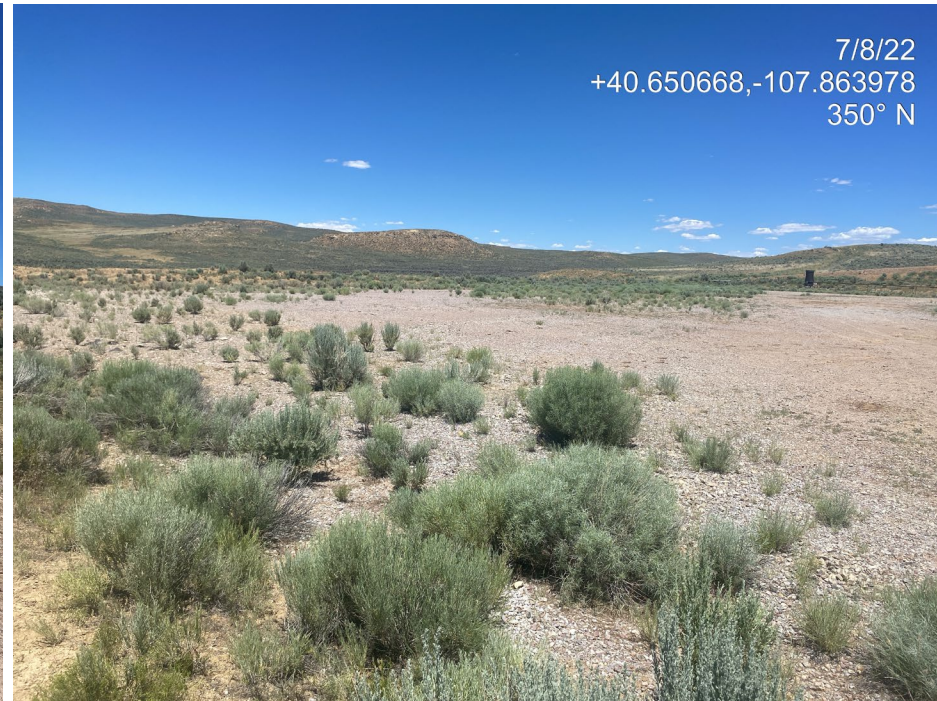
Photo 2. Photo taken from the Location entrance shows an overview of the western portion of the Location. Photo shows a portion of the pad not necessary for production operations where interim reclamation is required.

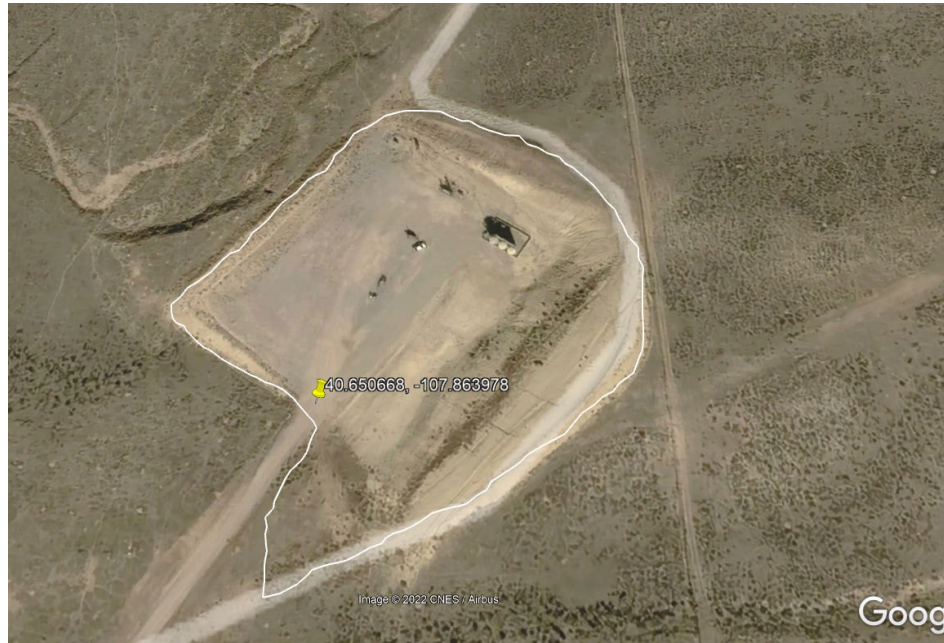
Photo 3. Photo shows aerial imagery of the Location from Google Earth. Imagery is dated 10/2019. White line indicates a ground track walked during the 7/8/2022 inspection showing the approximate disturbance/unreclaimed area.

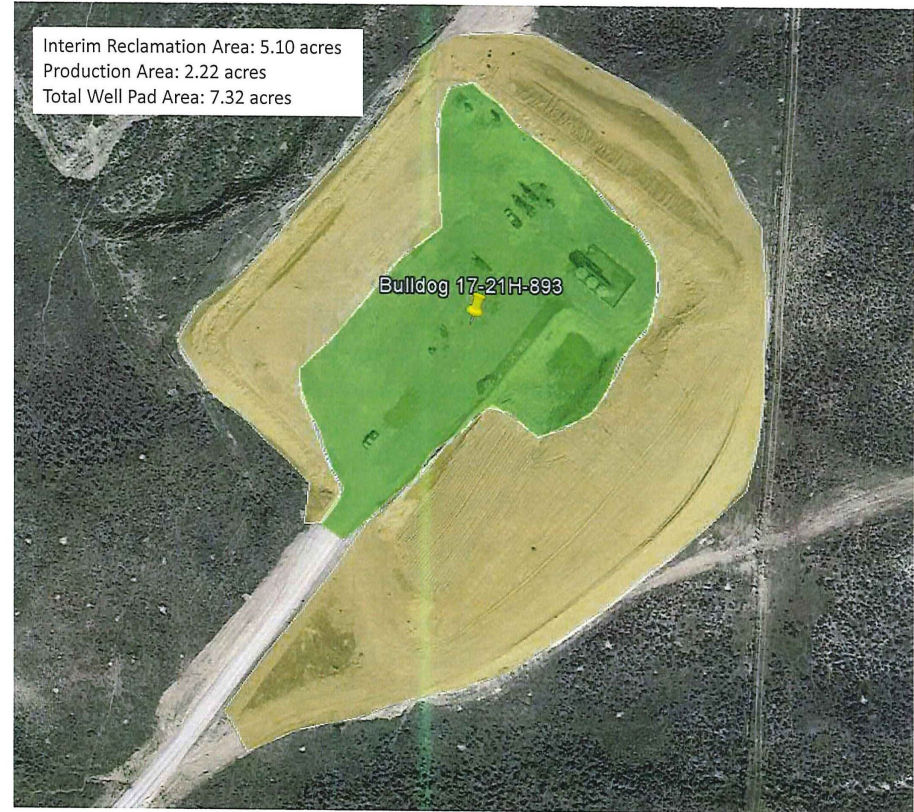
Photo 4. Photo shows the “Location Drawing” from document #401412049 which shows an estimate of production areas and interim reclamation areas included in variance request document #401291906. Variance expired 5/1/2022. Interim reclamation is required.

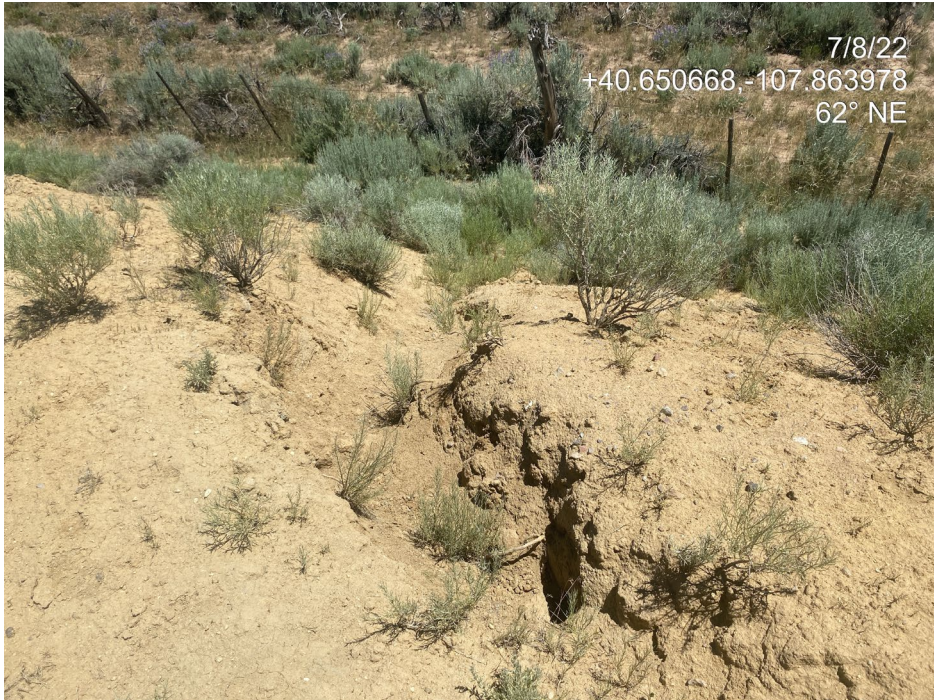
Photo 5. Photo taken from the south of the Location shows gully erosion occurring on sparsely vegetated, unstabilized slopes of the Location.

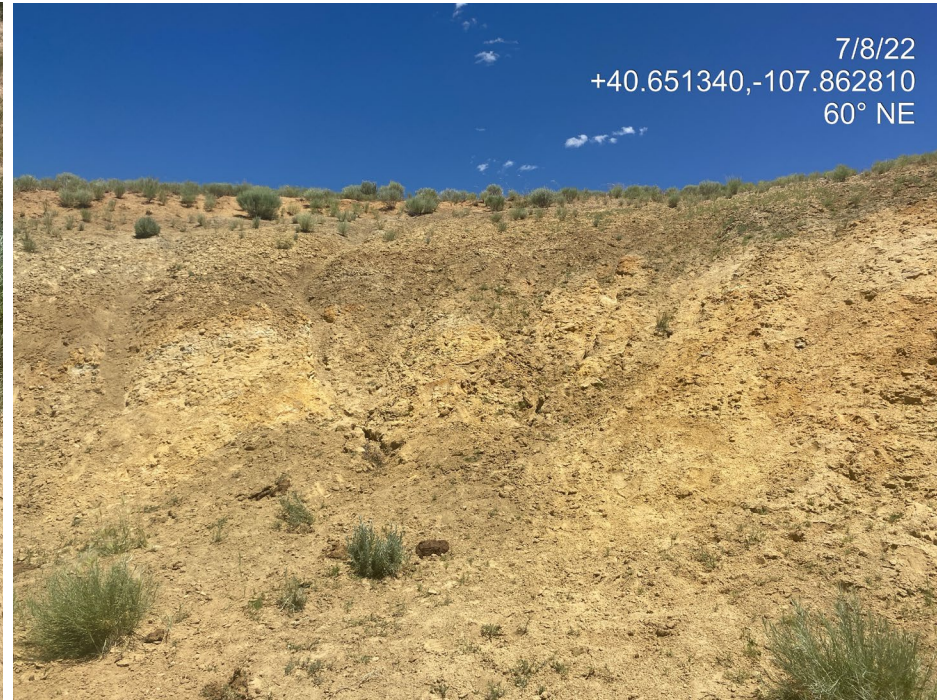
Photo 6. Photo taken from the northeast of the Location shows widespread rill erosion occurring on the cut slope.

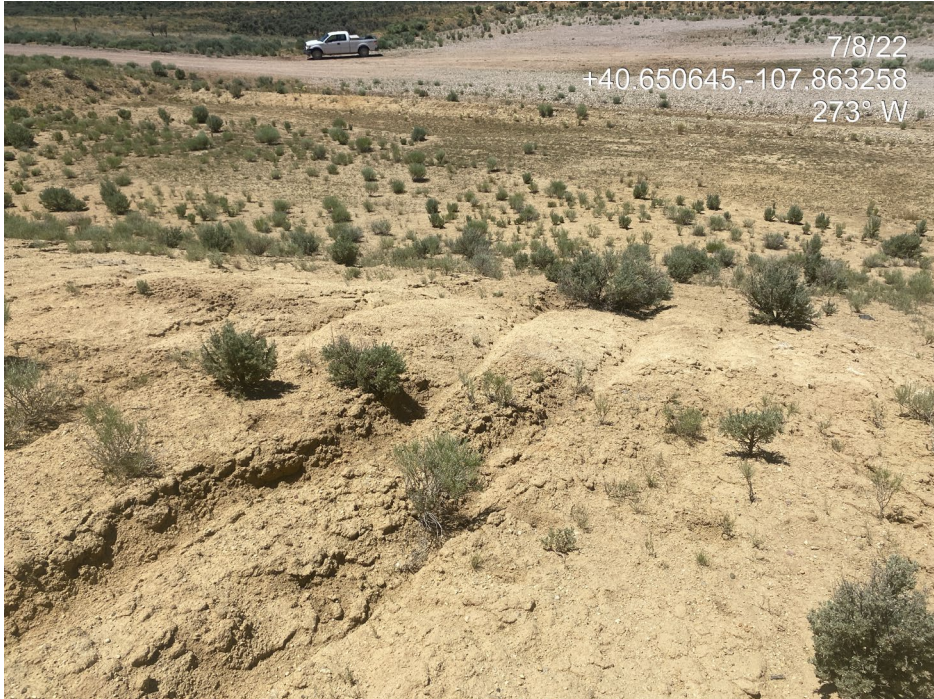
Photo 7. Photo taken from the southeast of the Location shows gully erosion occurring on sparsely vegetated, unstabilized slopes.

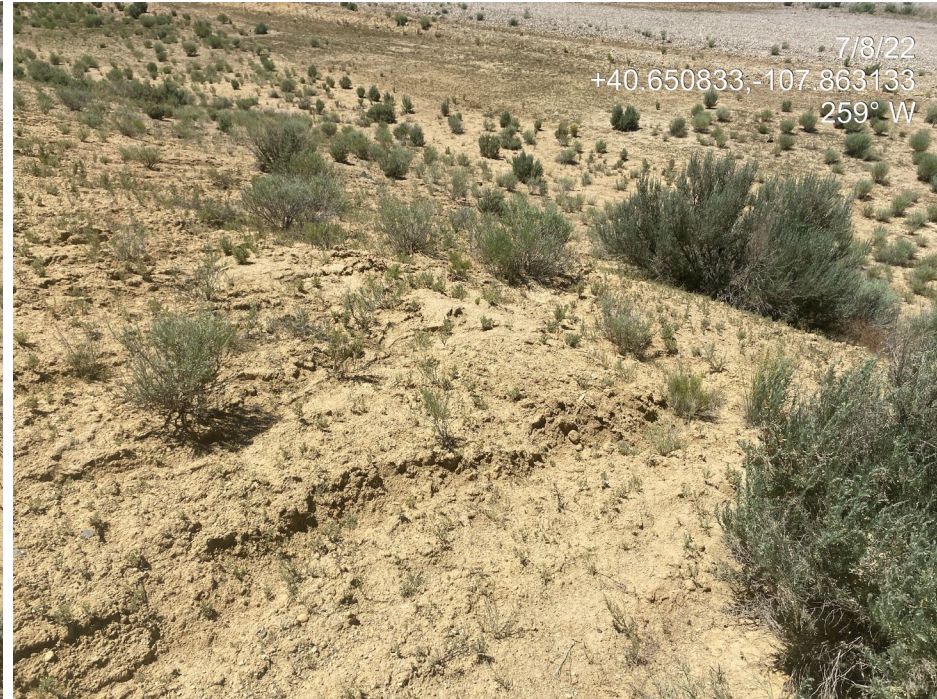
Photo 8. Photo taken from the east of the Location shows gully erosion occurring on sparsely vegetated, unstabilized slopes.

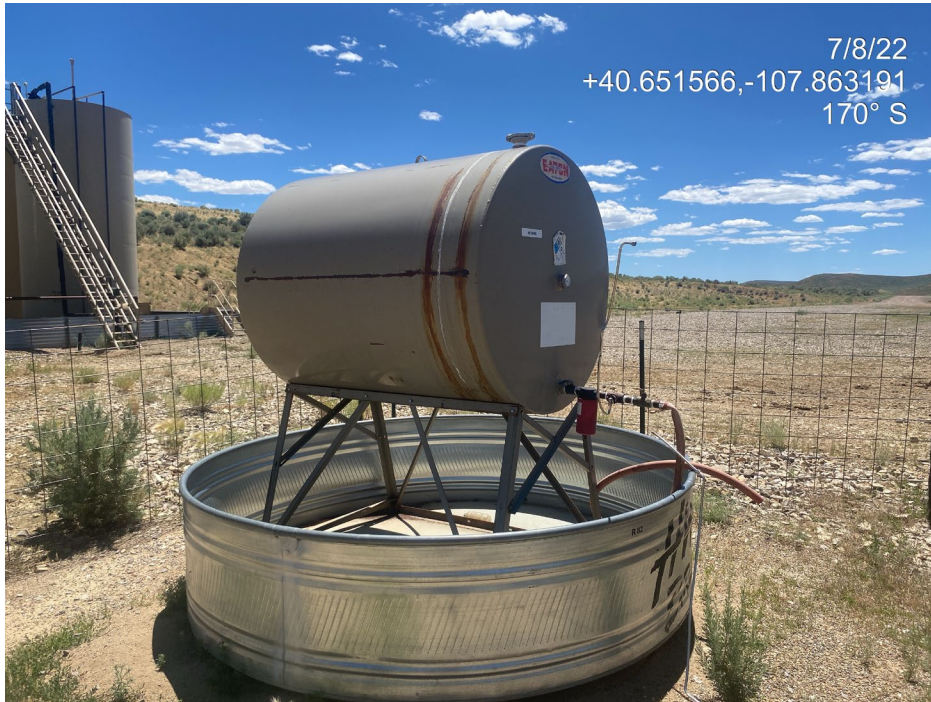
Photo 9. Photo shows a methanol tank at the north of the Location with inadequate wildlife protection BMPs on the secondary containment stock tank.

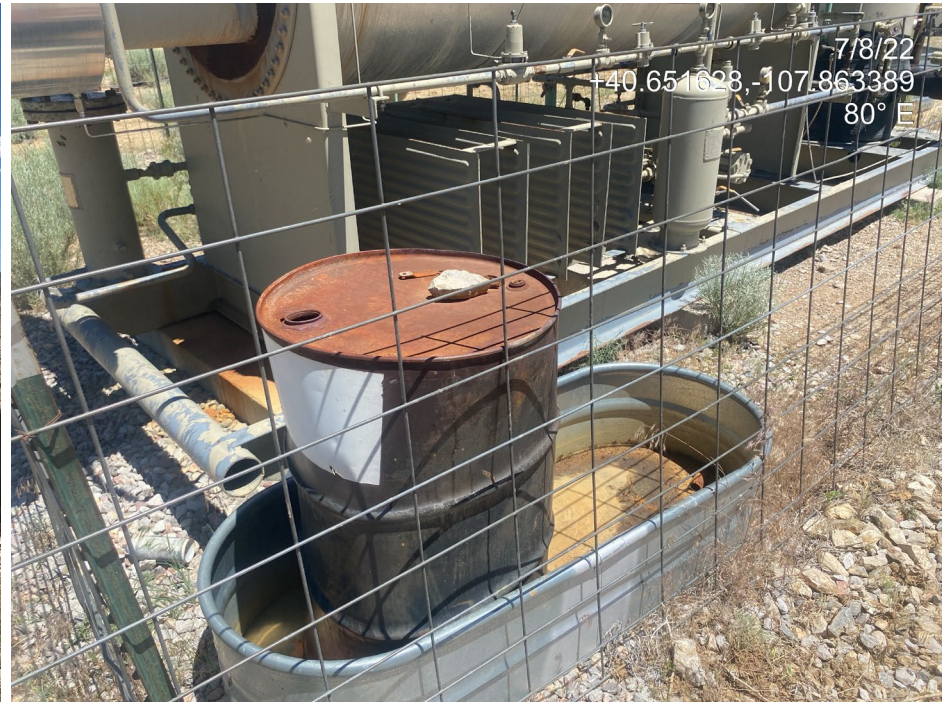
Photo 10. Photo taken at the north of the Location shows inadequate wildlife protection BMPs on the secondary containment stock tank.

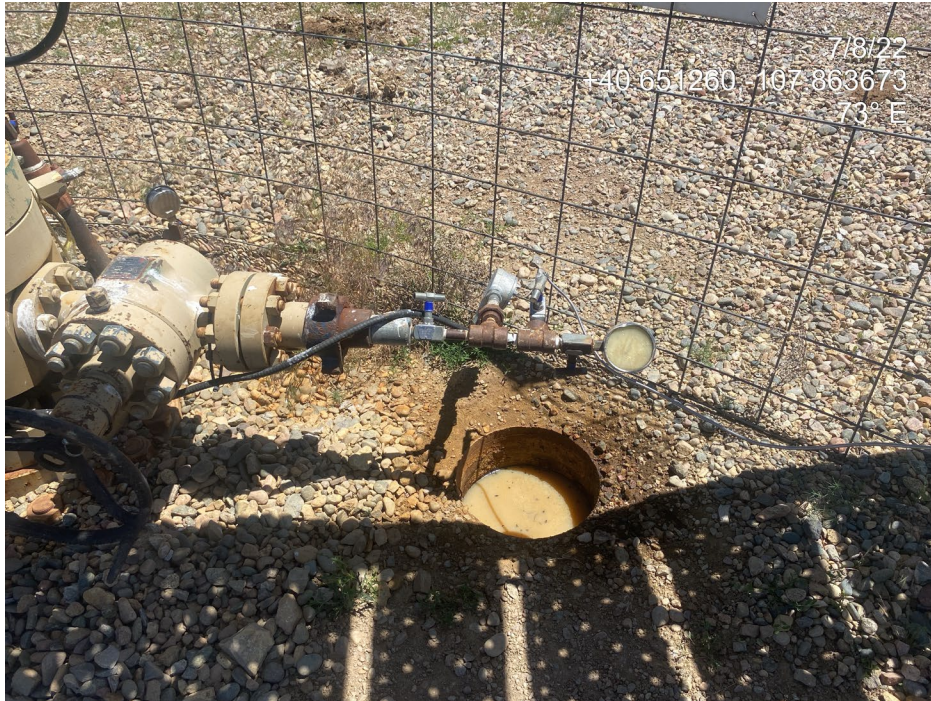
Photo 11. Photo shows an open pipe at the wellhead.

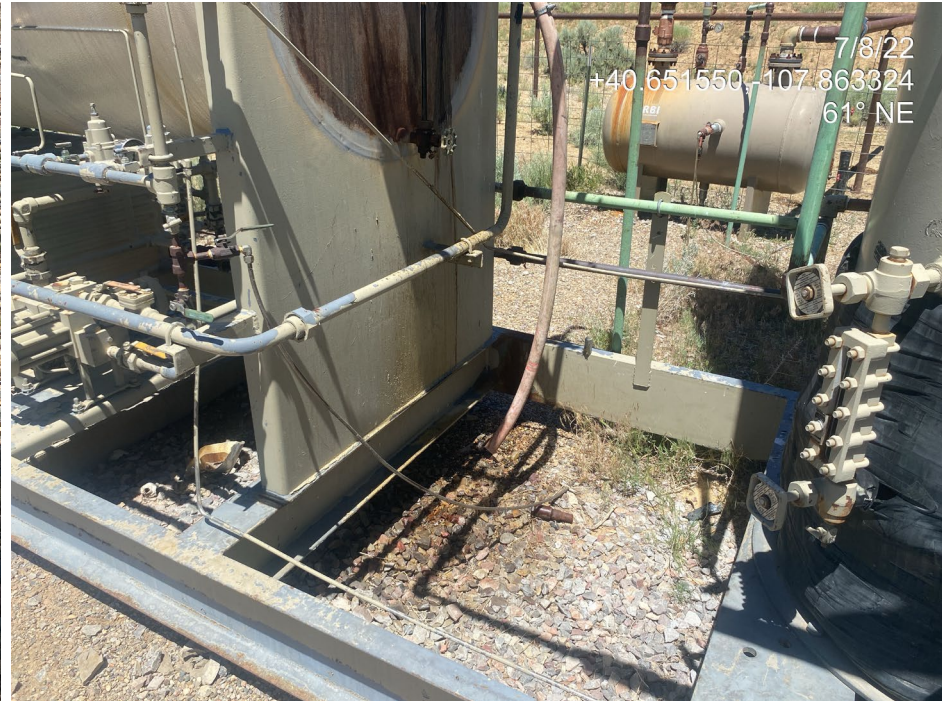
Photo 12. Photo taken at the north of the Location shows fluid dripping from separator equipment onto the ground.
