Inspection Photos

API: 071-09921

Operator: VECTA OIL & GAS LTD

Inspection Date: 7/15/2022

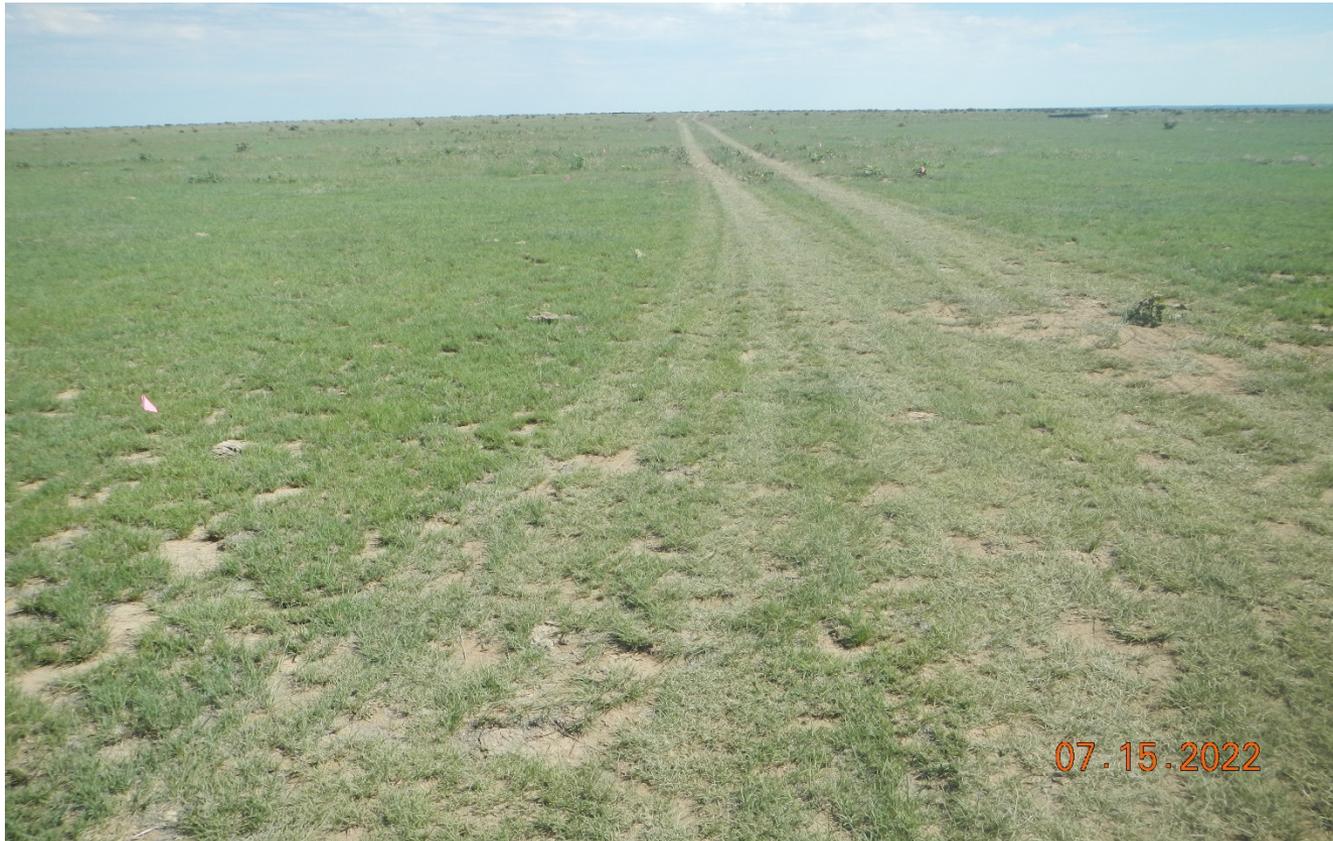
Photo 1. Facing east toward the access road.

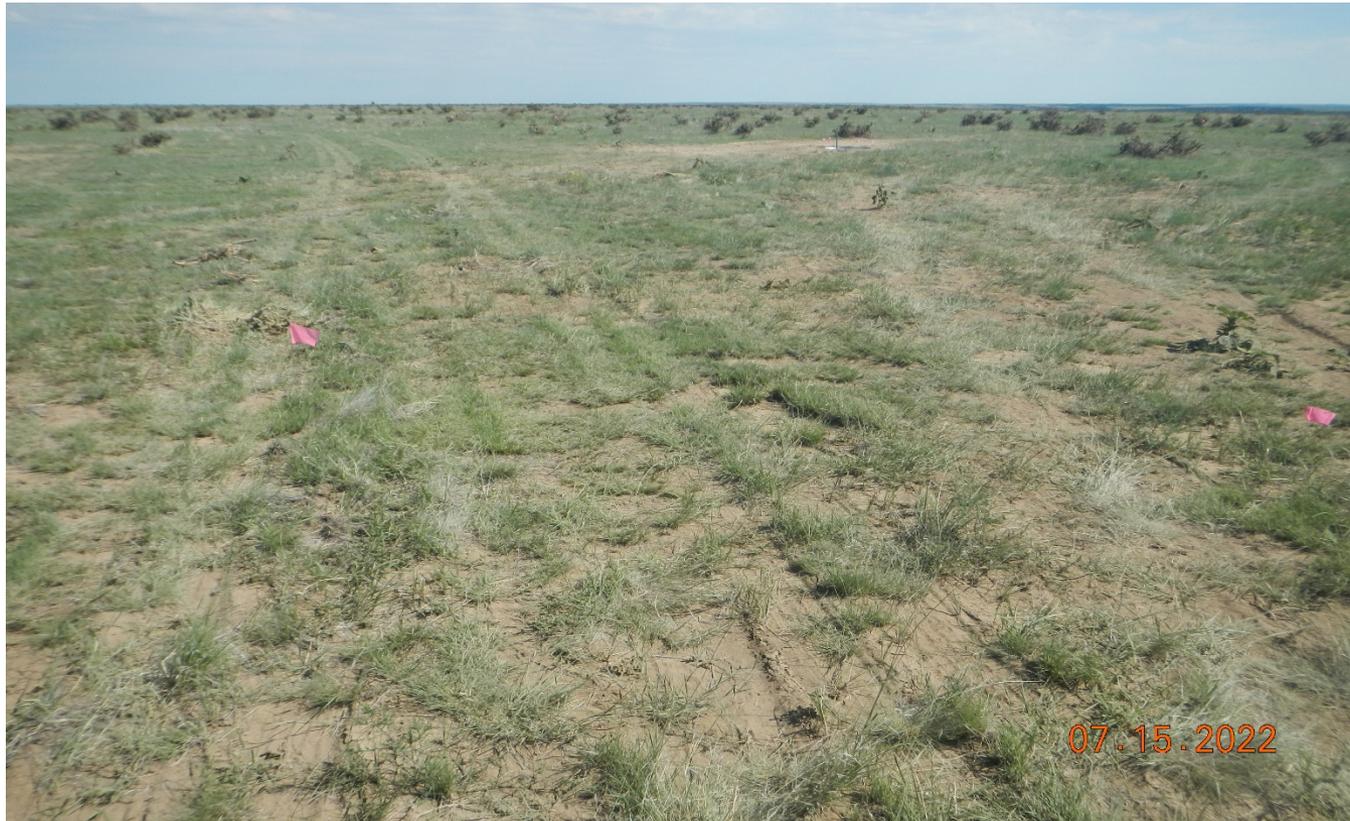
Photo 2. Facing north toward the location.

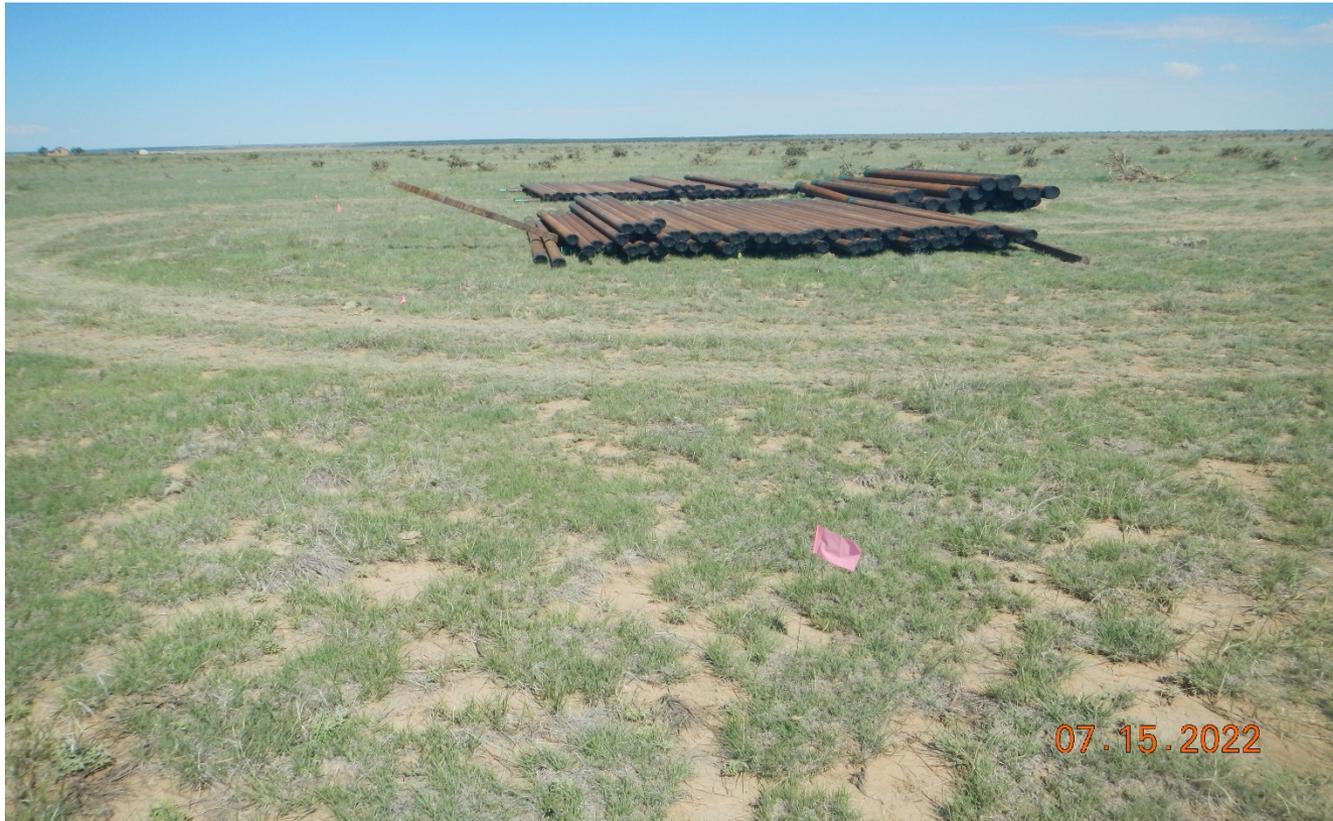
Photo 3. There is pipe stored on location in preparation of drilling.

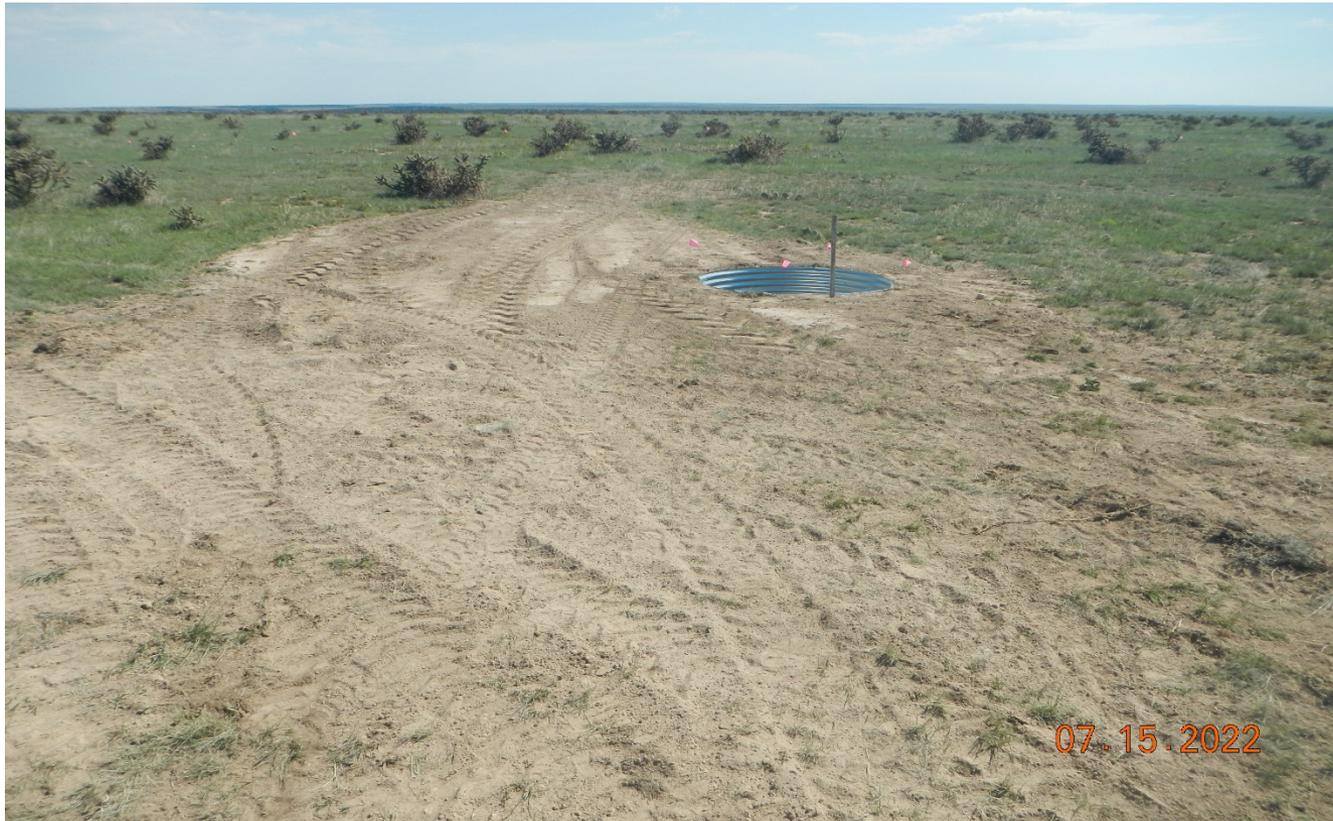
Photo 4. Facing northeast. A conductor has been set in preparation of drilling. The open culvert needs to be covered up to prevent wildlife or livestock entry.

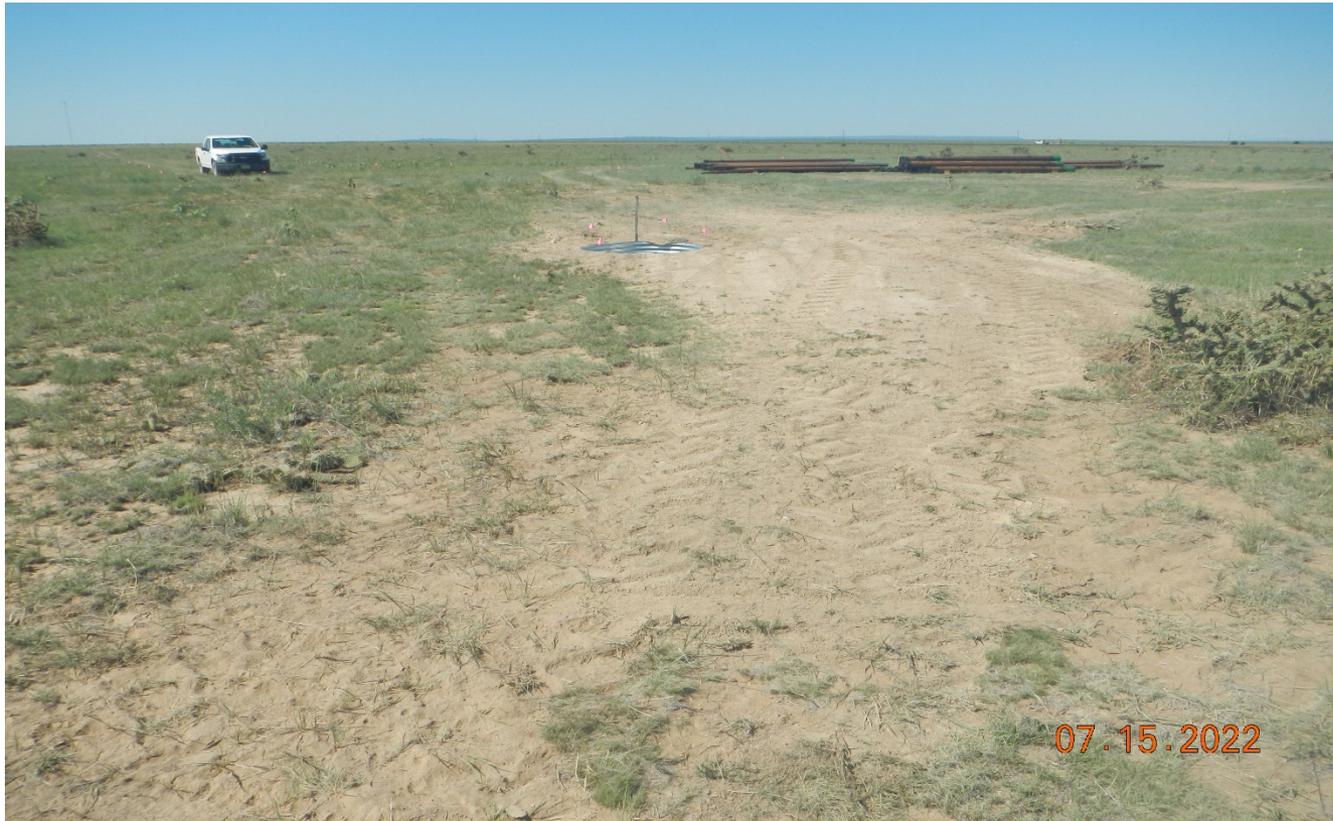
Photo 5. Facing southwest toward the location.
