## Dickens 44-14, 2

Document # 702500200

Date completed 7/21/2022

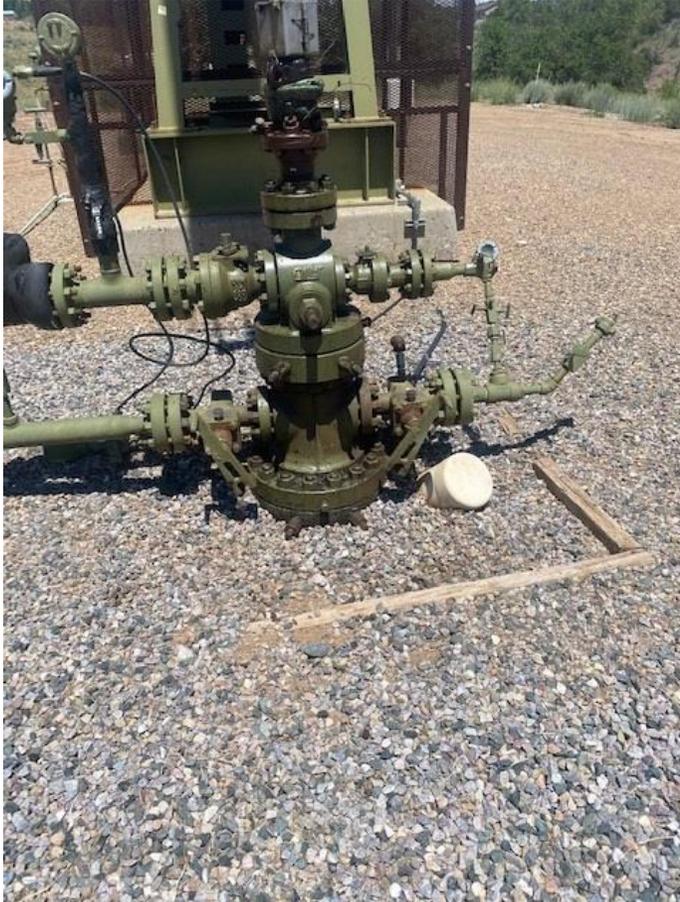
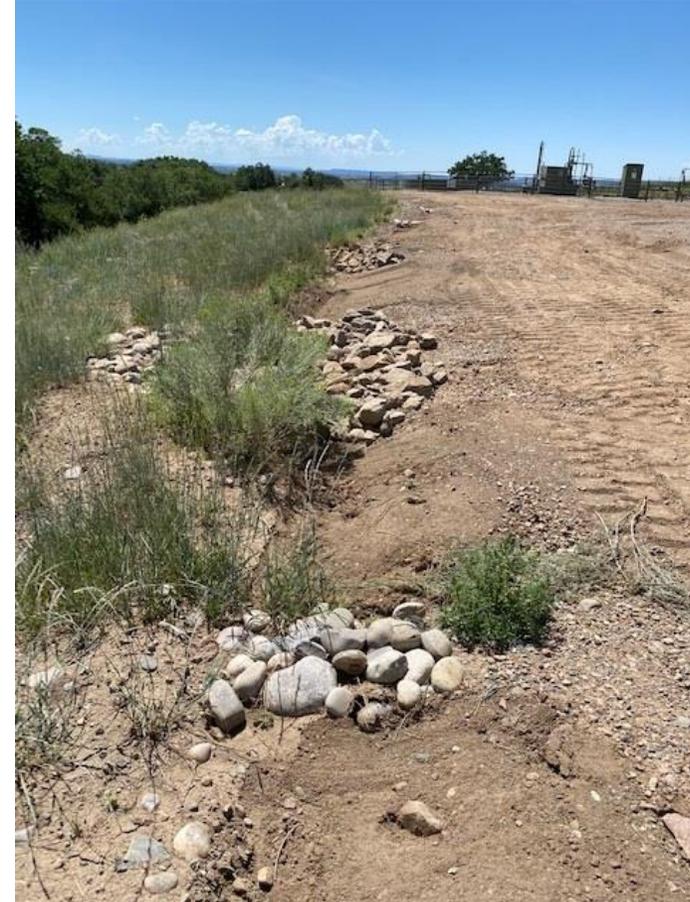
contaminated soil around wellhead cleaned up, tubing picked up

Erosion channels on edge of location repaired and rock runouts installed

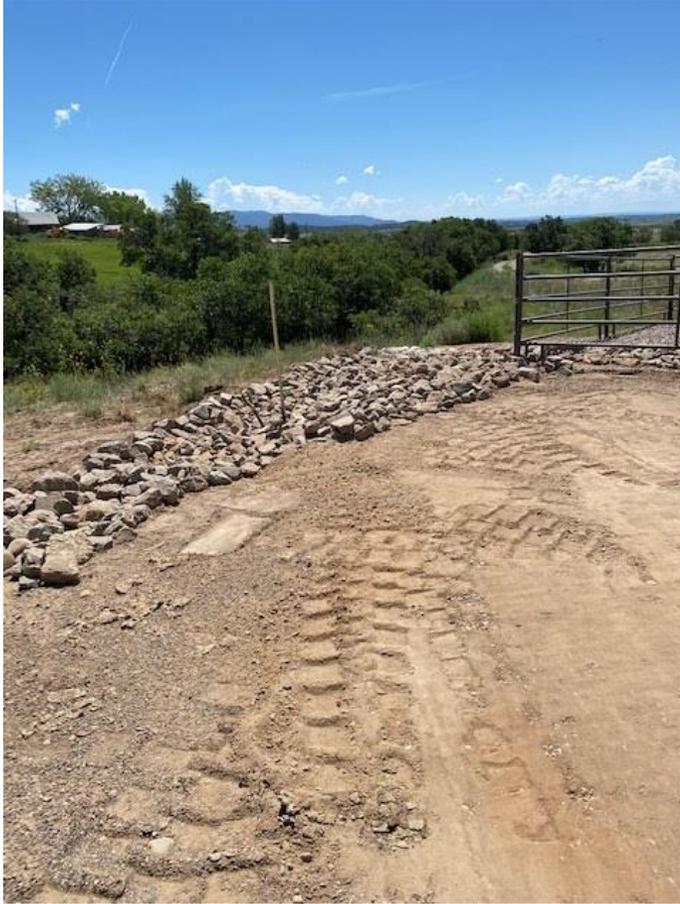
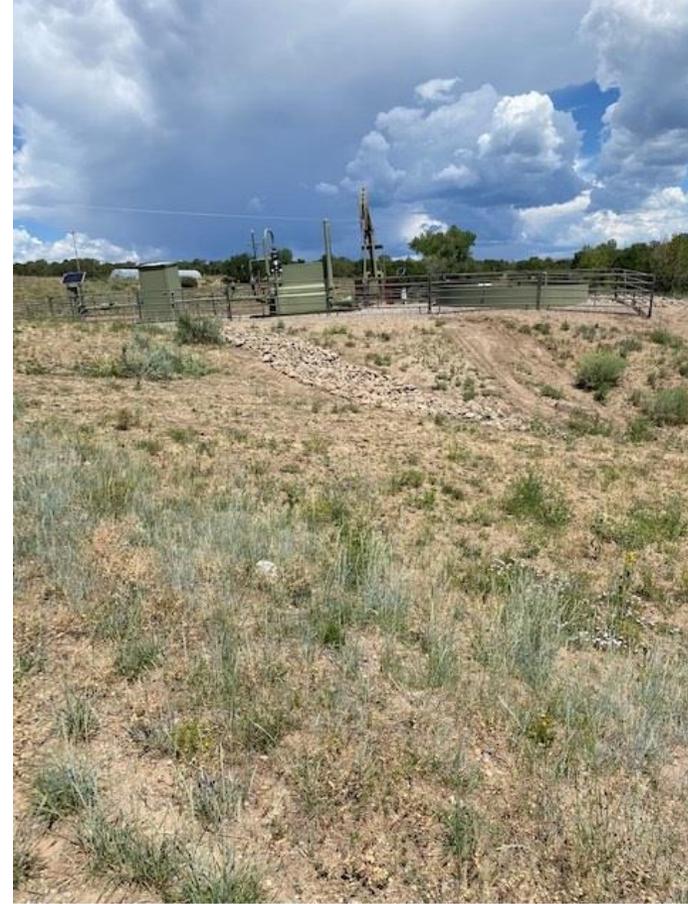
Erosion channels repaired and rock runouts installed
