Inspection Photos

API: 125-06706

Operator: PRIME OPERATING COMPANY

Inspection Date: 7/20/2022

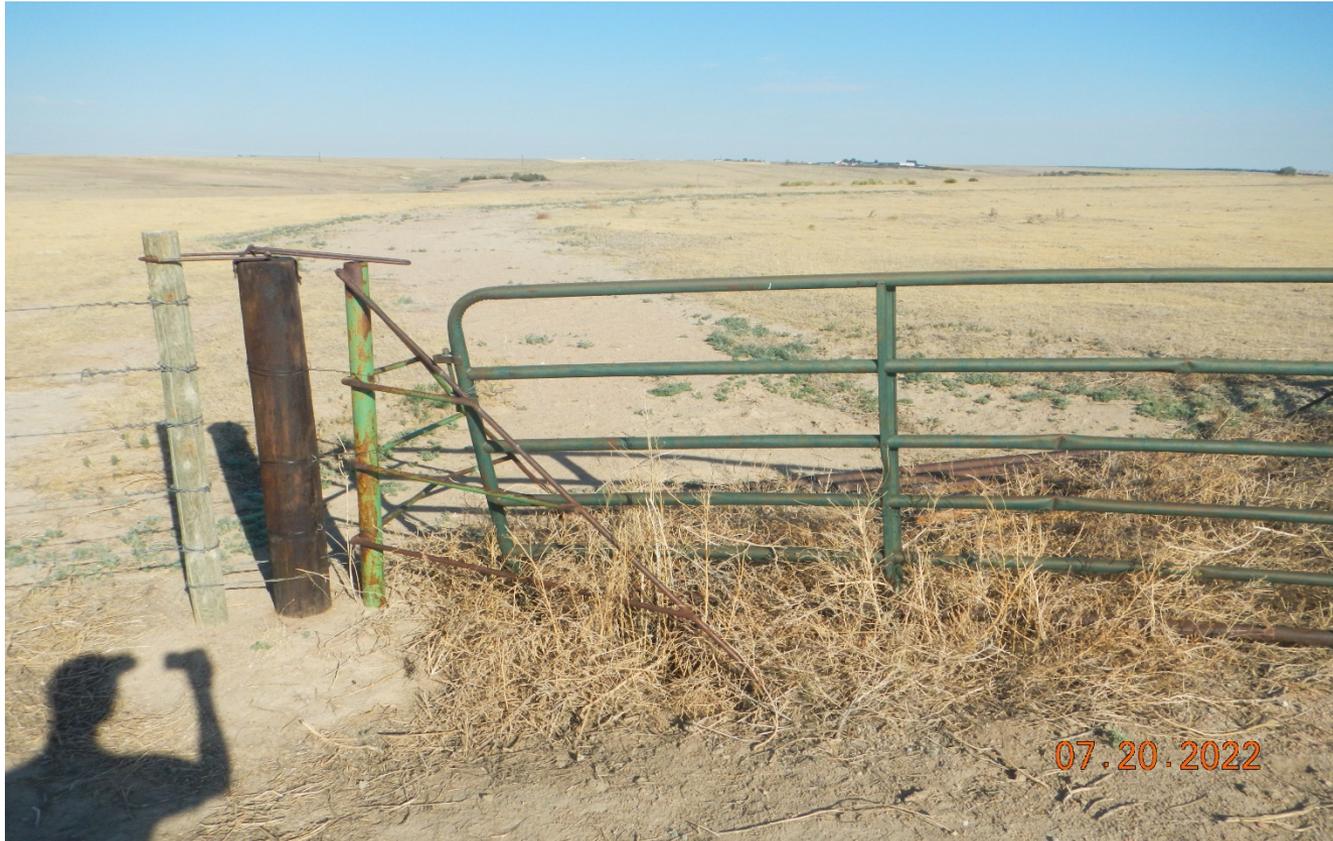
Photo 1. Facing east at the beginning of the access road. The cattle guard remains and the access road has not been reclaimed.

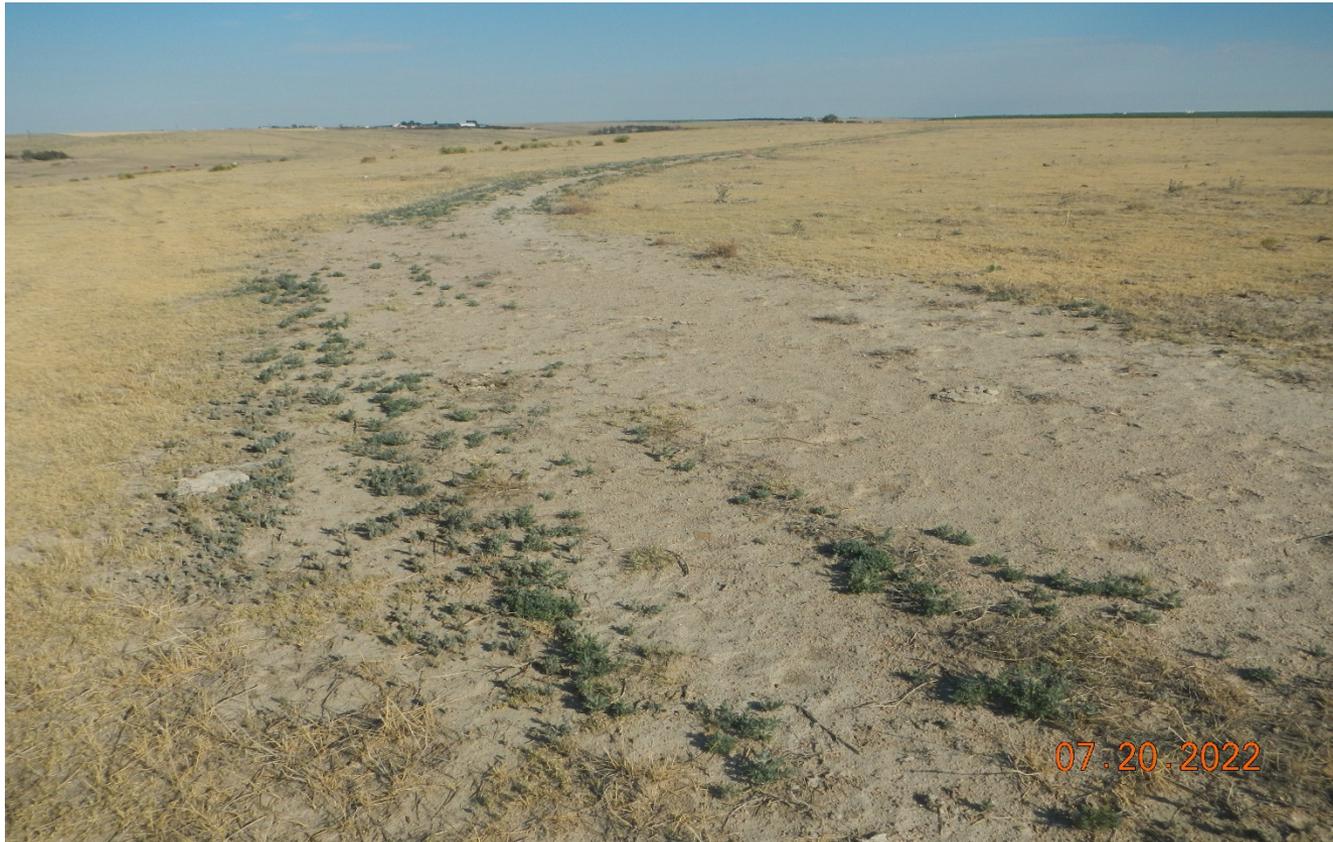
Photo 2. Facing northwest along the access road. The former road has not been reclaimed and soils are bare of vegetation.

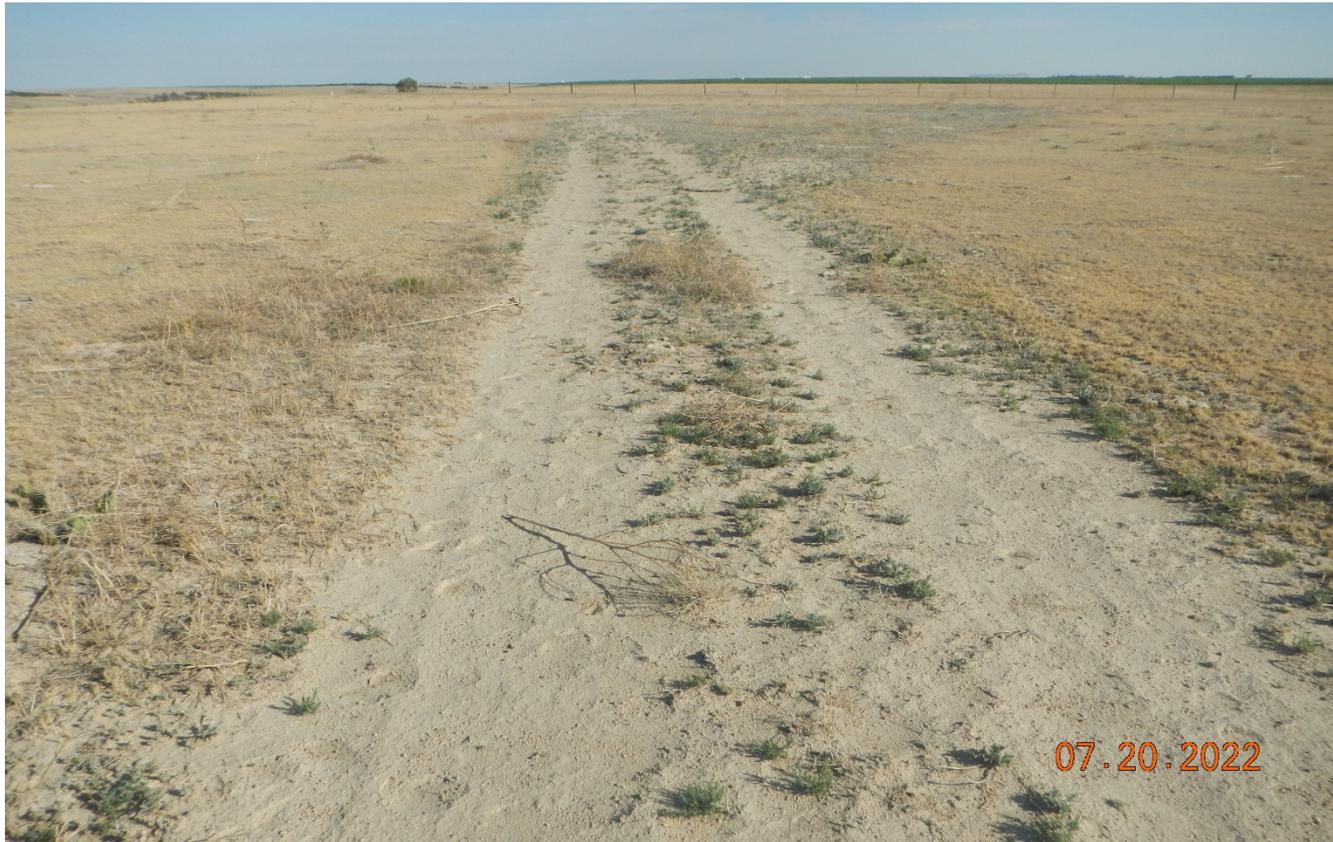
Photo 3. Facing north along the former road which dead ends at the well site location.

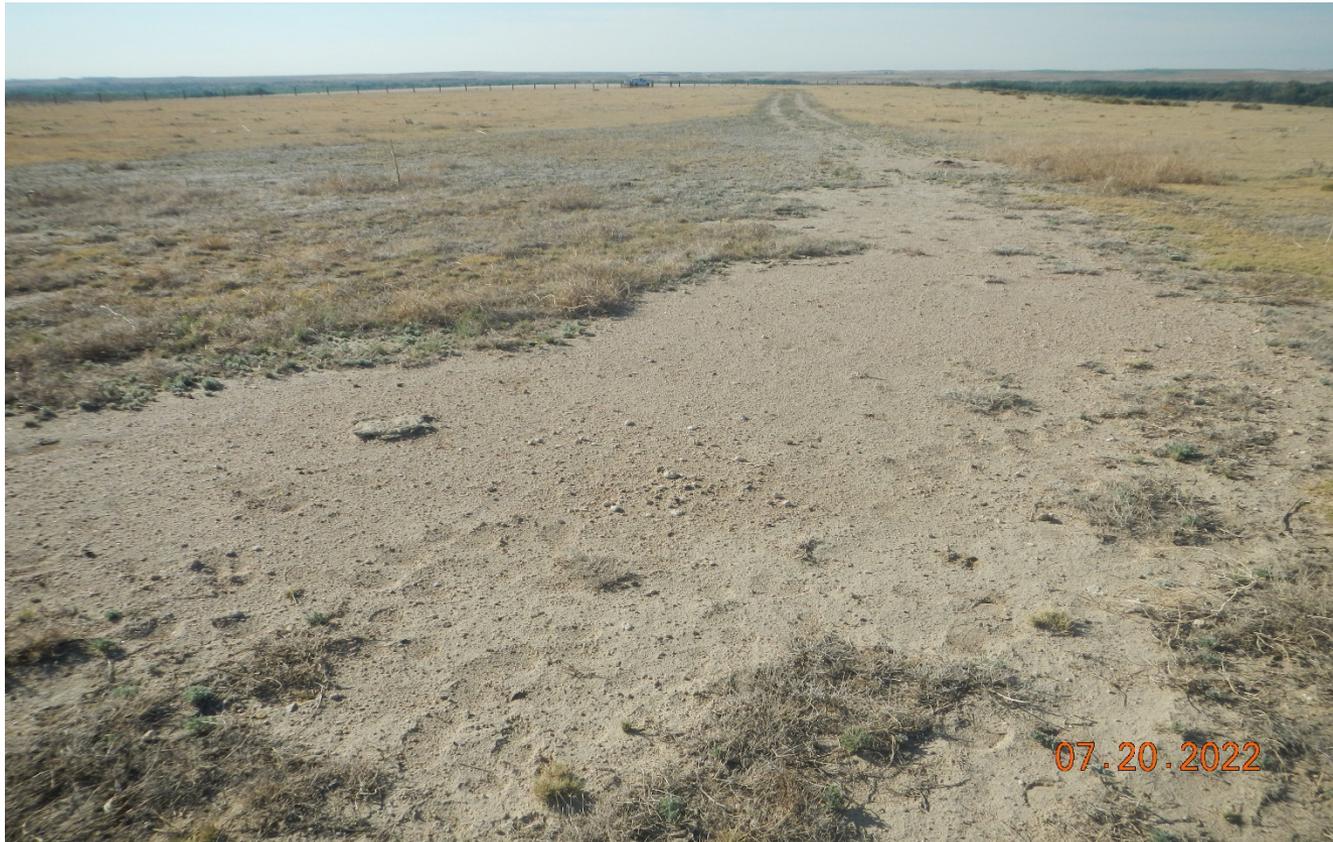
Photo 4. Facing south at the location. The location has not been reclaimed.

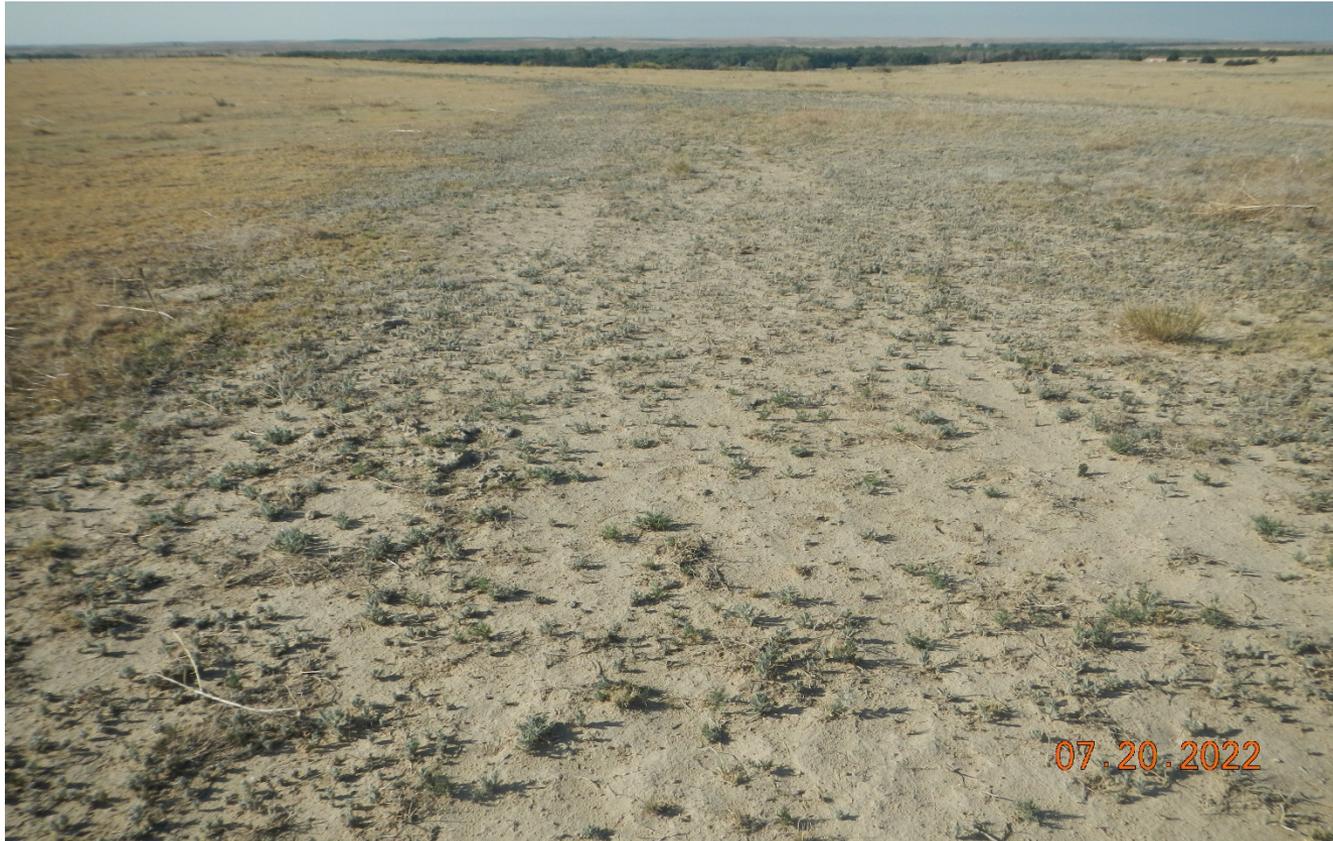
Photo 5. Facing southwest at the location. There are areas of sparse vegetation and undesirable weeds (Kochia).

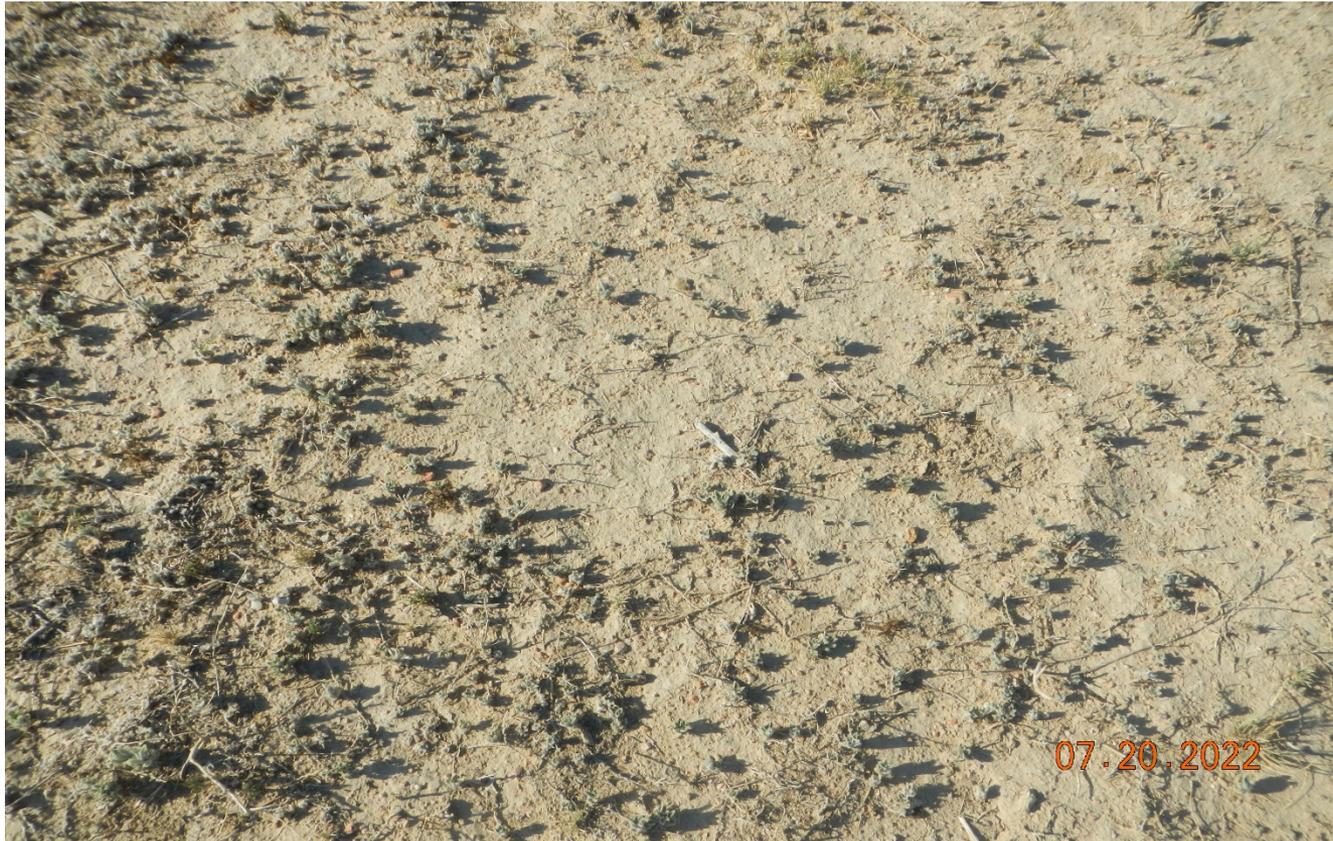
Photo 6. View of groundcover at the center of the location shows bare soils as well as undesirable weeds (Kochia).

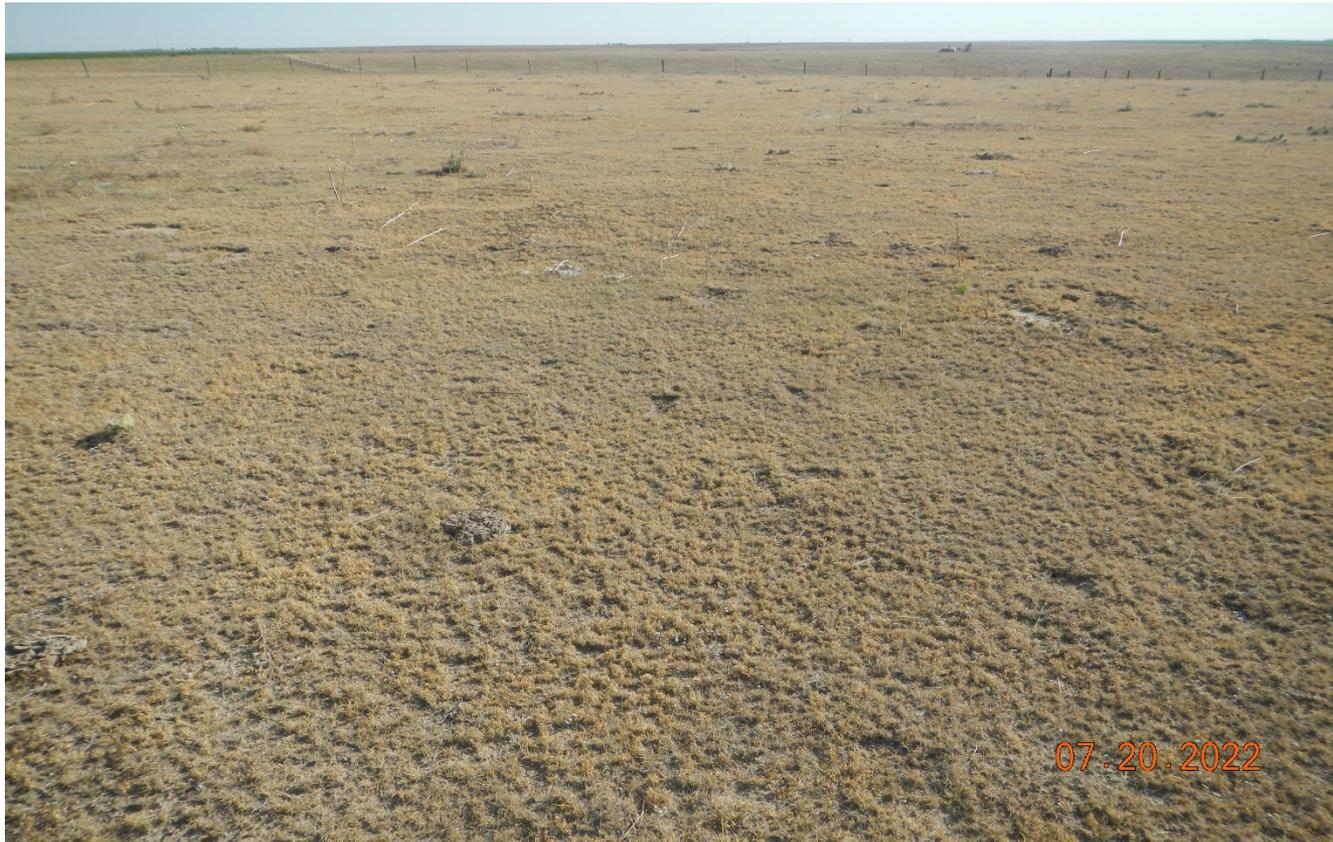
Photo 7. Facing north at the surrounding undisturbed Buffalo grass pasture.
