# Inspection Photos

API: 125-06704

Operator: PRIME OPERATING COMPANY

Inspection Date: 7/20/2022

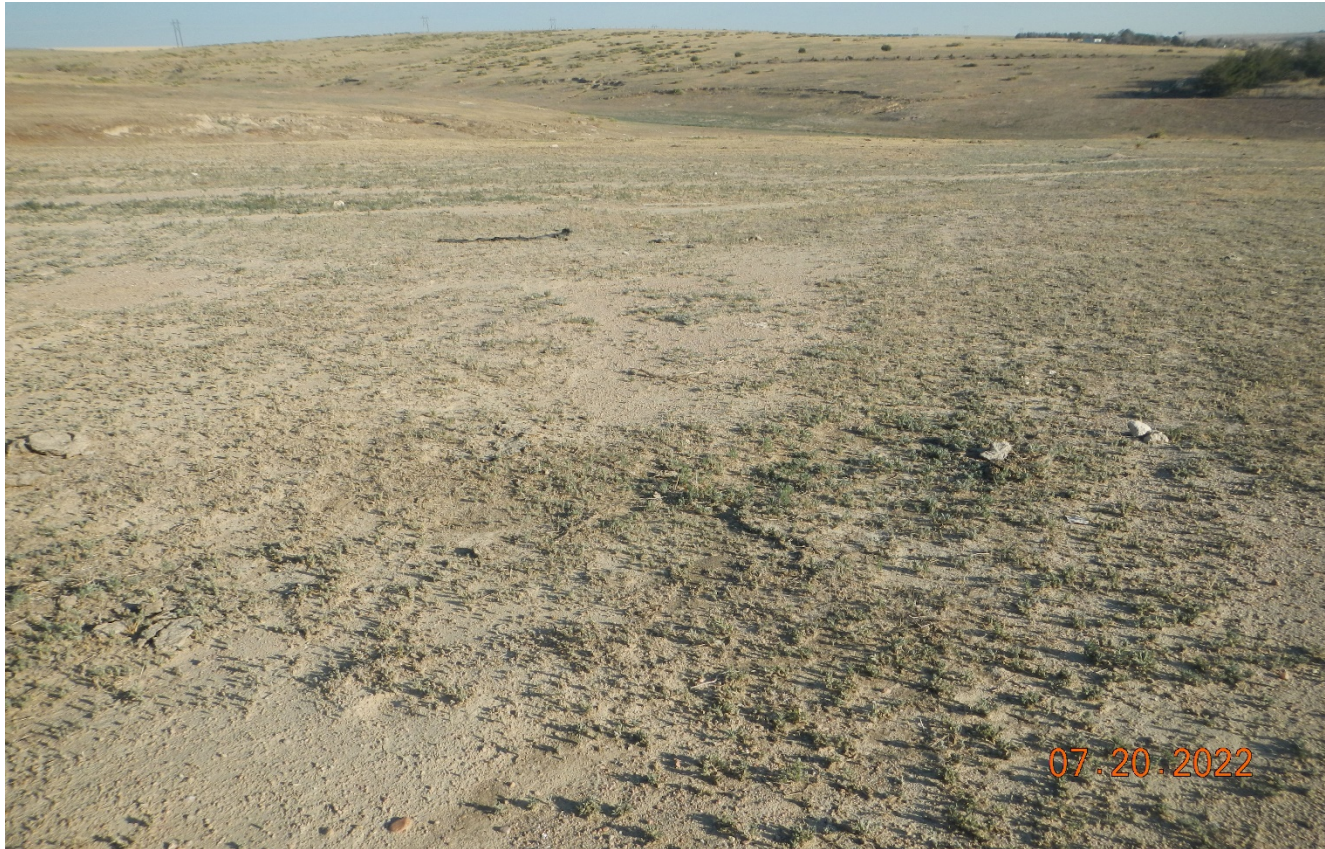
**Photo 1.** Facing northwest toward the location.. The location has not established desirable vegetation cover of at least 80% of reference area levels.

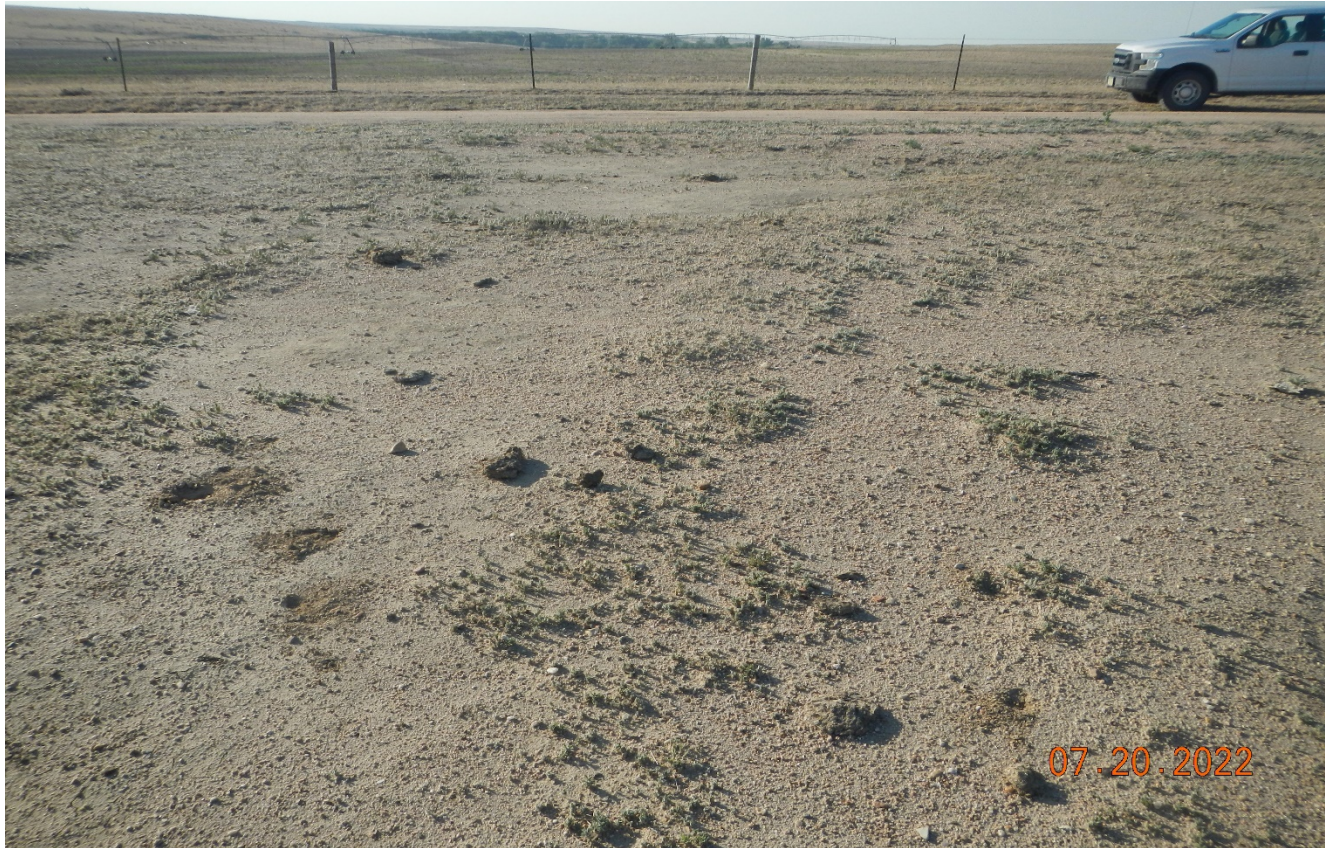
**Photo 2.** Center of the location facing southeast. The location has not established desirable vegetation cover of at least 80% of reference area levels.

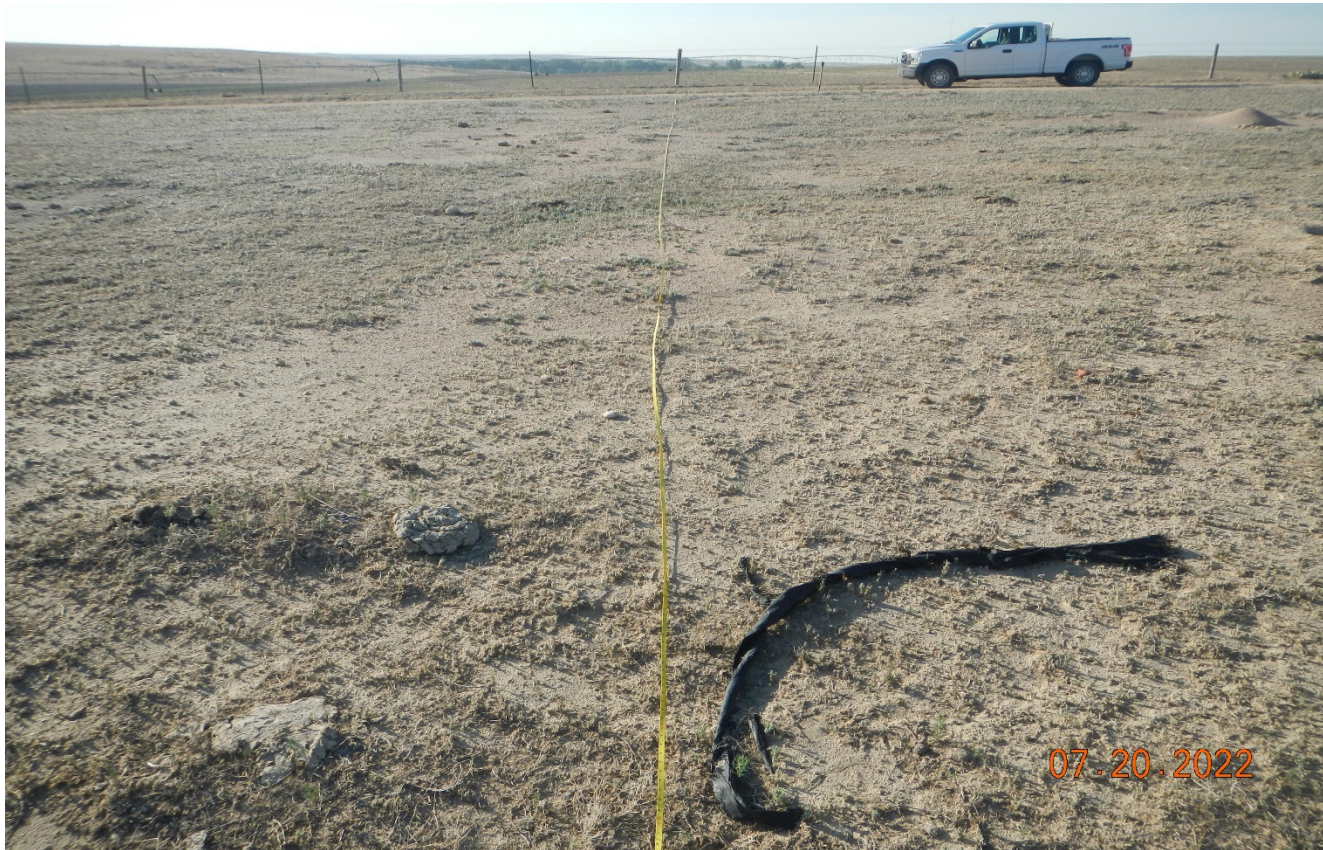
**Photo 3.** Facing southeast at the location. A 100 ft. tape measure is placed across the location for scale. This area does not have sufficient vegetation establishment and consists of undesirable weeds (Kochia). There is a piece of silt fence debris shown in the photo.

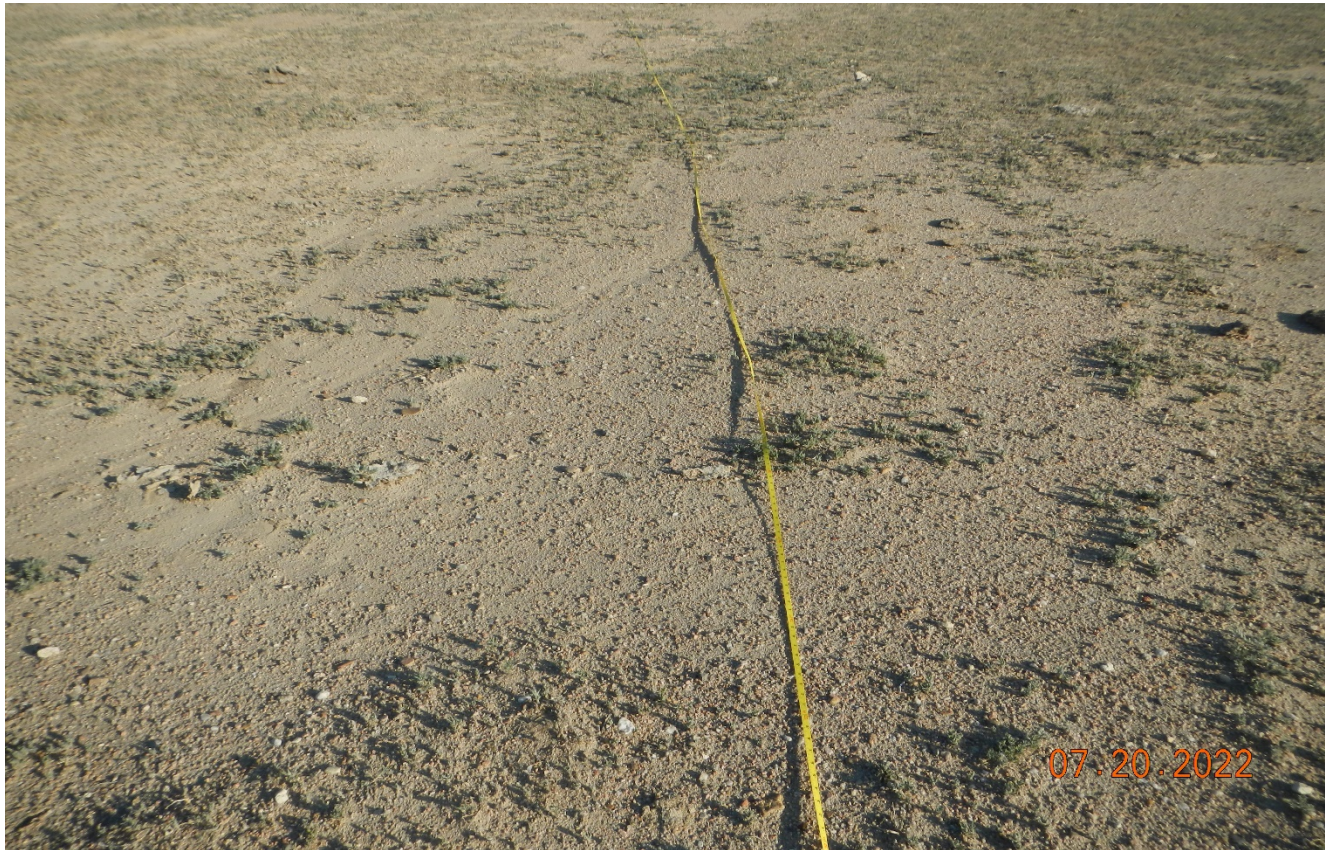
**Photo 4.** View of groundcover at the center of the location shows bare soils as well as undesirable weeds (Kochia).

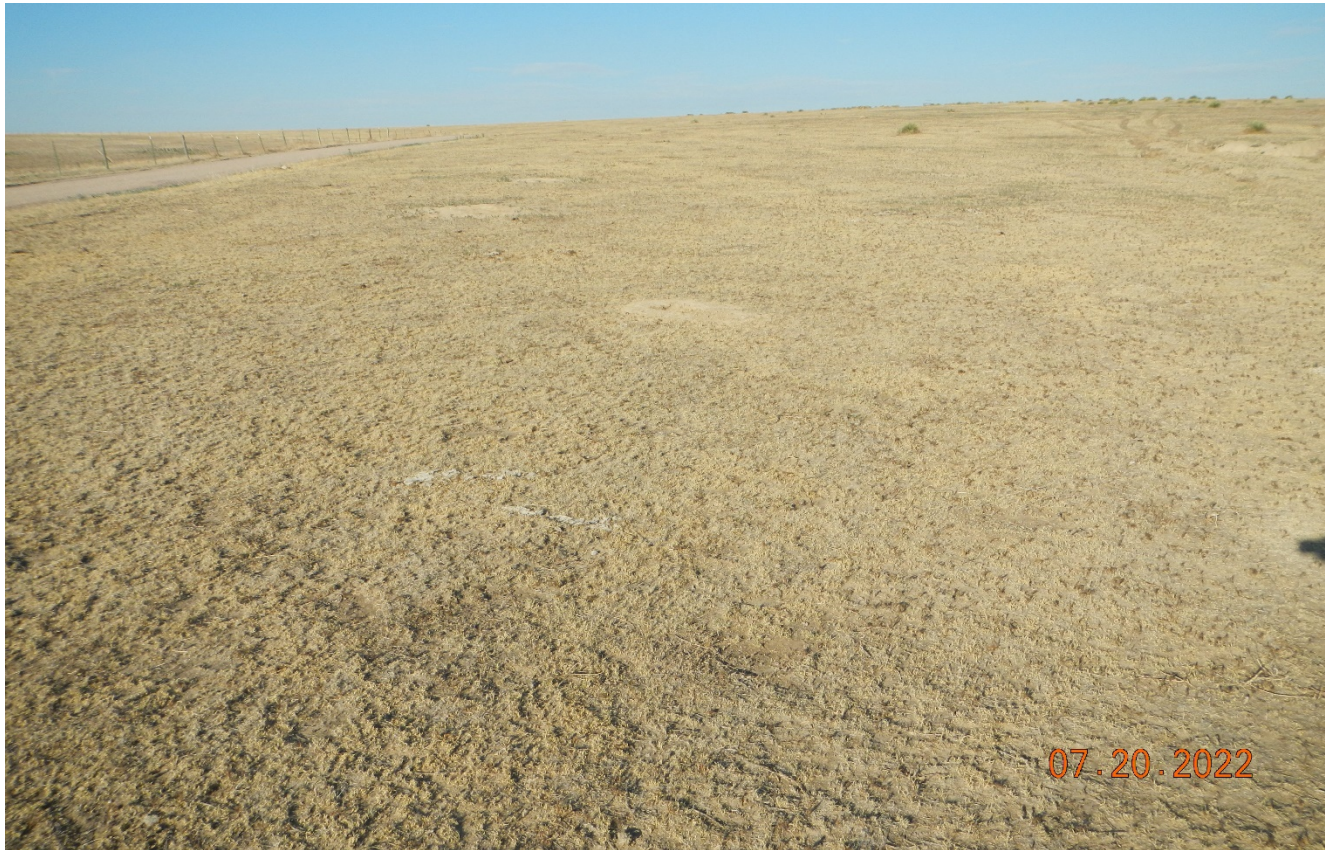
**Photo 5.** Facing southwest at the surrounding undisturbed Buffalo grass pasture.
