Inspection Photos

API: 125-09762

Operator: ENERGY QUEST II LLC

Inspection Date: 7/20/2022

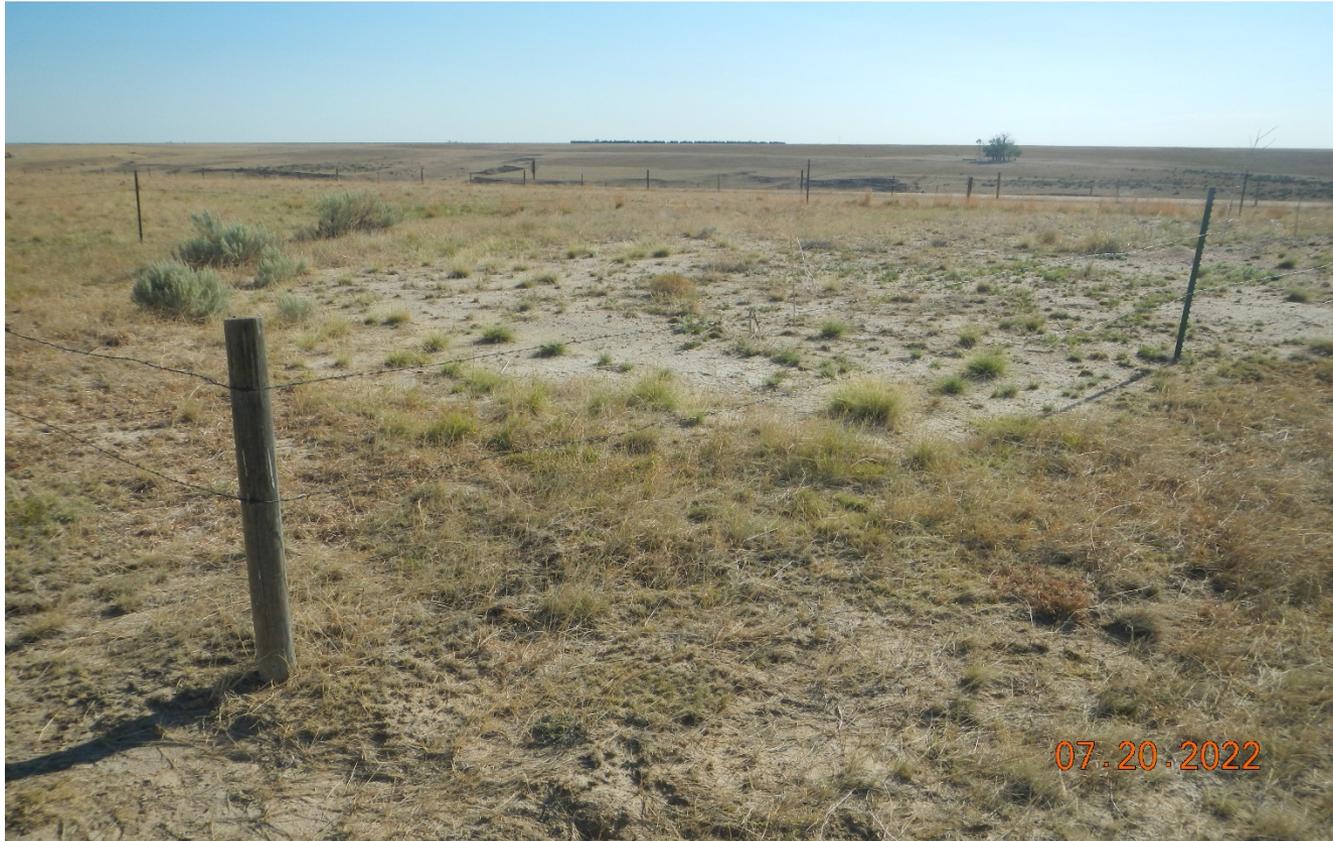
Photo 1. There is a fence that remains at the associated facility located by the County Road. Lat/Long:39.64564,-102.27091
The vegetation has not re-established in this area.

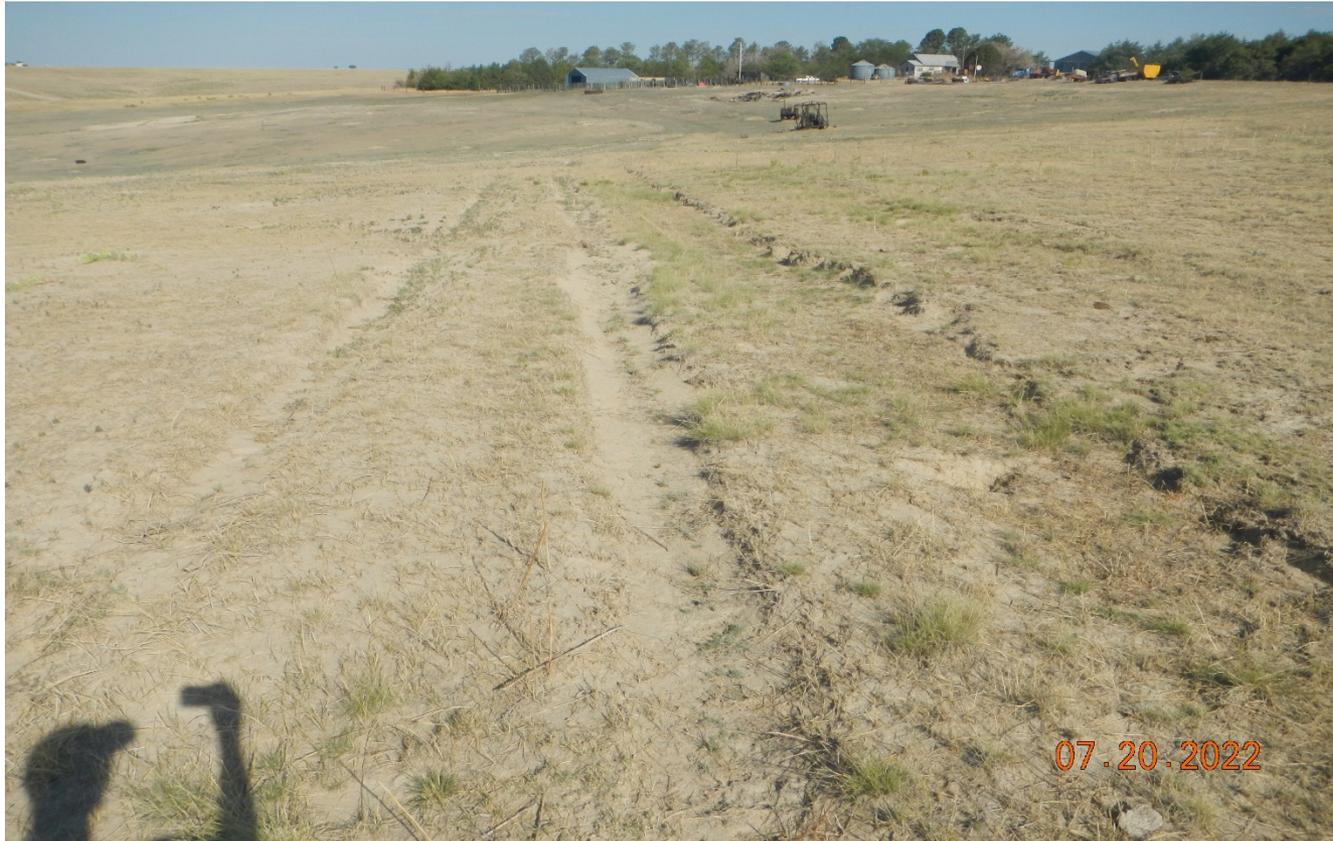
Photo 2. Facing northwest along the former road. There is erosion along the two track road which has not been reclaimed.

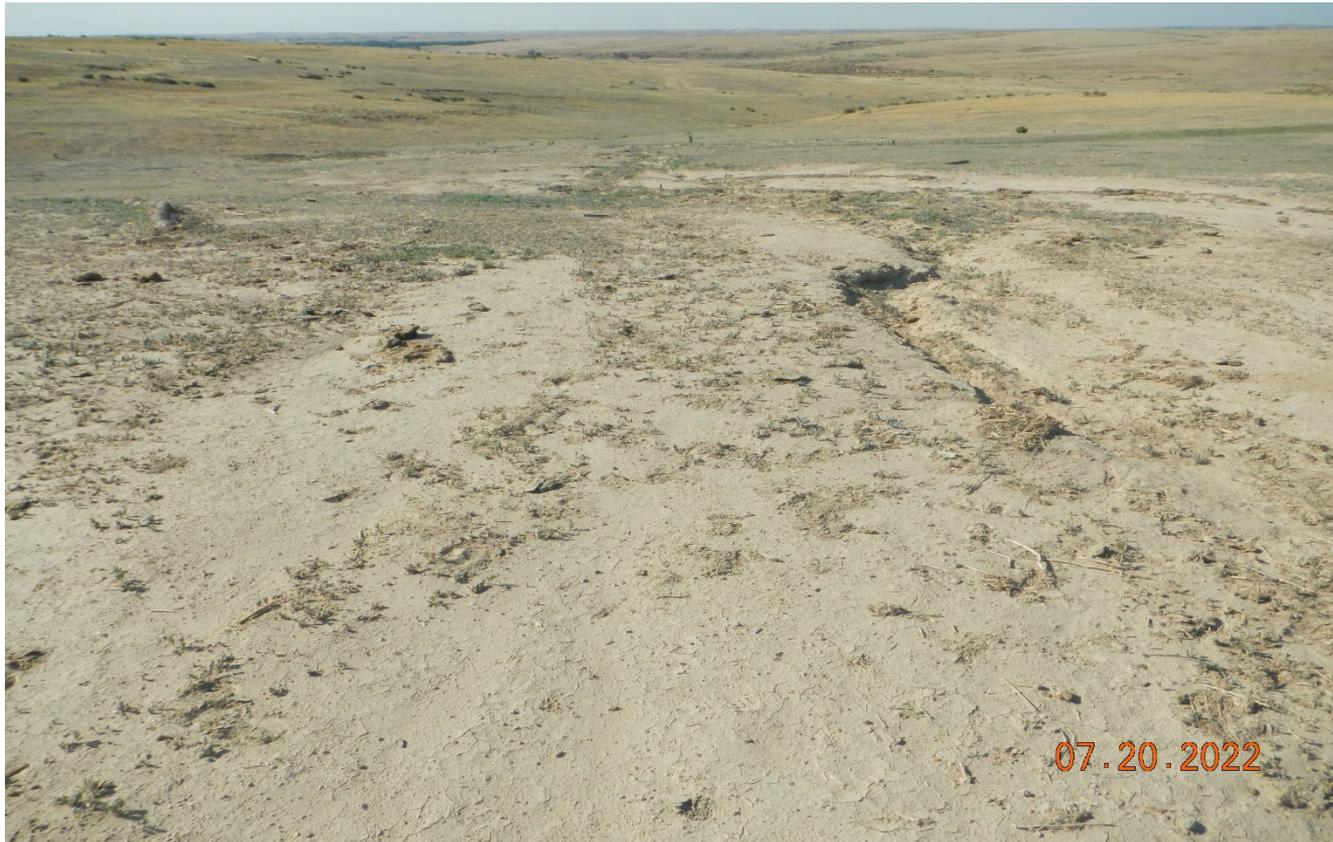
Photo 3. Facing southwest toward the location. The location has not been reclaimed. The location is not stabilized and there are signs of erosion.

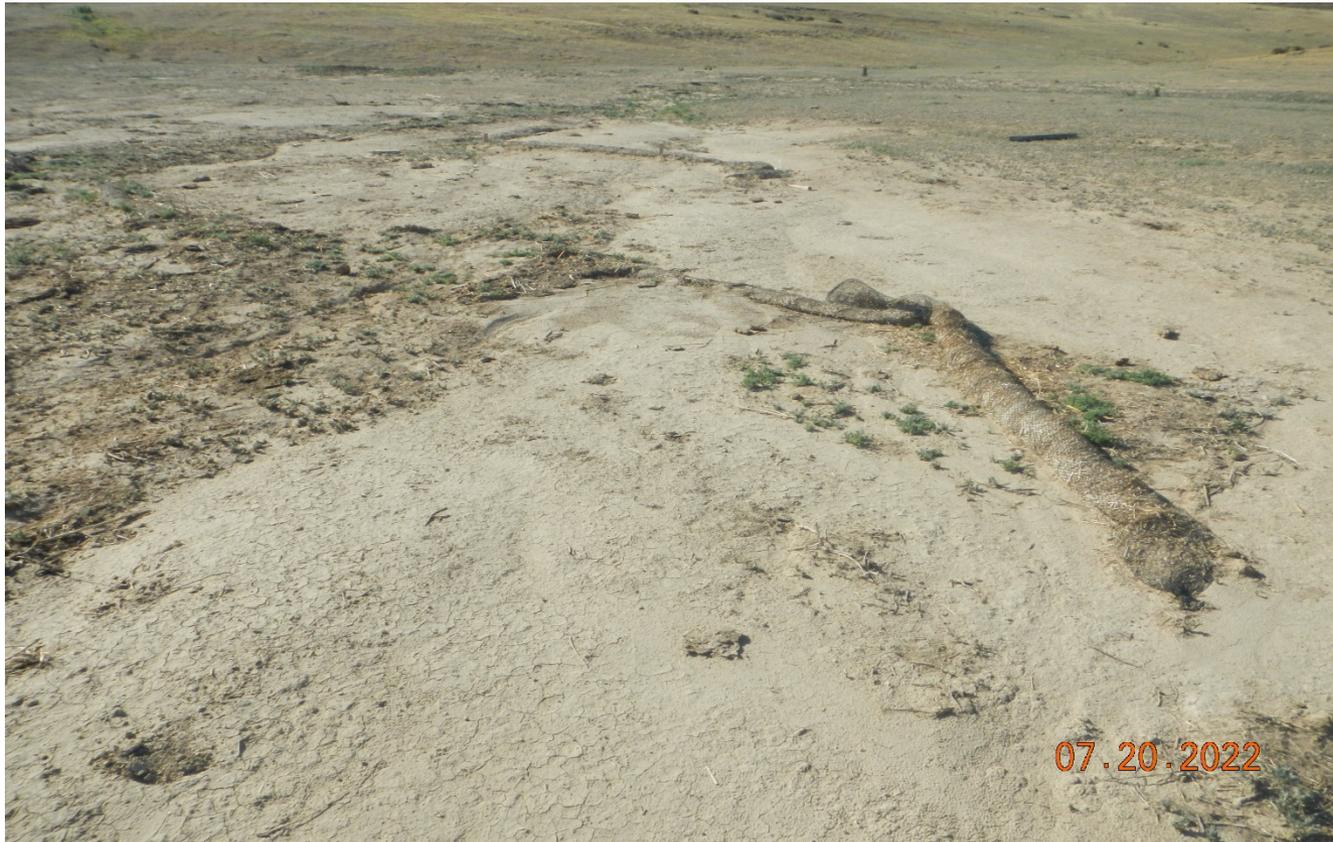
Photo 4. There are degraded and displaced wattles that are now debris. BMP's must be installed and maintained.

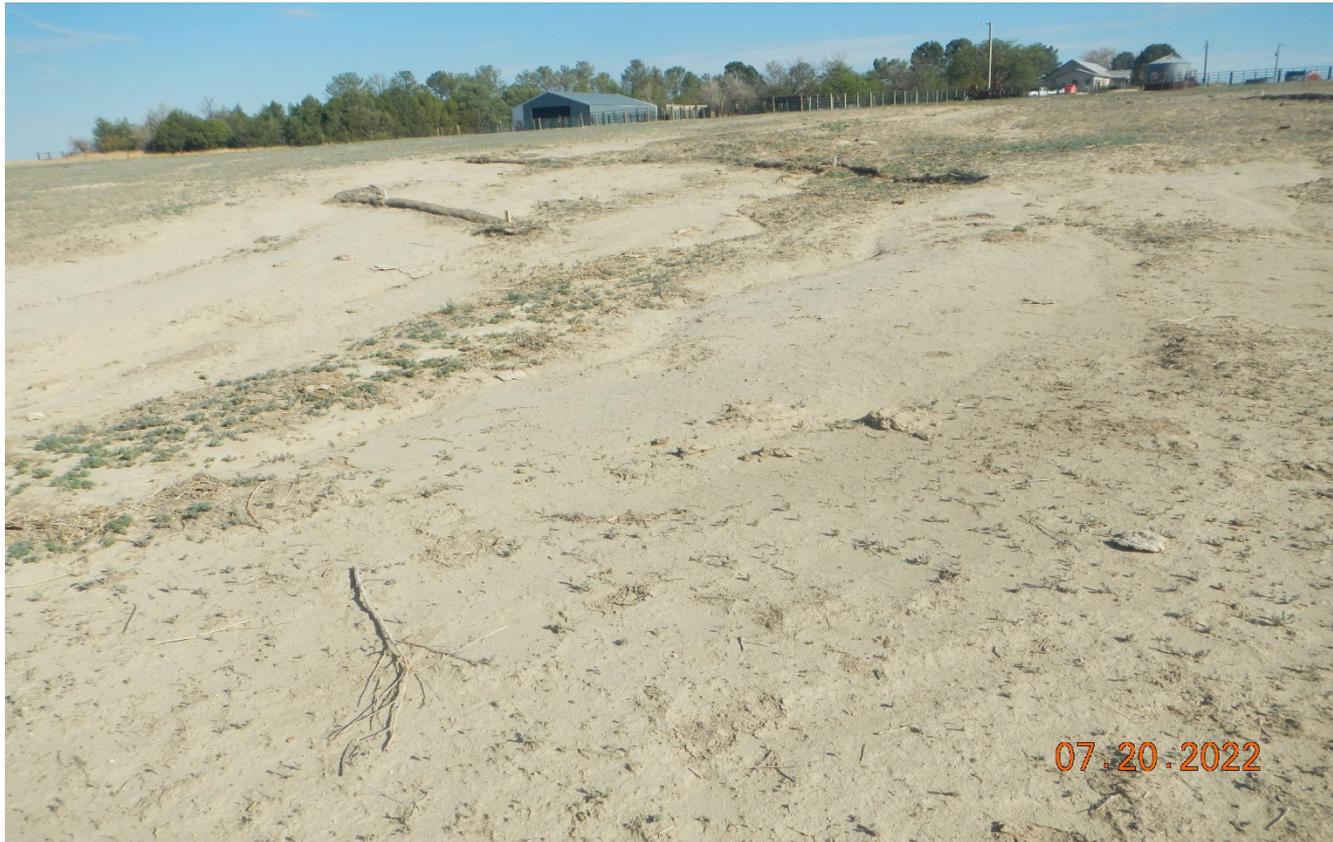
Photo 5. Facing northwest at the location. There are signs of erosion and soils are not stabilized. BMP's must be installed and maintained.

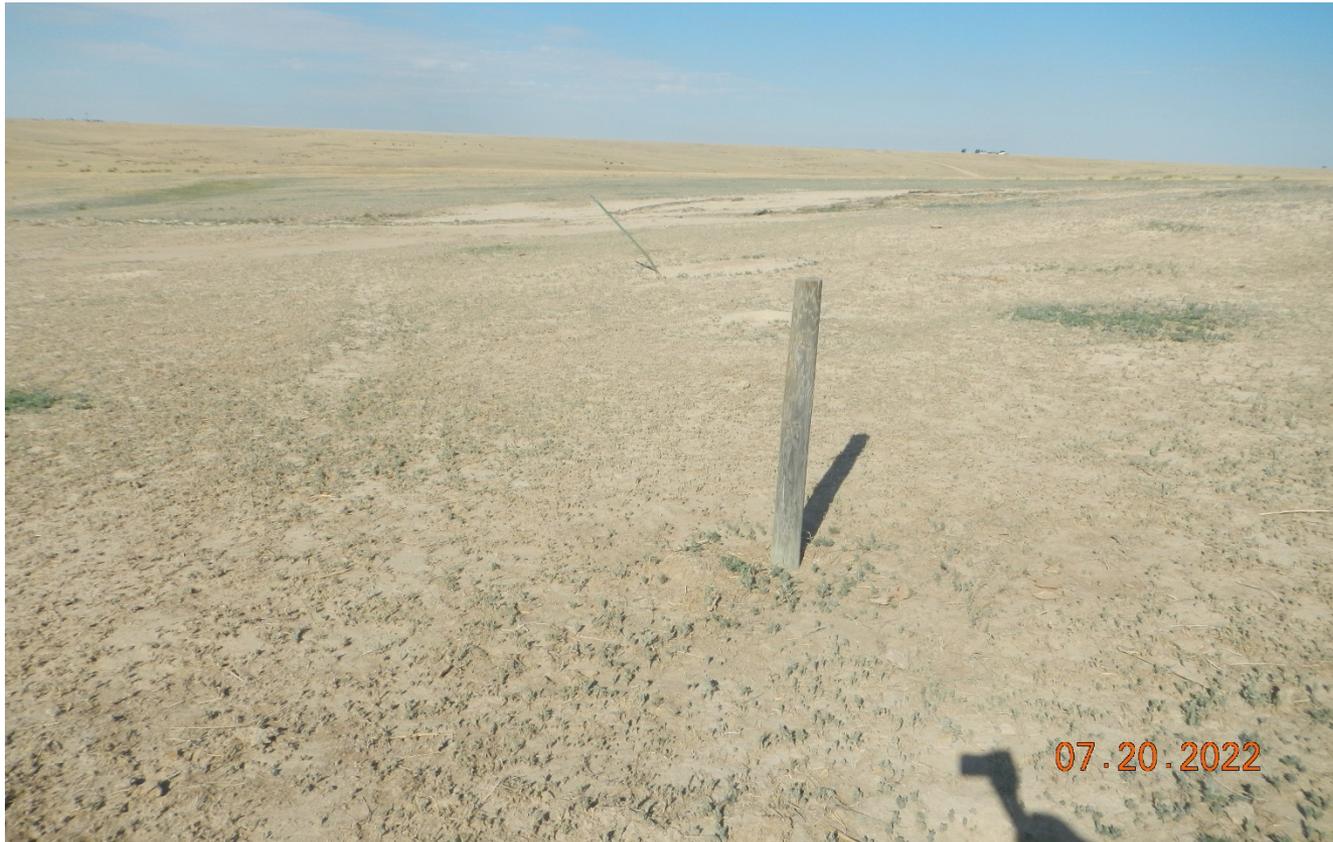
Photo 6. Facing west at the location. There is a t-post and wood post that must be removed.
