# Inspection Photos

Operator: Beeman Oil & Gas Inc - #7125

Location Name: Welker 6-92 /1-2H11

Inspection Document #: 702800491

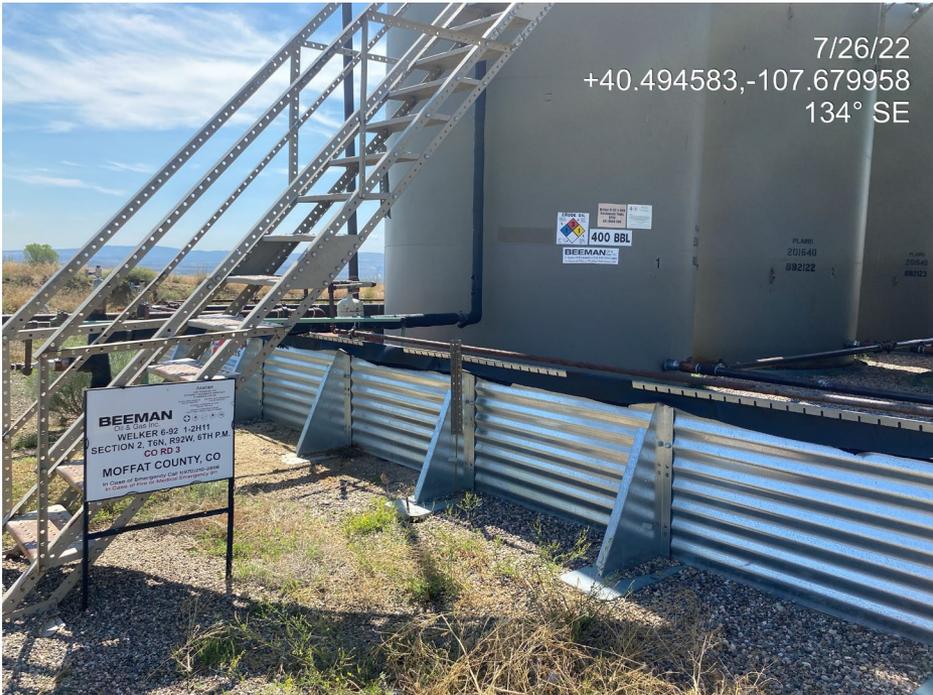
**Photo 1.** Photo taken from the tank battery shows Beeman Oil & Gas Inc. as the Operator listed on tanks and tank battery signage.

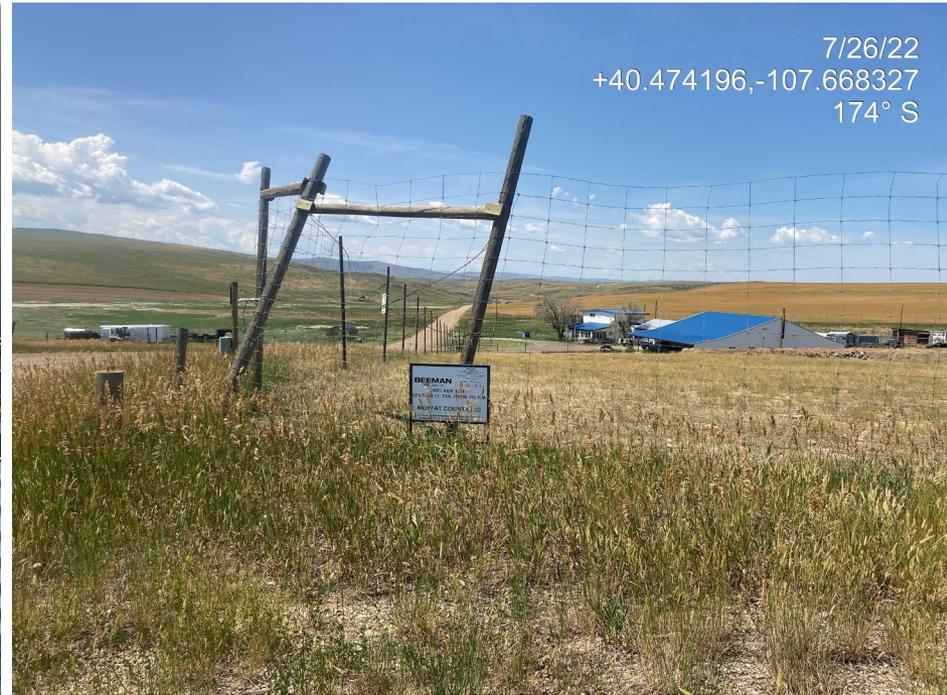
**Photo 2.** Photo taken from the Location access road shows Beeman Oil & Gas Inc. as the Operator listed on signage.

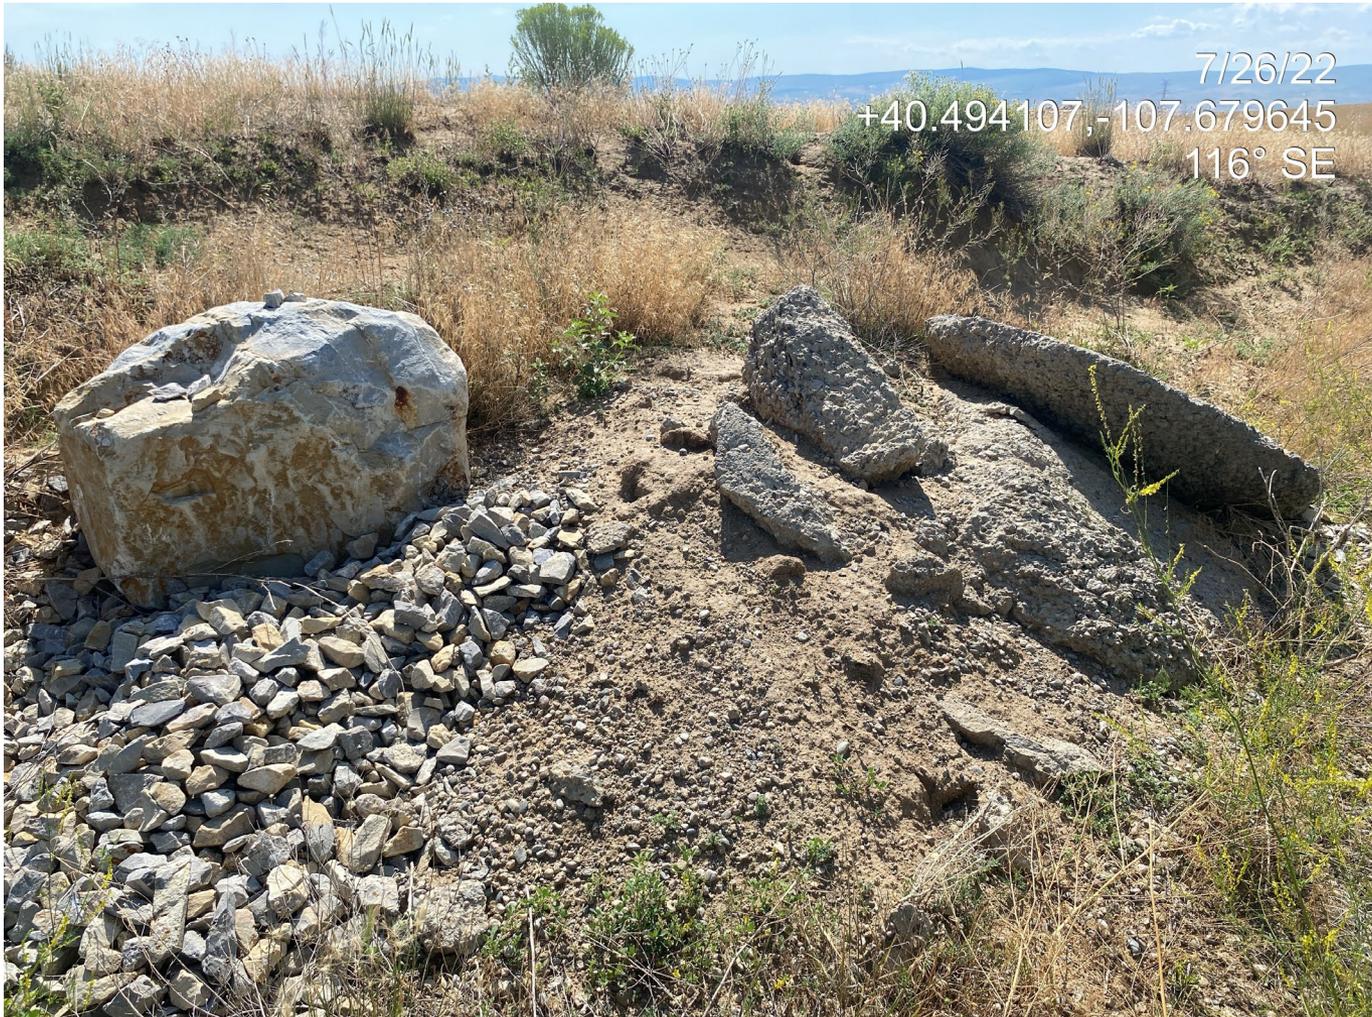
**Photo 3.** Photo taken from the east of the Location shows concrete debris.

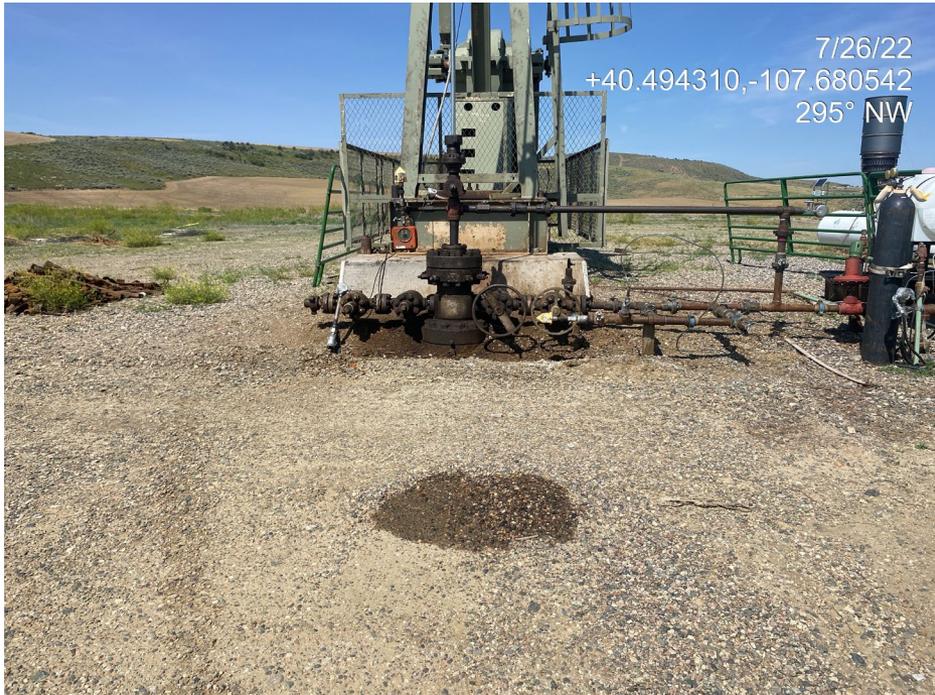
**Photo 4.** Photo taken from the wellhead shows stained soils.

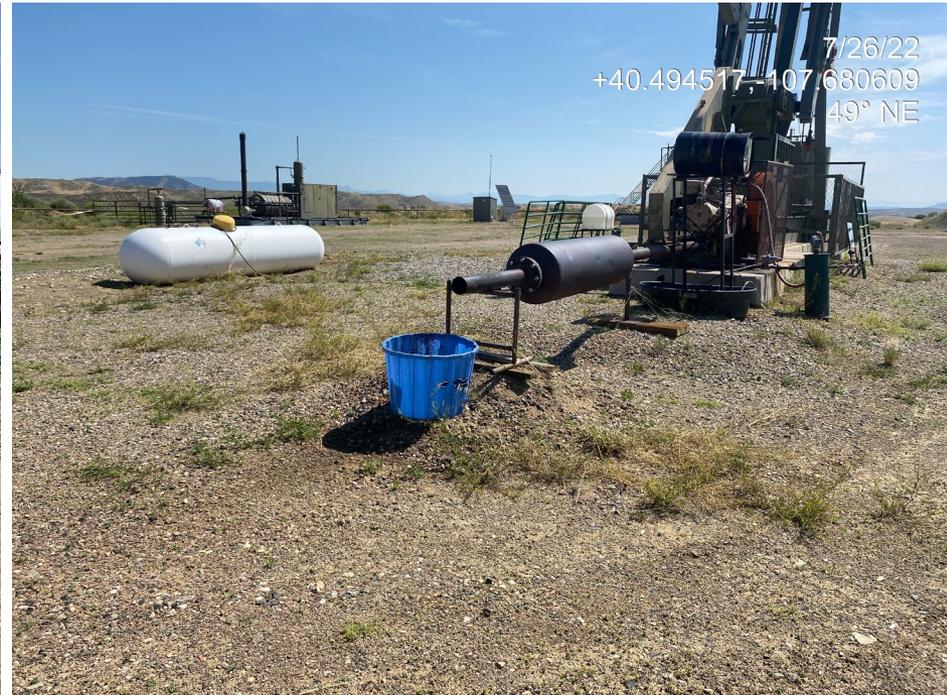
**Photo 5.** Photo taken from the west of the pumpjack shows stained soils.

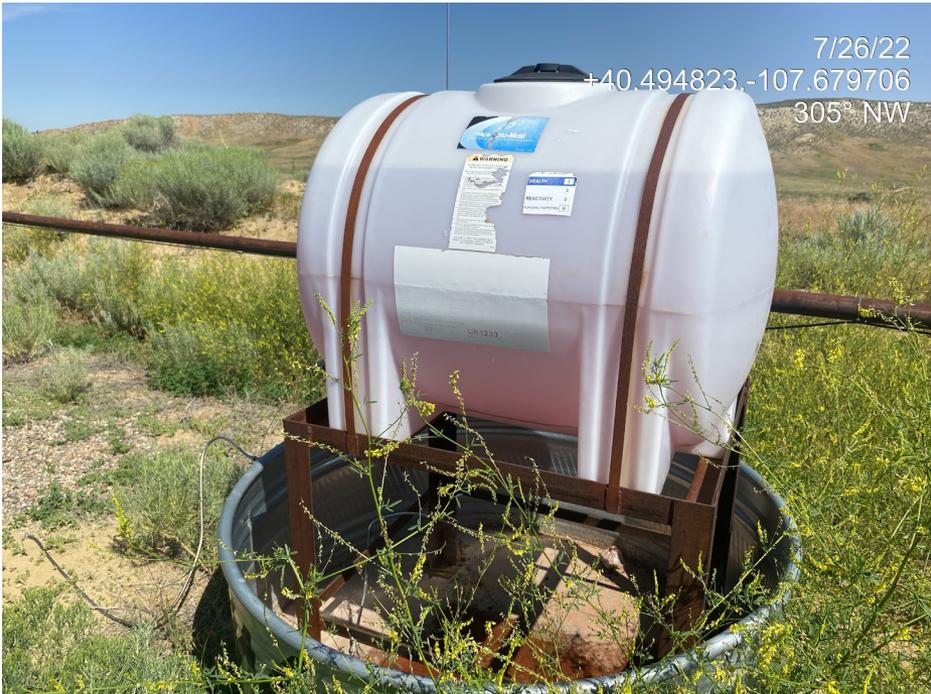
**Photo 6.** Photo taken from the north of the Location shows a methanol tank. The secondary containment stock tank lacks wildlife protection BMPs. Safety labeling on the tank is faded and/or peeling and inadequate.

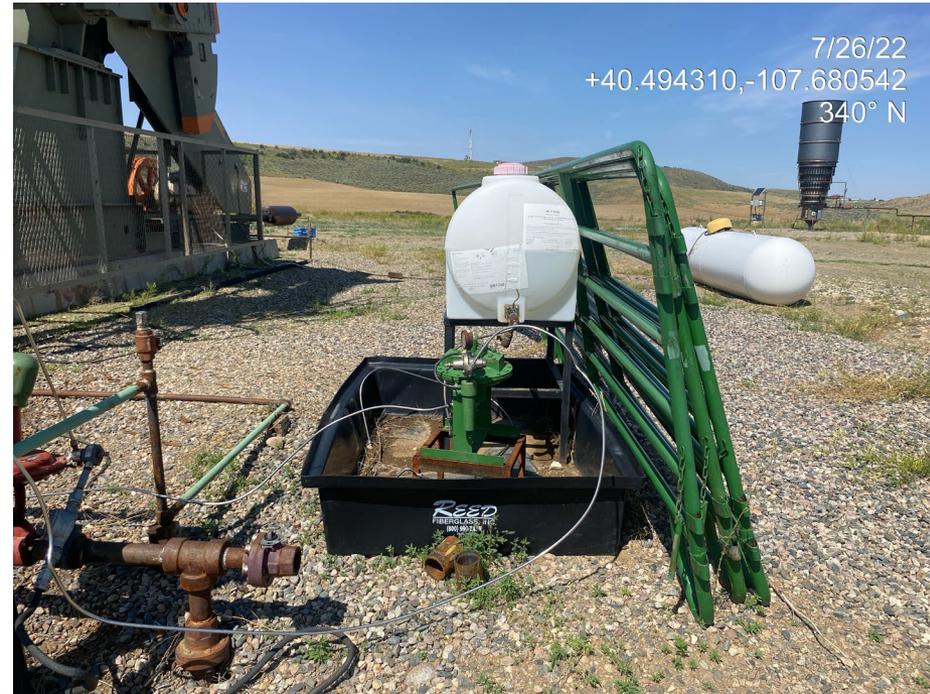
**Photo 7.** Photo taken from the well area shows a methanol tank lacking wildlife protection BMPs on the secondary containment device.

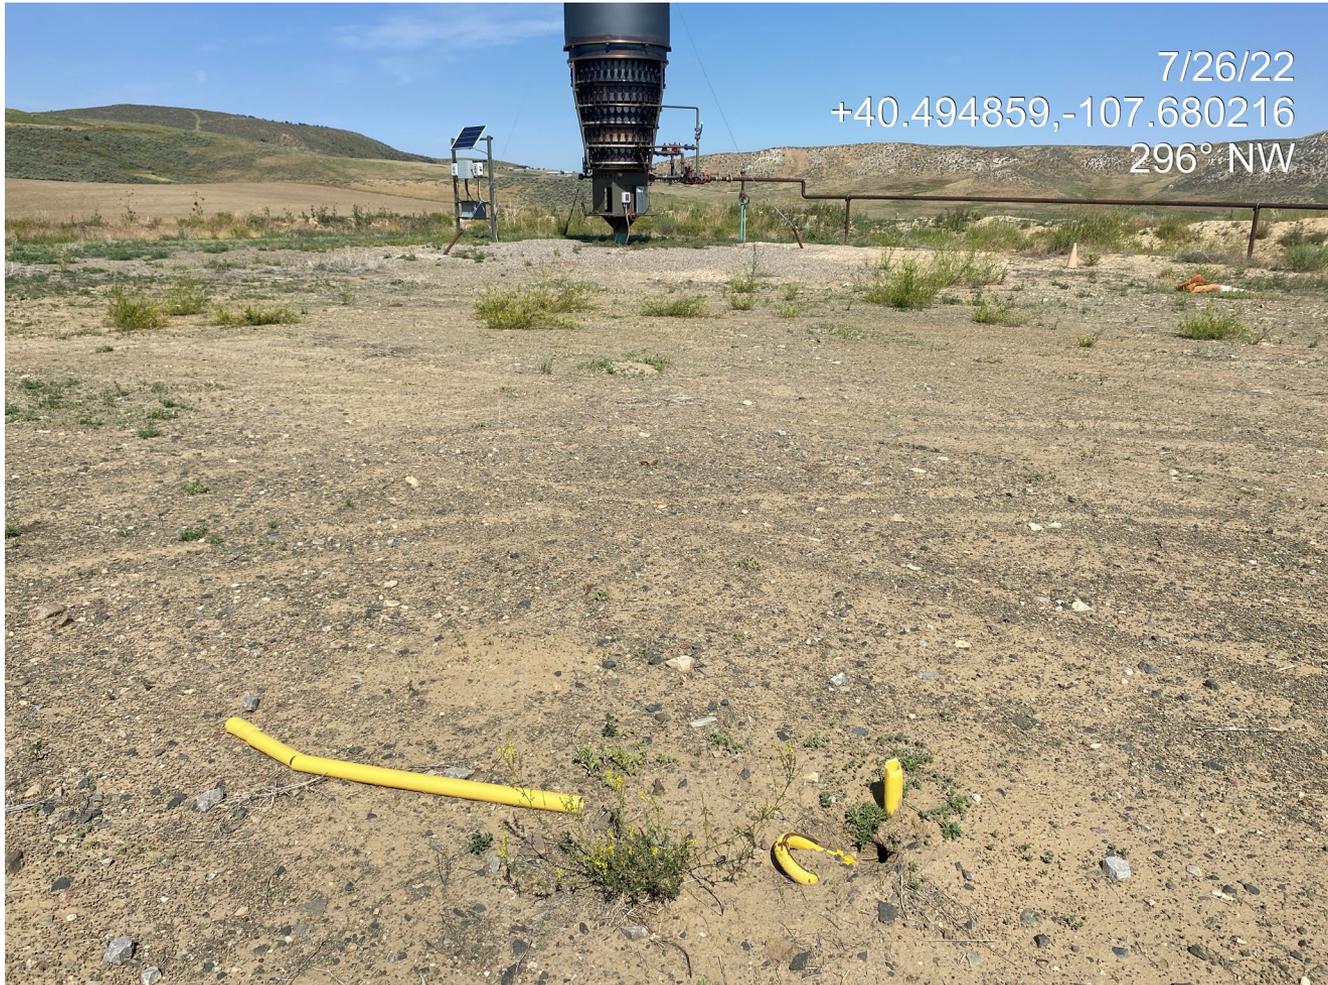
**Photo 8.** Photo taken from the northwest of the Location shows an anchor marker in disrepair. Four anchor markers on Location were observed in disrepair.

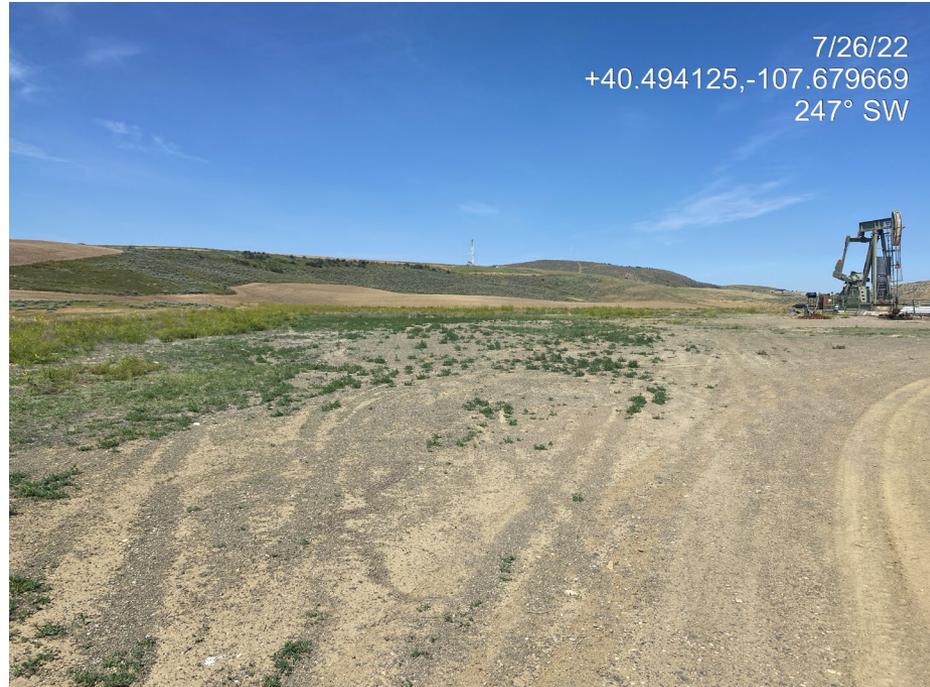
**Photo 9.** Photo taken from the southeast of the Location shows areas of the Location at the southwest not necessary for production operations which have not been reclaimed. Photo also shows weeds growing on Location and contributing to debris.

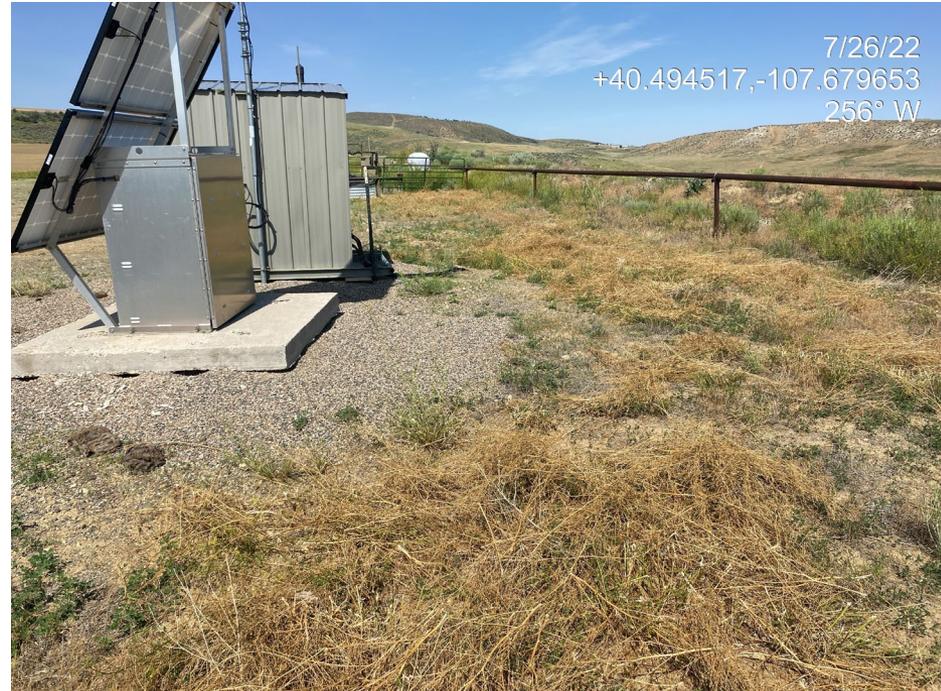
**Photo 10.** Photo taken from the northeast of the Location shows weeds have been cut and left on Location contributing to debris.

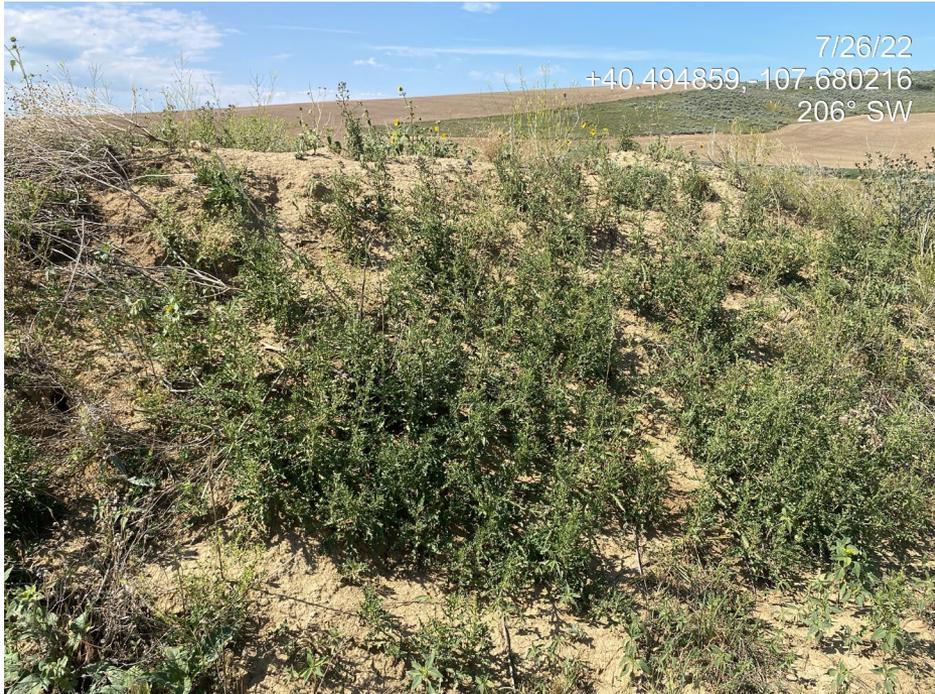
**Photo 11.** Photo taken from the Location perimeter berm shows establishment of Canada thistle, a CO State List B Noxious Weed.

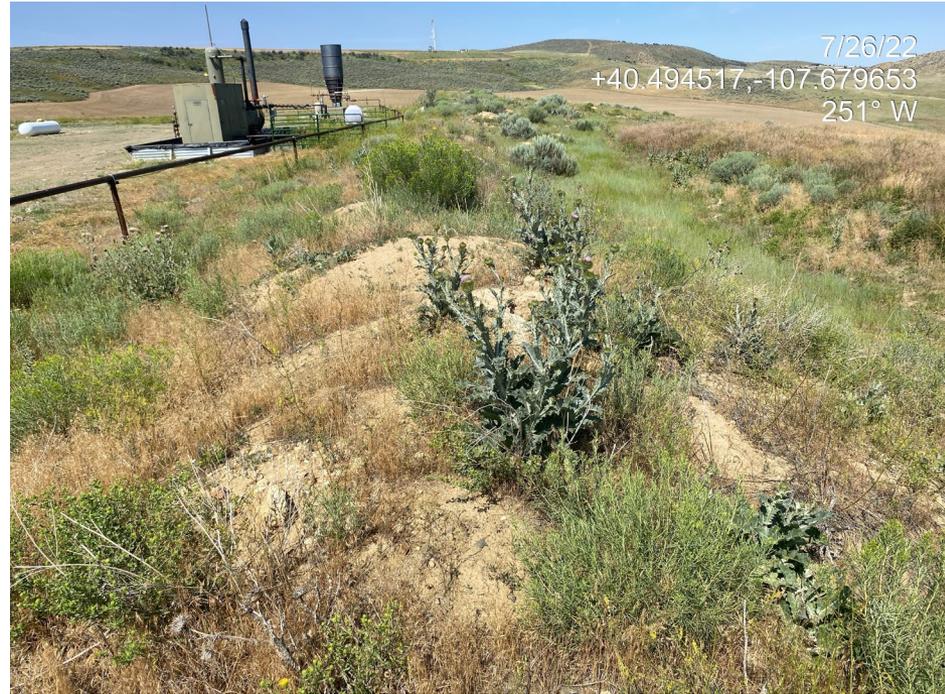
**Photo 12.** Photo taken from the Location perimeter berm shows establishment of Scotch thistle, a CO State List B Noxious Weed.

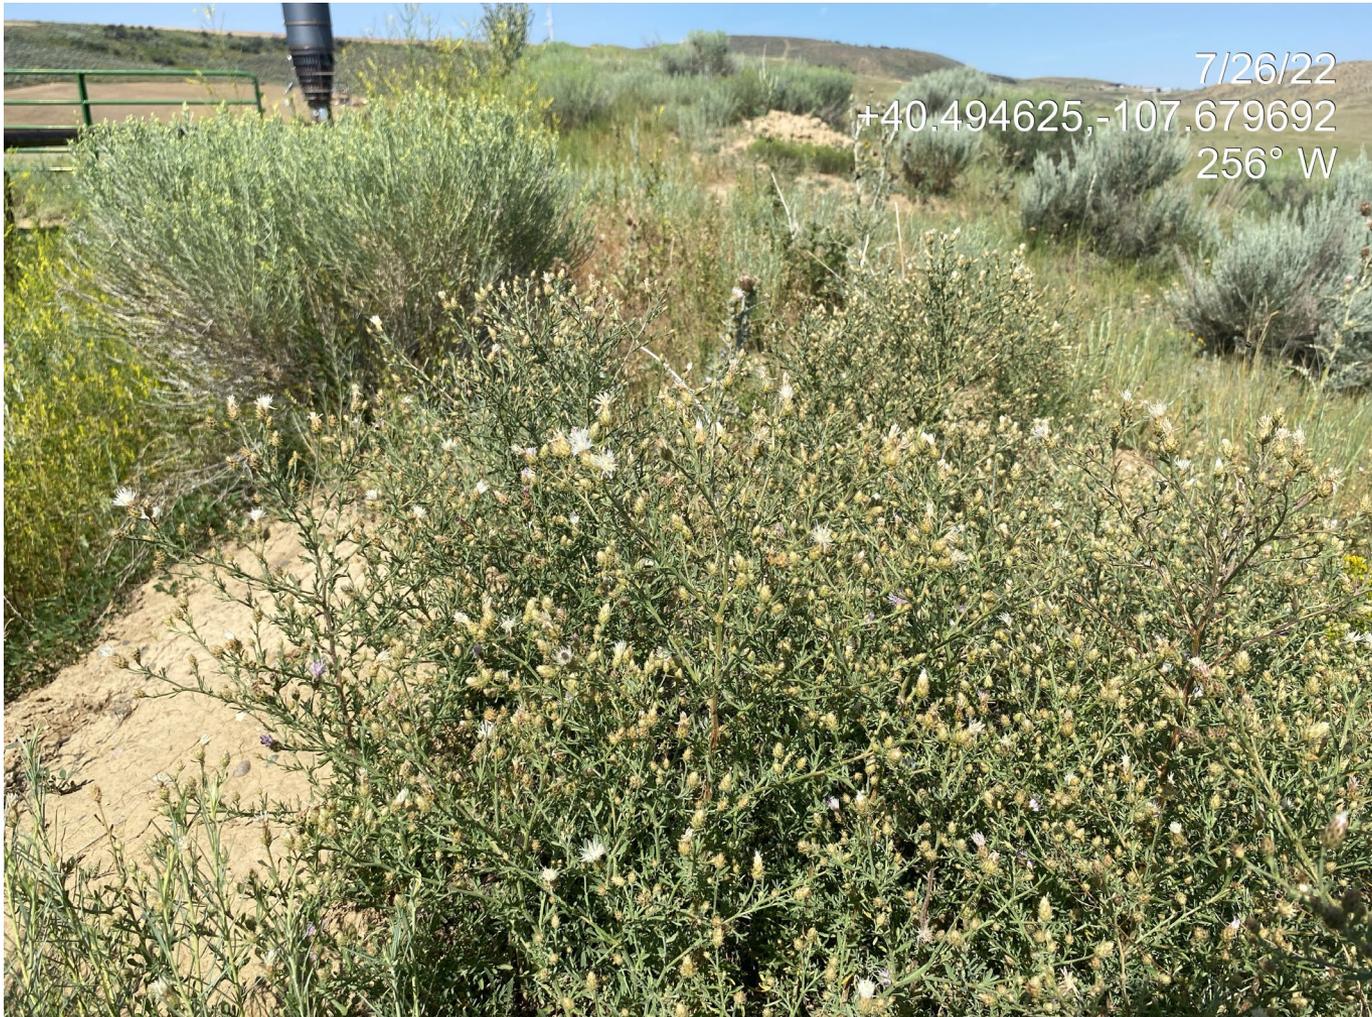
**Photo 13.** Photo taken from the Location perimeter berm shows spotted and diffuse knapweed, CO State List B Noxious Weeds.

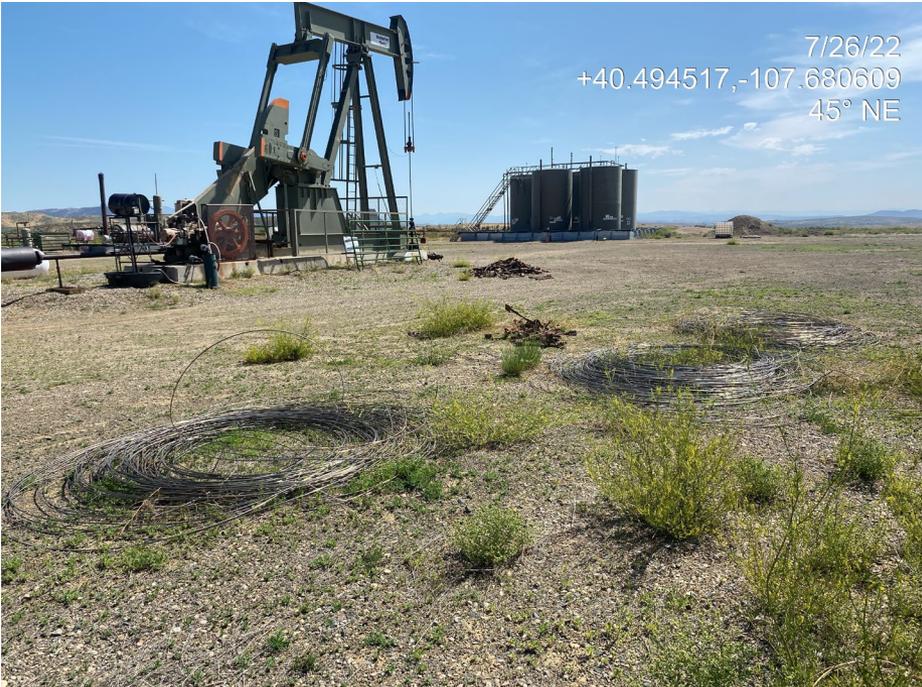
**Photo 14.** Photo taken from the south of the pump jack shows a variety of unused equipment stored on Location.

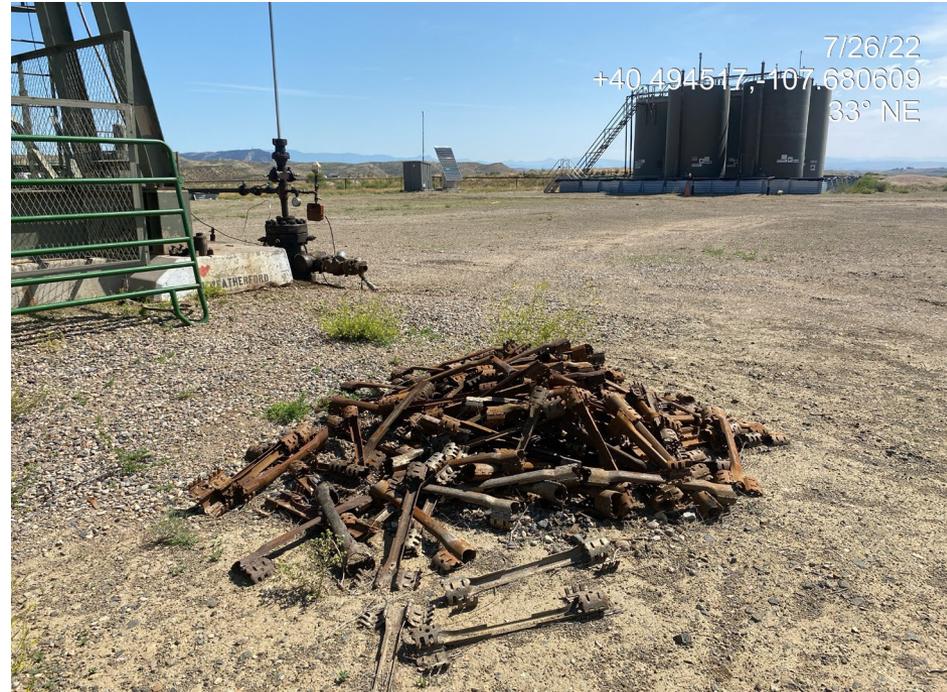
**Photo 15.** Refer to Photo 14 comment.
