Stormwater Inspection Report

| Operator: | Laramie Energy, LLC |
| Project: | Collbran |
| Location: | My Way Ranch 17-7 Pad |

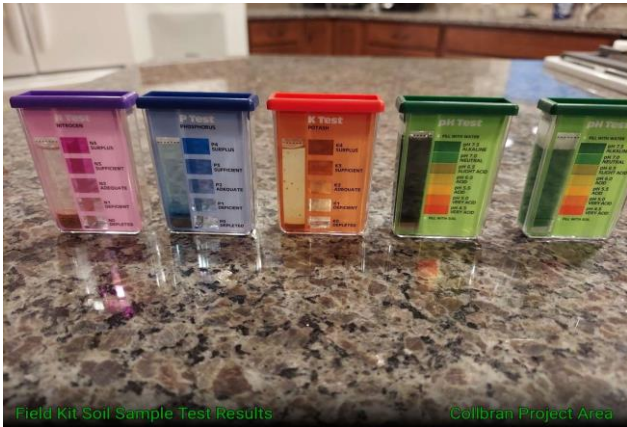
Photo 1

Field Kit Soil Sample Test Results

Soil Sample Results (Water used for Test on Far Right)

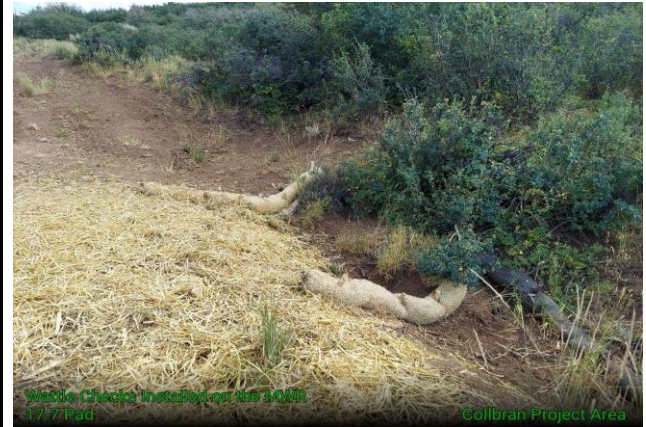
Photo 2

Wattle Checks Installed on SW 140th 17-7 Pad

Two Wattle Checks Installed on Southwest Corner of the MWR 17-7 Pad

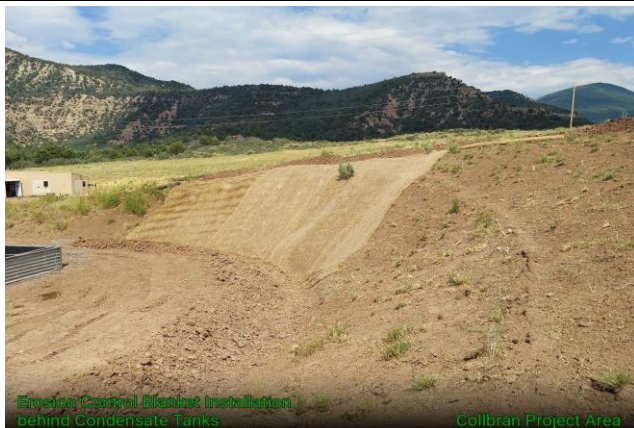
Photo 3

Erosion Control Blanket Installation behind Condensate Tanks

Partially Installed Erosion Control Blankets behind Condensate Tanks

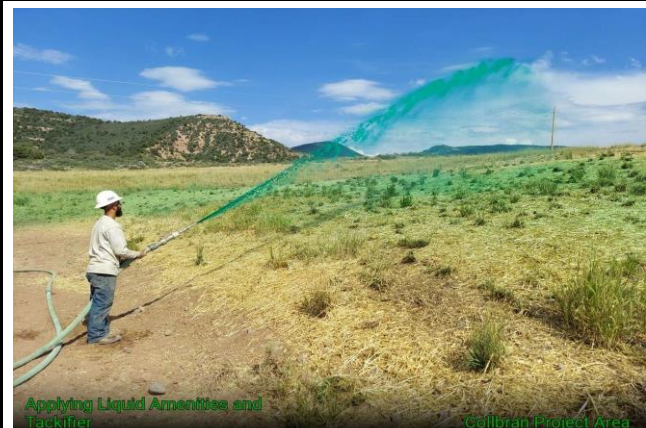
Photo 4

Applying Liquid Amenities and Tackifier

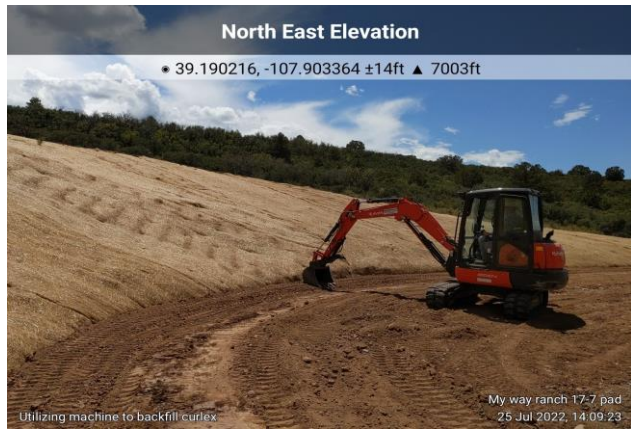
Photo 1

Installing Erosion Control Blanket on the MWR 17-7 Pad

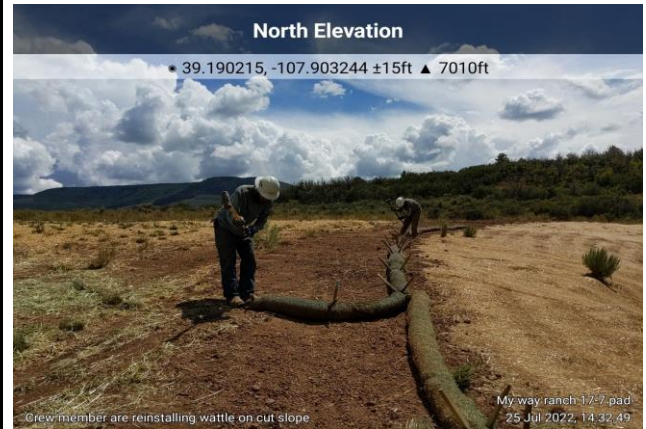
Photo 2

Reinstalling Excelsior Wattle on the My Way Ranch 17-7 Pad

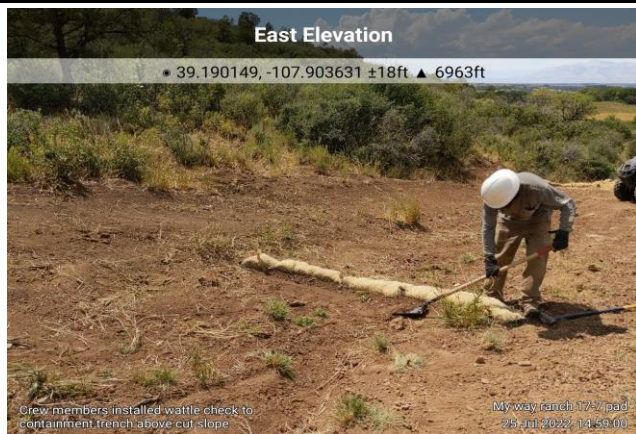
Photo 3

Installing New Excelsior Wattle Check

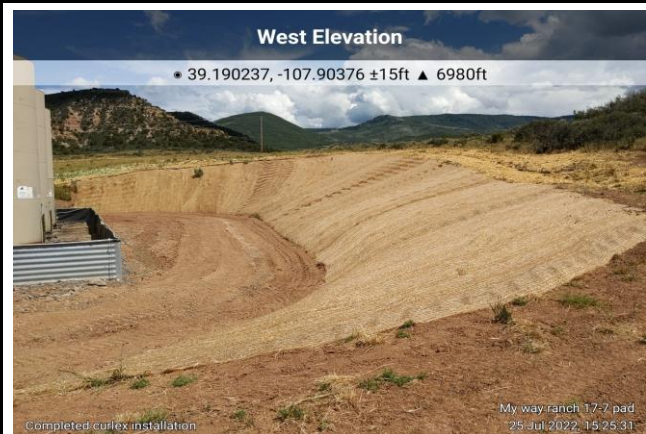
Photo 4

Erosion Control Blanket Installation on the MWR 17-7 Pad

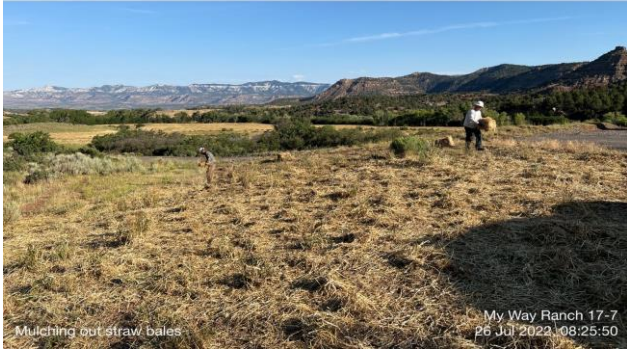
Photo 1

Applying Straw Mulch by Hand on the My Way Ranch 17-7 Pad

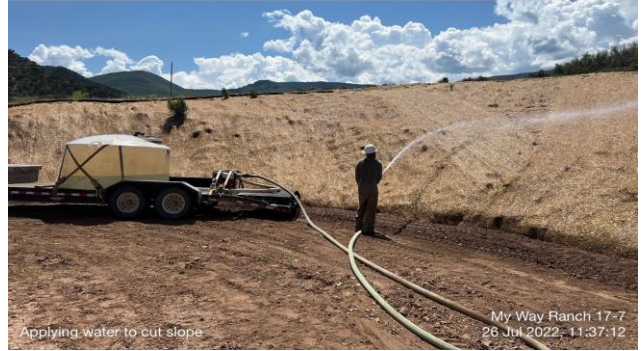
Photo 2

Applying Fresh Water to Erosion Control Blanket Installation

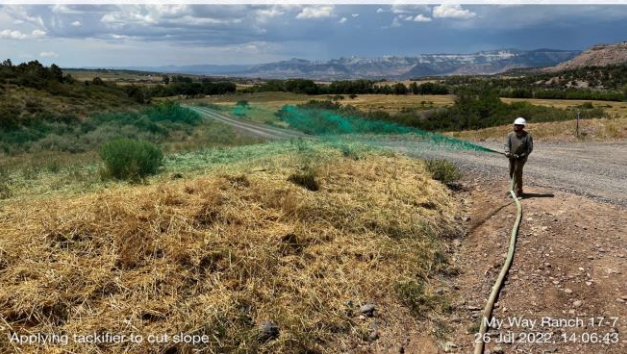
Photo 3

Applying Liquid Amenities and Tackifier on the My Way Ranch Pad

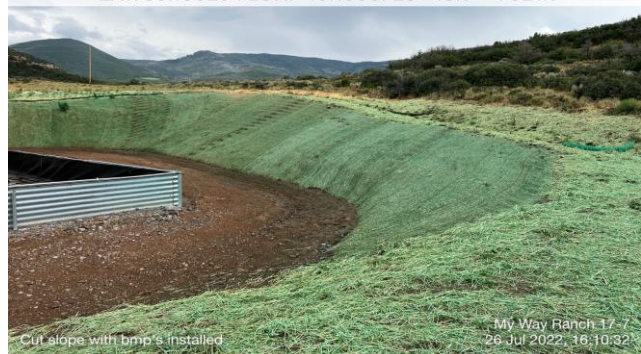
Photo 4

Erosion Control Blanket Installation on the MWR 17-7 Pad after Treated with Liquid Amenities
