# Inspection Photos and Issue Report

7/27/2022

Operator: CAERUS PICEANCE LLC # 10456

Location #479149

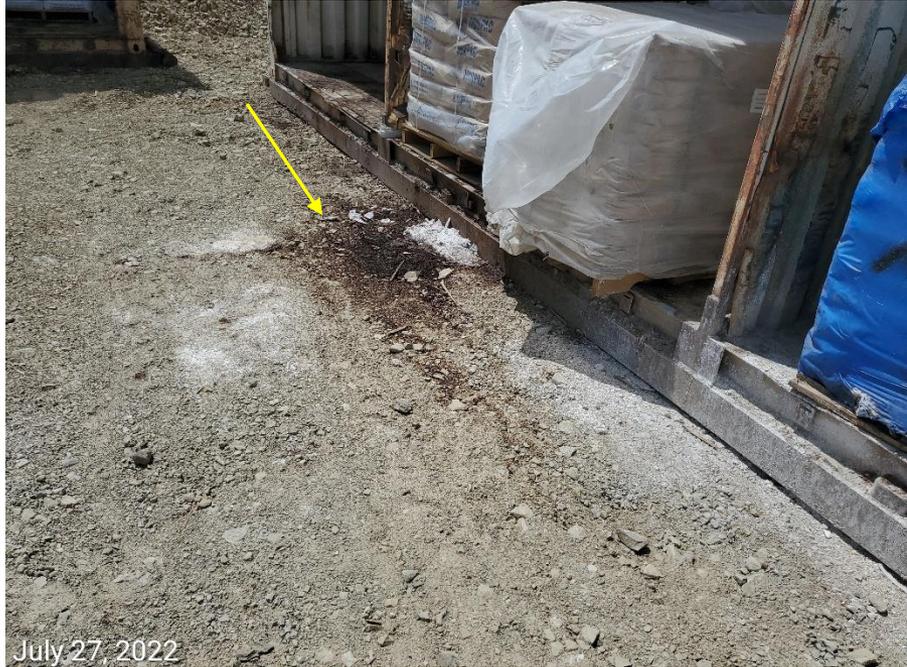
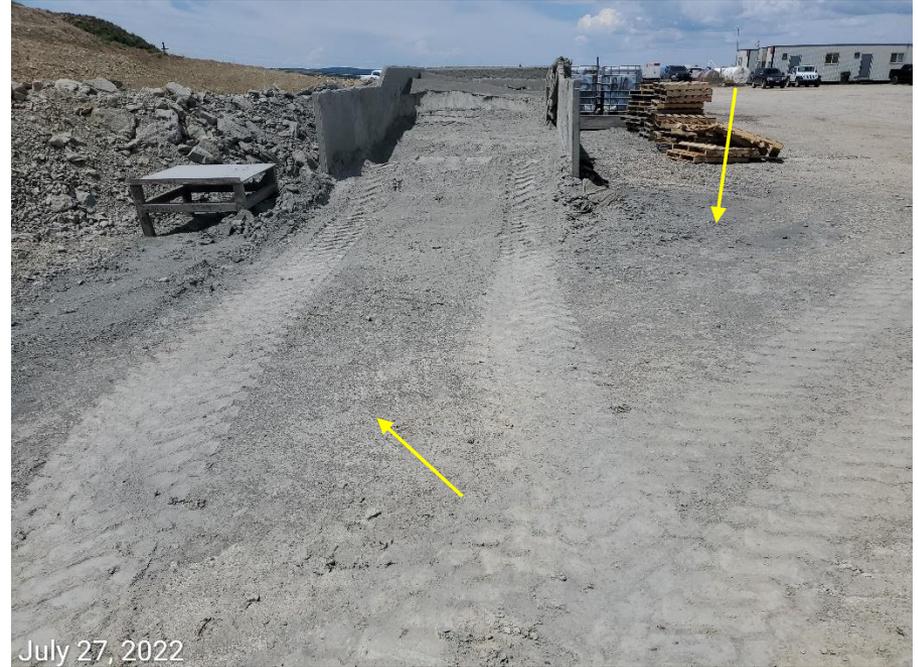
**Photo 1:** Photos show additional material spills observed on the Location.

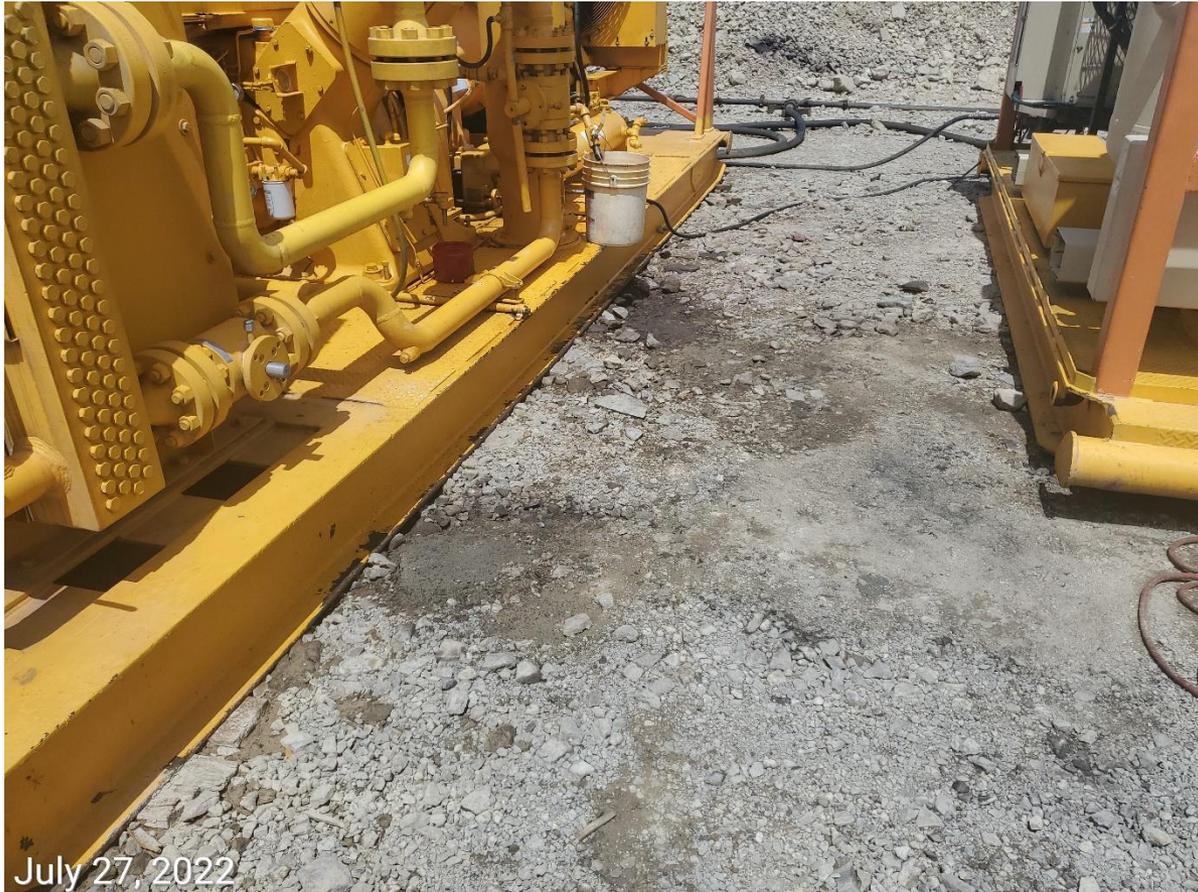
**Photo 2:** Photo shows impacted soils due to spills from equipment.

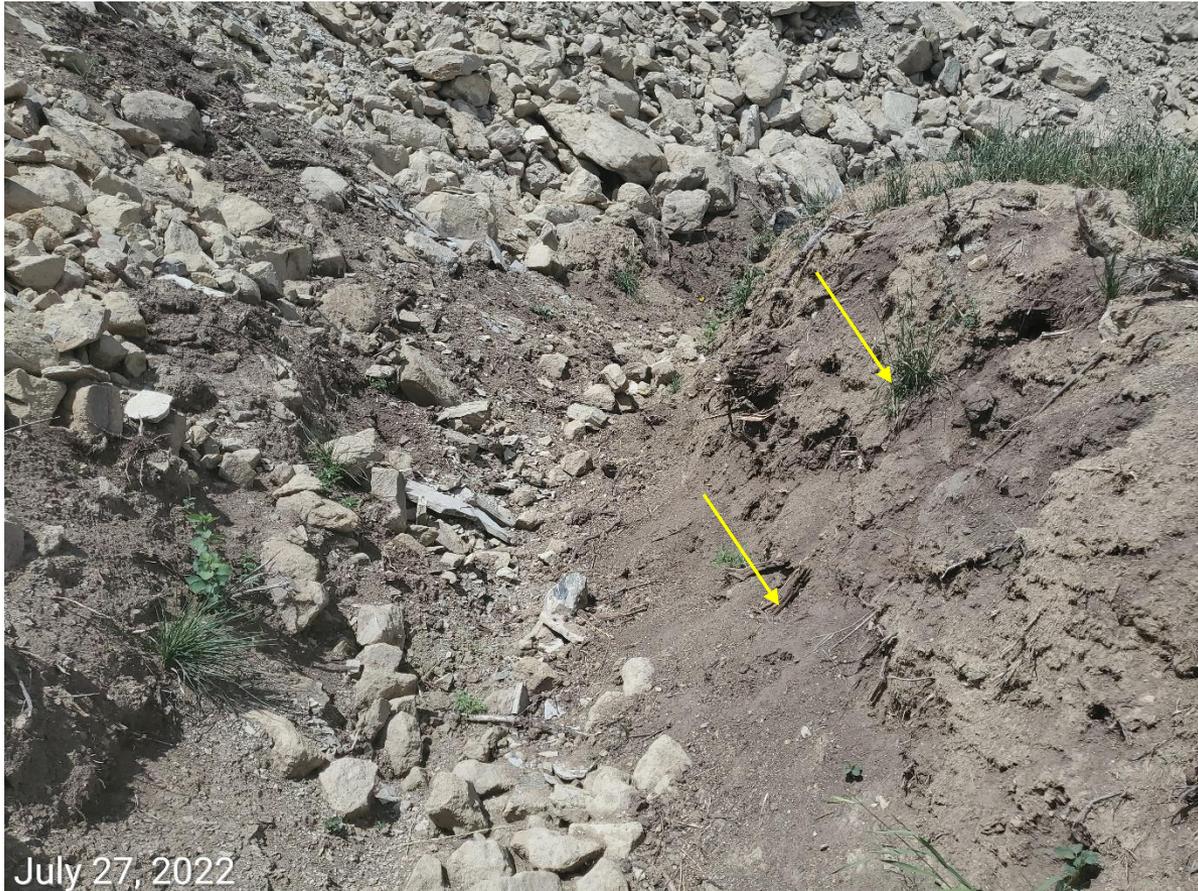
**Photo 3:** Photo taken from the perimeter stormwater ditch. Photo example showing topsoil (yellow arrow) in use as part of stormwater controls (ditch/berm) to manage runoff on the Location. Photo also provide example of areas where controls to stabilize and protect topsoil has degraded, resulting in topsoil eroding into ditch and mixing with subsoils.

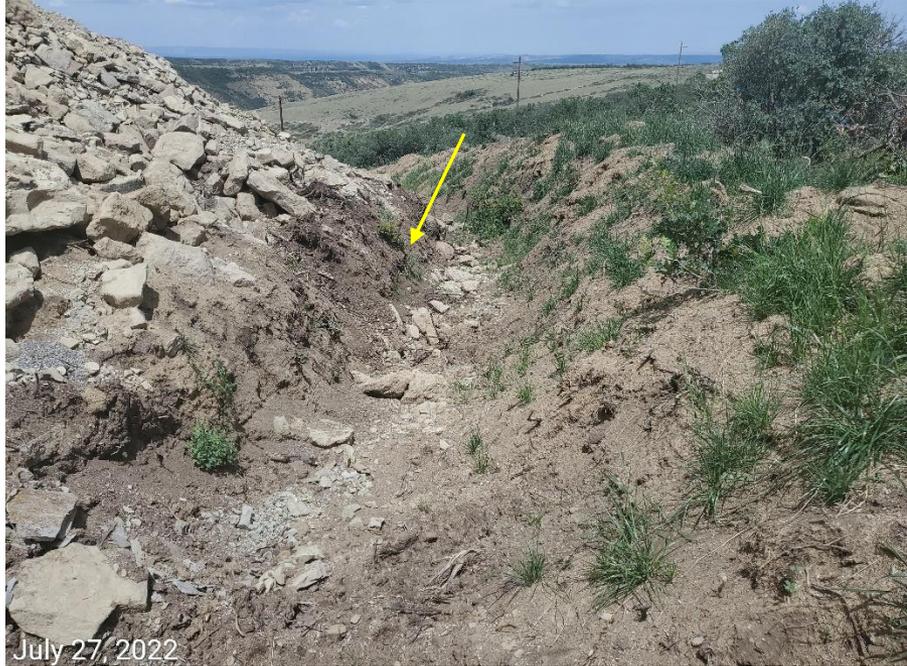
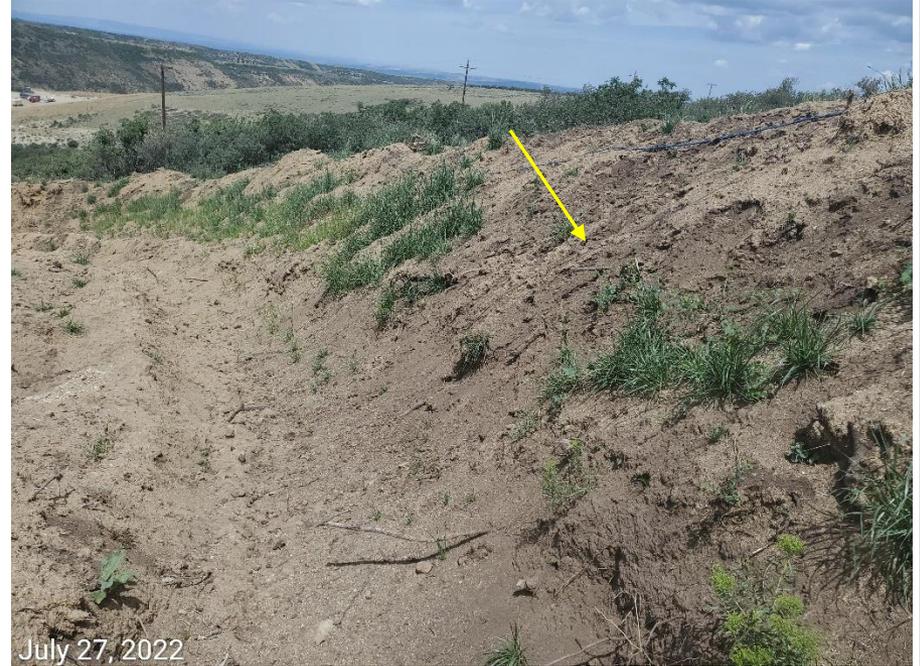
**Photo 4:** See comments under photo 3.

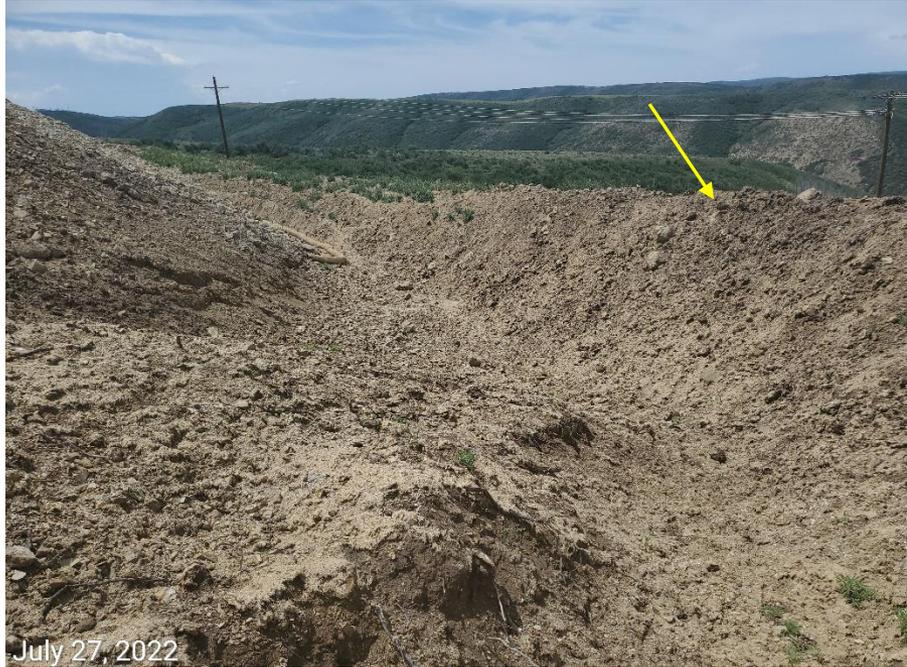
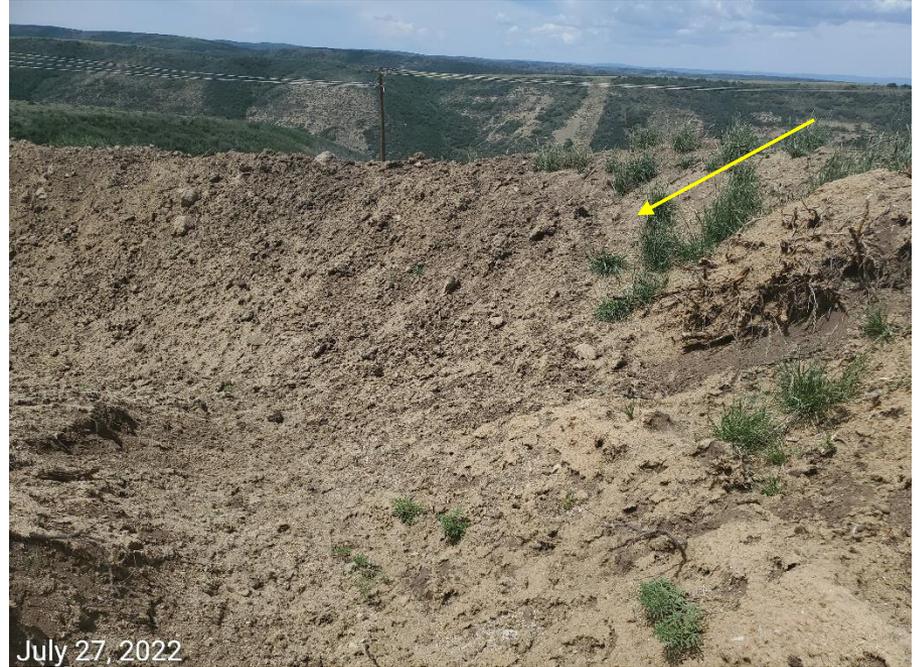
**Photo 5:** Photos examples showing topsoil remains in use as part of the Locations perimeter stormwater controls, specifically, one of the three sediment traps on the Location. Photo also shows control has not been constructed with an engineered outlet to allow for proper stormwater discharge.

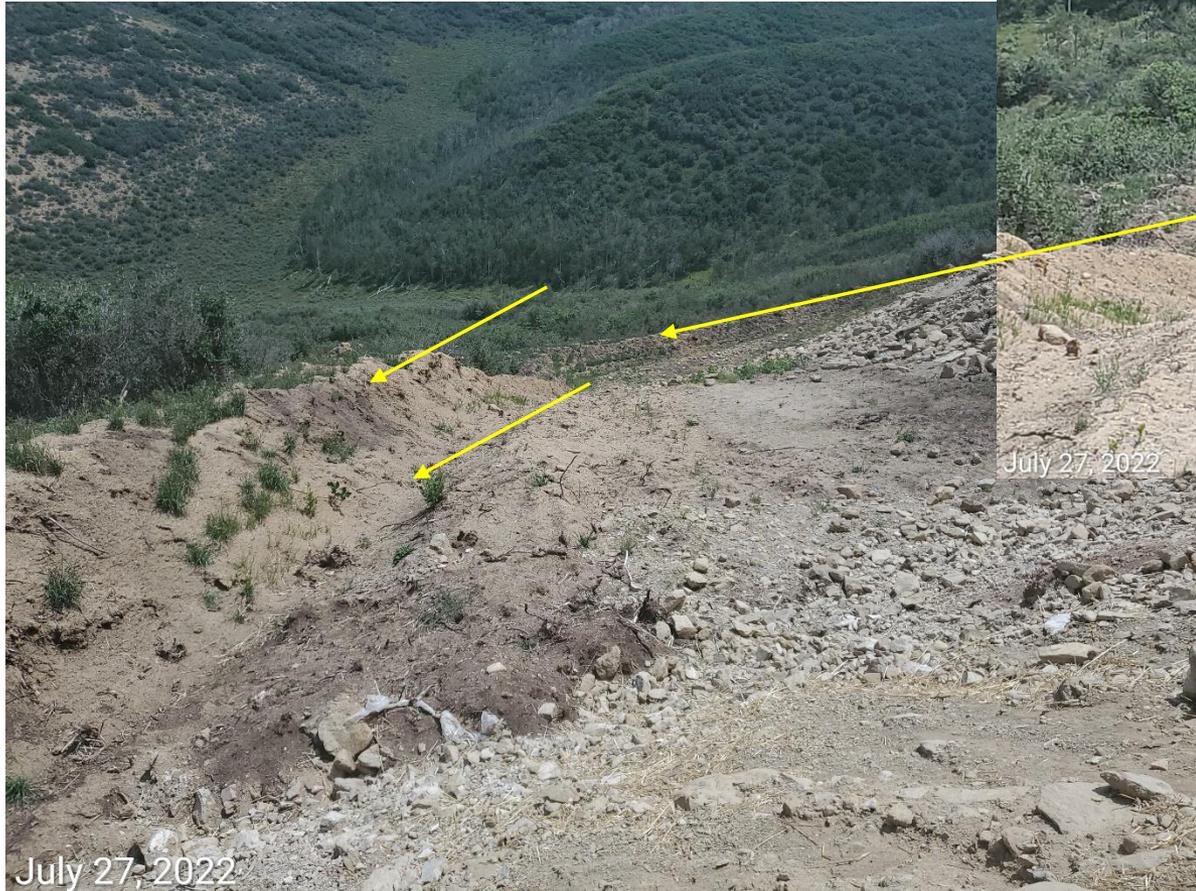
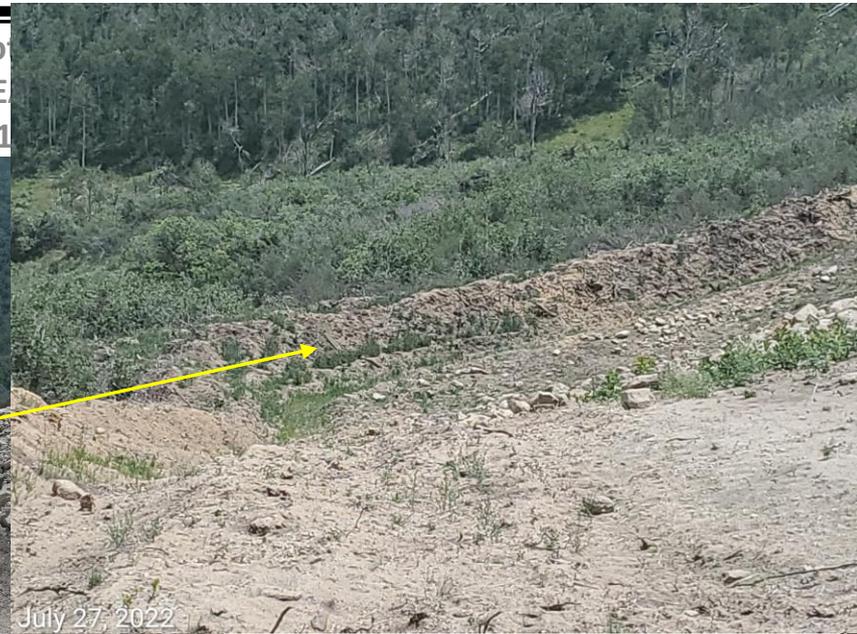
**Photo 6:** Additional photo example showing topsoil in use as part of the perimeter's ditch and berm, as well as the sediment traps. See comments under photo 6.
