Inspection Photos

API: 071-07915

Operator: WAPITI OPERATING LLC

Inspection Date: 8/1/2022

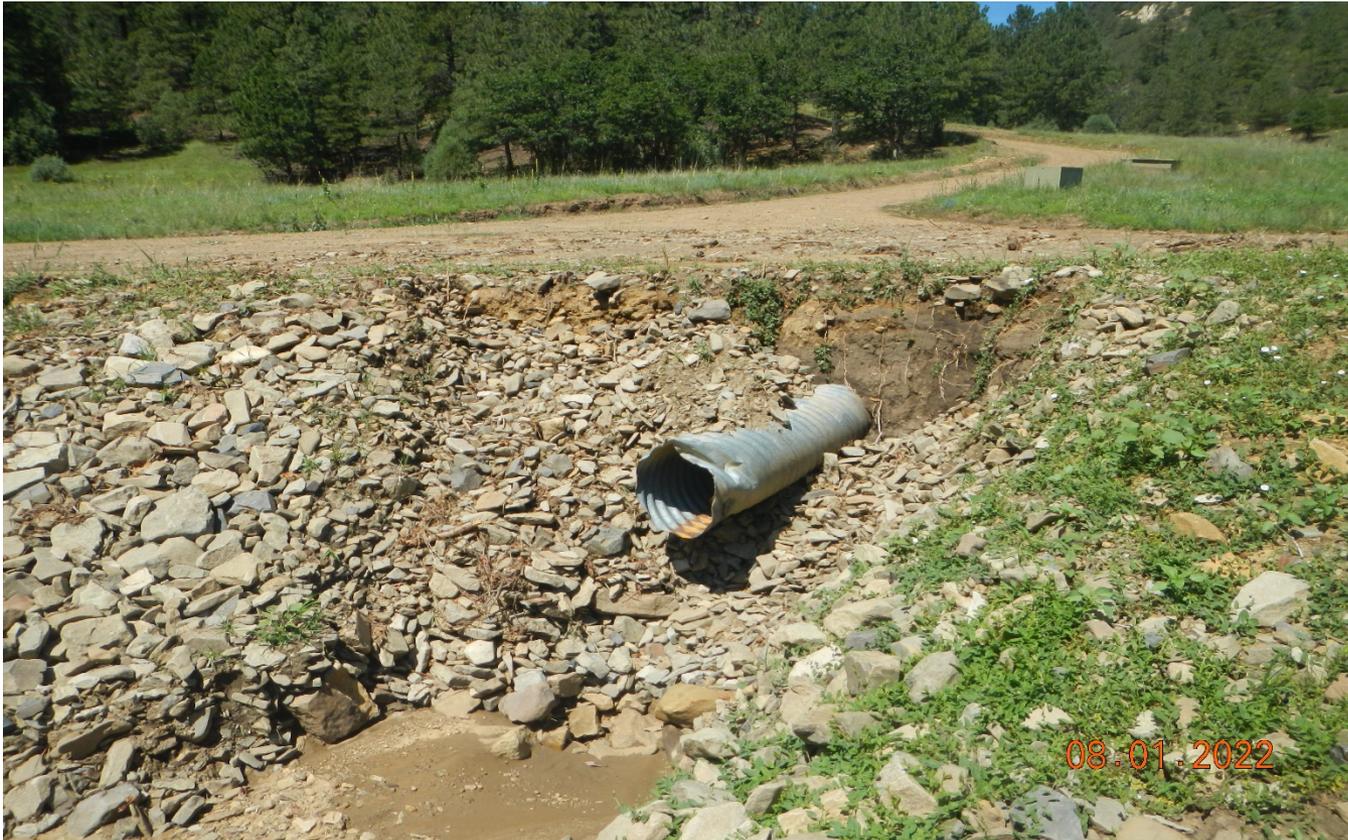
Photo 1. Facing west toward near the access road ascending the hillside. The culvert outlet has been washed out from recent storm event. It appears a larger culvert is needed along with larger rock rip/rap outlet protection.

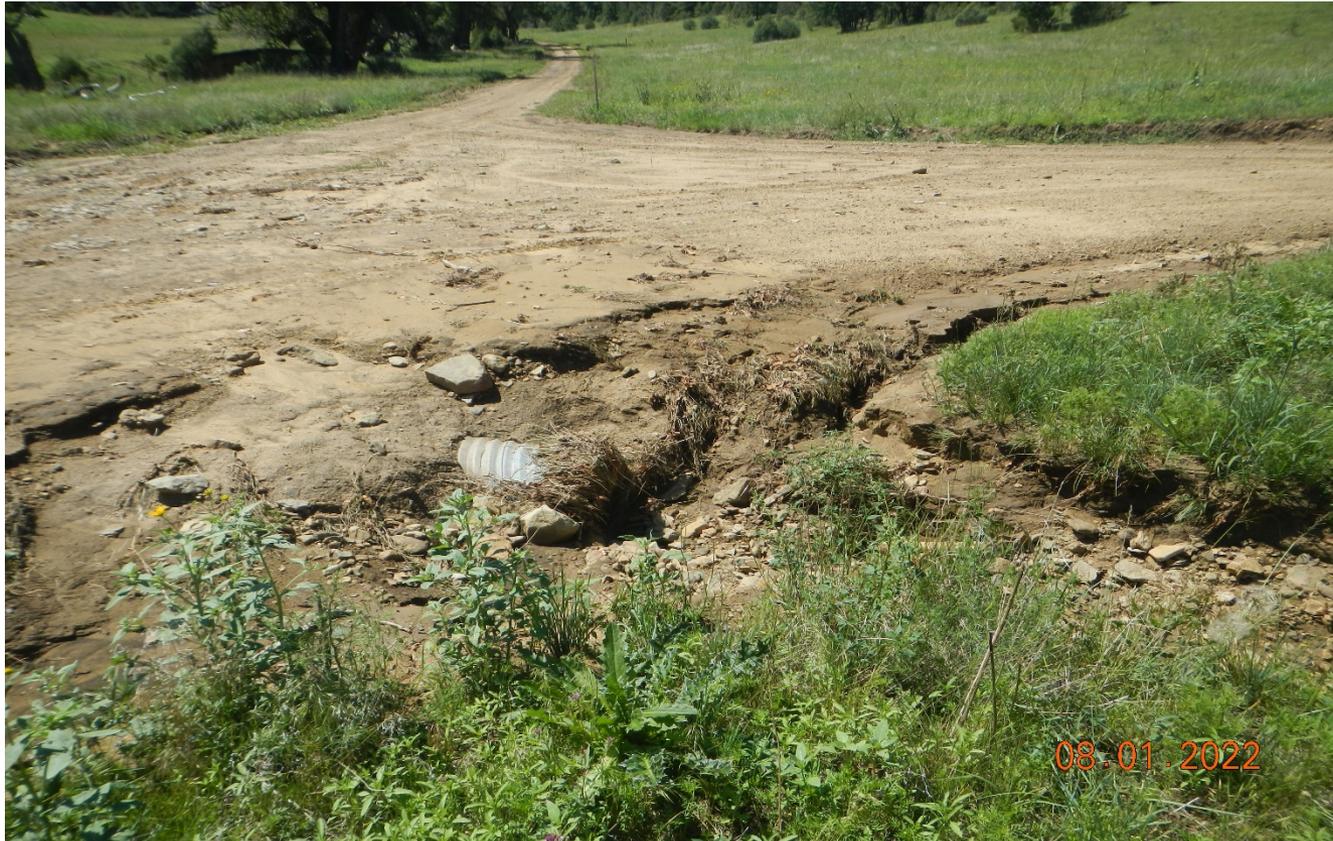
Photo 2. The culvert inlet is filled in with sediment. It appears a larger culvert is needed at this area to handle stormwater coming off the road and drainage.

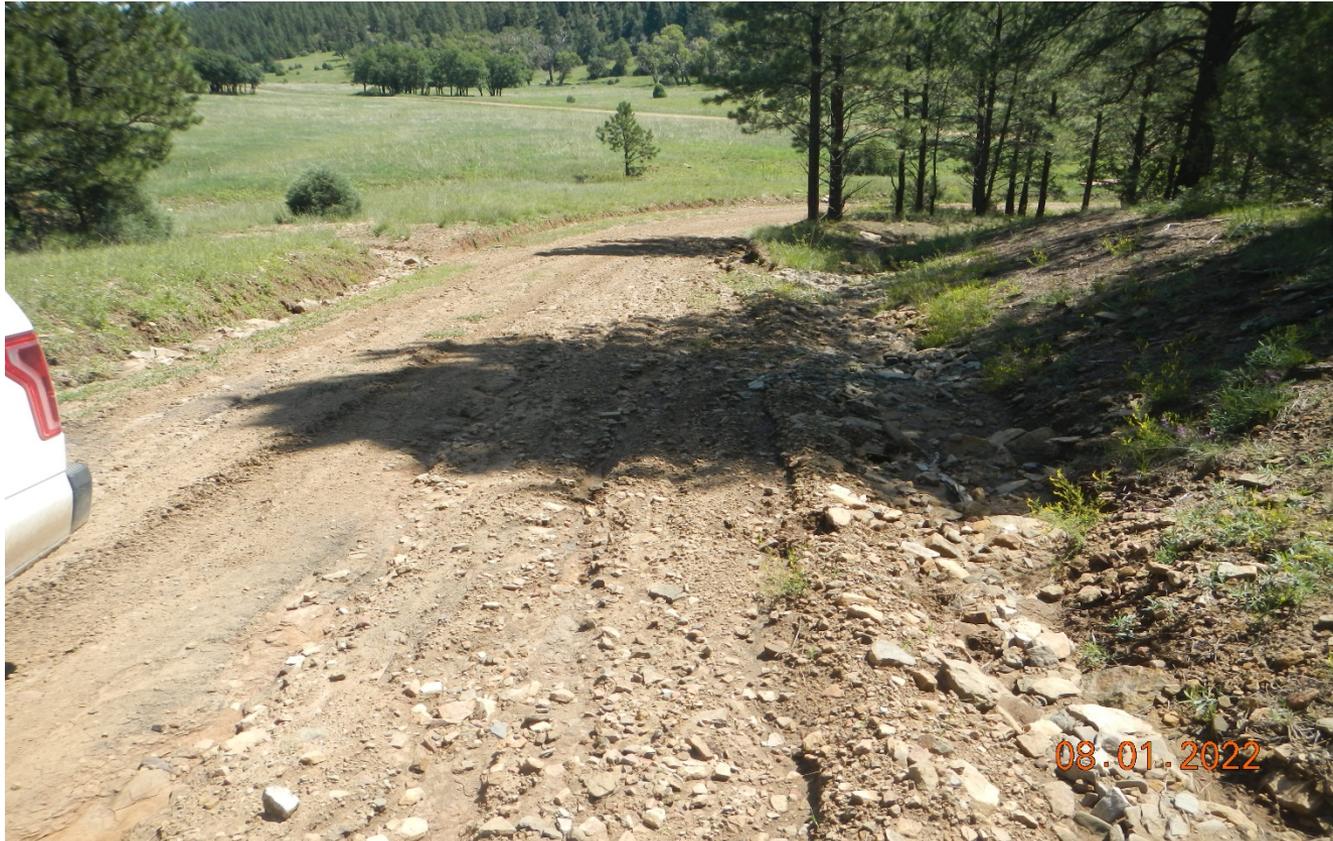
Photo 3. There are signs stormwater is flowing down the road causing erosion. This area has been a problem before. A water bar may help in this area.

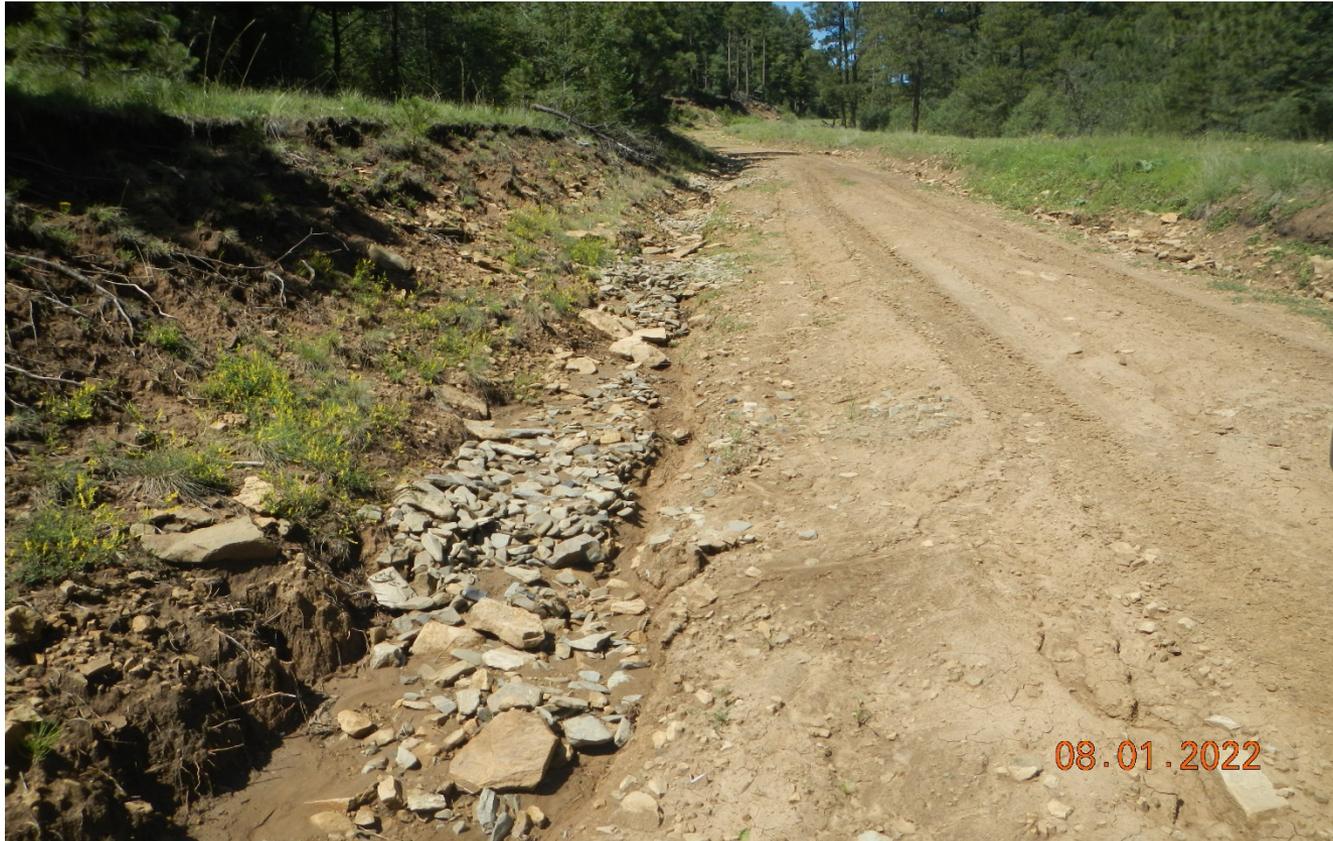
Photo 4. Facing west along the access road. Some of the rock check dams previously installed have washed out. Larger rock was likely needed.

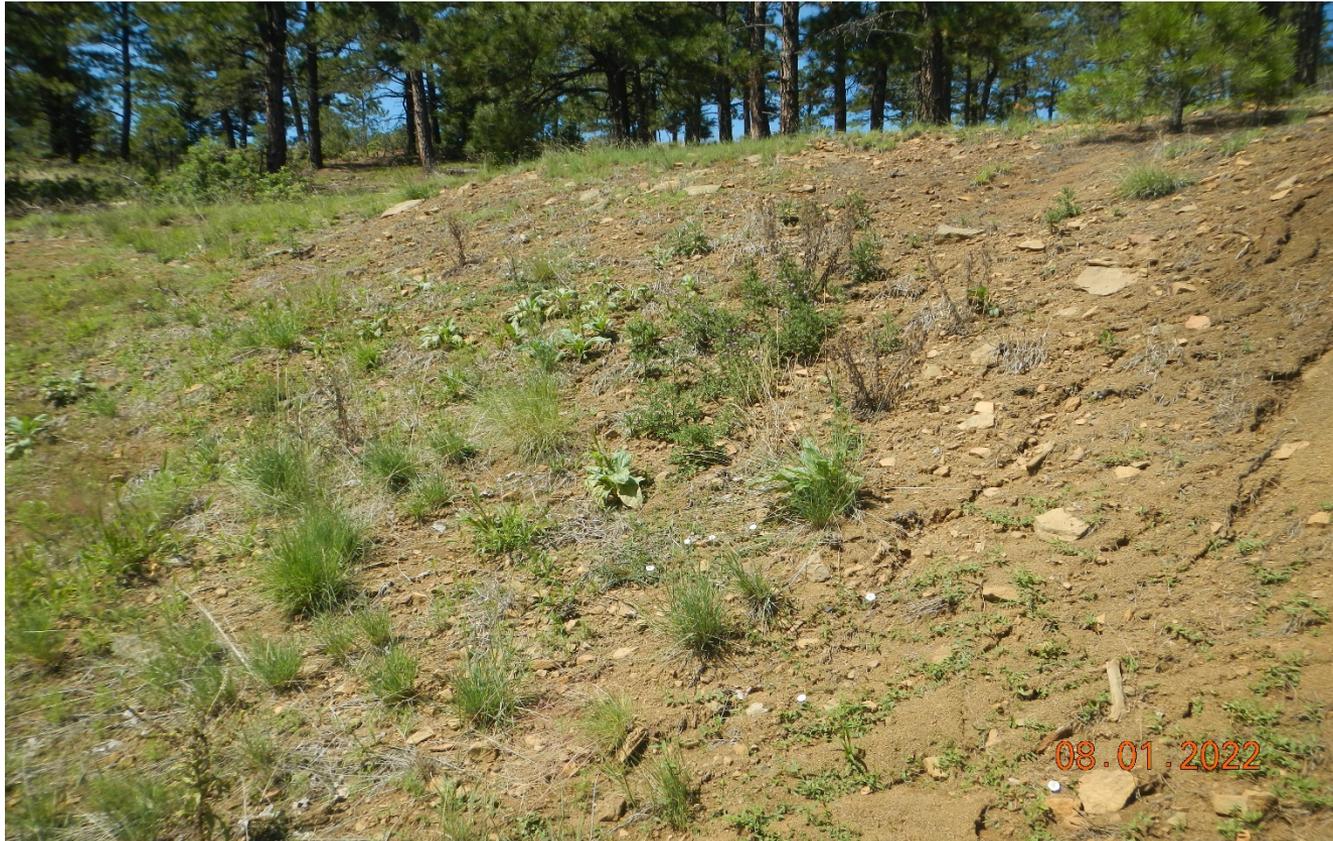
Photo 6. There are still noxious weeds Hounds tongue which have not been controlled. The noxious weeds have already produced seed so the weeds will now need to be bagged and removed.
