Inspection Photos

API: 071-09838

Operator: WAPITI OPERATING LLC

Inspection Date: 8/1/2022

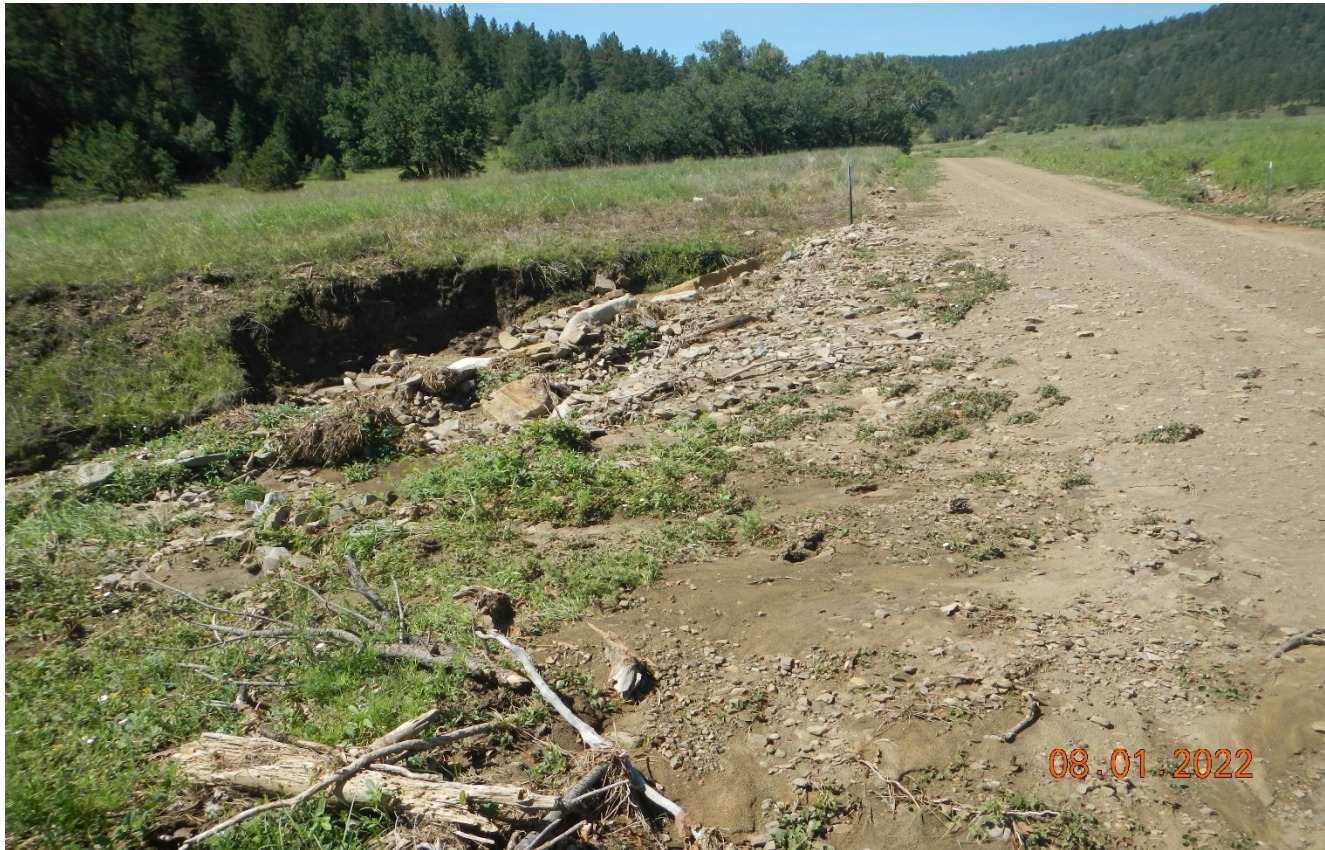
Photo 1. Facing southwest along the main road near the well site. There was a recent rain event that caused stormwater to flow across the road.

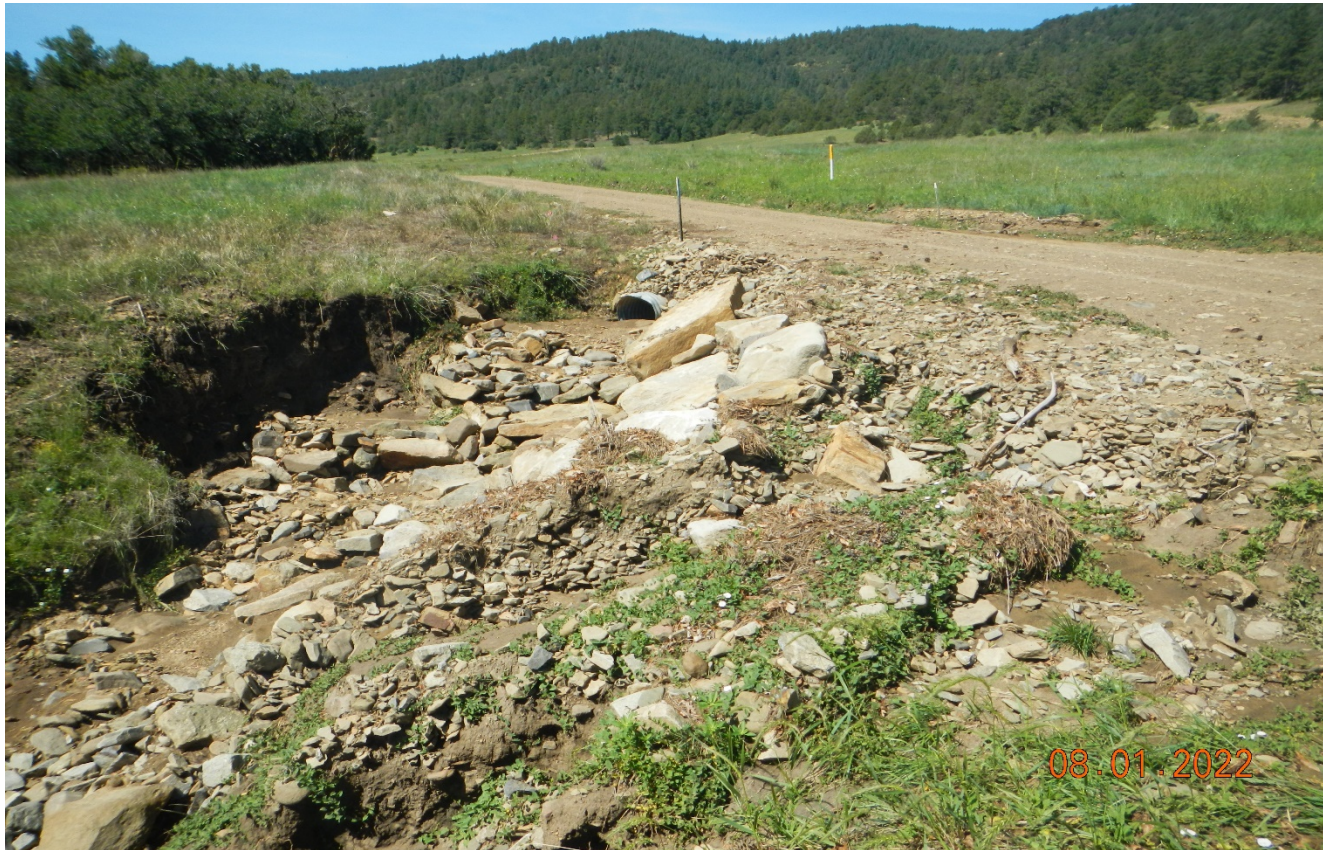
Photo 2. The culvert outlet has eroded and needs to be repaired.

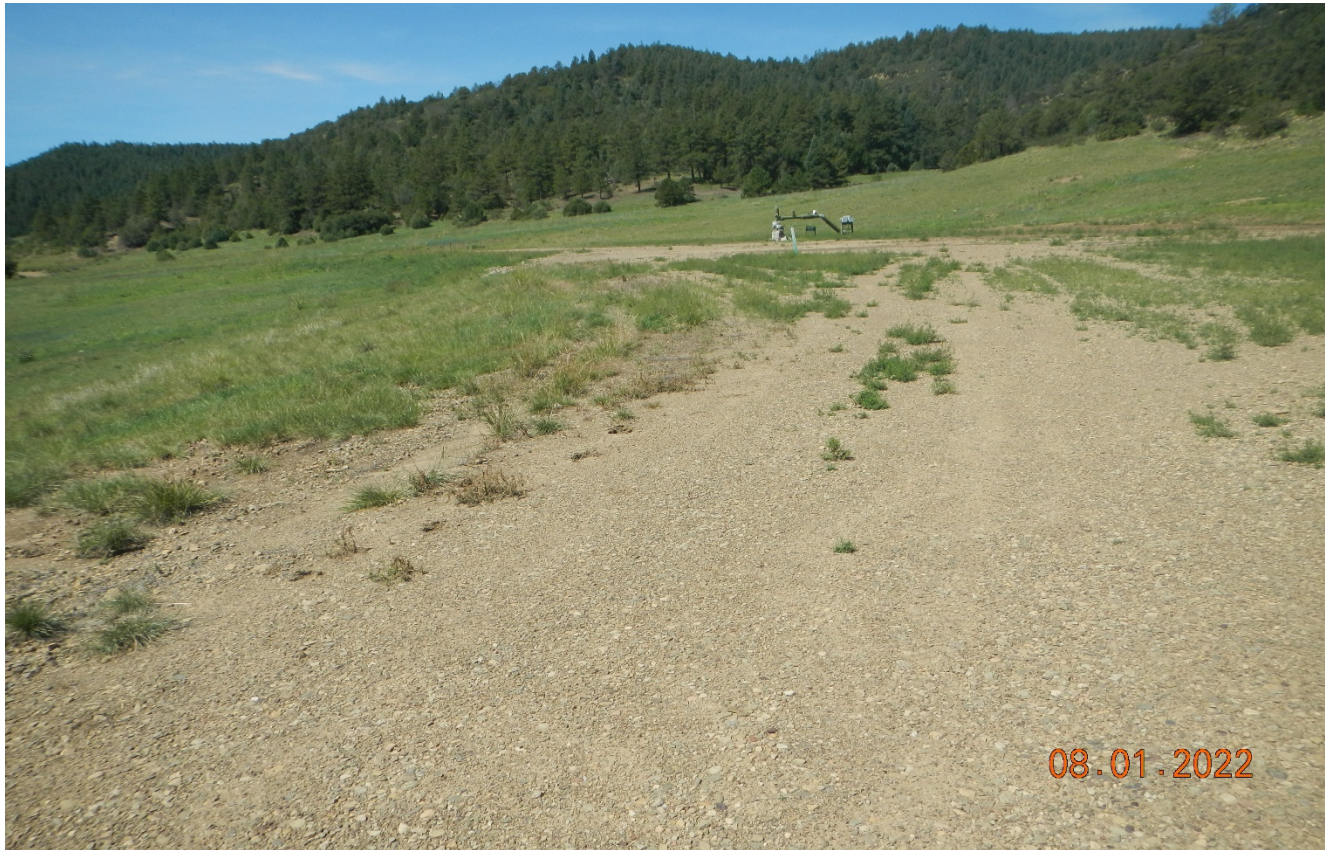
Photo 3. Facing toward the northwest toward the location.

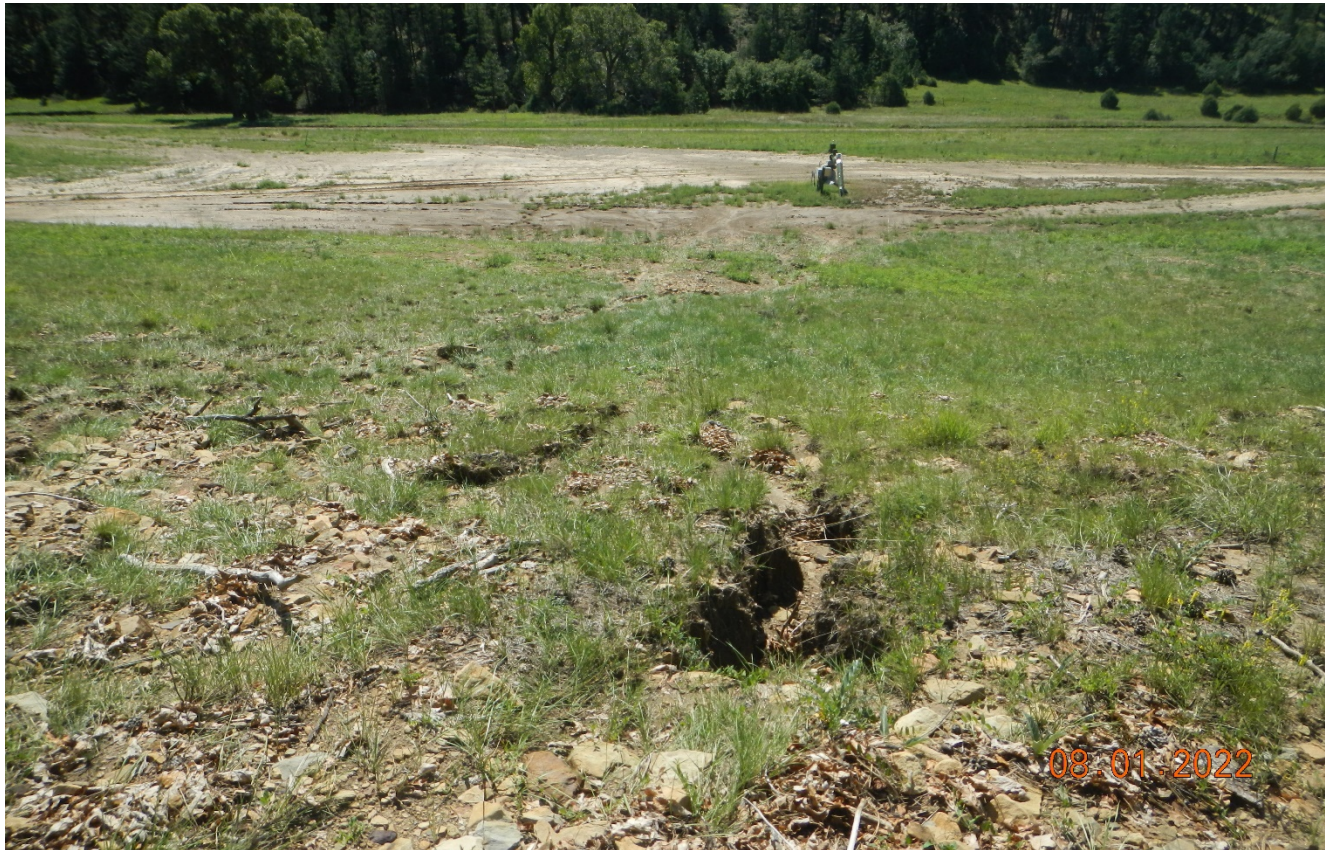
Photo 4. Facing east toward the location at the upper cut slope area. Stormwater runoff is causing erosion. This area needs to be repaired and stabilized.

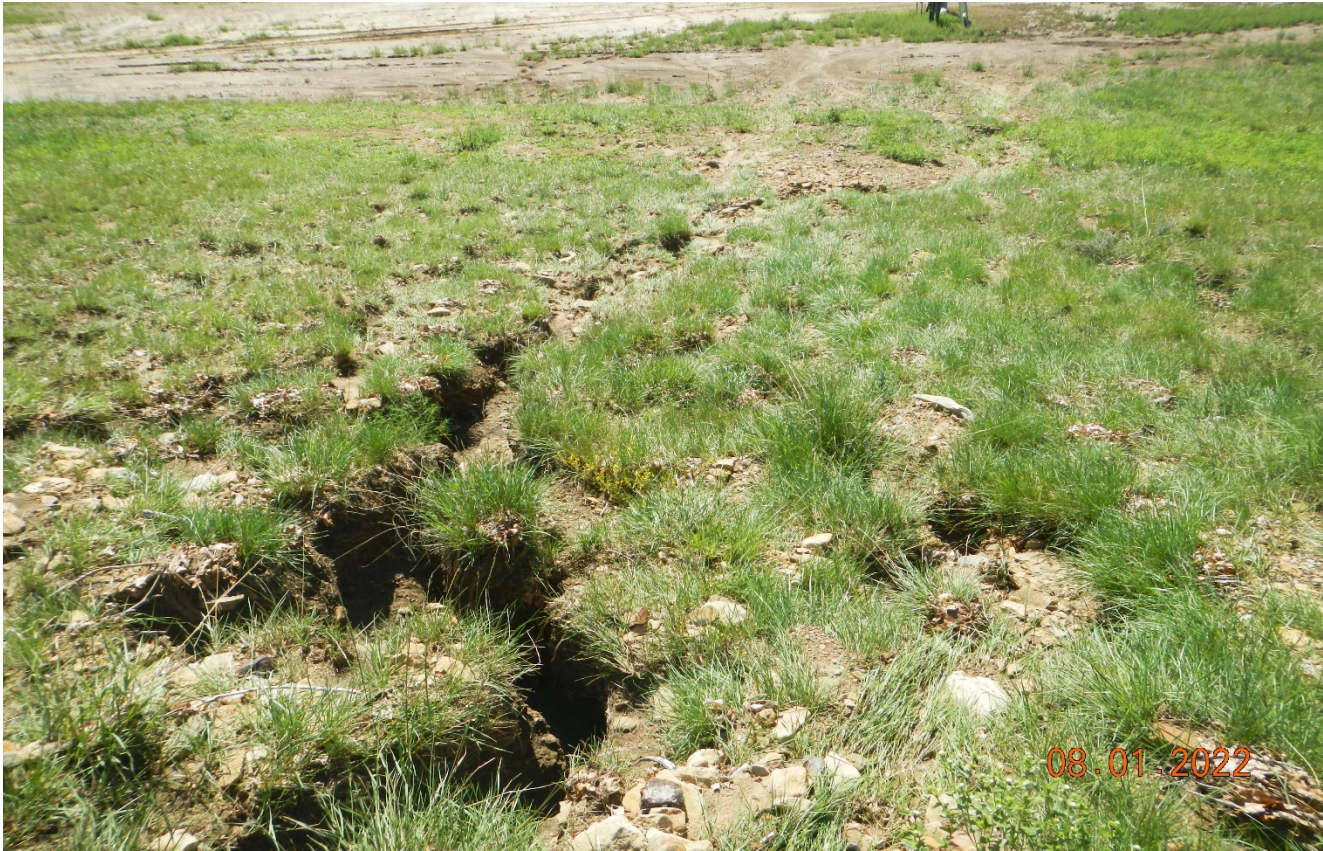
Photo 5. There is deep channeling occurring along the cut slope which must be repaired.

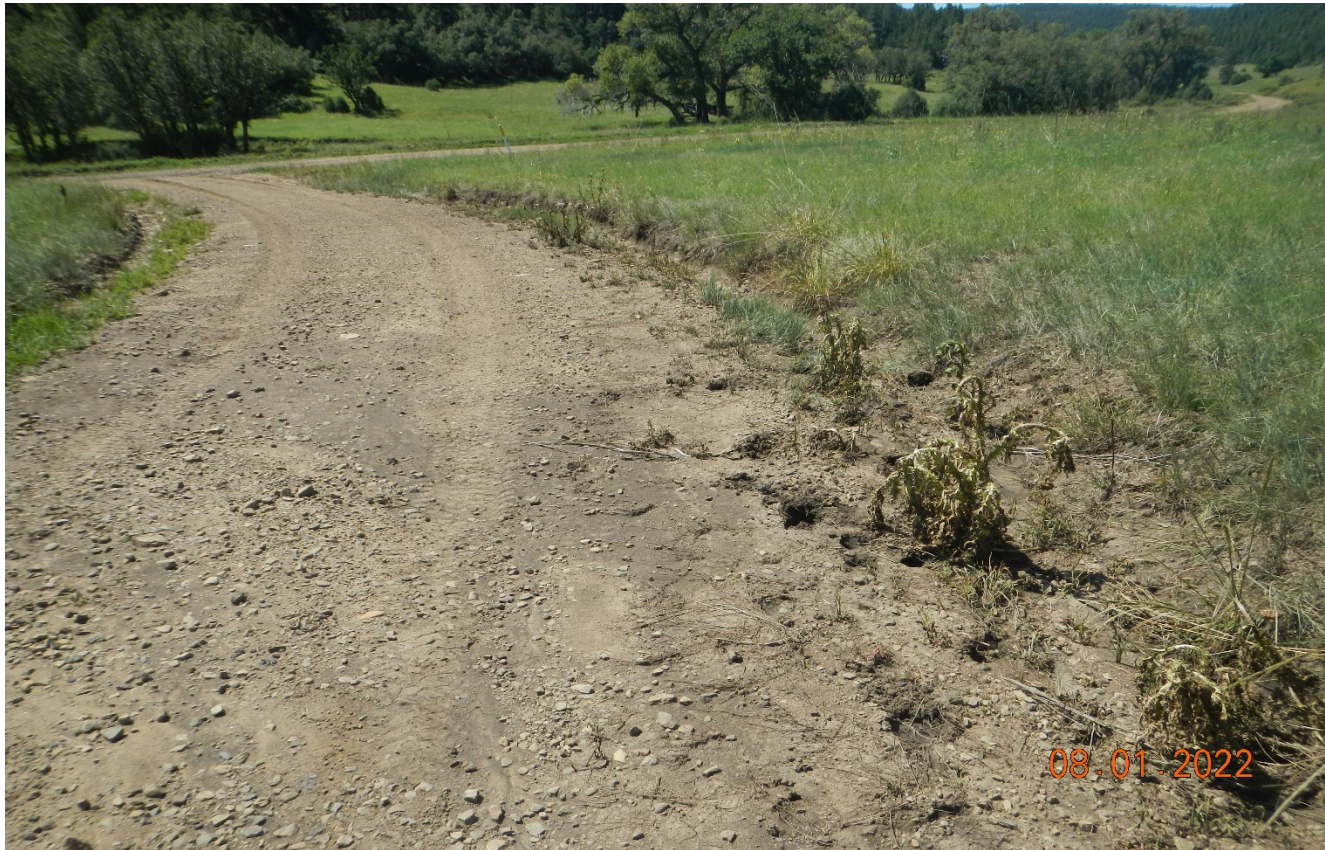
Photo 6. There are noxious weeds wilted along the roadside.
