Inspection Photos

ID: 412161

Operator: WAPITI OPERATING LLC

Inspection Date: 8/1/2022

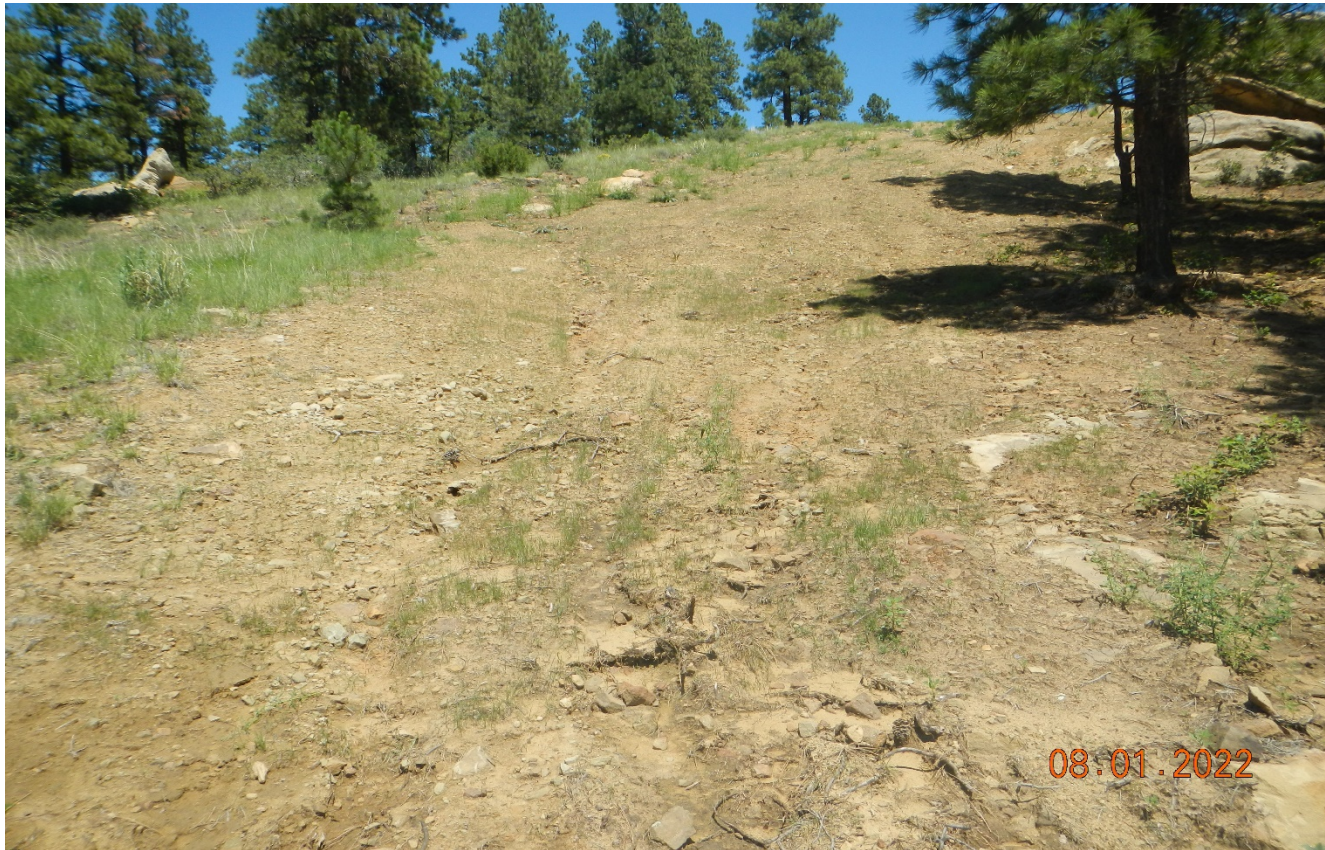
Photo 1. Facing northwest at the disturbance along the gathering pipeline at Lat/Long:37.05440,-104.76614. This area has been reseeded however, soils are not stabilized and there is now erosion occurring.

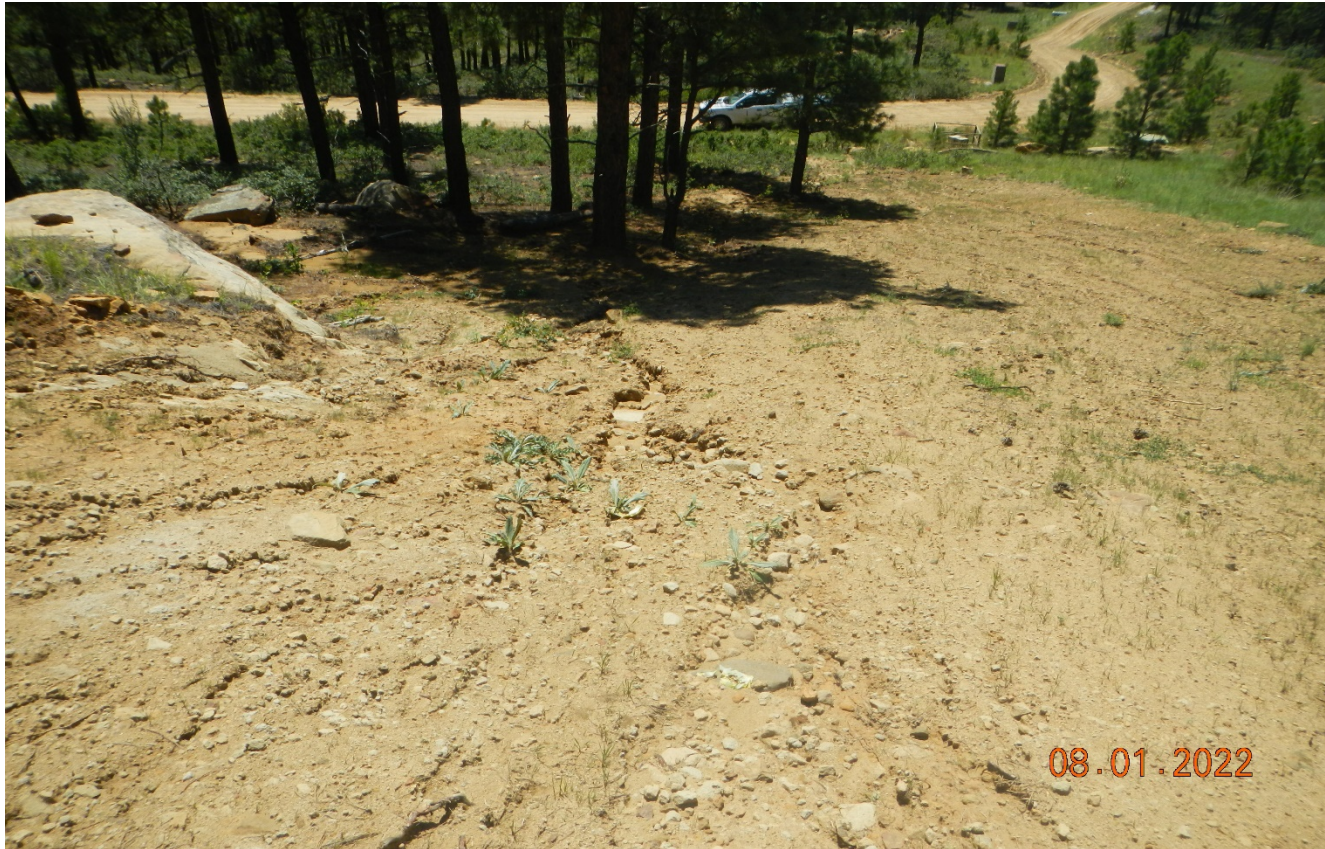
Photo 2. Facing southeast along the pipeline disturbance. There are signs of erosion occurring.

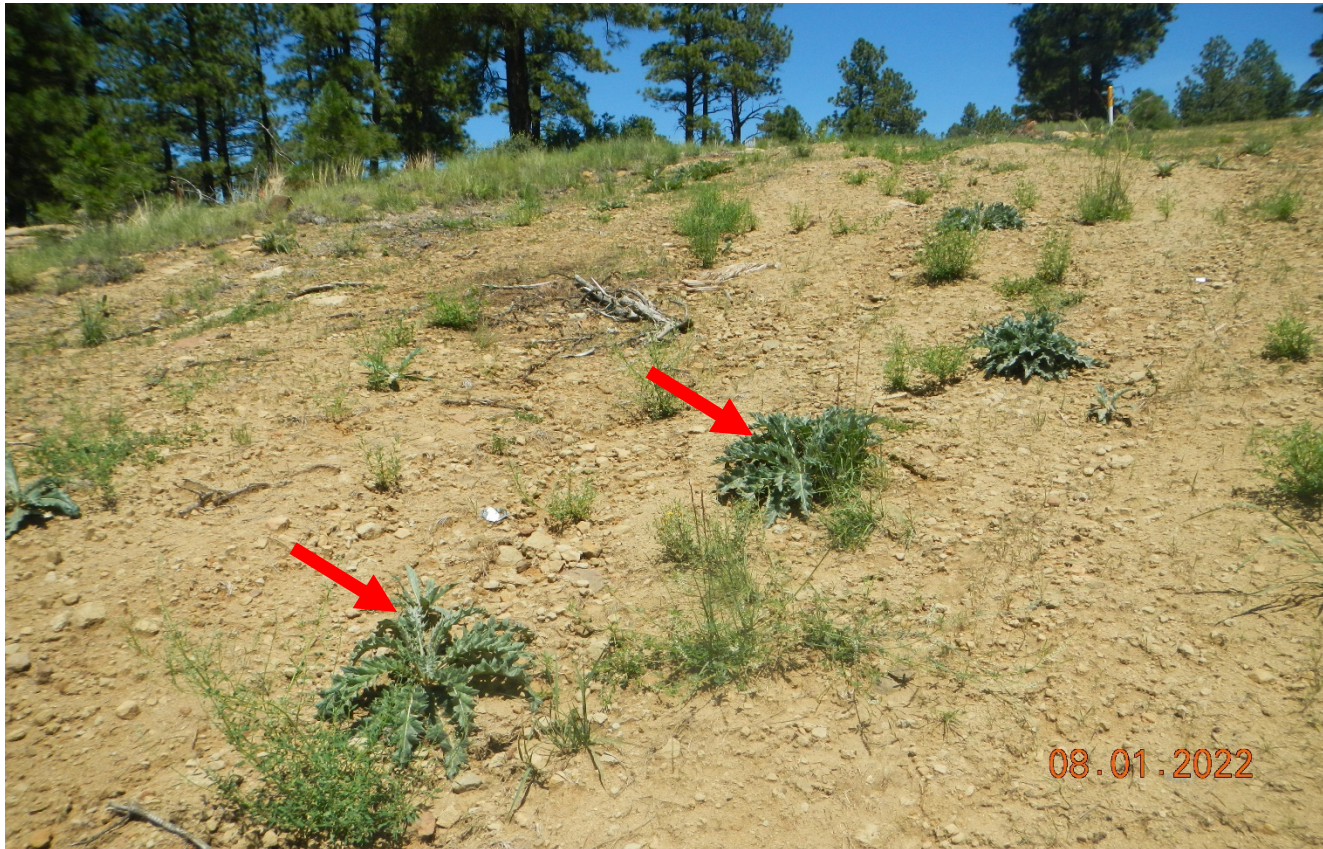
Photo 3. Facing northwest along the pipeline disturbance. There are noxious weeds beginning to establish which must be controlled.

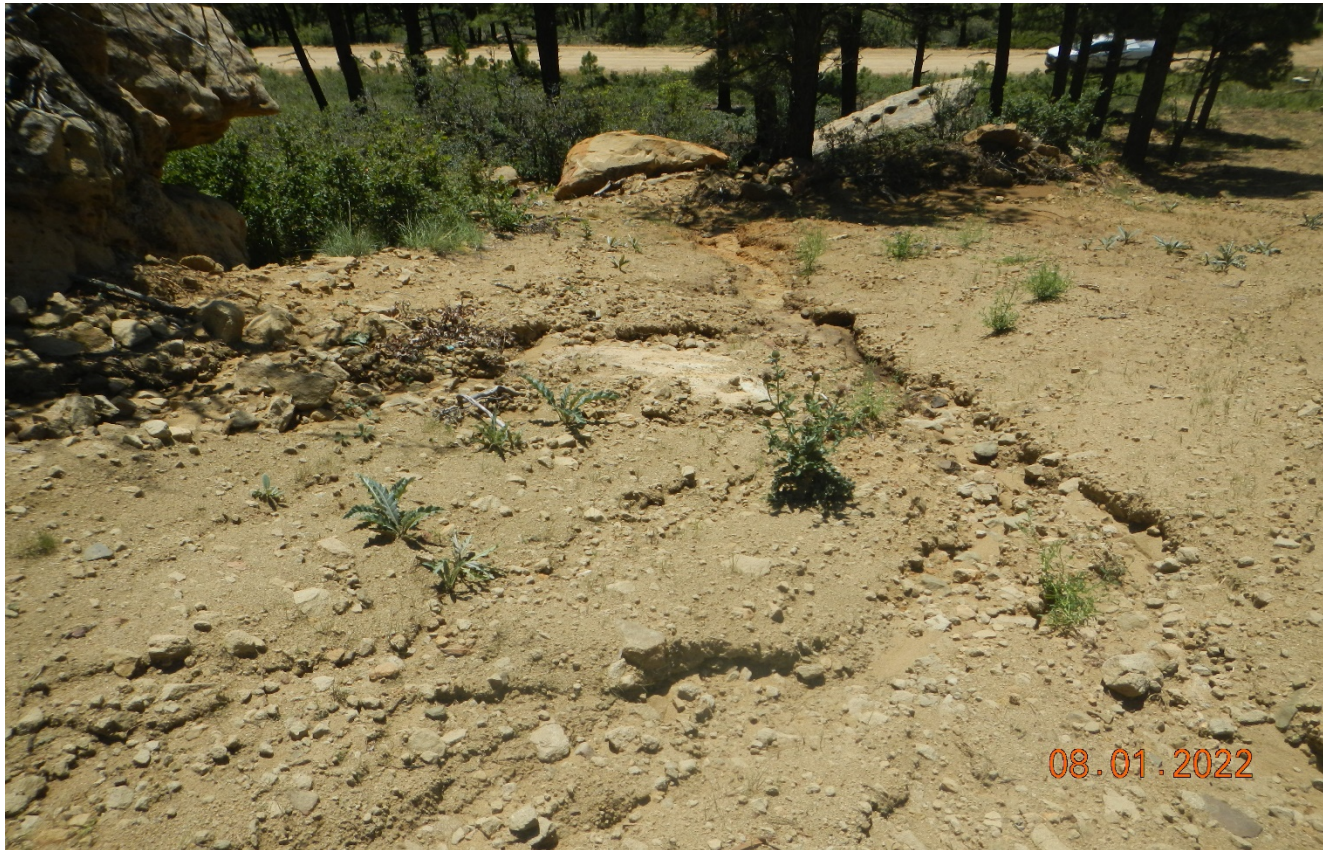
Photo 4. View of some of the erosion occurring. Additional BMP's are needed to prevent erosion.
