Inspection Photos

Location Name: TEP ROCKY MOUNTAIN LLC WATSON RANCH PAD /24B-17-07-95

Location ID: 413055

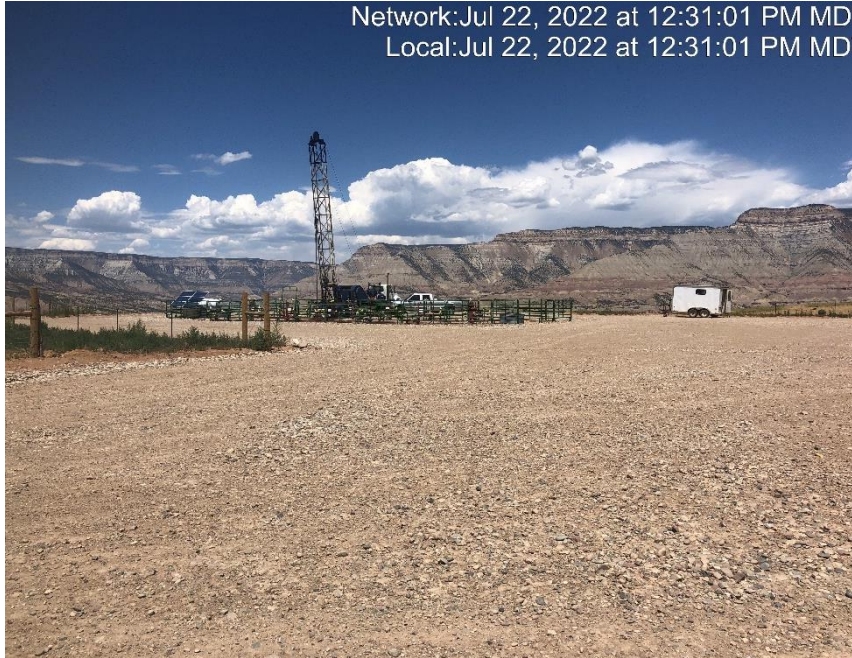
Photo #7247 from entrance to location.

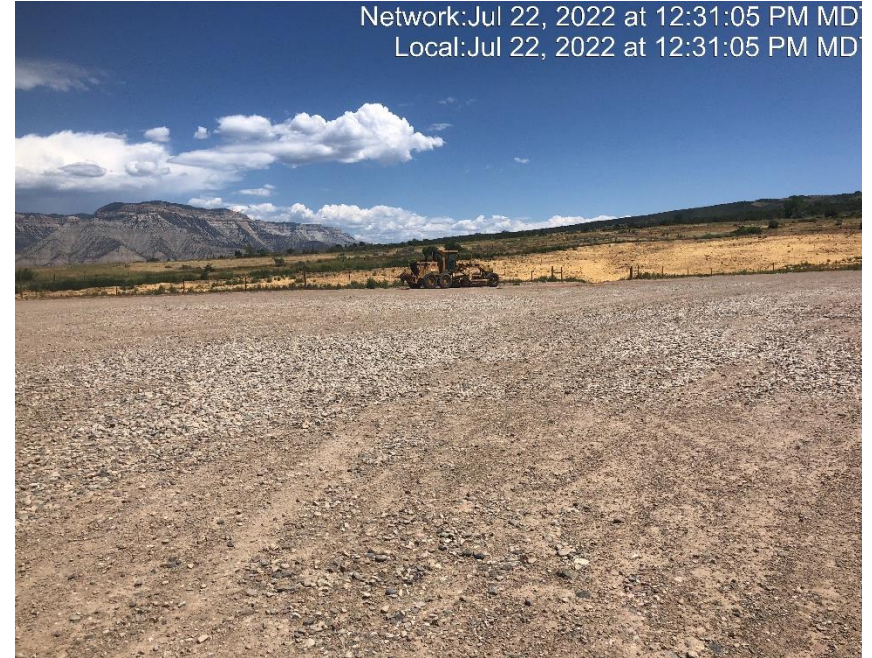
Photo #7248 from entrance to location.

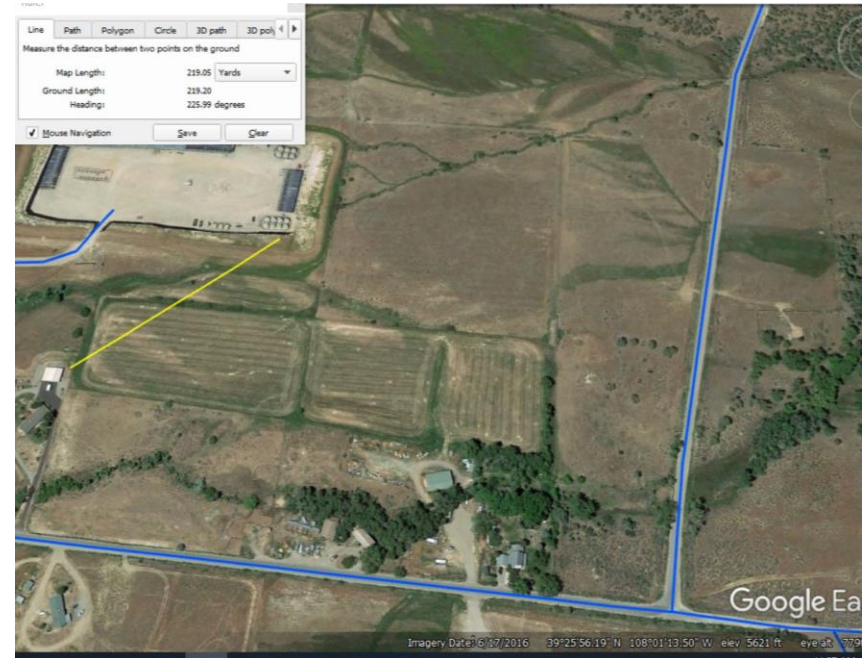
Photo #7249 from entrance to location.

Approximate distance to nearest residents 220 yards.

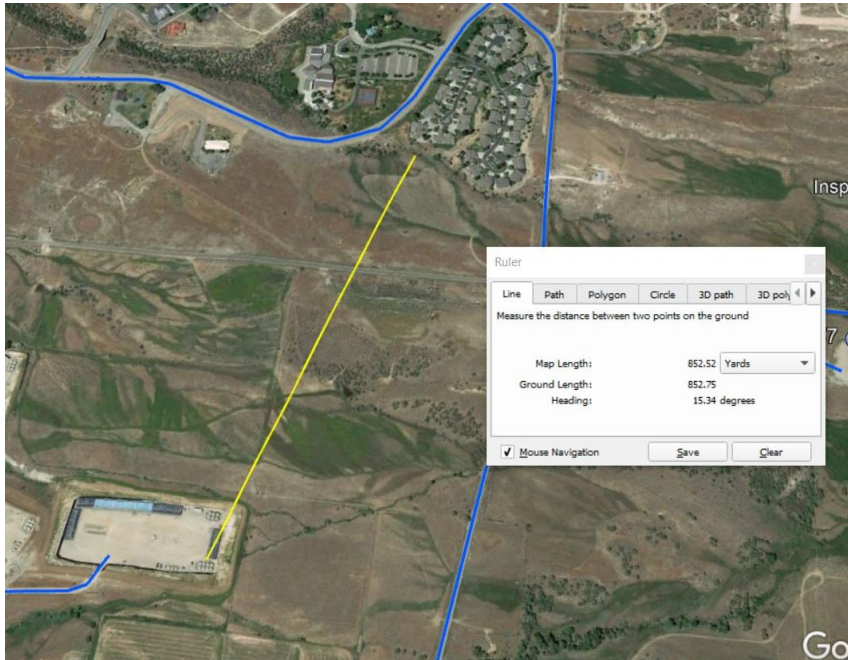
Approximate distance to nearest subdivision.

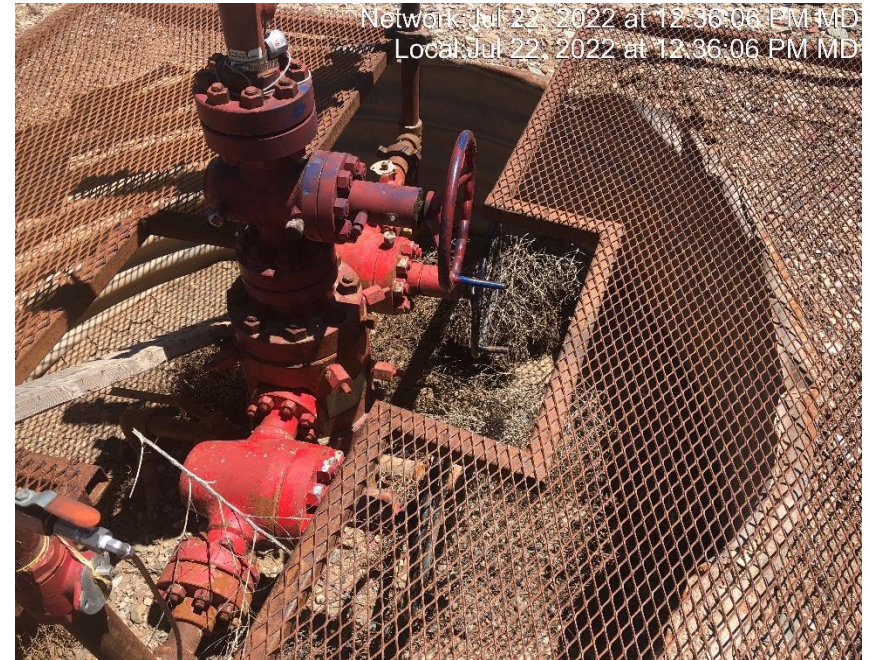
Photo #7252 Multiple places with debris on location.

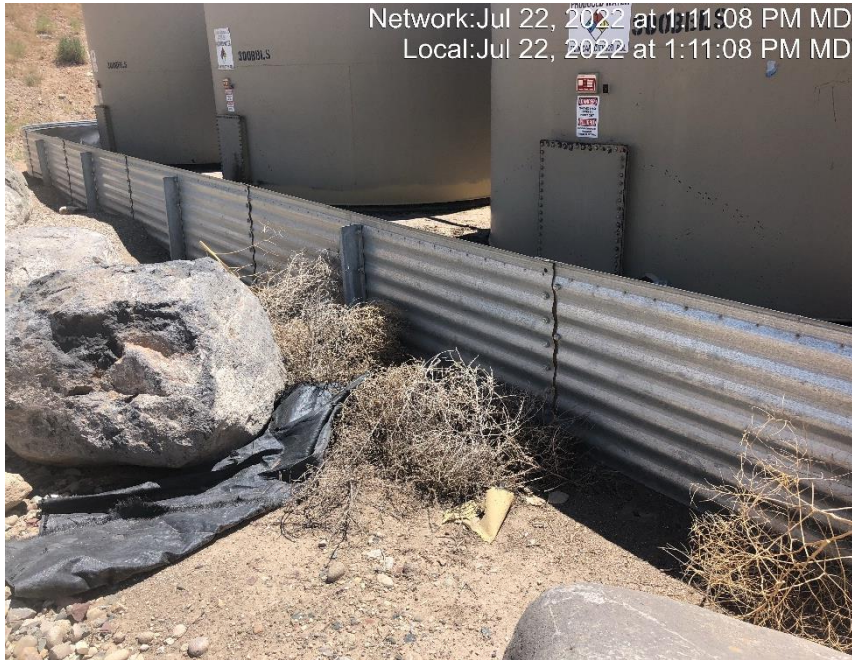
Photo #7280 Multiple places with debris on location.

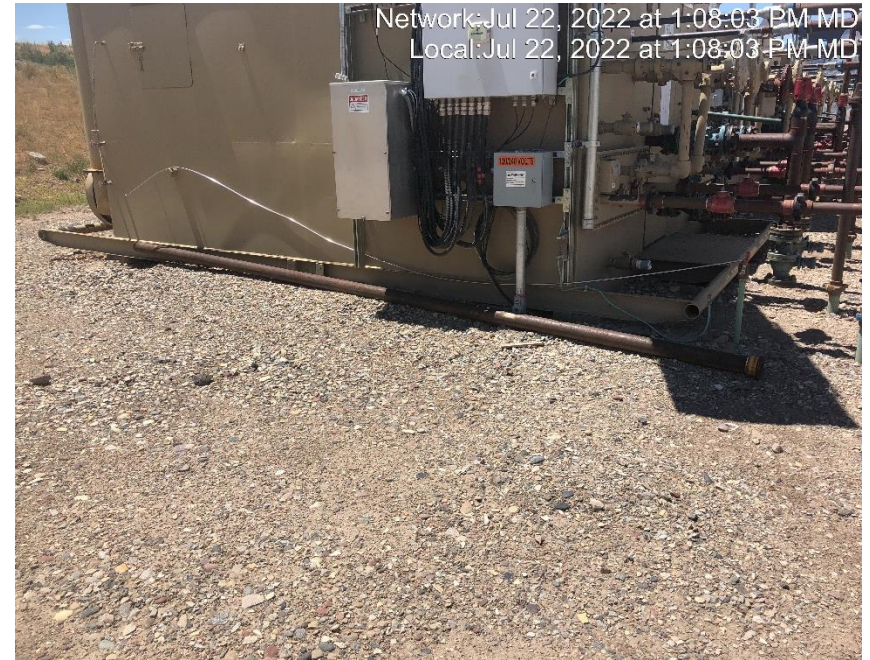
Photo #7271 Unused equipment on location.

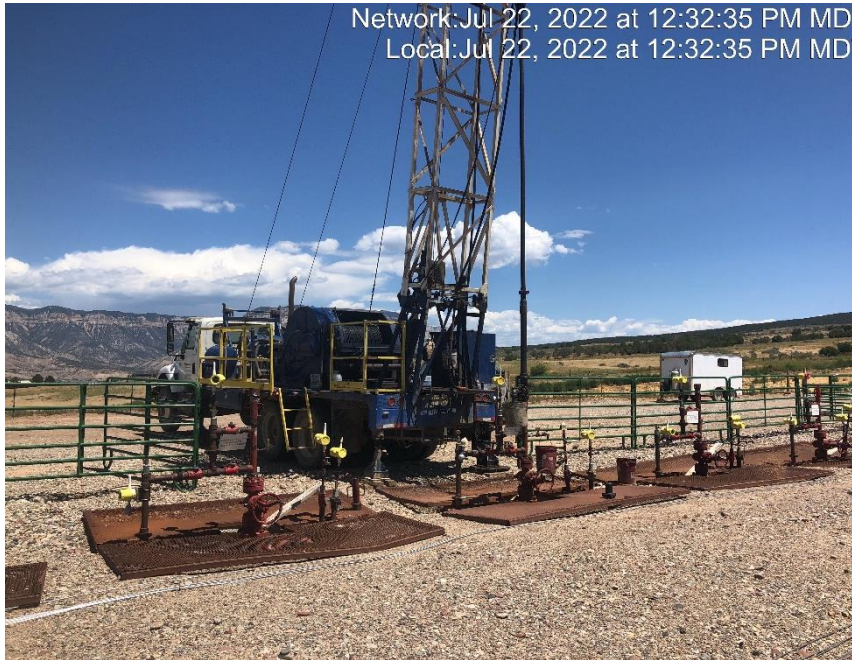
Photo #7250 Swabbing truck rigged up on well 23A-17-07.

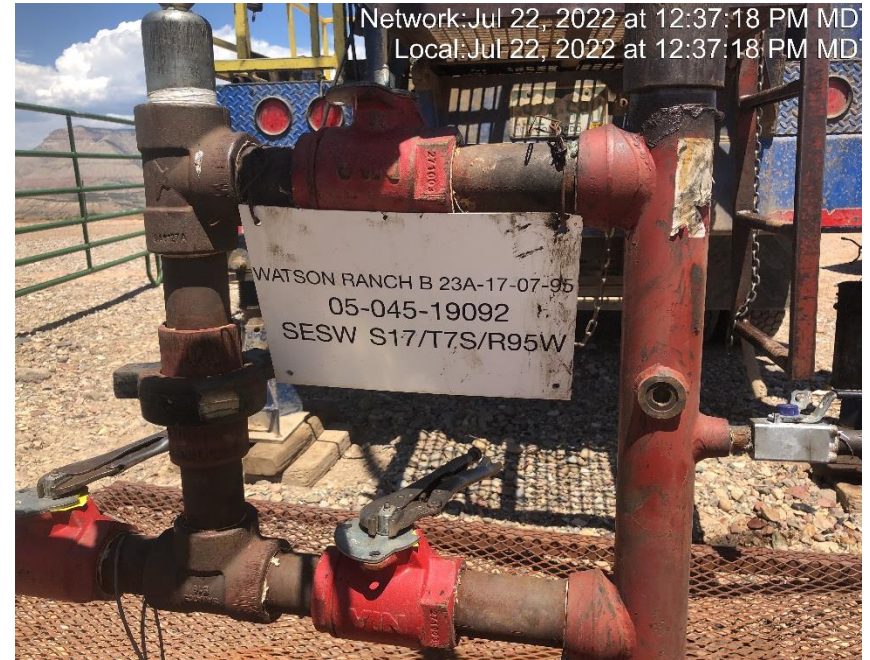
Photo #7253 Swabbing truck rigged up on well 23A-17-07

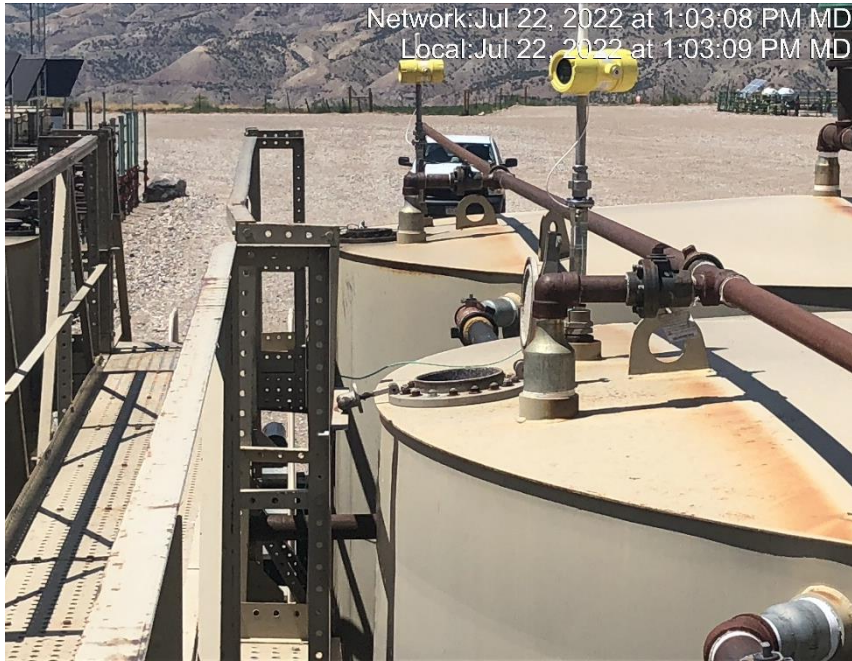
Photo #7255 Thief hatches opened for depressurizing tank battery.

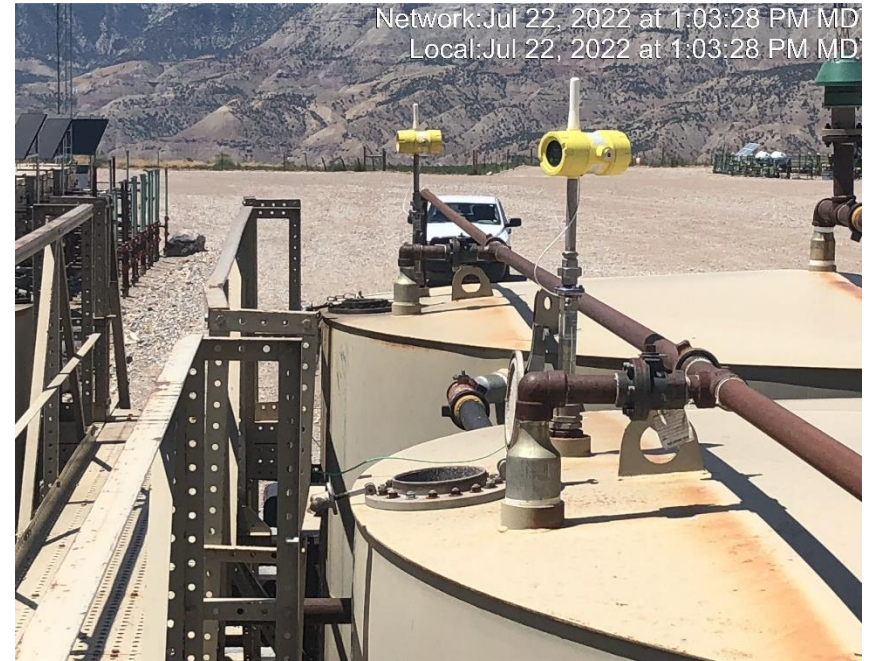
Photo #7256 Thief hatches opened for depressurizing tank battery.

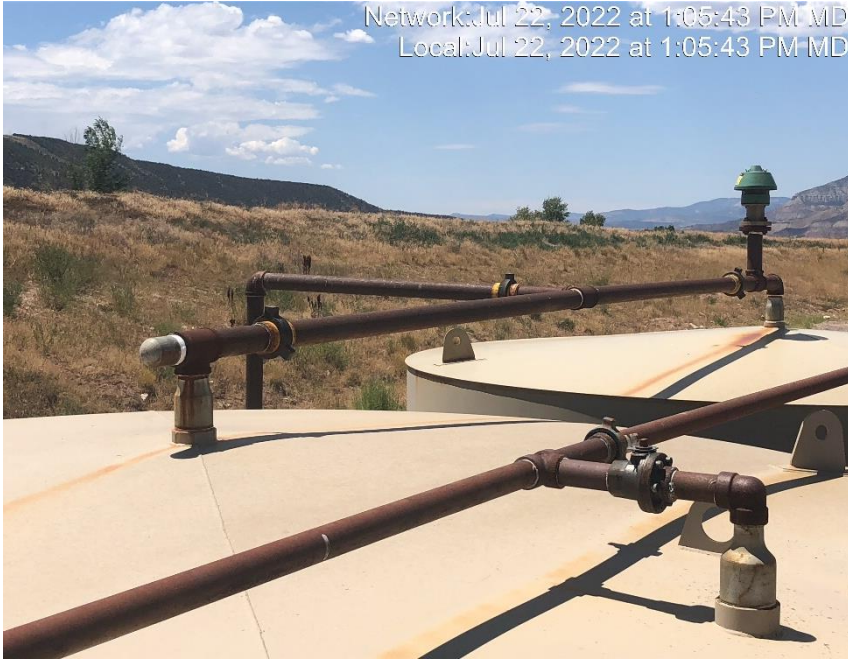
Photo #7358 Vent line on condensate side of tank battery.

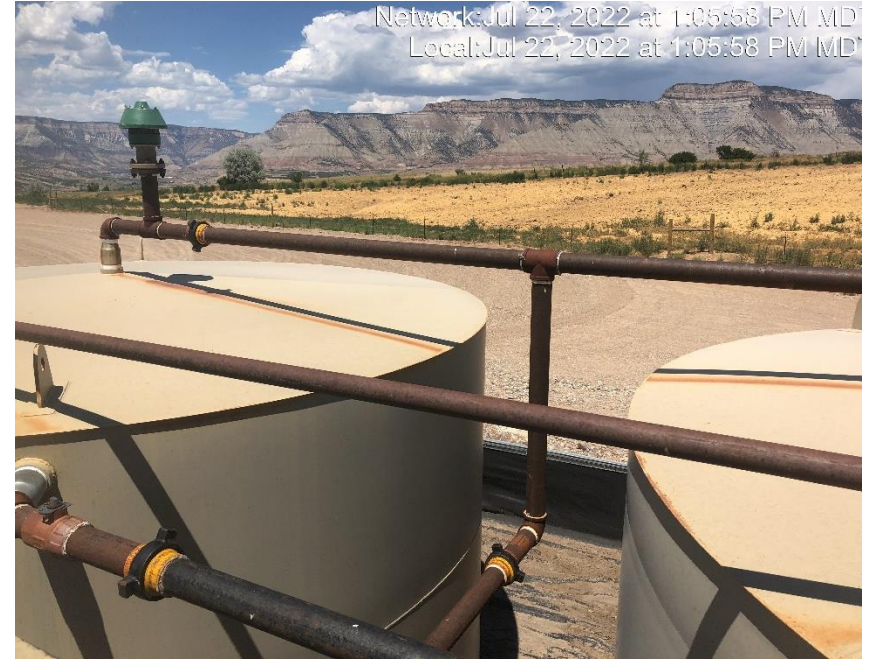
Photo #7260 Vent line on Produced water side of tank battery.

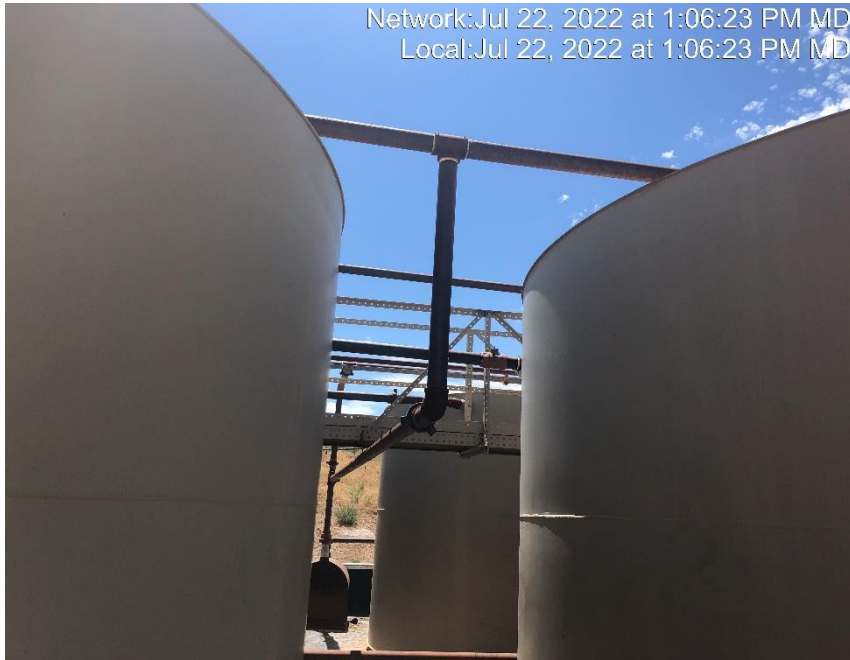
Photo #7262 Vent line from produced water tank to condensate tanks no isolation.

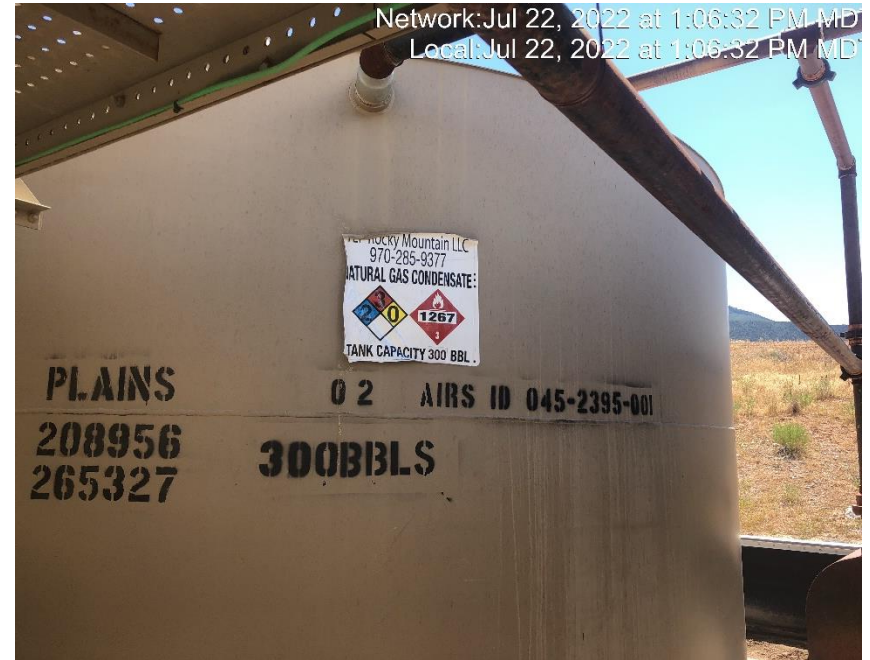
Photo #7263 Condensate tanks and AIRS ID.

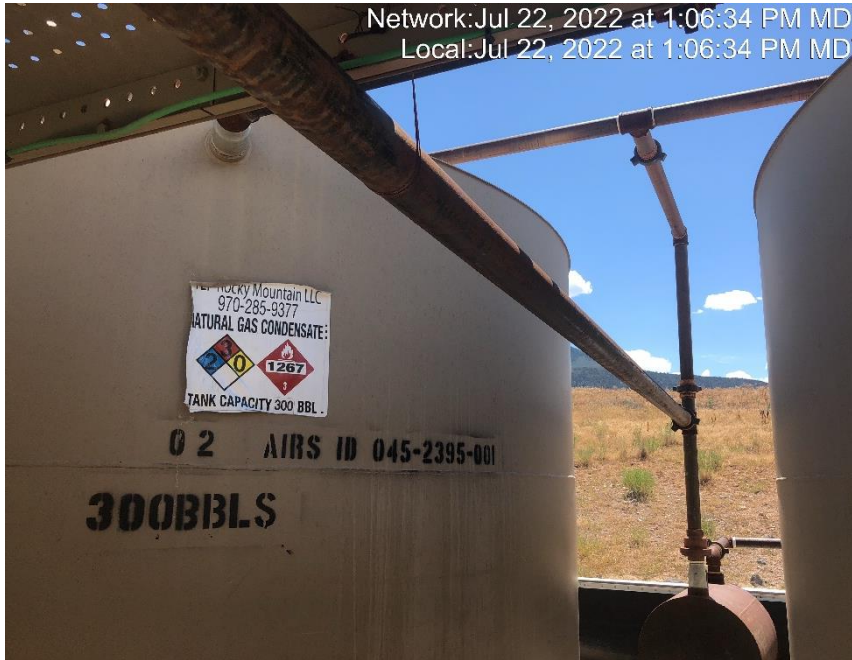
Photo #7264 Condensate tanks, AIRS ID and fluid knock out.

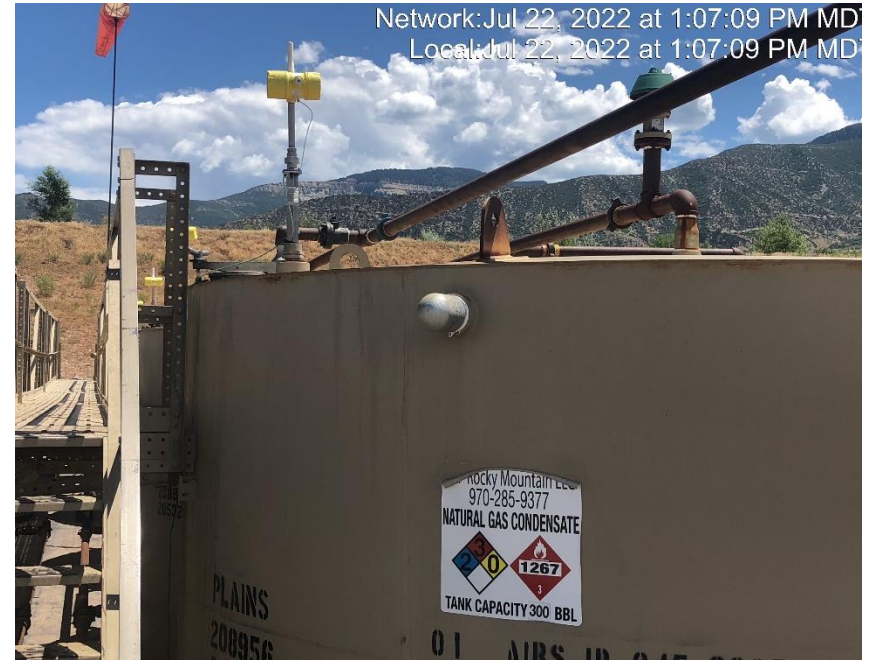
Photo #7264 Condensate tanks.

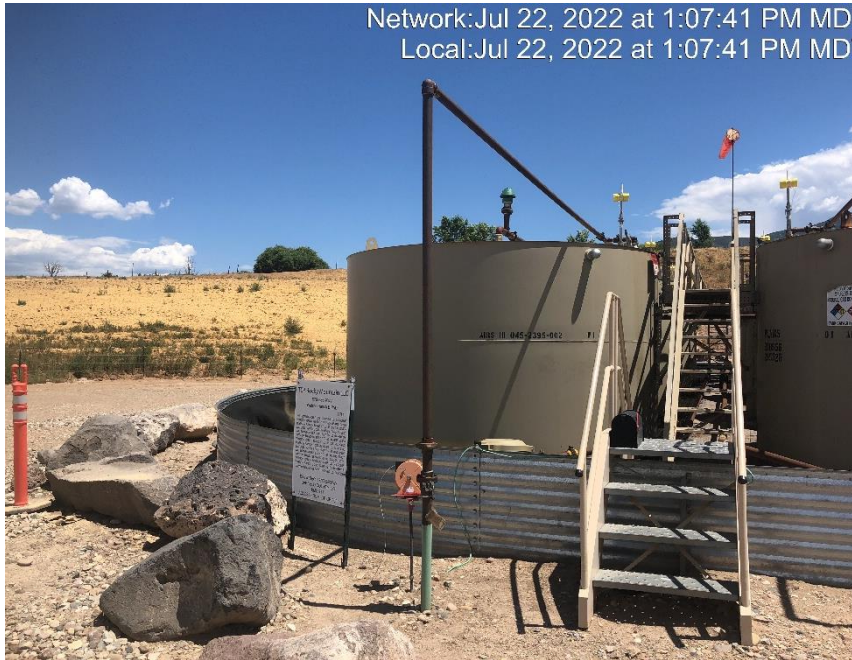
Photo #7268 Produced water tank dump line.

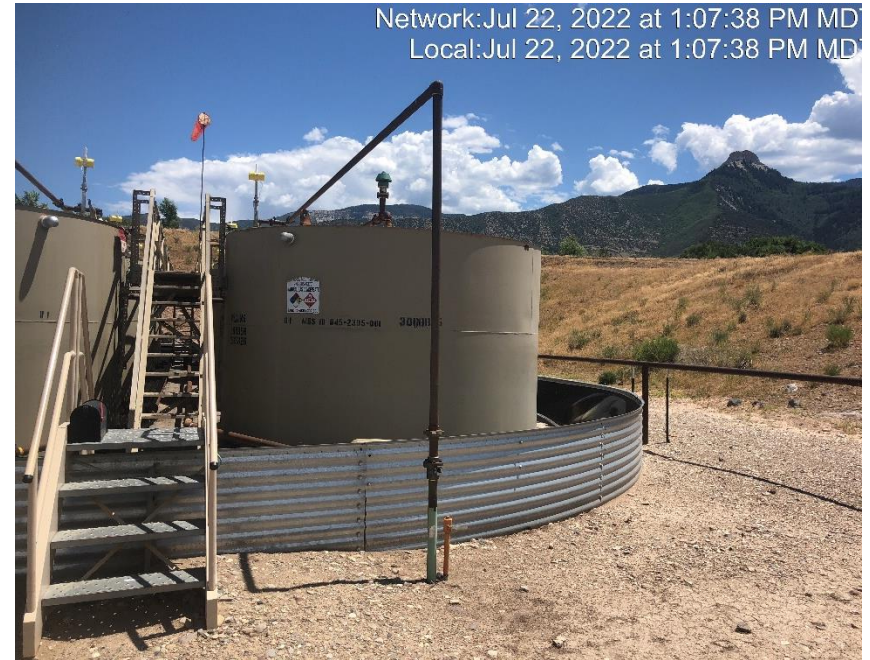
Photo #7269 Condensate dump line.

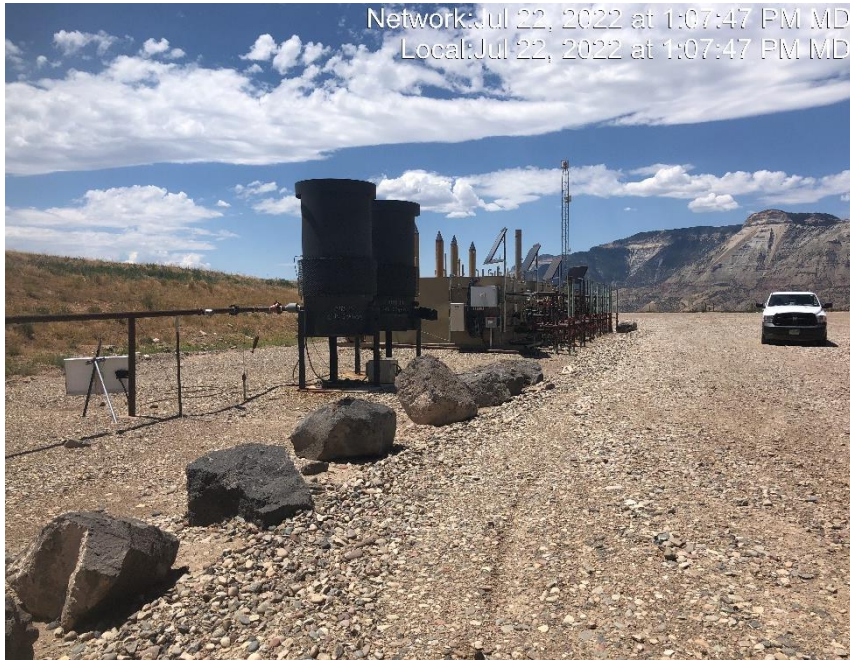
Photo #7270 Vent line coming from tank battery to combustors.

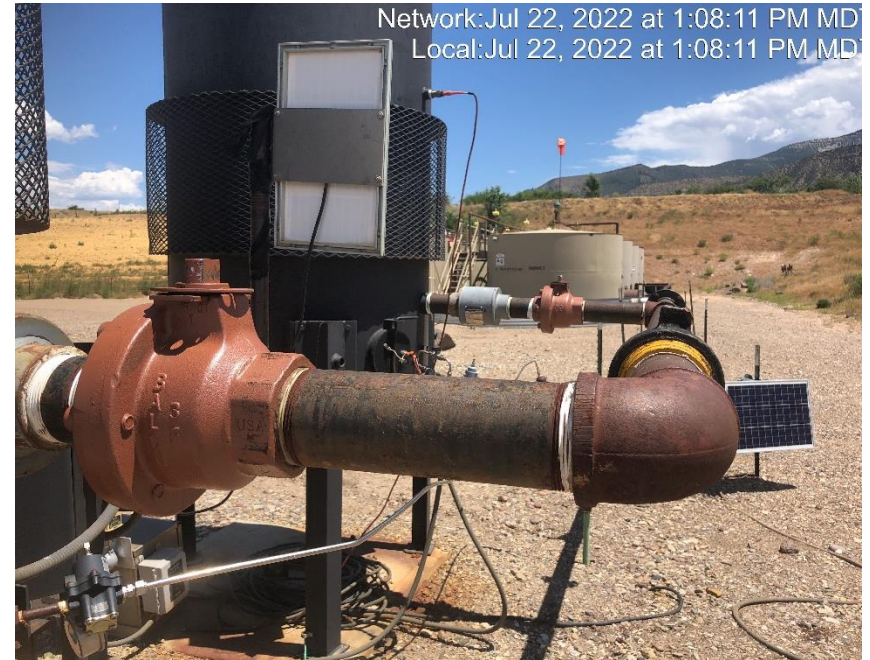
Photo #7272 combustors isolated from tank battery.

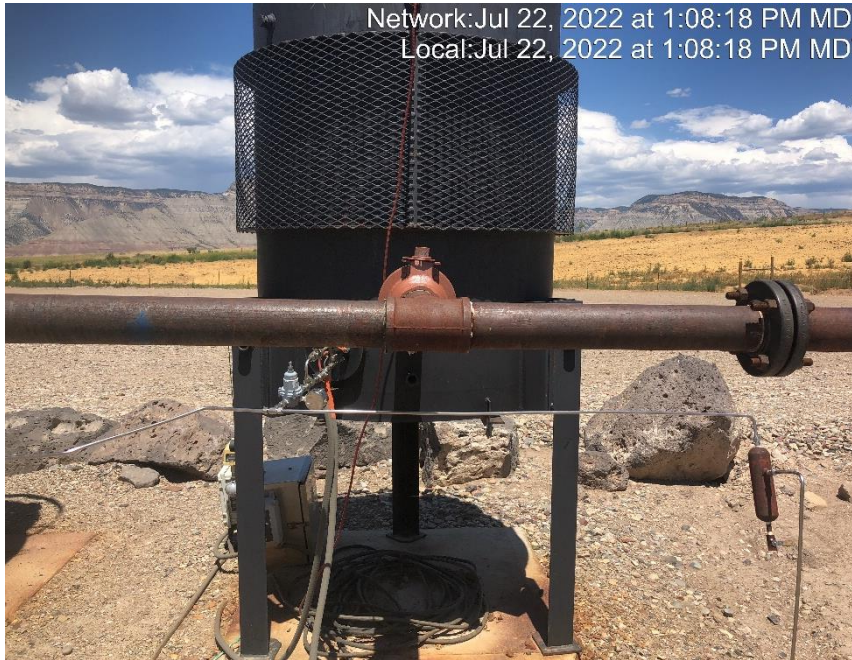
Photo #7273 Combustor isolated from tank battery.

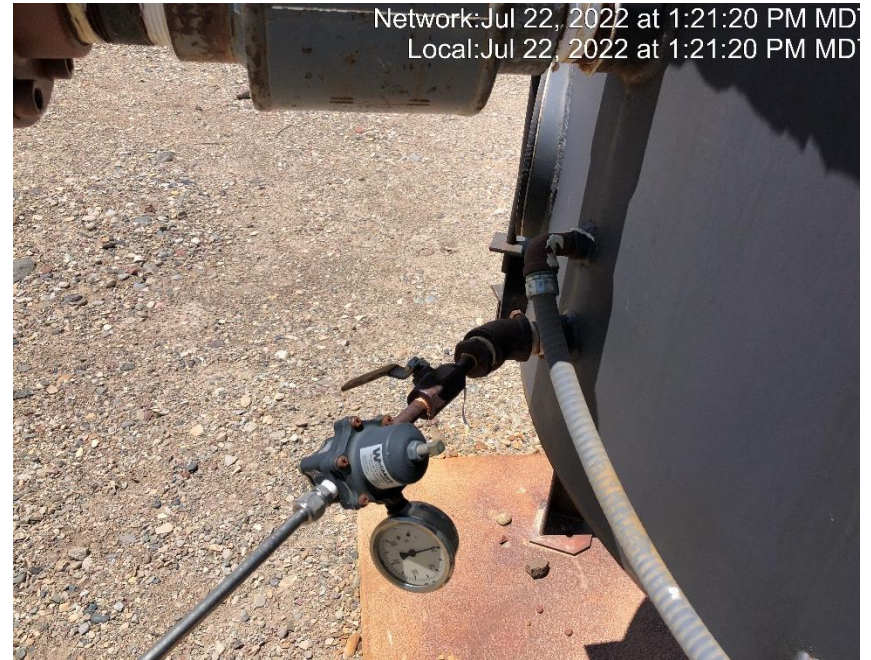
Photo #7282 Pilot supply gas shut.

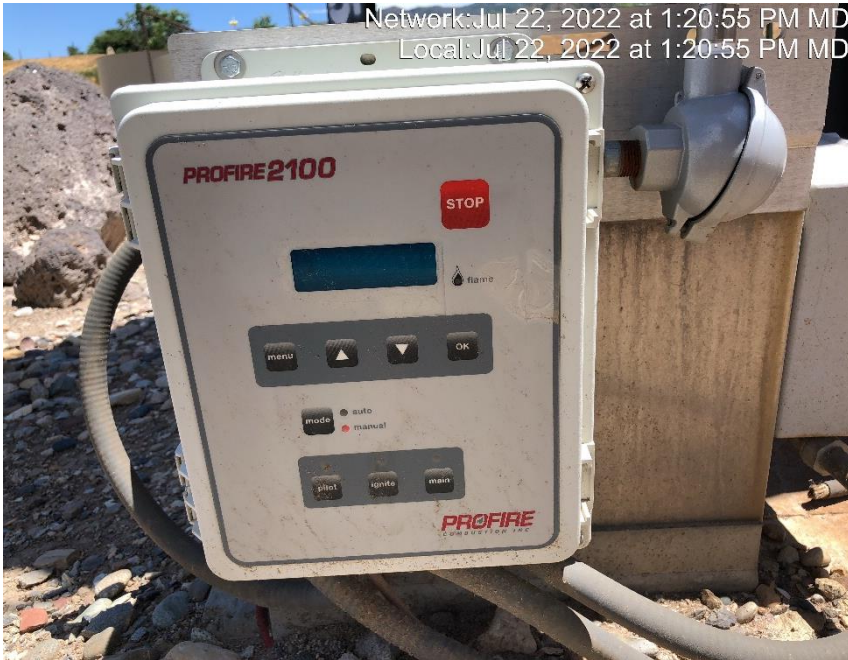
Photo #7281 Profire 2100 does not appear to be on.

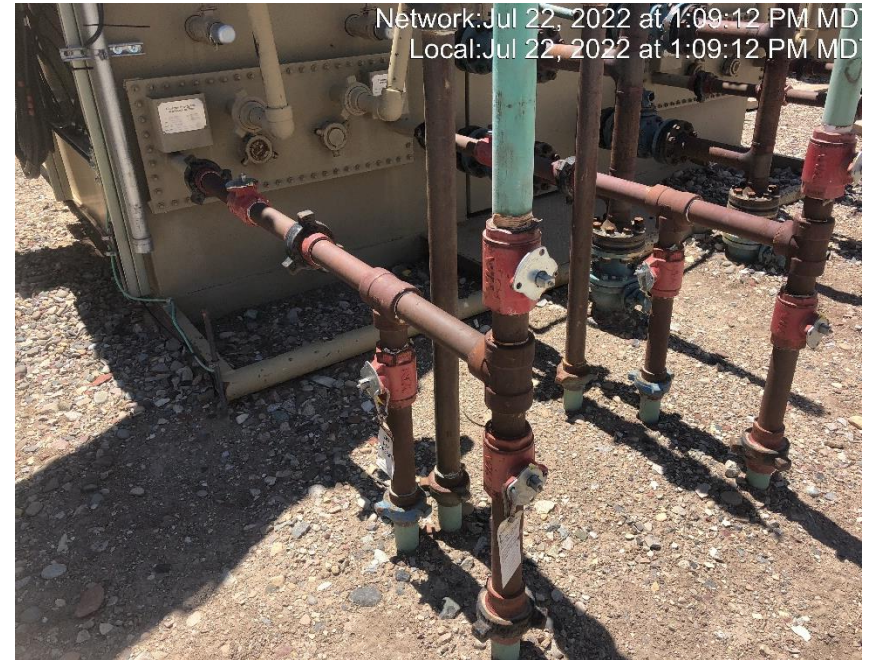
Photo #7276 23A-17-07 well blowdown line open to produced water tank and isolated from the separator.
