Inspection Photos

Location Name: TEP ROCKY MOUNTAIN LLC Monument Ridge Pad /

Location ID: 422286

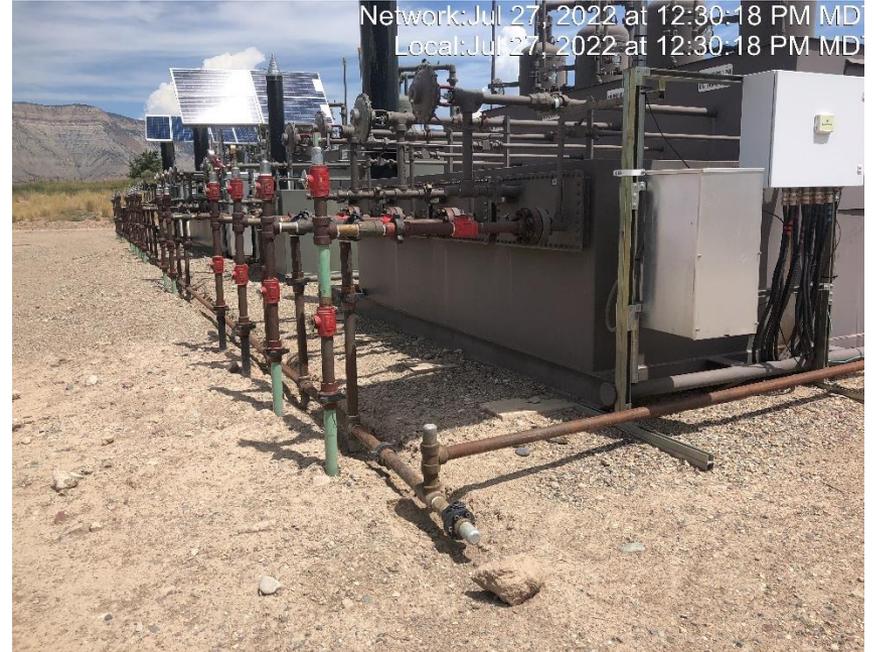
Photo #7320 2" flowline system that manifolds all 16 wells together.

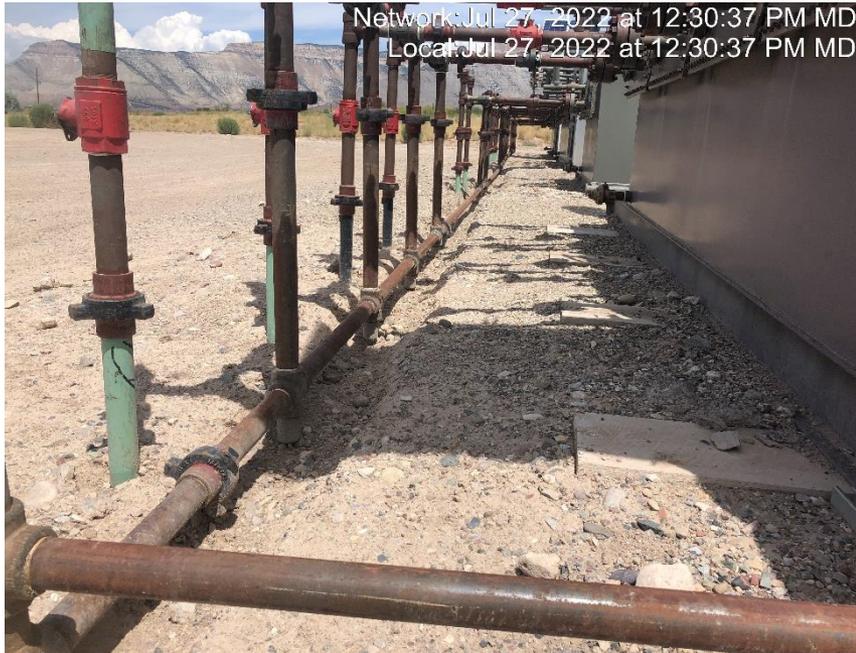
Photo #7321 It appears the 2" line has been added post location construction.

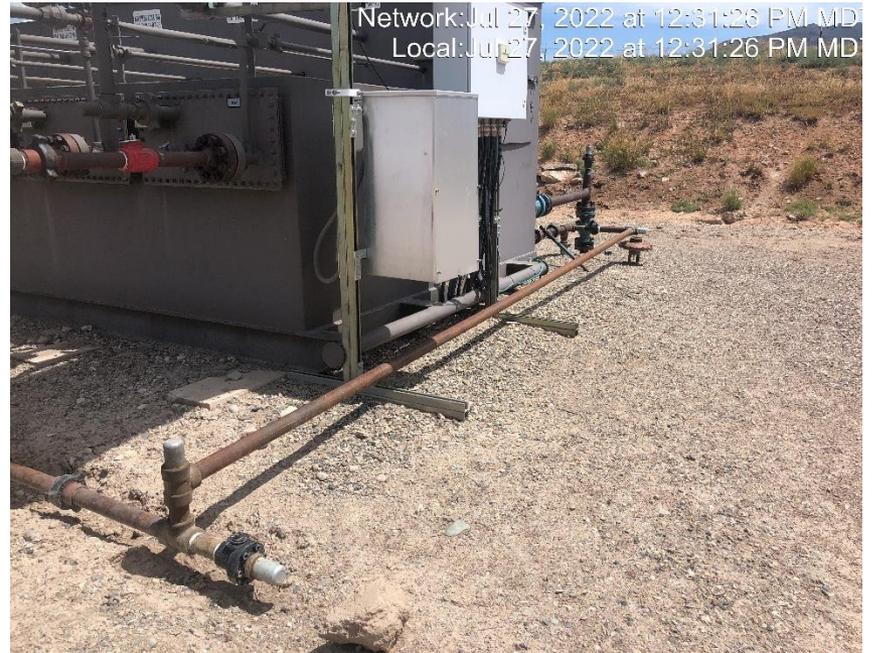
Photo #7324 2" flowline appears to have been added for liquid unloading operations.

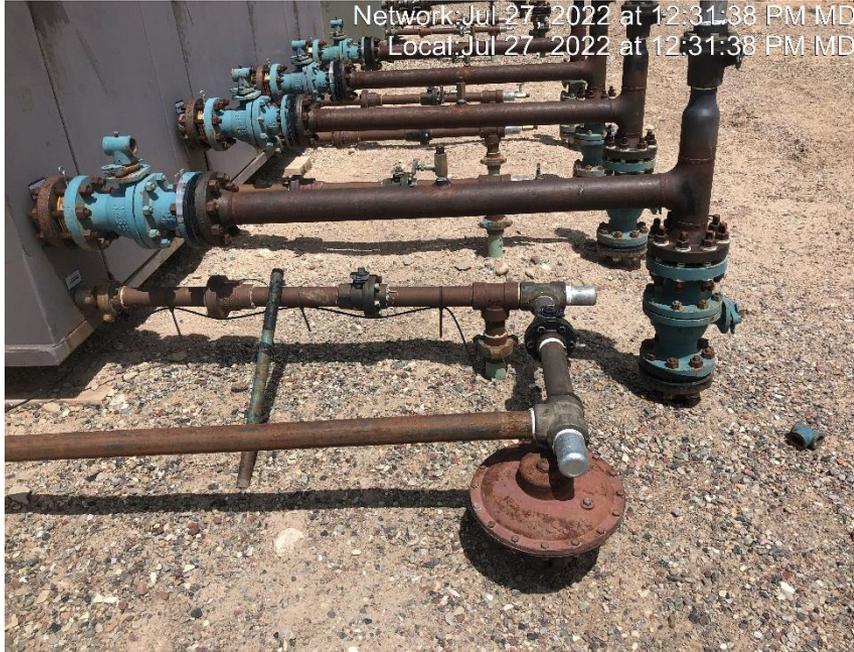
Photo #7325 2" line dumps into singular tank battery dump line.

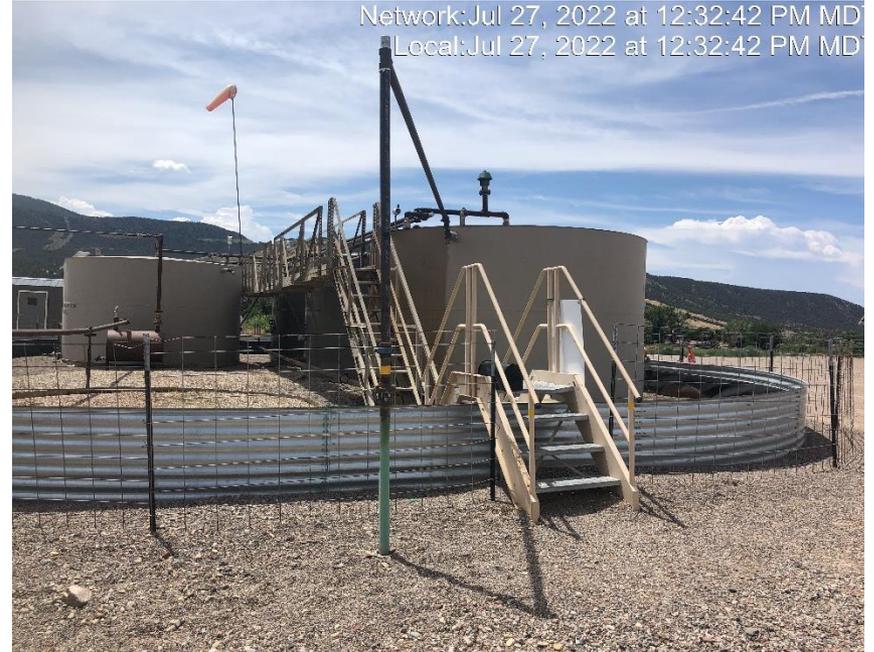
Photo #7327 Only dump line into tank battery.

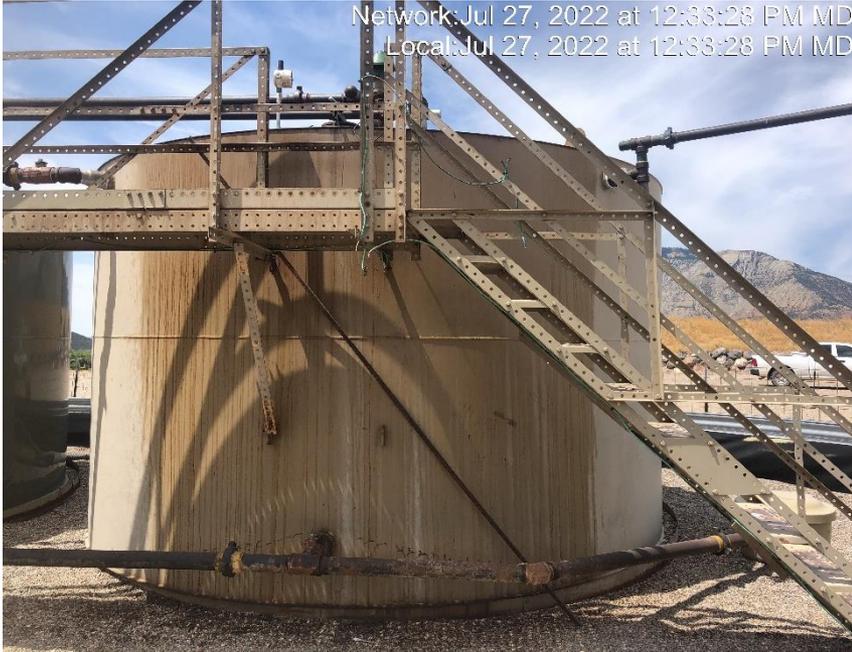
Photo #7329 Oil or condensate staining down tank.

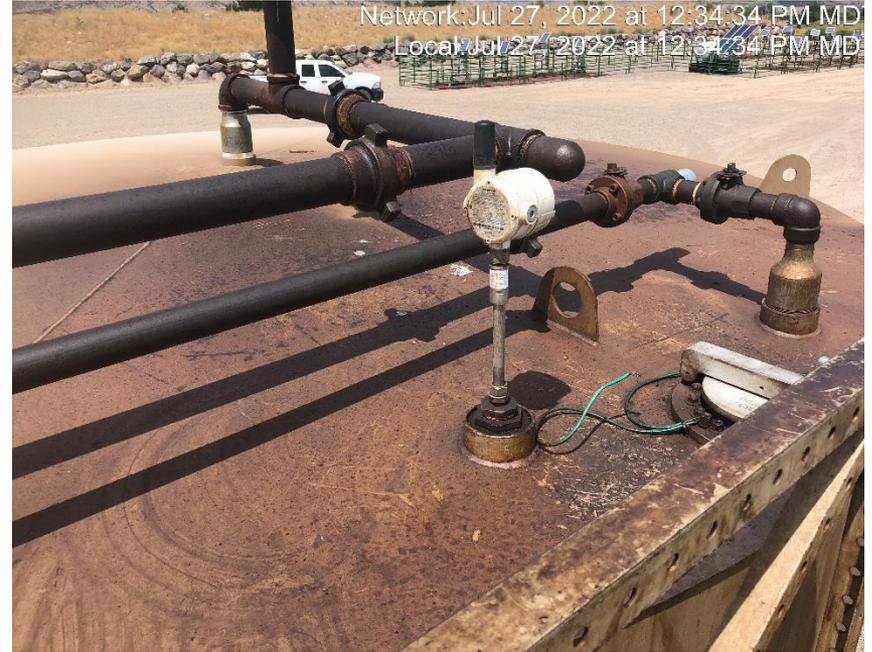
Photo #7331 Staining on top of tank indicates the tank has been over pressured.

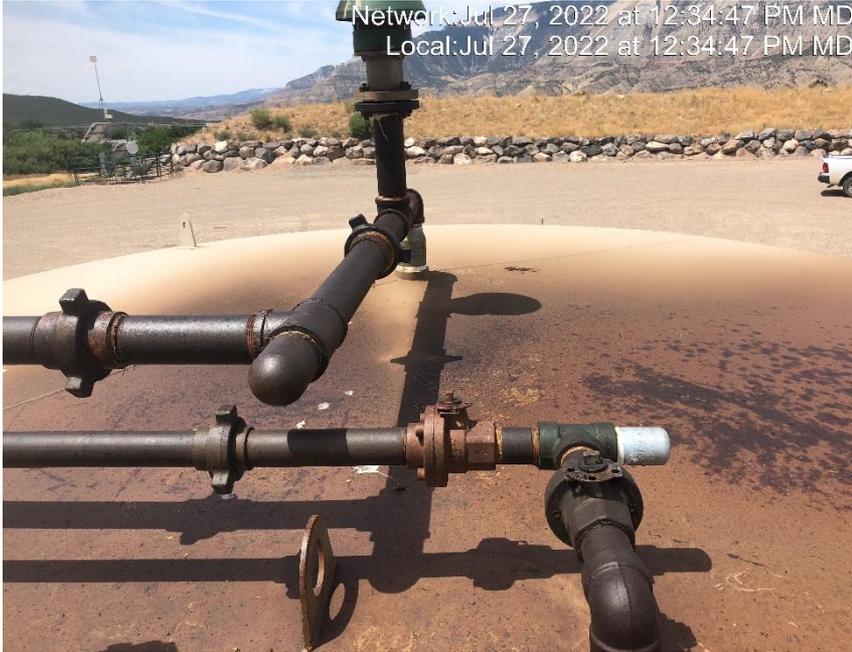
Photo #7333 Staining on top of tank indicates the tank has been over pressured.

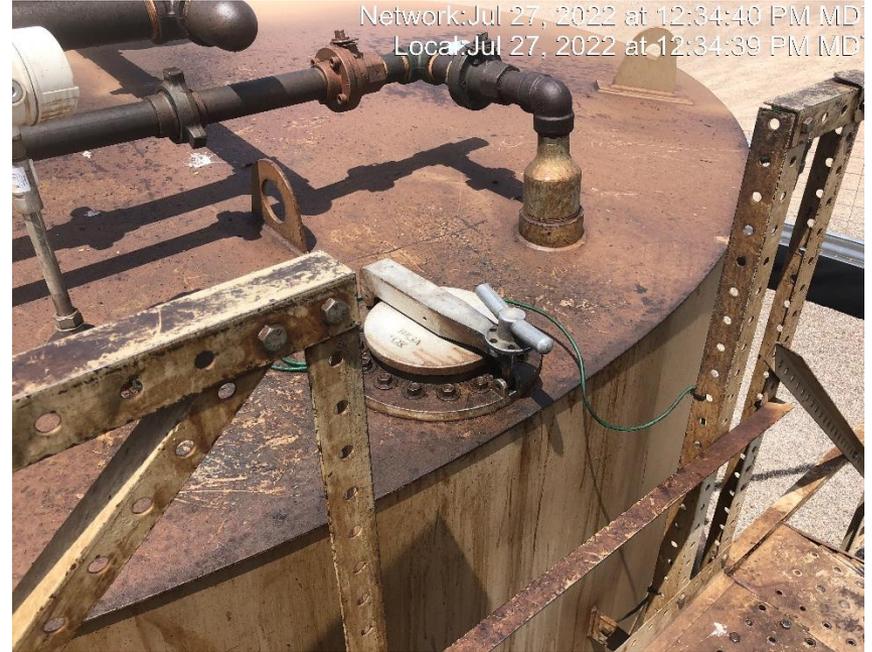
Photo #7332 Staining on top of tank indicates the tank has been over pressured.

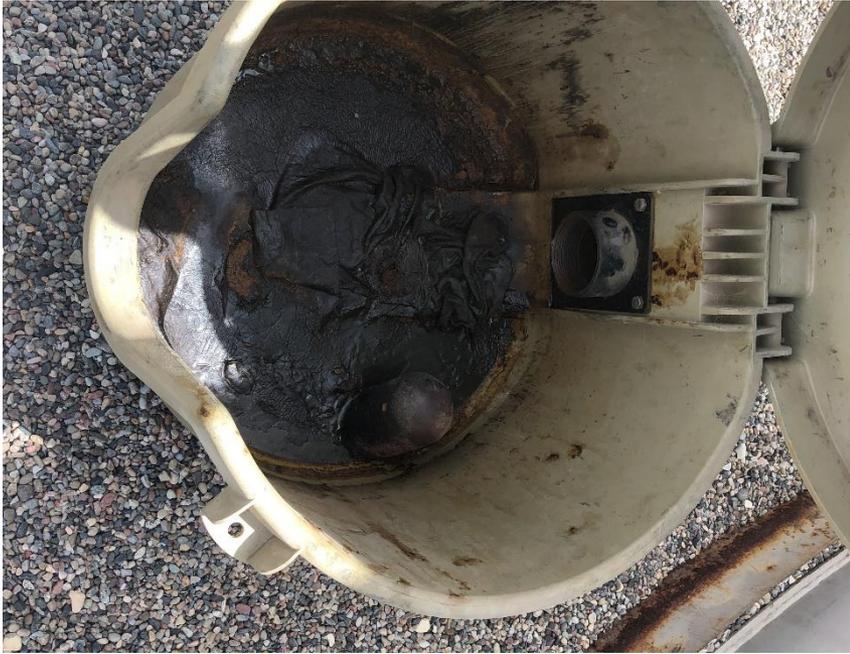
Photo #7328 Loadline open ended.

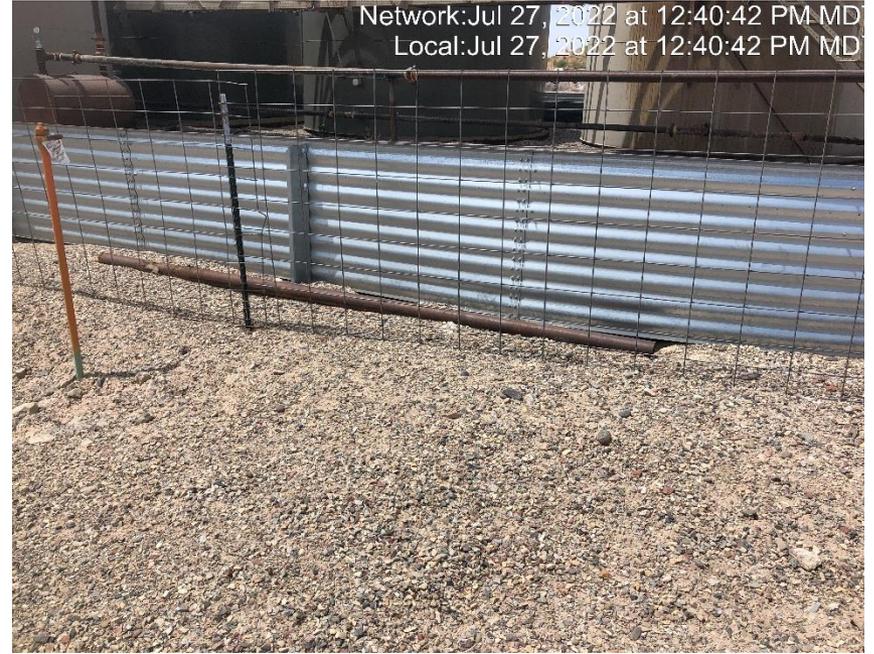
Photo #7335 Unused equipment.

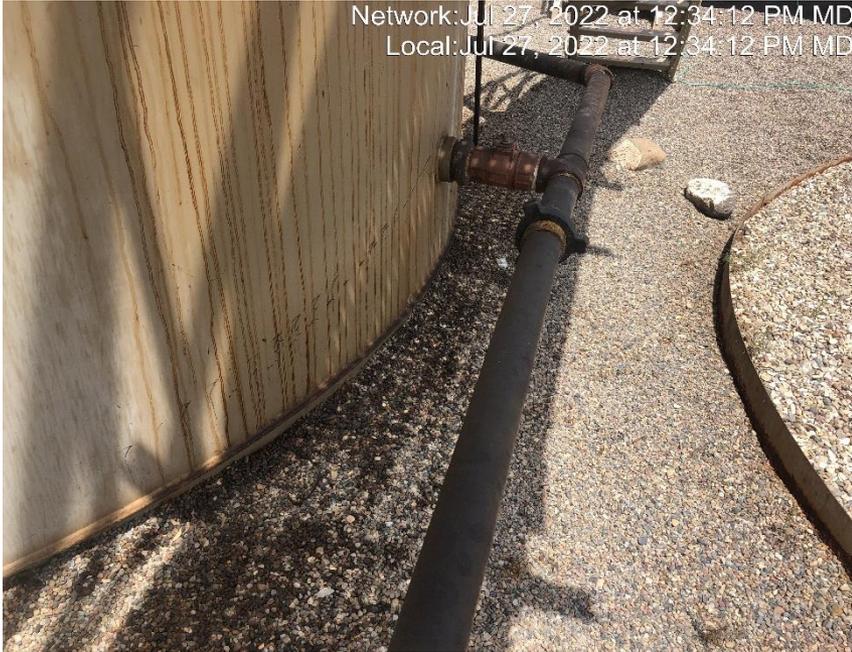
Photo #7330 Stained gravel in tank containment.

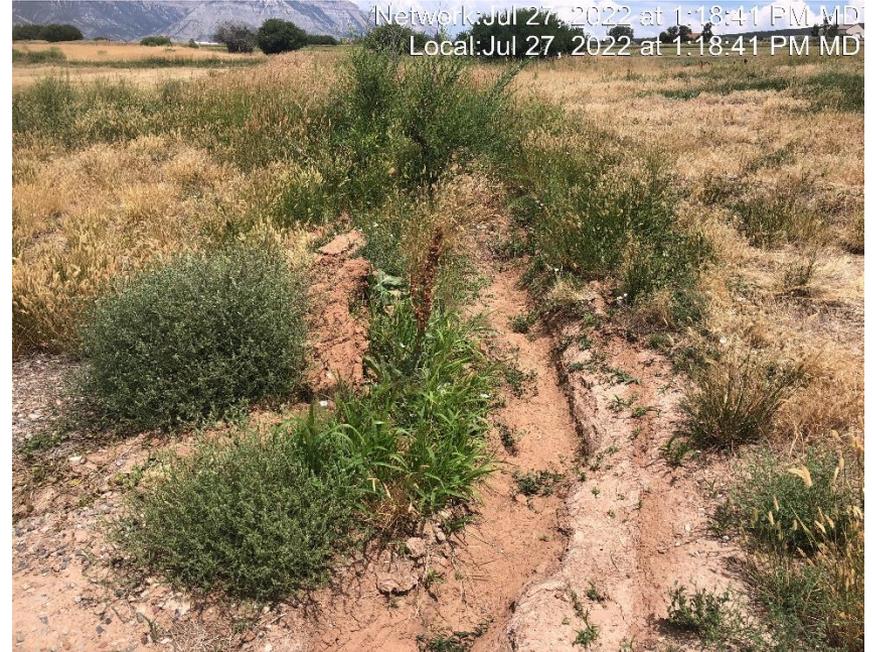
Photo #7336 No form of velocity check in ditch.

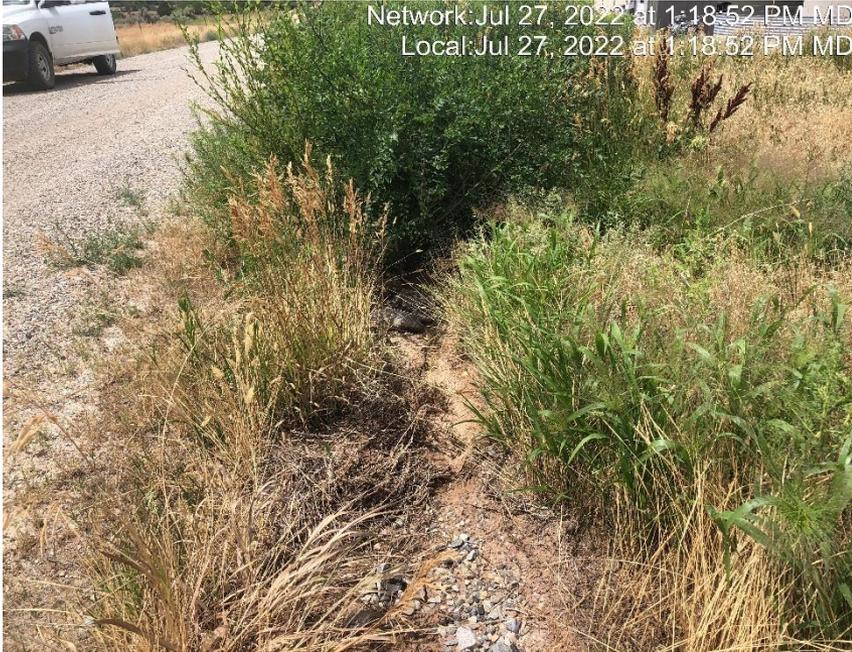
Photo #7338 No form of velocity checks in access road ditch.

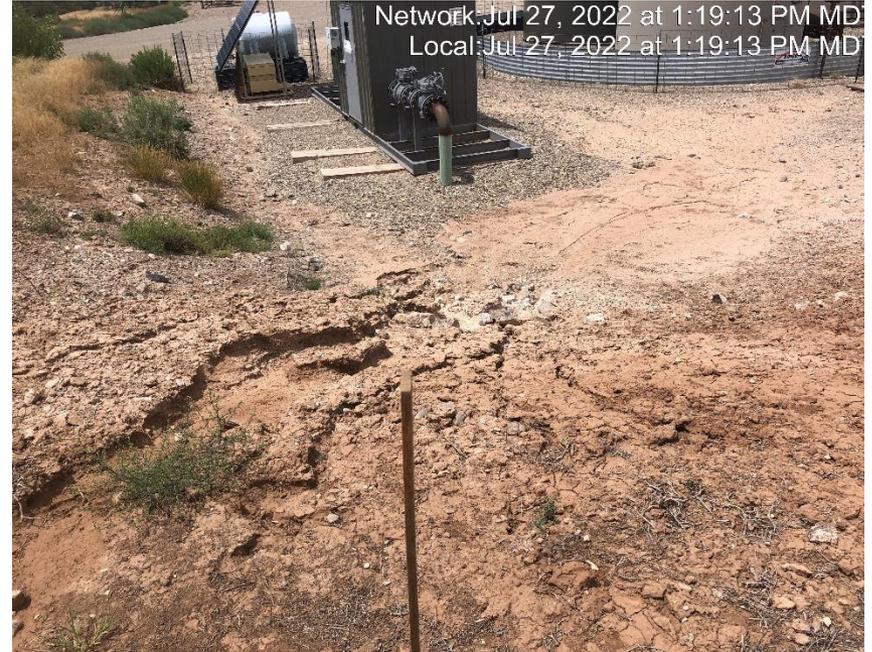
Photo #7339 Rill erosion occurring in North West corner of location.

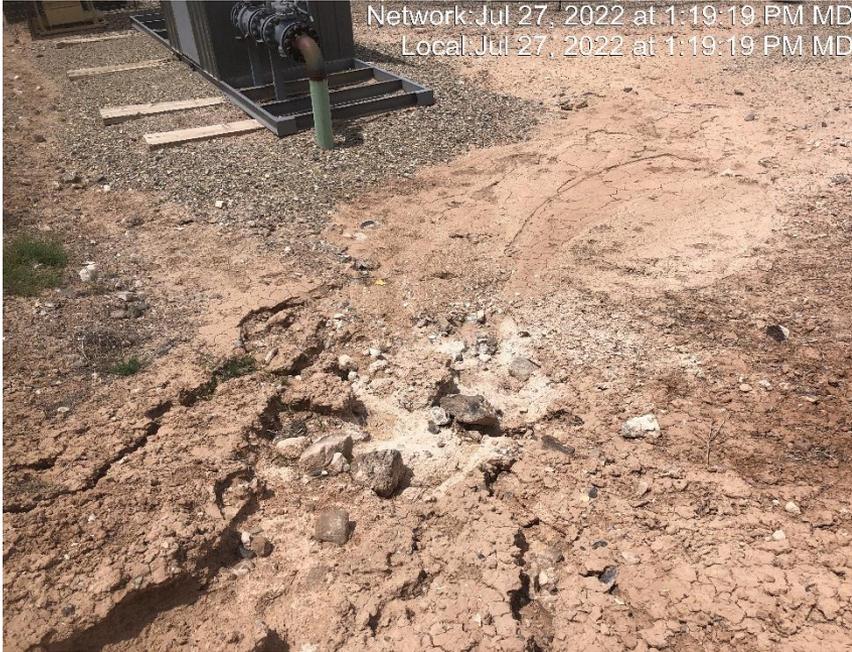
Photo #7340 Run on to location is not being controlled.

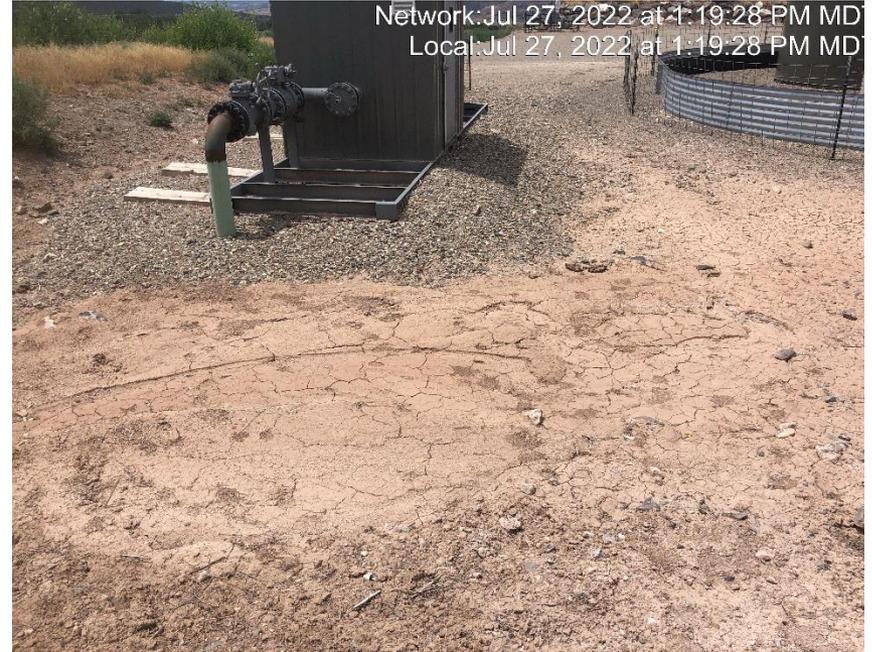
Photo #7341 Run on to location is not being controlled.
