MarCom Photo Template

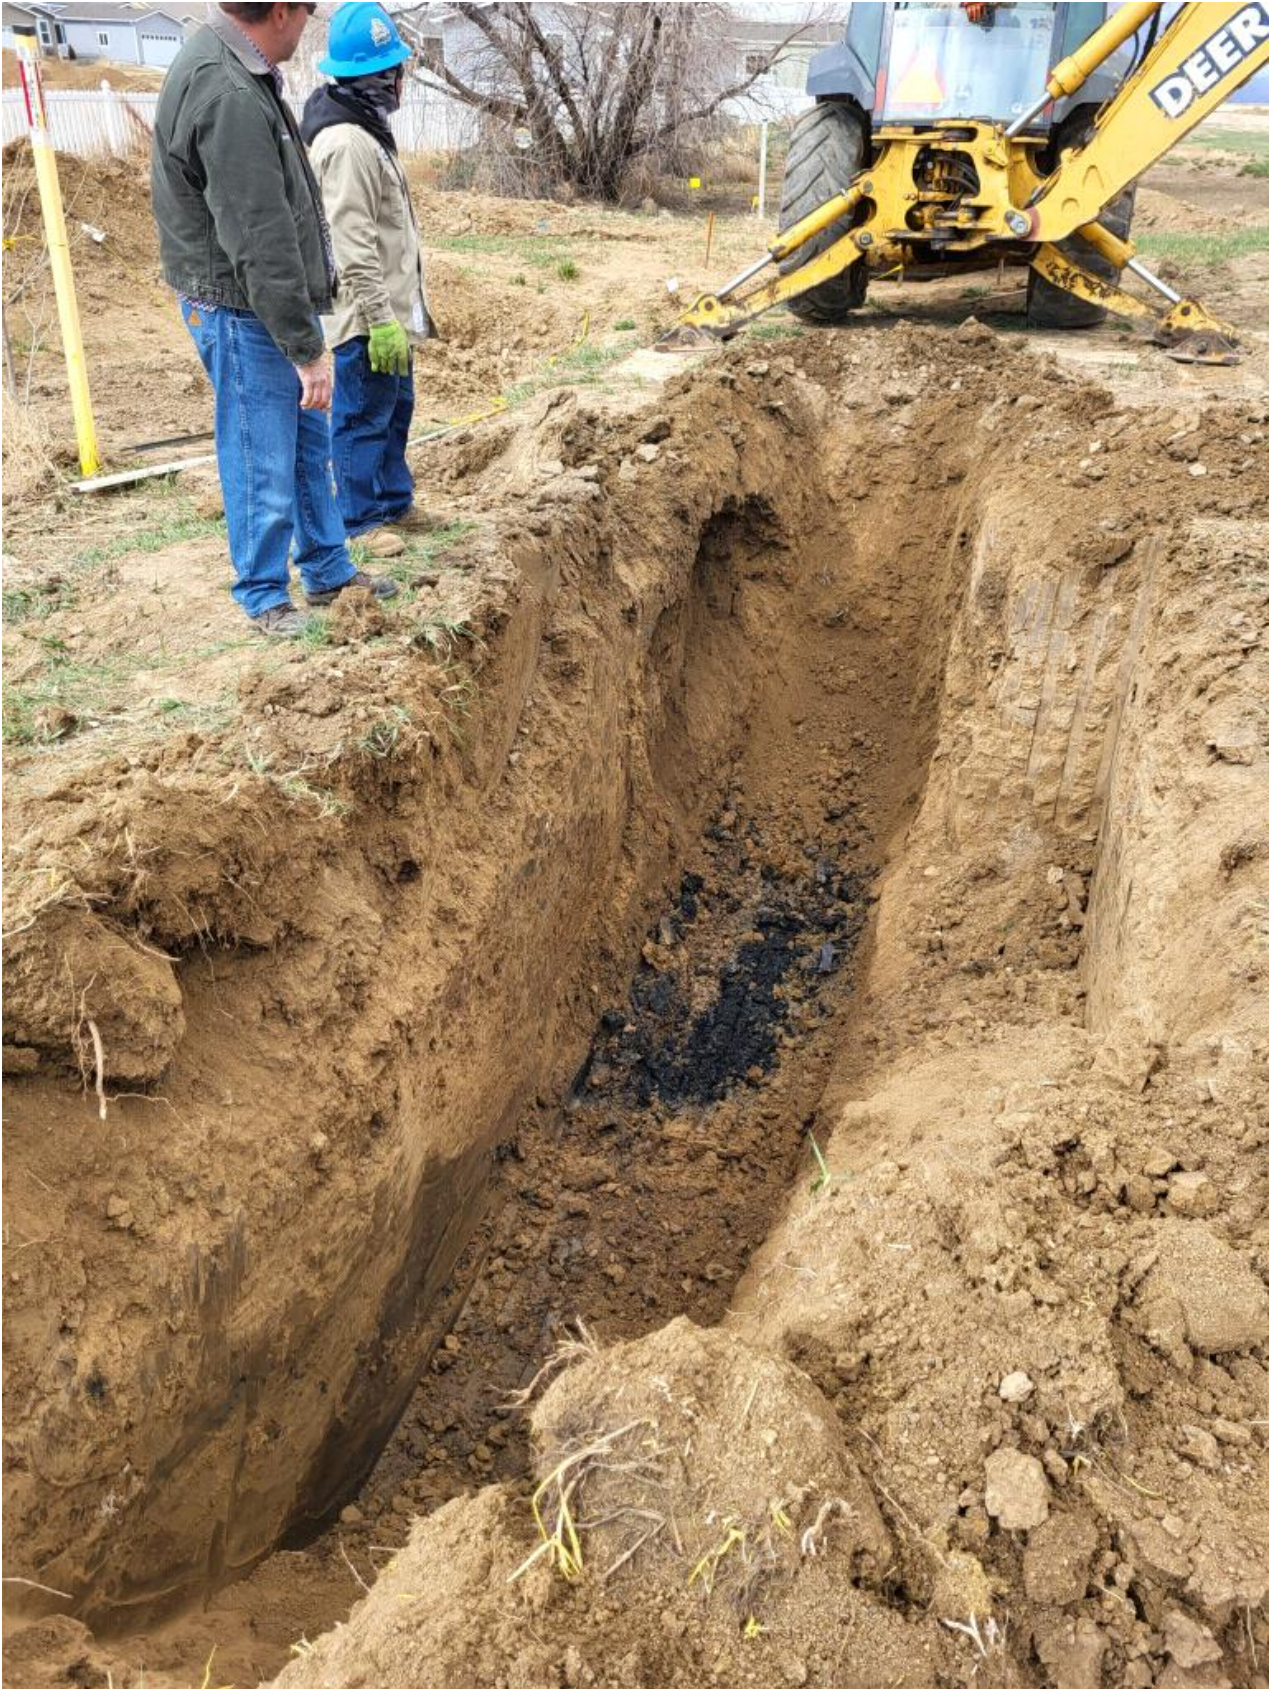
20220405\_101540.jpg

Stained soil in excavation.

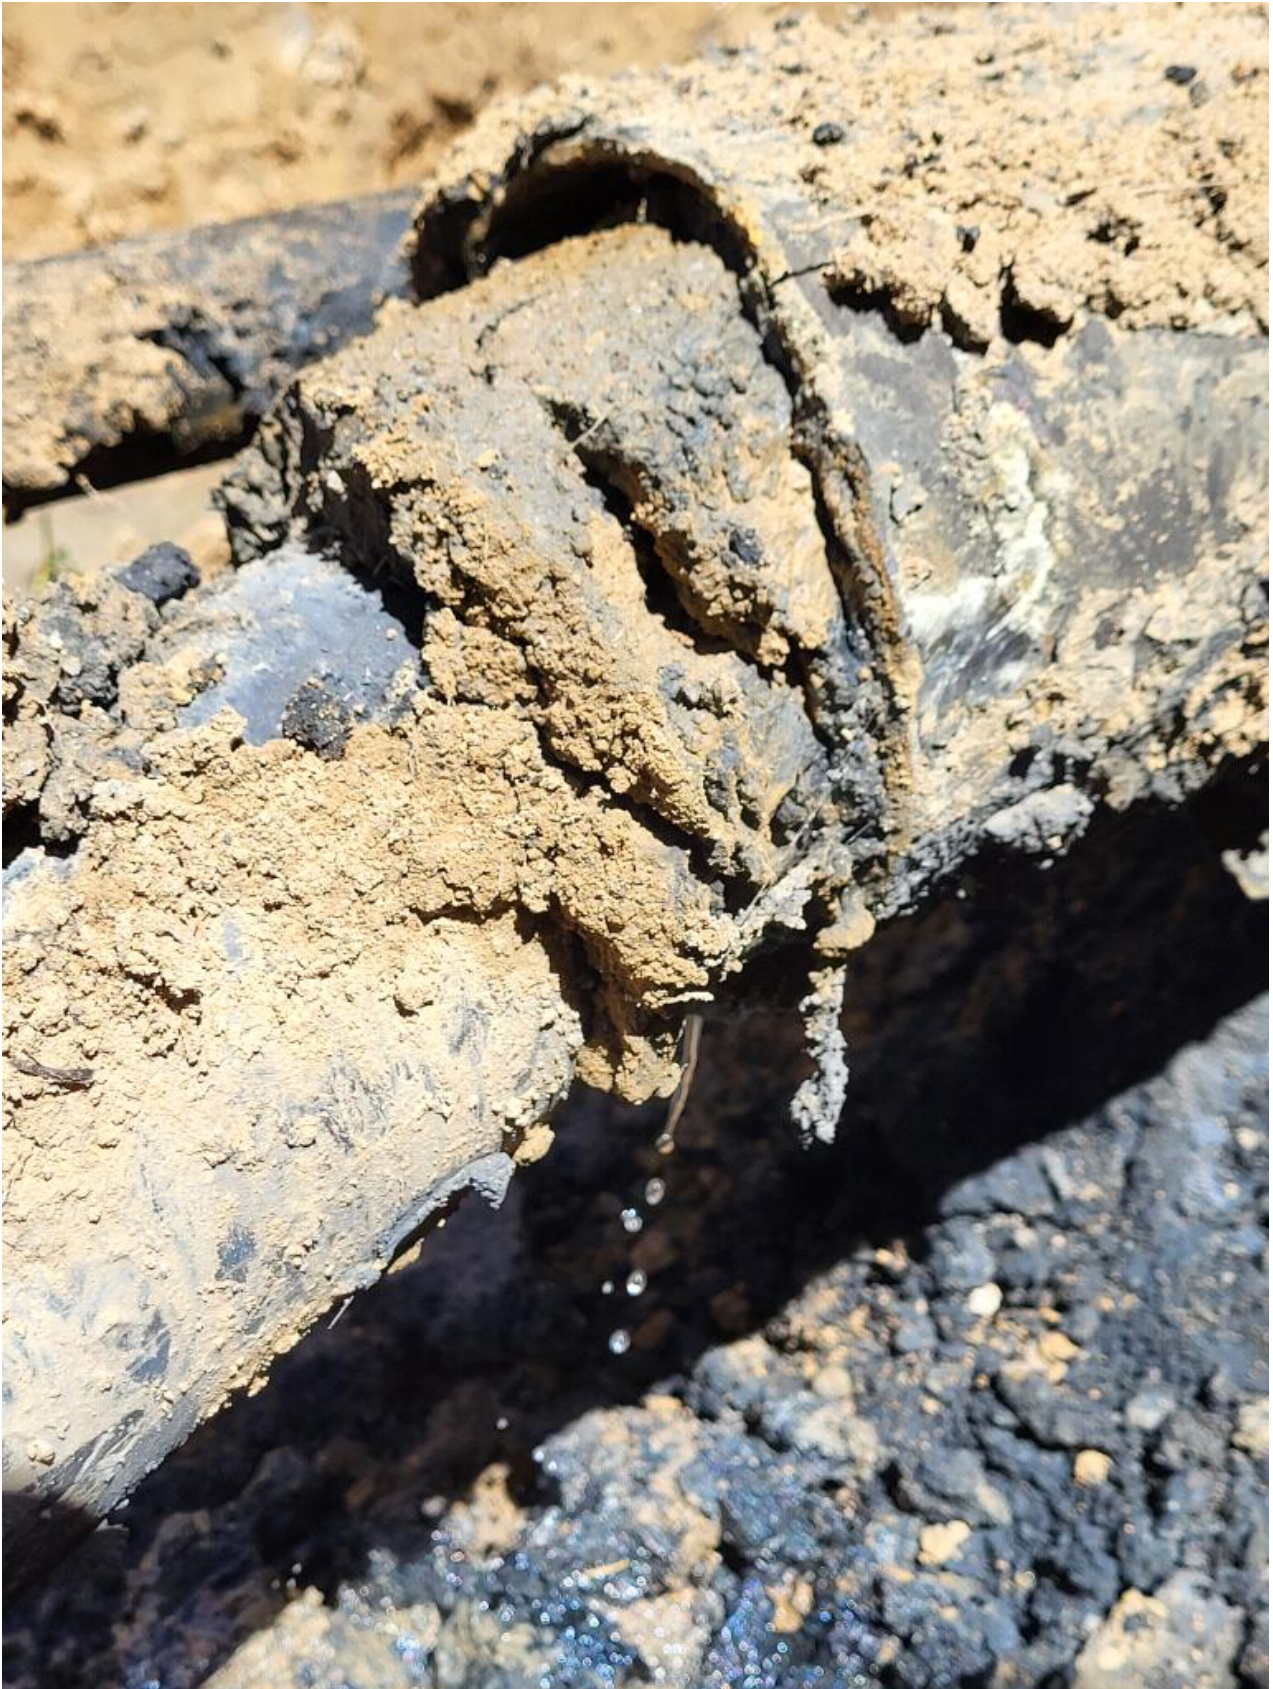
20220406\_130935.jpg

Damaged section of flowline.

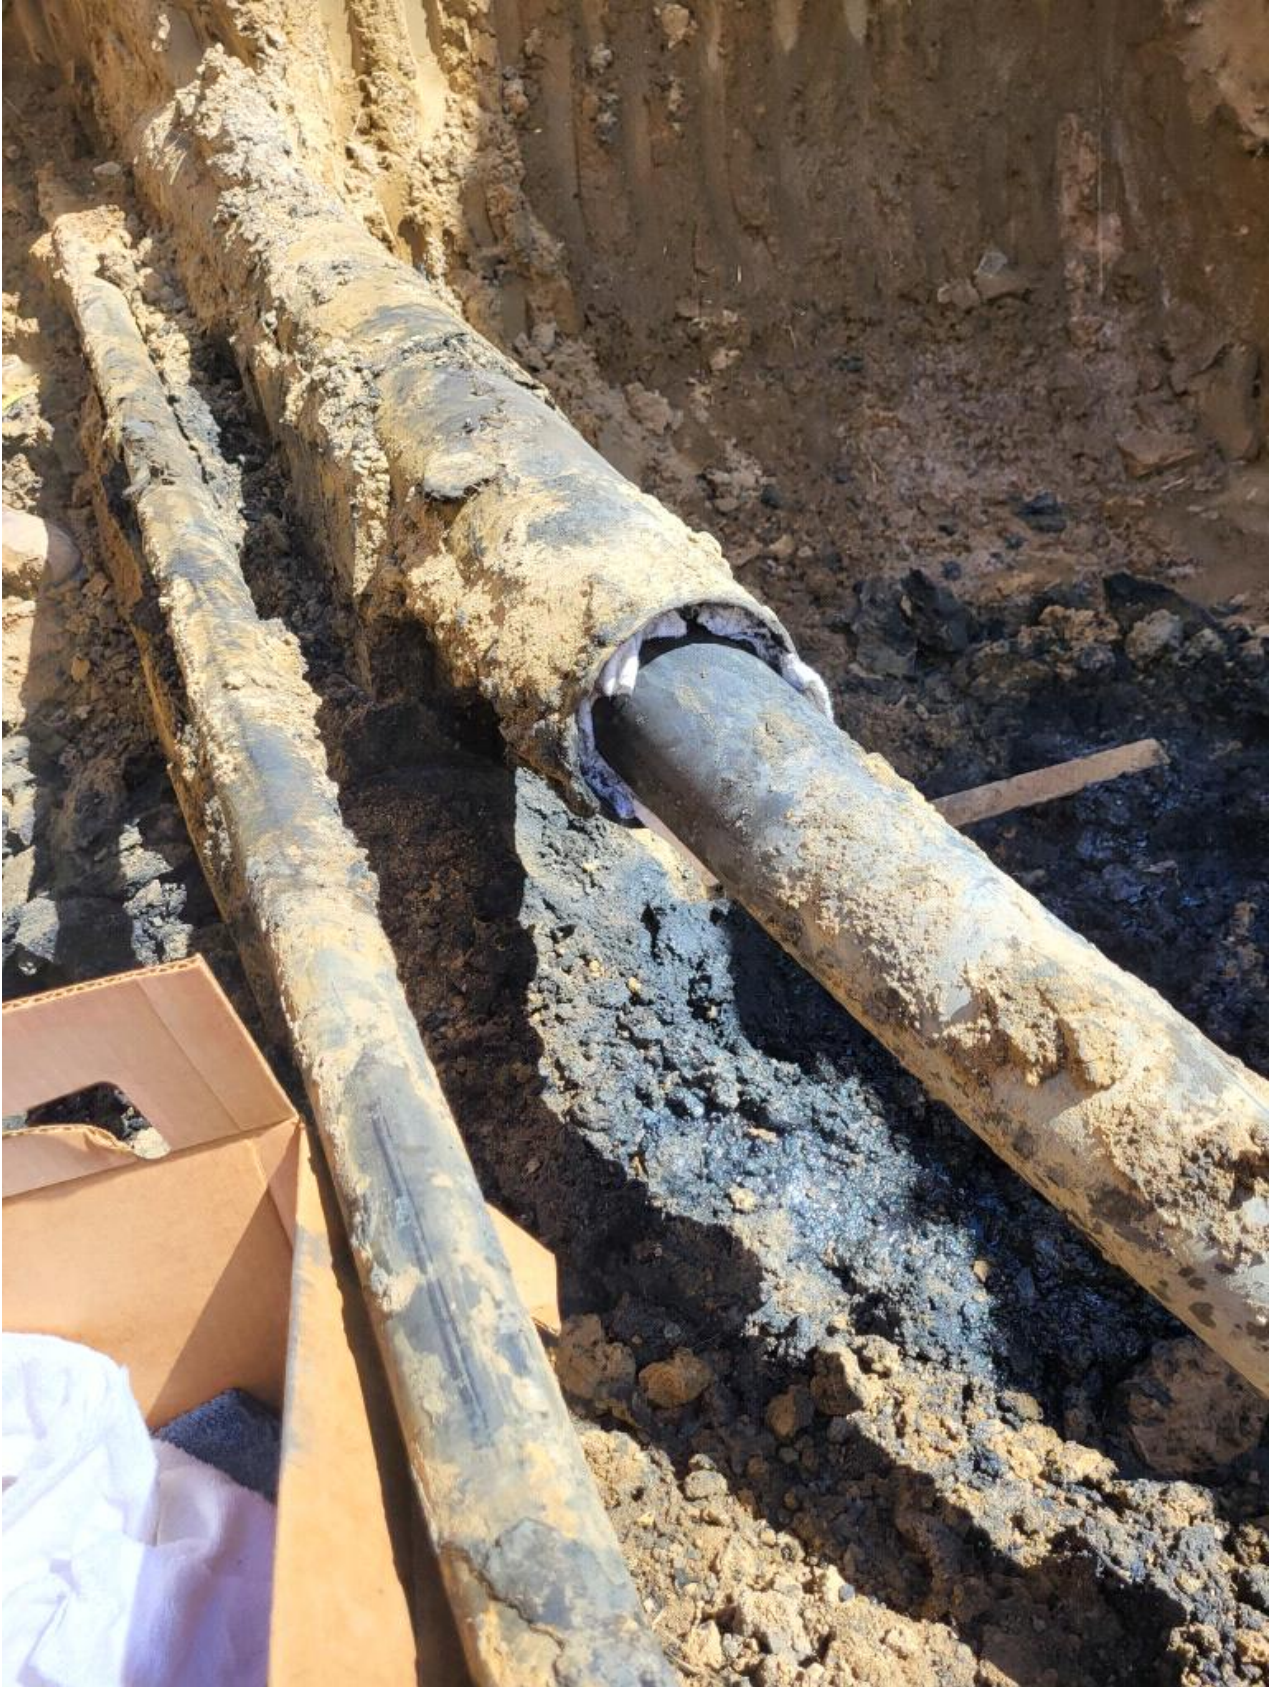
20220406\_140248.jpg

Pipeline insert showing no damage or leaks.

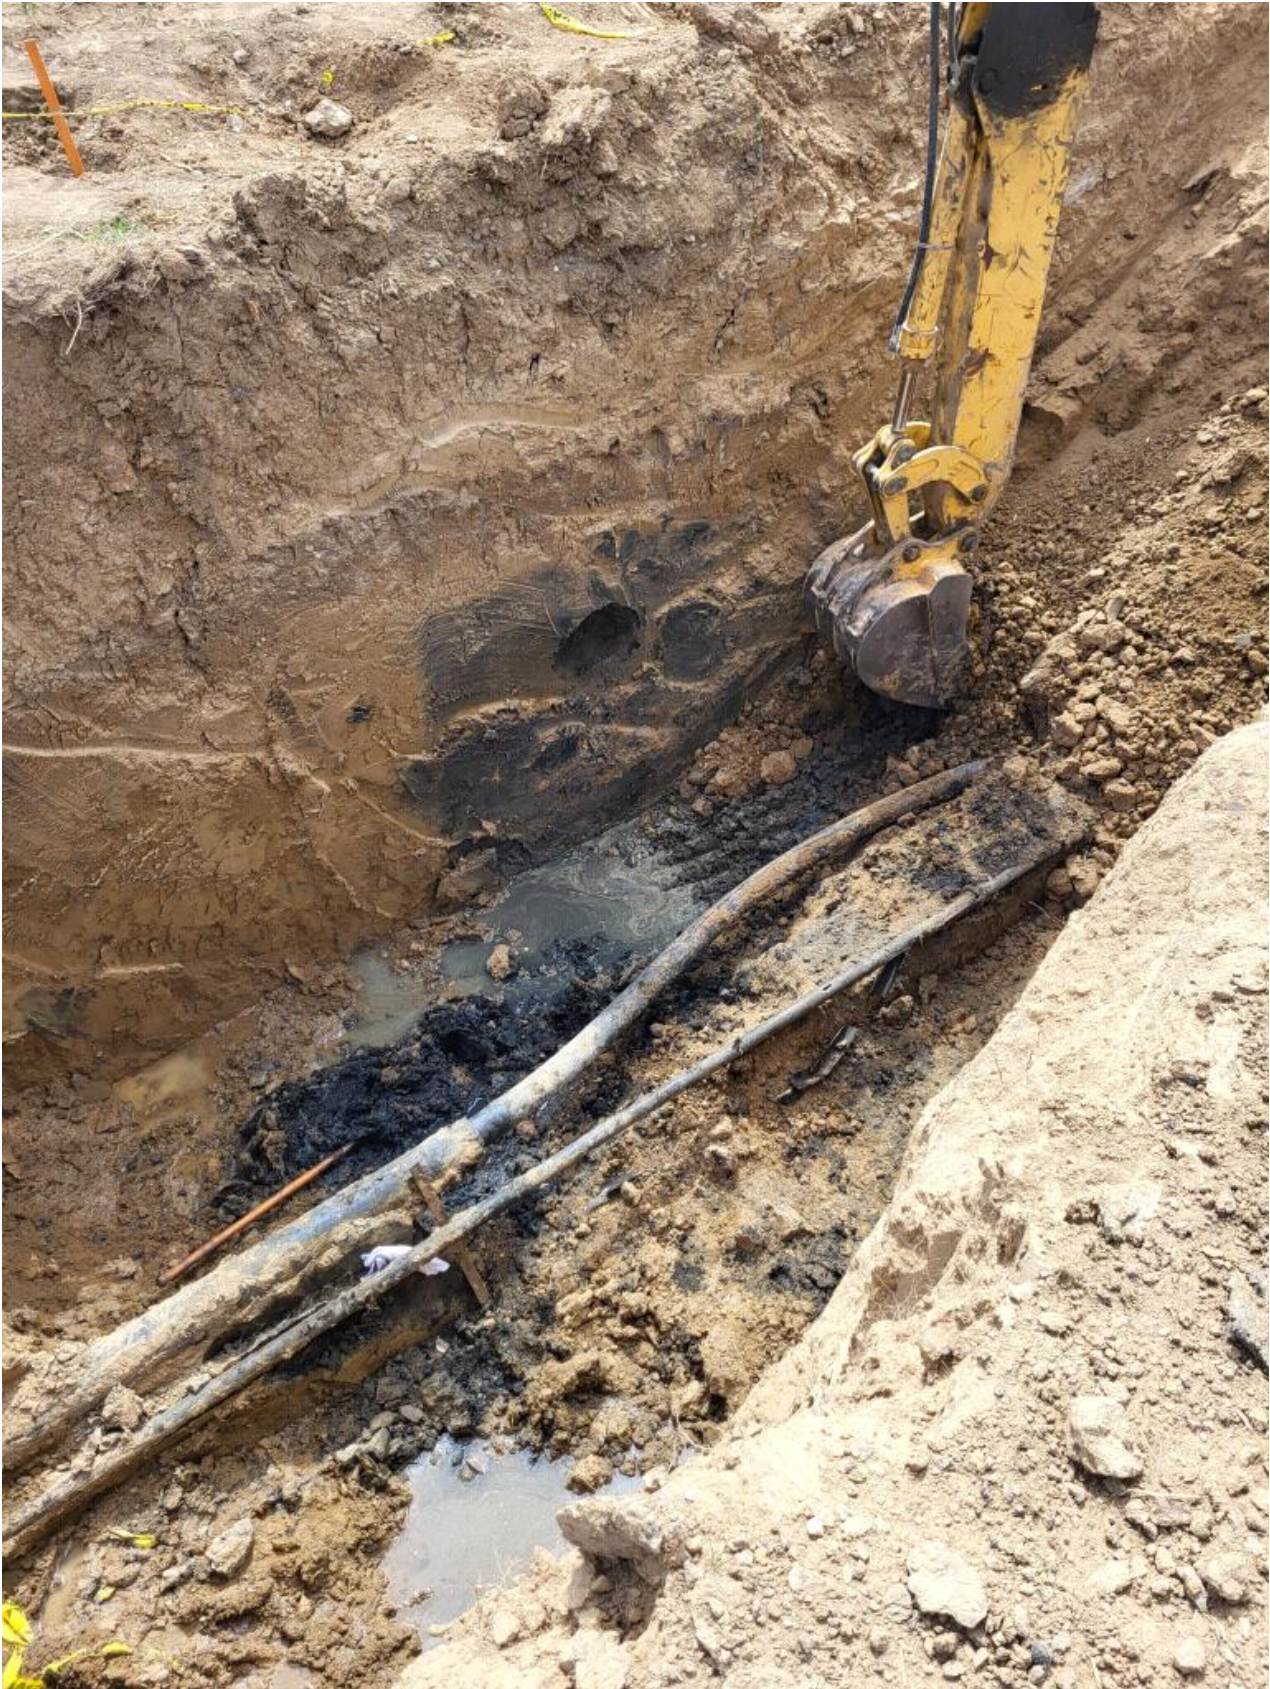
20220406\_141545.jpg

Excavation of impacted soil.
