KP Kauffman - COGCC Inspection Photos
Location: AJ #1 Consolidation Flowline
Spill ID #482628 Date 07/28/2022

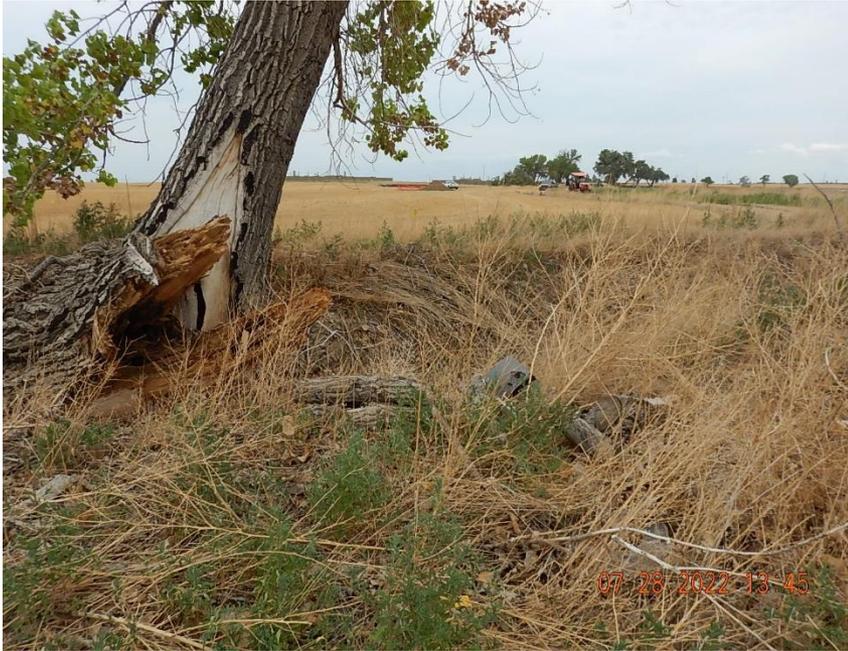
AJ #1 consolidated flowline; approximate release area; view North.

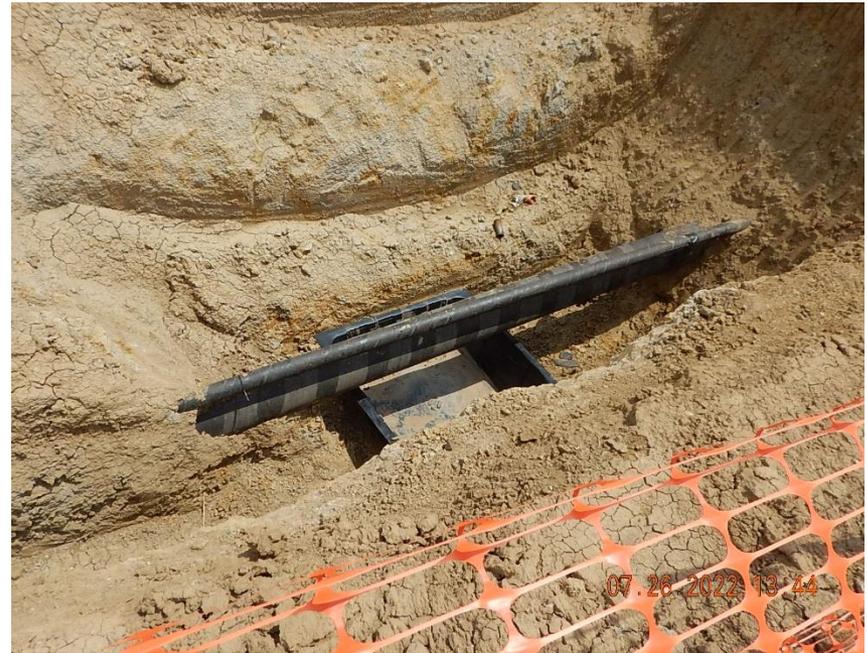
View of flowlines exposed in south bellhole excavation prior to repair; (1) 10" carbon steel AJ #1 consolidation flowline; (1) 2" carbon steel off location gas flowline.
