Construction and Stormwater Inspection

Operator: Verdad Resources LLC -10651

Location ID: 441041

Inspection Photos
Location Name: MARTIN 3030-3031
Location ID: 441041

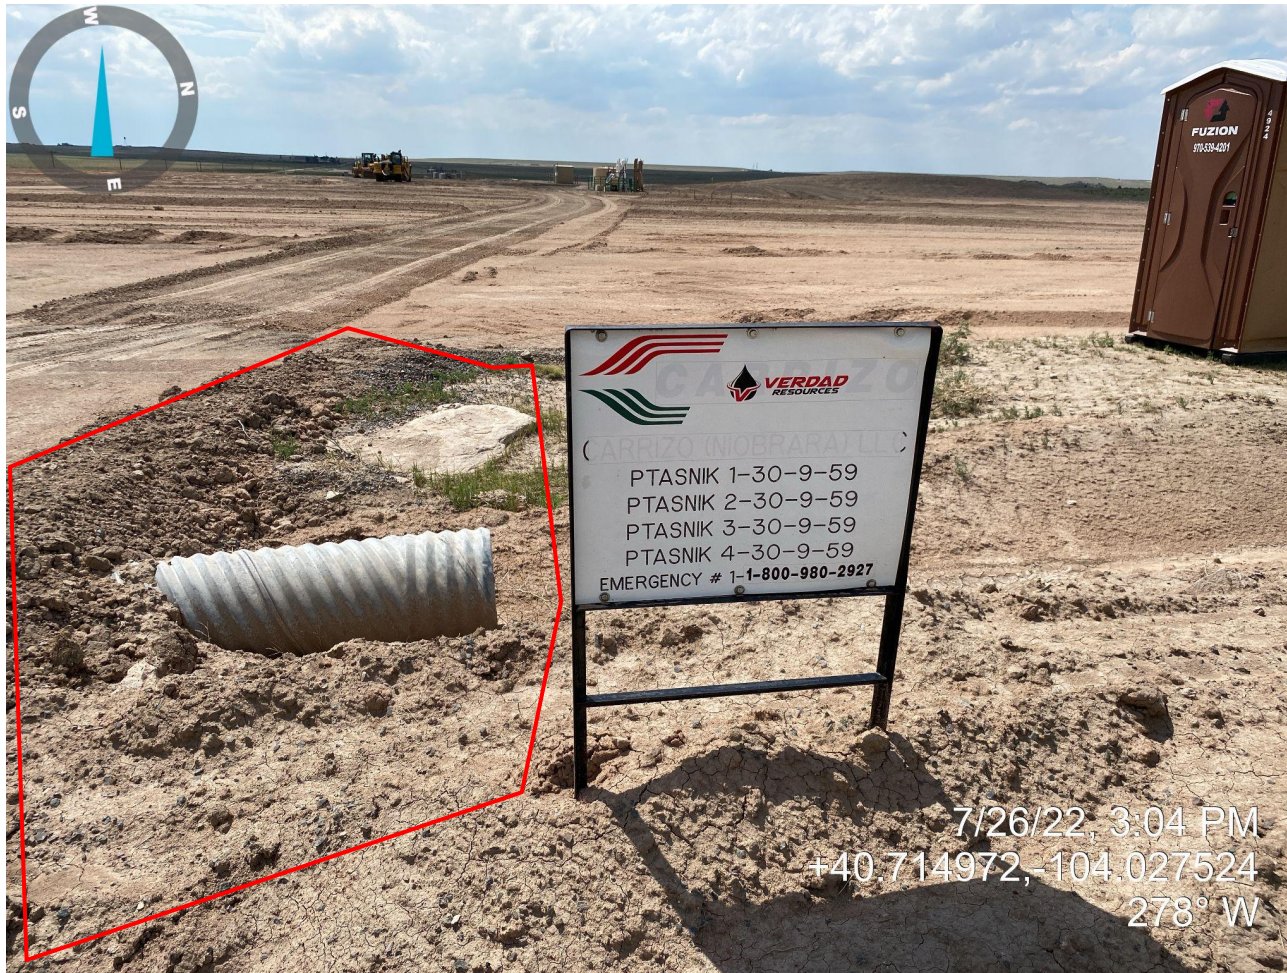
Photo 1. Location photo taken from entrance, facing west. Photo illustrates unconsolidated material around culvert (highlighted in red).

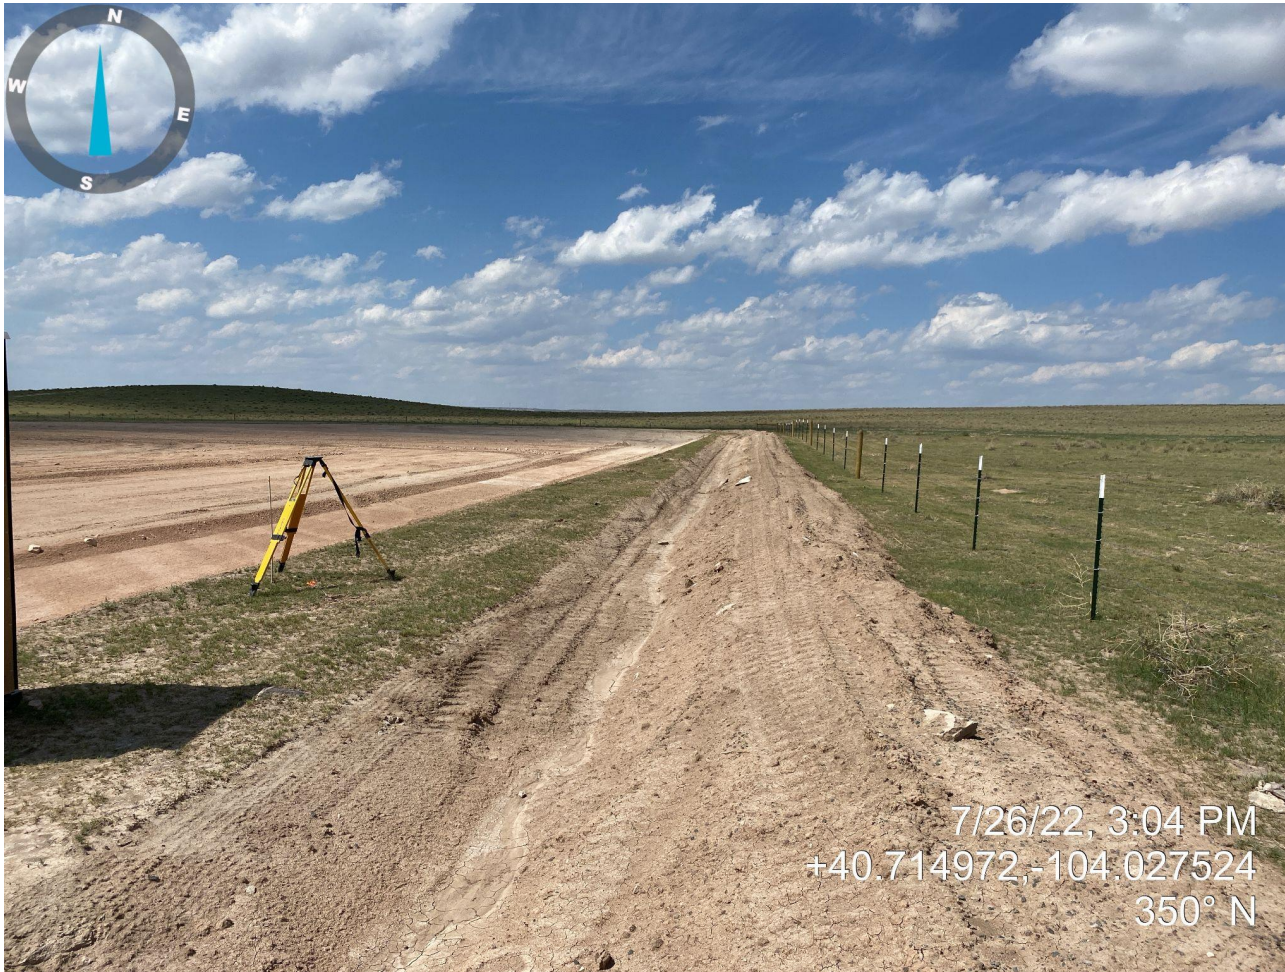
Photo 2. Location photo taken from entrance, facing north. Photo illustrates ditch and berm BMP installed during construction phase.

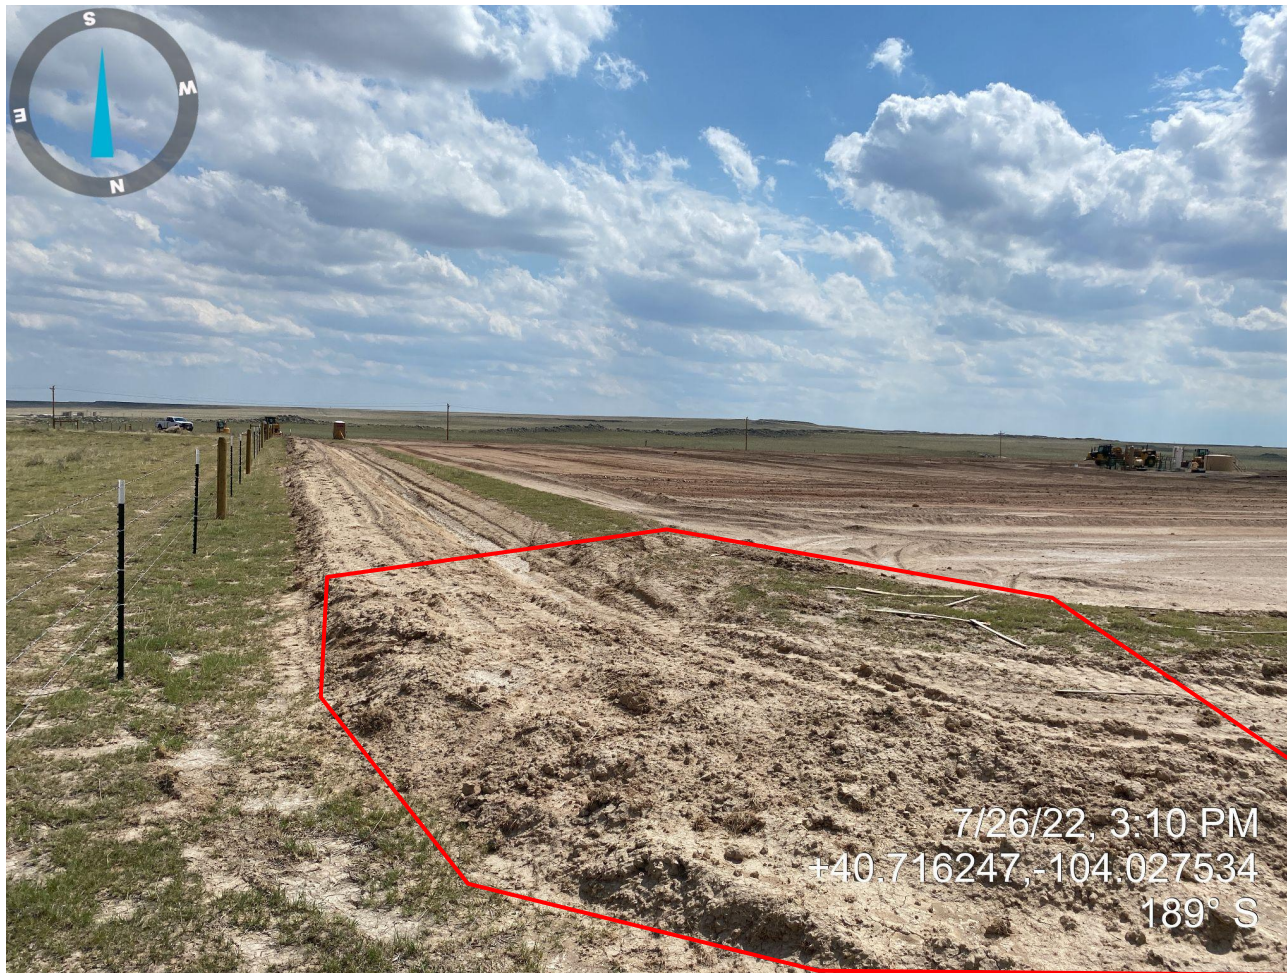
Photo 3. Location photo taken from northeastern portion, facing south. Photo illustrates unconsolidated material in ditch and berm BMP (highlighted in red).

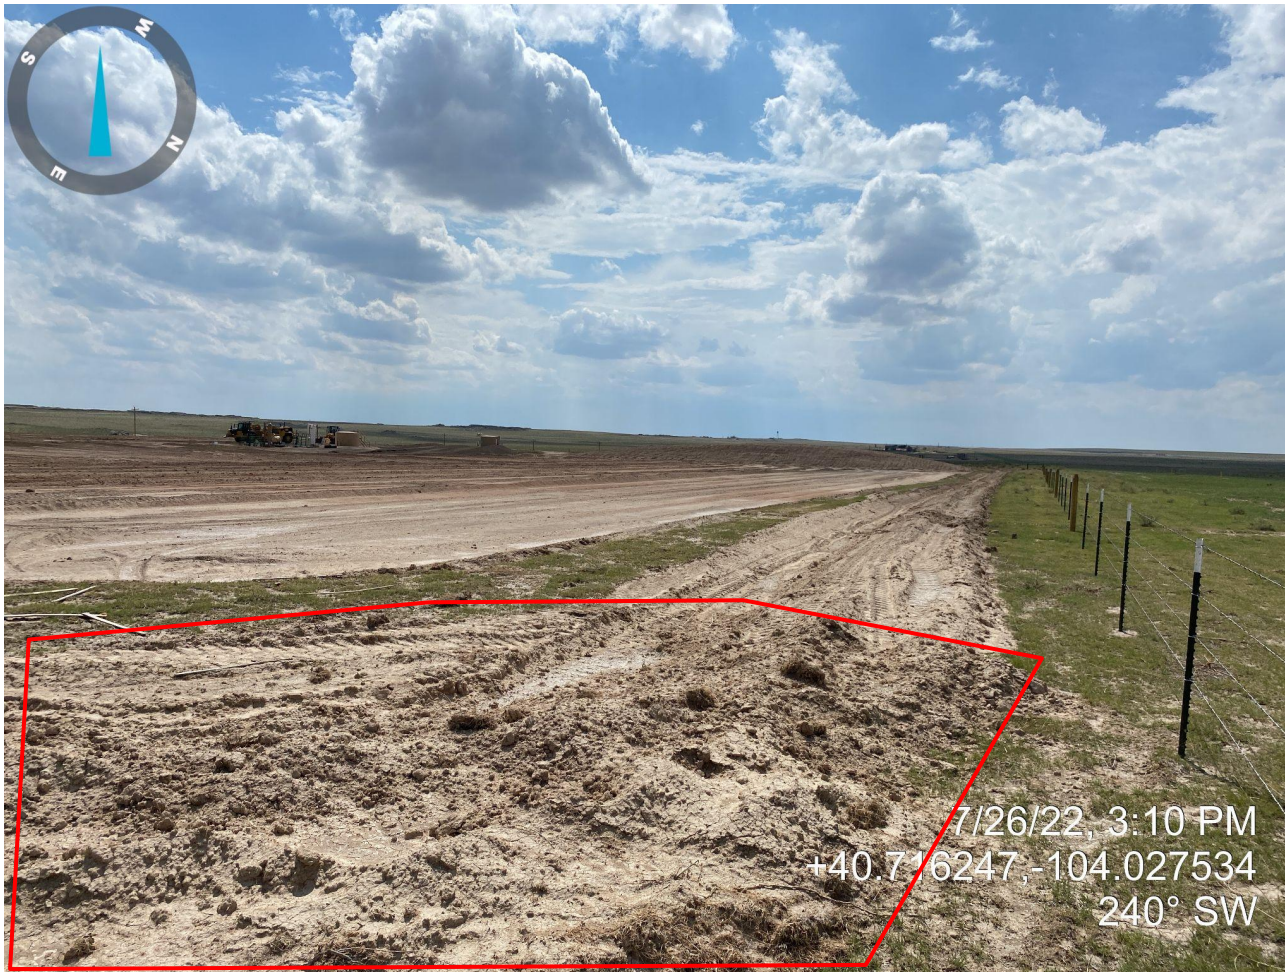
Photo 4. Location photo taken from northeastern portion, facing southwest. Photo illustrates unconsolidated material in ditch and berm BMP (highlighted in red).

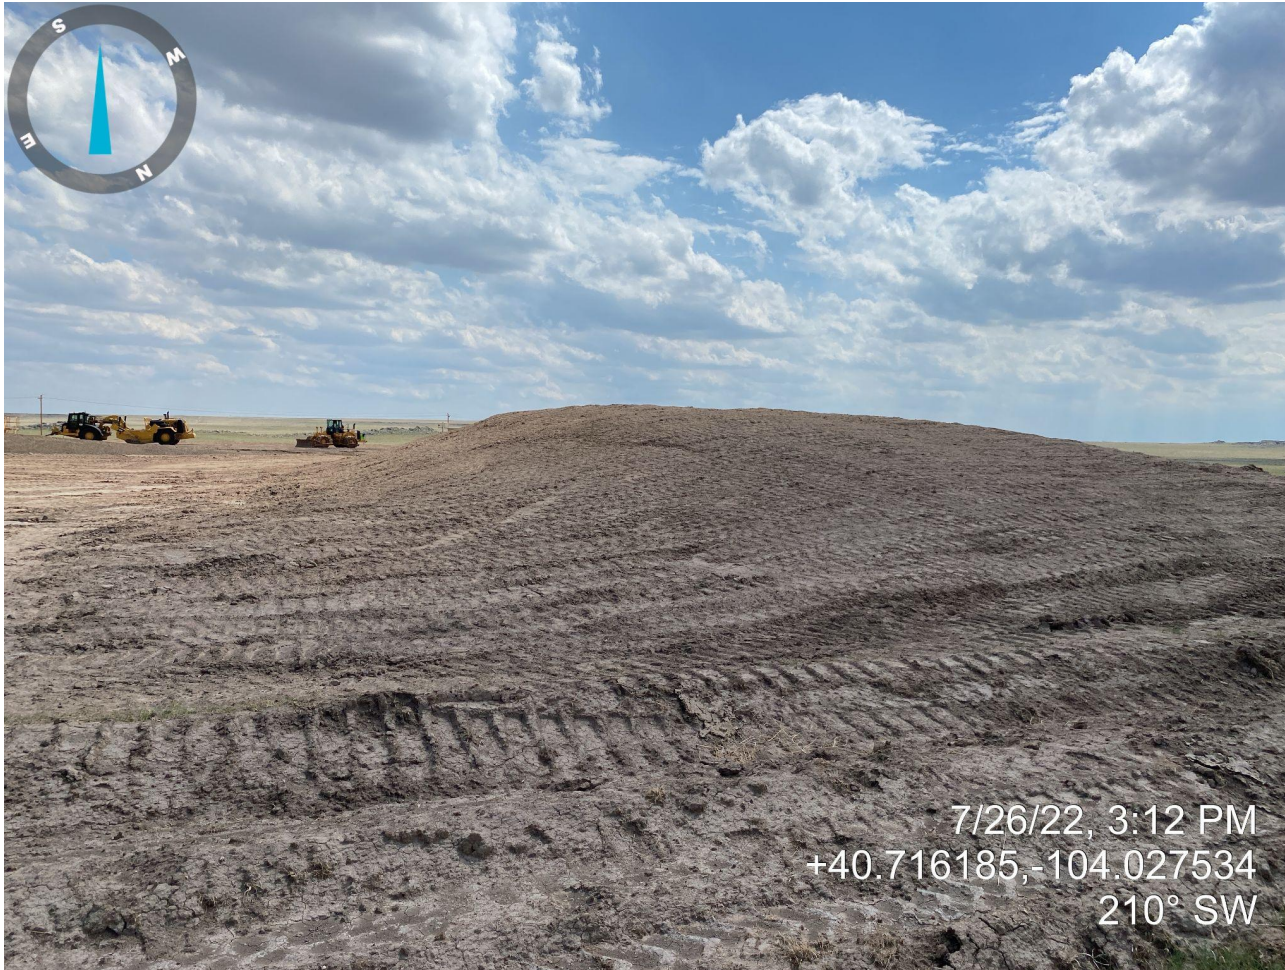
Photo 5. Location photo taken from northwestern portion, facing southwest. Photo illustrates topsoil stockpile has been temporarily stabilized with equipment tracking.

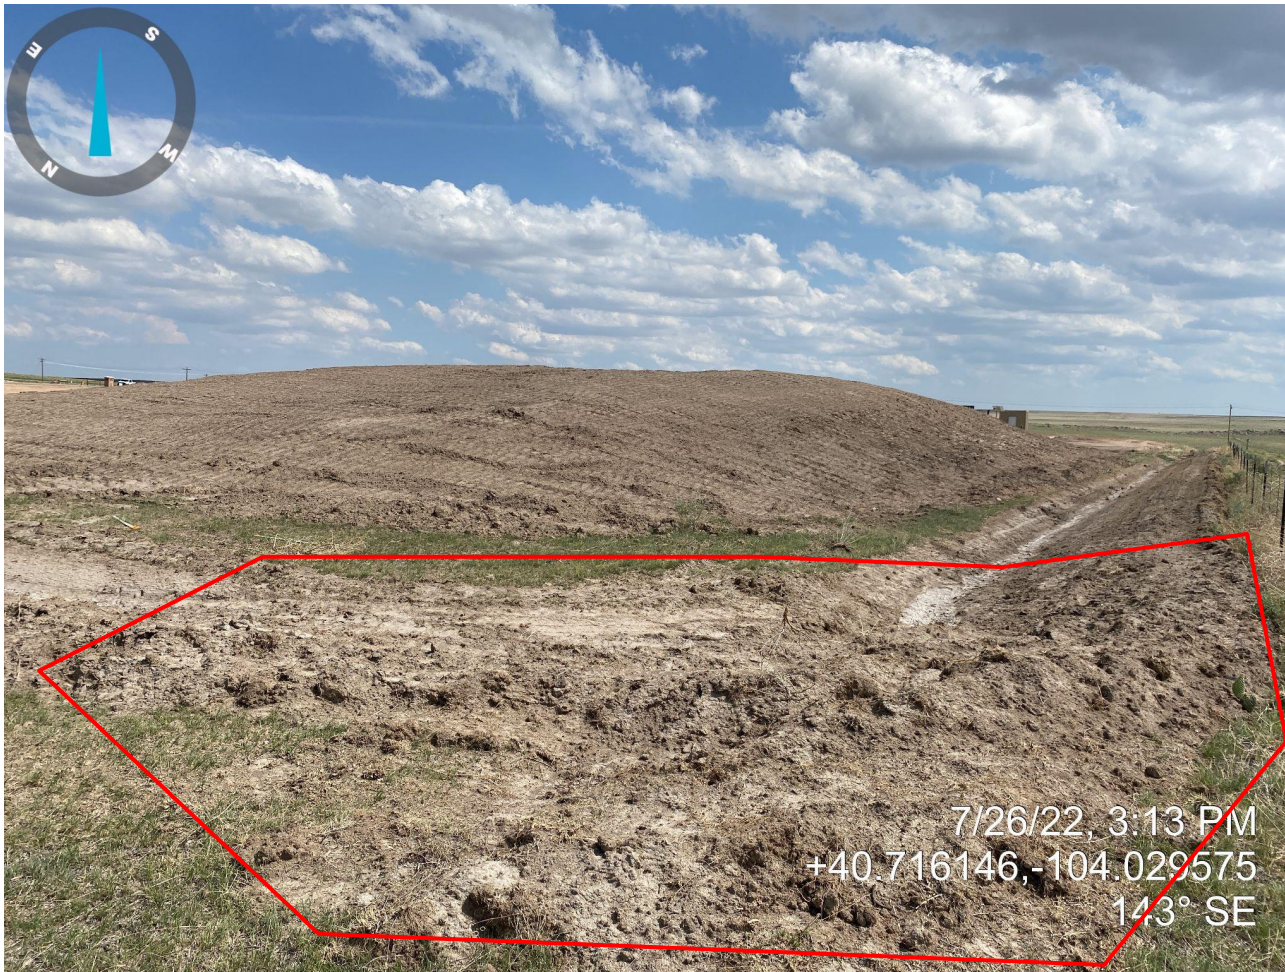
Photo 6. Location photo taken from northwestern portion, facing southeast. Photo illustrates unconsolidated material in ditch and berm BMP (highlighted in red).

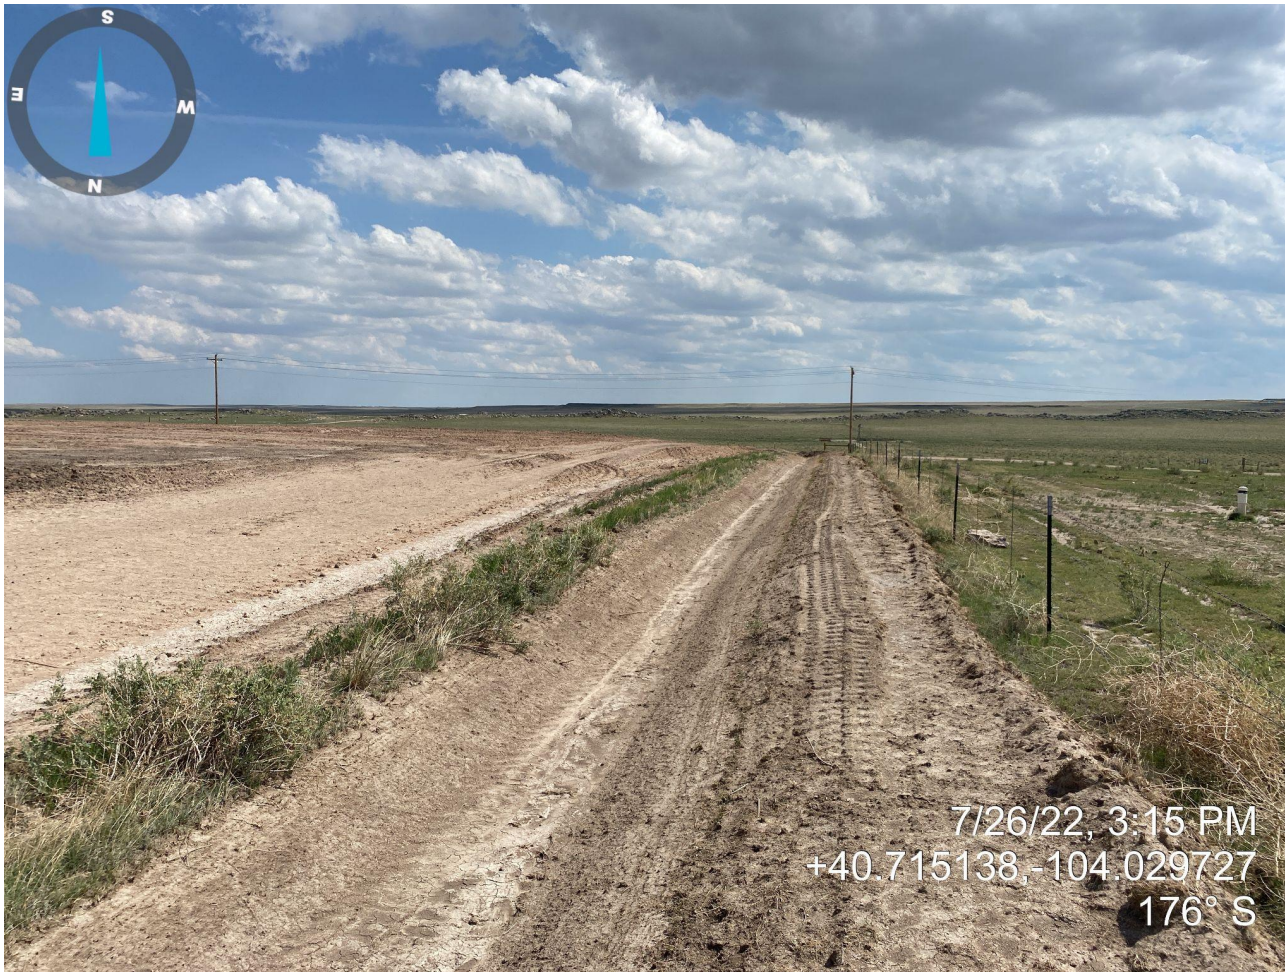
Photo 7. Location photo taken from western portion, facing south. Photo illustrates ditch and berm BMP installed during construction phase.

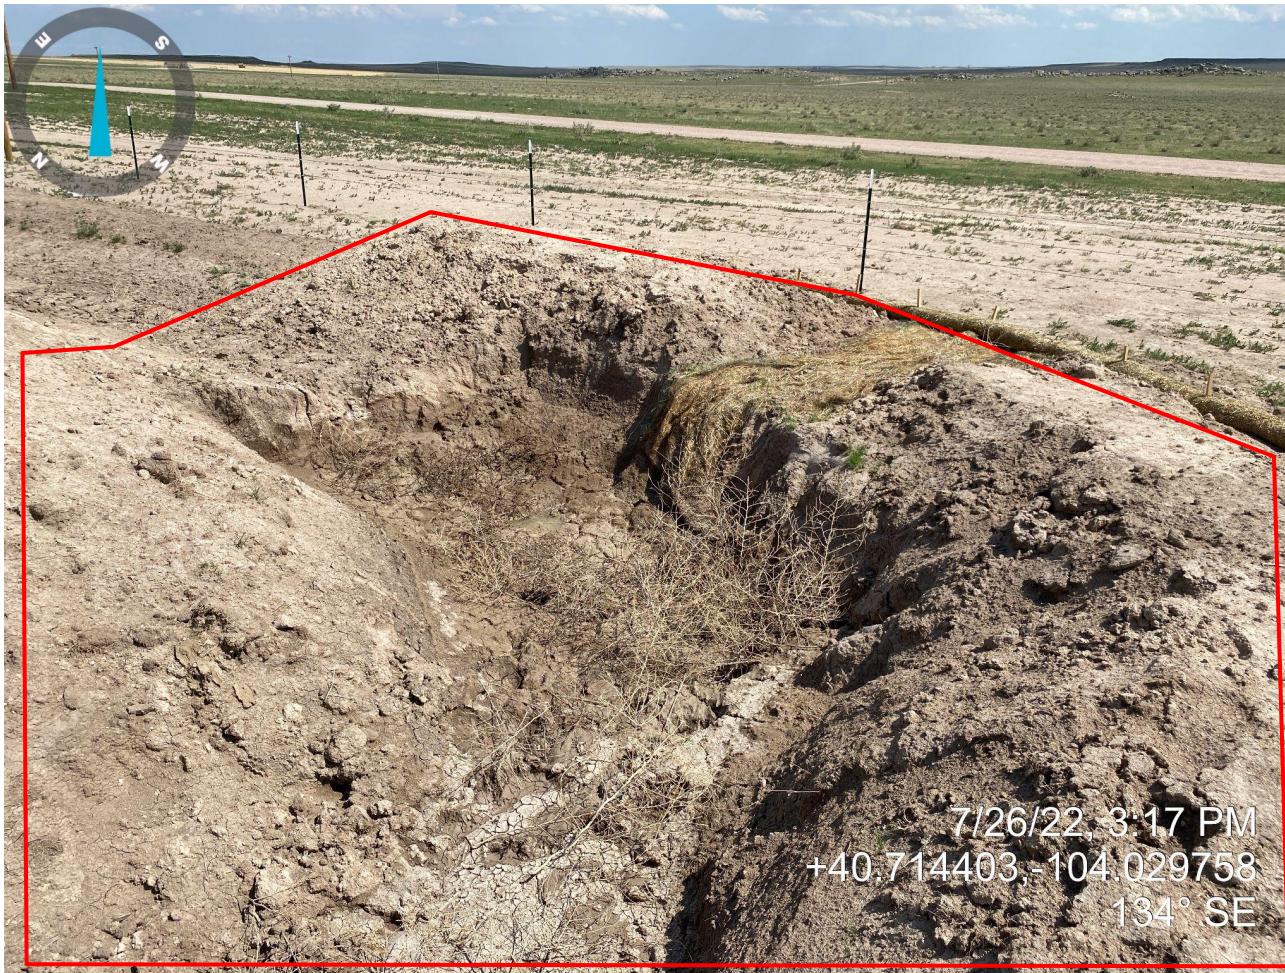
Photo 8. Sediment trap photo taken from southwest portion of location, facing southeast. Photo illustrates sediment trap walls not properly stabilized (e.g. vertical) and unconsolidated material.

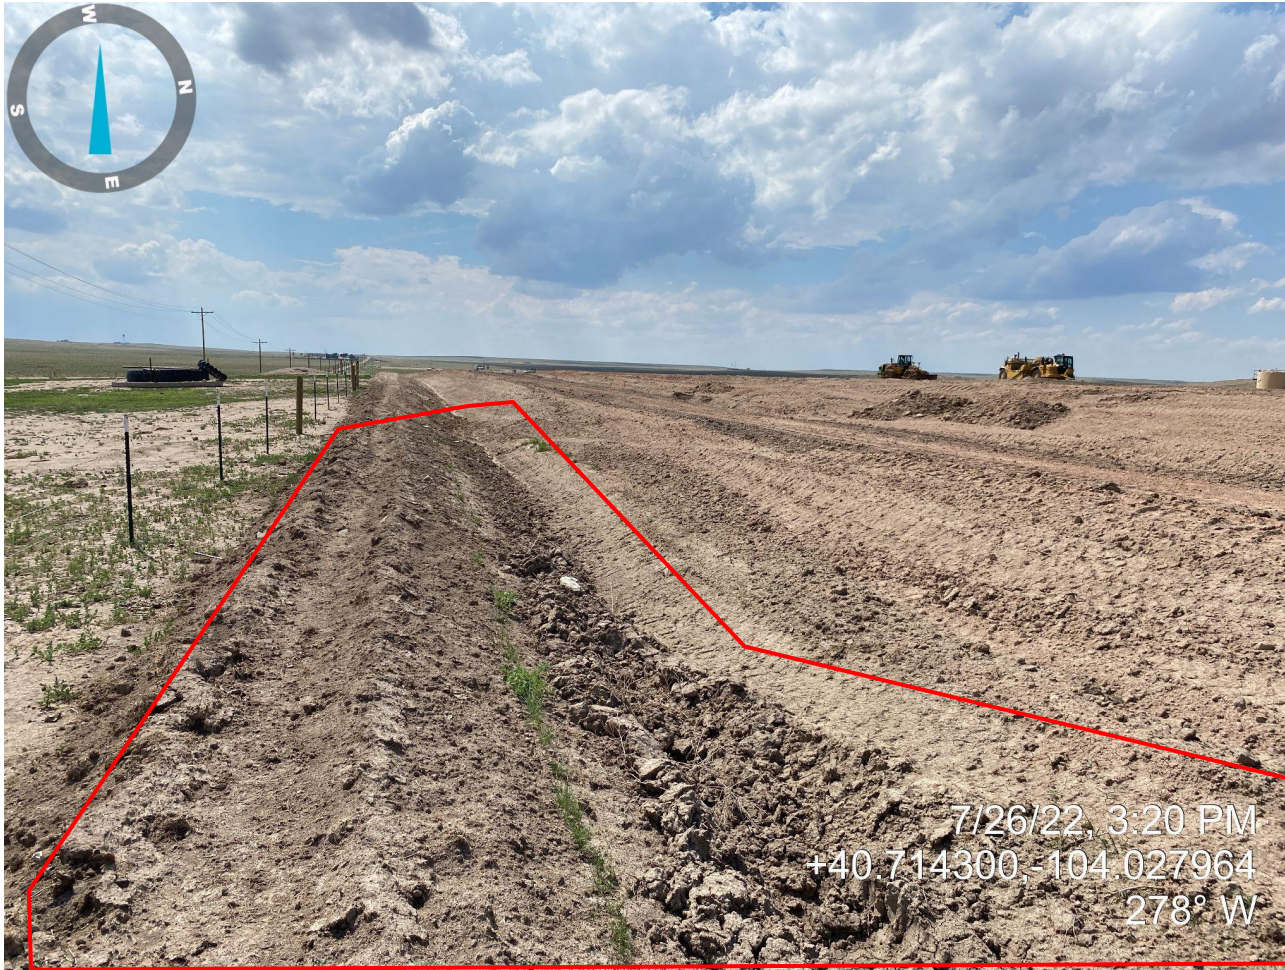
Photo 9. Ditch and berm photo taken from southern portion of location, facing west. Photo illustrates unconsolidated material in ditch (highlighted in red).

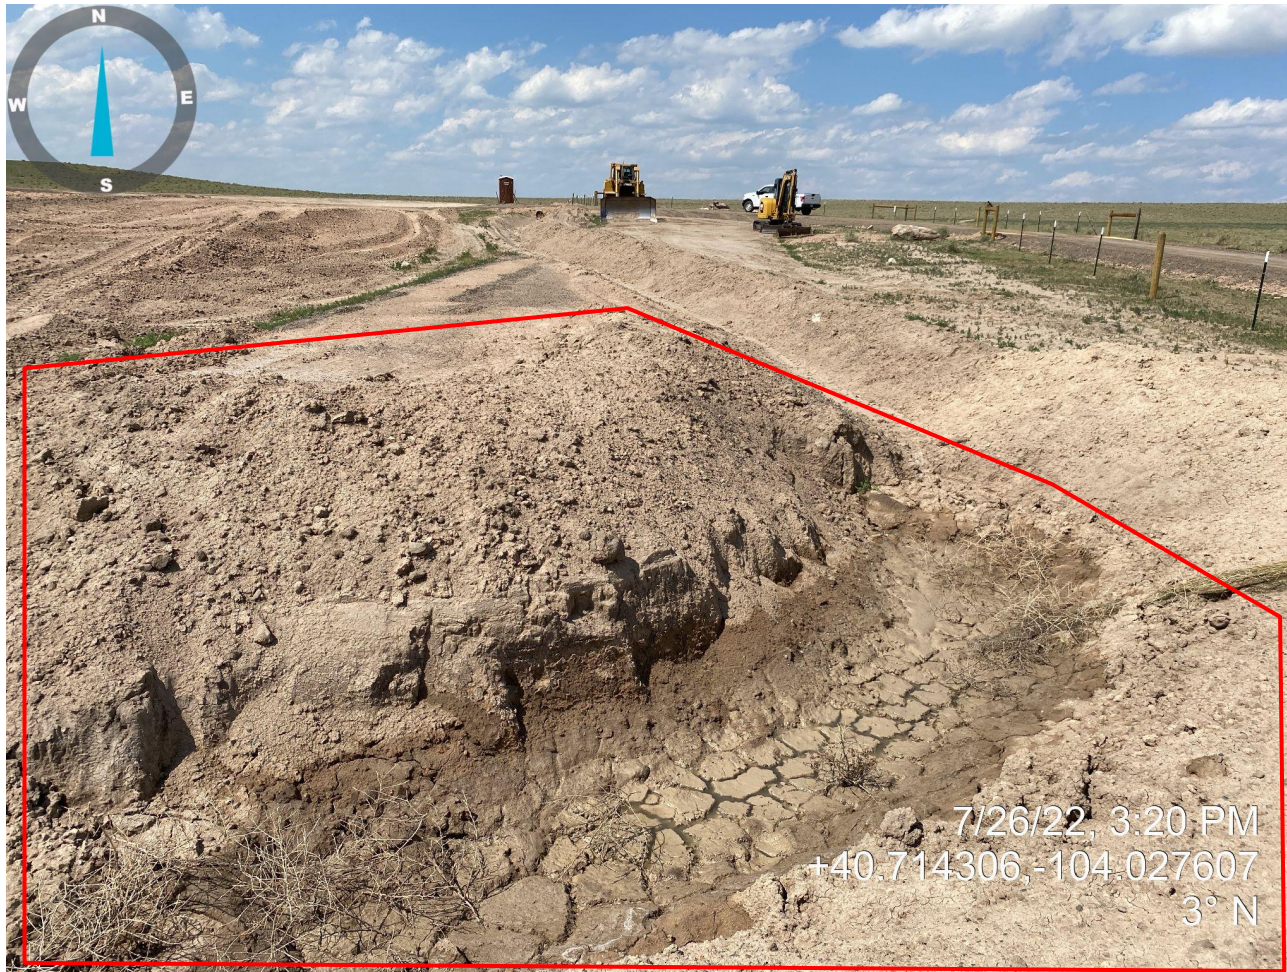
Photo 10. Ditch and berm photo taken from southeast portion of location, facing north. Photo illustrates unconsolidated material (highlighted in red).
