Inspection Photos

API: 055-06285

Operator: CAPTUREPOINT LLC

Inspection Date: 8/8/2022

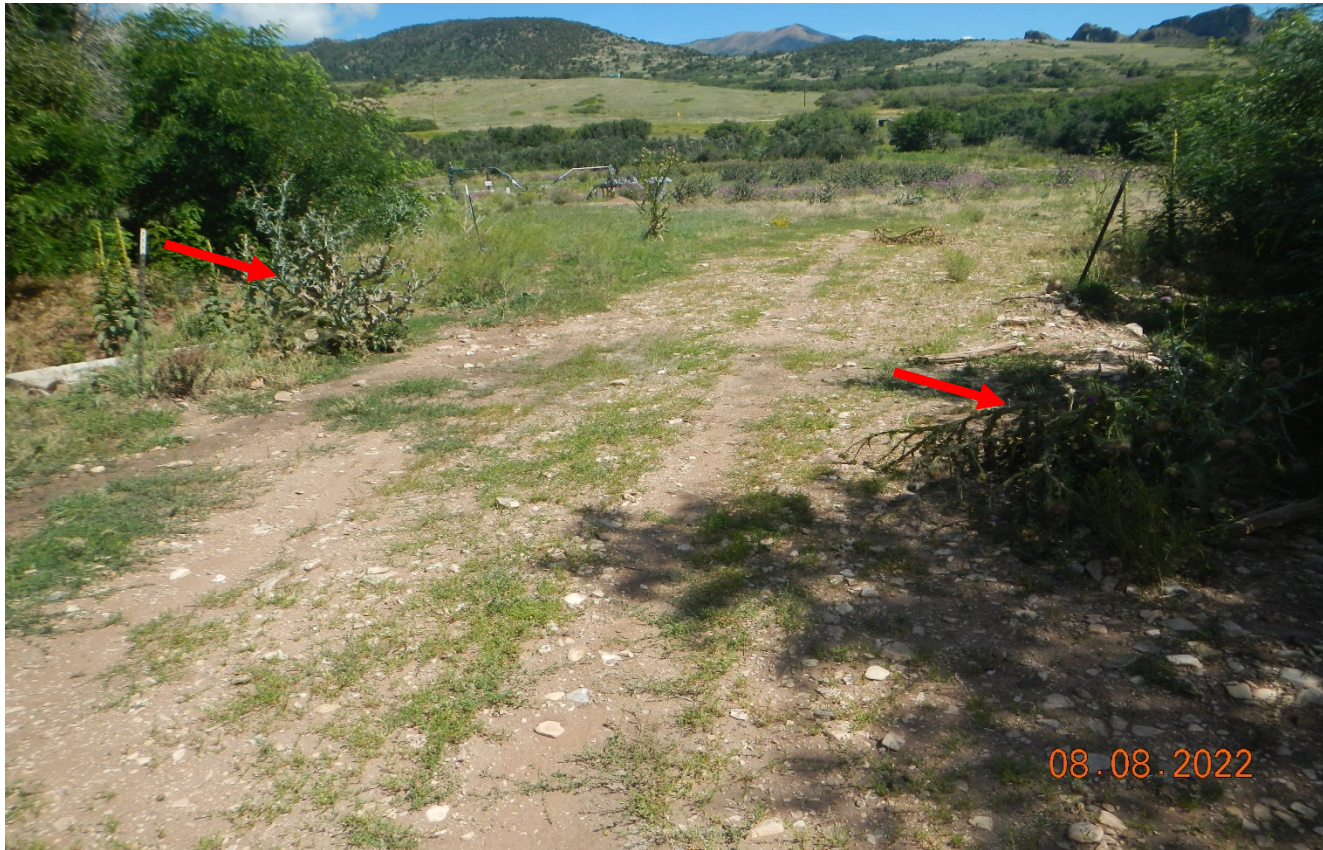
Photo 1. Facing west toward the access road. There are noxious weeds along the road that need to be controlled. Red arrow → Scotch thistle

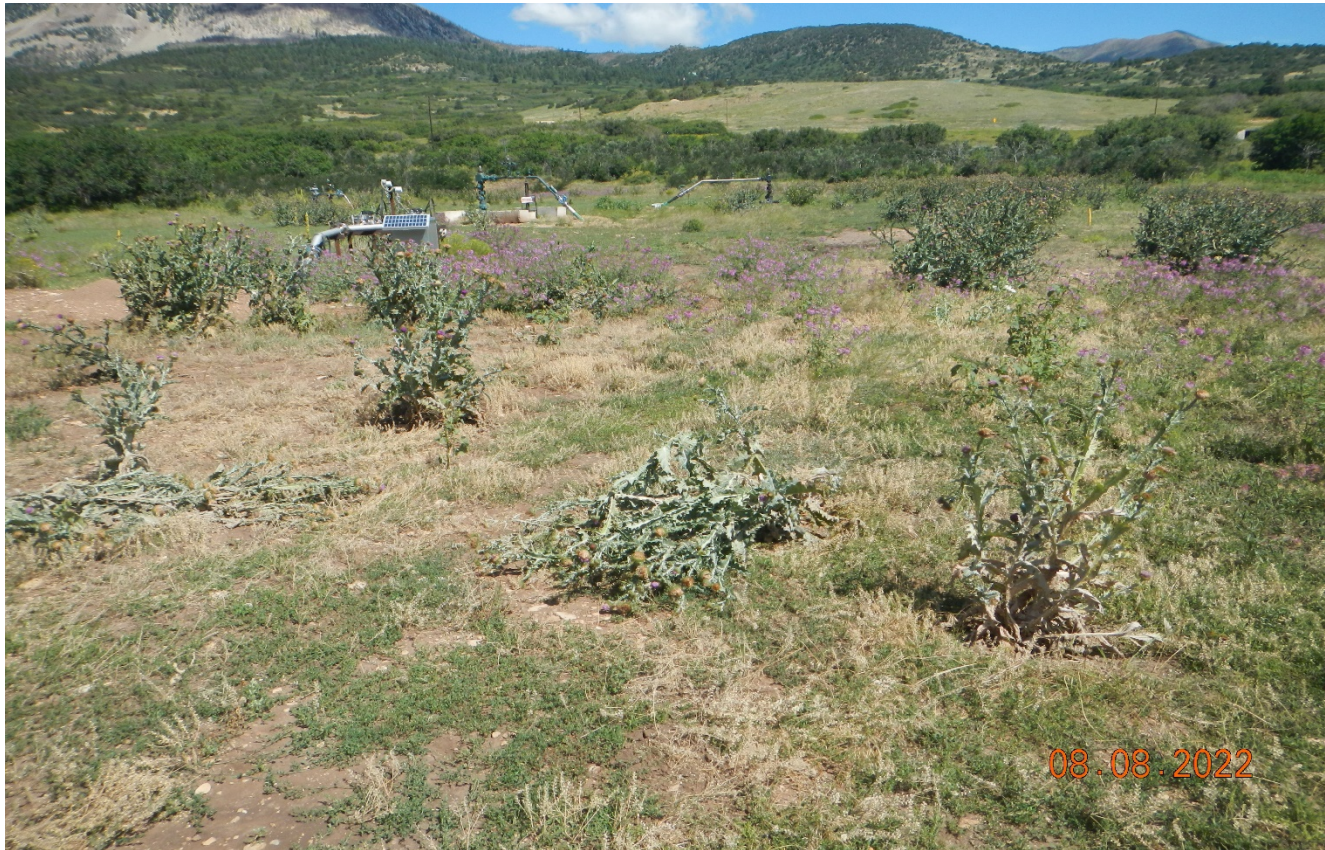
Photo 2. Facing northwest toward the location. There is numerous noxious weeds at the location that need to be controlled. The weeds have produced seed heads which should be cut and removed.

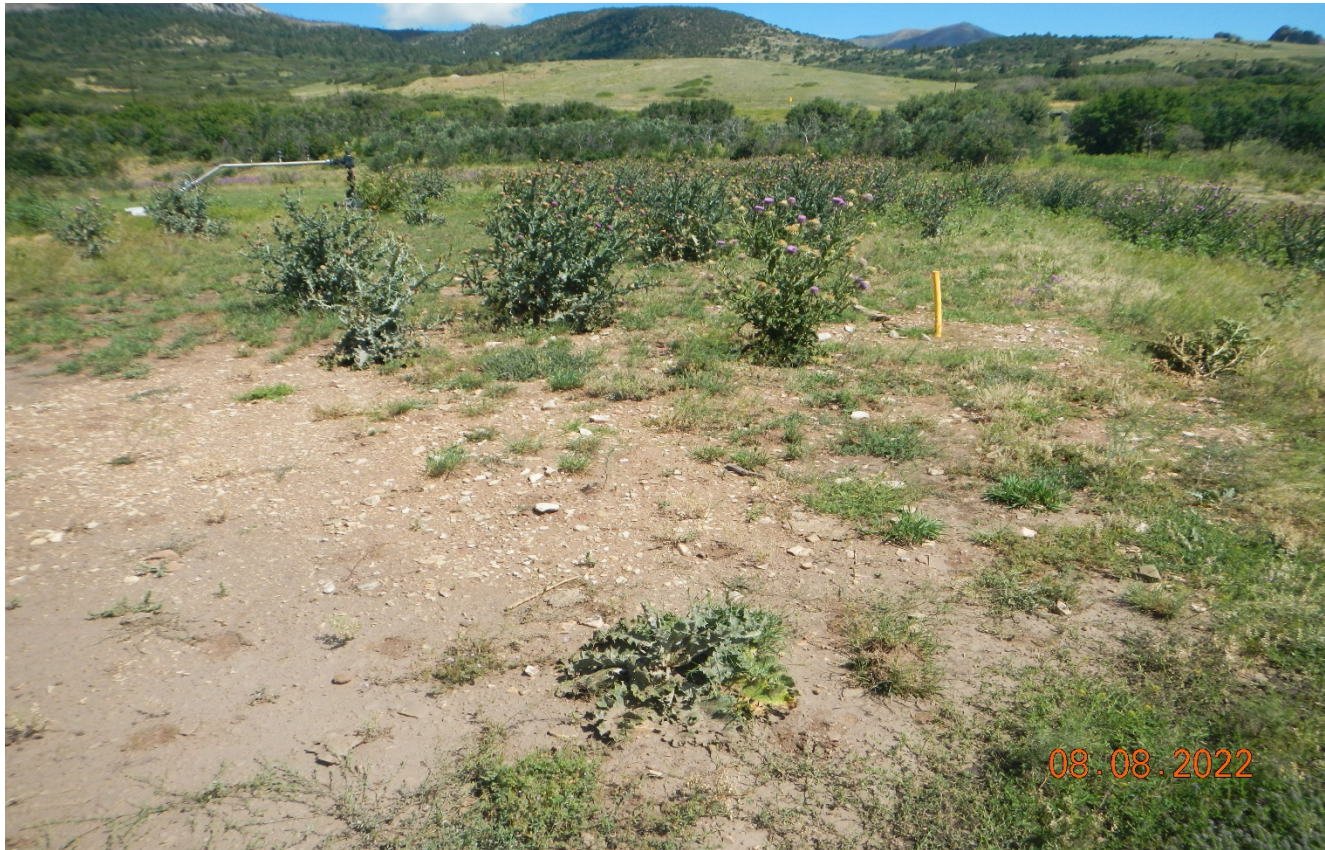
Photo 3. Facing north toward the location. There is numerous noxious weeds at the location that need to be controlled. The weeds have produced seed heads which should be cut and removed.

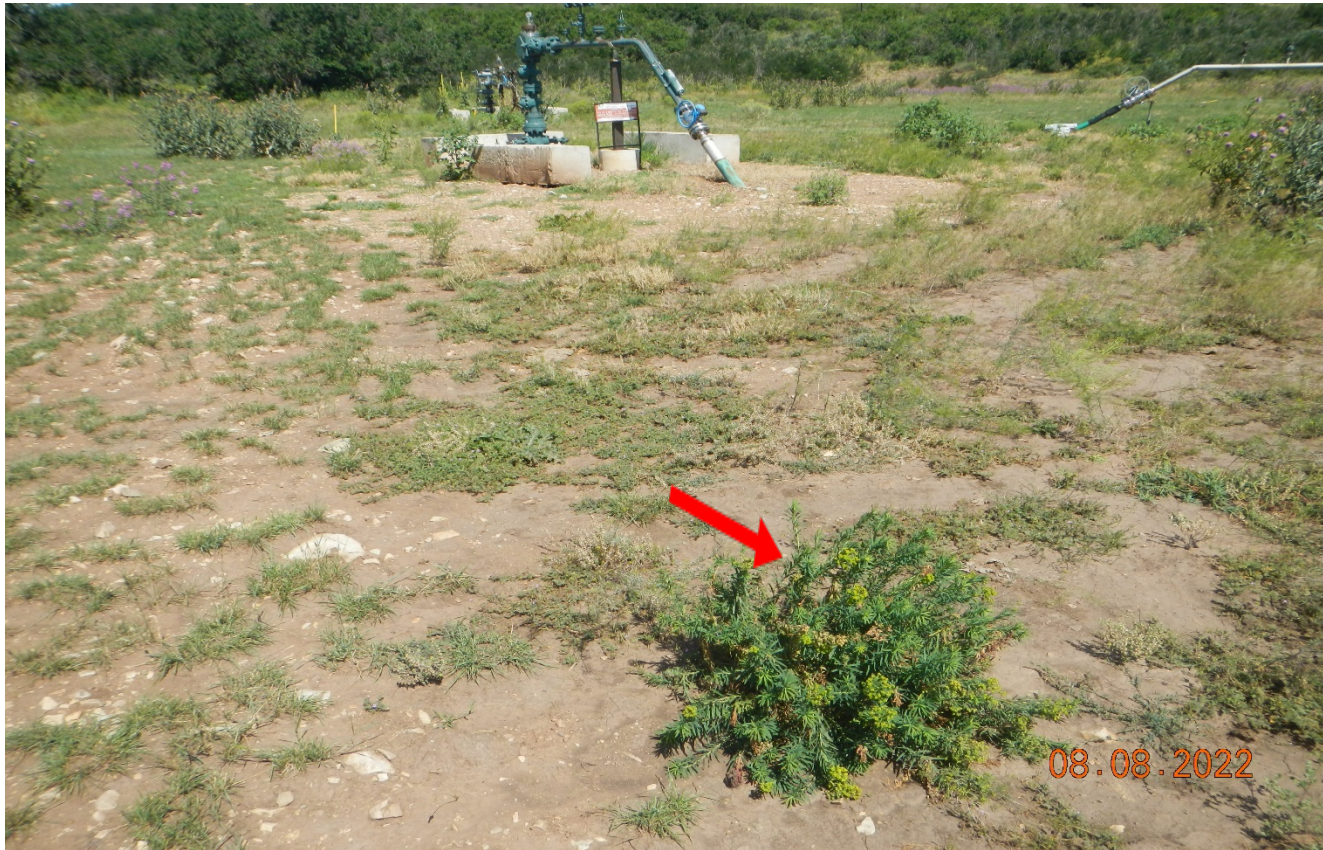
Photo 4. Facing northwest toward the well site. Red arrow points to Leafy spurge a List B noxious weed that needs to be controlled.

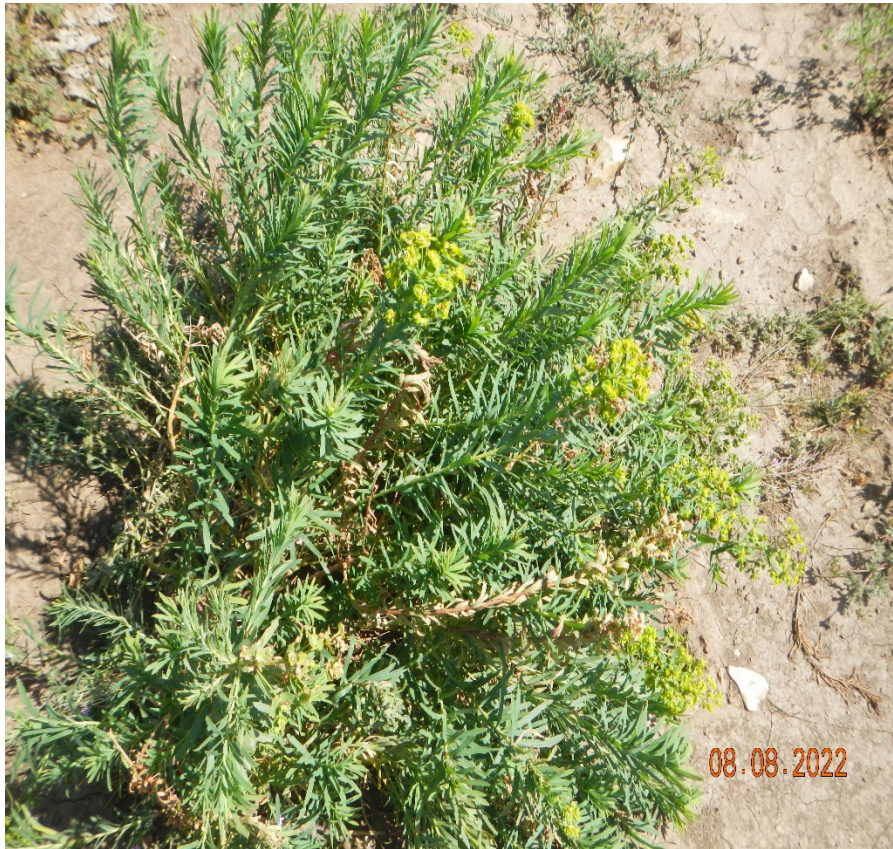
Photo 5. List B noxious weed → Leafy Spurge

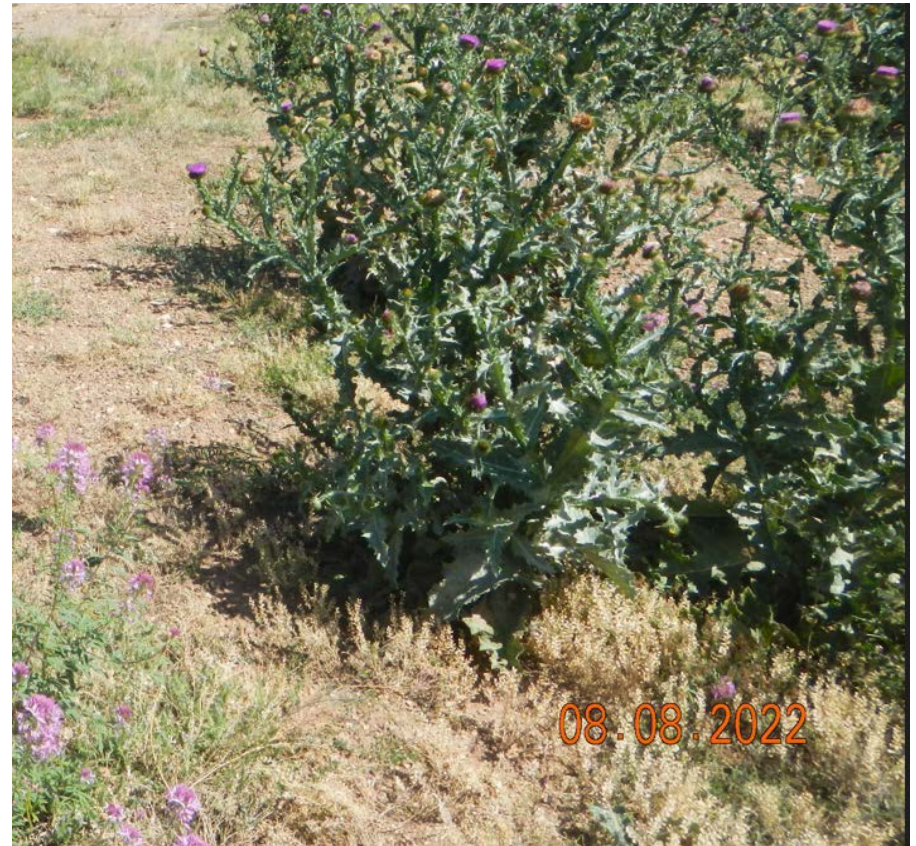
Photo 6. List B noxious weed → Scotch thistle
