Inspection Photos

API: 055-06219

Operator: PETROGLYPH OPERATING CO

Inspection Date: 8/8/2022

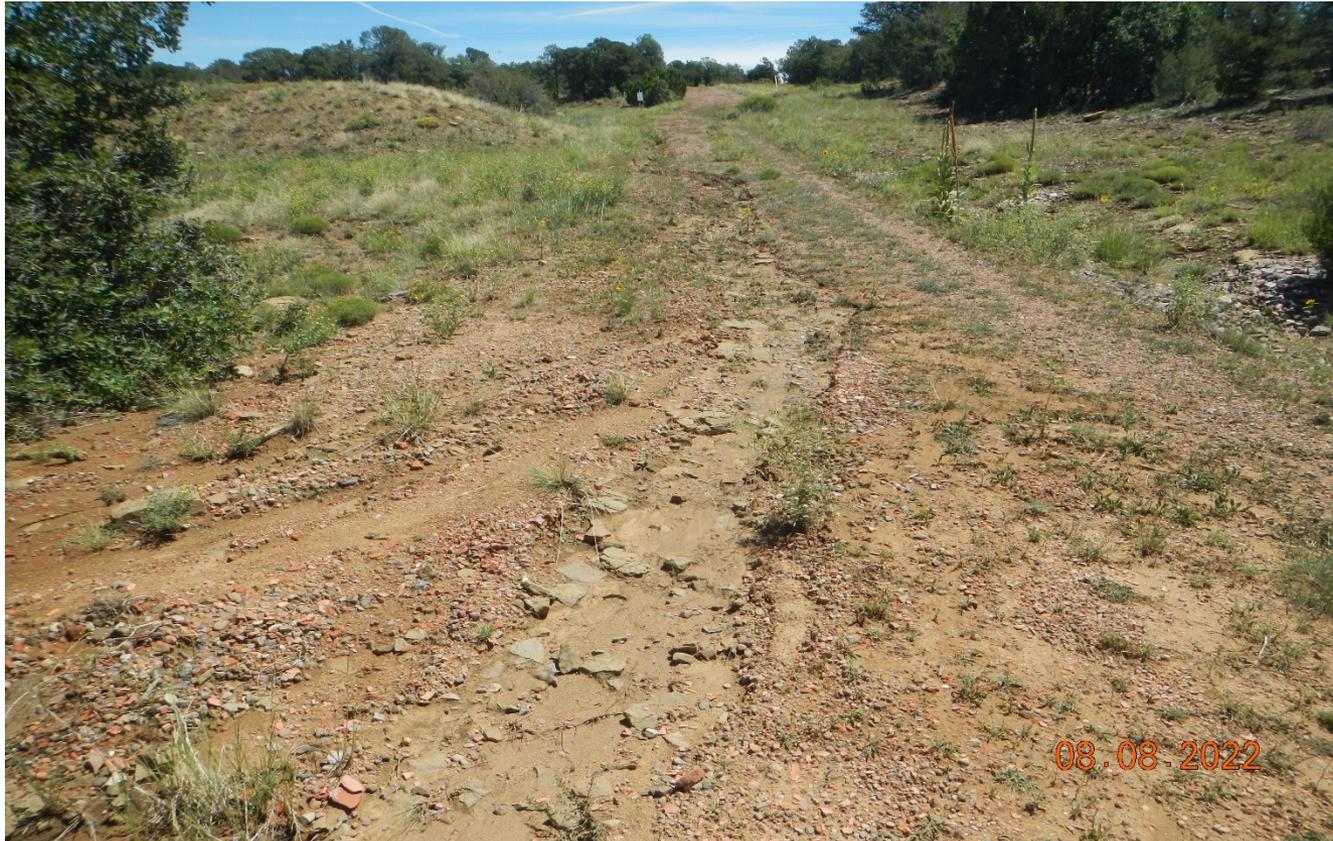
Photo 1. Facing southeast along the access road. There is erosion occurring along the road that has not been repaired and has worsened since previous inspection. Previous corrective action not completed

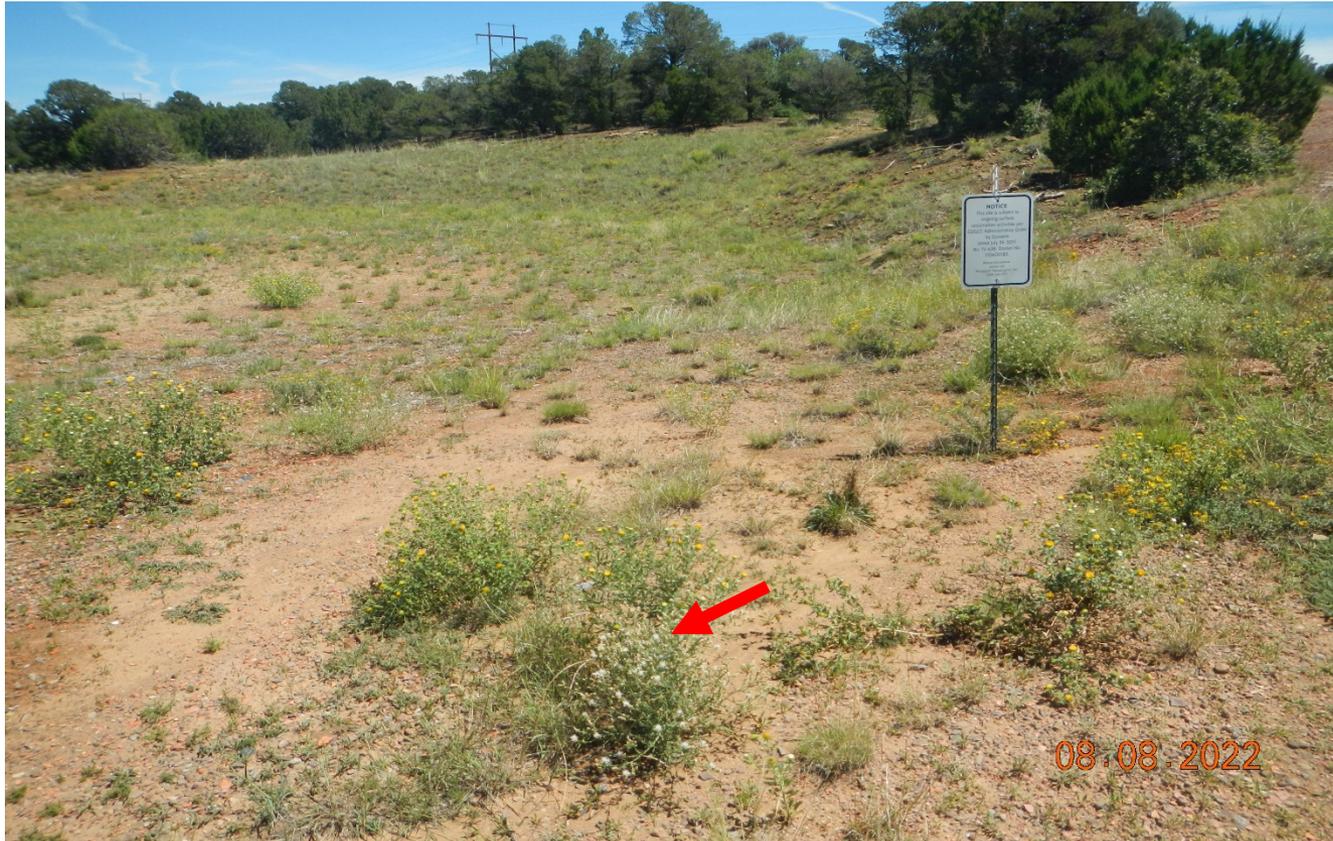
Photo 2. Facing southeast toward the location. There is noxious weeds shown red arrow which have seeded out. → Diffuse knapweed

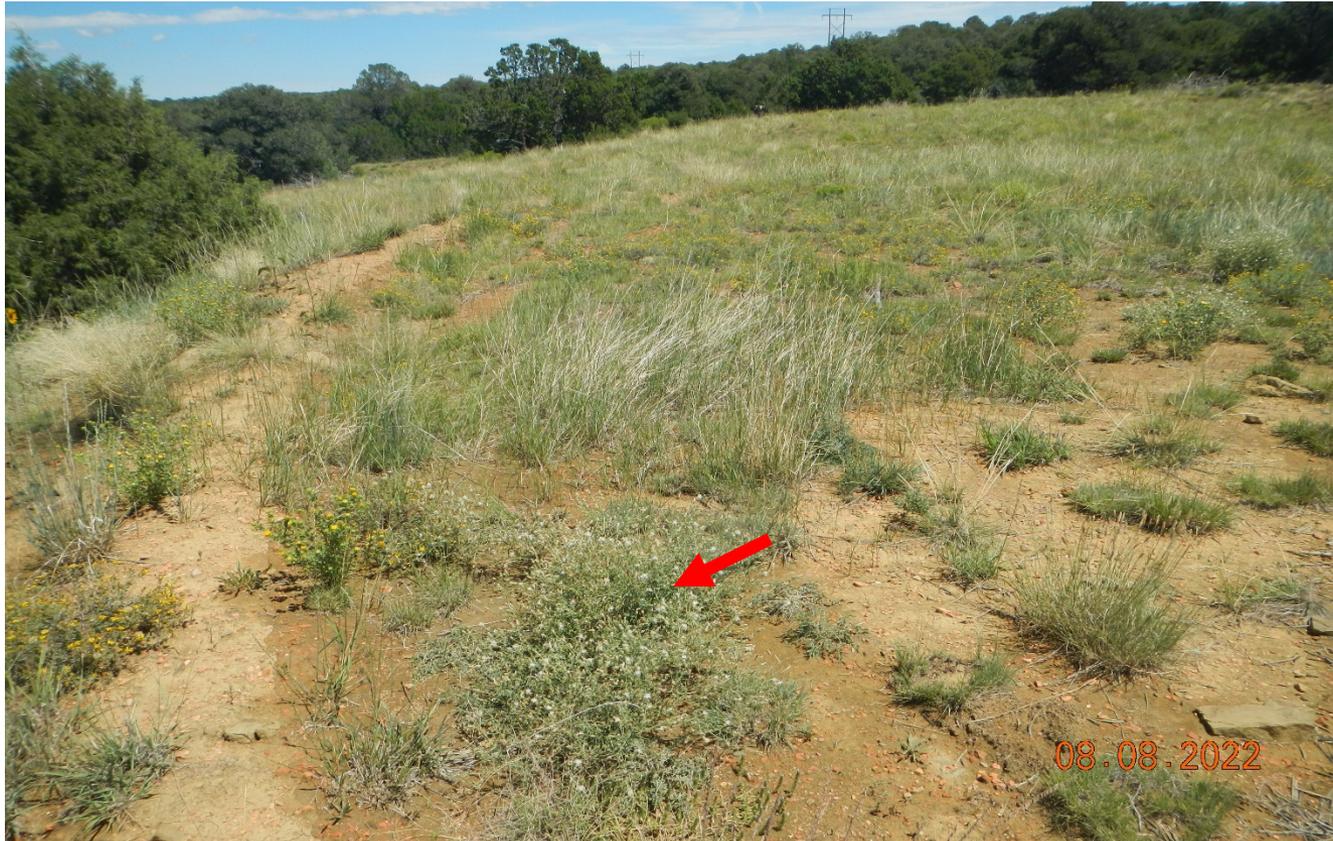
Photo 3. Facing east toward the location. There is noxious weeds shown red arrow which have seeded out. → Diffuse knapweed

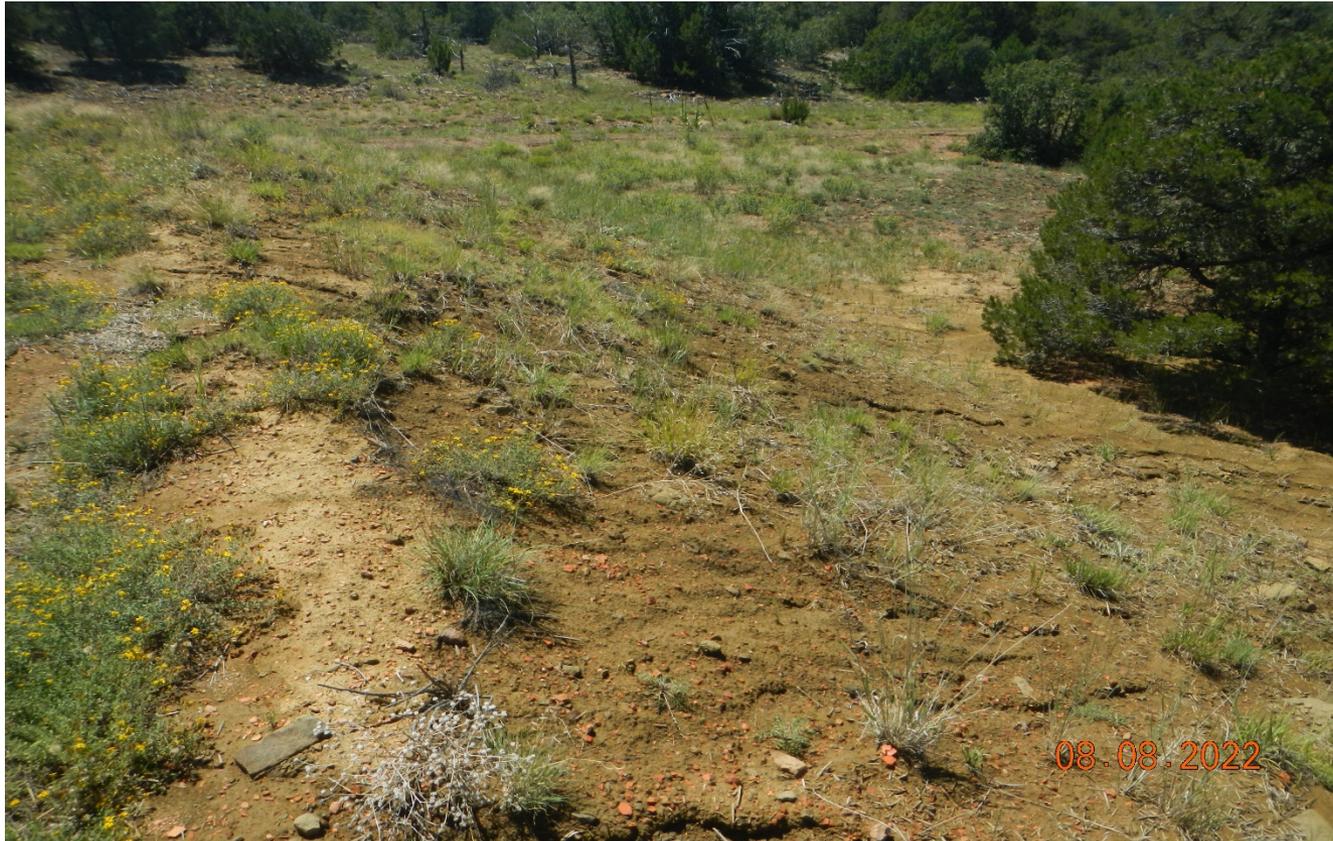
Photo 4. Facing toward the fill slope. There erosion occurring along the fill slope which is not stabilized.

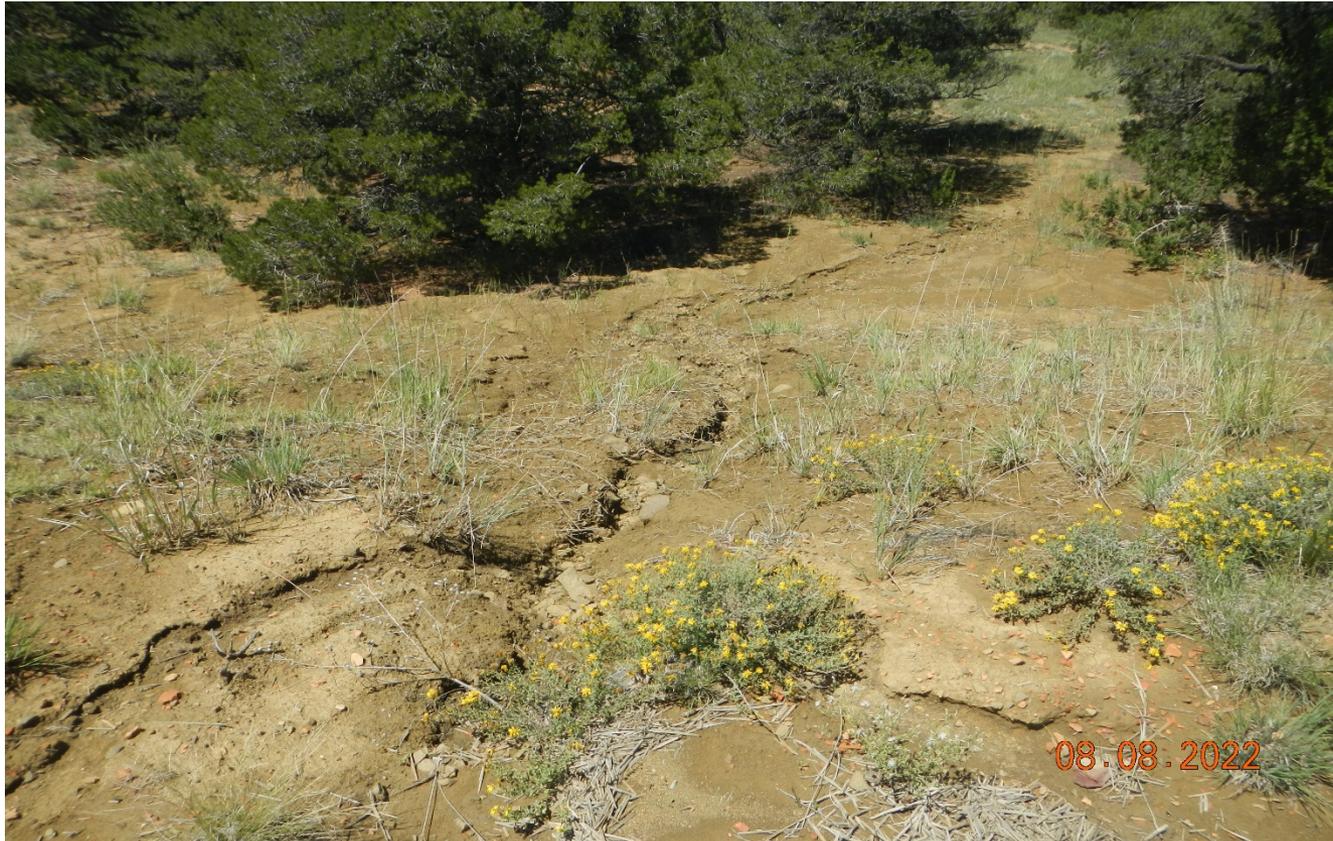
Photo 5. Facing toward the fill slope. There erosion occurring along the fill slope which is not stabilized.

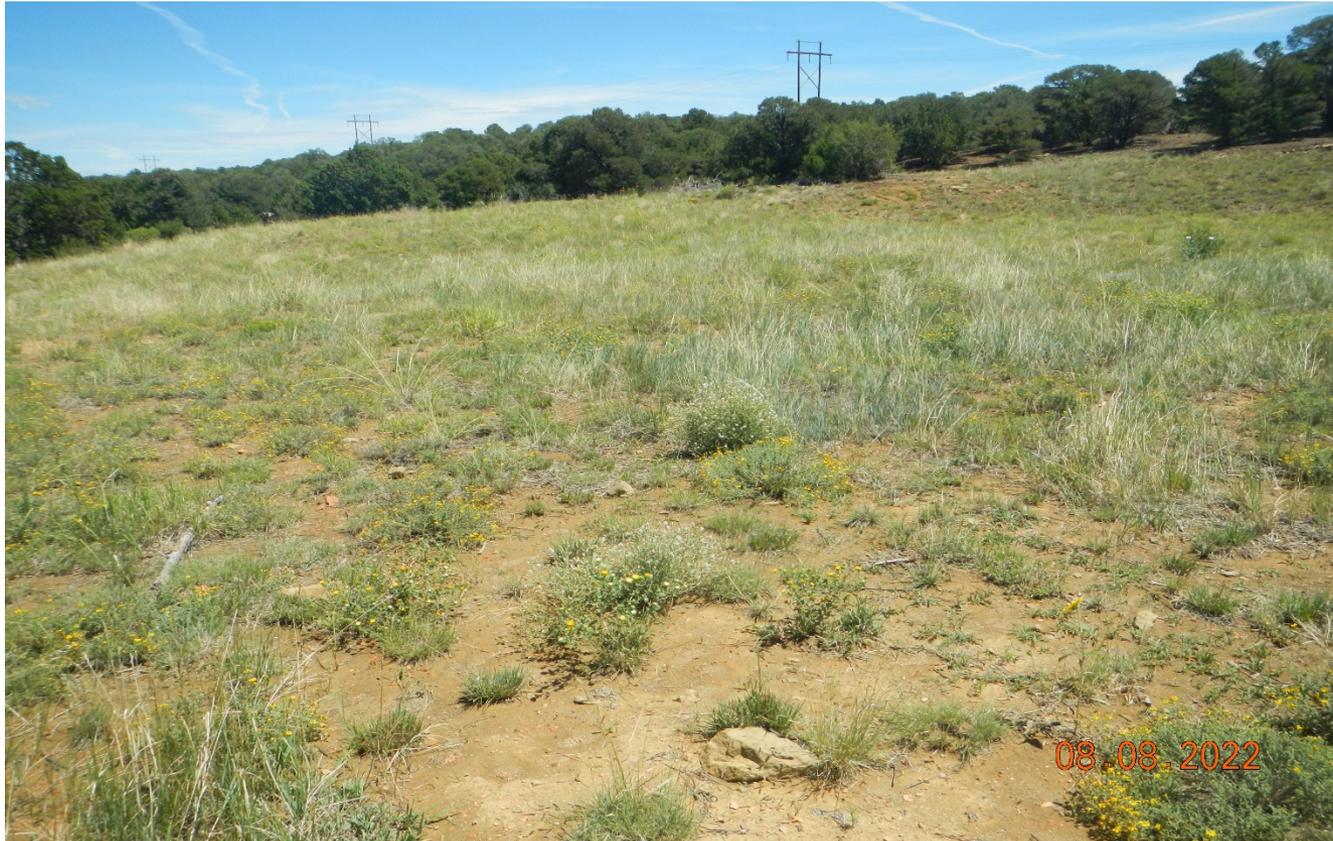
Photo 6. Facing toward the east side of the location. The vegetation is well established at the eastern portion of the location.
