Inspection Photos

Location Name: Silver Spur Minerals 35-2H

API: 05-057-06490

Date: July 25, 2022

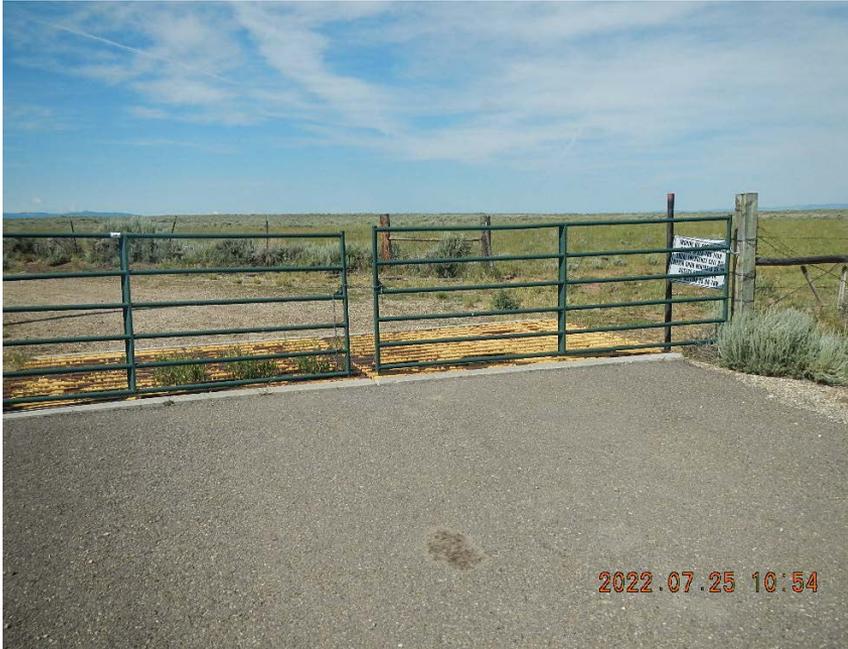
Location sign off of Hwy 14.

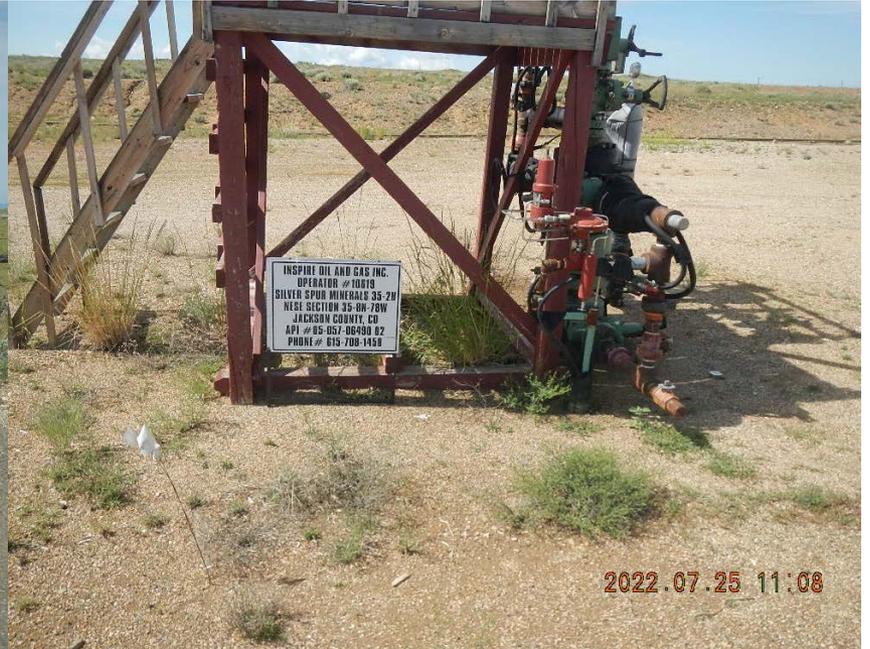
Well sign.

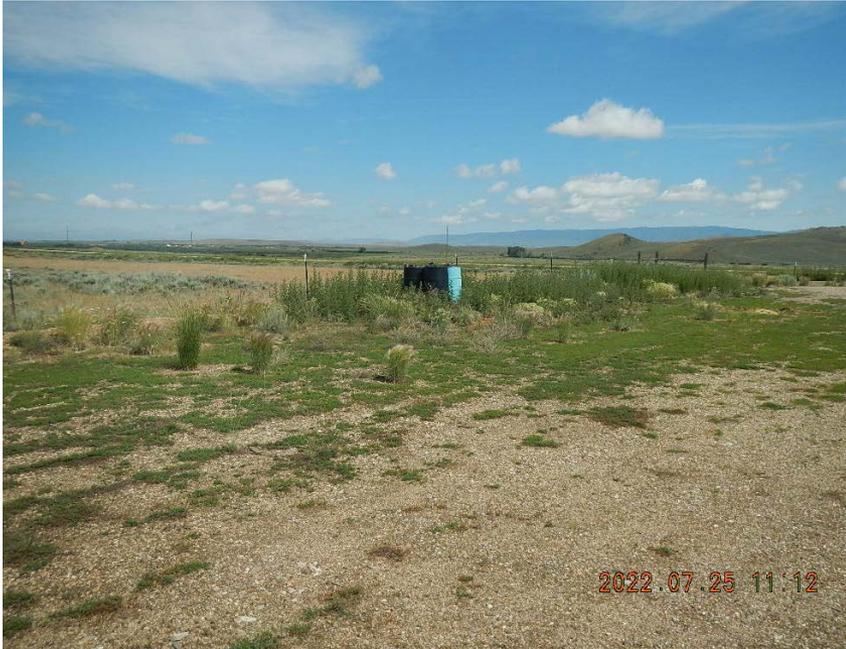
Equipment stored on Location. Pipe and tubing noted in previous inspections has been removed.

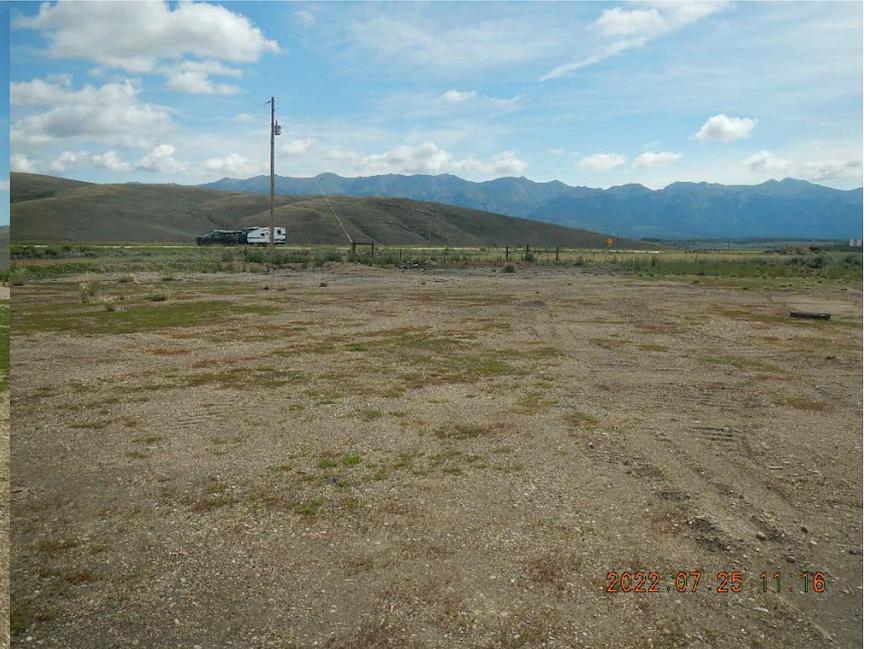
Pipe and tubing noted in previous inspections has been removed.

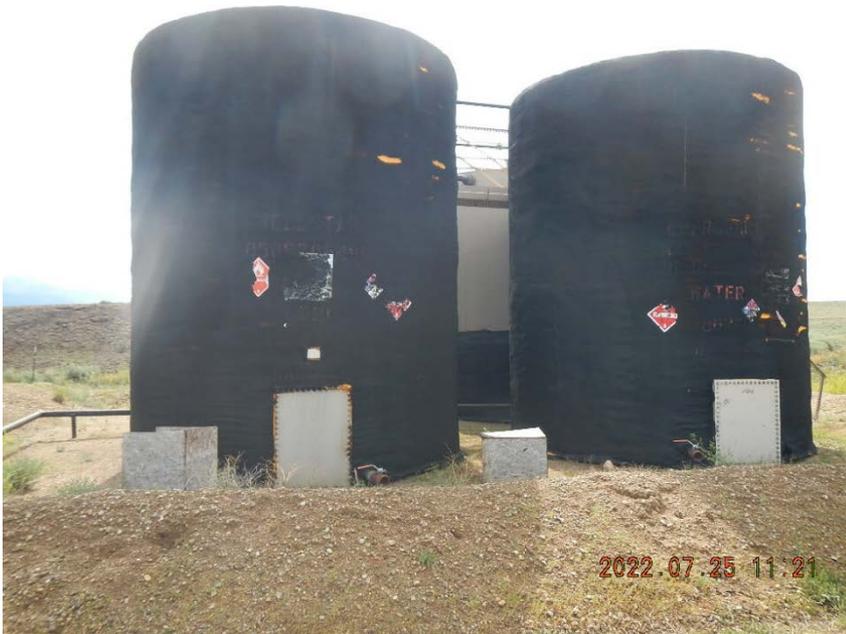
Tank signage, labels, and placards are illegible

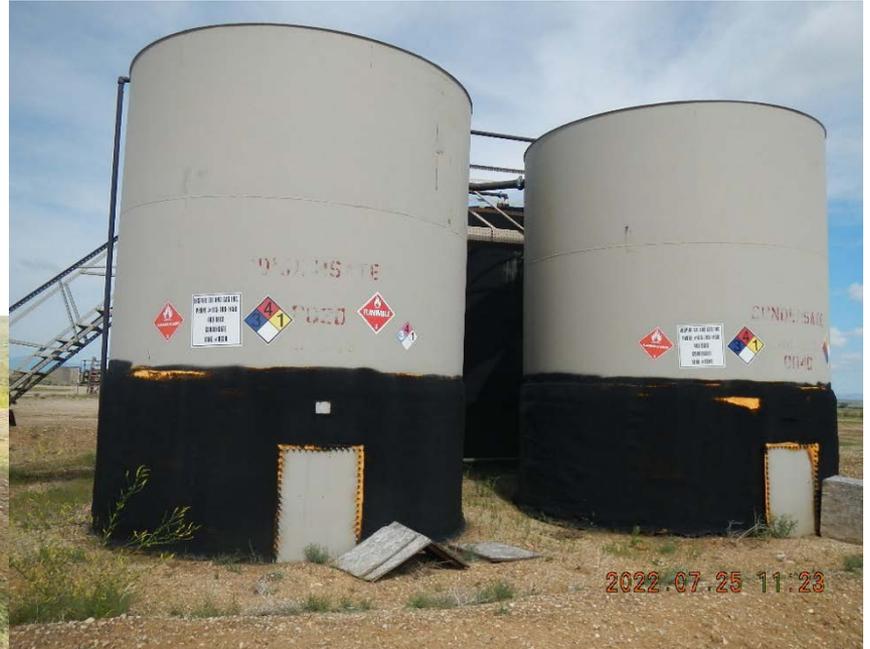
Tank labels is illegible.

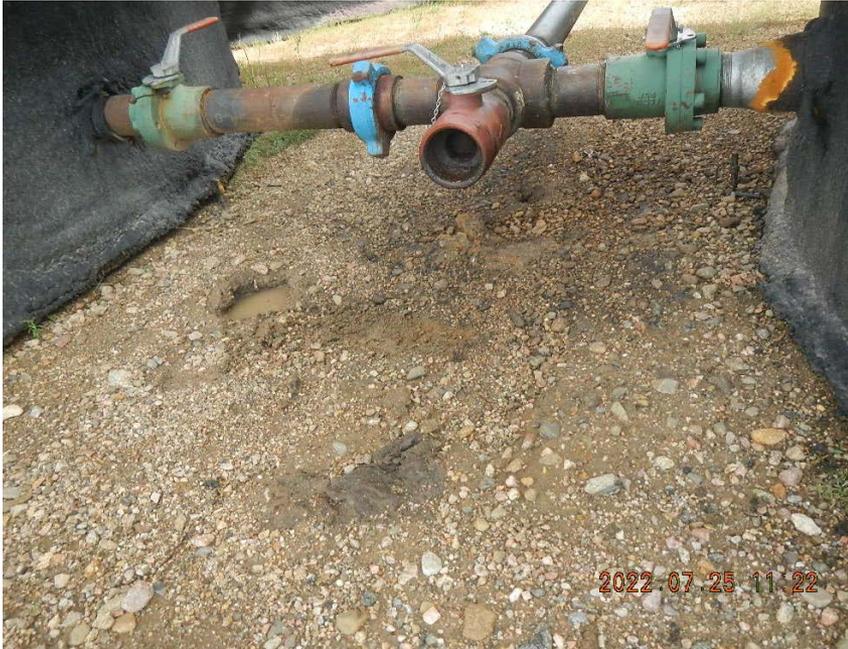
Tank 0030, staining beneath hammer unions. Possible weeping of fluids from valve.

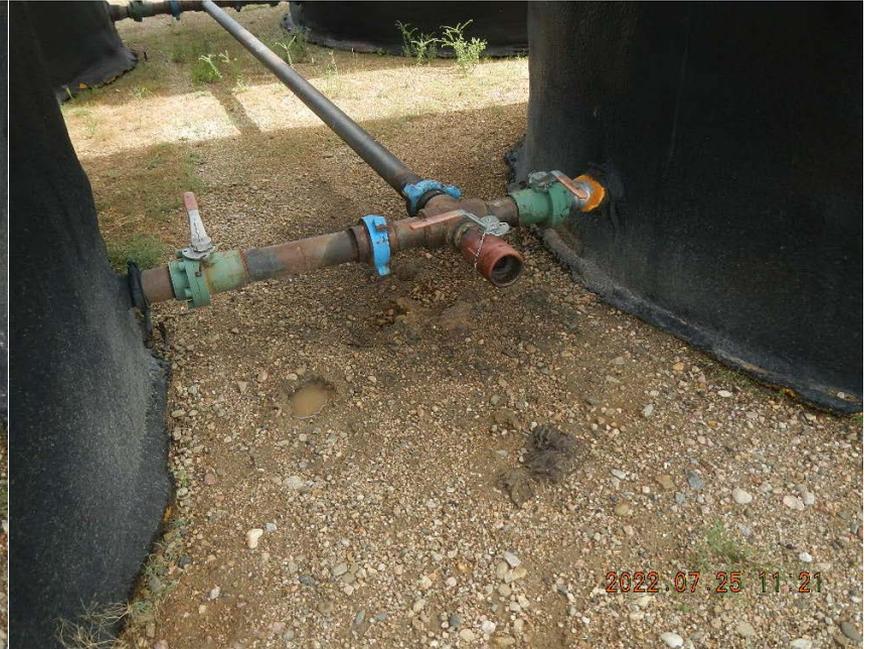
Tank 0030, staining beneath hammer unions.

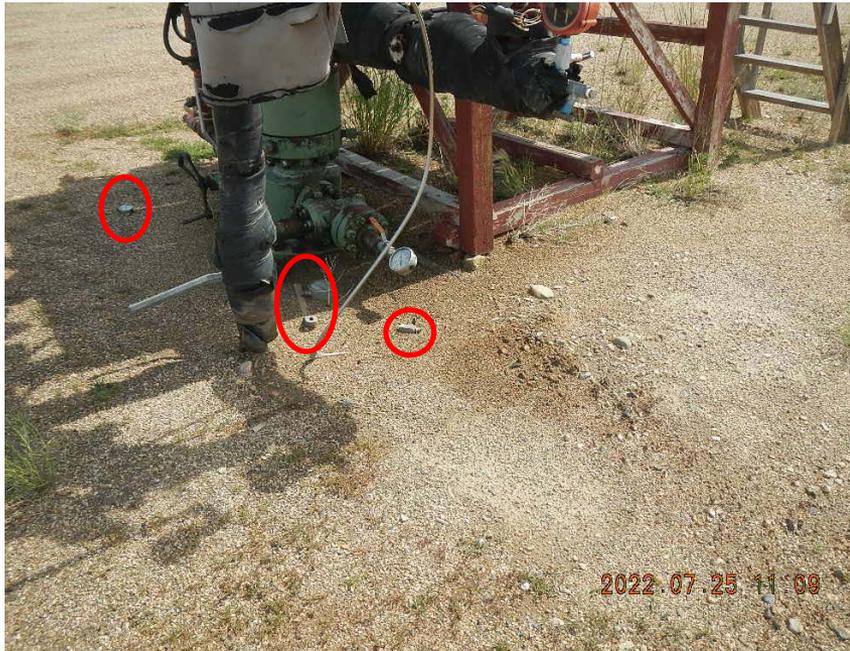
Staining from May 2021 gas leak/vent and condensate around wellhead. Trash/unused equipment (wrenches, needle valve and pressure gauge).

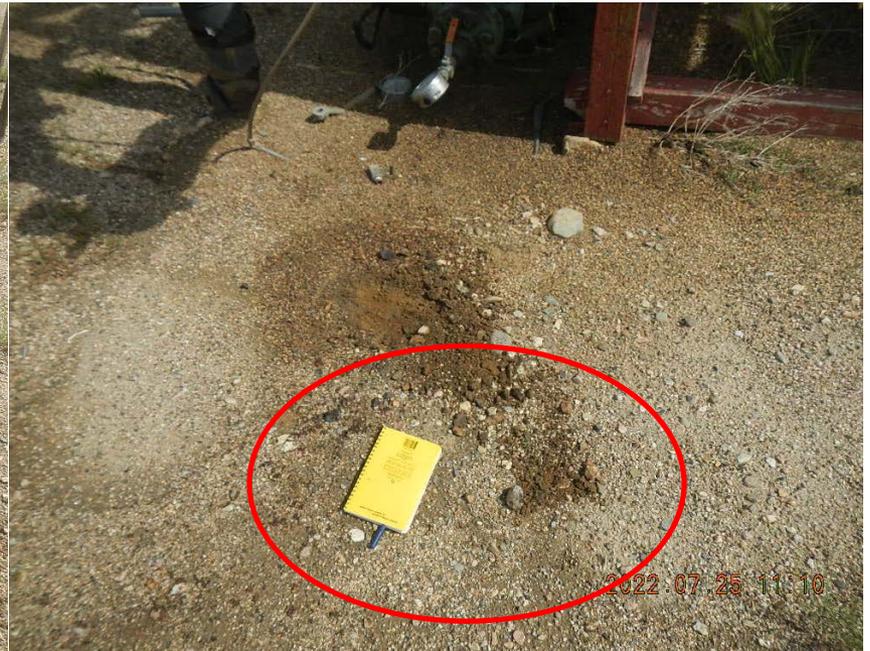
Staining from May 2021 gas leak/vent and condensate around wellhead. Apparent newer material imported over previously impacted area.

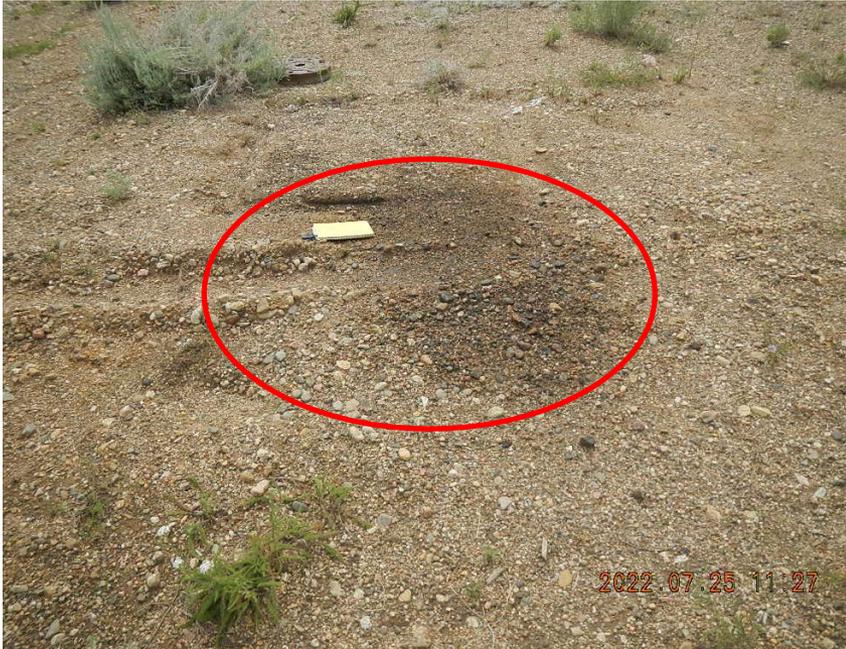
Area where oil heater was positioned. Not the hydrocarbon stained soil. Per Rule 911.a. operator shall submit a Form 27 prior to the removal of facility equipment.

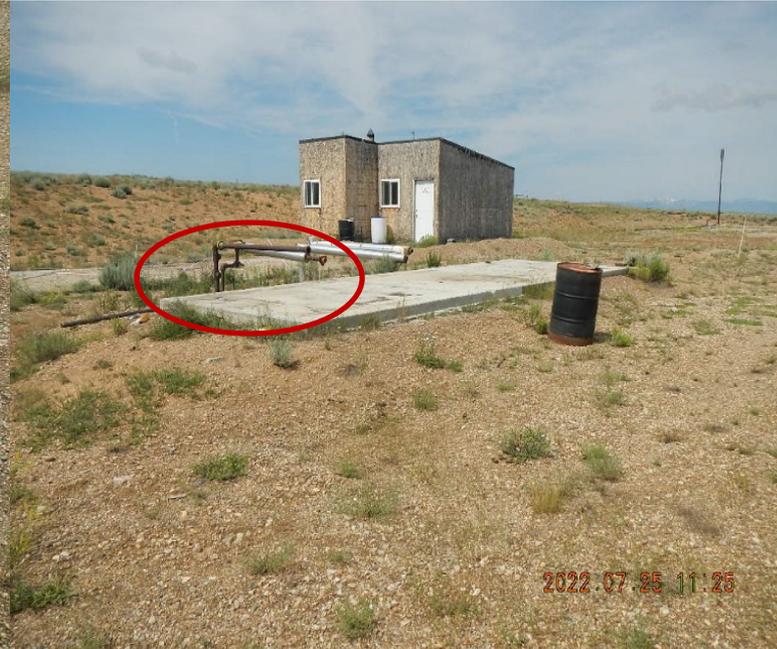
Area where oil heater and associated equipment once were positioned. Per Rule 911.a. operator shall submit a Form 27 prior to the removal of facility equipment. Note: unmarked risers and piping.

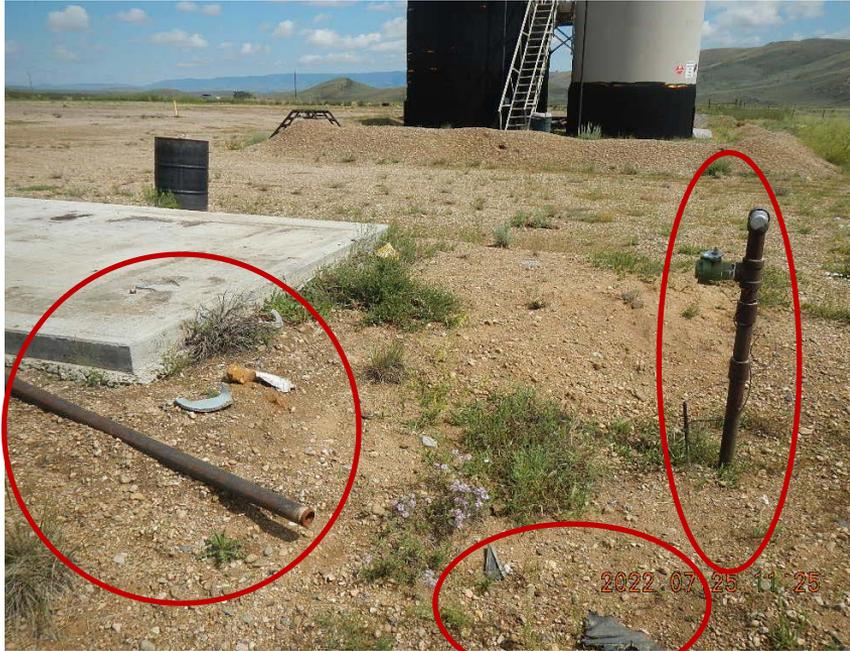
Area where oil heater and associated equipment once were positioned. Per Rule 911.a. operator shall submit a Form 27 prior to the removal of facility equipment. Note: unmarked risers and piping, trash and debris.

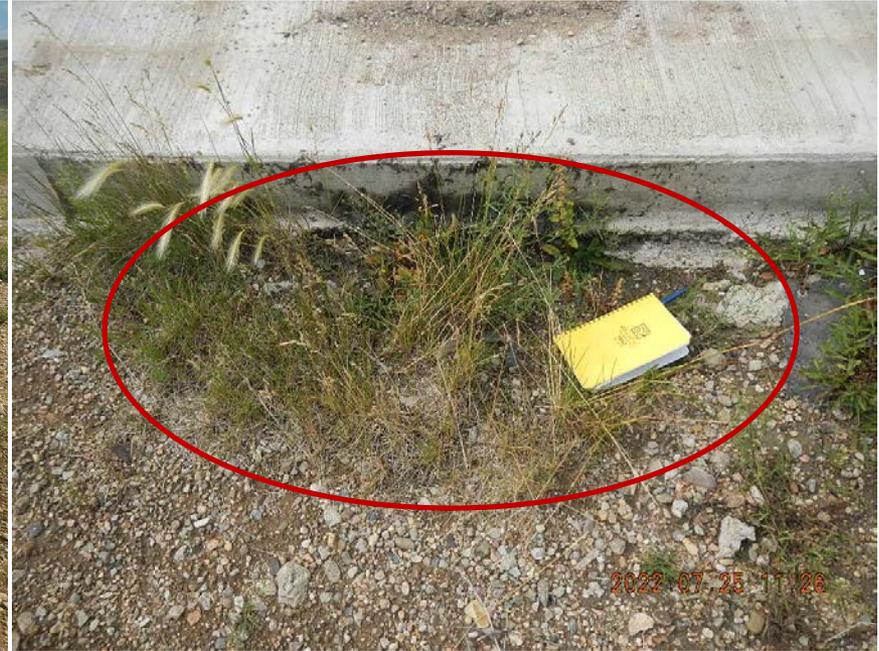
Area where oil heater and associated equipment once were positioned. Stained soil noted in previous inspections.
