Site Inspection Report

Site: COSSLET A 9 FLOWLINE
06/13/2022

SITE INSPECTION REPORT

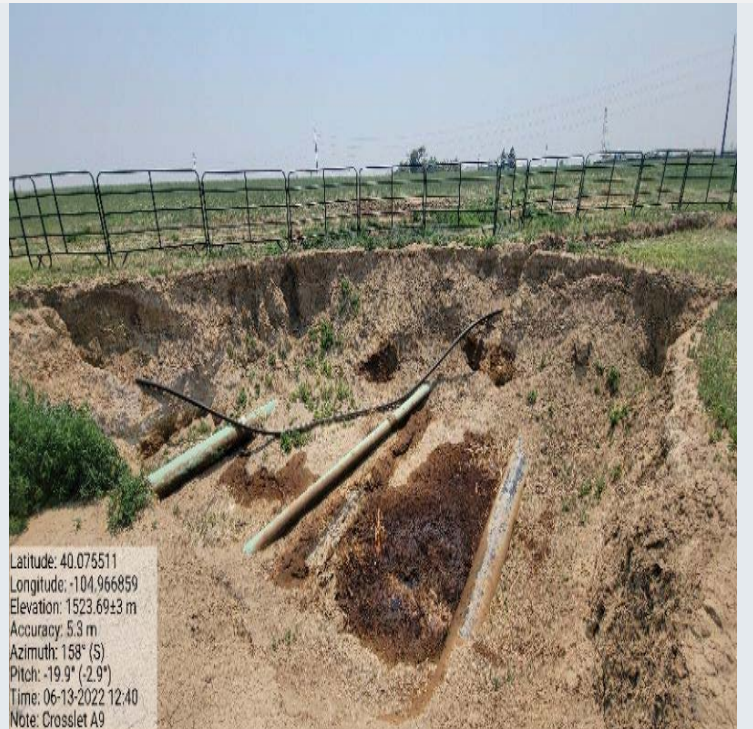
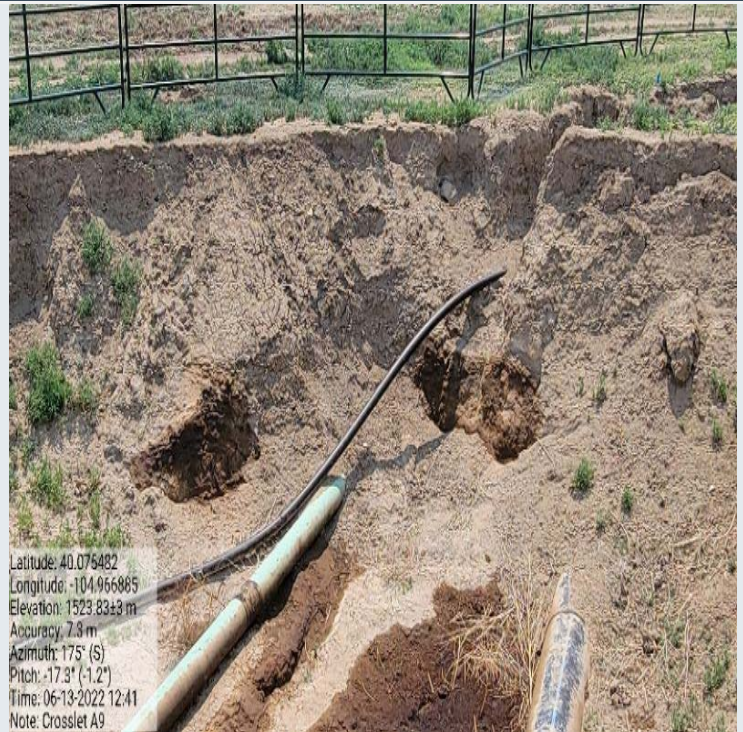
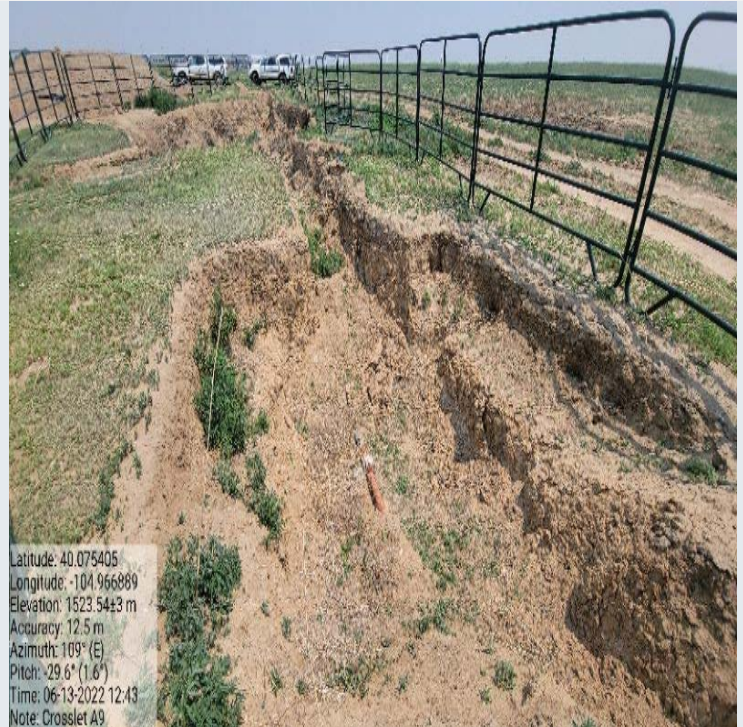
Question: Open excavation? Approximate size (Length x Width x Depth, ft)

Response: Yes

Notes: Main Excavation – 40x30x7
Southern Flowline Extent – 40x10x4
Northern Flowline Extent – 30x10x4

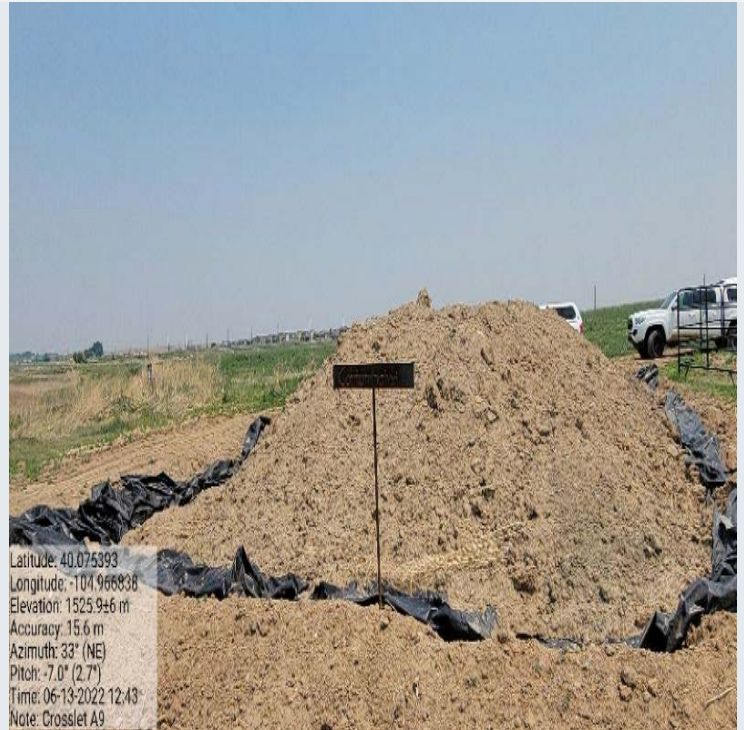
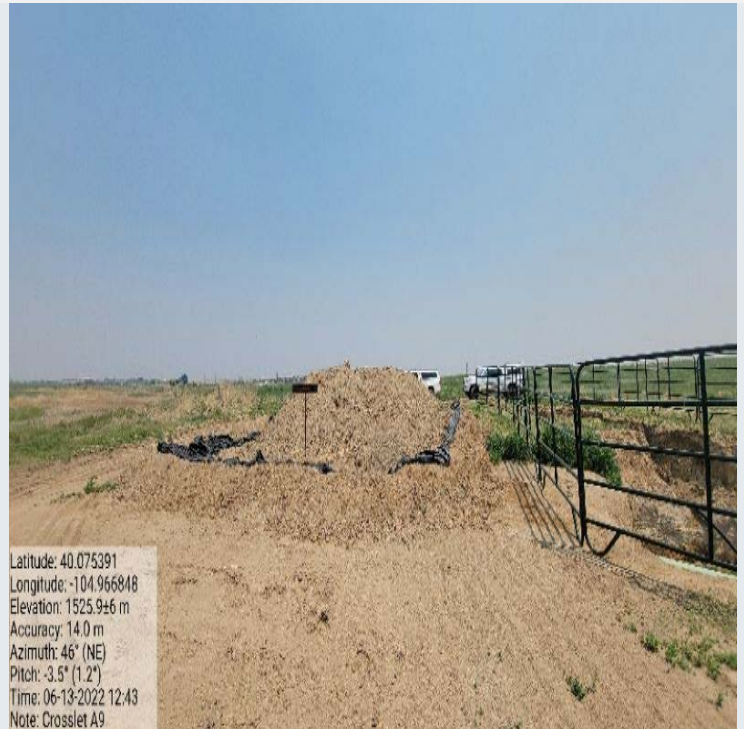
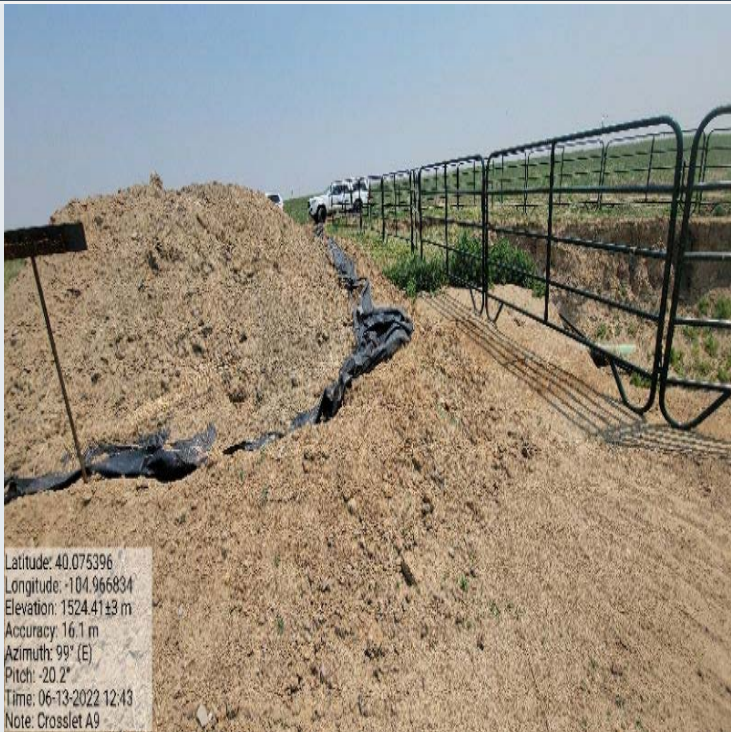
Question: Stockpiled waste and approximate volume (cubic feet)

Response: Yes

Notes: 5800

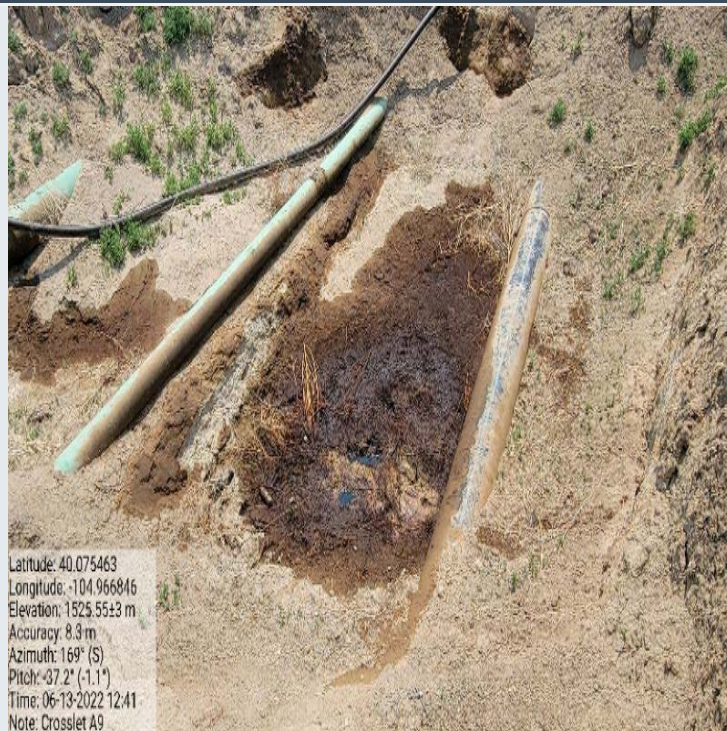
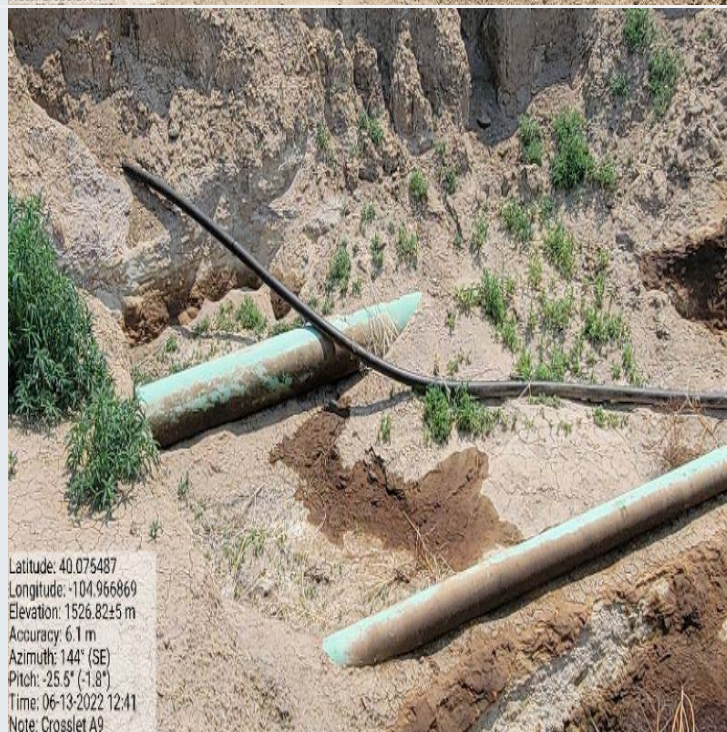
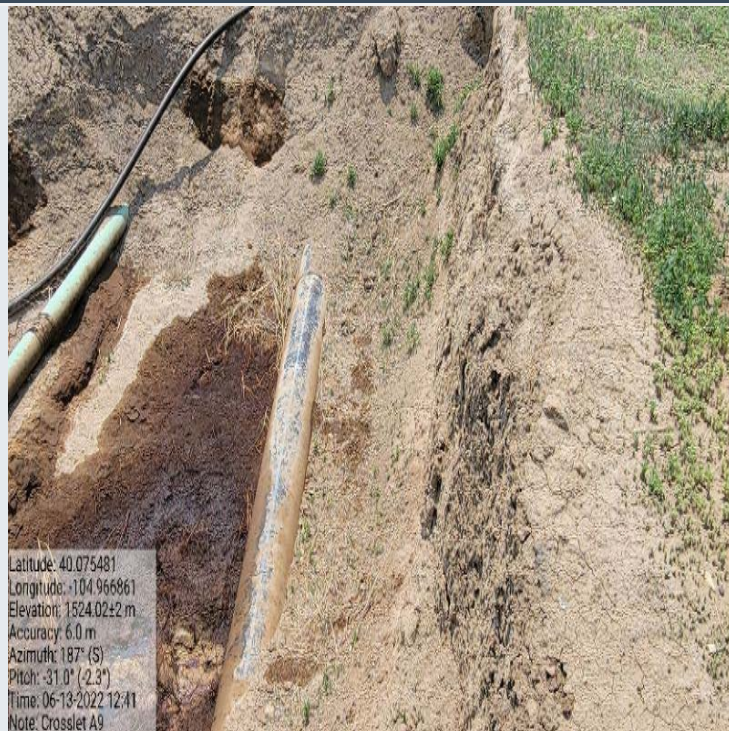
SITE/LOCATION	DATE	TIME	INSPECTOR
COSSLET A 9 FLOWLINE	06/13/2022	12:43 PM	COGCC Contractor
Comments	Staining is becoming more visible and showing up in more areas within the excavation		
Work Activity Notes			
Changes since previous inspection?	No	Drive by inspection	No
Actively being worked?	No		
Fieldwork Oversight Performed?	No	Oversight Type	N/A
Were Oversight Samples Collected?	N/A	Sample Details	N/A

Question: Ground surface appears clean (no evidence of new equipment leaks, oil leaks, spills, or releases)?

Response: No

Notes: Additional staining observed within the excavation along the flowline

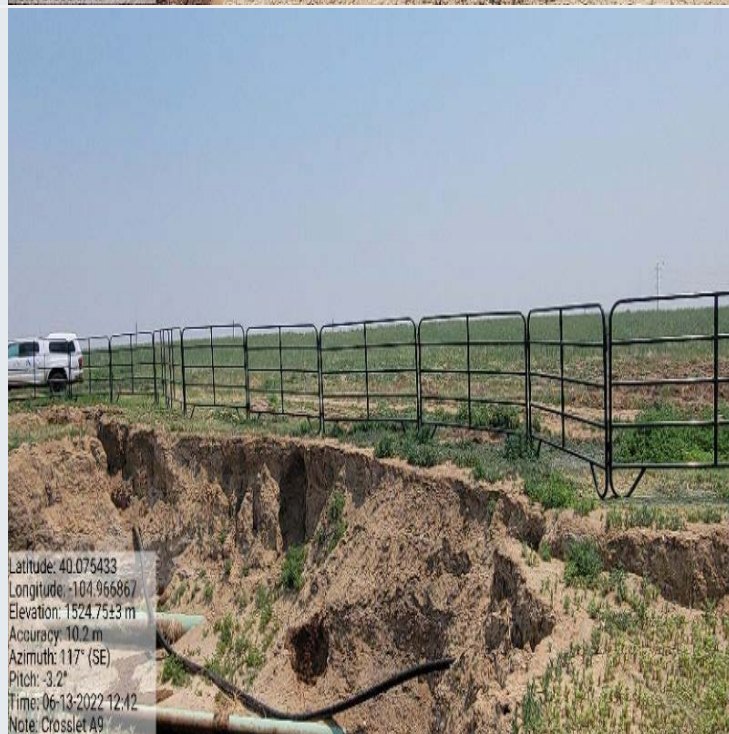
Question: Open excavation properly fenced/covered (in accordance with Rule 913.b.(5)B.i.)?

Response: Yes

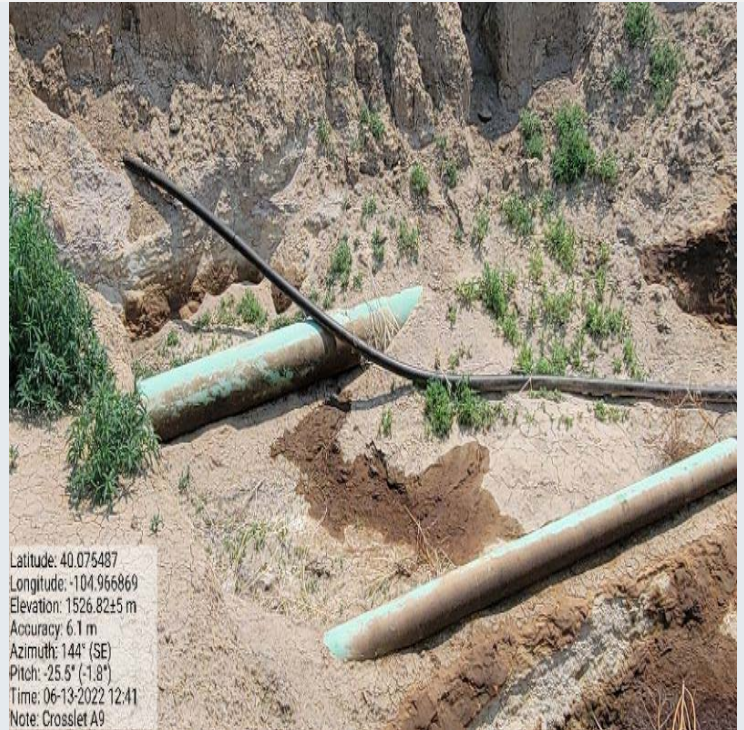
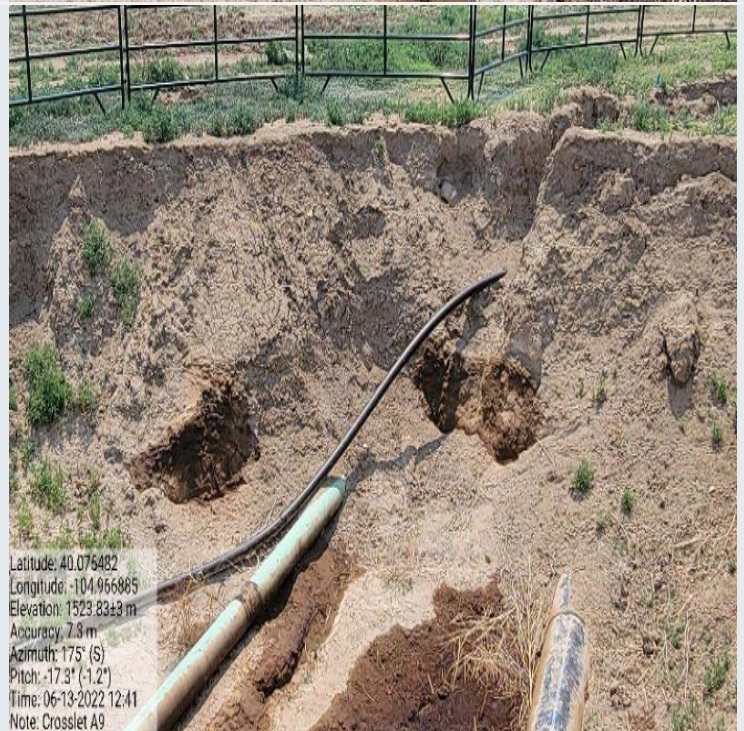
Question: Exposed buried/underground flowlines?

Response: Yes

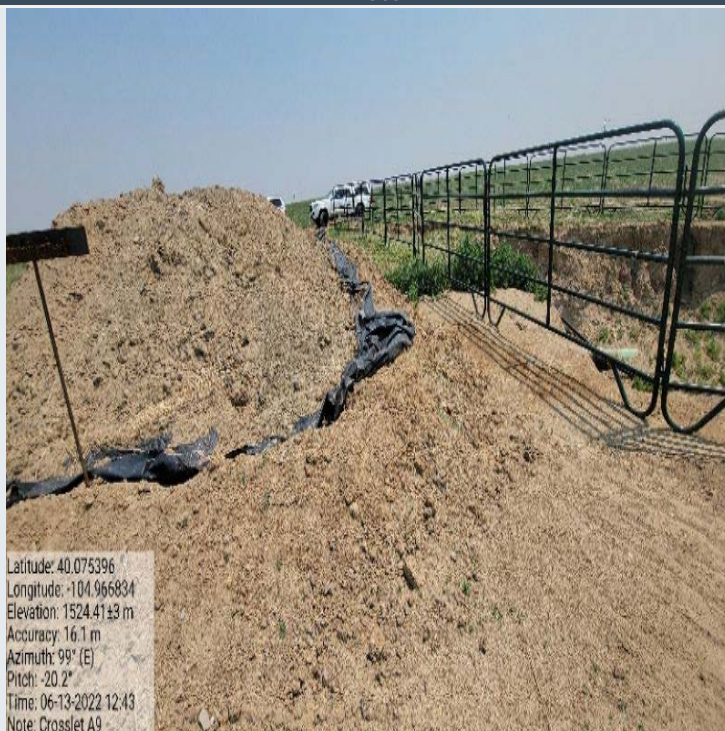
Question: Is an earthen berm secondary containment present and in good condition (no evidence of erosion, animal burrowing, etc.)?

Response: Yes

Notes: Earthen berm is inadequate
