Site Inspection Report

Site: H. HUETT CONSOLIDATION
RELEASE
06/23/2022

SITE INSPECTION REPORT

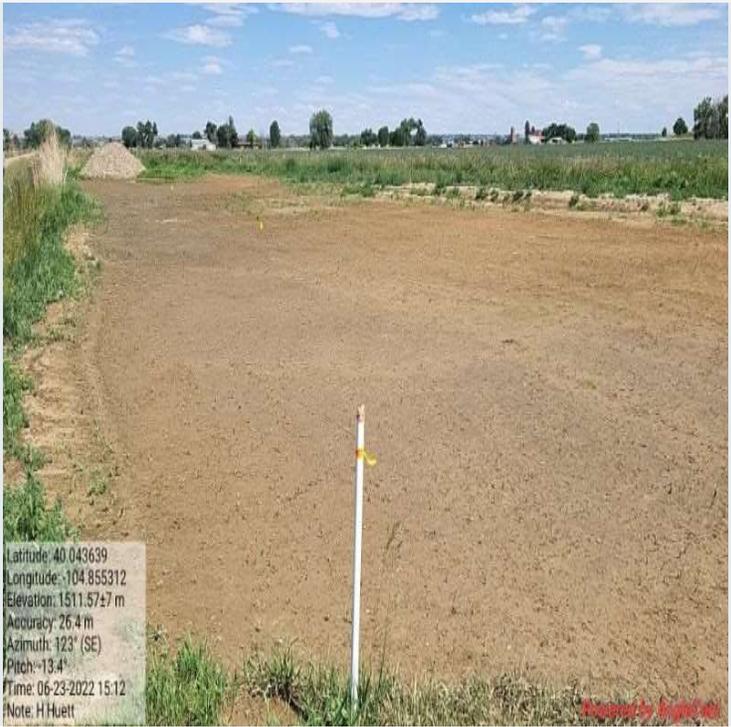
Photo
<p>Question: Monitoring well(s) present? Note: Number, approximate location(s), condition Response: Yes Notes: One</p>

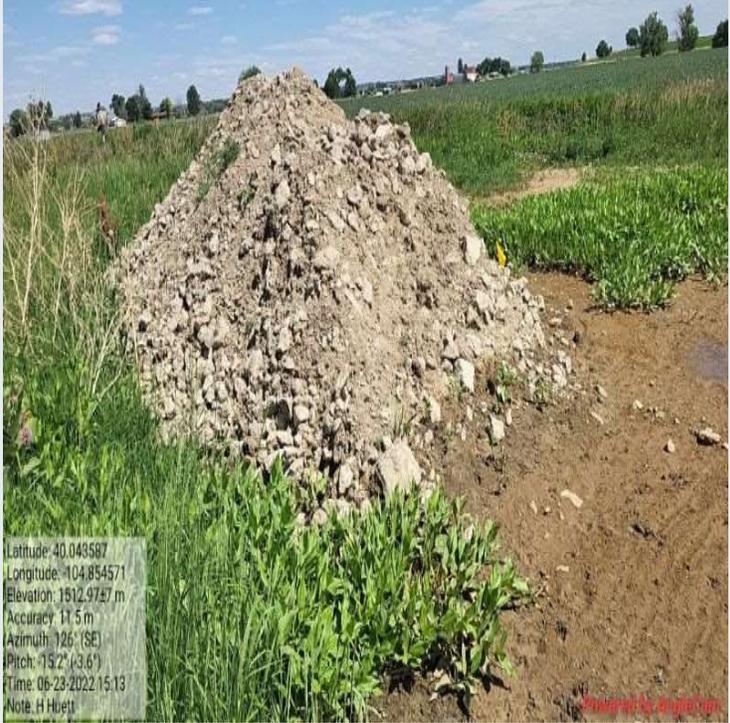
Site Condition Checklist	
	Photo
<p>Question: Is work being conducted in a minimal footprint? Note: Any property/crop damage Response: Yes Notes:</p>	No Photo
<p>Question: Is location adjacent to any Potential Receptors? Note: Livestock, surface water, occupied structure, adjacent land use, etc. Response: Yes Notes: Irrigation ditch</p>	No Photo
<p>Question: Stockpiled waste stored and handled in compliance with Rule 913.b.(5).B.iv.? Response: No Notes: Stock pile to the east of the former excavation. No indication if clean or dirty.</p>

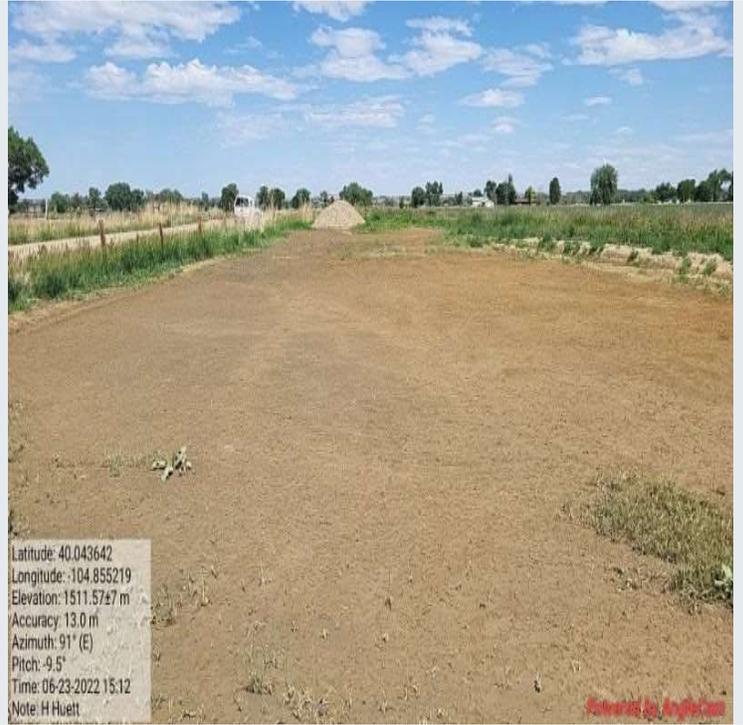
Question: Site free of unused equipment, weeds, debris/trash?

Response: Yes
