Inspection Photos

API: 061-06867

Operator: MULL DRILLING COMPANY INC

Inspection Date: 8/10/2022

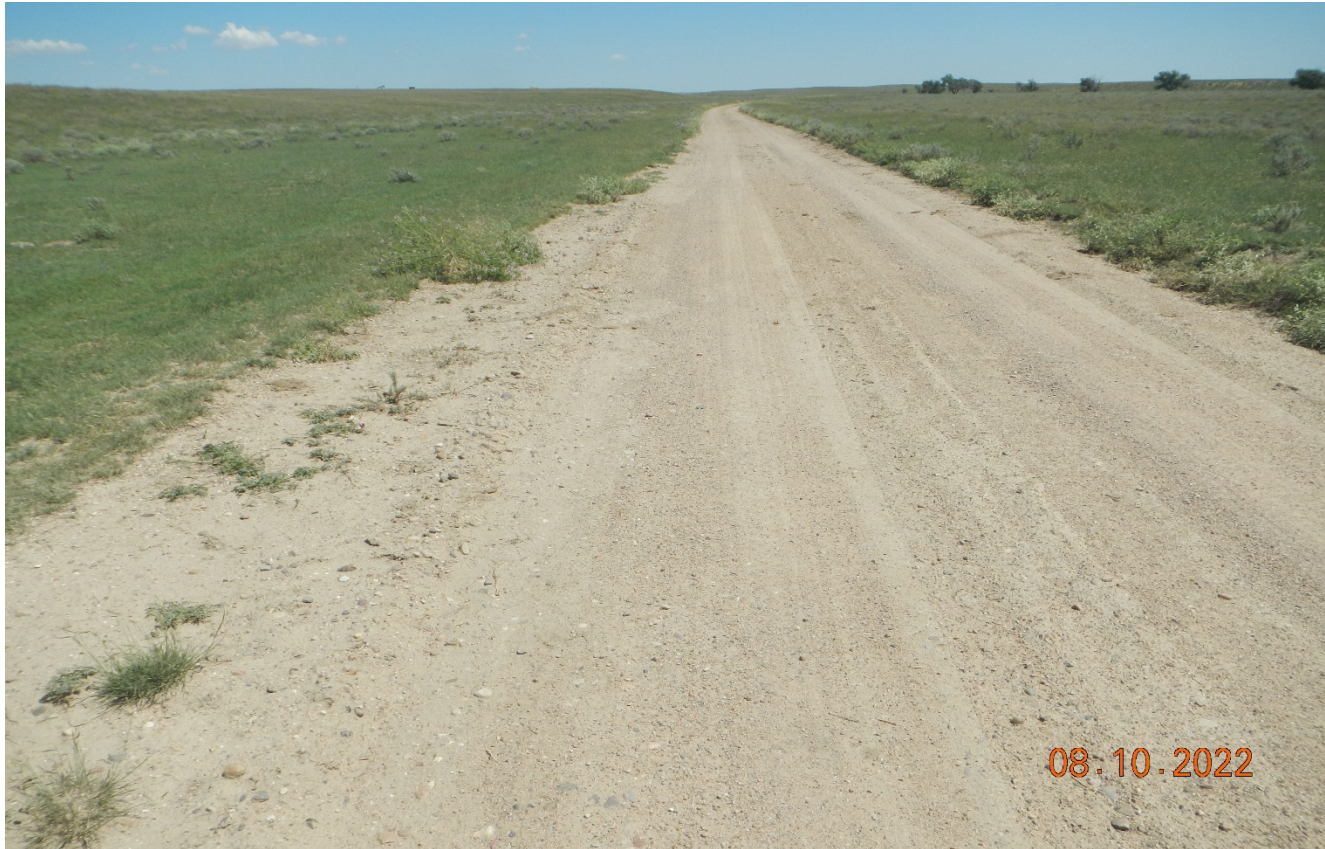
Photo 1. Facing northeast along the access road. There was road work performed along the access road. It is still a concern that stormwater may pool along low areas of the road.

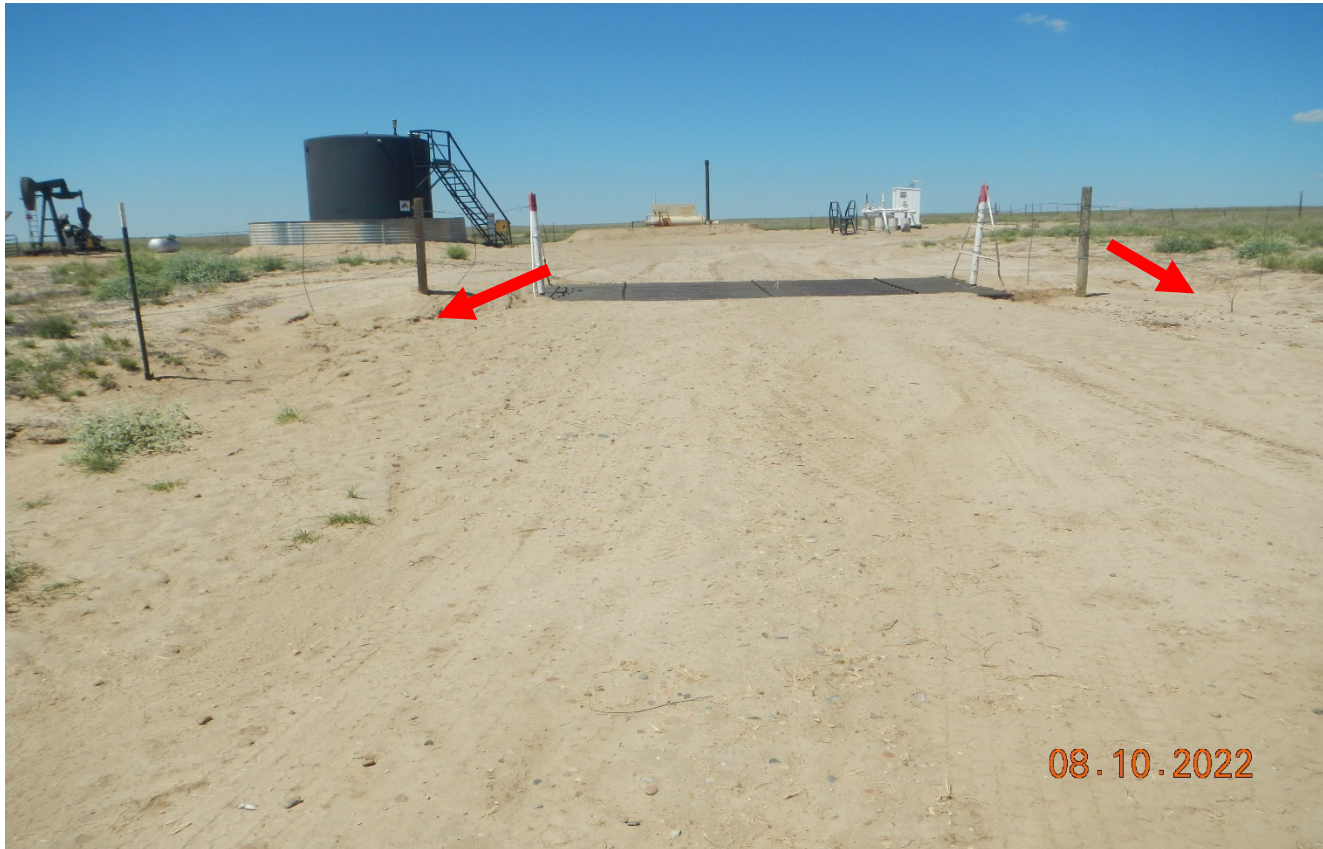
Photo 2. Facing west toward the location. Areas of erosion have been repaired. Areas along the roadside shown at red arrow need to be stabilized and seeded.

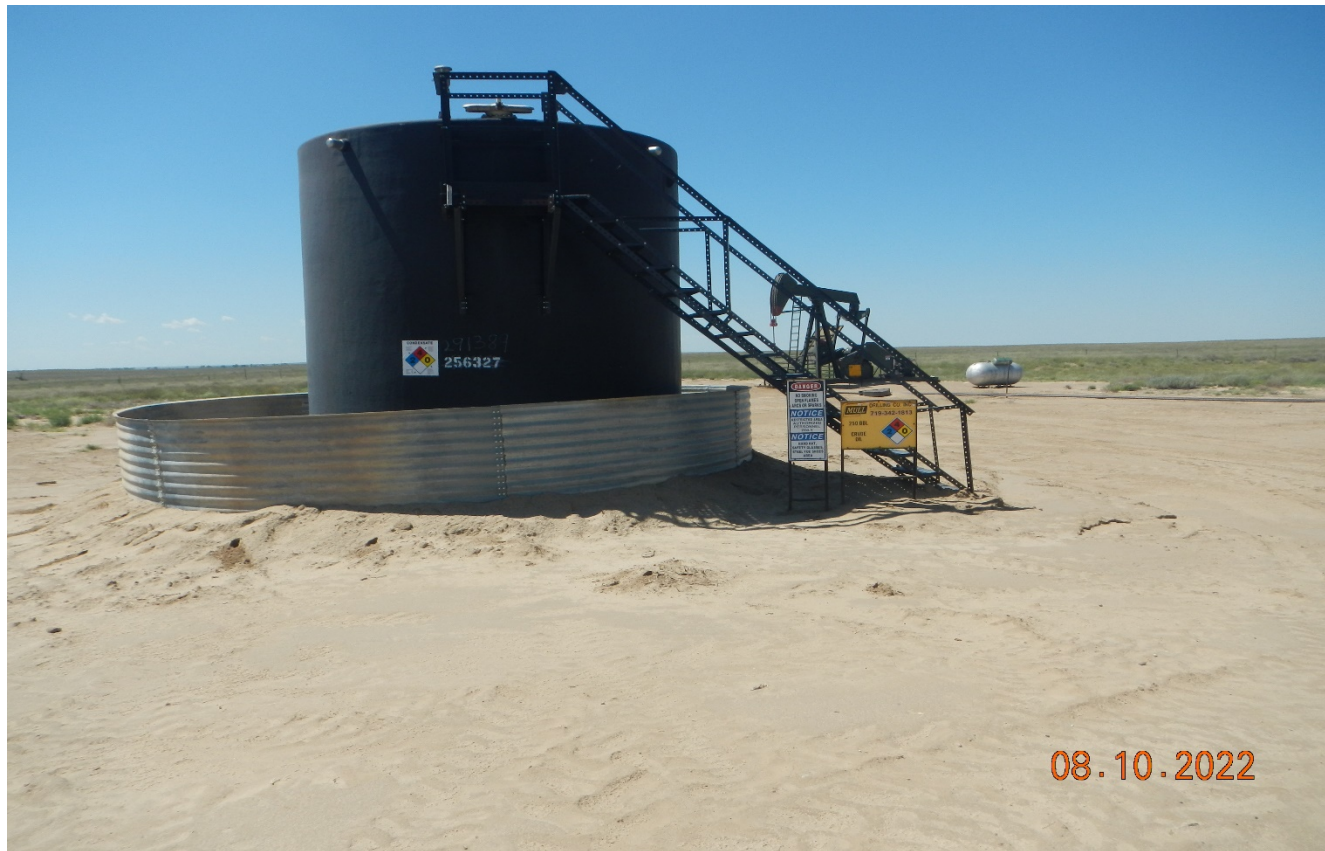
Photo 3. Facing toward the tank battery. A metal containment has been installed.

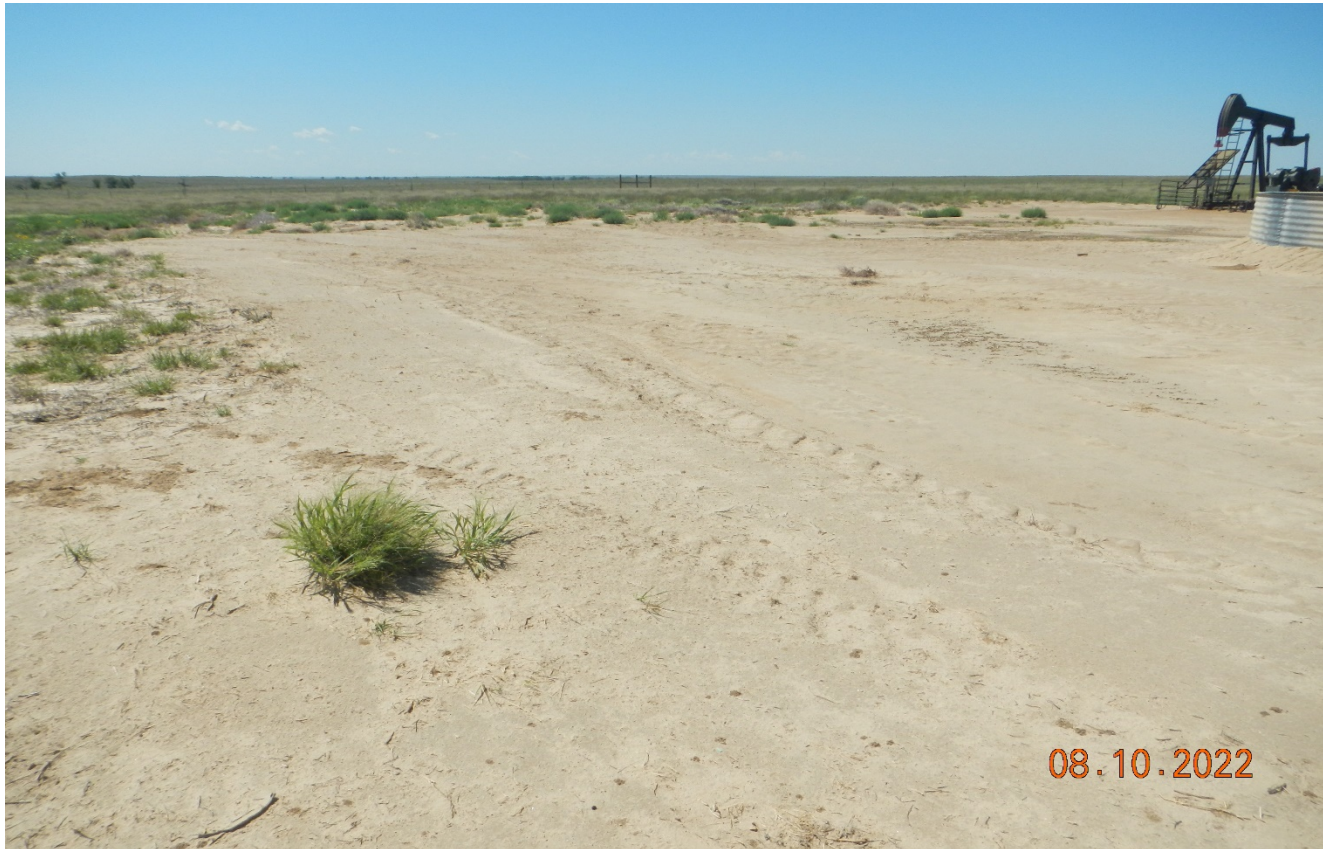
Photo 4. Facing southwest at the location. Unused areas of the location need to be reclaimed and stabilized.

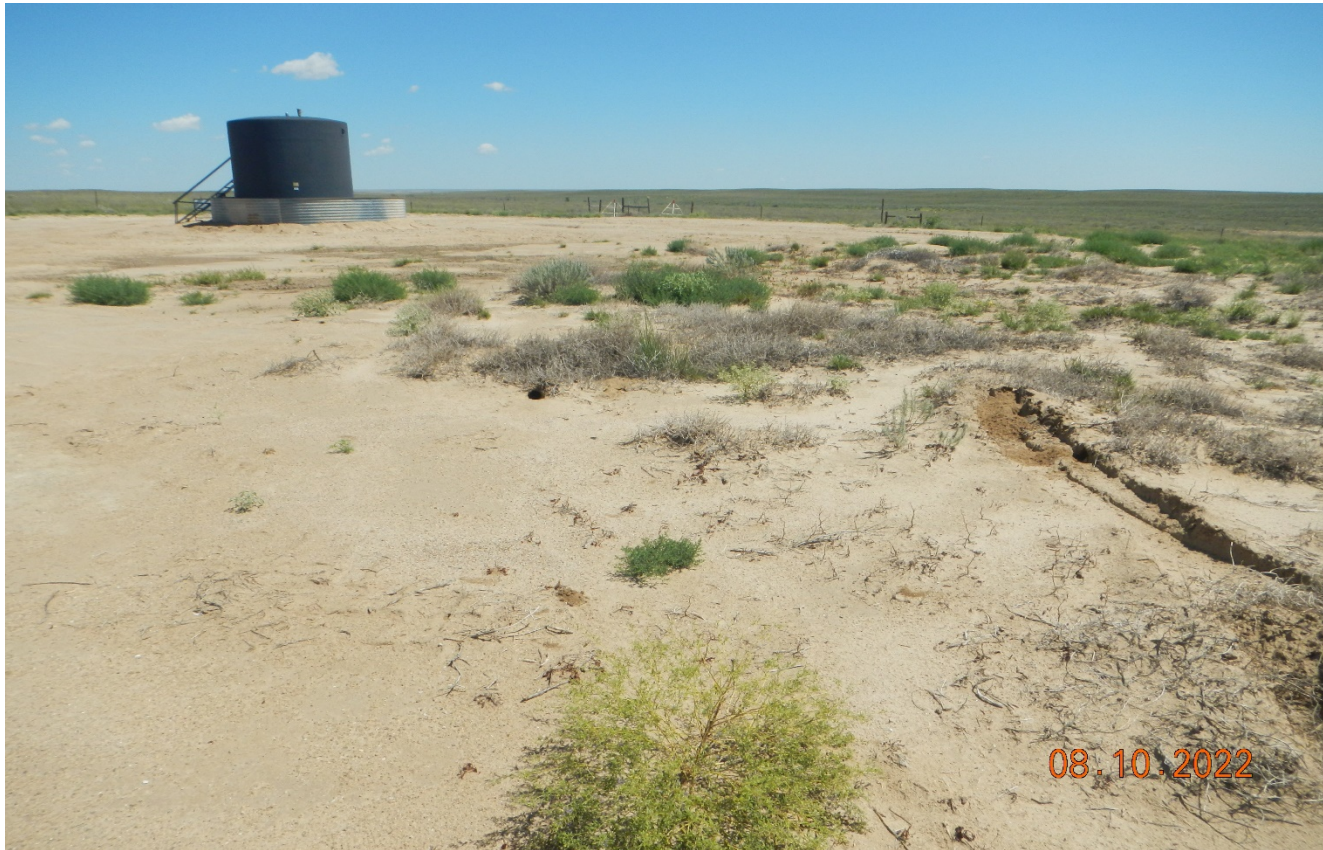
Photo 5. Facing northeast at the location. Unused areas of the location need to be reclaimed and stabilized.
