Inspection Photos

API: 061-06179

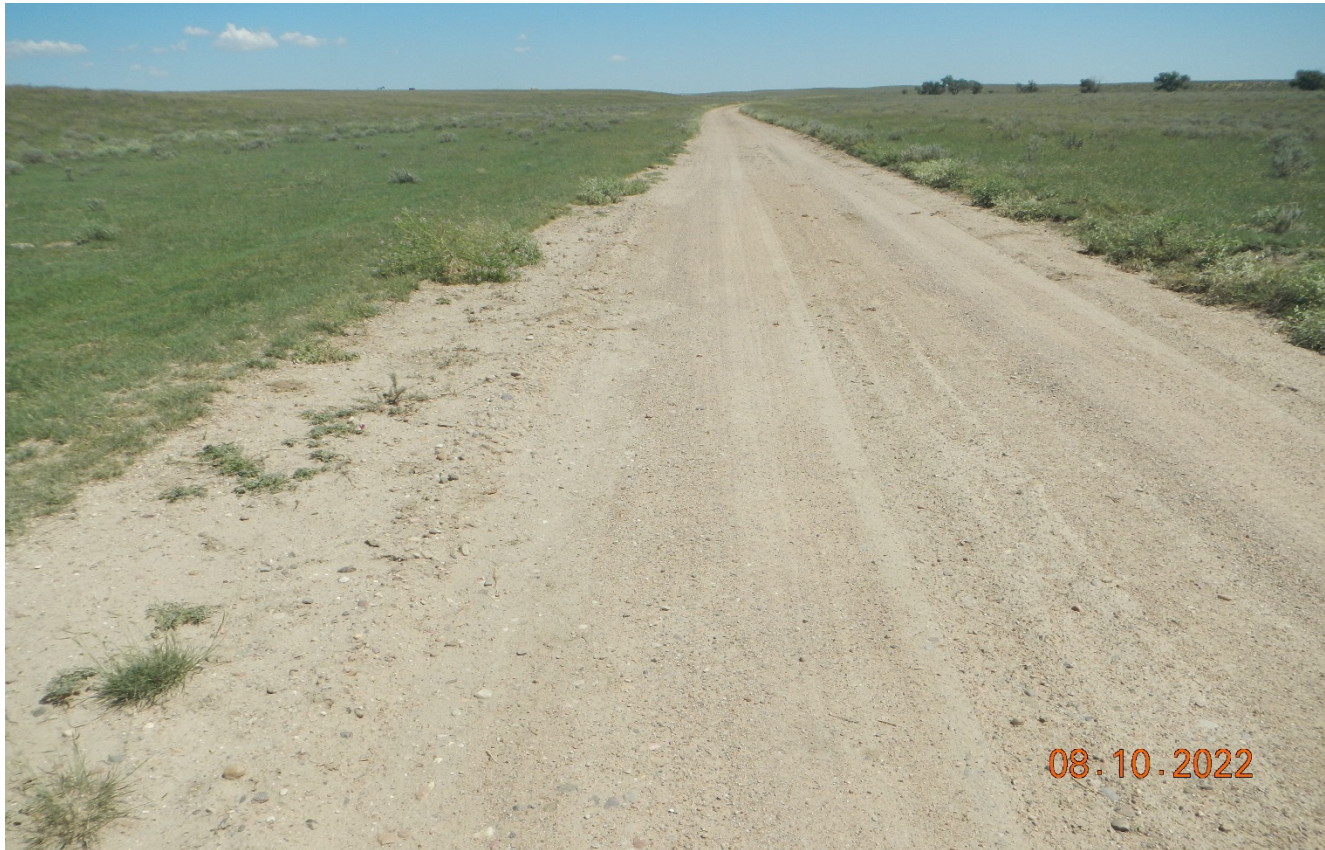
Photo 1. Facing northeast along the access road. There are areas where stormwater was previously observed pooling on the road causing vehicles to drive around and widen the road. Stormwater needs to be diverted off the road.

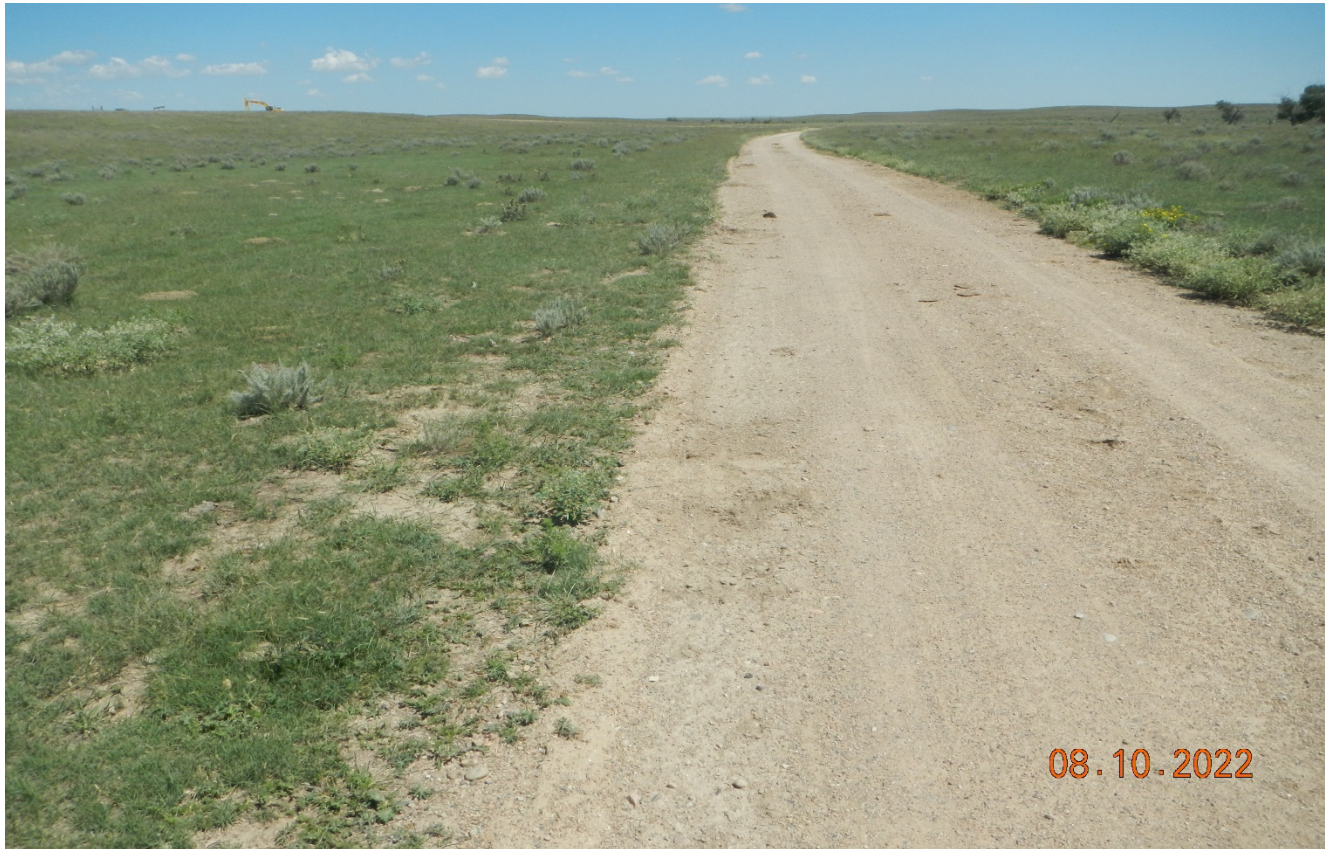
Photo 2. Facing northeast along the access road. There are areas where stormwater was previously observed pooling on the road causing vehicles to drive around and widen the road. Stormwater needs to be diverted off the road.
