**Inspection Photos**  
**Location Name: Spike St GWS CC 30-14**  
**API #05-123-15829**

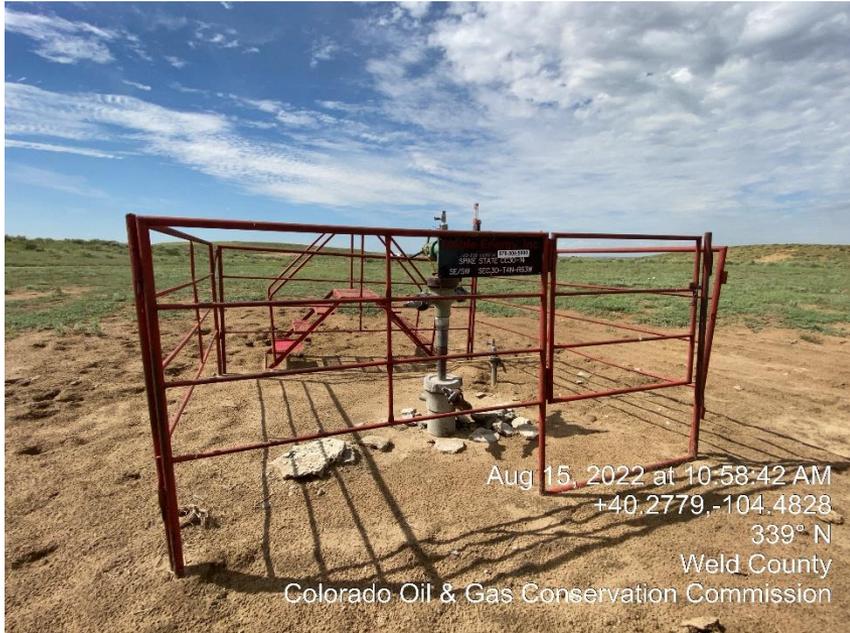
**Photo #1 Well & debris**

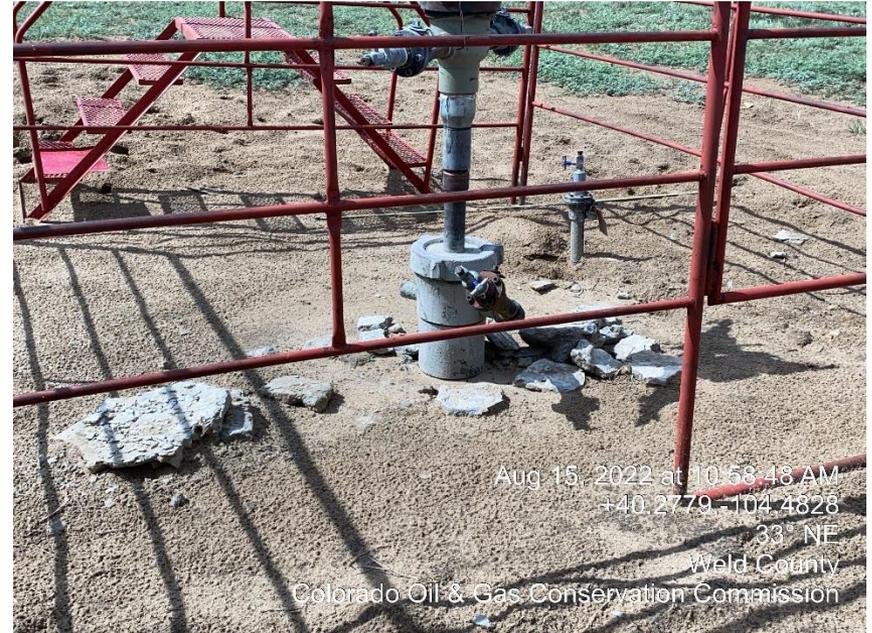
**Photo #2 Debris**
