Inspection Photos

ID: 412295

Operator: RENCO GAS PIPELINE INC

Inspection Date: 8/11/2022

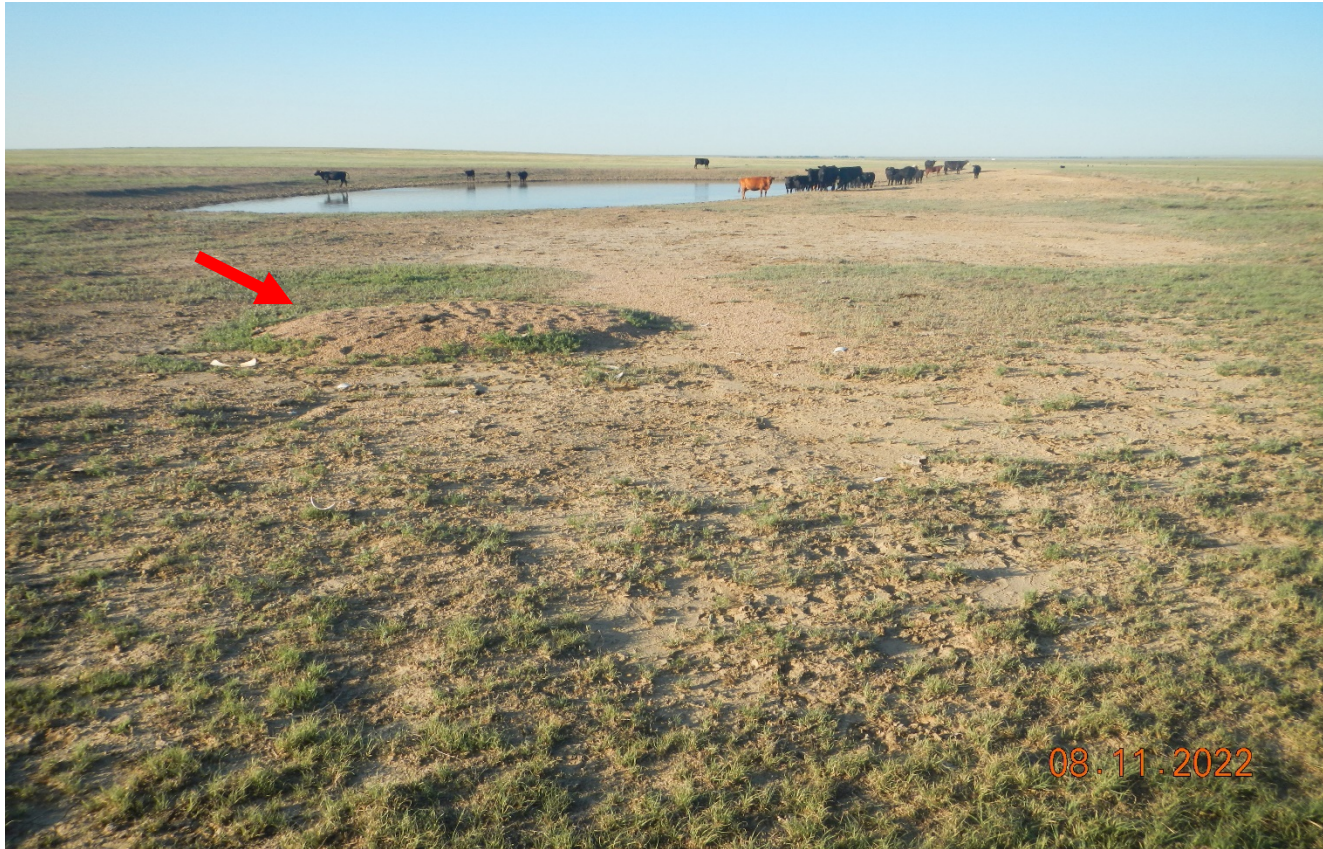
Photo 1. Facing southwest at the abandoned facility. The tank has been removed since previous inspection. No reclamation has been performed and there is some debris and gravel shown at red arrow.

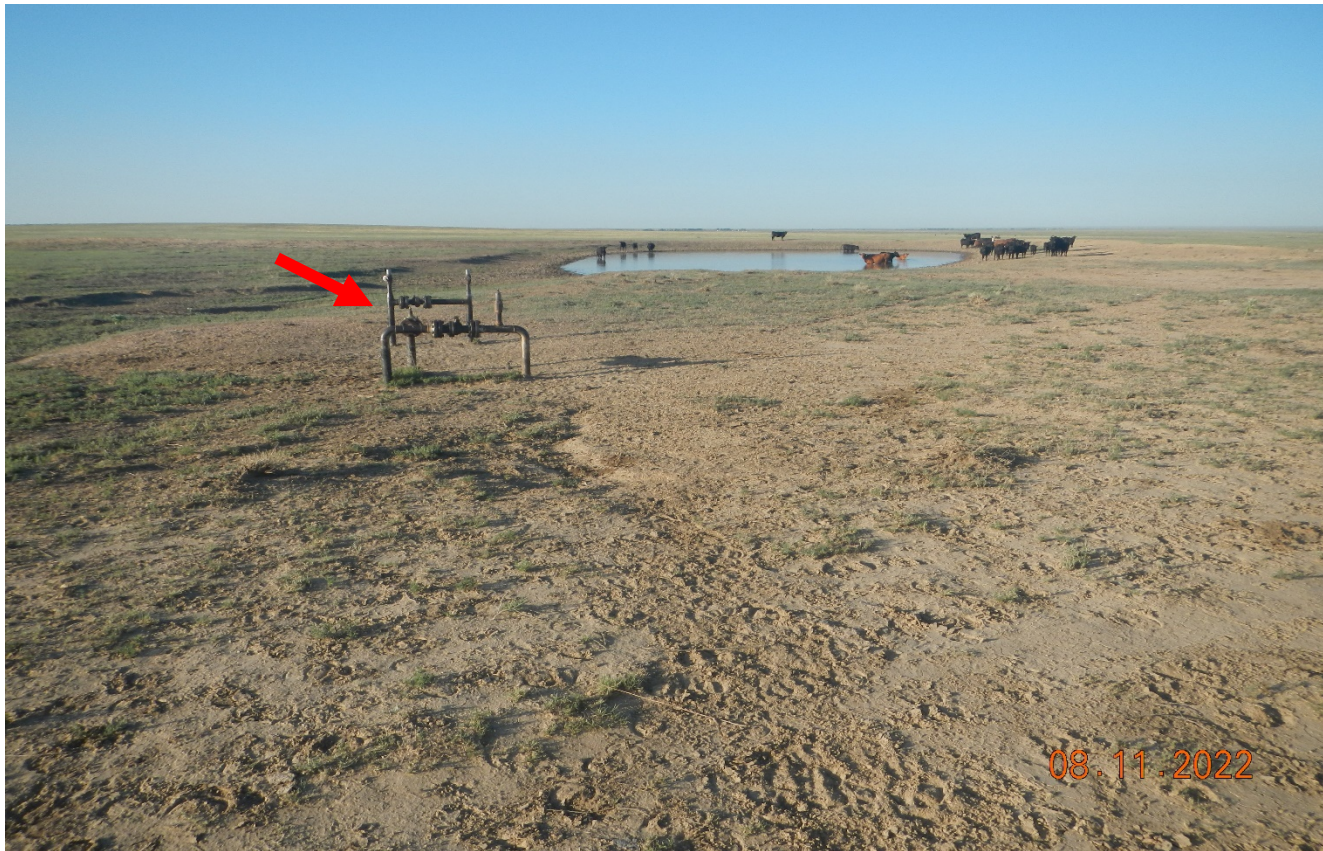
Photo 2. There is a flowline riser which is on an active line shown at red arrow.

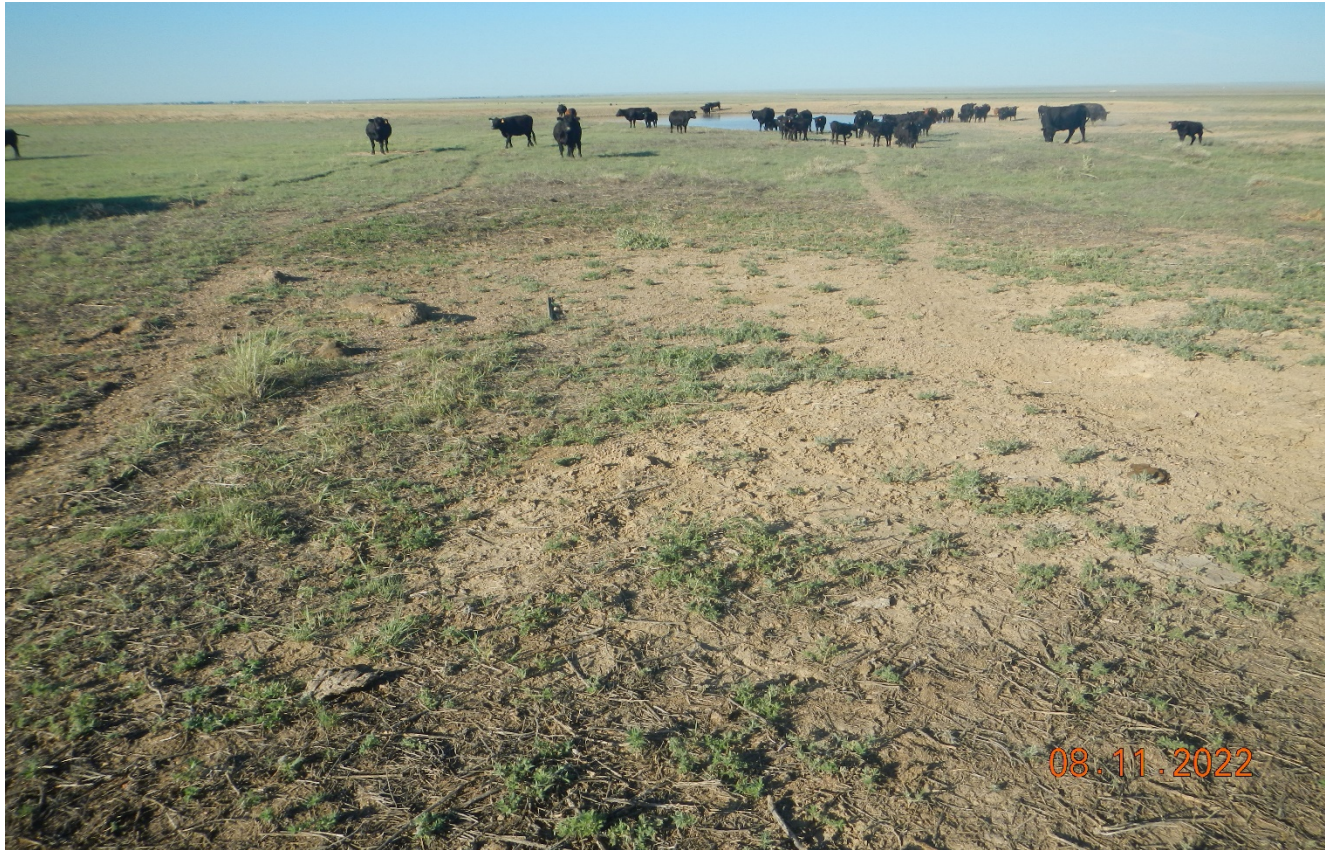
Photo 3. The abandoned engine compresor has been removed since the previous inspection. This area has not been reclaimed and consists of weeds and bare soil.

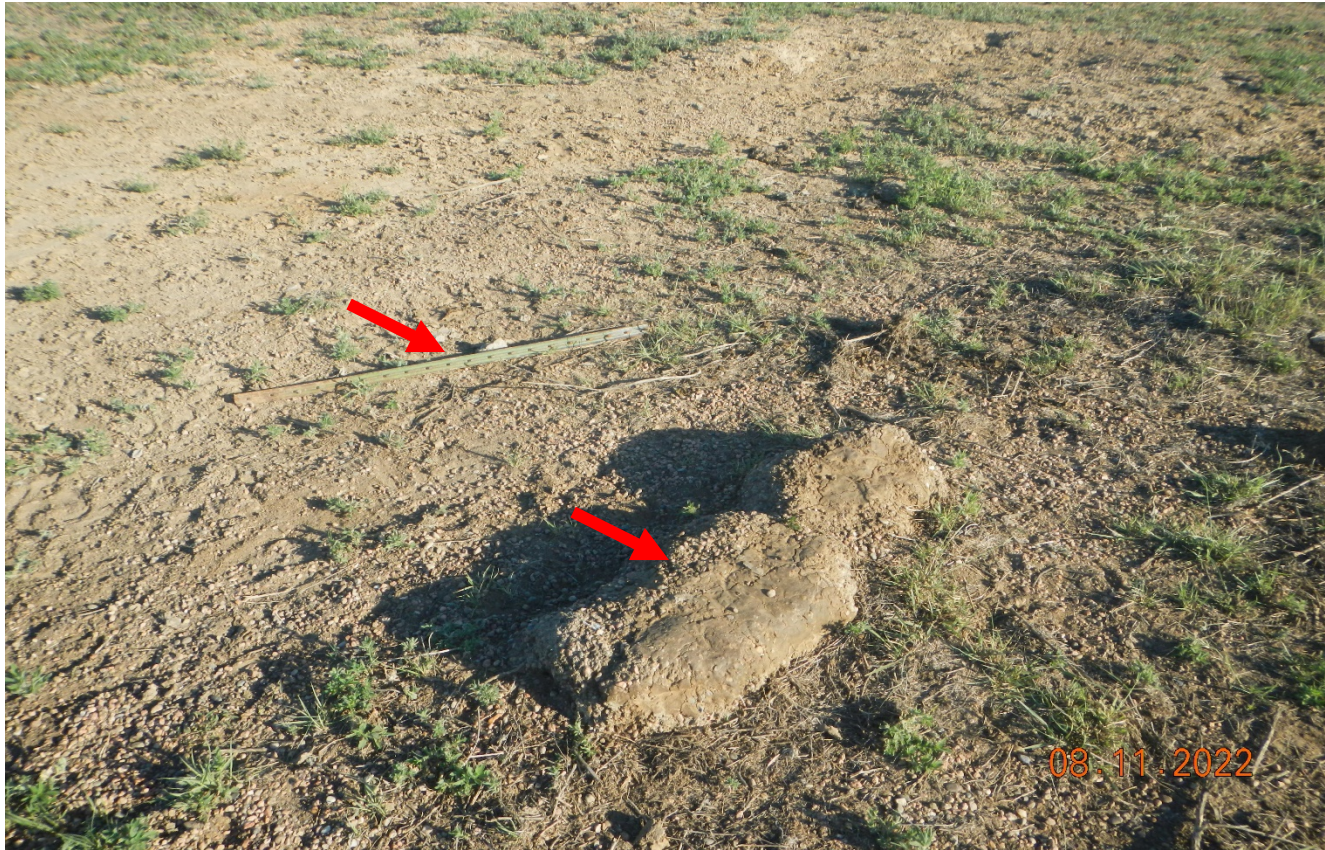
Photo 4. There is a pile of hardened oily waste that remains shown at red arrow. A t-post remains at red arrow.

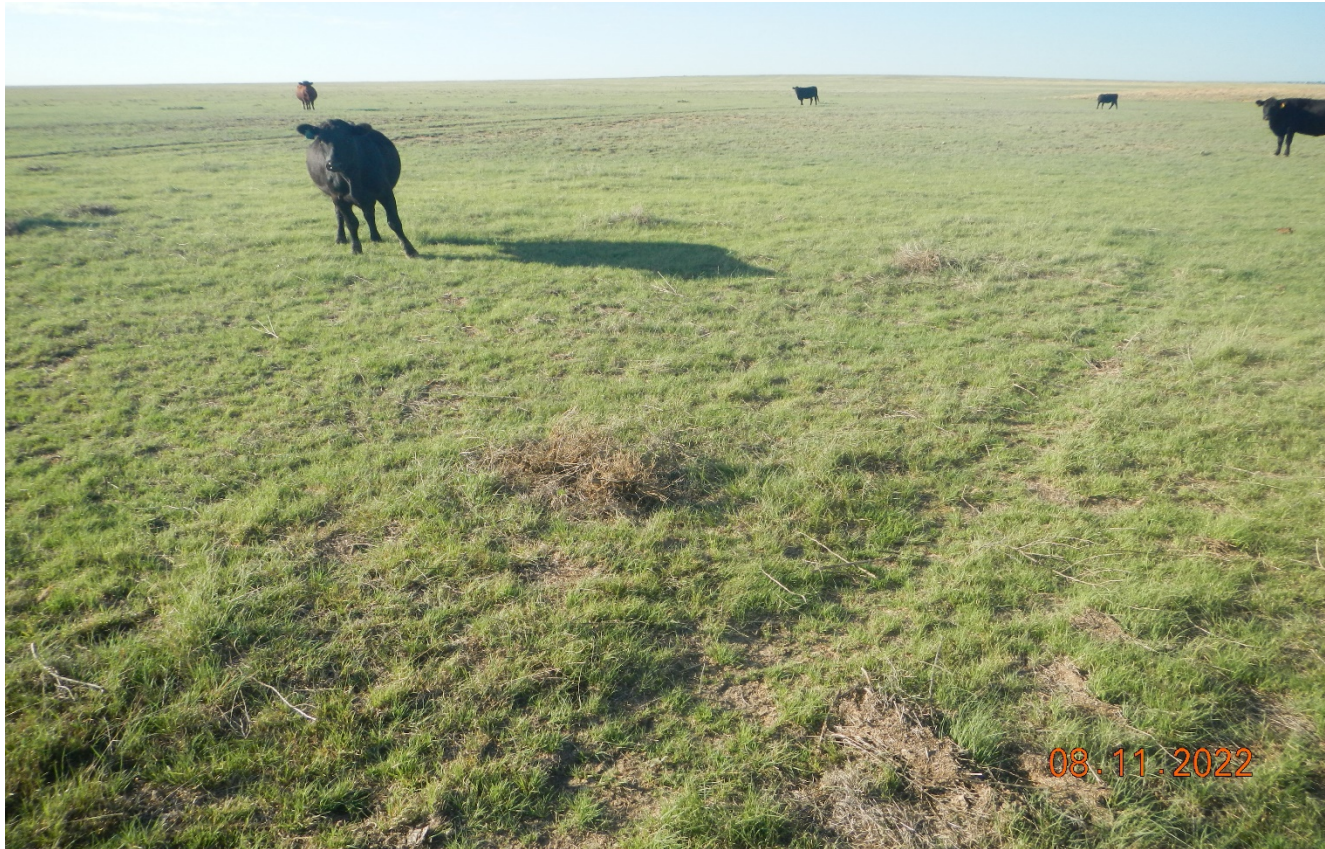
Photo 5. Facing toward the surrounding undisturbed pasture that consists of native Blue grama grassland.
