# Site Inspection Report

**Site: UPRR PAN AM I #23**  
08/12/2022

SITE/LOCATION	DATE	TIME	INSPECTOR
UPRR PAN AM I #23	08/12/2022	12:05 PM	COGCC Representative
Comments			
Work Activity Notes	Crews are working on the excavation and hauling off contaminated soil at the time of the inspection		
Changes since previous inspection?	Yes	Drive by inspection	No
Actively being worked?	Yes		
Fieldwork Oversight Performed?	No	Oversight Type	
Were Oversight Samples Collected?	No	Sample Details

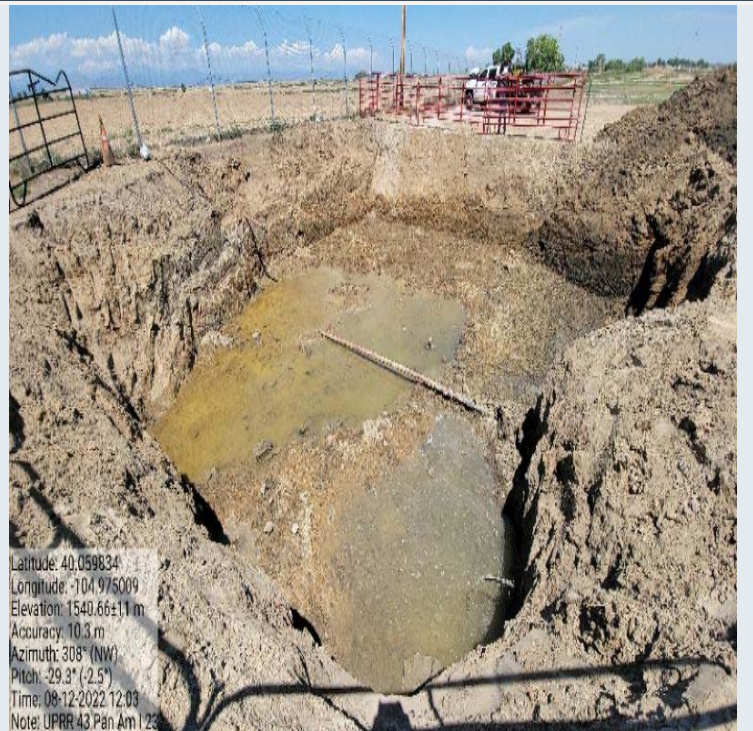
Remediation Activity Checklist	
	Photo
<p><b>Question:</b> Open excavation(s)? Note: Approximate size(s) (Length x Width x Depth, ft)</p> <p><b>Response:</b> Yes</p> <p><b>Notes:</b> Actively being worked on</p>

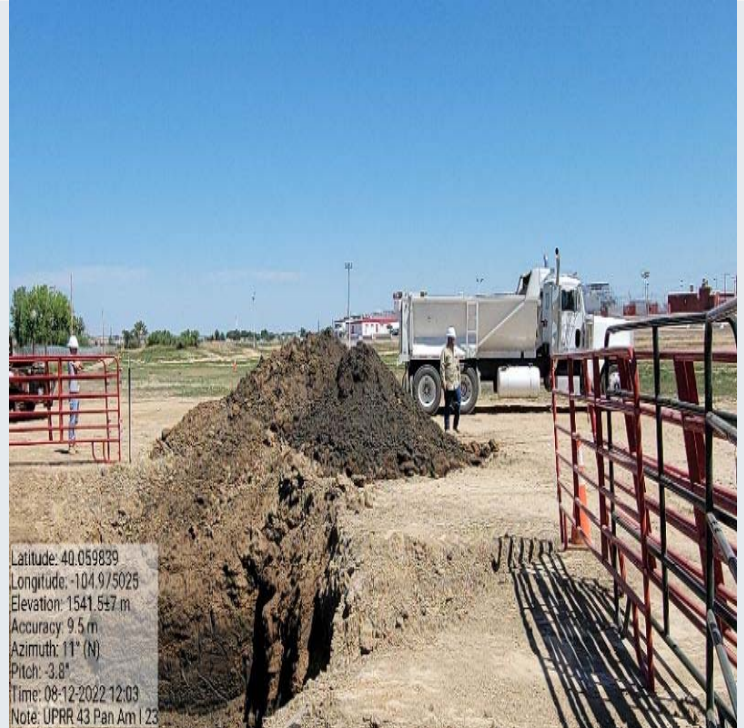
**Question:** Stockpiled E&P waste and approximate volume (cubic feet)?

**Response:** Yes

**Notes:** Actively being hauled off site

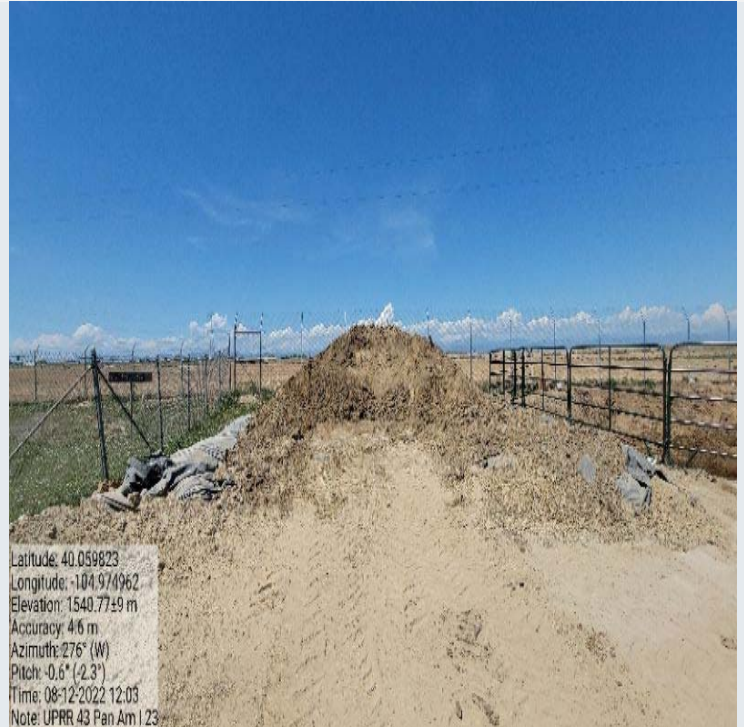
**Question:** Stockpiled E&P waste and approximate volume (cubic feet)?

**Response:** Yes

**Notes:** Actively being hauled off site

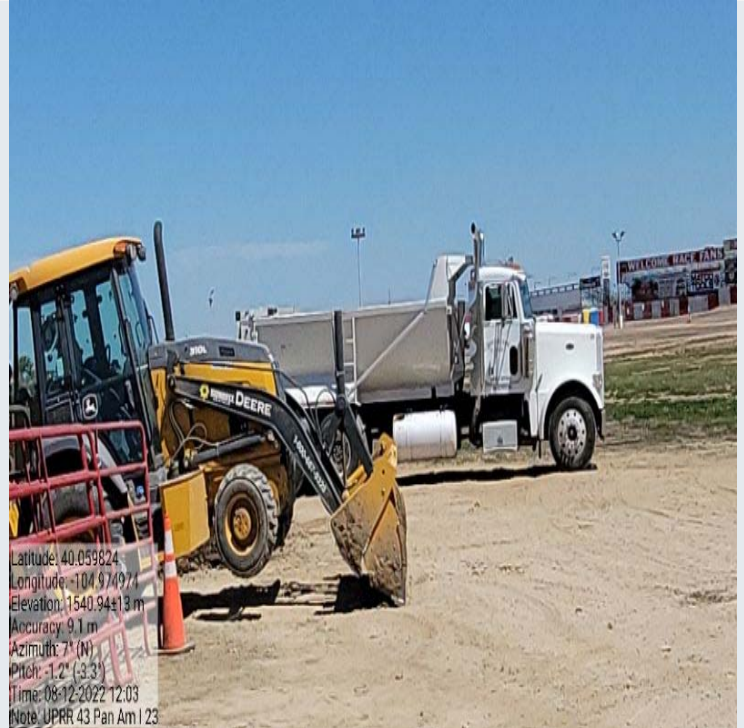
**Question:** Stockpiled E&P waste and approximate volume (cubic feet)?

**Response:** Yes

**Notes:** Actively being hauled off site

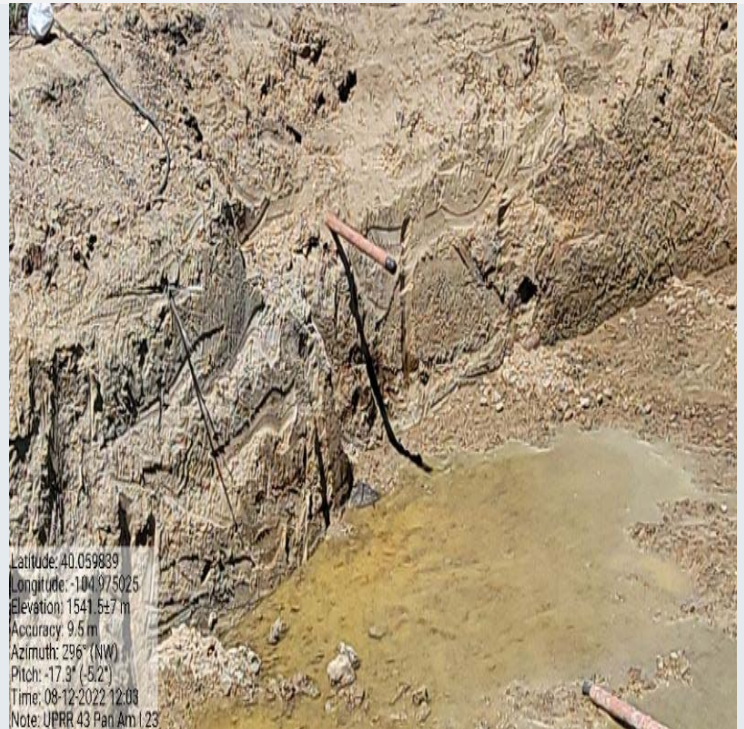
**Question:** Groundwater present within excavation? Note: Depth to water below grade surface (ft), free product/sheen

**Response:** Yes

**Notes:** ~8 ft

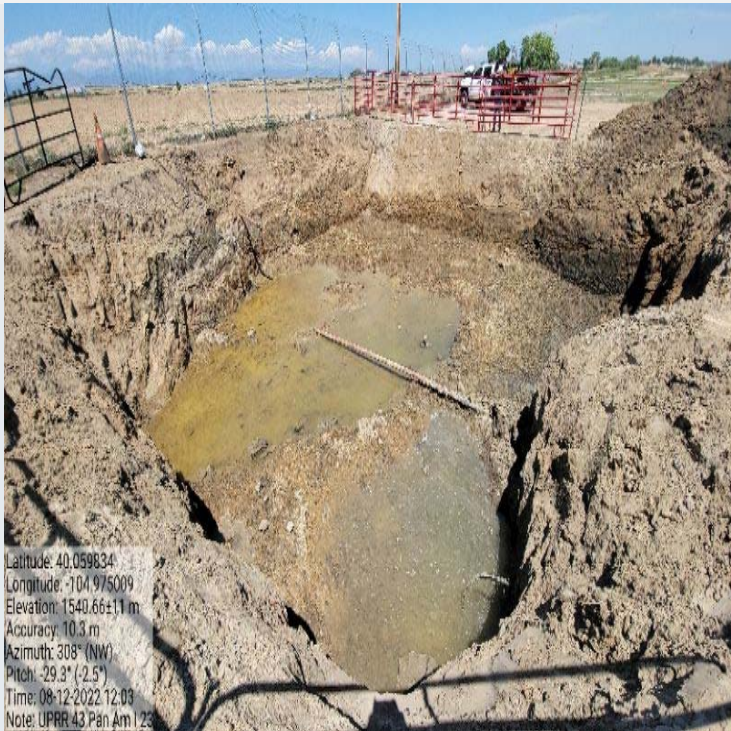
Photo
<p><b>Question:</b> Groundwater present within excavation? Note: Depth to water below grade surface (ft), free product/sheen</p> <p><b>Response:</b> Yes</p> <p><b>Notes:</b> ~8 ft</p>

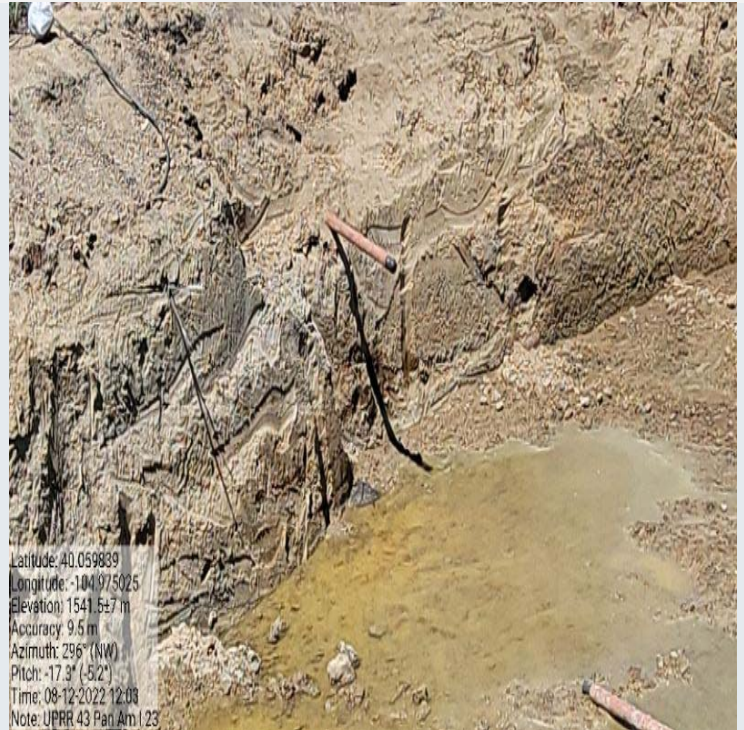
**Question:** Ground surface appears clean (no evidence of new equipment leaks, oil leaks, spills, or releases)?

**Response:** No

**Notes:** Staining is still visible in the excavation

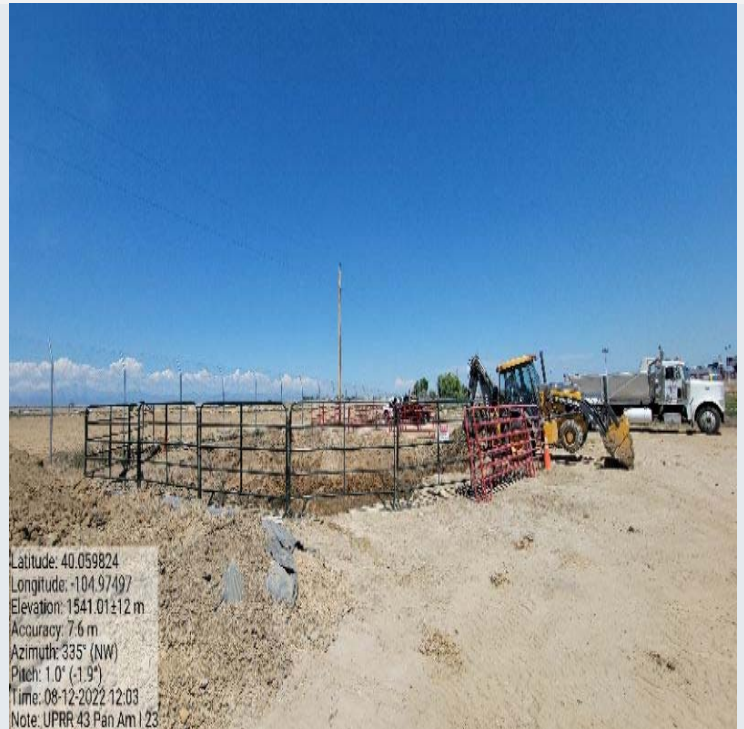
**Question:** Open excavation properly fenced/covered (in accordance with Rule 913.b.(5)B.i.)?

**Response:** Yes

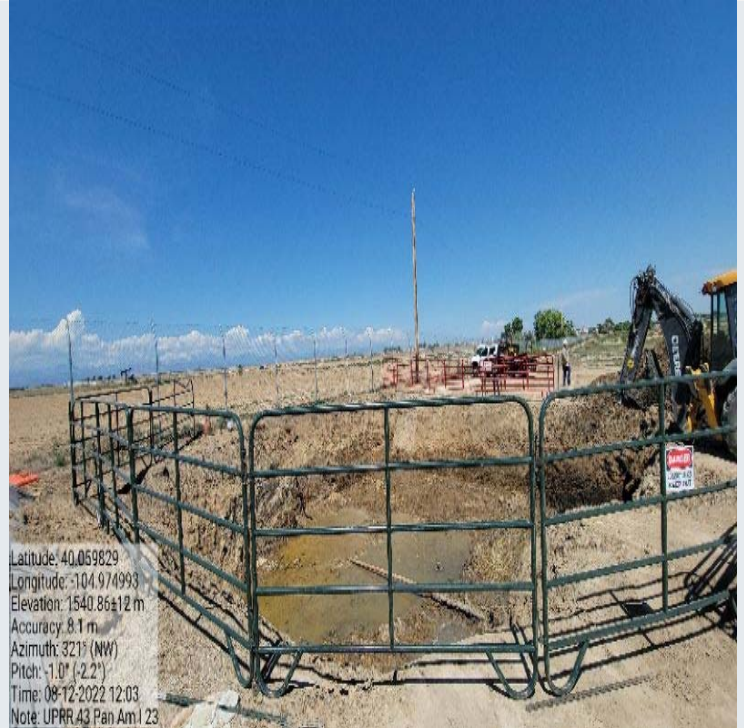
**Question:** Open excavation properly fenced/covered (in accordance with Rule 913.b.(5)B.i.)?

**Response:** Yes

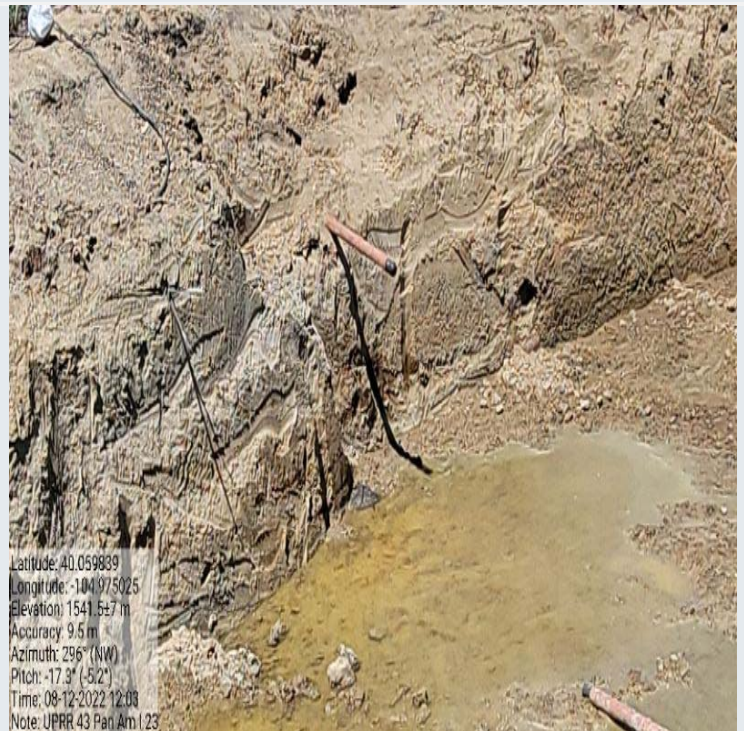
**Question:** Exposed buried/underground flowlines within excavation?

**Response:** Yes

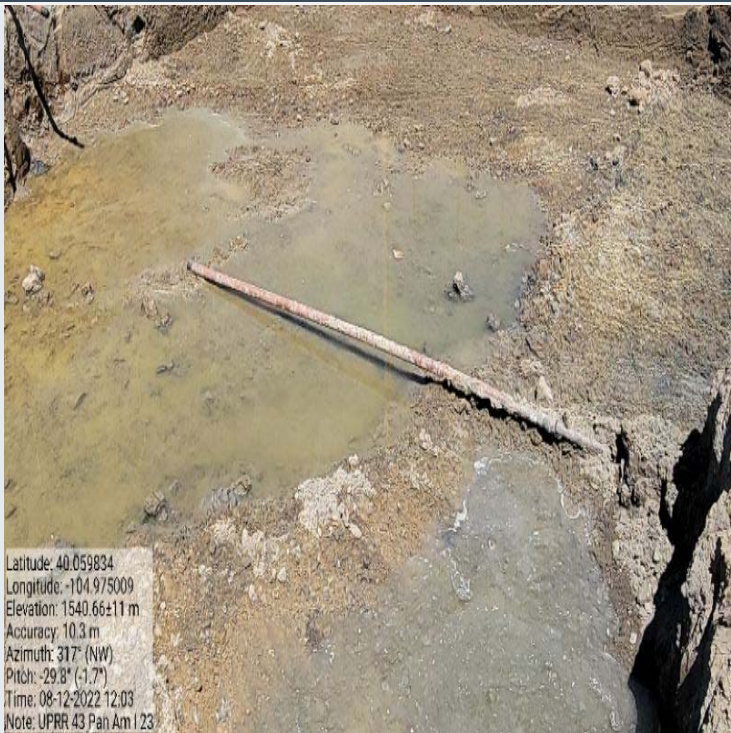
Site Condition Checklist	
	Photo
<p><b>Question:</b> Exposed buried/underground flowlines within excavation?</p> <p><b>Response:</b> Yes</p> <p><b>Notes:</b></p>

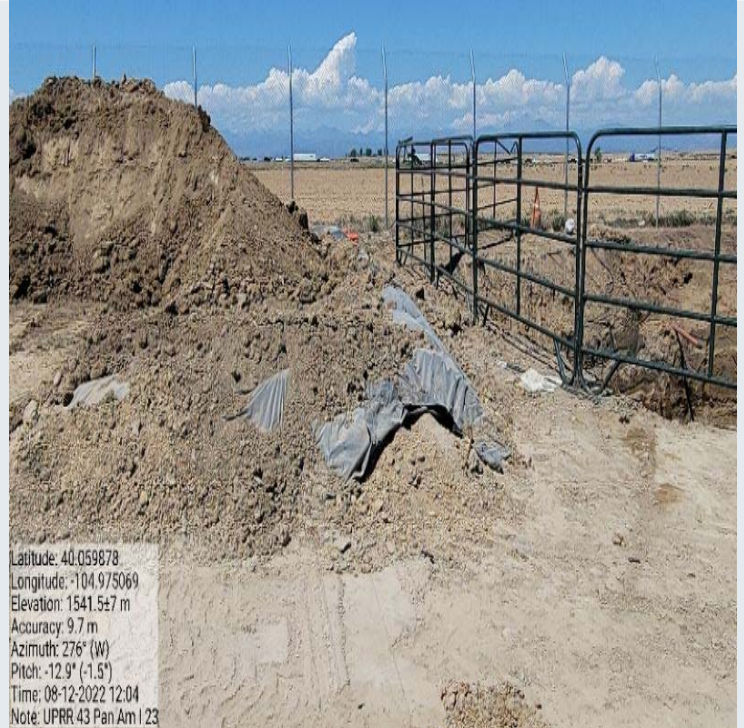
**Question:** Is earthen berm secondary containment present and in good condition (compacted, complete, no evidence of erosion, animal burrowing, etc.)?

**Response:** Yes

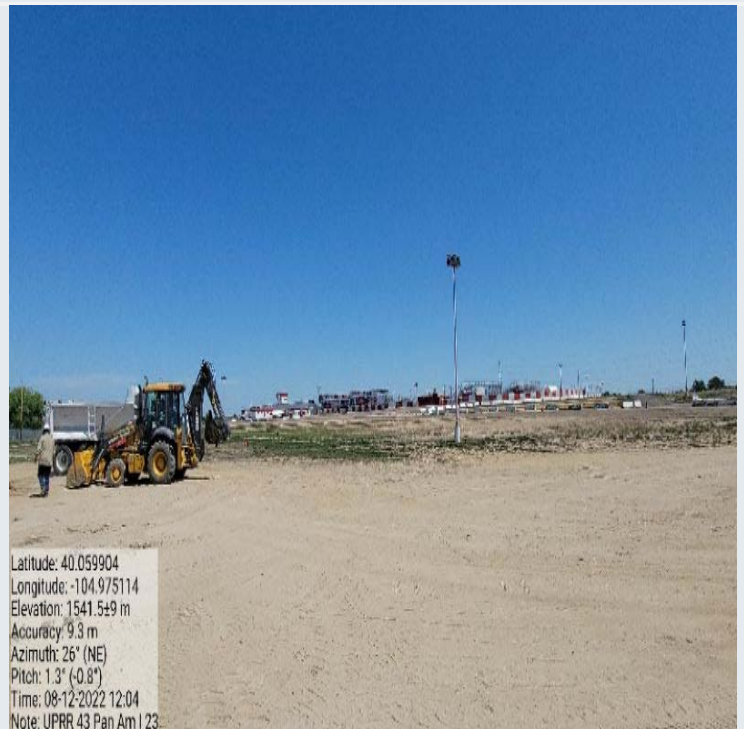
**Question:** Is location adjacent to any Potential Receptors?

**Response:** Yes

**Notes:** Surface water and occupied structure

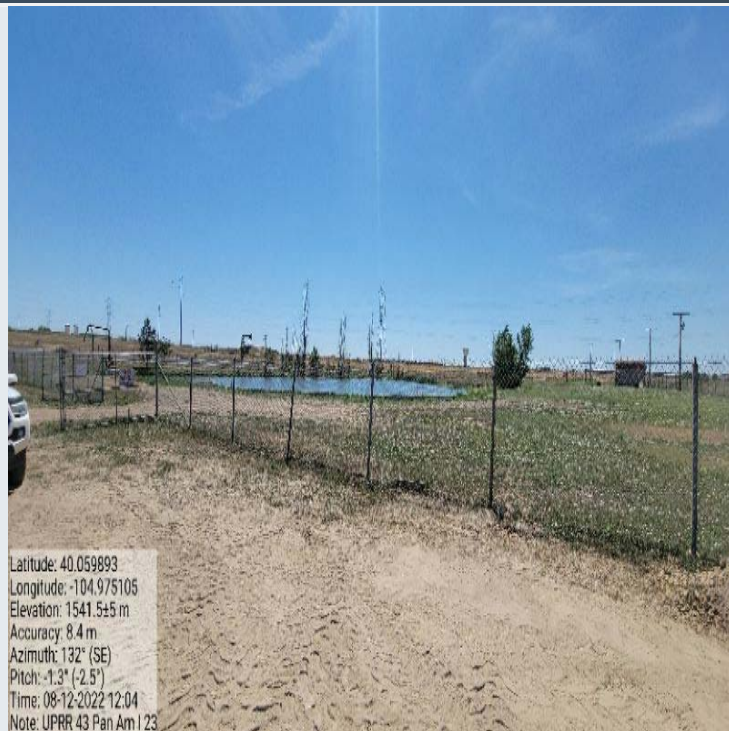
**Question:** Is location adjacent to any Potential Receptors?  
**Note:** Livestock, surface water, occupied structure, adjacent land use, etc.

**Response:** Yes

**Notes:** Surface water and occupied structure

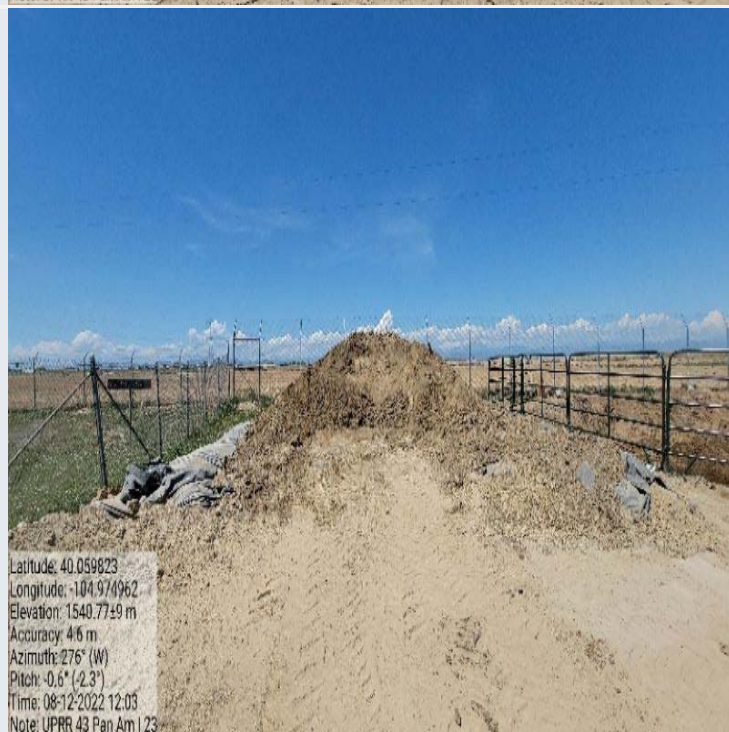
**Question:** Stockpiled waste stored and handled in compliance with Rule 913.b.(5).B.iv.?

**Response:** Yes

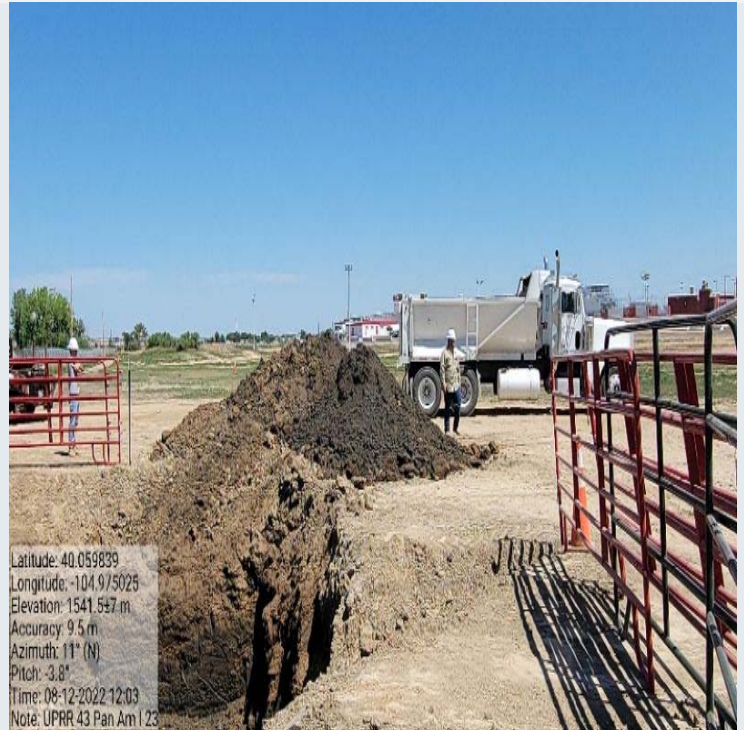
**Question:** Stockpiled waste stored and handled in compliance with Rule 913.b.(5).B.iv.?

**Response:** Yes

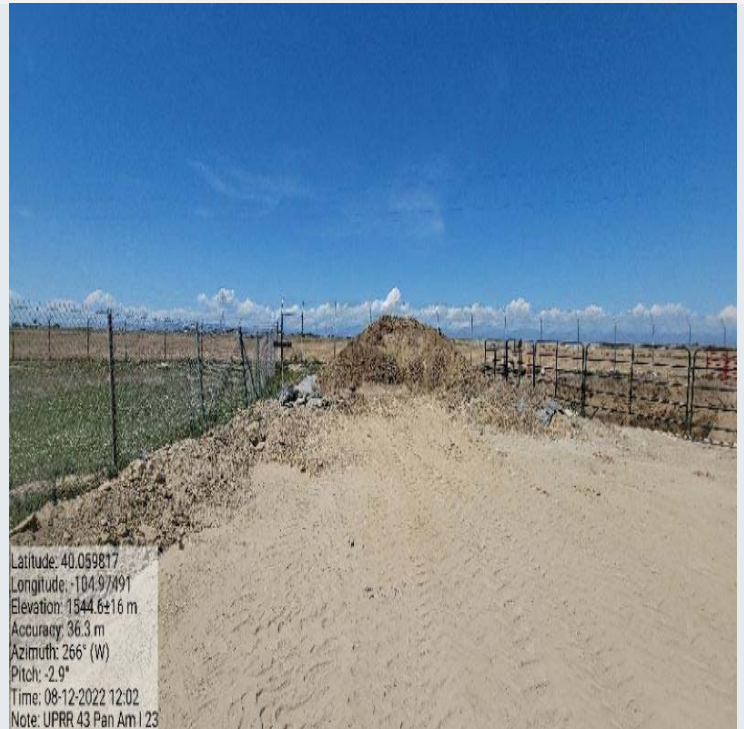
**Question:** Stockpiled waste stored and handled in compliance with Rule 913.b.(5).B.iv.?

**Response:** Yes
