Inspection Photos

API: 05-071-07968

Operator: PRESCO INC

Inspection Date: 8/15/2022

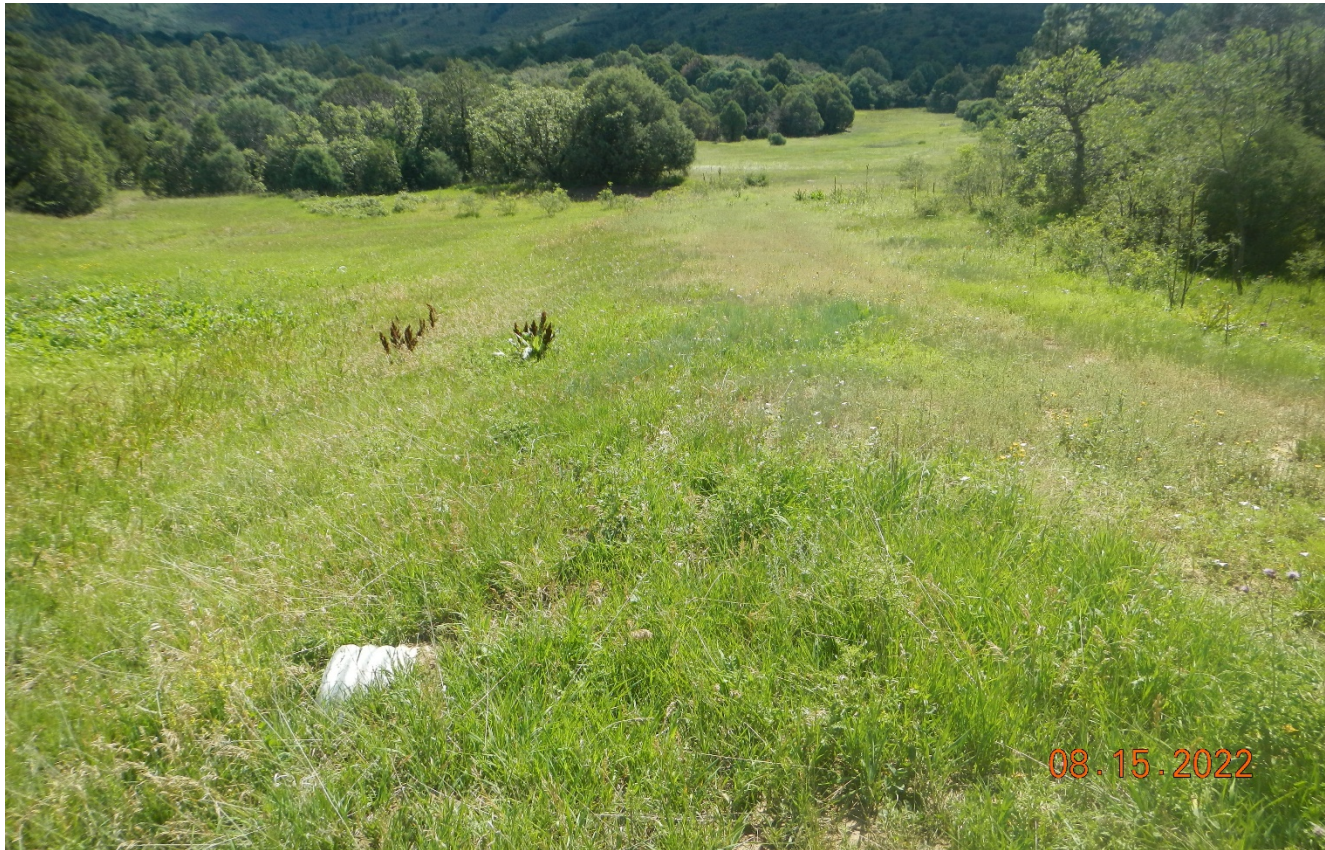
Photo 1. Facing east along the former access road. The pre-existing road is stabilized with perennial vegetation. A culvert is installed at the drainage crossing.

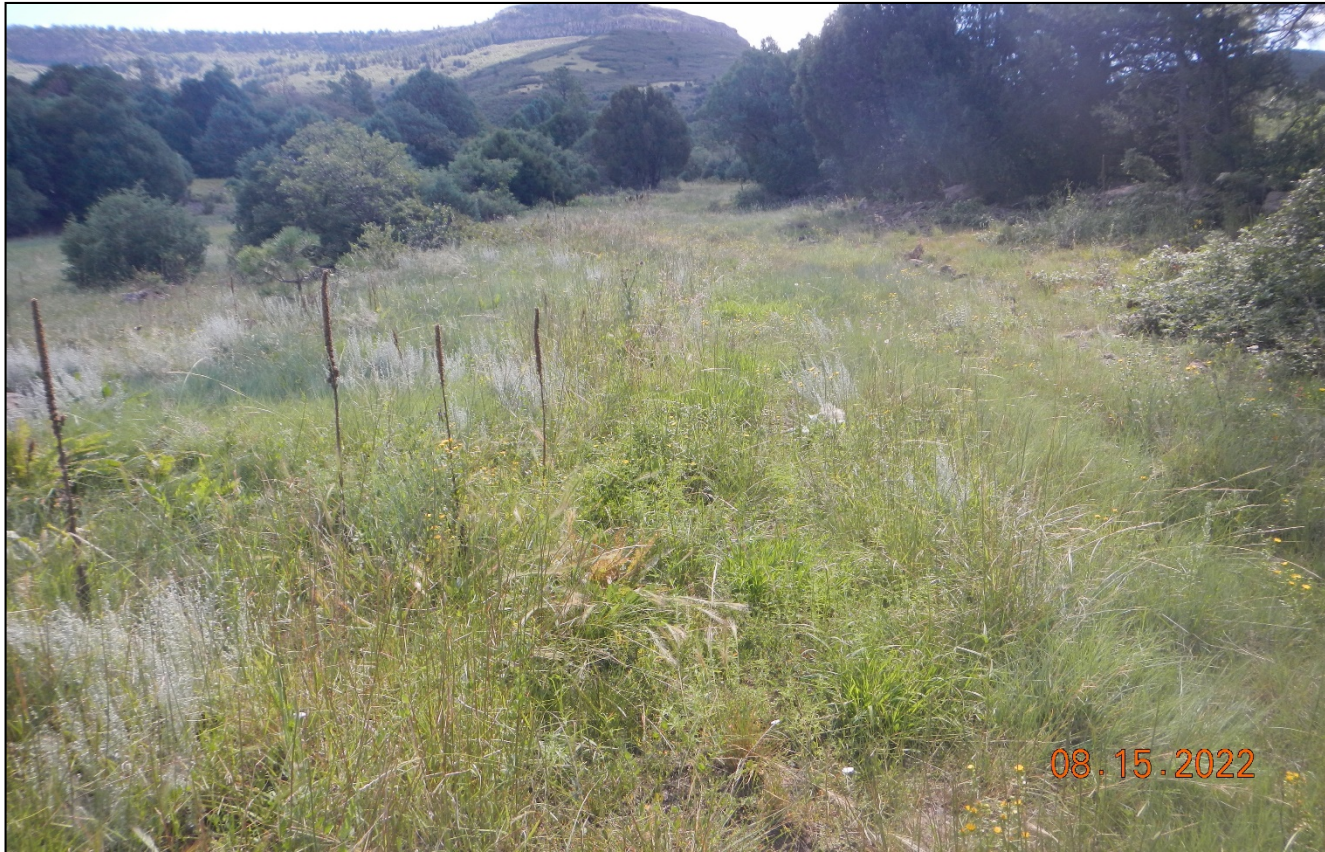
Photo 2. Facing southeast along the former access road. The road is stabilized with vegetation.

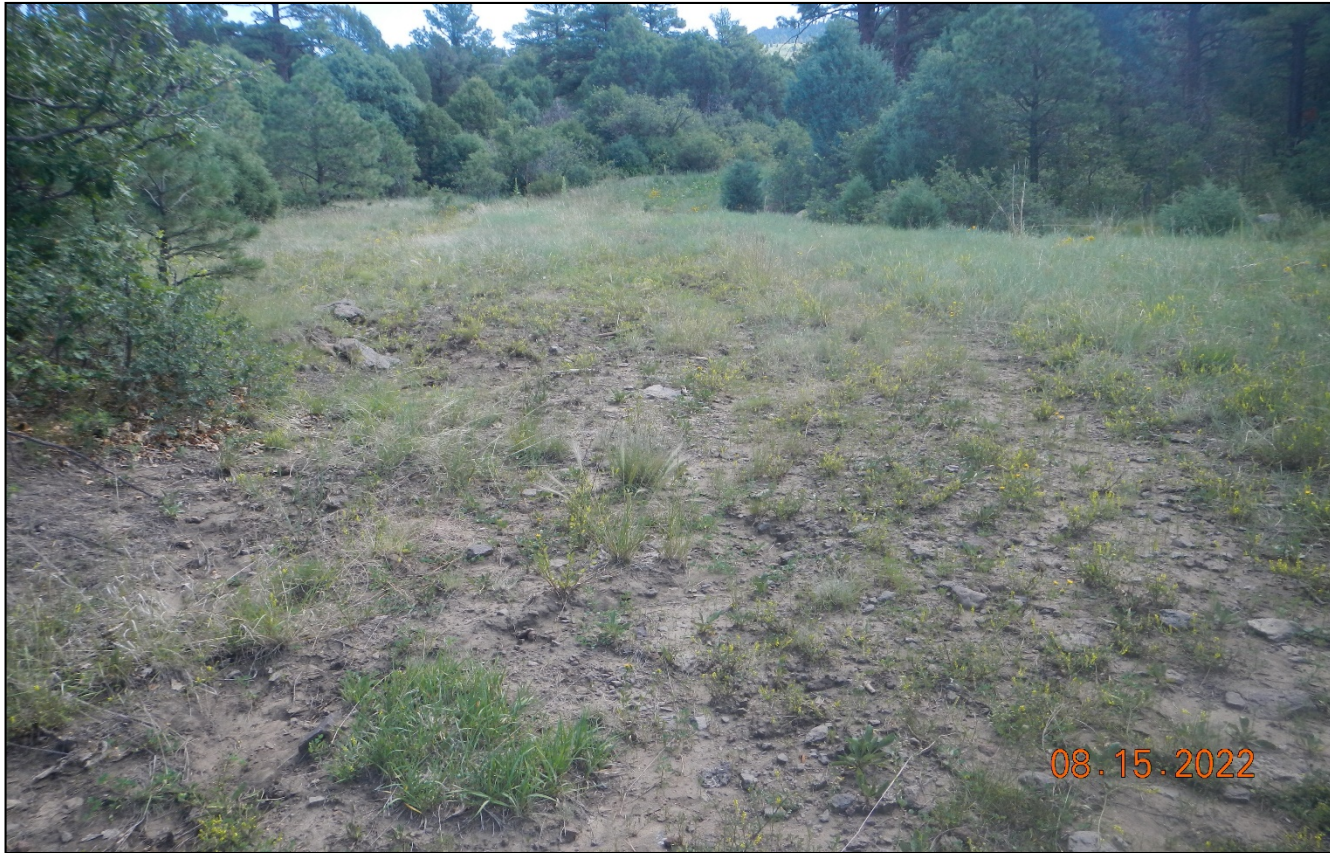
Photo 3. Facing northeast along the former access road.

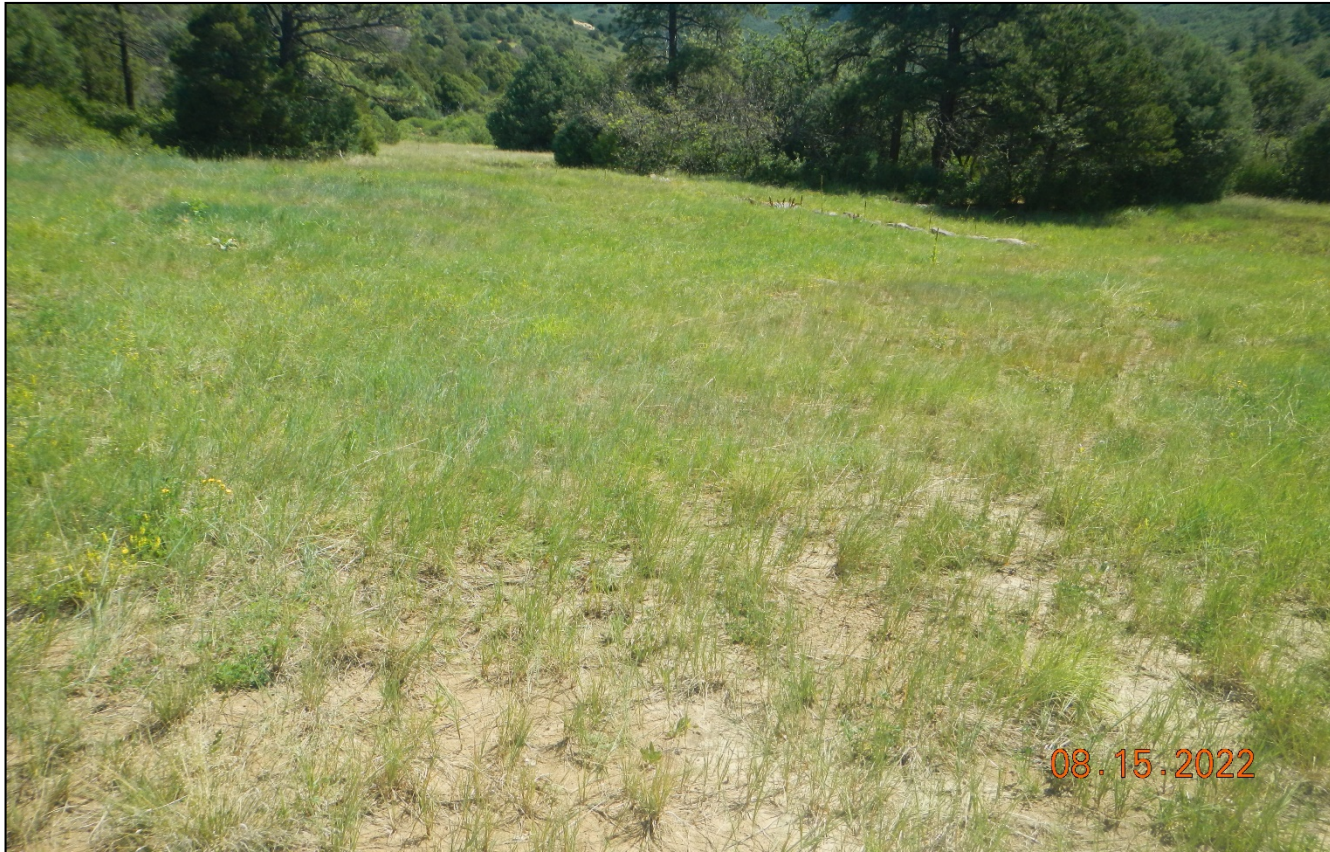
Photo 4. Facing northeast toward the location. Perennial vegetation has established throughout the location and reflects reference area levels consisting of Western wheatgrass, Sand dropseed, Blue grama, among other species.

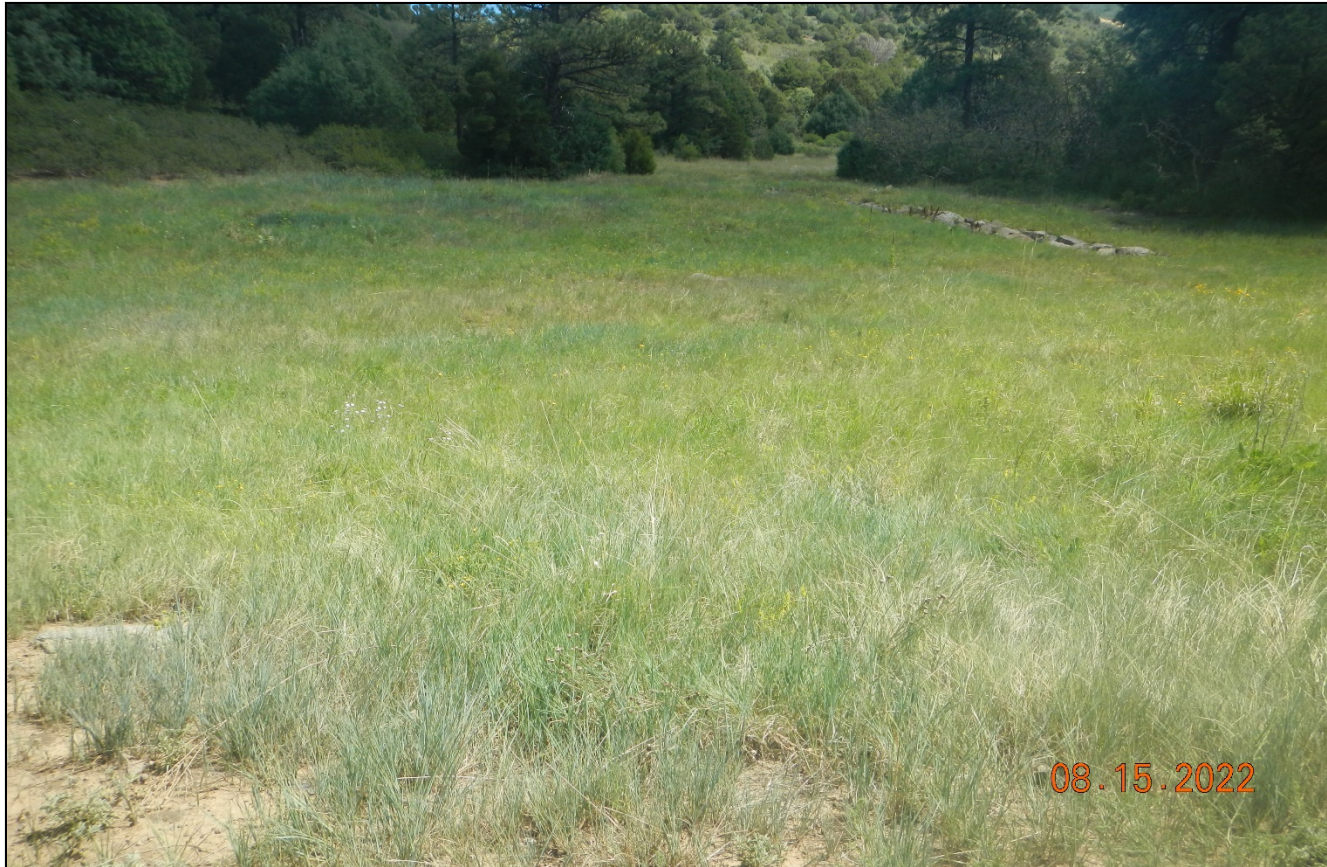
Photo 5. Facing north at the location. Perennial vegetation has established throughout the location and reflects reference area levels consisting of Western wheatgrass, Sand dropseed, Blue grama, among other species.
