Inspection Photos

API: 05-071-07956

Operator: PRESCO INC

Inspection Date: 8/15/2022

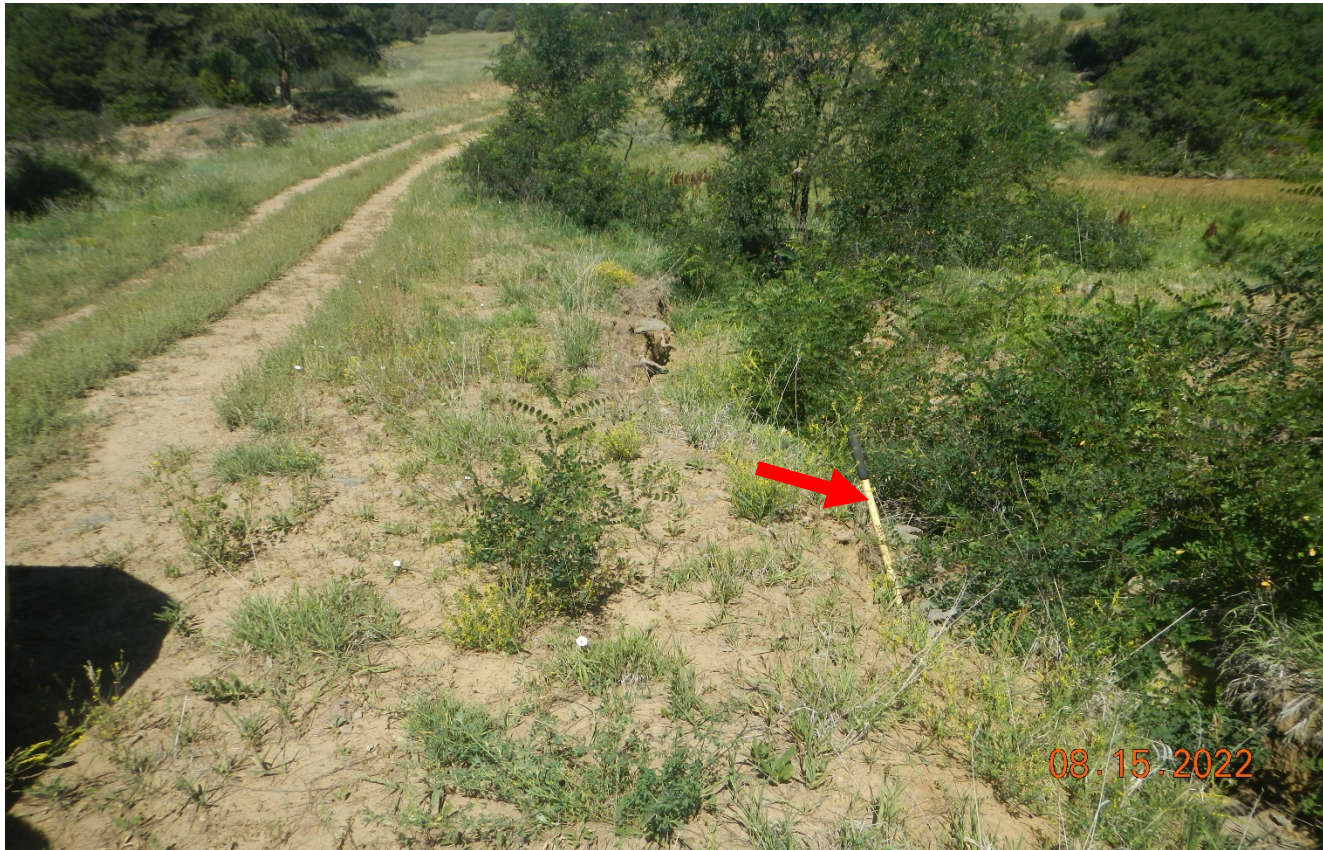
Photo 1. There is an erosional gully along the access road that was not repaired at Lat/Long:37.02219,-104.48216. Arrow points to 4.5 ft shovel.

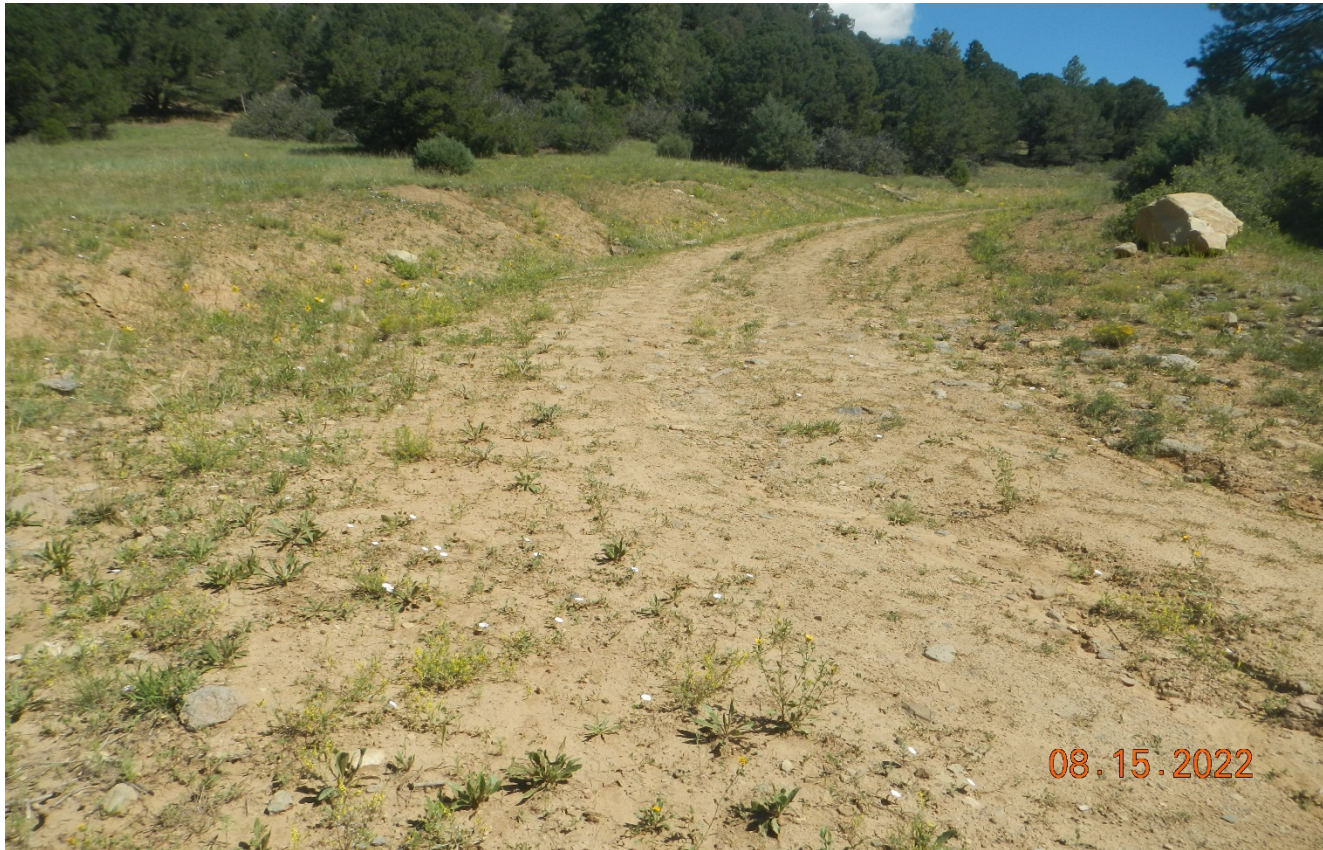
Photo 2. Facing northeast along the access road. The roadside was seeded in this area and vegetation is progressing.

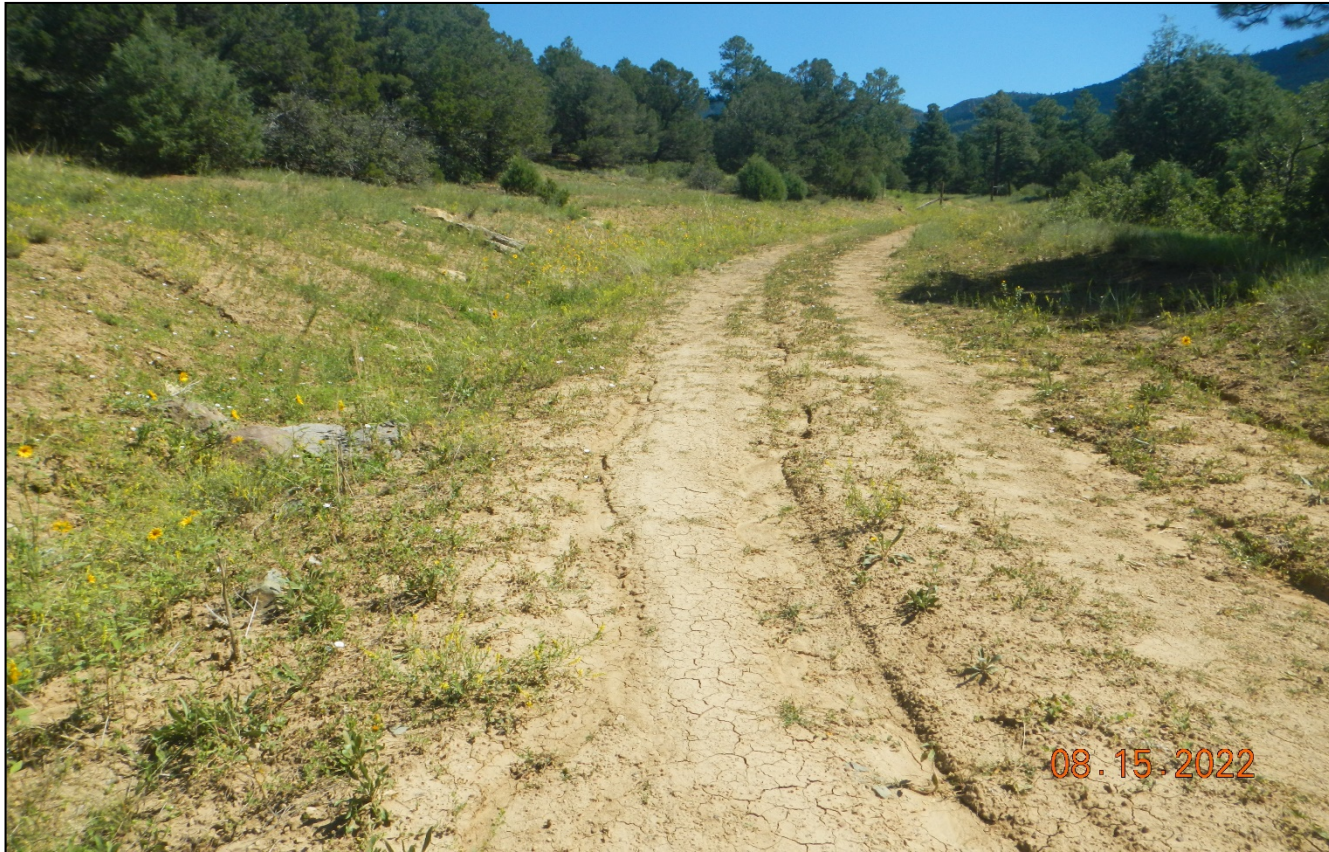
Photo 3. Facing northeast along the access road. There is vegetation establishing along the road side and rock check dams are installed.

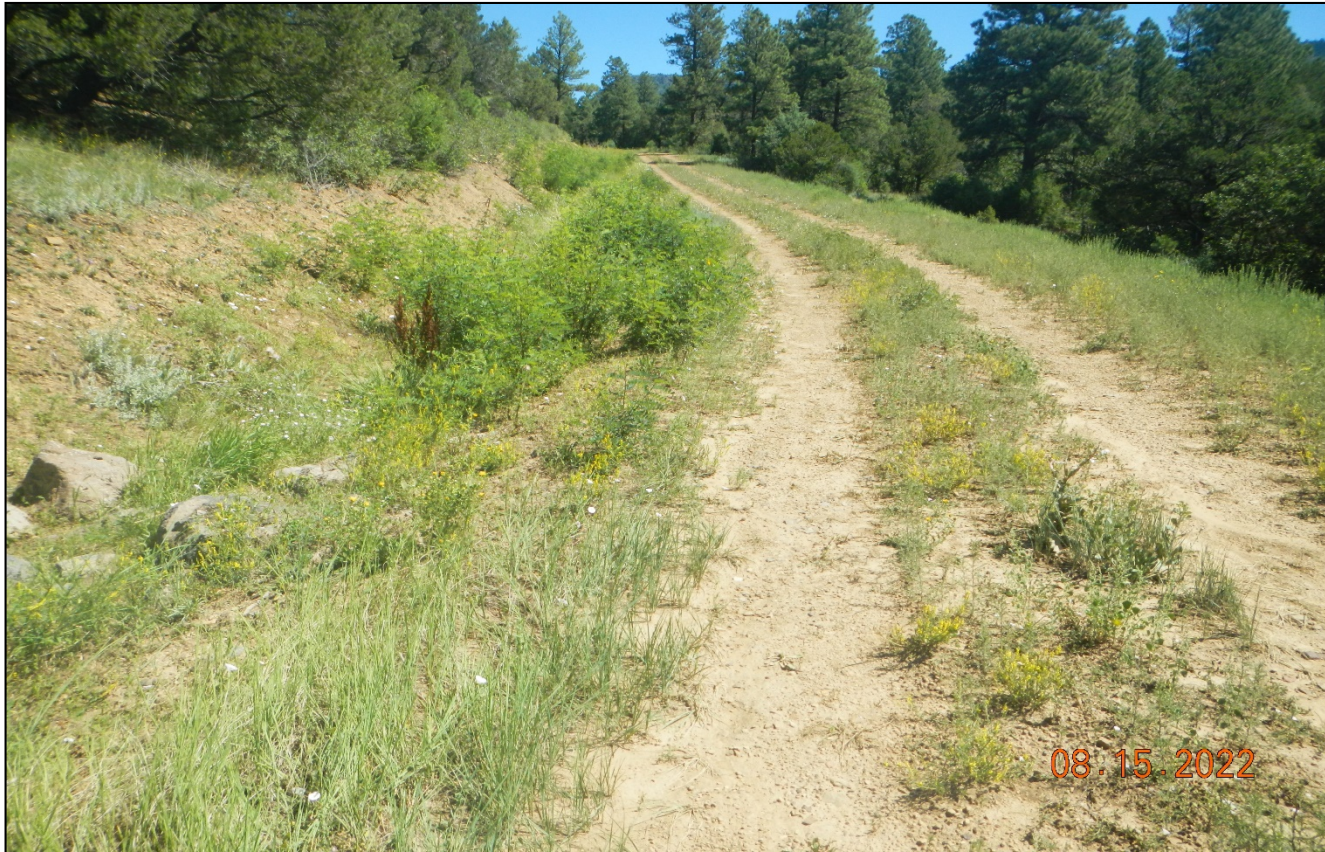
Photo 4. Facing northeast further along the access road. There is vegetation establishing along the road side and rock check dams are installed.

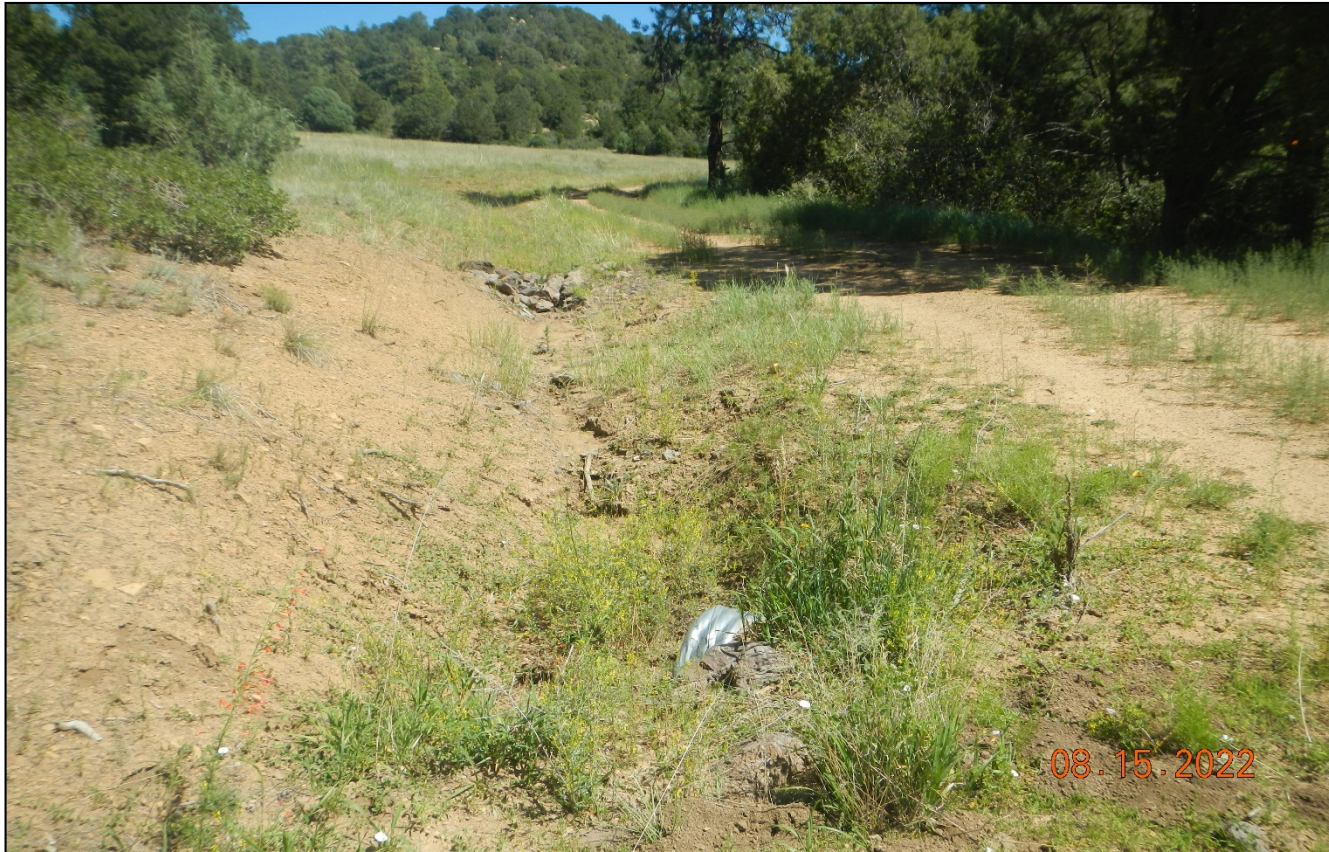
Photo 5. There are culverts installed along the road which has improved stormwater drainage. Culverts appear to be maintained.

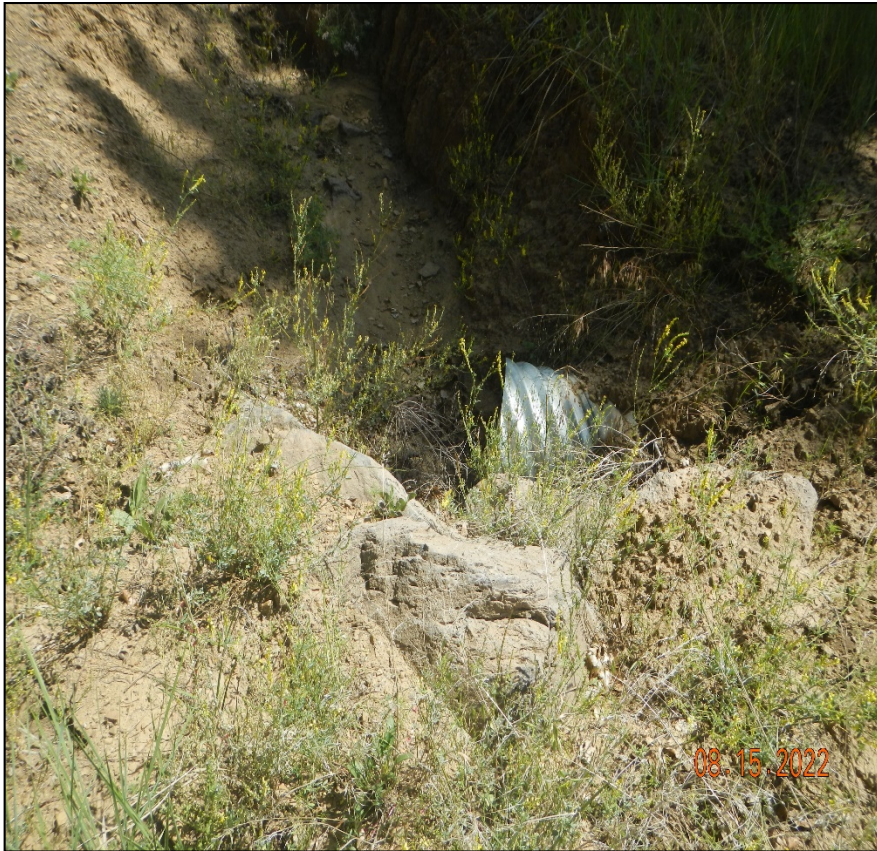
Photo 6. The culvert inlets are maintained and clear of debris and sediment.

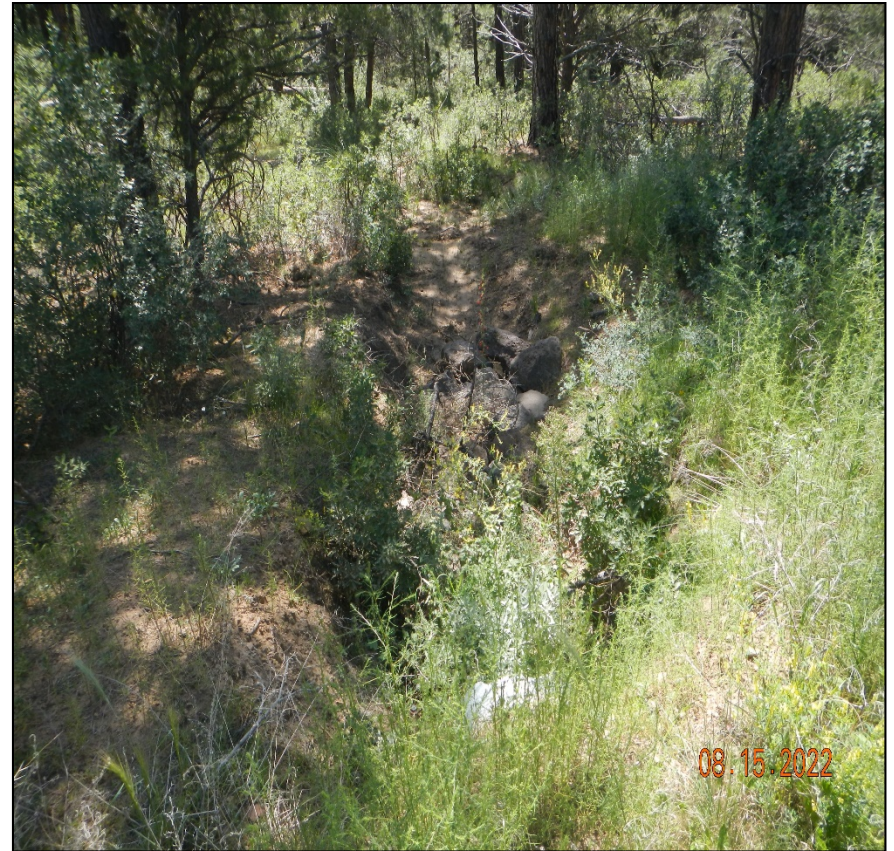
Photo 7. The culvert outlets have rock rip/rap outlet protection.

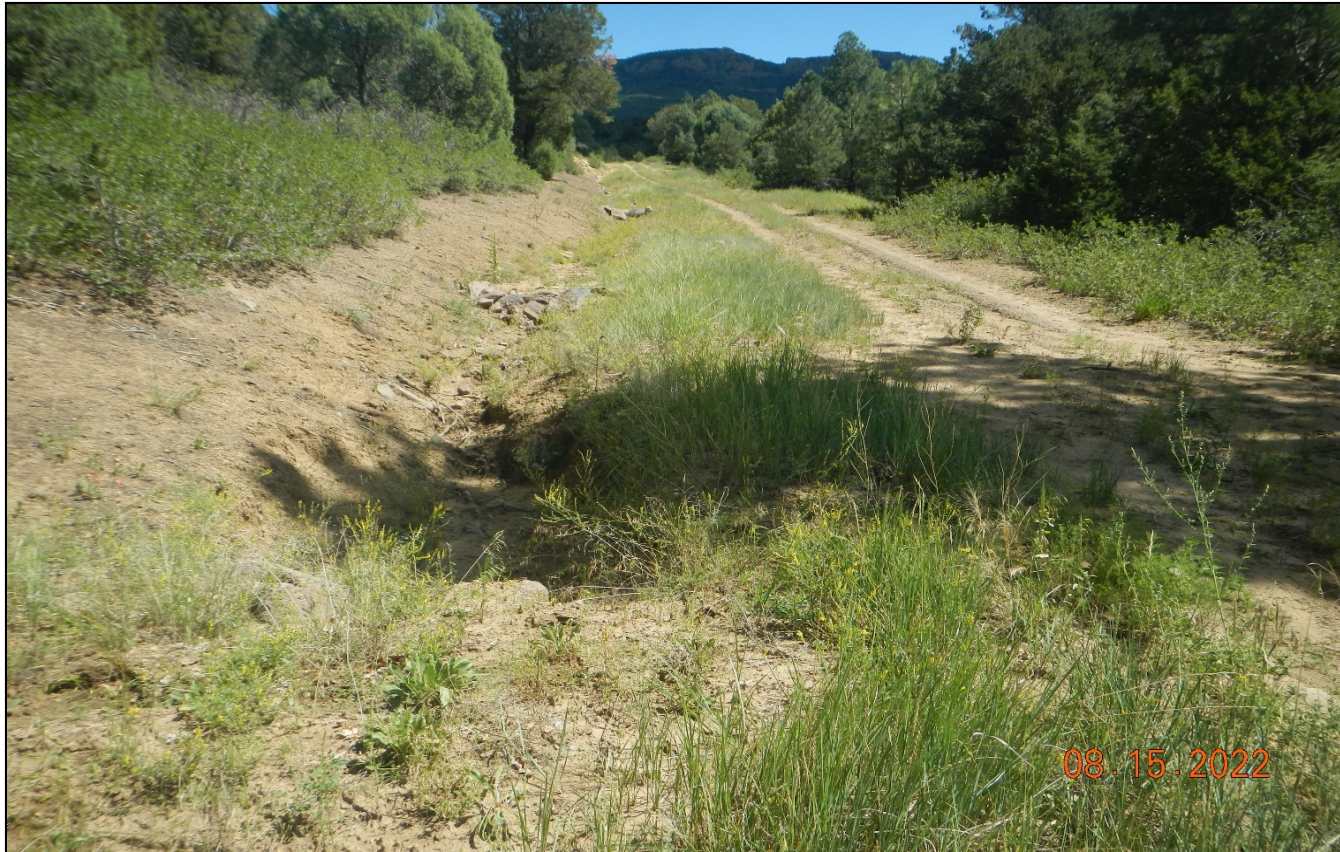
Photo 8. Facing northeast further along the access road. There is vegetation establishing along the road side and rock check dams are installed.

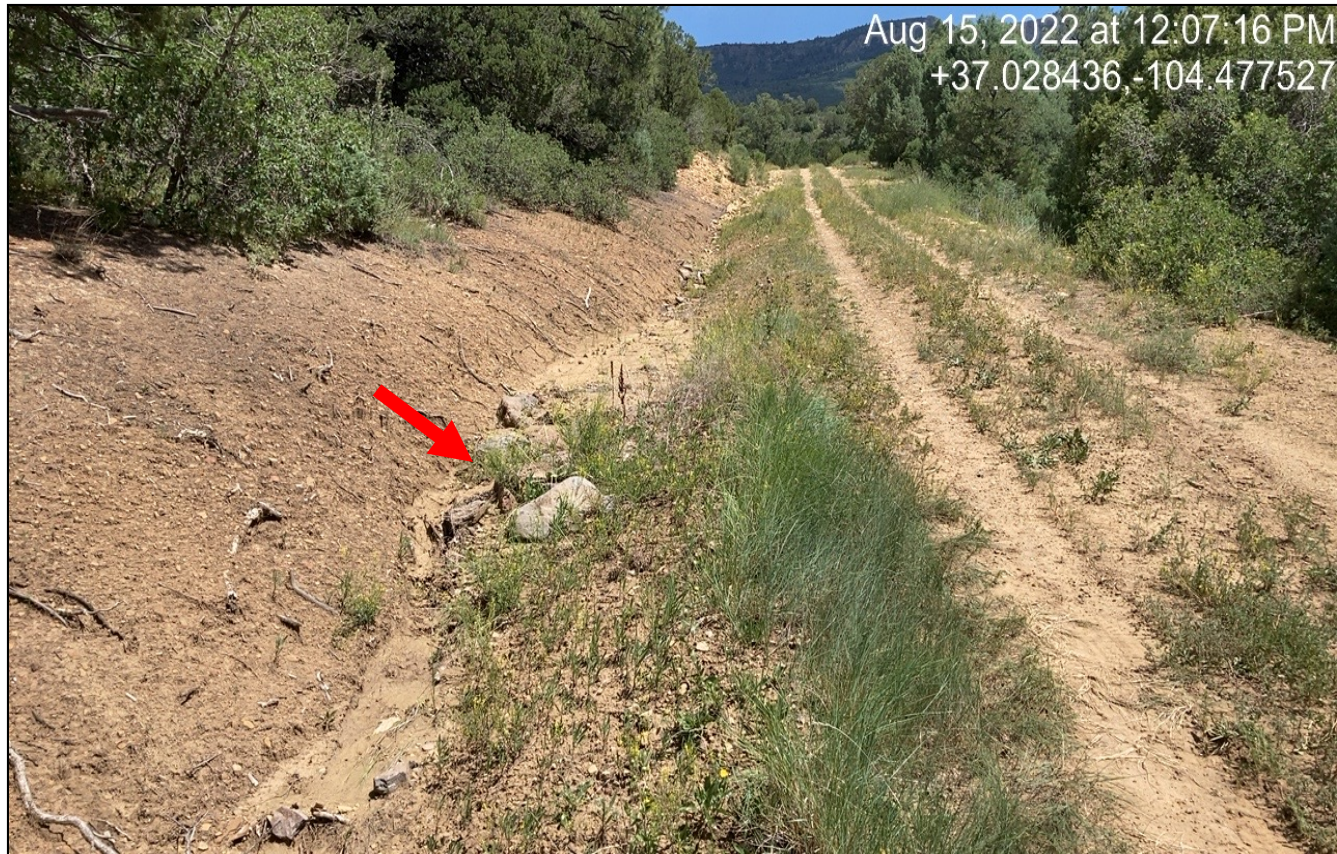
Photo 9. Facing northeast further along the access road. Some of the rock check dams are in need of maintenance. The road side along this area has not established vegetation.

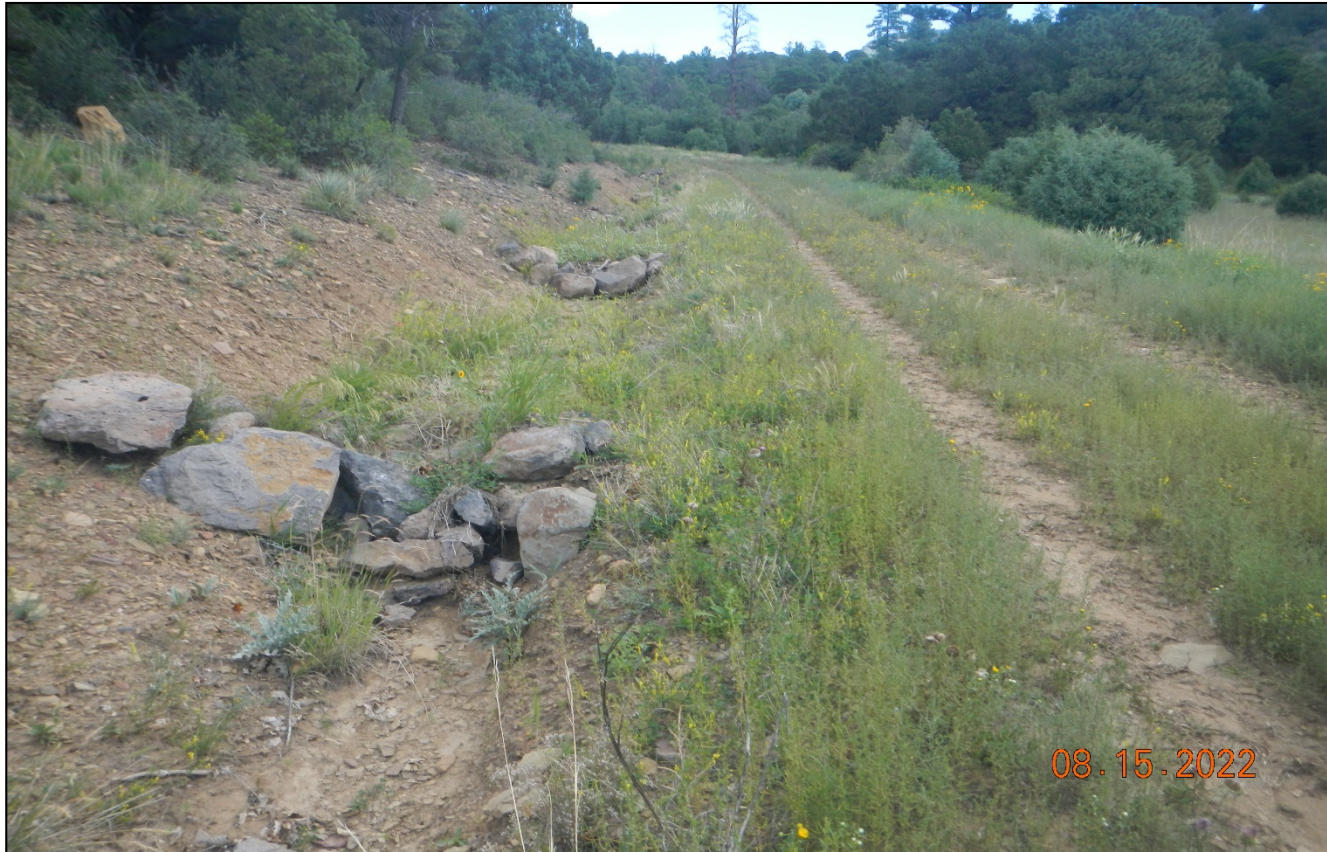
Photo 10. Facing northeast further along the access road. There is vegetation establishing along the road side and rock check dams are installed.

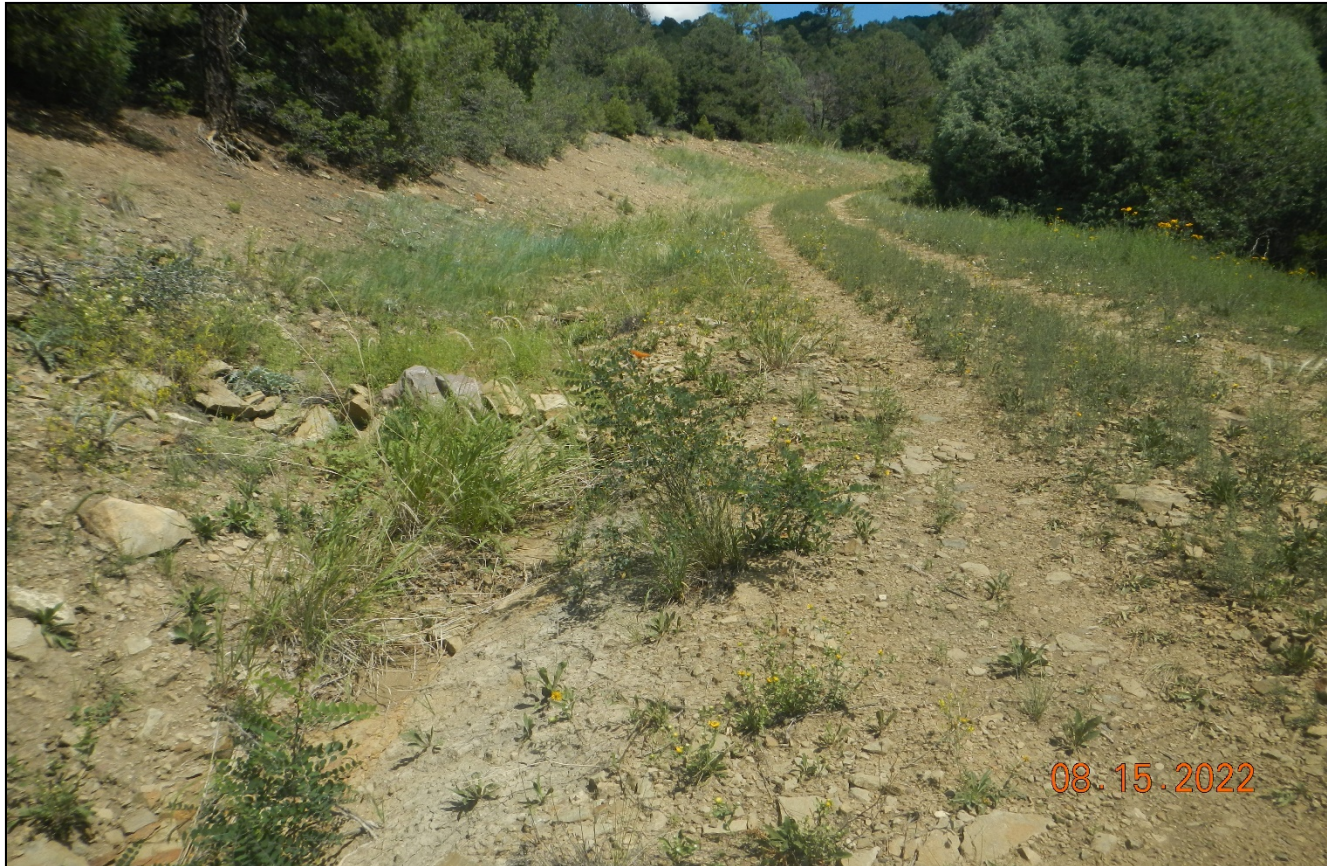
Photo 11. Facing northeast further along the access road. There is vegetation establishing along the road side and rock check dams are installed.

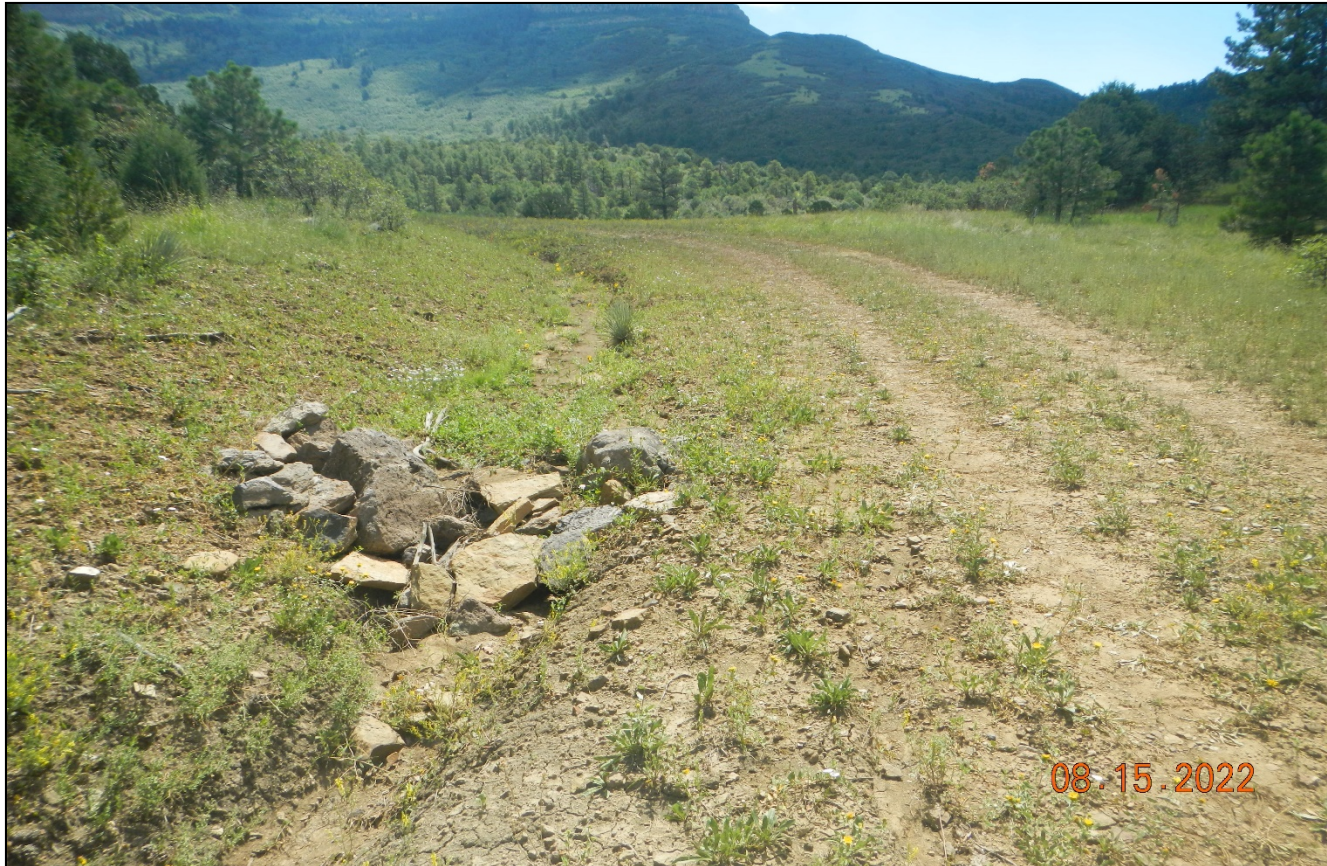
Photo 12. Facing northeast further along the access road. There is vegetation establishing along the road side and rock check dams are installed.

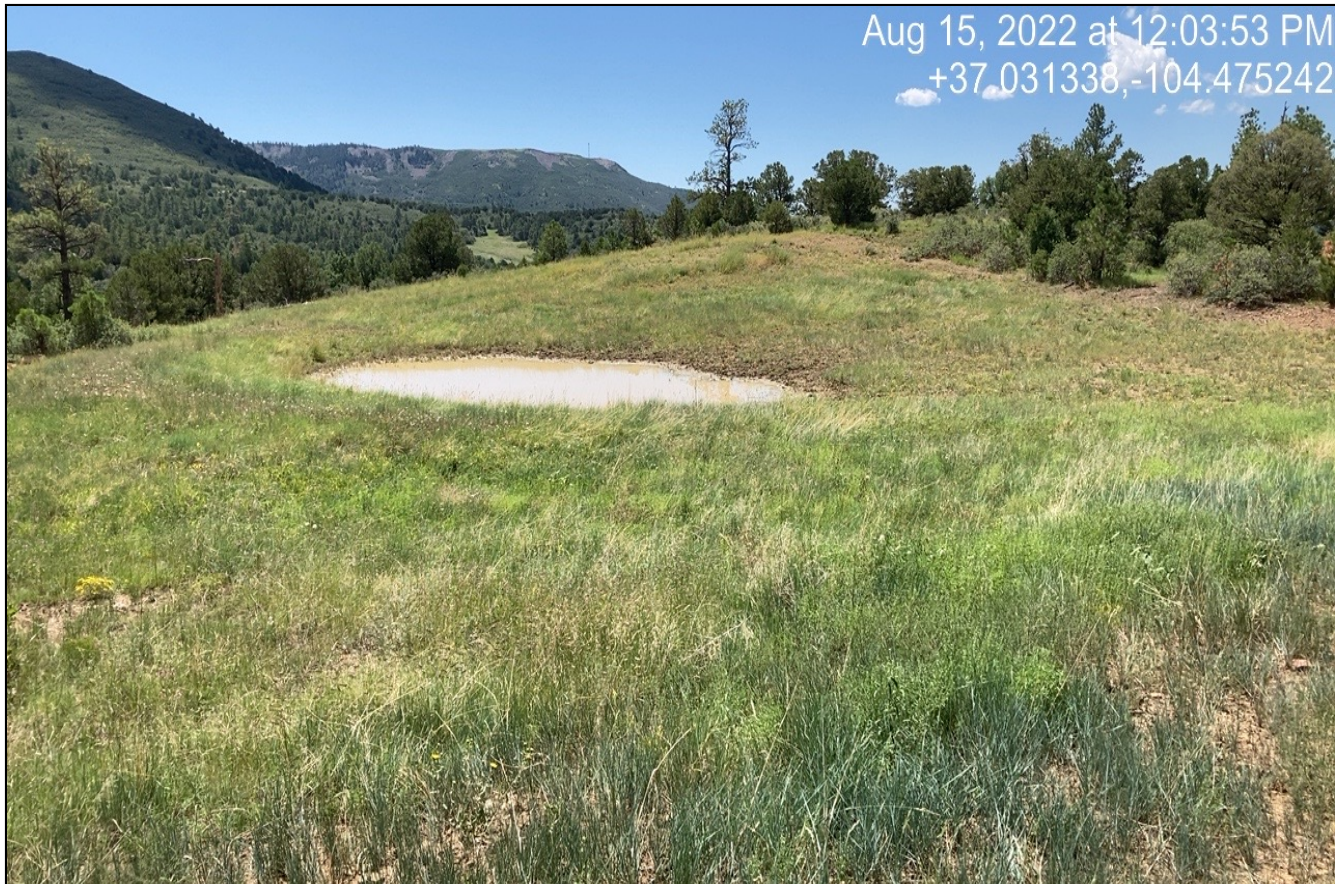
Photo 13. Facing southeast toward the location. The perennial vegetation establishment is progressing throughout the location.

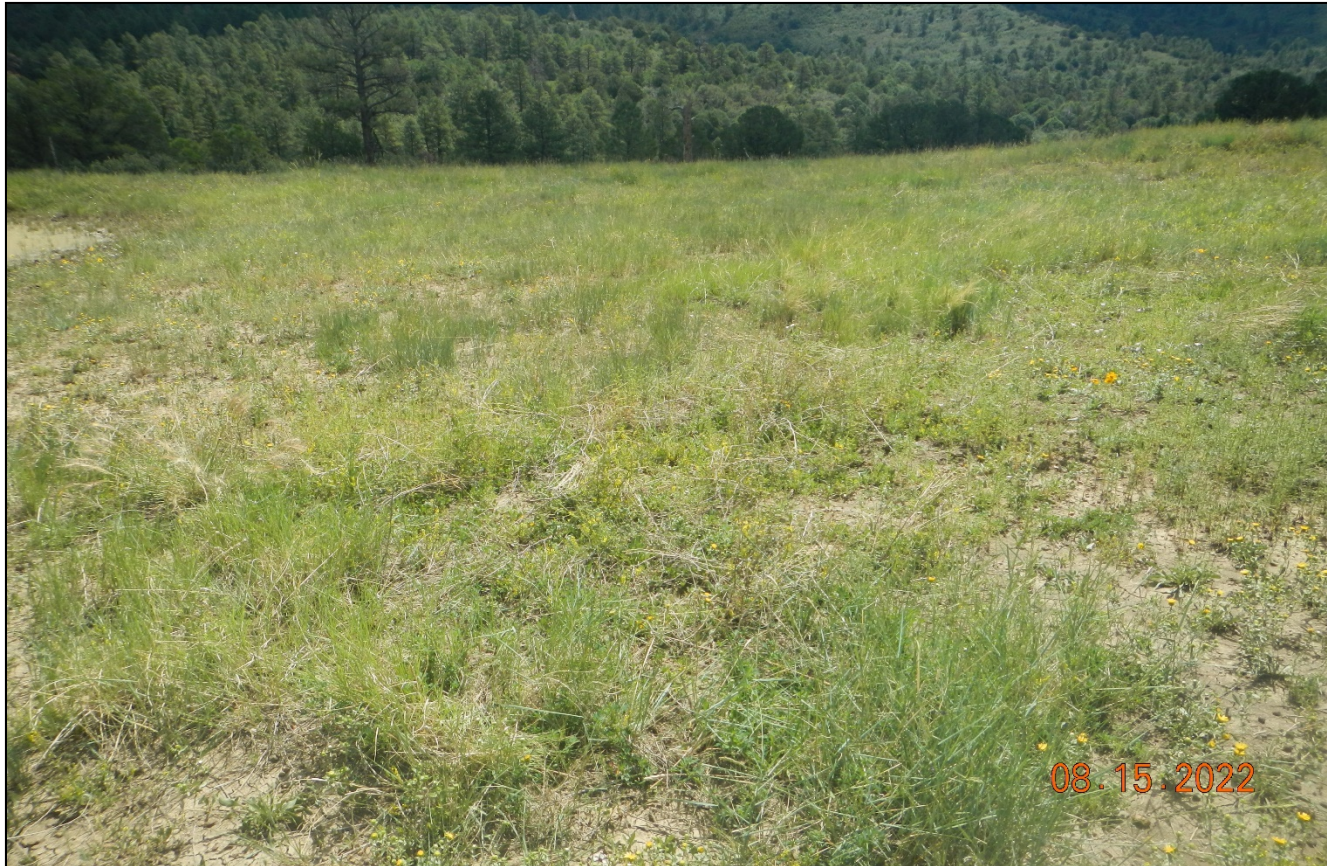
Photo 14. Facing east at the location. The perennial vegetation establishment is progressing throughout the location.

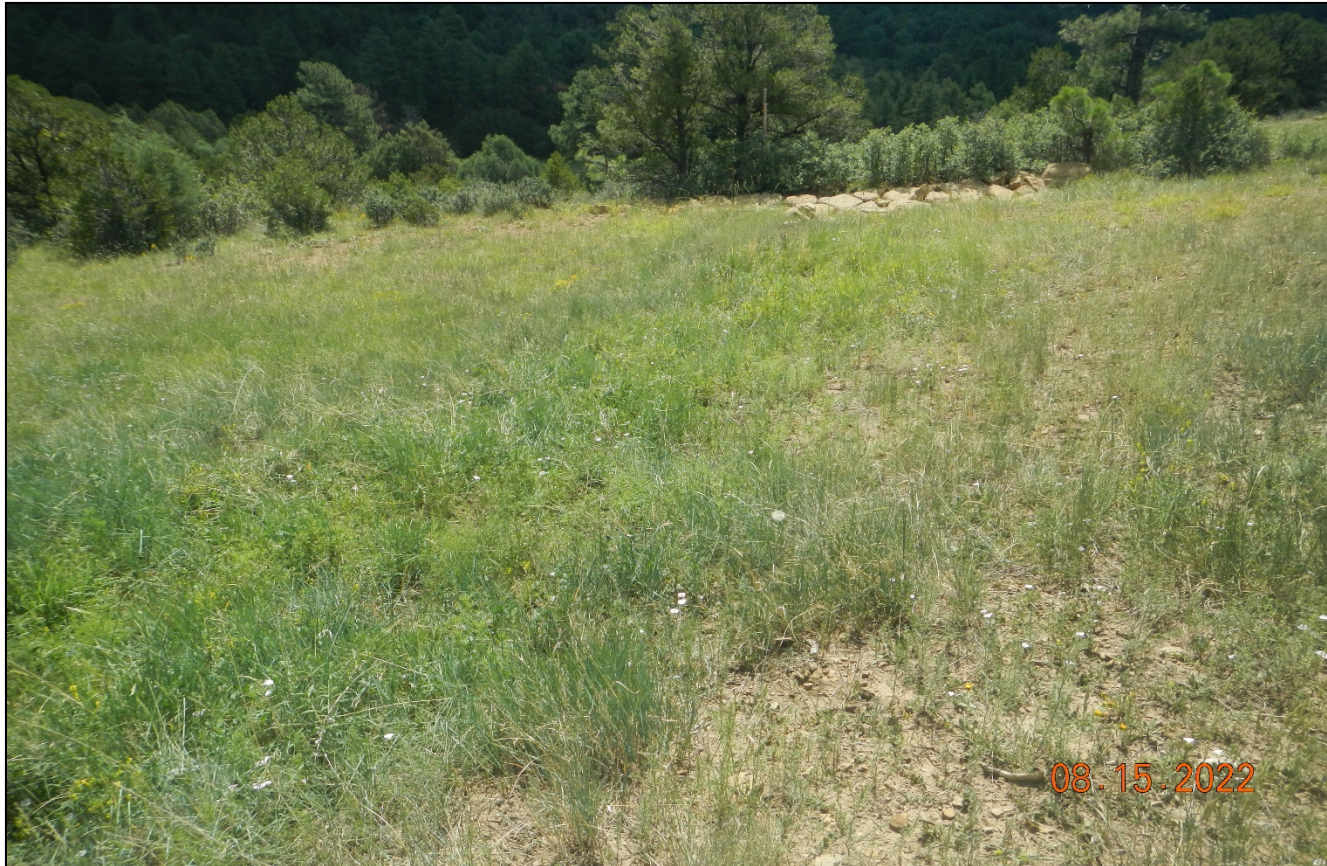
Photo 15. Facing east at the northeast side of the location. The perennial vegetation establishment is progressing throughout the location.

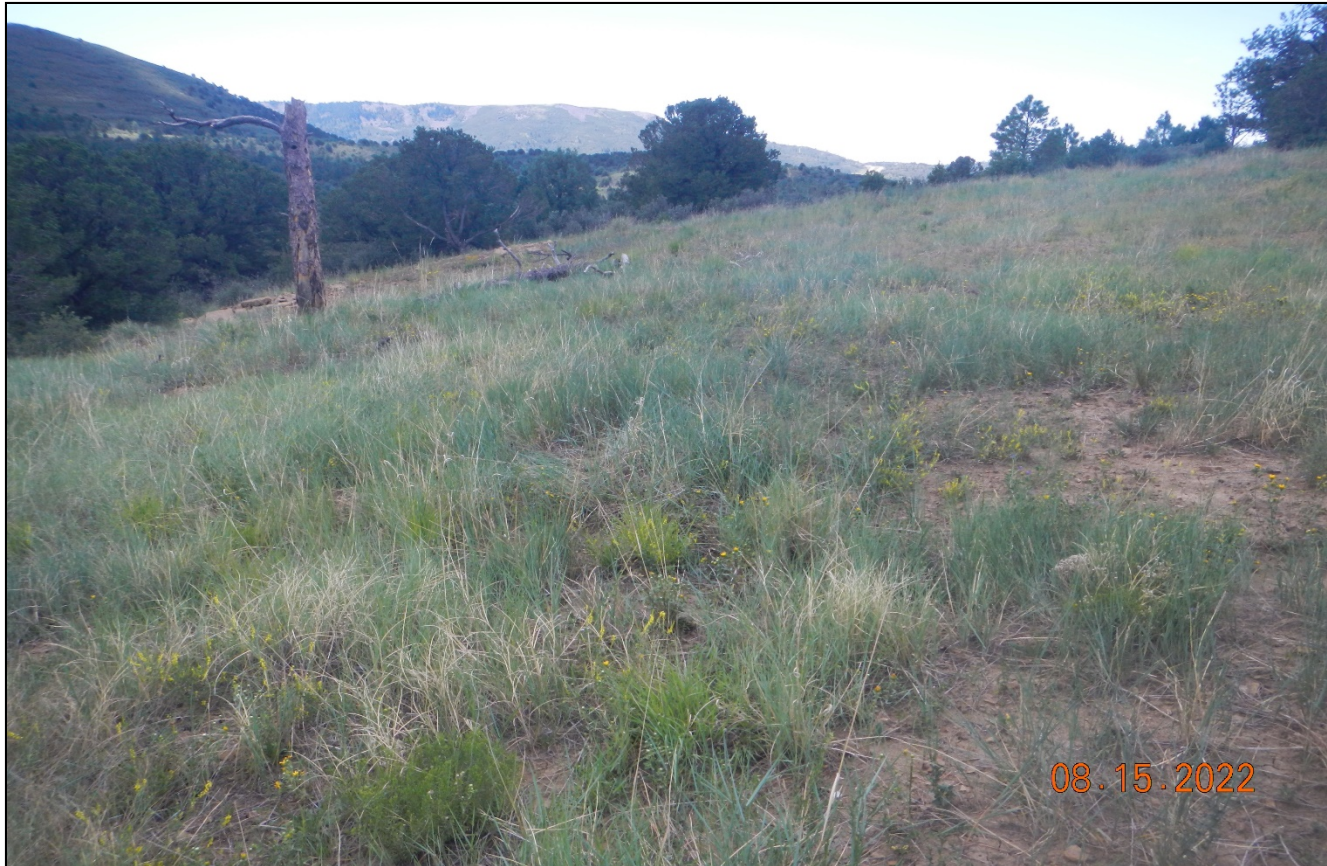
Photo 16. Facing southeast at the location. The perennial vegetation establishment is progressing throughout the location.
