Inspection Photos

Location Name: CAERUS PICEANCE LLC ROLES-67S93W /13SESW

Location ID: 334677

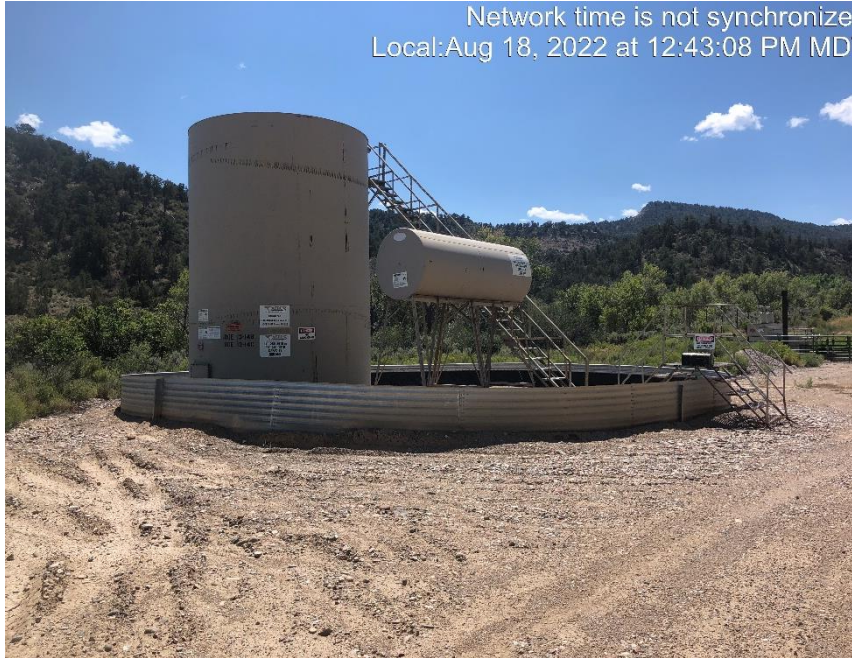
Photo #7481 from entrance to location.

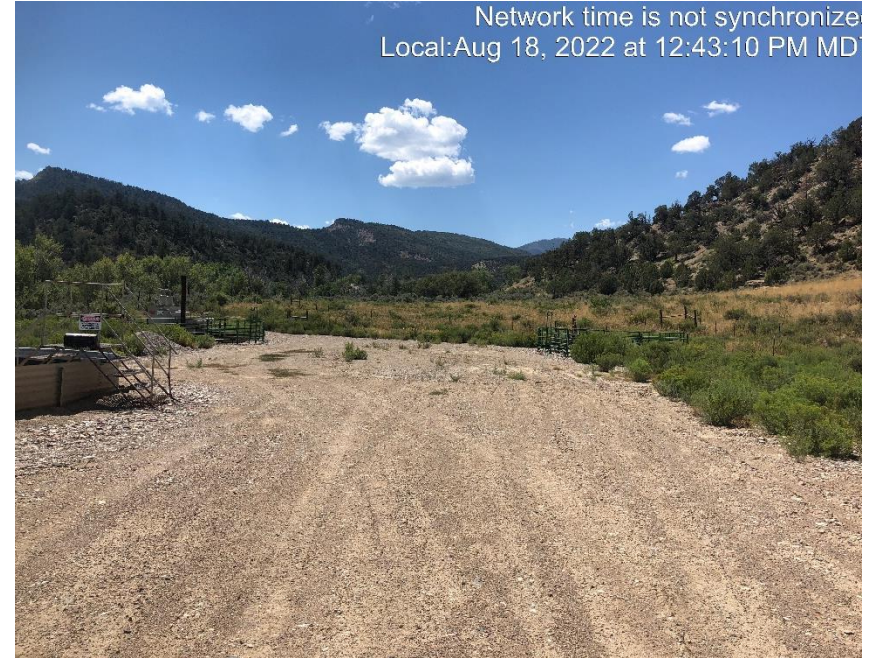
Photo #7482 from entrance to location.

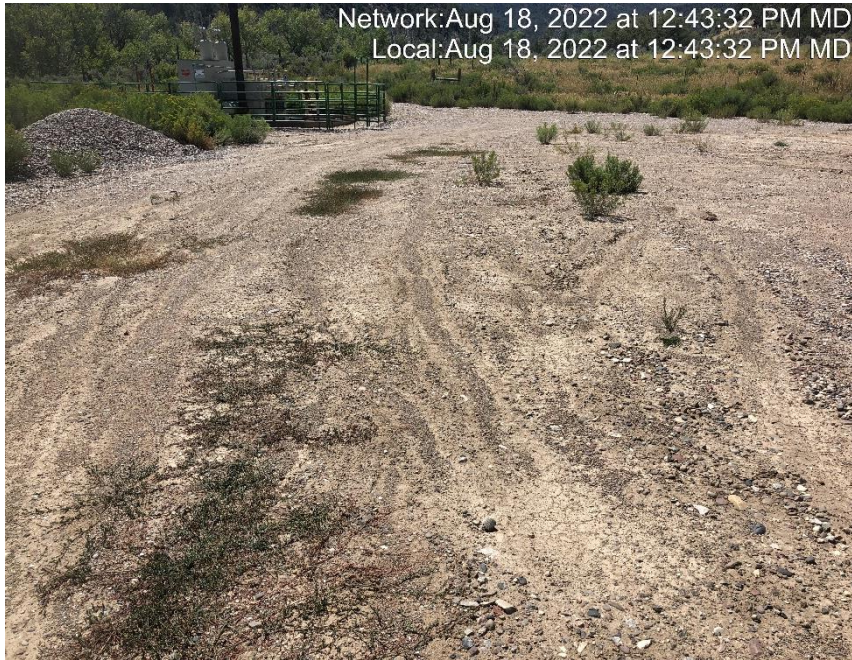
Photo #7483 Undesirable plant species on location.

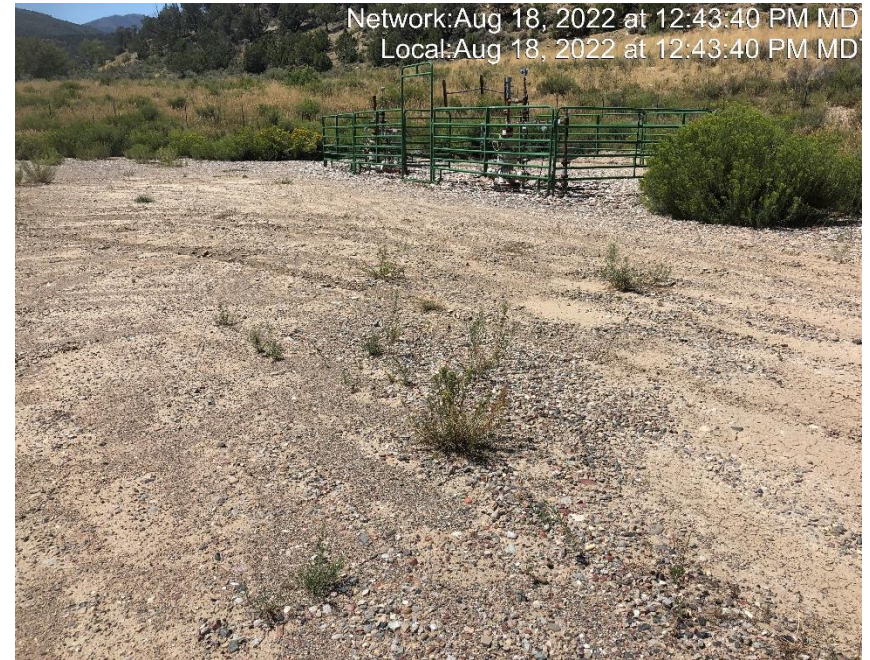
Photo #7484 Undesirable plant species on location.

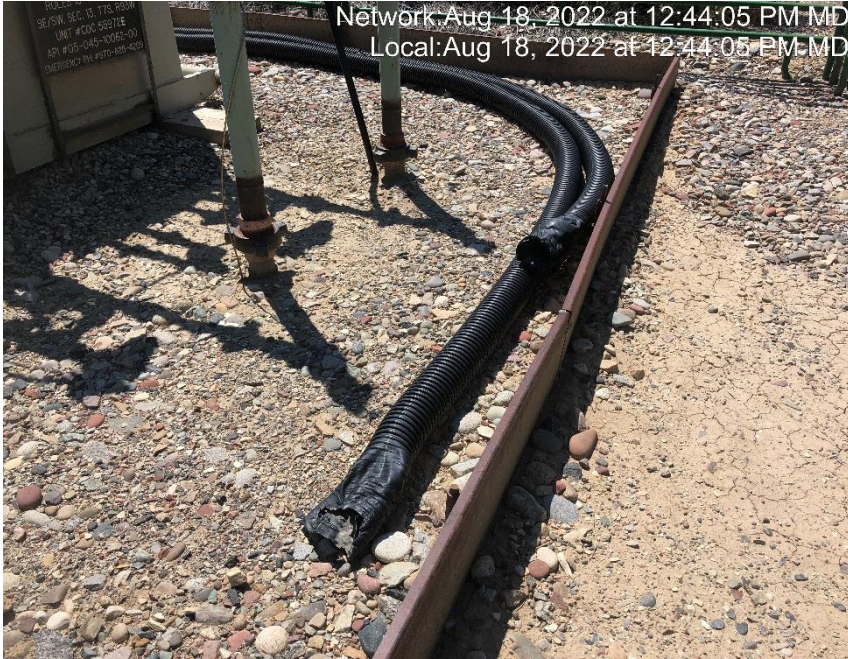
Photo #7485 Heating insulation open ended and not capped.
