## Inspection Photos

Location Name: CAERUS PICEANCE LLC ROLES-67S93W /13SESW

Location ID: 334593

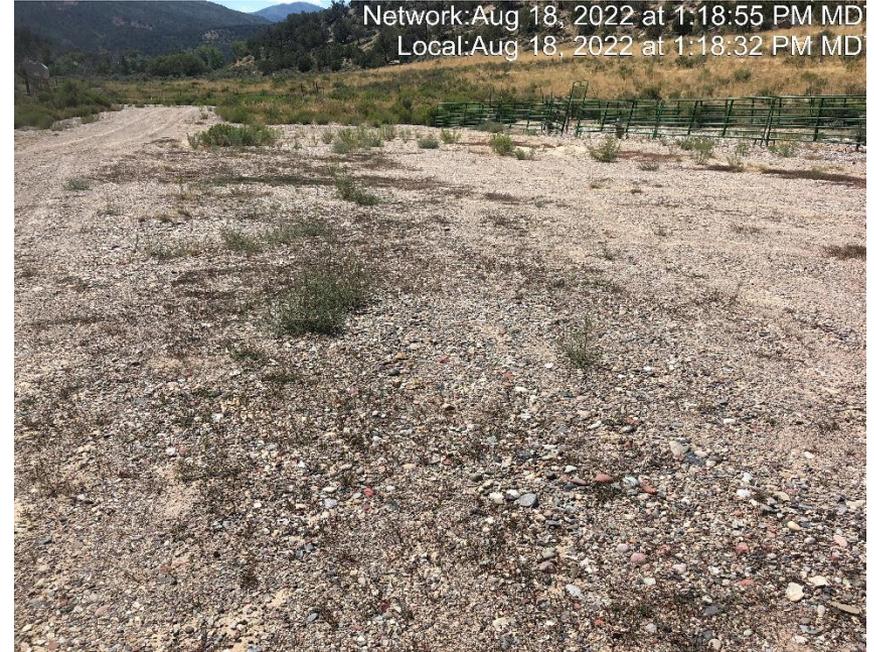
Photo #7490 Multiple places with undesirable plant species on location.

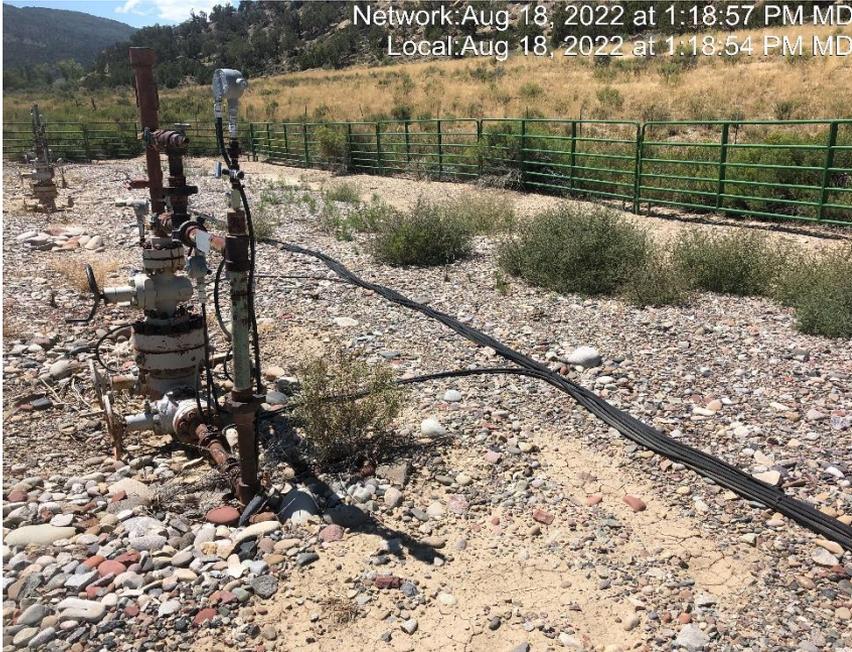
**Photo #7491 Multiple places with undesirable plant species on location.**

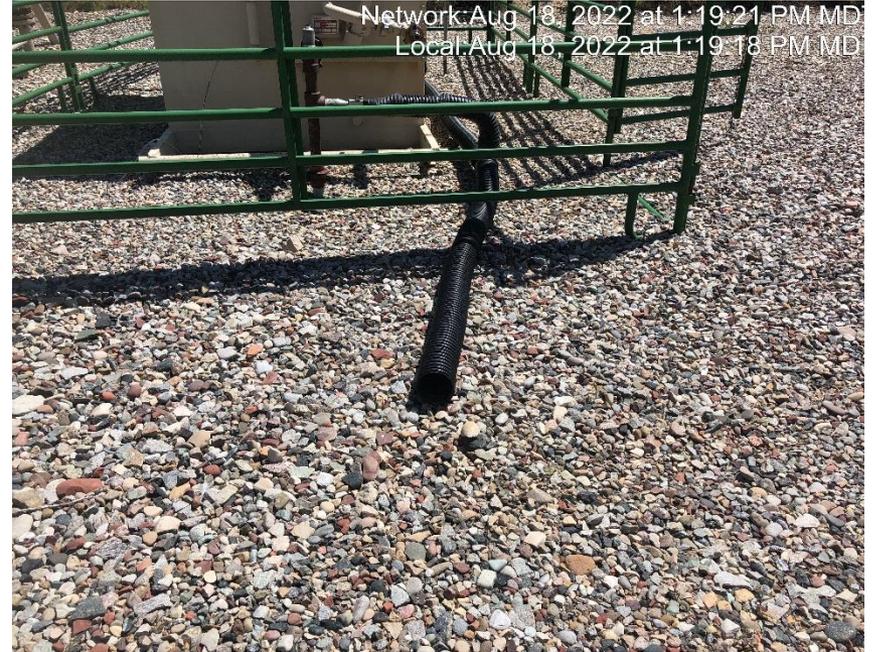
**Photo #7492 Flow line heating insulation open ended and not capped.**

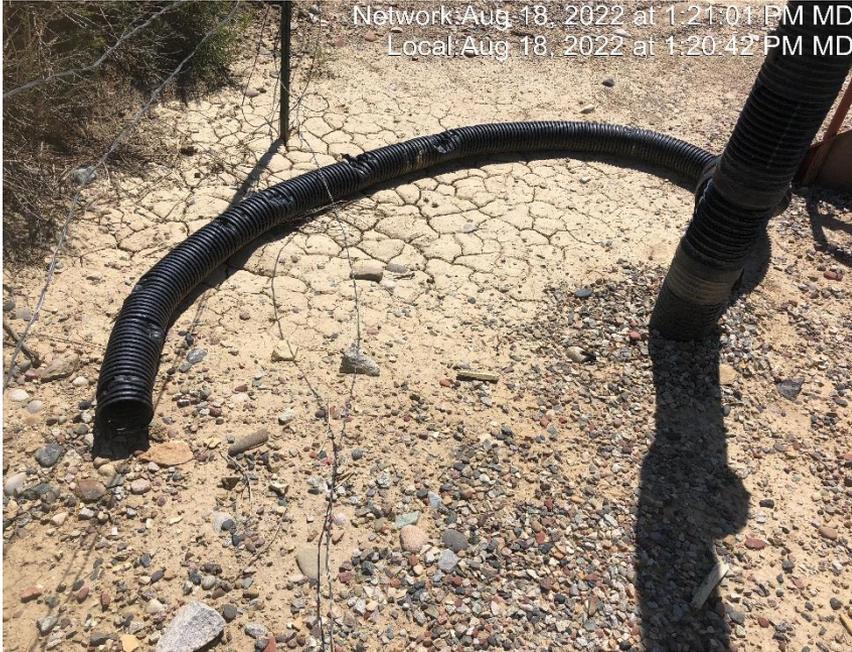
**Photo #7493 Flow line heating insulation open ended and not capped.**
