Inspection Photos

Location Name: CAERUS PICEANCE LLC ROLES-67S93W /13NESE

Location ID: 334558

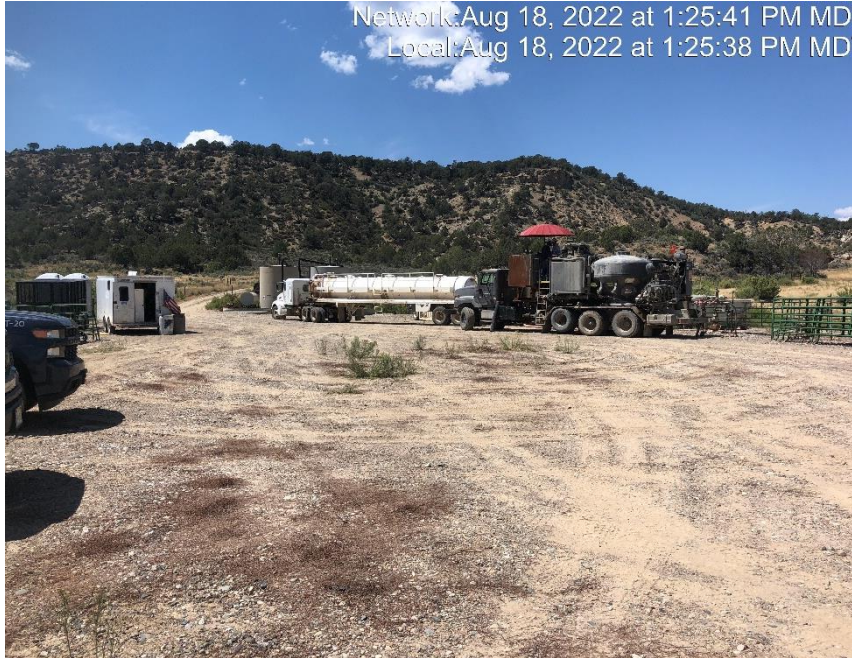
Photo #7494 from entrance to location.

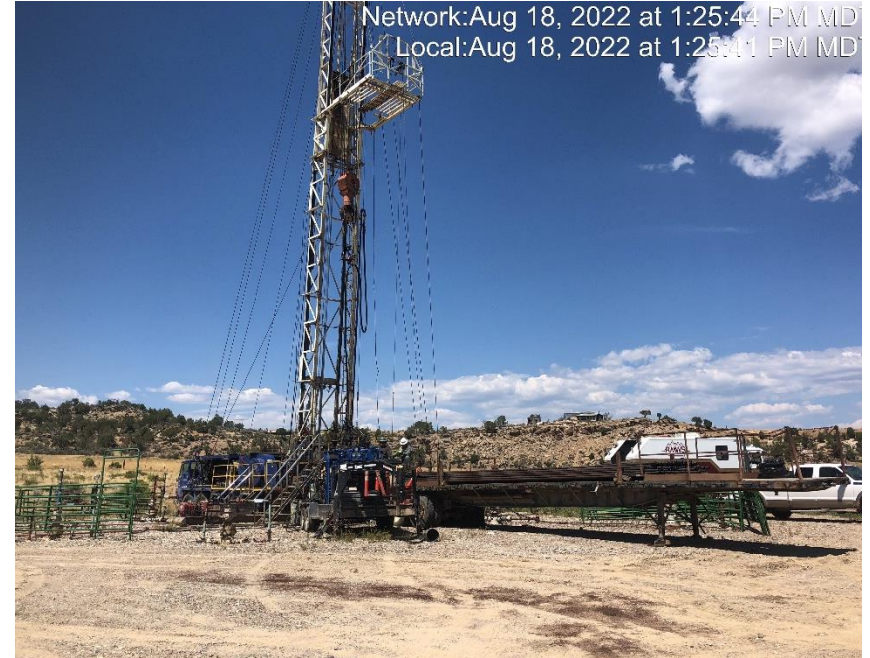
Photo #7495 from entrance to location.

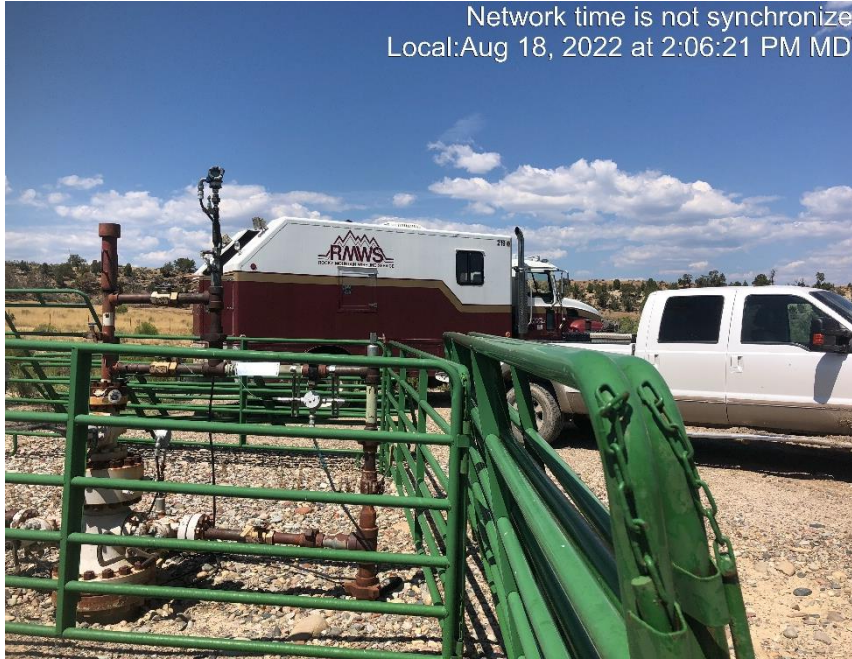
Photo #7496 Wireline.

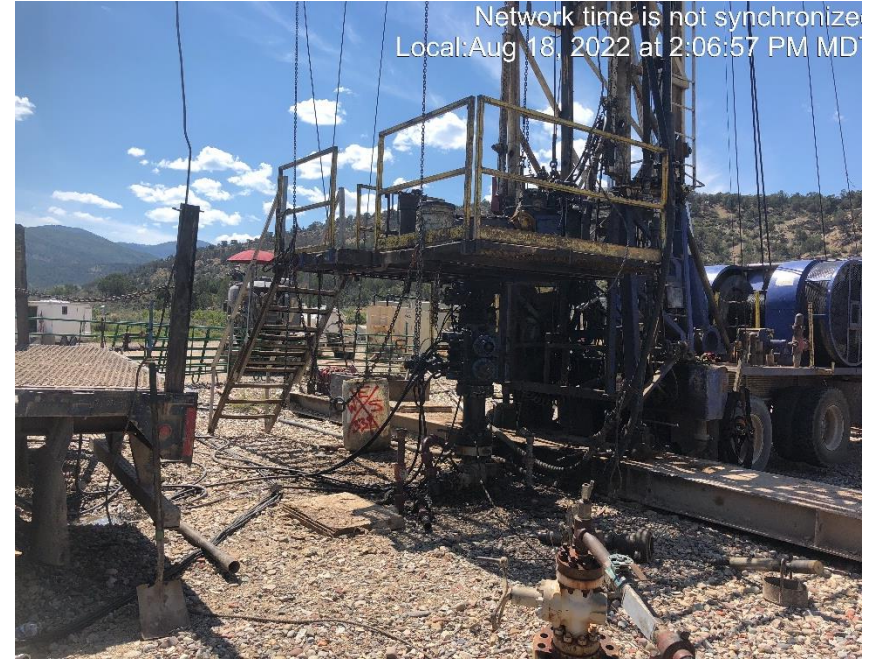
Photo #7498 Workover rig.

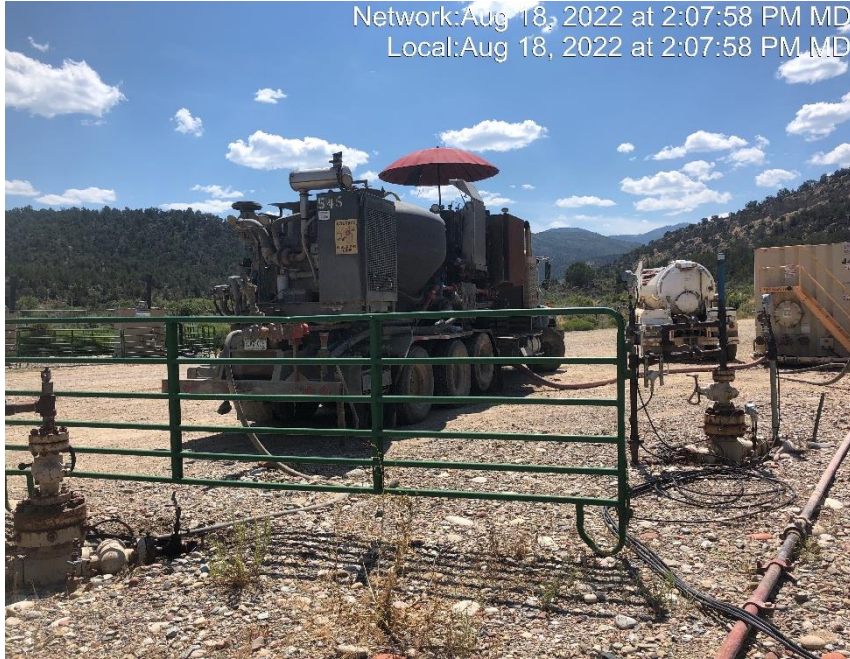
Photo #7500 Cement pump.

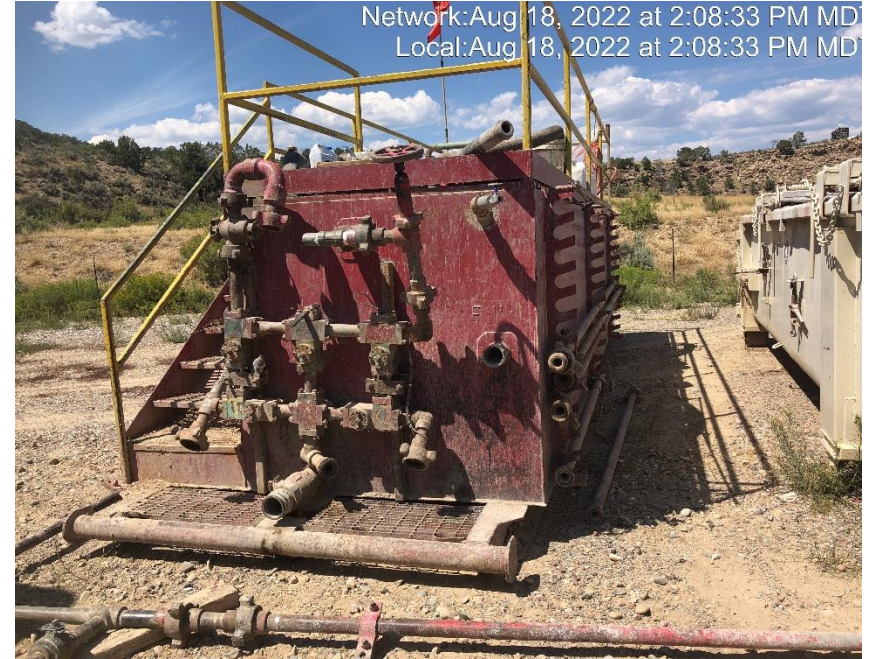
Photo #7502 Flat tank.

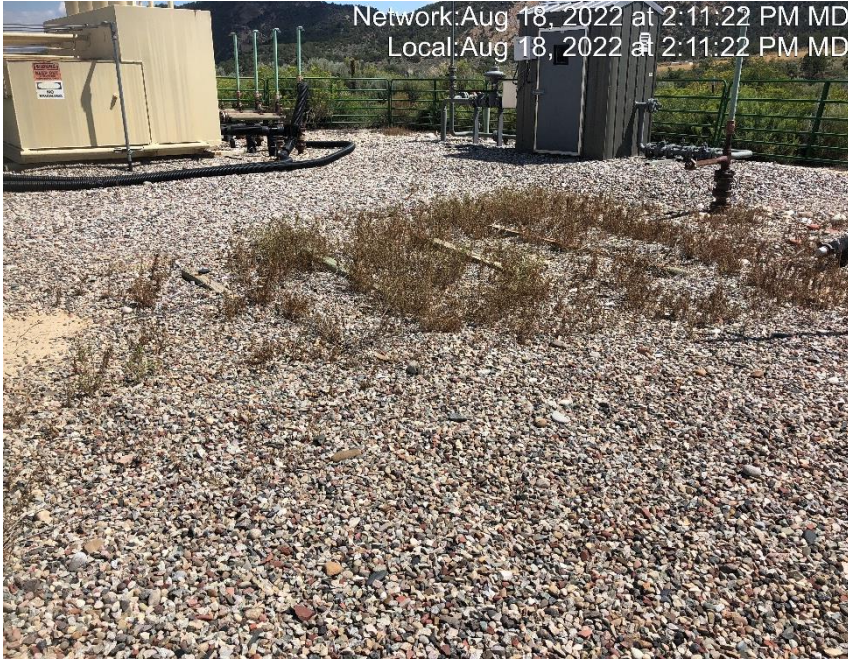
Photo #7505 Undesirable plant species.

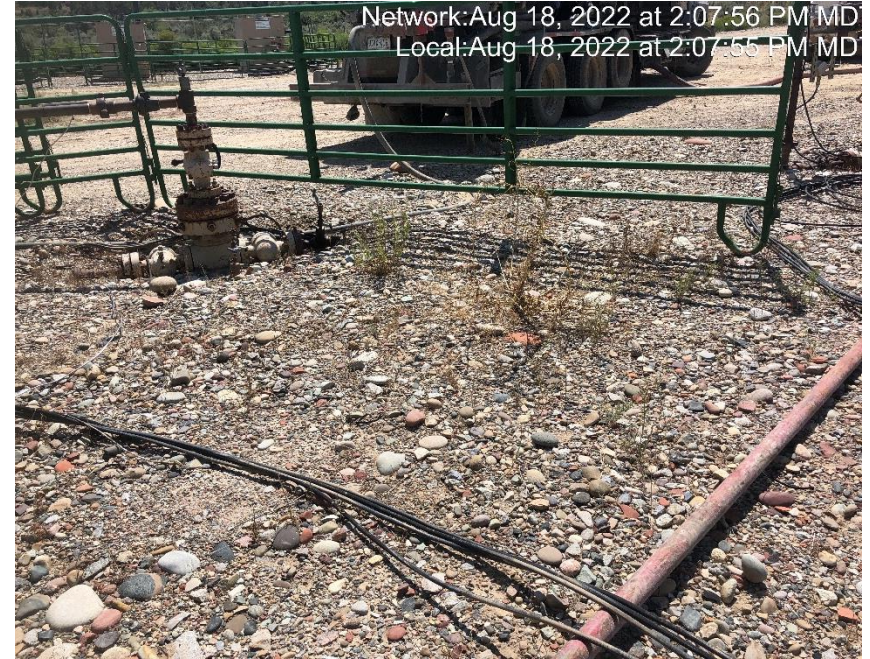
Photo #7499 Undesirable plant species.
