Inspection Photos
Location Name: Huber-Rhoades 4-33
Location ID: 326516

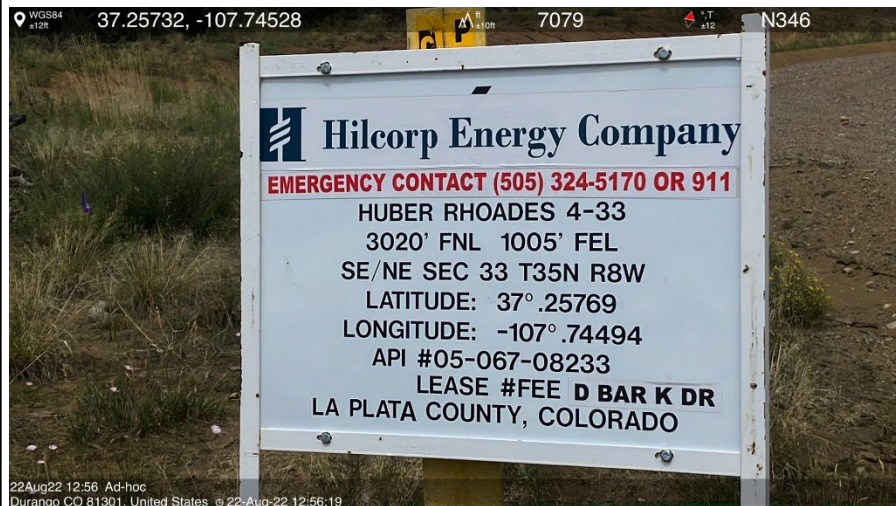
IMG 01
Well sign

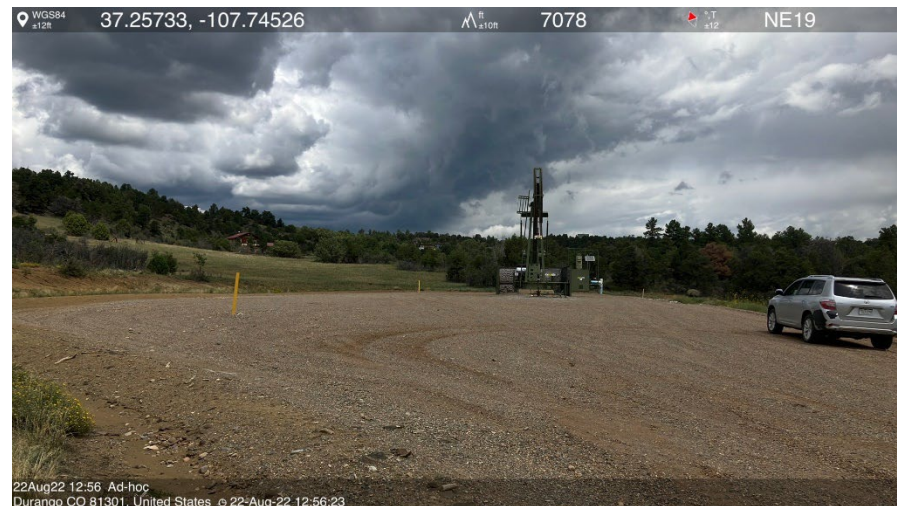
IMG 02
Location overview

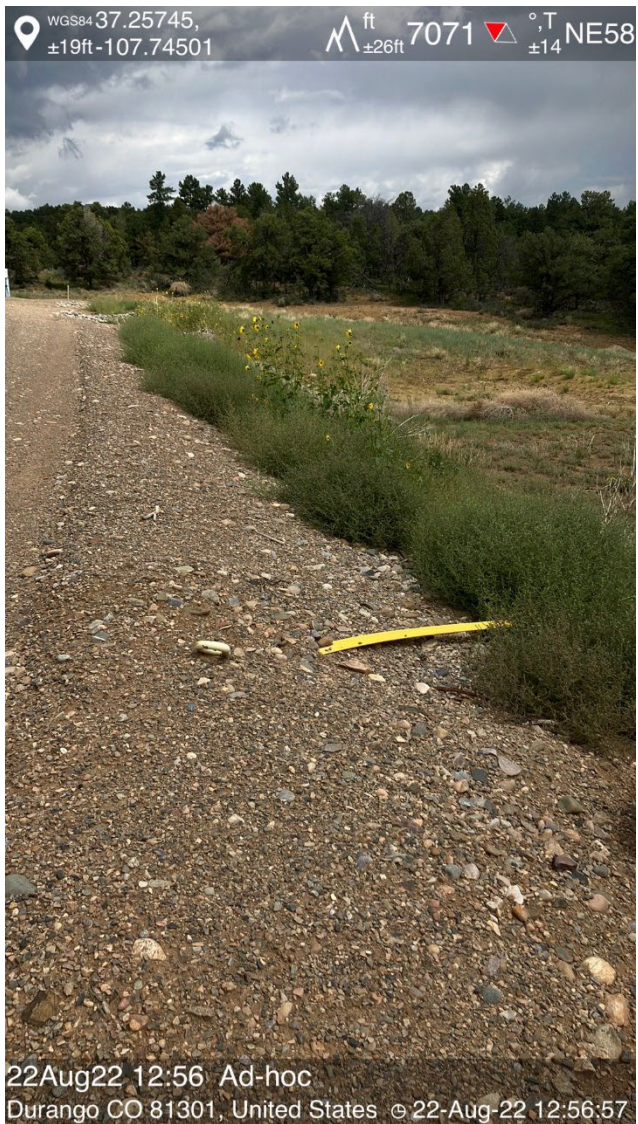
IMG 03

Rig anchor not secured properly

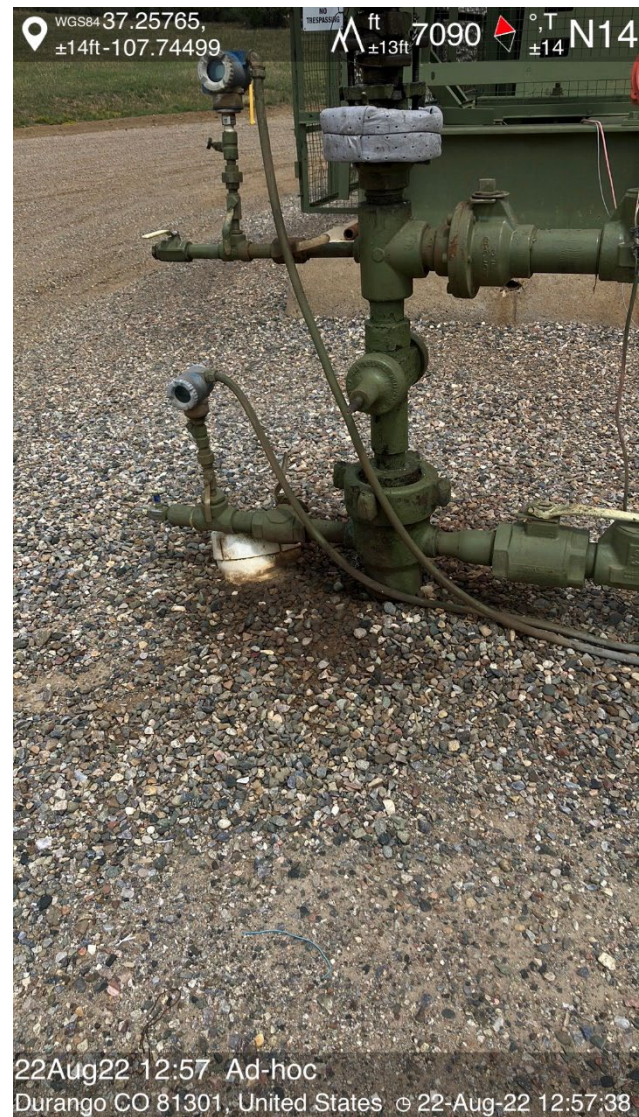
IMG 04

Lube oil has begun to impact surface material

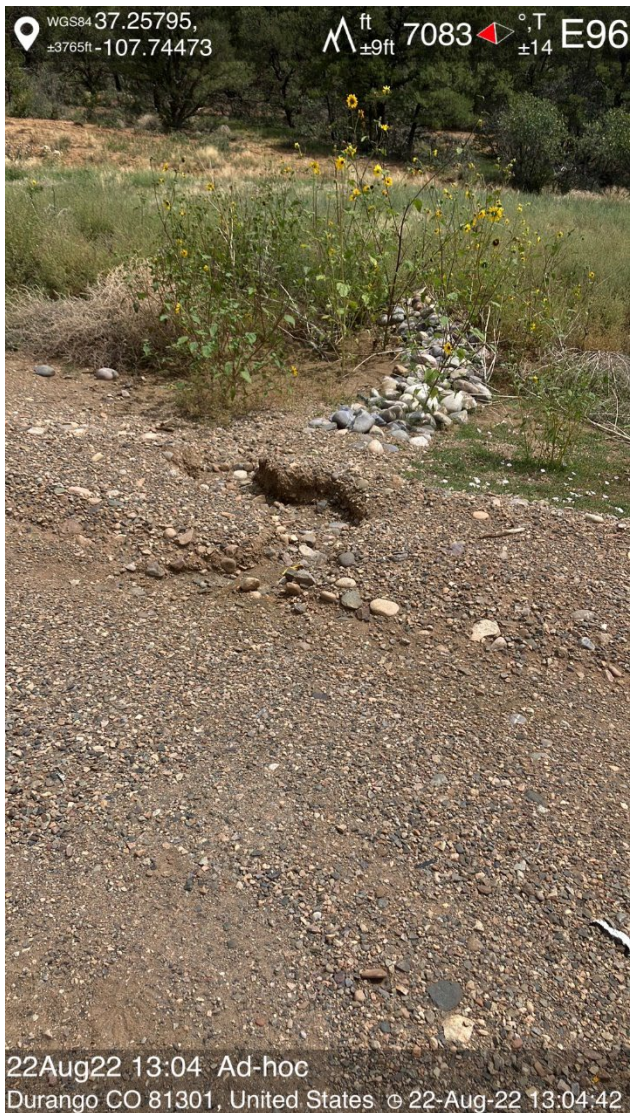
IMG 05

Stomwater channel has begun to form
