Inspection Photos and Issue Report

8/17/2022

Operator: CAERUS PICEANCE LLC #10456

Location #467272

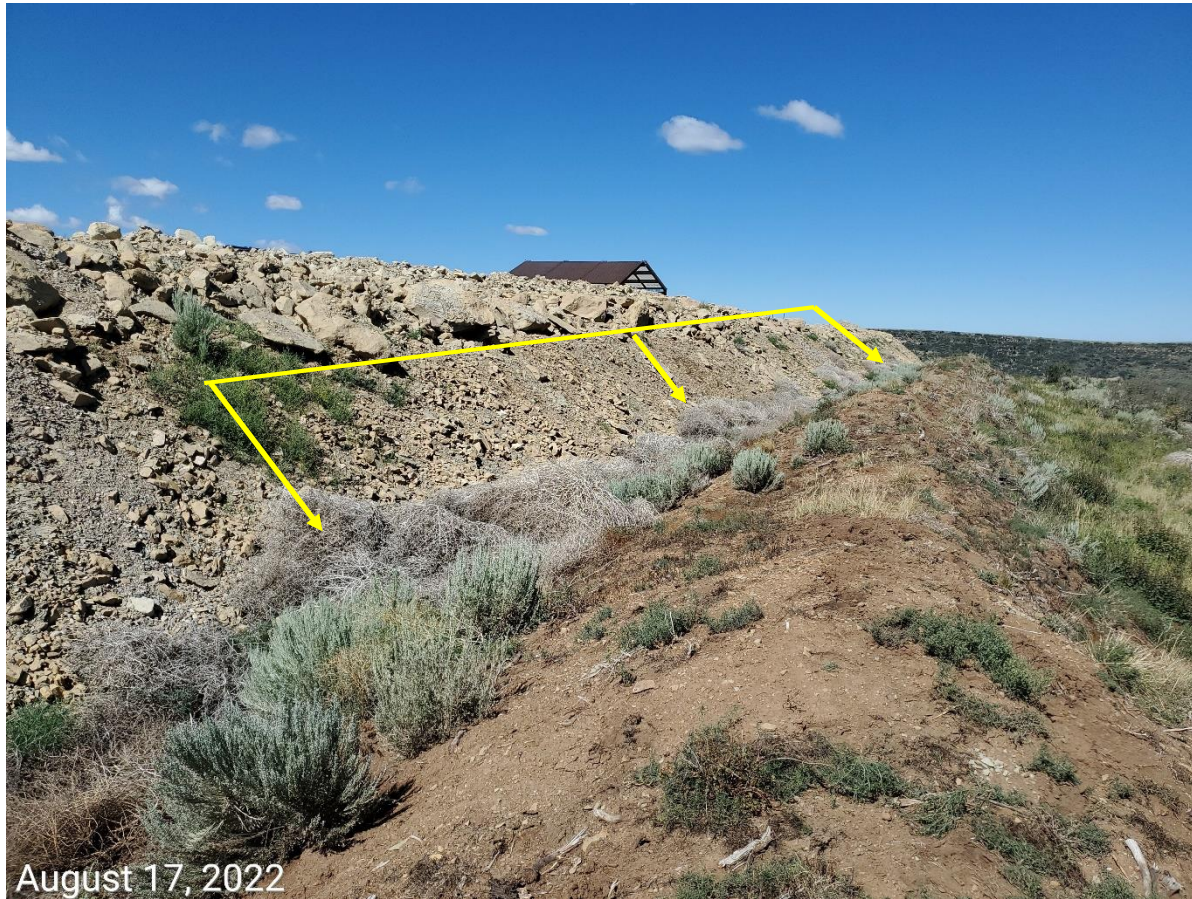
Photo 1: Photo taken from the north end of the Location. Photo shows topsoil stockpile in use as part of the perimeter stormwater ditch/berm leading from the sediment trap/basin; topsoil stockpile predominantly bare/exposed; BMPs to protect topsoil remain missing or insufficient. Photo also shows weed debris accumulation within the ditch has not been removed (arrow).

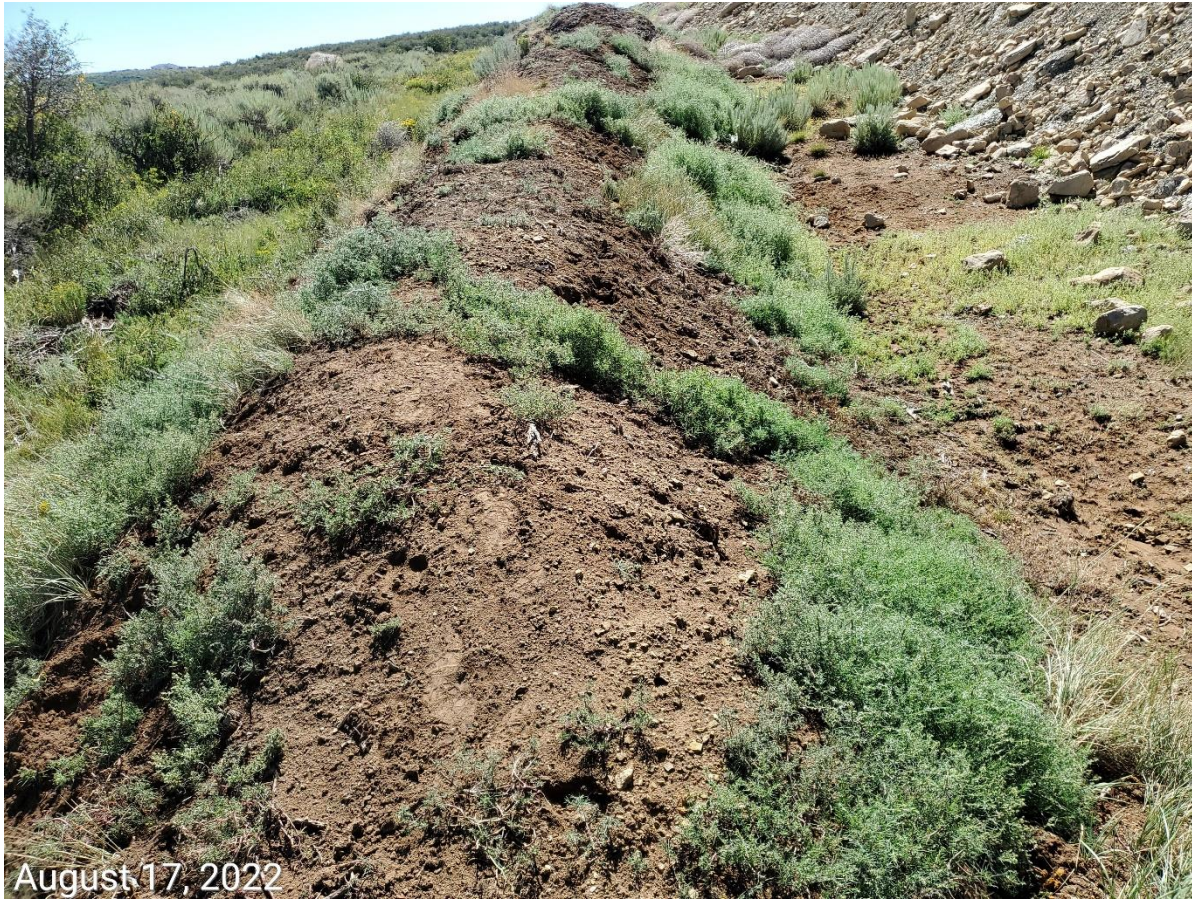
Photo 2: Photo example showing the topsoil stockpile in use as part of the perimeter stormwater ditch/berm; photo also shows weed establishment on the topsoil; BMPs to protect topsoil remain missing or insufficient.

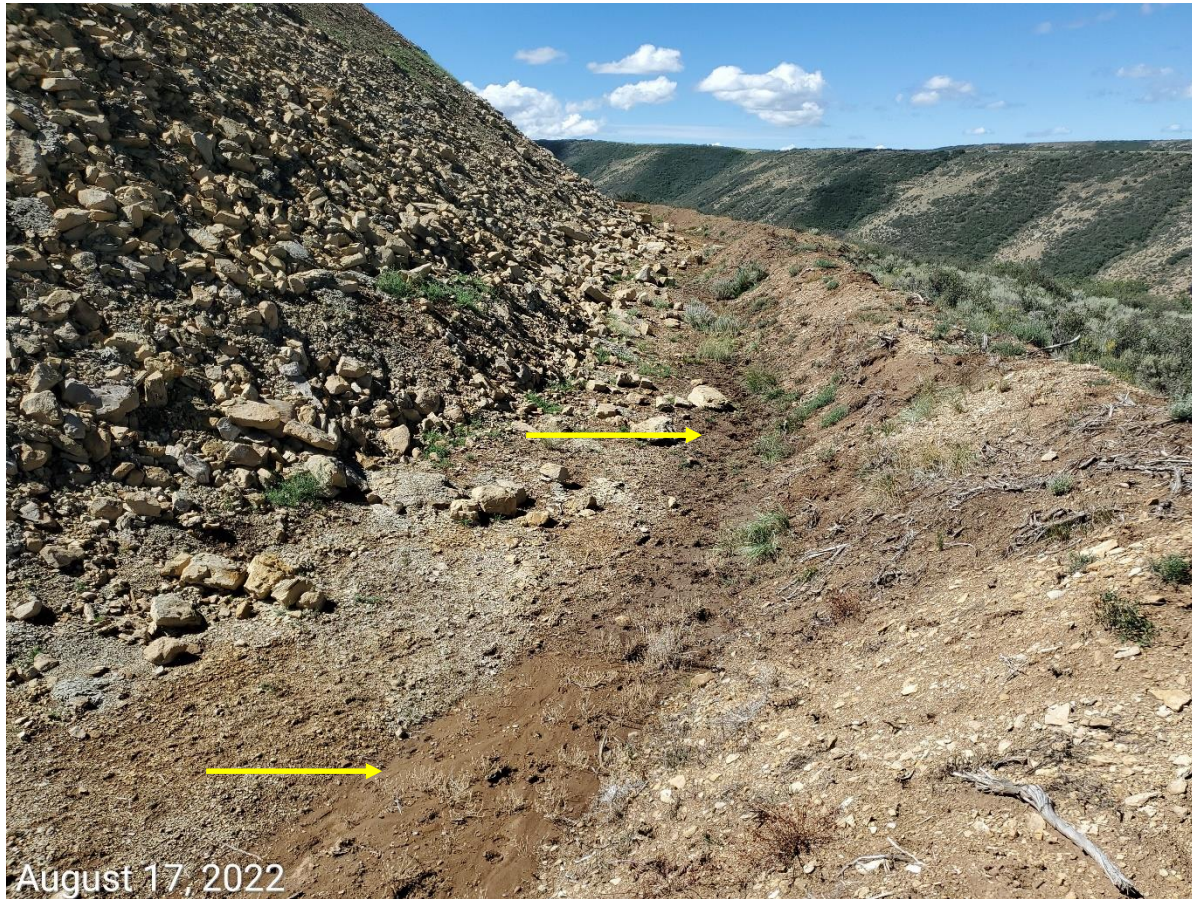
Photo 3: Photo example showing the topsoil stockpile in use as part of the perimeter stormwater ditch/berm. Photo also shows water movement patterns due to stormwater runoff (arrow) that has resulted in sediment transport, deposition and ponding along the stockpile. Photo also example showing soils at the stockpile remain bare; BMPs to protect soils remain missing or insufficient.

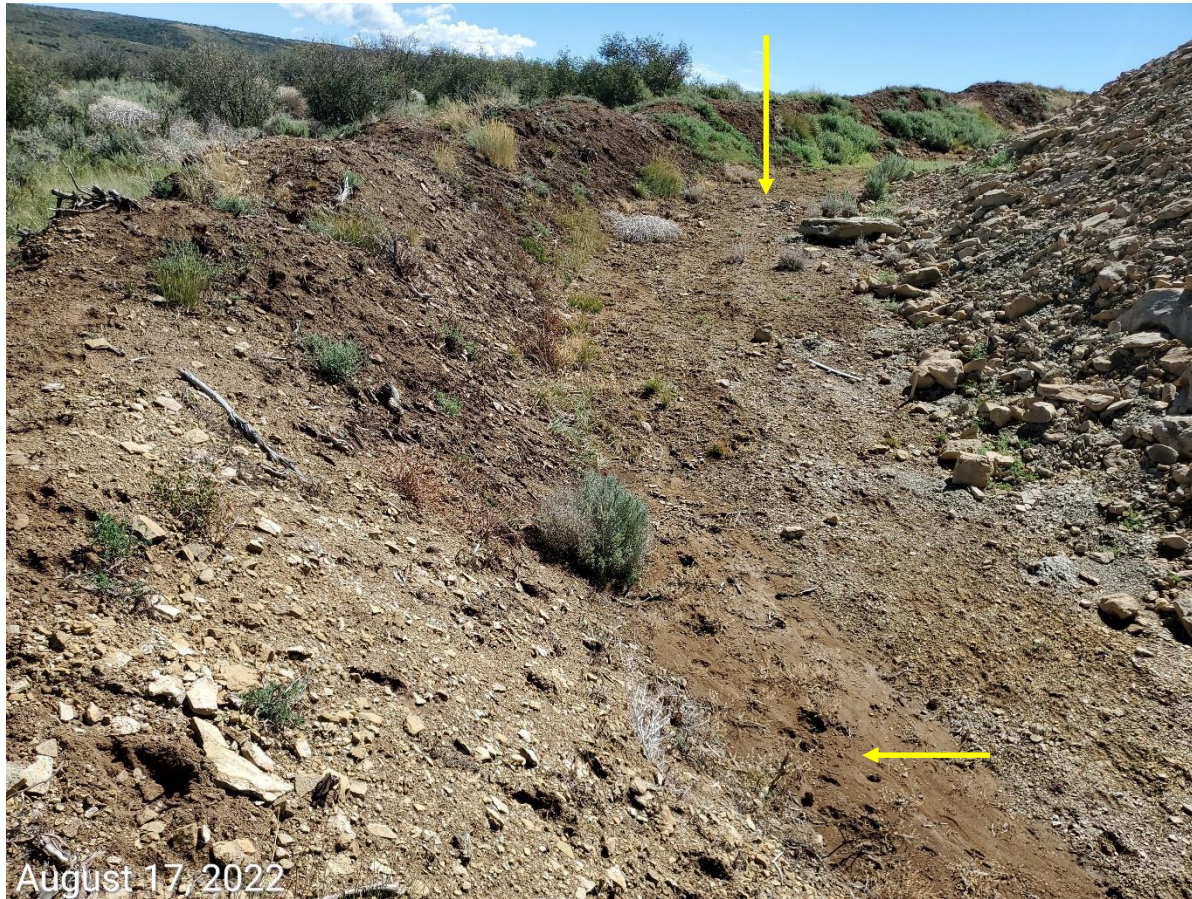
Photo 4: Photo example showing the topsoil stockpile in use as part of the perimeter stormwater ditch/berm. Photo also shows water movement patterns due to stormwater runoff (arrow) that has resulted in sediment transport, deposition (red arrow) and ponding along the stockpile. Photo also example showing soils at the stockpile remain bare; BMPs to protect soils remain missing or insufficient.

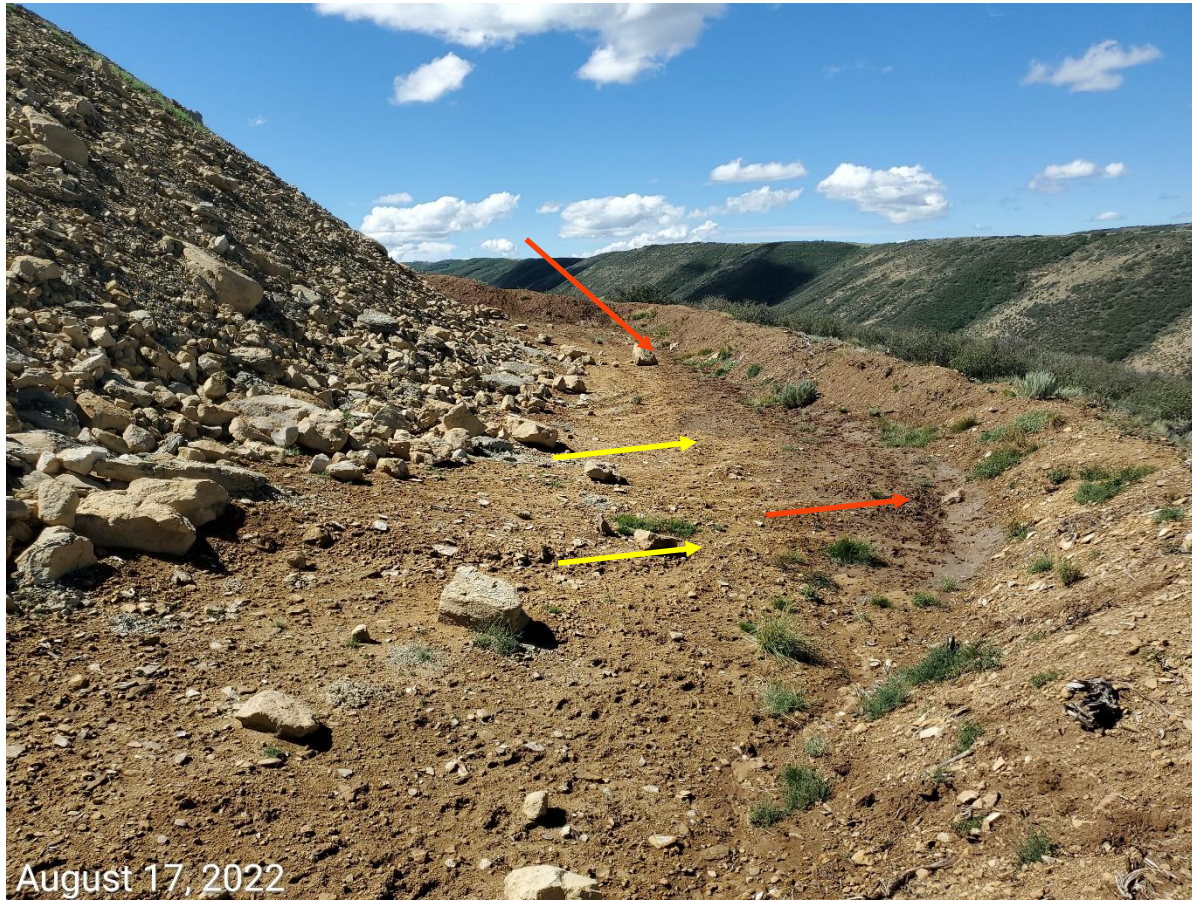
Photo 5: Photo example showing the topsoil stockpile in use as part of the stormwater sediment trap/basin on the west end of the Location. Photo also shows water movement patterns (yellow arrow) due to stormwater runoff that has resulted in sediment transport/deposition and ponding (red arrow) along the stockpile. Photo also example showing topsoil stockpiles remain bare/exposed soil; BMPs to protect soils remain missing or insufficient.

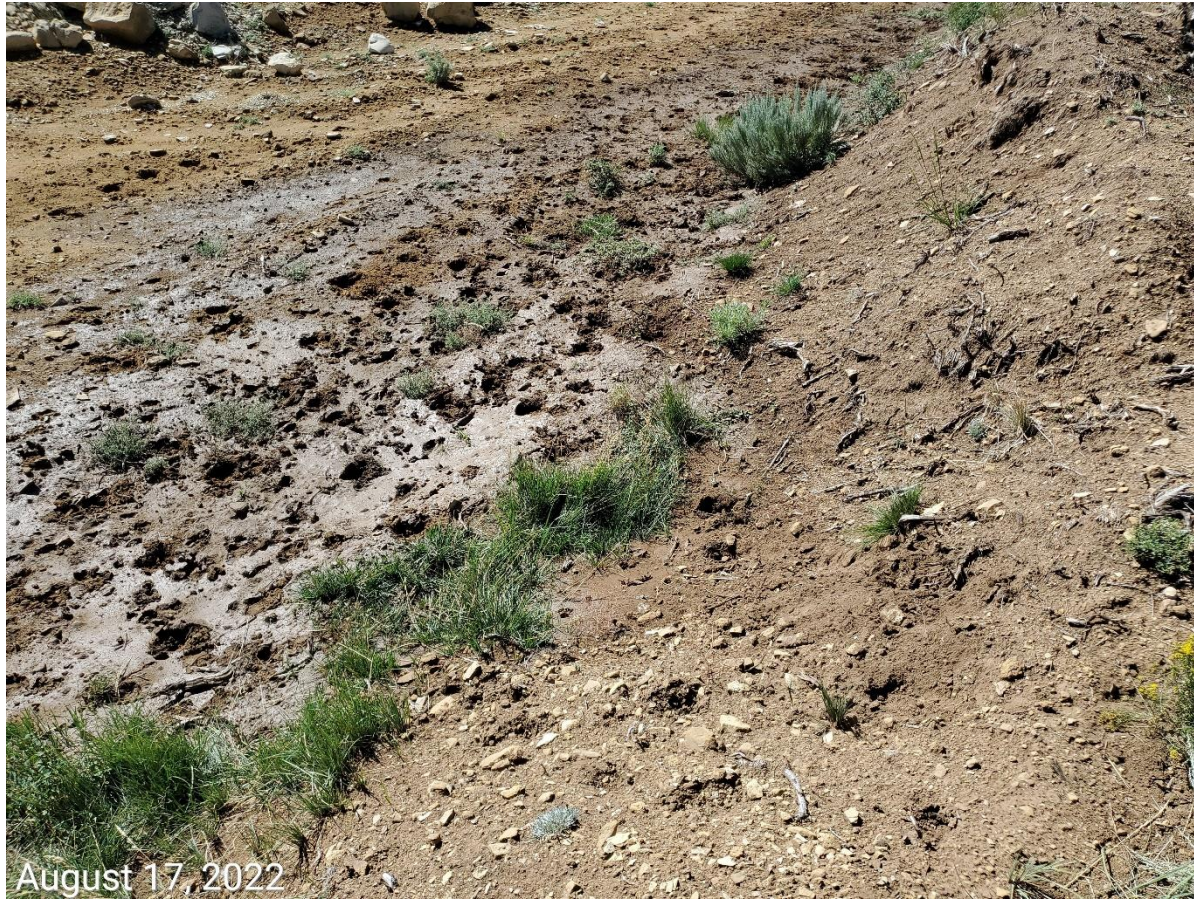
Photo 6: Photo taken from the west end of the Location. Photo shows topsoil stockpile in use as part of the stormwater sediment trap/basin. Photo shows evidence of stormwater runoff, ponding, and sediment transport/deposition along the stockpiles. Photo also example showing topsoil stockpiles remain bare/exposed soil; BMPs to protect soils remain missing or insufficient.

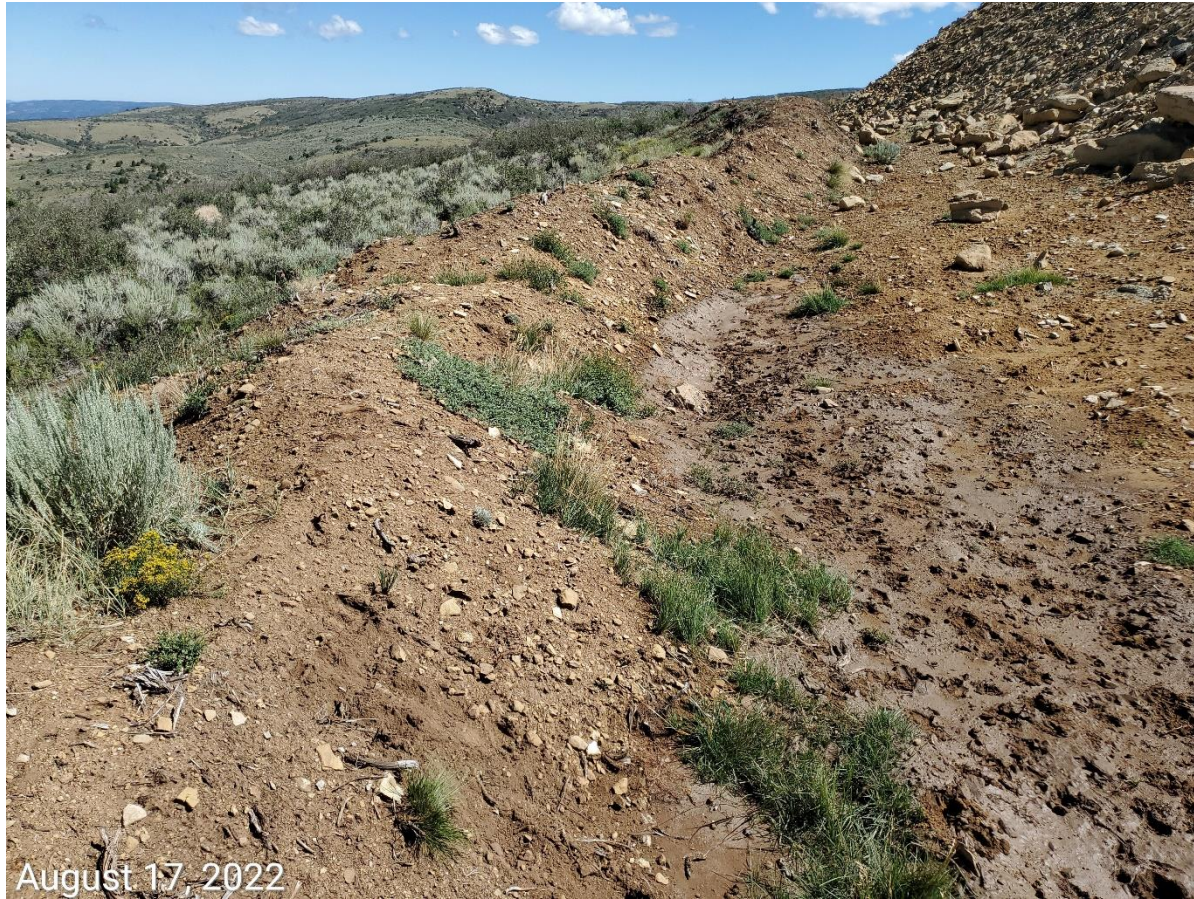
Photo 7: Photo taken from the west end of the Location. Photo shows topsoil stockpile in use as part of the stormwater sediment trap/basin. Photo shows evidence of stormwater runoff, ponding, and sediment transport/deposition along the stockpiles. Photo also example showing topsoil stockpiles remain bare/exposed soil; BMPs to protect soils remain missing or insufficient.

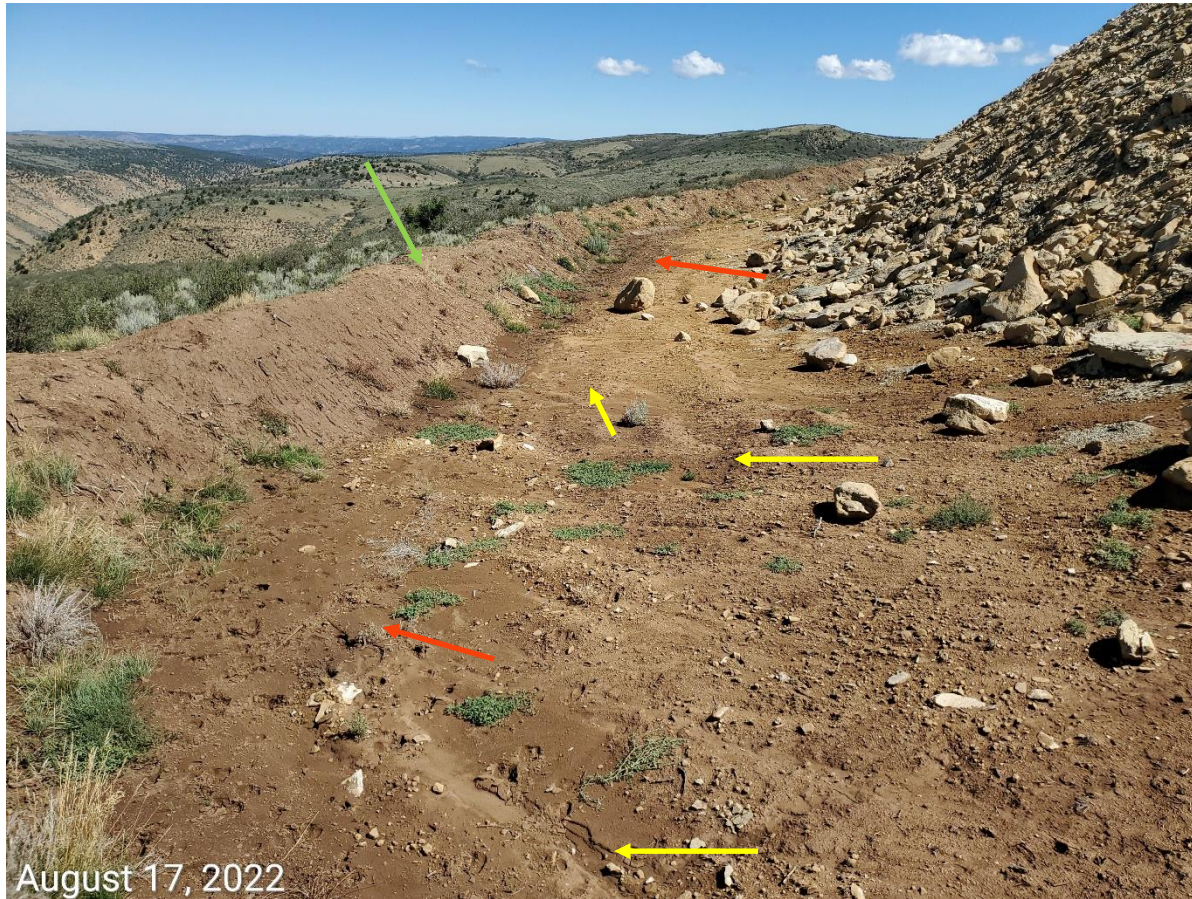
Photo 8: Photo taken from the west end of the Location. Photo shows topsoil stockpile (green arrow) in use as part of the stormwater sediment trap/basin. Photo also shows water movement patterns (yellow arrow) due to stormwater runoff that has resulted in sediment transport/deposition and ponding (red arrow) along the stockpile. Photo also example showing topsoil stockpiles remain bare/exposed soil; BMPs to protect soils remain missing or insufficient.

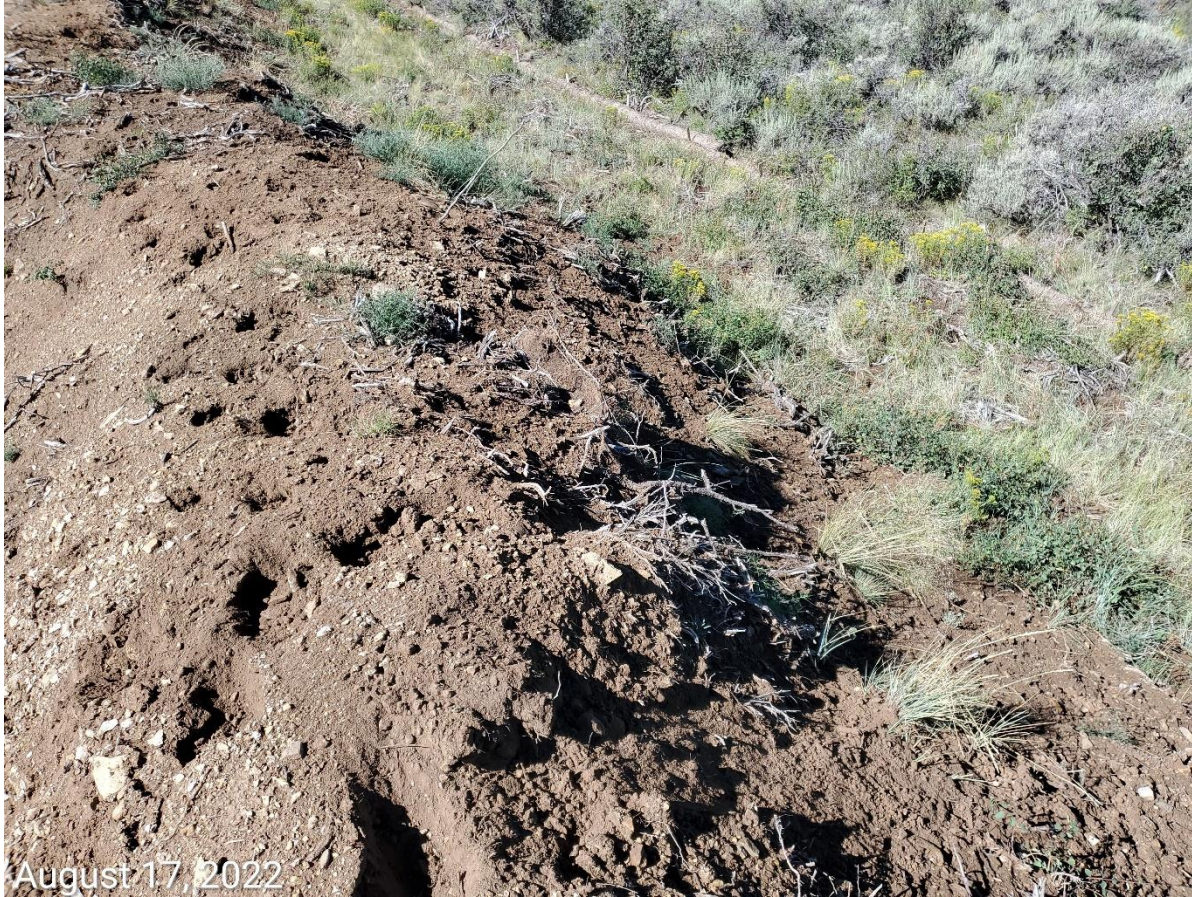
Photo 9: Photo example showing topsoil stockpiles along perimeter of the Location remain bare and exposed; BMPs to protect topsoil remains missing or insufficient; erosion degradation evident.

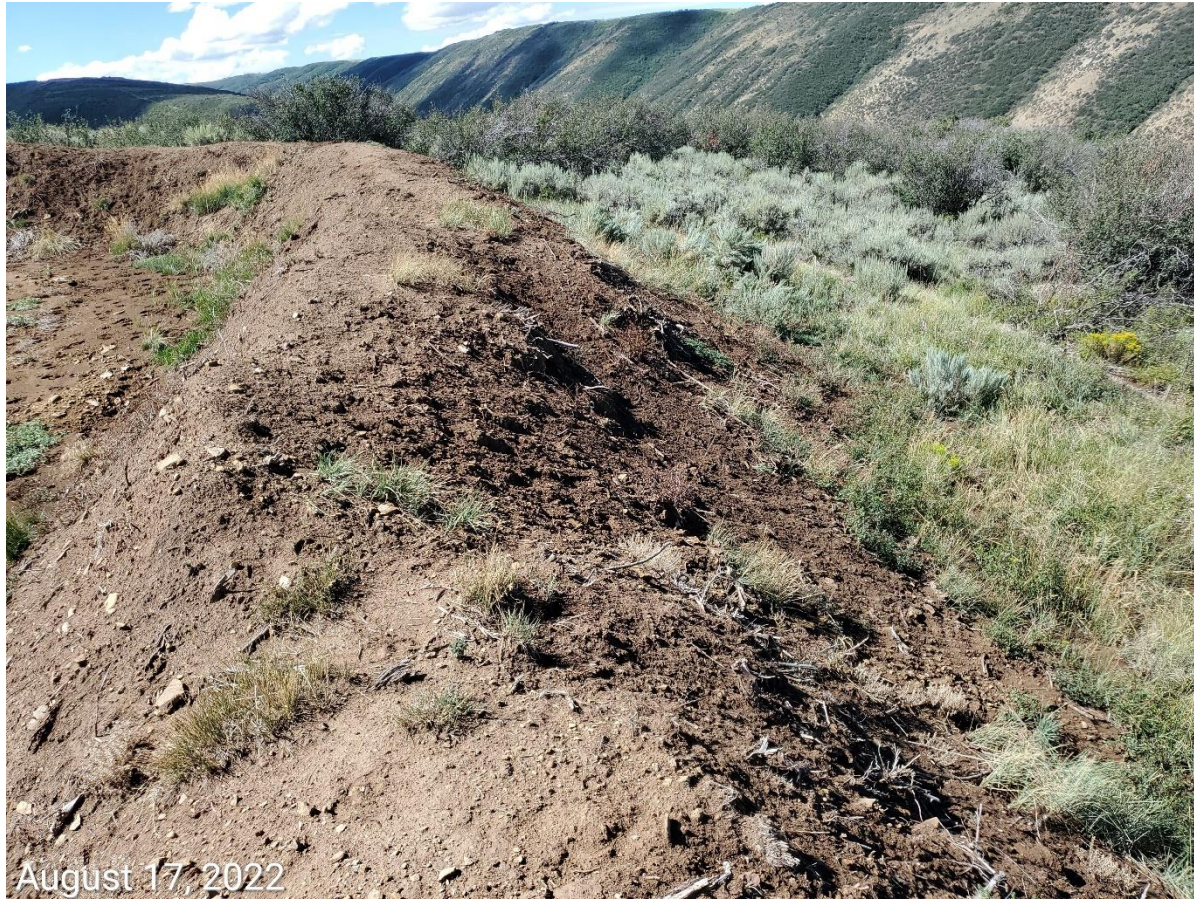
Photo 10: Photo example showing topsoil stockpiles along perimeter of the Location remain bare and exposed; BMPs to protect topsoil remains missing or insufficient; erosion degradation evident.

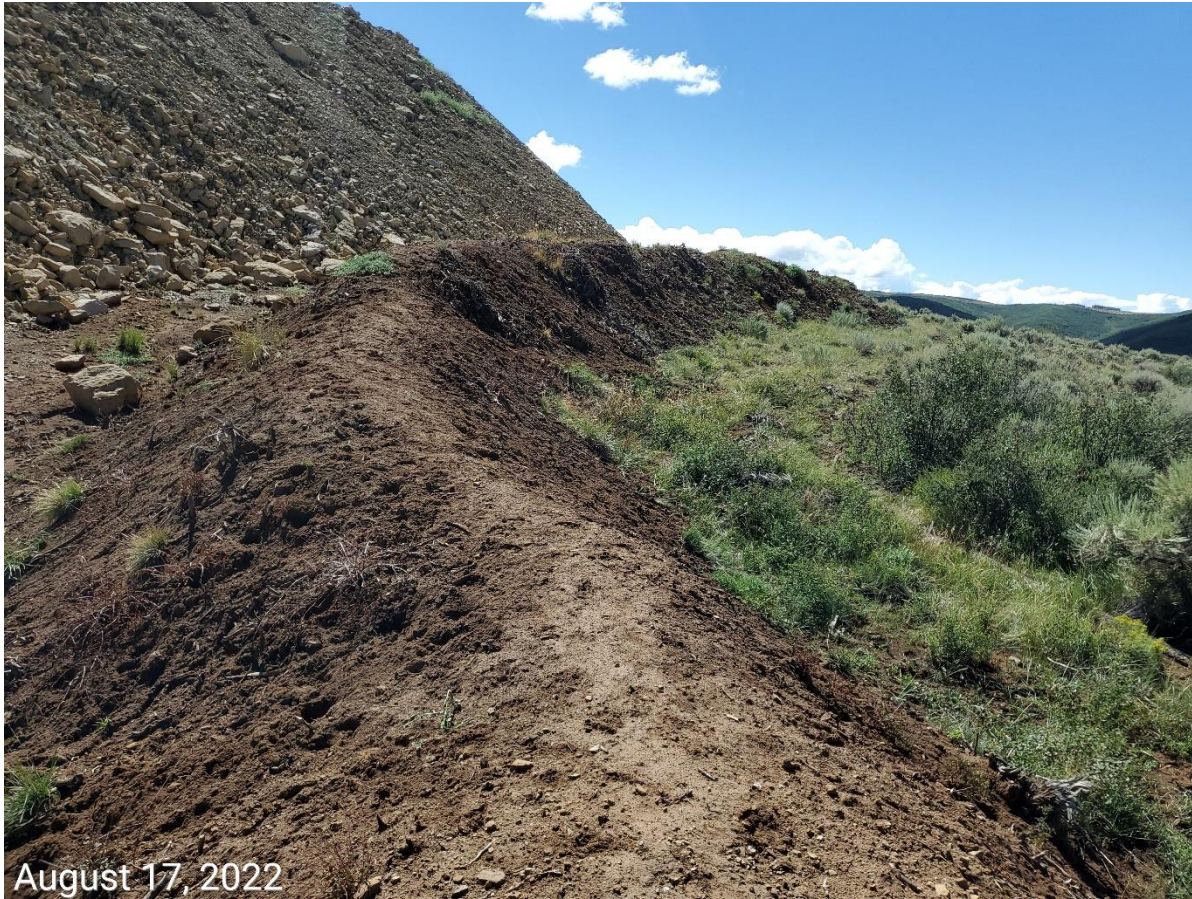
Photo 11: Photo example showing topsoil stockpiles along perimeter of the Location remain bare and exposed; BMPs to protect topsoil remains missing or insufficient; erosion degradation evident.

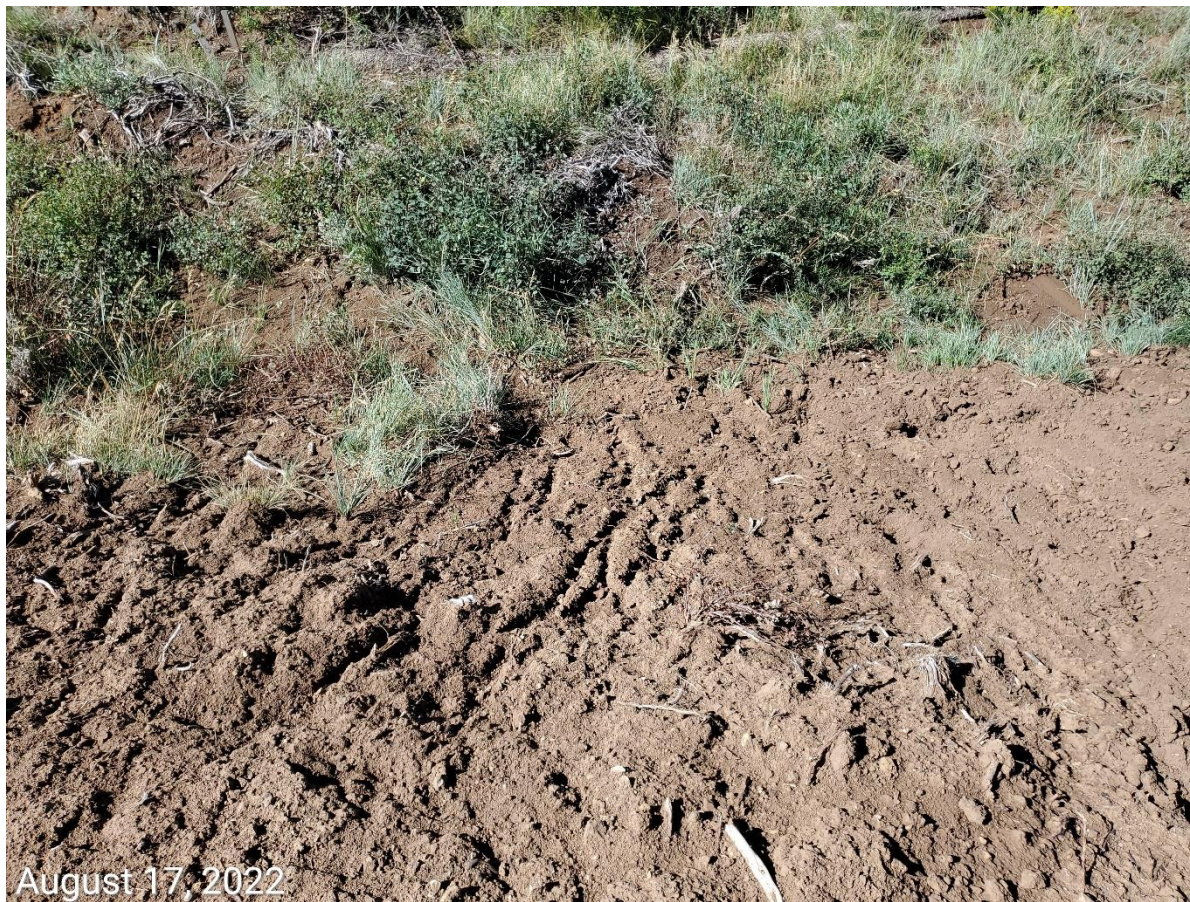
Photo 12: Photo shows erosion degradation/sediment transport observed at the topsoil stockpile.

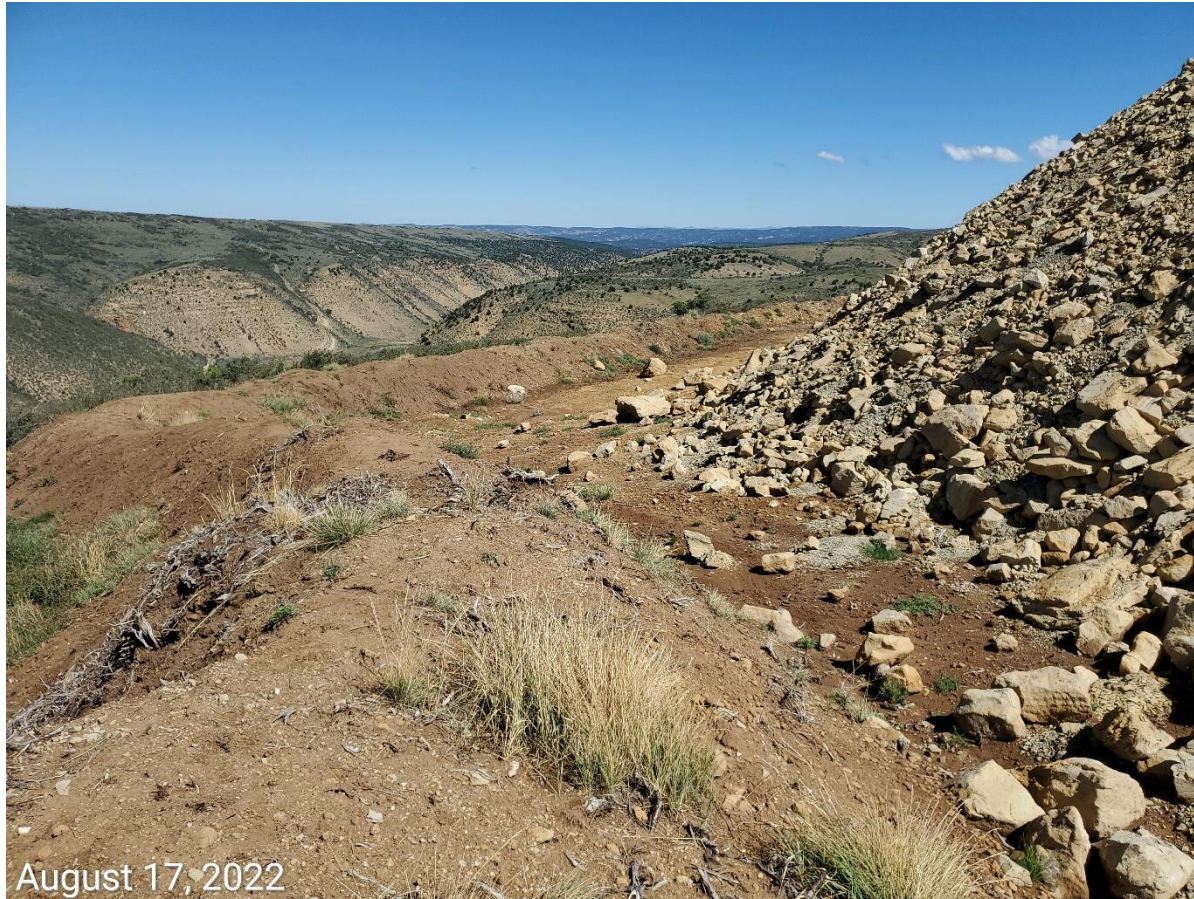
Photo 13: Photo example showing the topsoil stockpile in use as part of the perimeter stormwater ditch/berm and sediment trap/basin. Photo also example soils remain bare; BMPs to protect soils remain missing or insufficient.

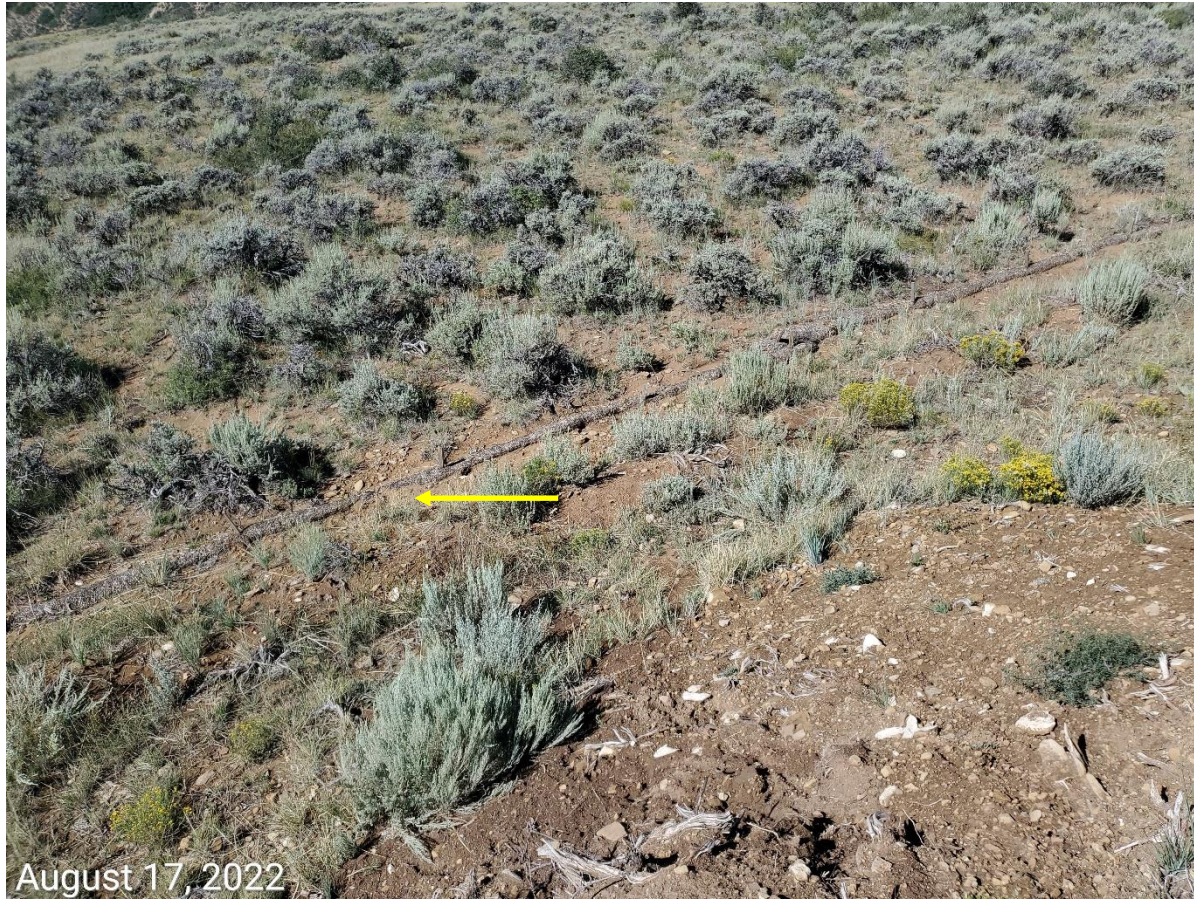
Photo 14: Photo example showing a single row of straw wattle erosion log in place along perimeter of the Location. BMP appears to have exceeded its manufactured life span and does not appear to be maintained; wattle in disrepair along sections; offsite sediment transport and deposition on top of wattles apparent (arrow).

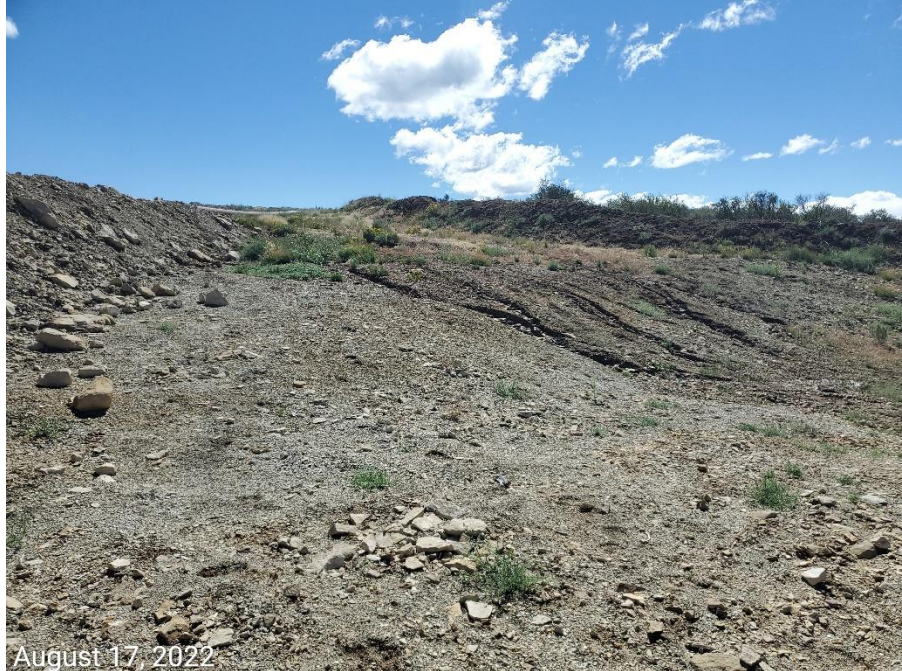
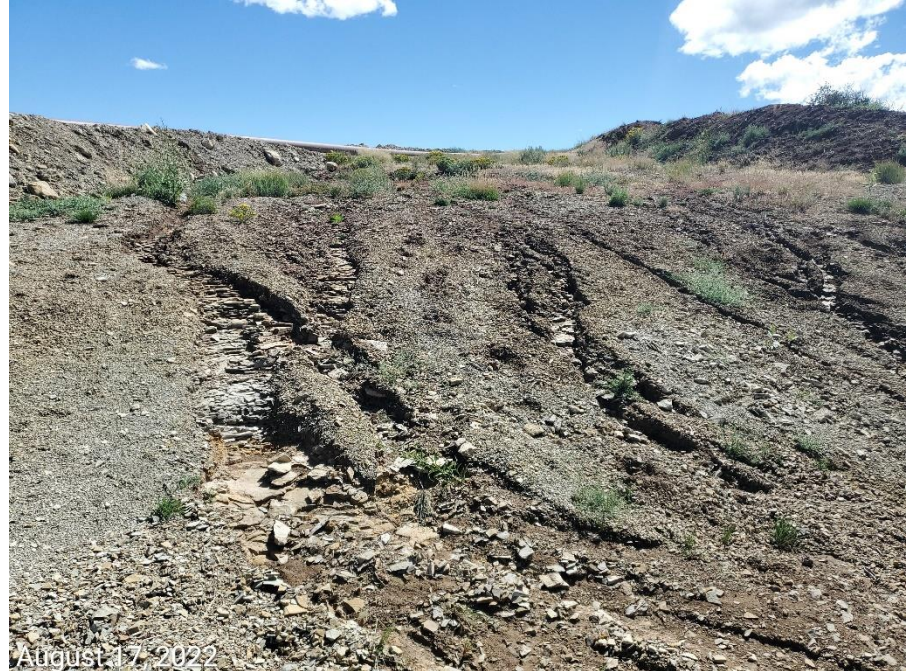
Photo 15: Photos taken from the sediment trap/basin on the south end of the Location. Photo shows inlet to the sediment trap/basin has not been properly engineered/stabilized, resulting in degradation to the control and sediment transport.

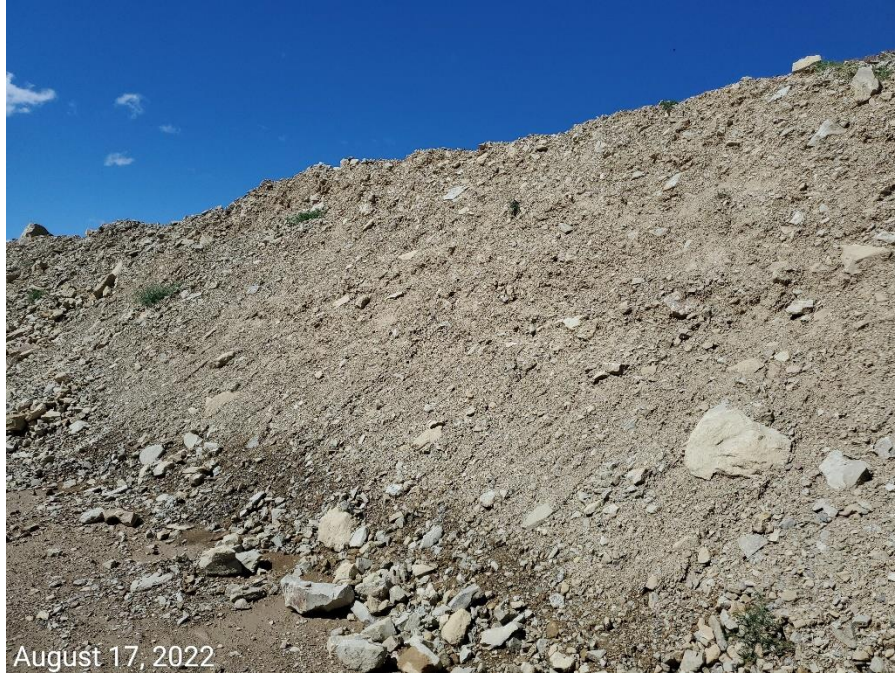
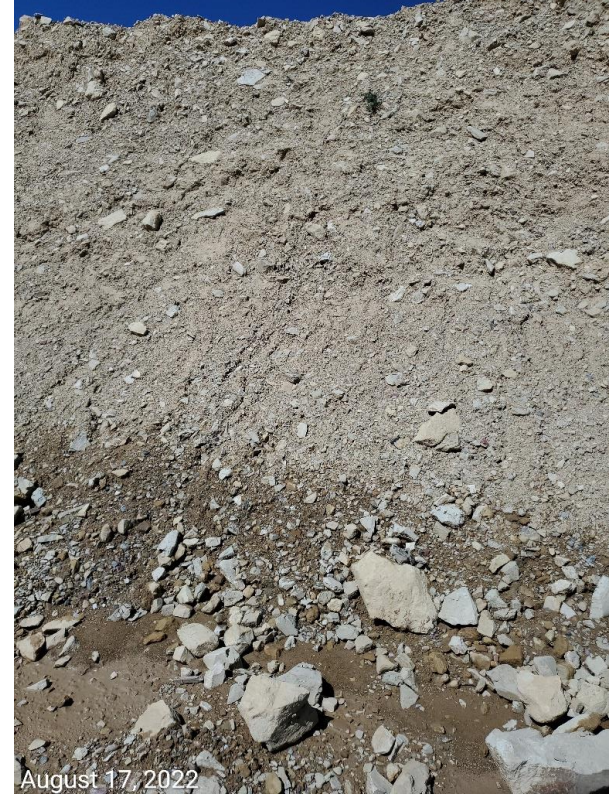
Photo 16: Photo example showing BMPs to protect and stabilize the slopes of the Location remain missing or insufficient. .

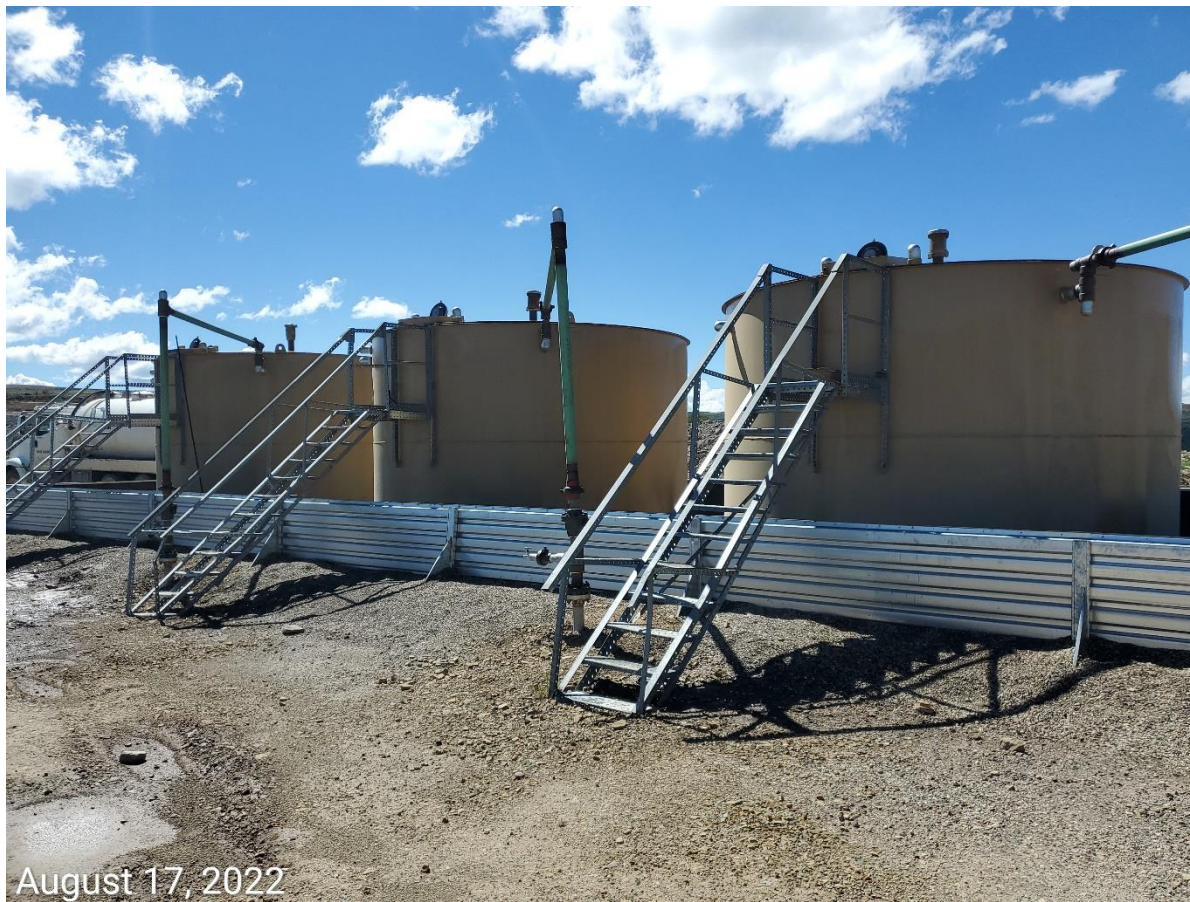
Photo 17: Photo taken from the tank battery on the southwest end of the Location. Photo shows signage and labeling remain missing from the tanks/battery.

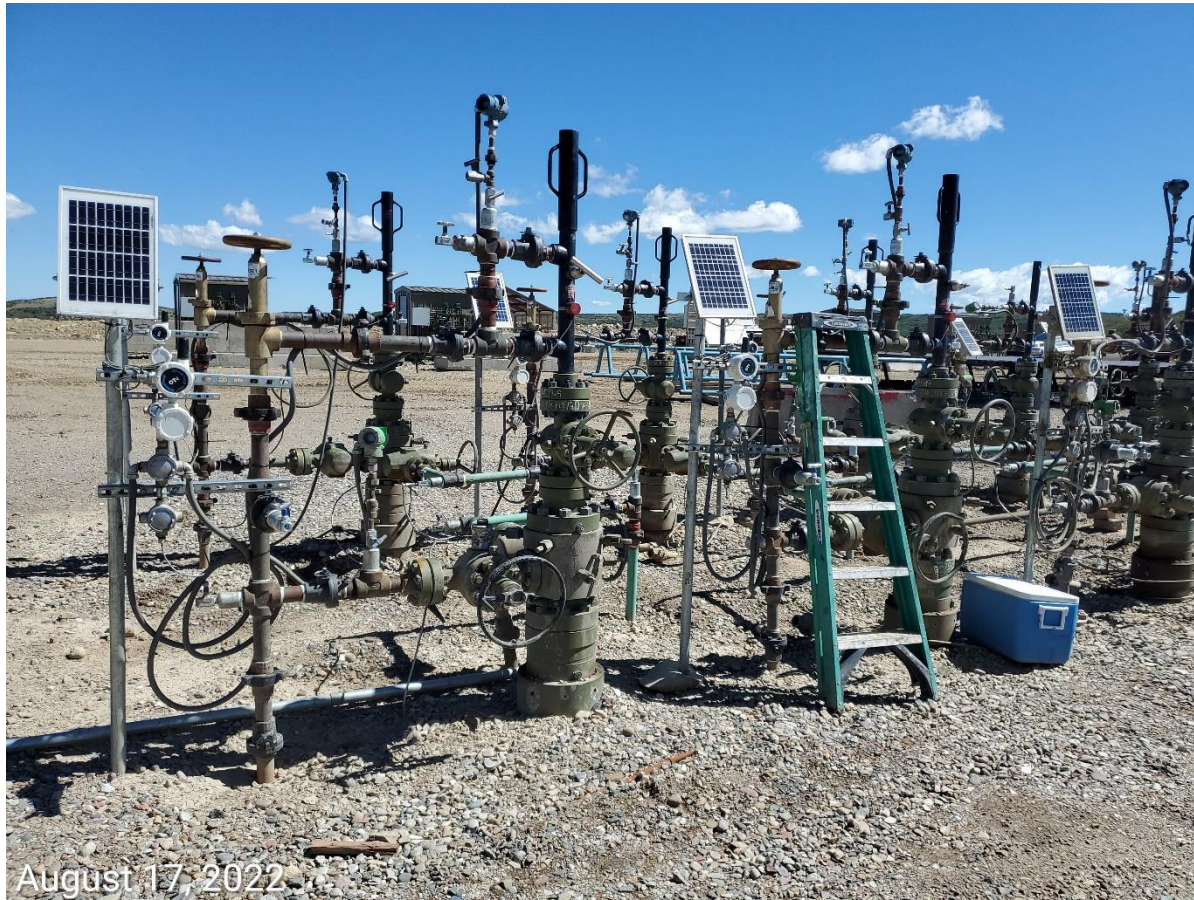
Photo 18: Photo example showing signage remains missing from the wells on the Location.

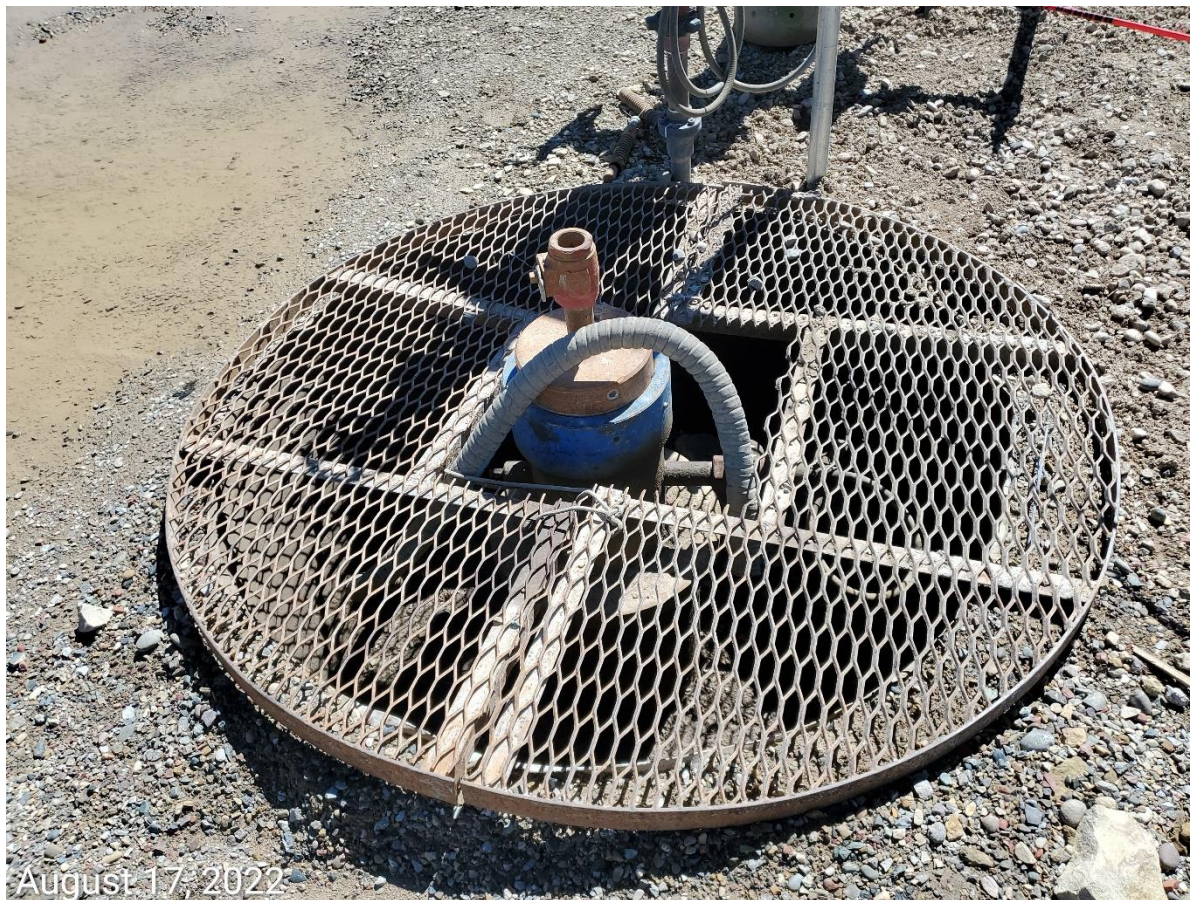
Photo 19: Photo shows pipe/cellar/conductor/equipment remains evident a the PA'd ELU J14 FED #11B-14-496 well site
