# Site Inspection Report

**Site: RODGERS #1 FLOWLINE**  
08/22/2022

## SITE INSPECTION REPORT

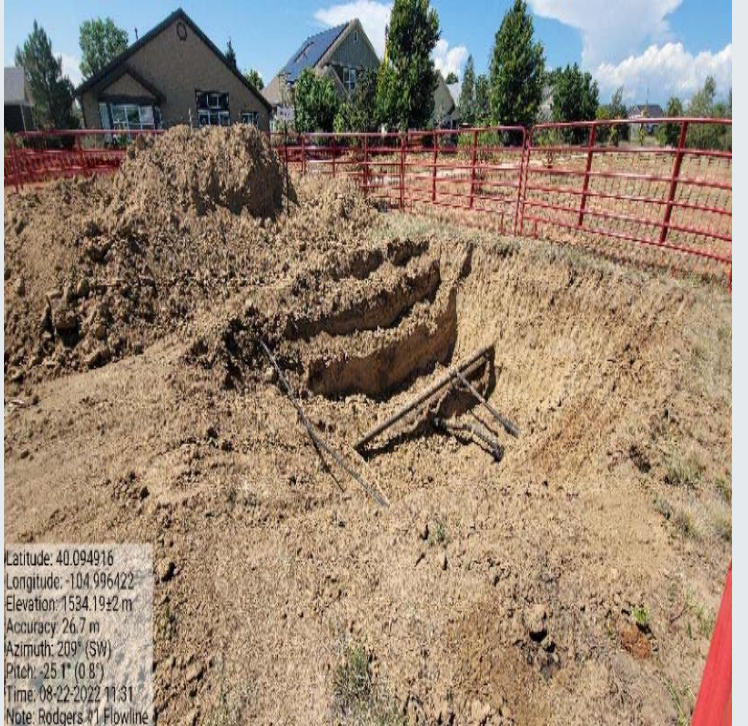
Remediation Activity Checklist	
	Photo
<p><b>Question:</b> Open excavation(s)? Note: Approximate size(s) (Length x Width x Depth, ft)</p> <p><b>Response:</b> Yes</p> <p><b>Notes:</b> 3 excavations. At the end of the flowline and the spill location</p>

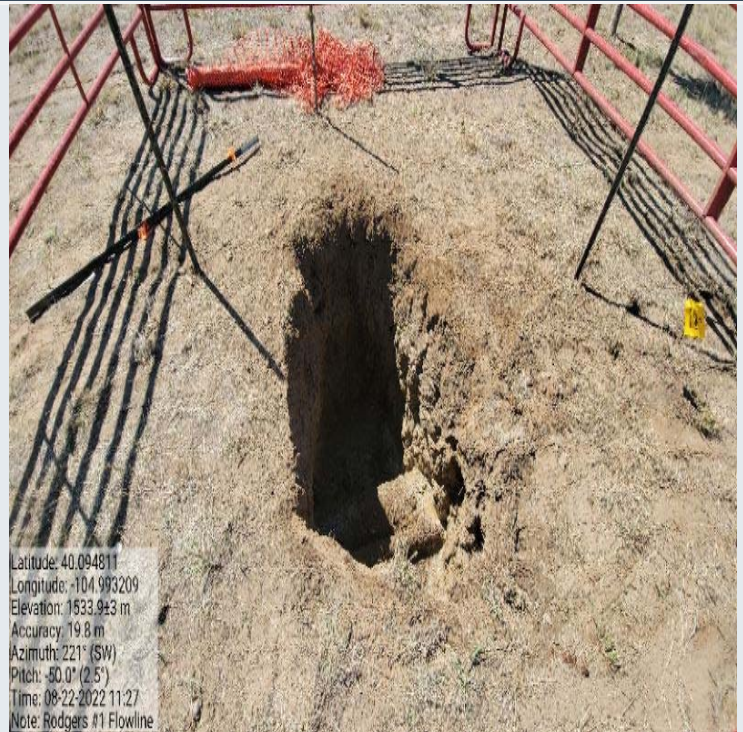
**Question:** Open excavation(s)? Note: Approximate size(s) (Length x Width x Depth, ft)

**Notes:** Spill Location in the photo. 3 excavations. At the end of the flowline and the spill location

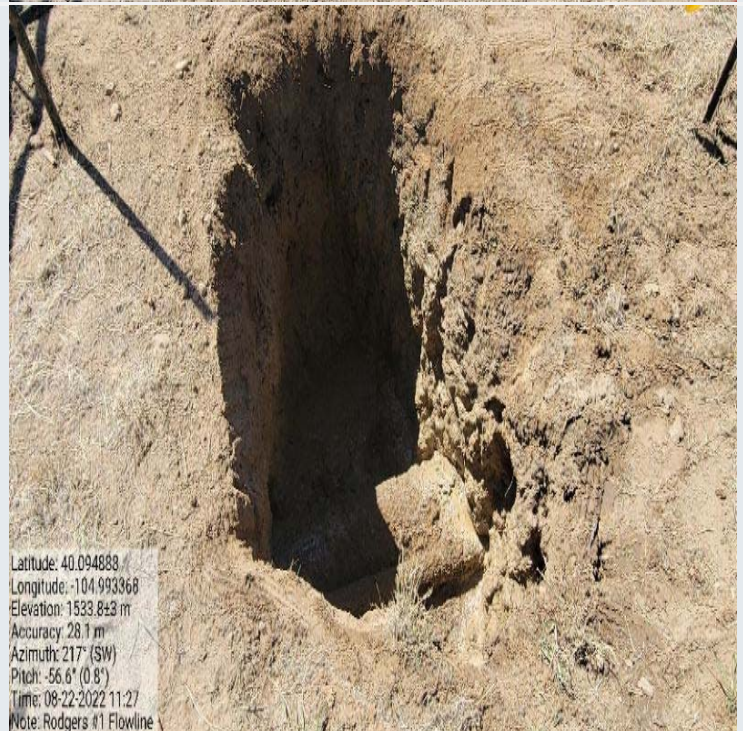
**Question:** Open excavation(s)? Note: Approximate size(s) (Length x Width x Depth, ft)

**Notes:** Spill Location in the photo. 3 excavations. At the end of the flowline and the spill location

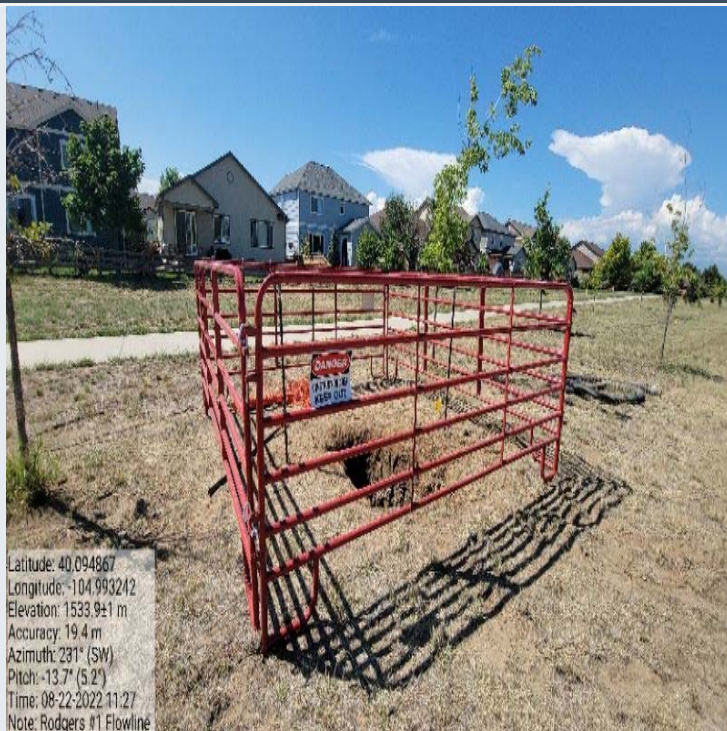
**Question:** Open excavation(s)? Note: Approximate size(s) (Length x Width x Depth, ft)

**Notes:** Spill Location in the photo. 3 excavations. At the end of the flowline and the spill location

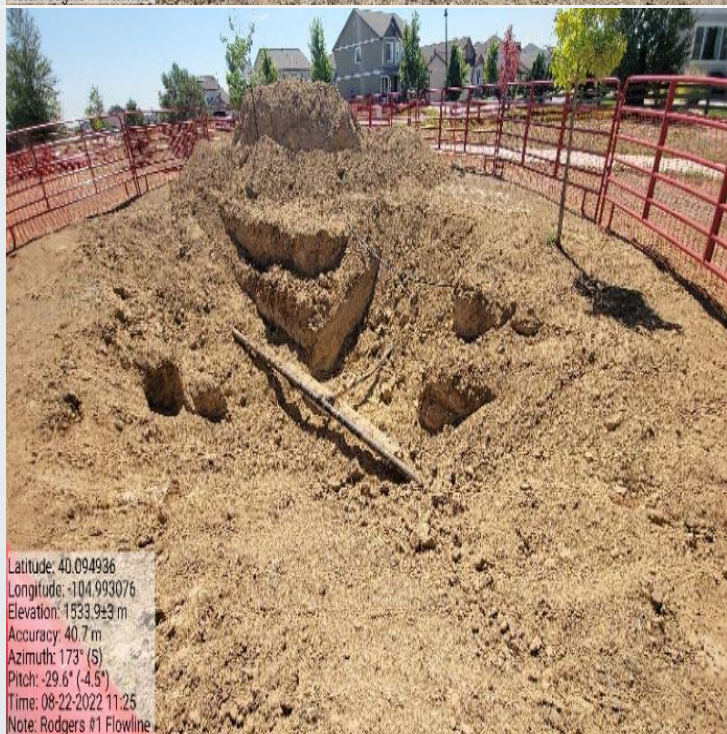
**Question:** Open excavation(s)? Note: Approximate size(s) (Length x Width x Depth, ft)

**Notes:** 3 excavations. At the end of the flowline and the spill location

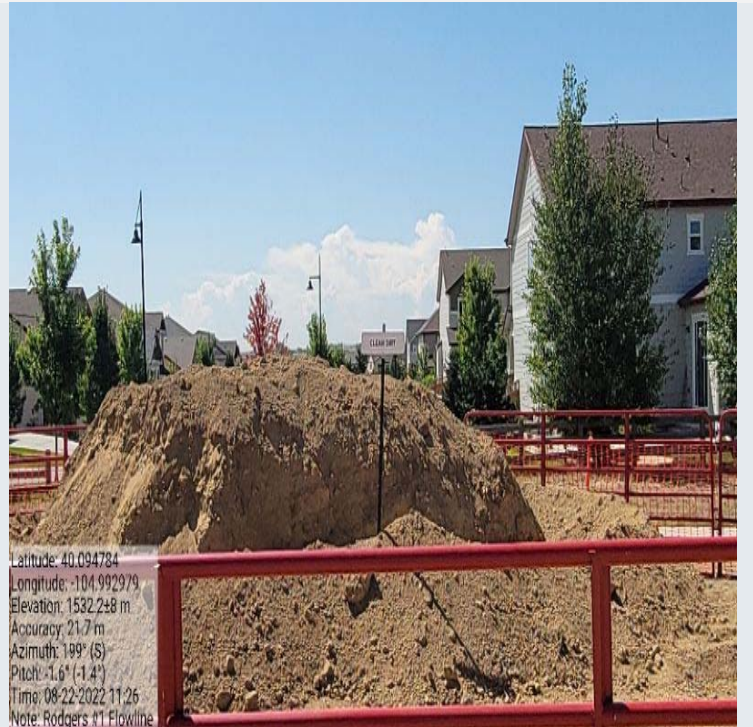
Photo
<b>Question:</b> E&P waste signage present, legible, accurate and up to date (labelled per KPK CWMP)? <b>Response:</b> Yes <b>Notes:</b> East and west ends of the flowline

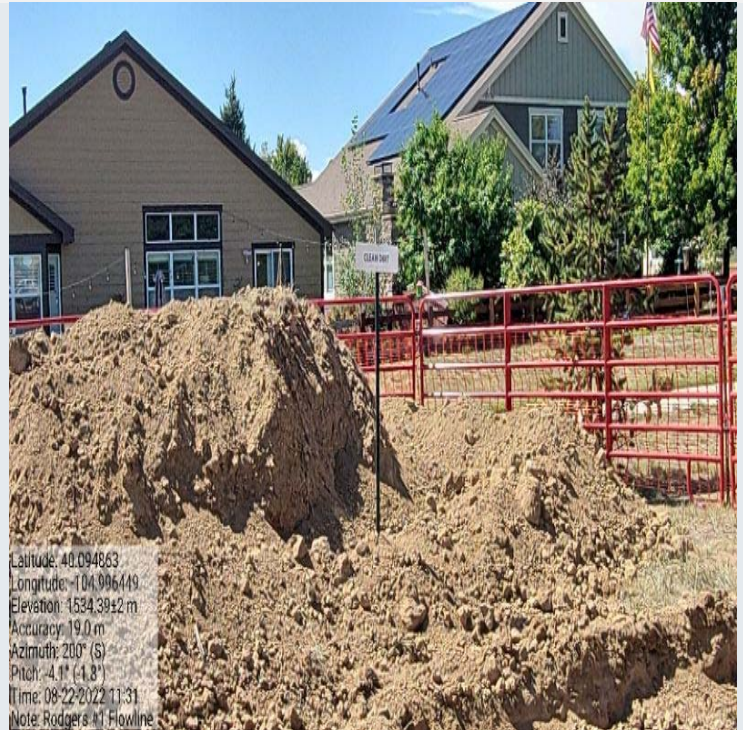
**Question:** E&P waste signage present, legible, accurate and up to date (labelled per KPK CWMP)?

**Notes:** East and west ends of the flowline

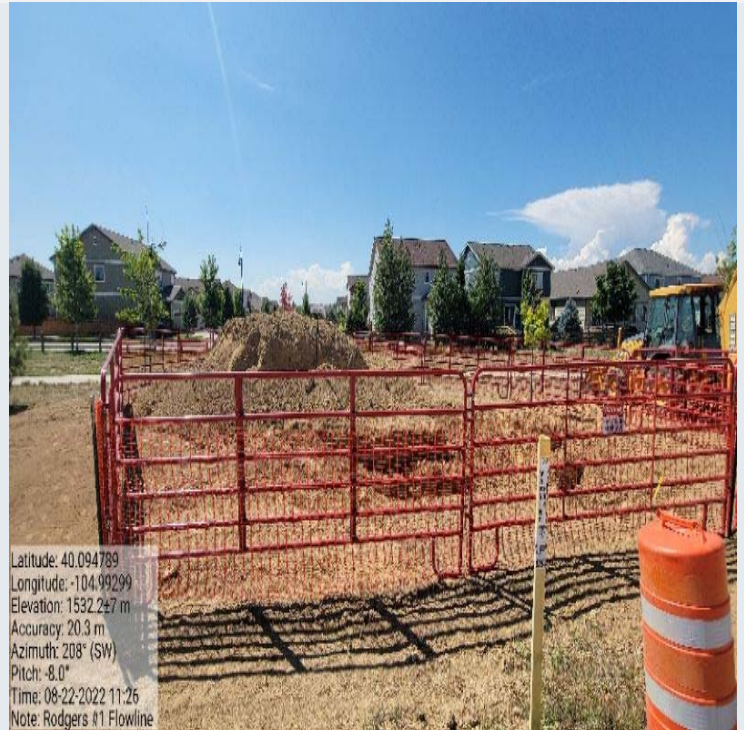
**Question:** Open excavation properly fenced/covered (in accordance with Rule 913.b.(5)B.i.)?

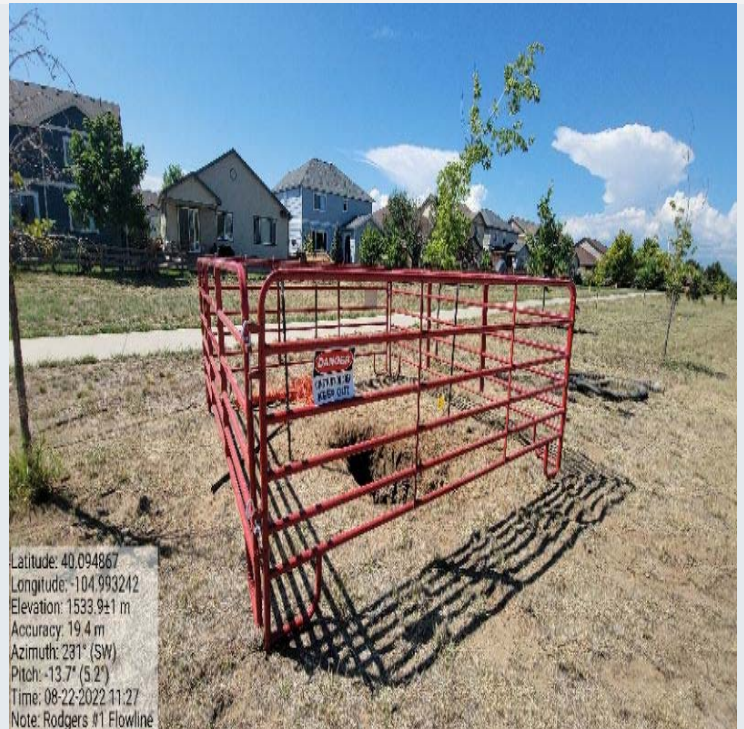
**Question:** Open excavation properly fenced/covered (in accordance with Rule 913.b.(5)B.i.)?

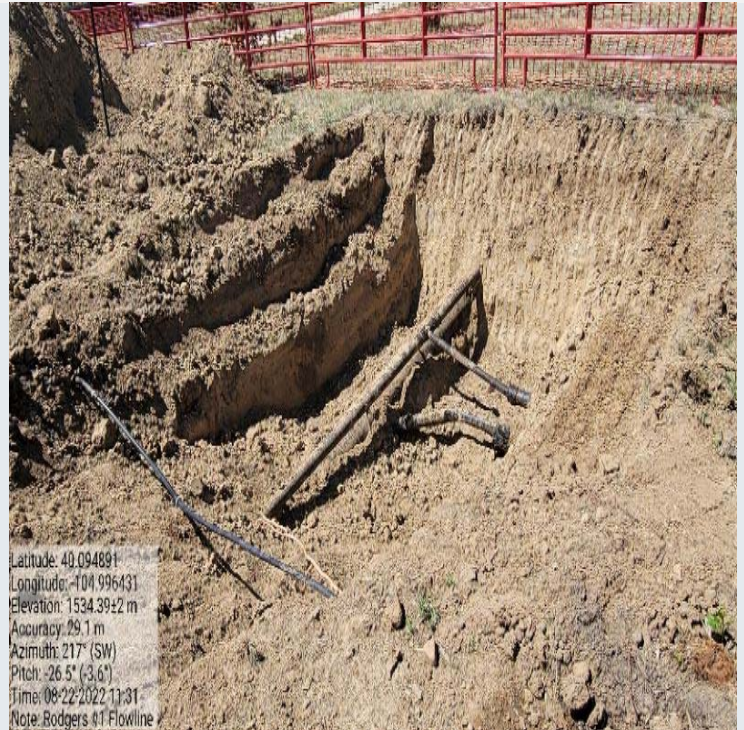
**Question:** Exposed buried/underground flowlines within excavation?

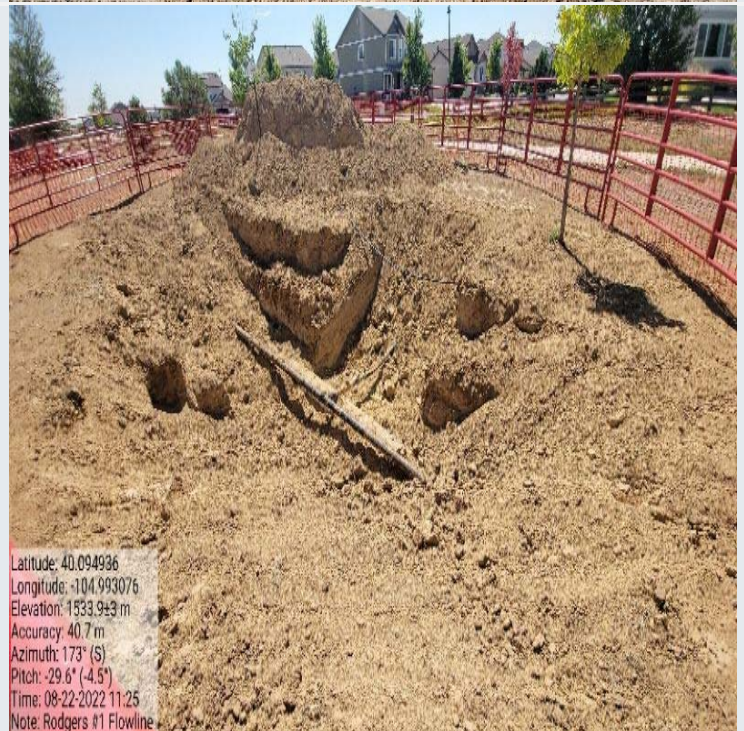
**Question:** Exposed buried/underground flowlines within excavation?

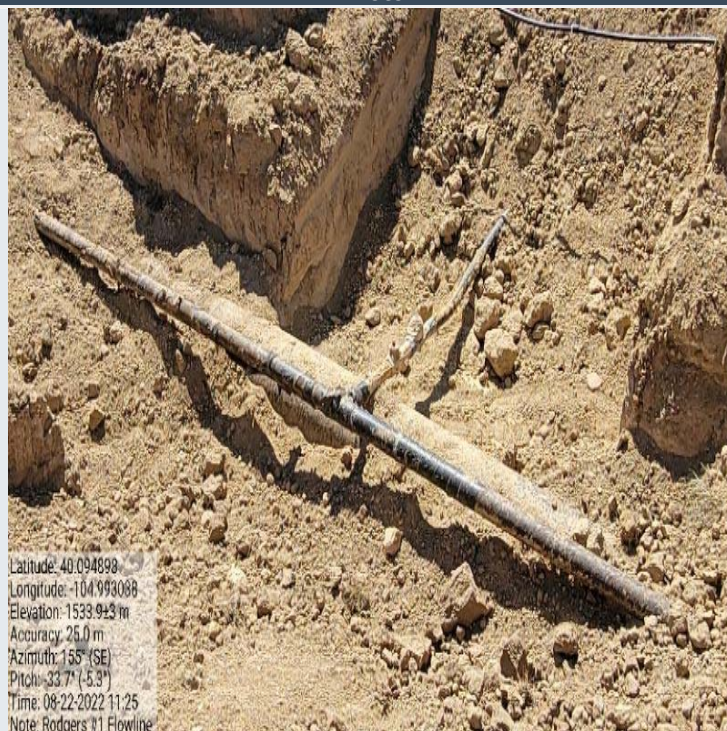
**Question:** Exposed buried/underground flowlines within excavation?

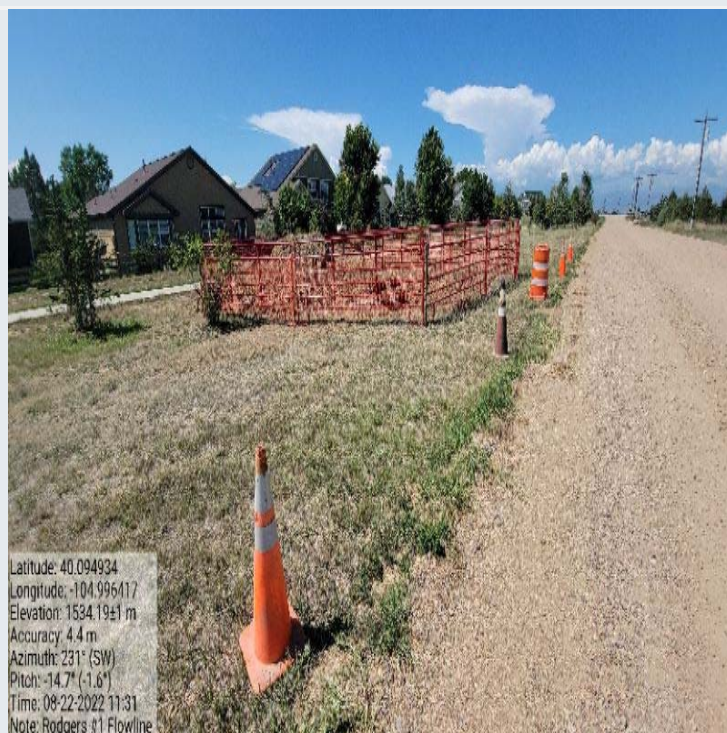
**Question:** Site is protected from vehicular traffic (properly fenced, gated or barricaded)?

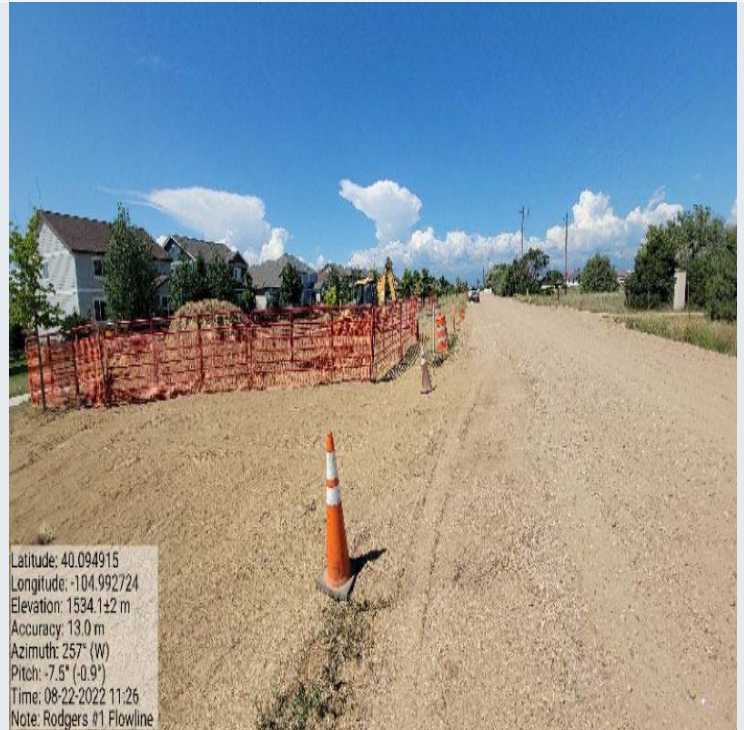
**Question:** Site is protected from vehicular traffic (properly fenced, gated or barricaded)?

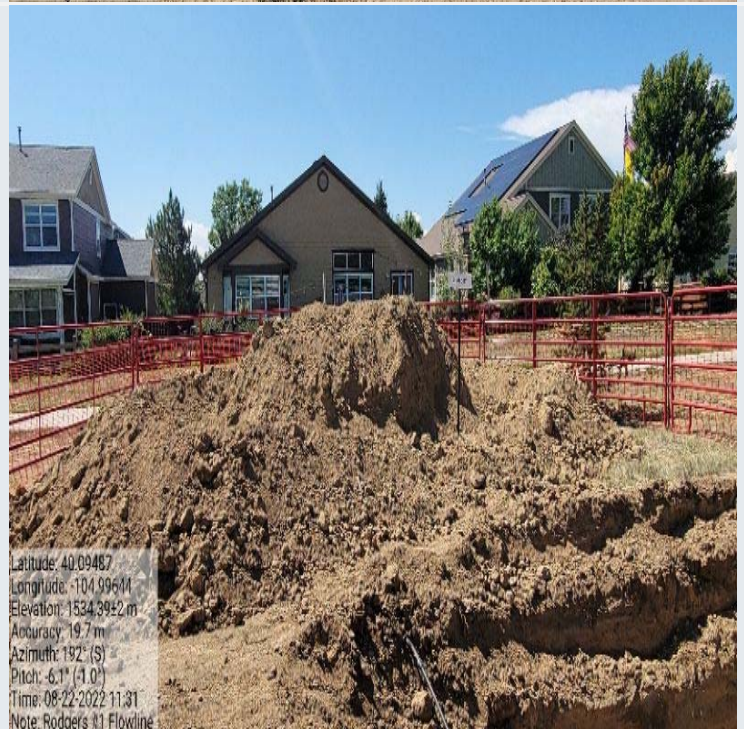
**Question:** Is earthen berm secondary containment present and in good condition (compacted, complete, no evidence of erosion, animal burrowing, etc.)?

**Notes:** Around clean stockpiles

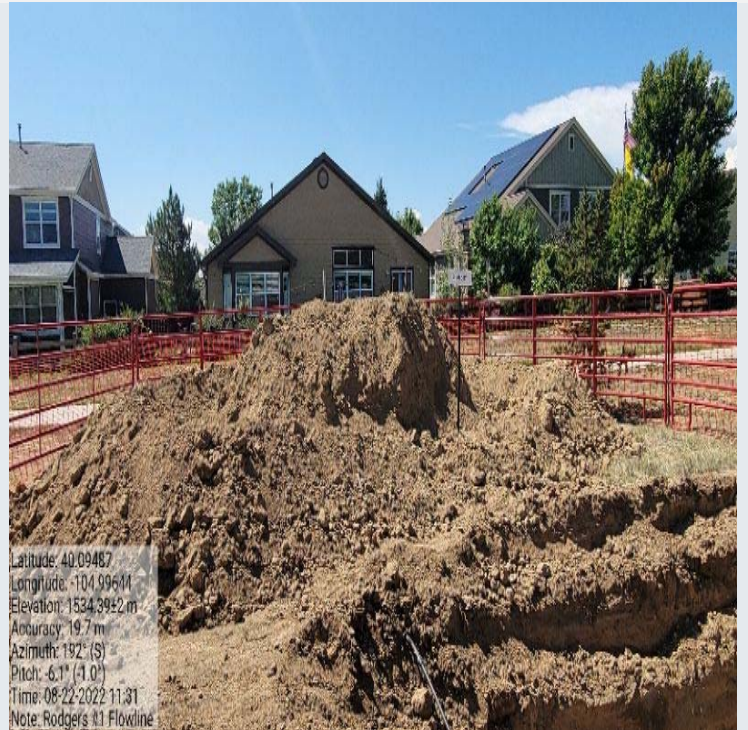
Photo
<p><b>Question:</b> Is location adjacent to any Potential Receptors?  <b>Note:</b> Livestock, surface water, occupied structure, adjacent land use, etc.  <b>Response:</b> Yes  <b>Notes:</b> Very close to neighborhood</p>

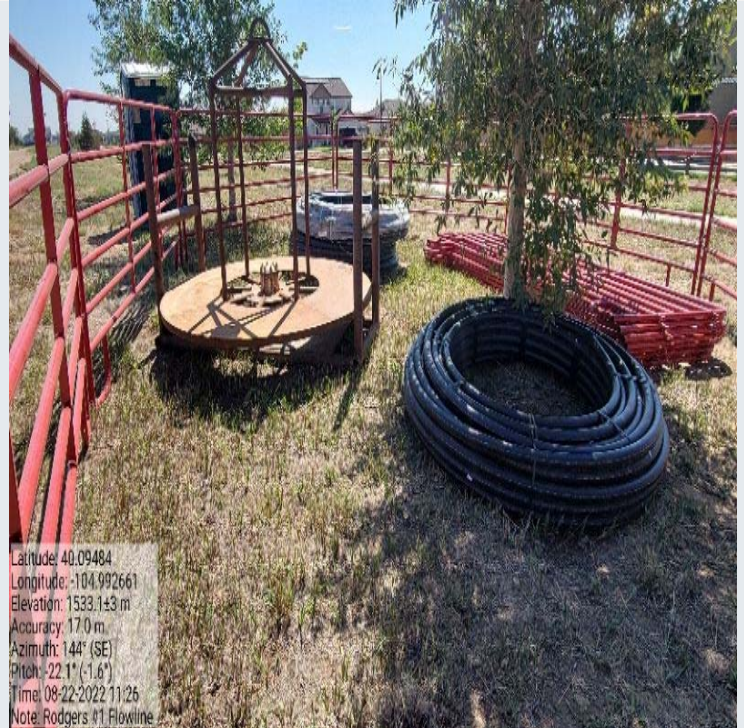
**Question:** Site free of unused equipment, weeds, debris/trash?

**Notes:** Materials are properly stored and fenced off.

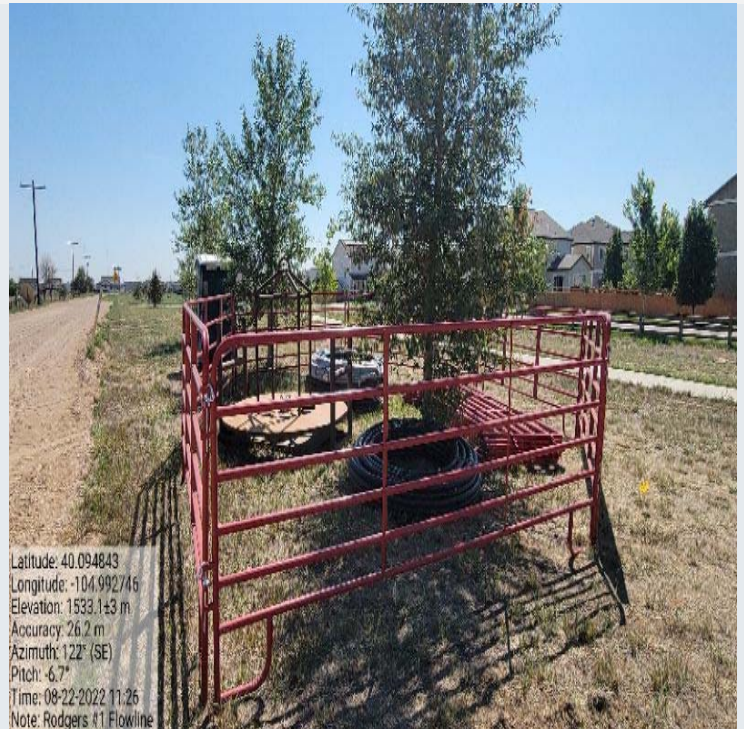
**Question:** Site free of unused equipment, weeds, debris/trash?

**Notes:** Materials are properly stored and fenced off.
