Construction and Stormwater Inspection

August 9, 2022

Operator: AXIS EXPLORATION LLC -#10646

Inspection Photos
Location Name: Jamaso /4-65
Location ID: 474389

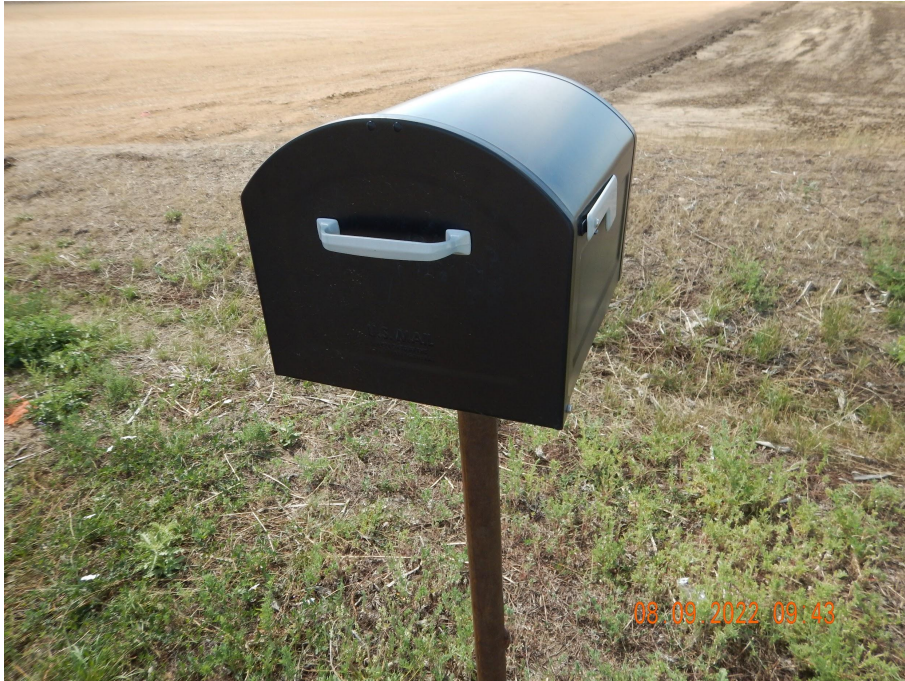
Photo 1. Photo taken from the entrance of location. Photo illustrates a mailbox to comply with 406.c. with the required paperwork.

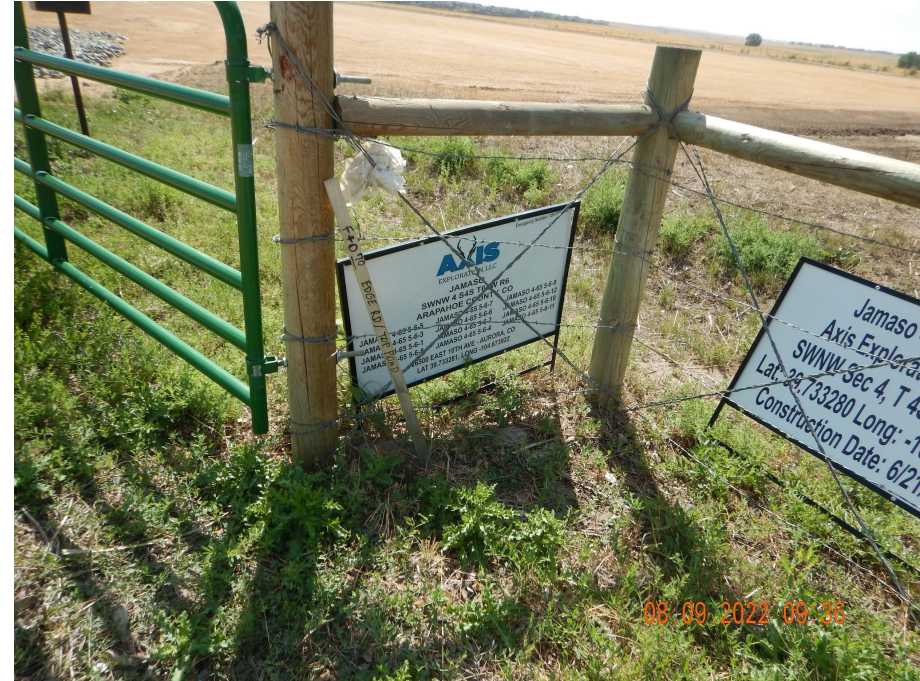
Photo 2. Photo taken from the entrance of location. Photo illustrates the Operator signage.

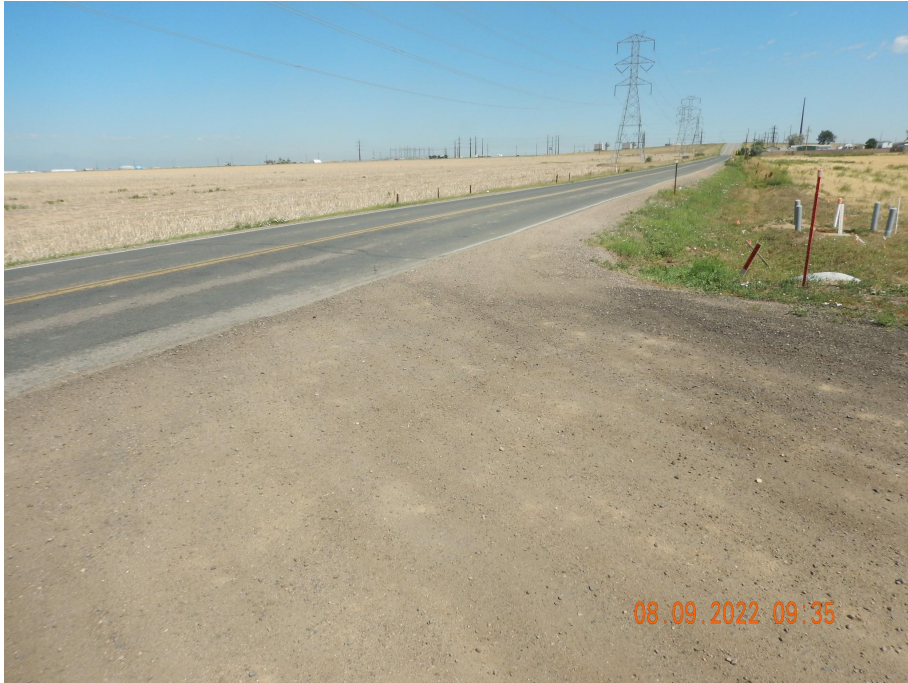
Photo 3. Photo taken from the entrance of location, facing North. Photo illustrates there was no observed vehicle track out.

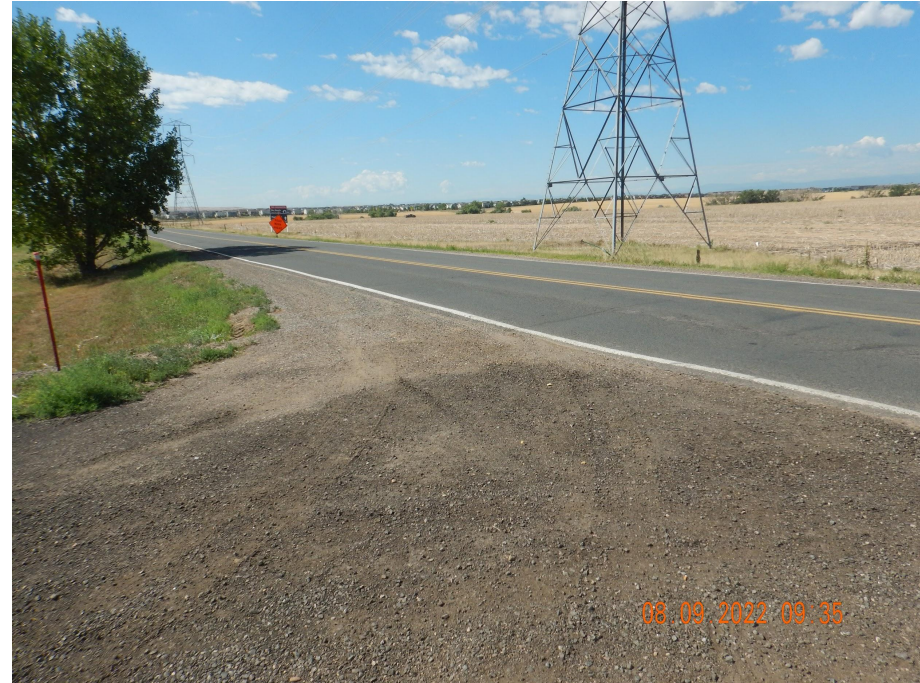
Photo 4. Photo taken from the entrance of location, facing South. See comments under Photo 3.

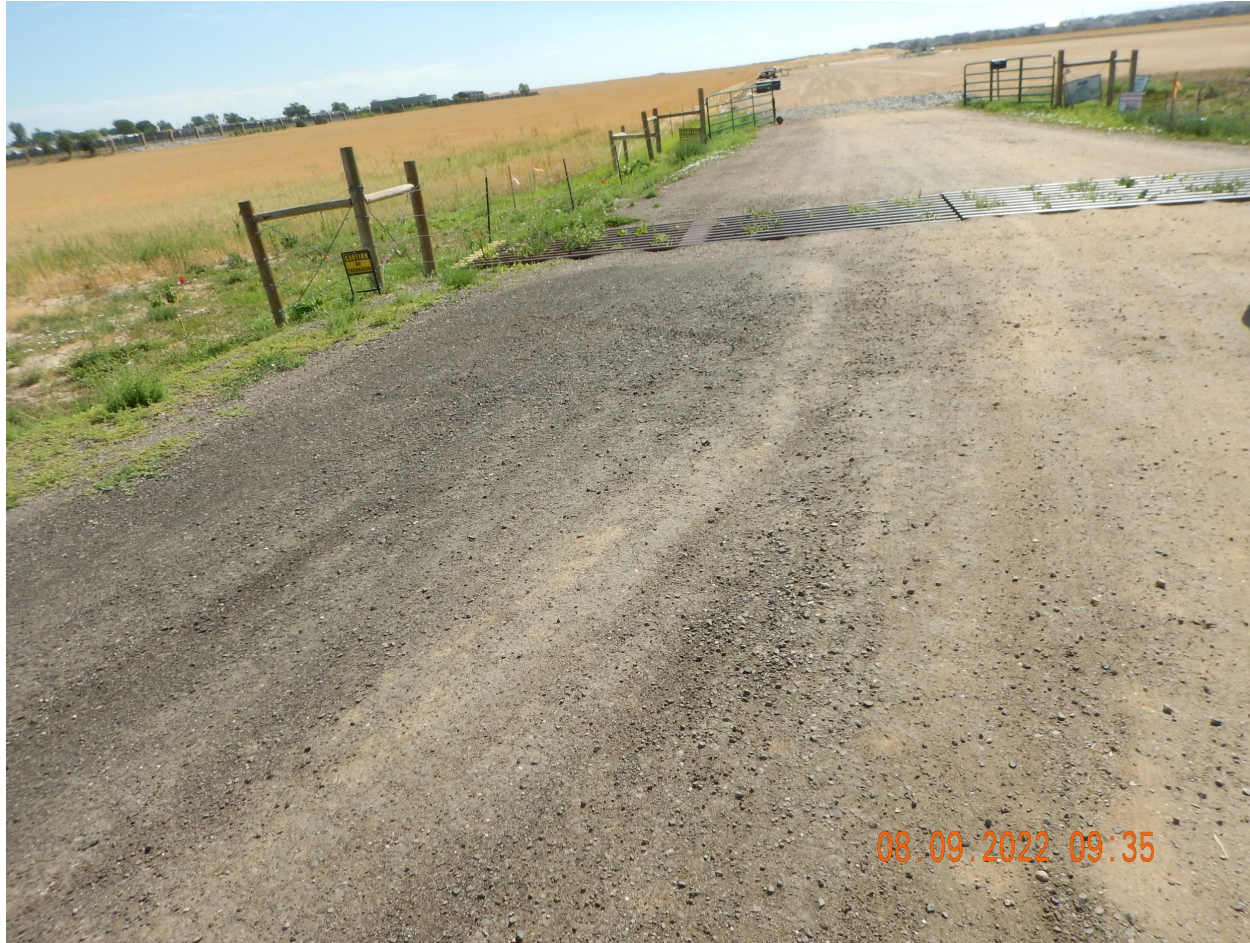
Photo 5. Photo taken from the entrance of location, facing East. Photo illustrates the VTC devices and the stabilized access road.

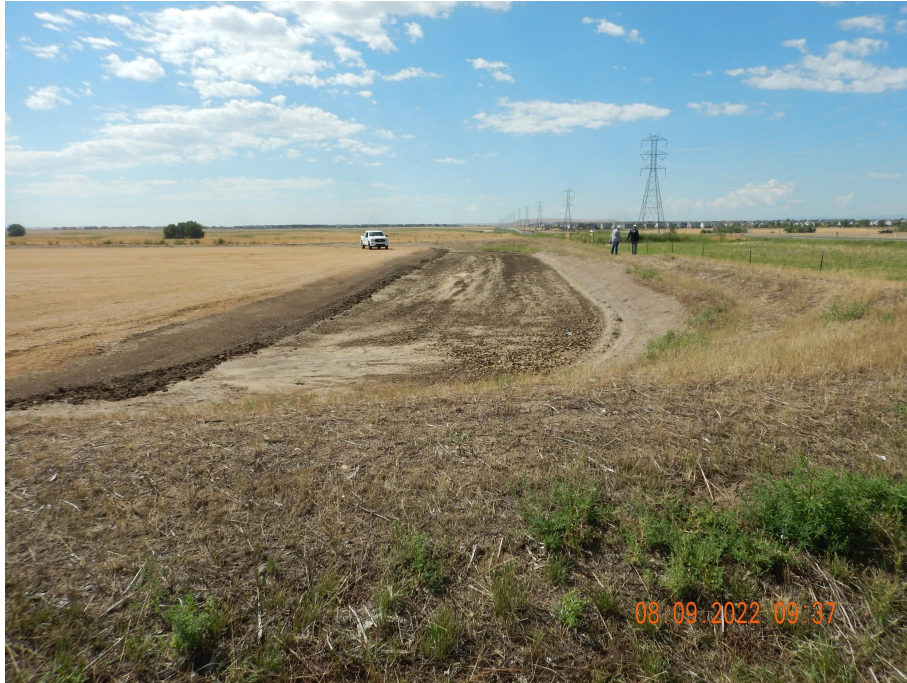
Photo 6. Photo taken from the entrance of location, facing South. Photo illustrates the retention pond with the contractor performing an inspection.

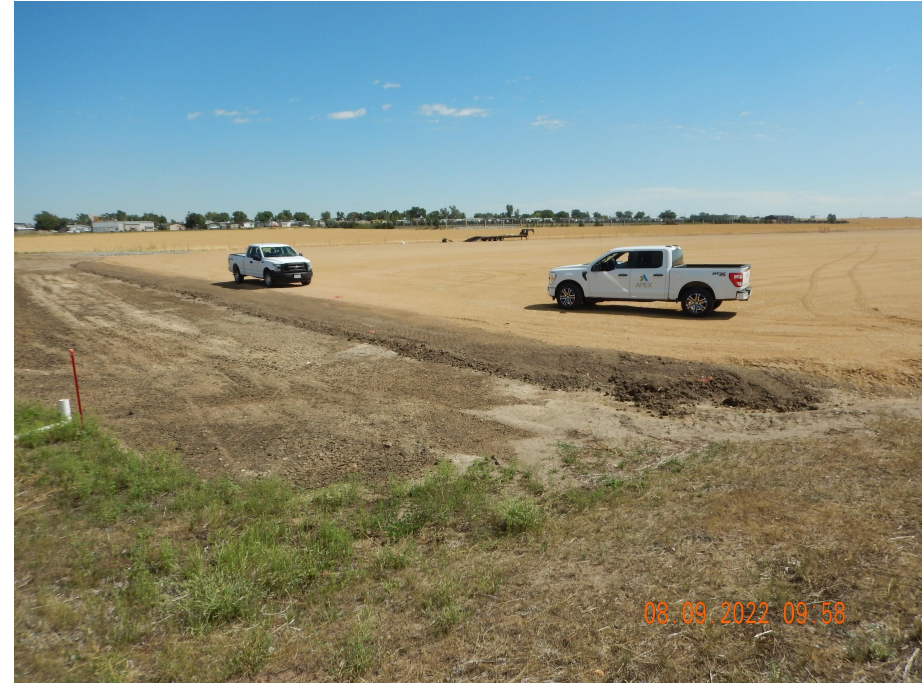
Photo 7. Photo taken from the southwestern location, facing North. See comments under Photo 6. Also, the photo illustrates the location is stabilized with road base.

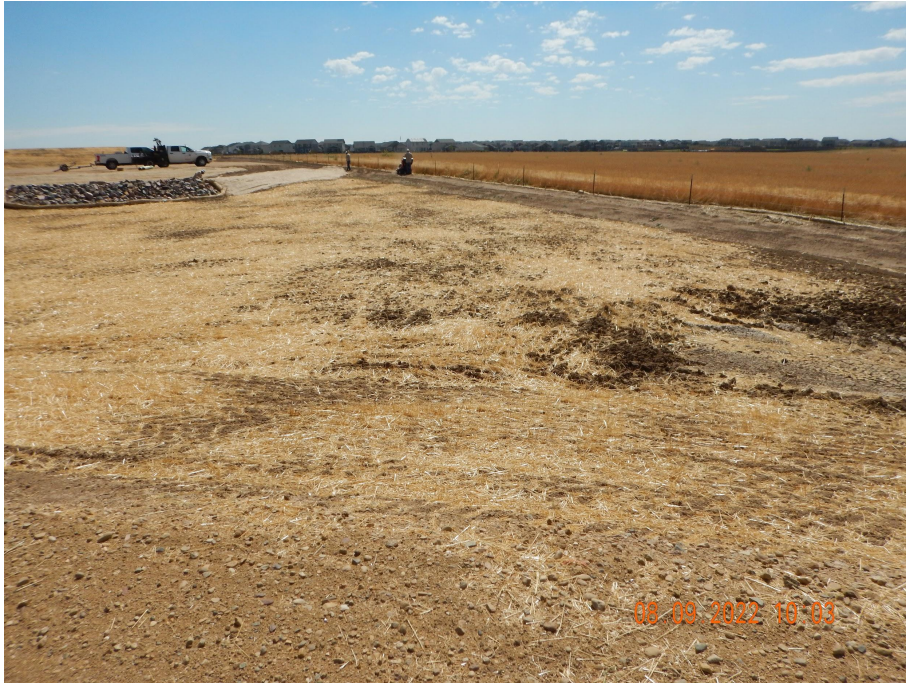
Photo 8. Photo taken from the southern location where it transects with a drainage flowing to First Creek, facing East. Photo illustrates the area has been straw crimped with mulch and seeded.

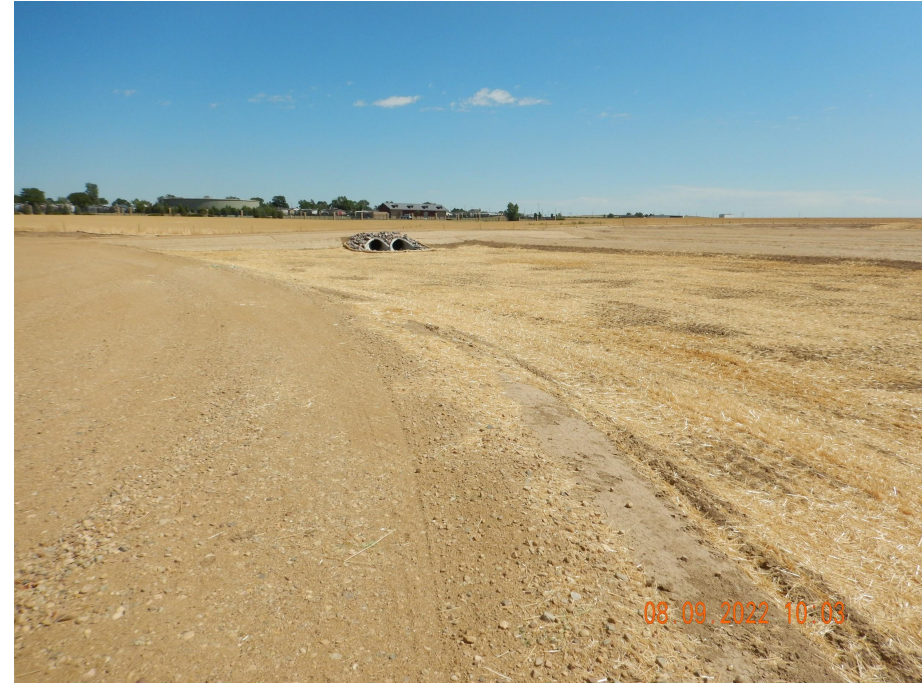
Photo 9. Photo taken from the southern location where it transects with a drainage flowing to First Creek, facing Northeast. Photo illustrates the Operator has installed engineered culverts to not impede channelized flow into First Creek.

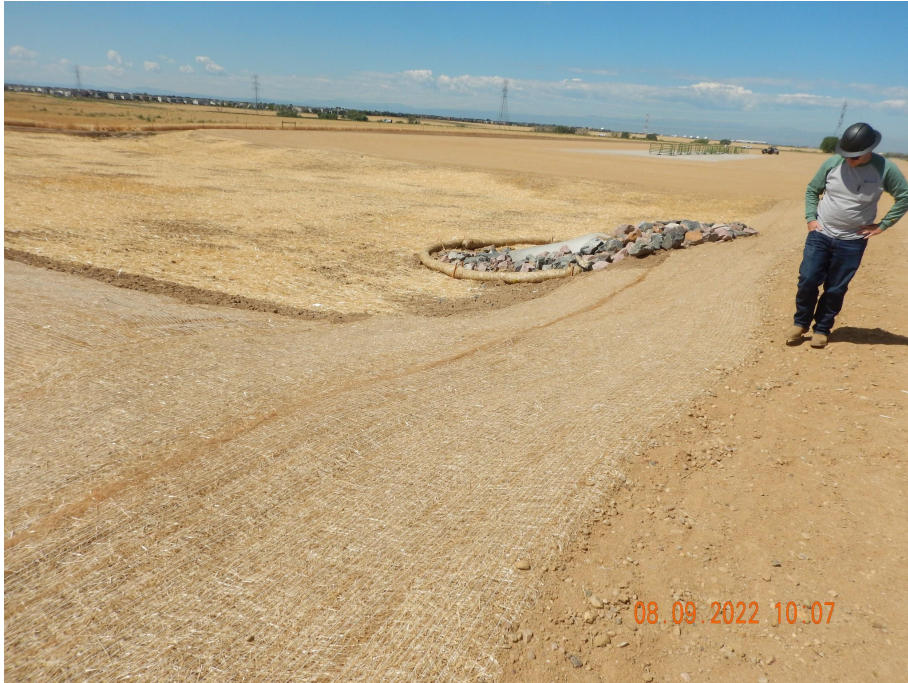
Photo 10. Photo taken from the outlet of the engineered culvert, facing West. Photo illustrates portions of the cut slope have been stabilized with erosion control blankets.

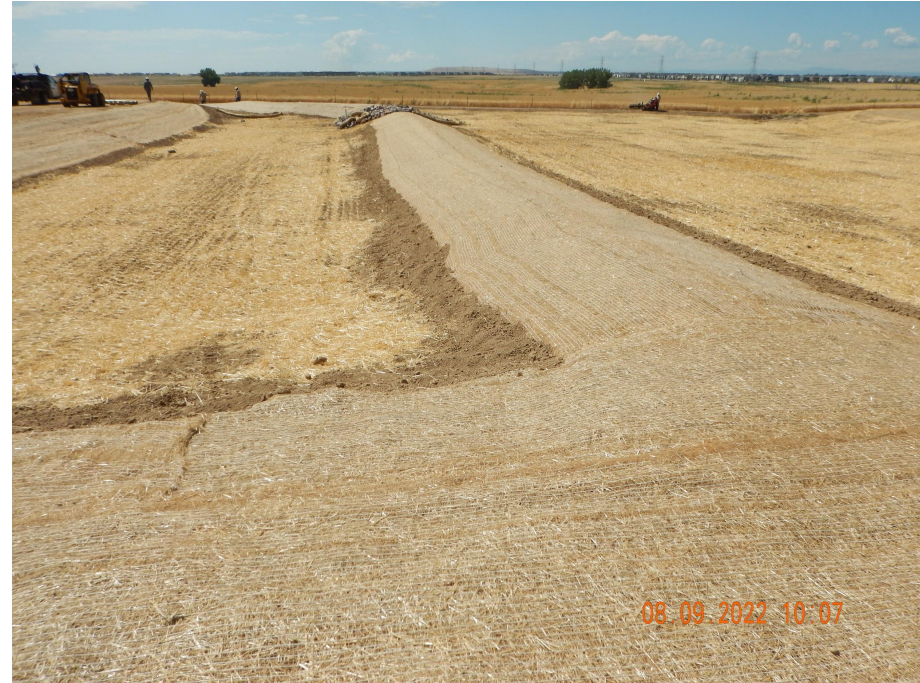
Photo 11. Photo taken from the outlet of the engineered culvert, facing South. Photo illustrates another retention area for the eastern portion of the location.

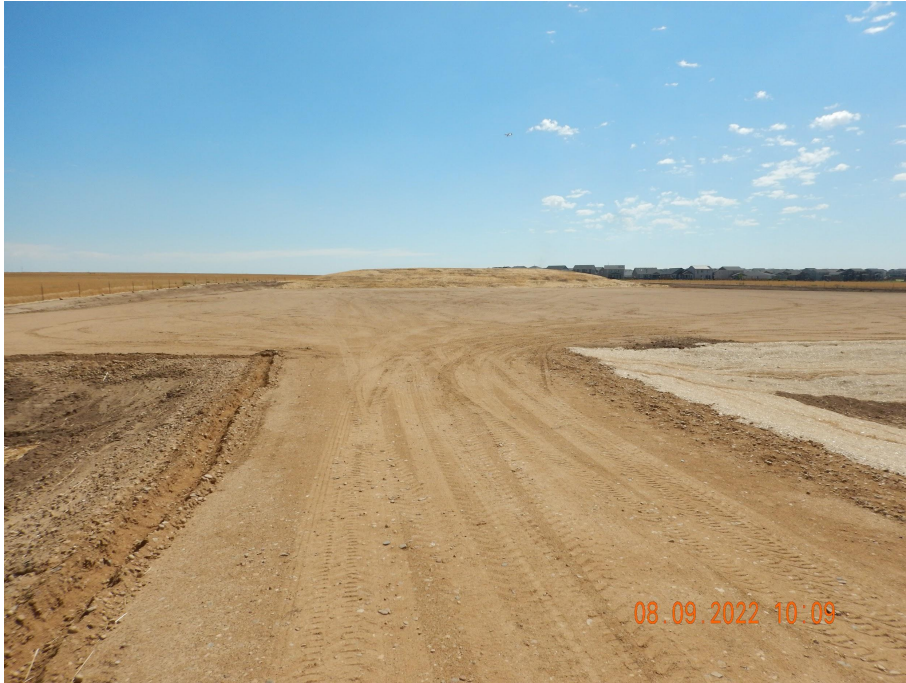
Photo 12. Photo taken from the drainage crossing, facing East. Photo illustrates topsoil has been stockpiled along the eastern perimeter of location.

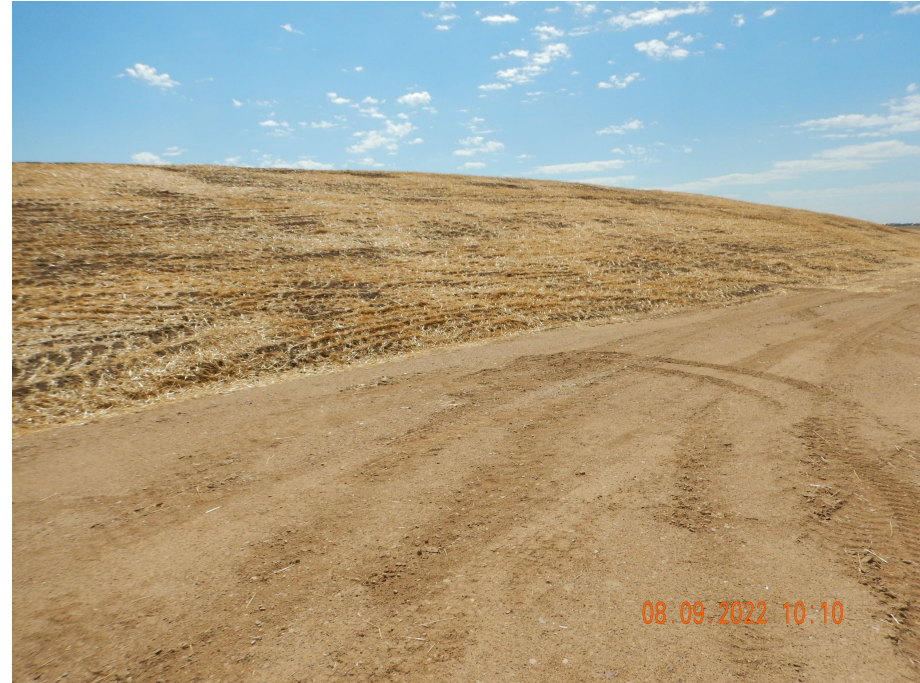
Photo 13. Photo taken from the eastern location, facing Southeast. Photo illustrates the topsoil stockpile has been straw crimped with mulch and seeded.

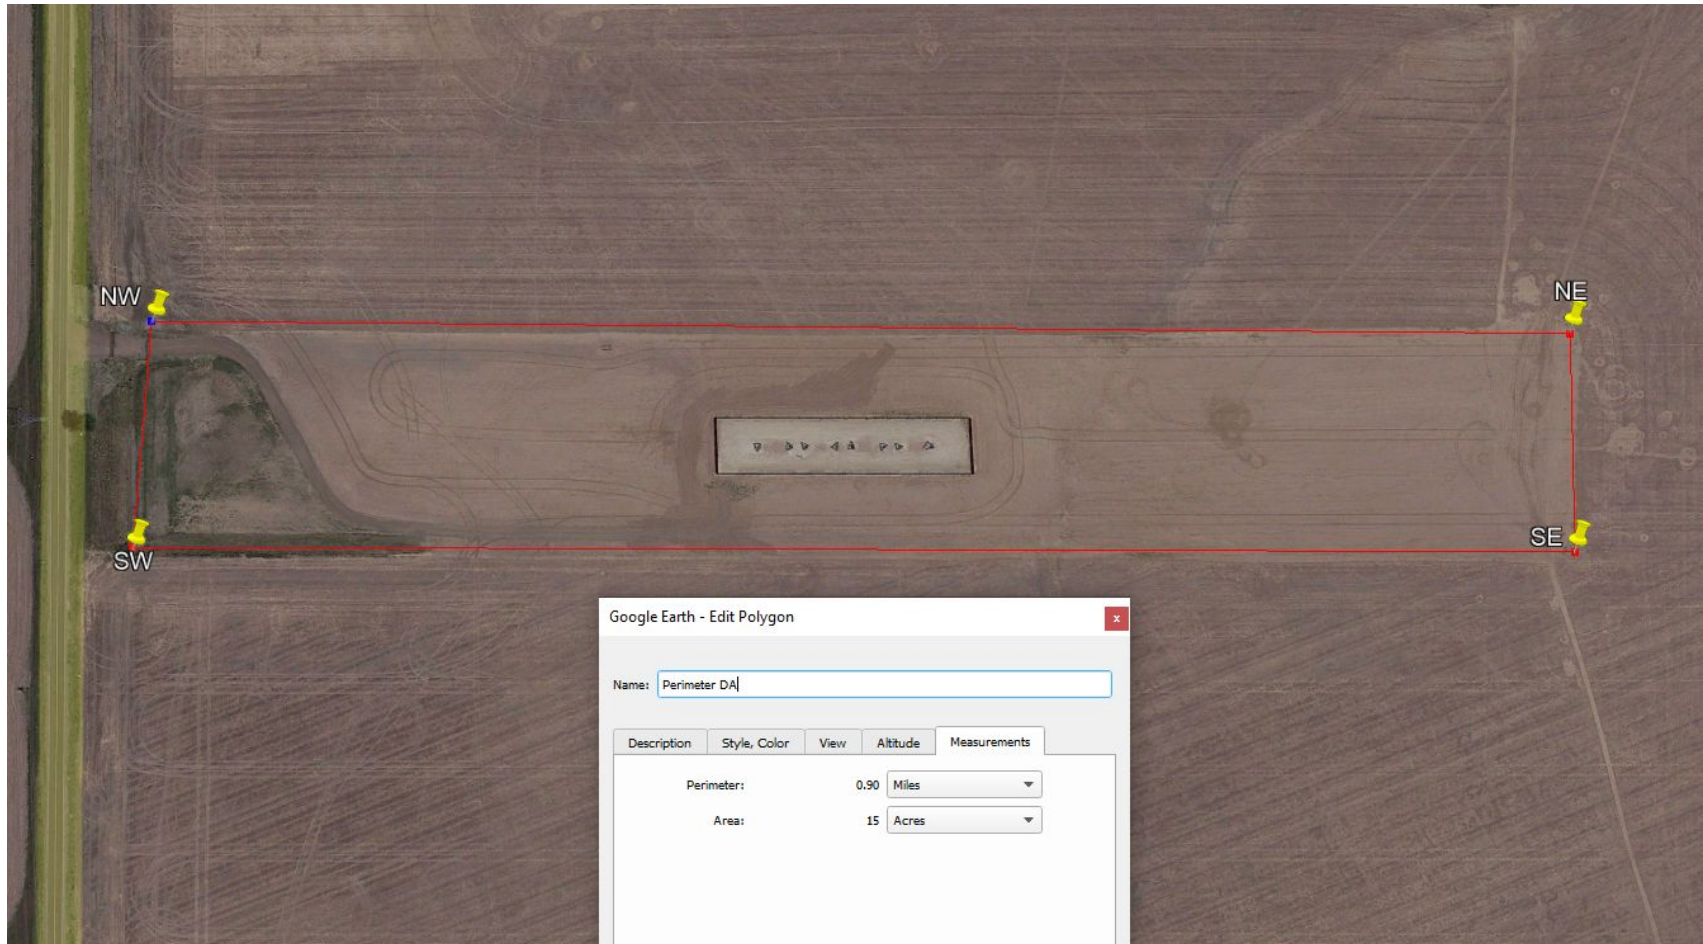
Photo 14. Google Earth aerial from 6/10/2021 illustrates field collected data using a Trimble handheld gps. The approximate area of disturbance is 15 acres.
