Interim Reclamation and Stormwater Inspection

August 9, 2022

Location ID: 459907

Inspection Photos
Location Name: TOWER LD PAD
Location ID: 459907

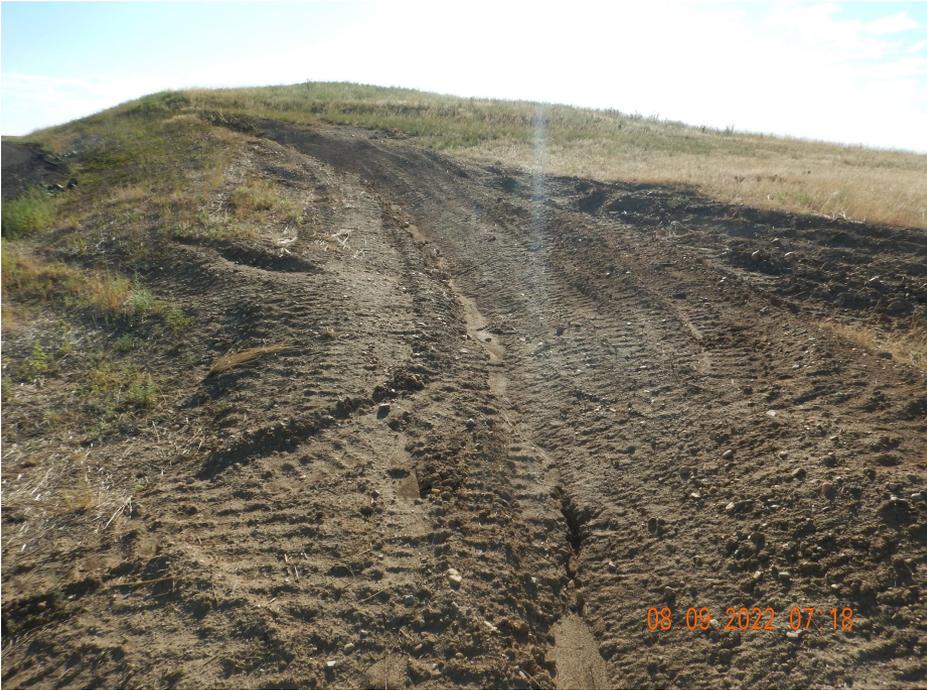
Photo 1. Photo taken from the entrance of location, facing East. Photo illustrates a ditch BMP along the perimeter of location. Operator should consider stabilizing the ditch BMP to reduce the velocity of stormwater.

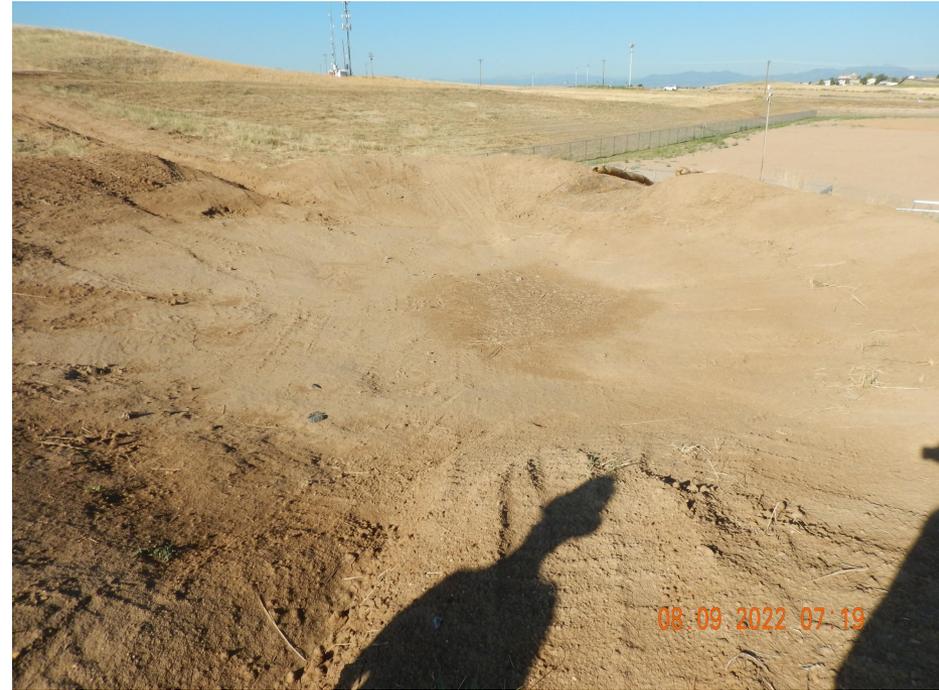
Photo 2. Photo taken from the entrance of location, facing West. Photo illustrates Operator has installed an additional BMP- sediment trap with a stabilized outlet.

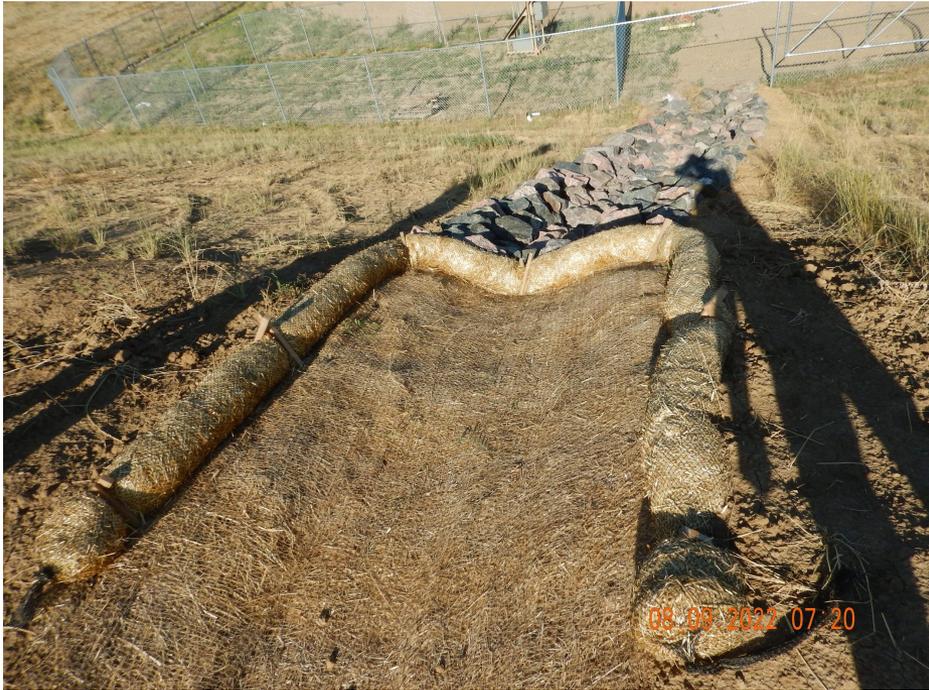
Photo 3. Photo taken of the stabilized outlet on the previous photo.

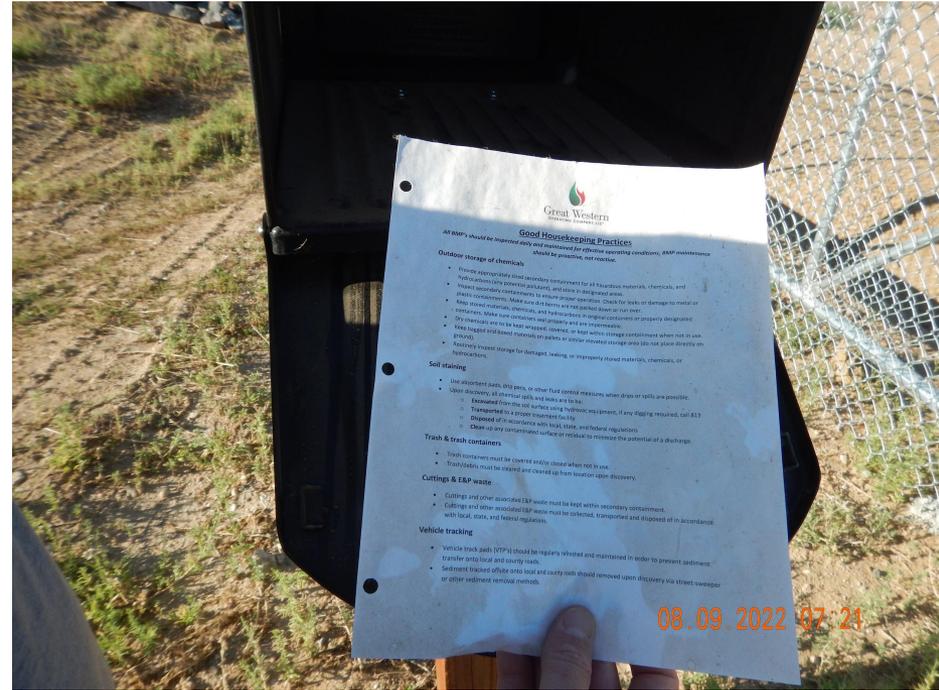
Photo 4. Photo taken from the entrance of location. Operator does not have the required paperwork per Rule 406.c.

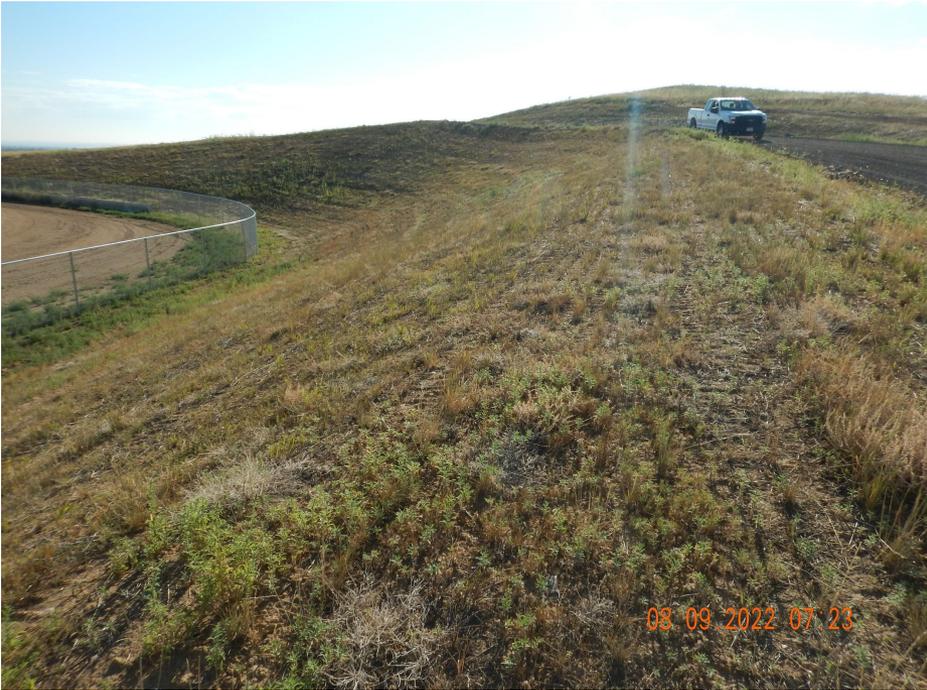
Photo 5. Photo taken from the entrance of location, facing East. Photo illustrates the cut slopes have been seeded and desirable vegetation is establishing to provide long term stabilization.

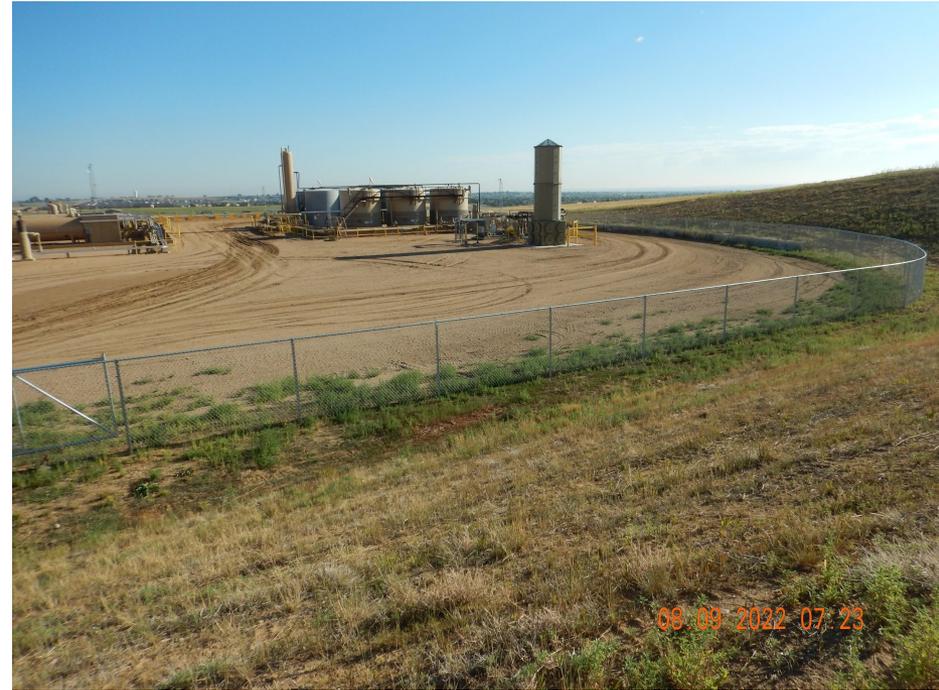
Photo 6. Photo taken from the entrance of location, facing North. Photo illustrates a fence has been installed around the entire location.

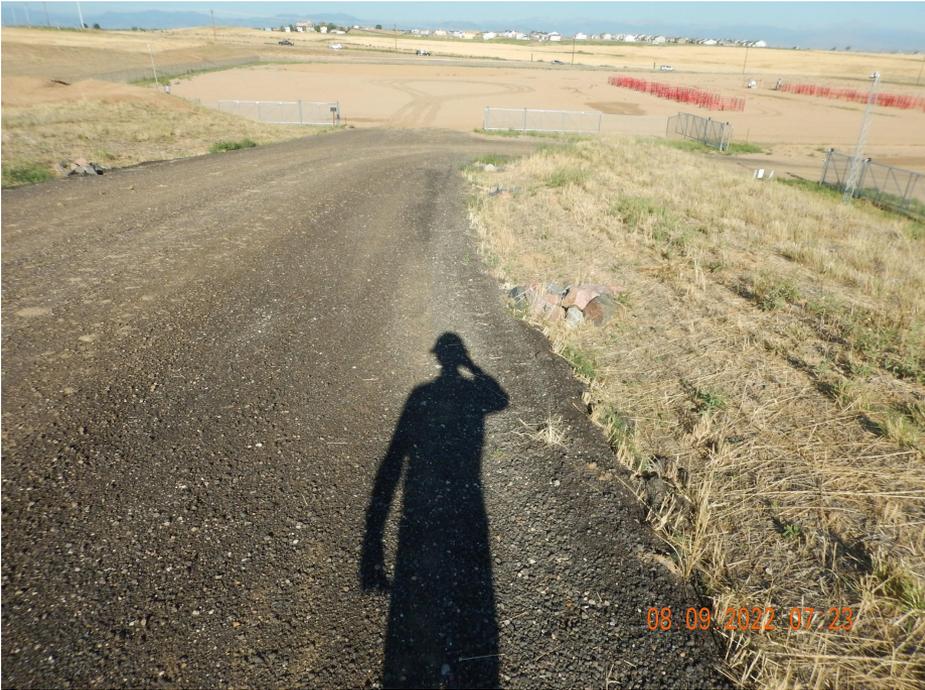
Photo 7. Photo taken from the entrance of location, facing West. See comments under Photo 6. Also, Operator has added recycled asphalt along the entire length of the access road to stabilize it and control erosion.

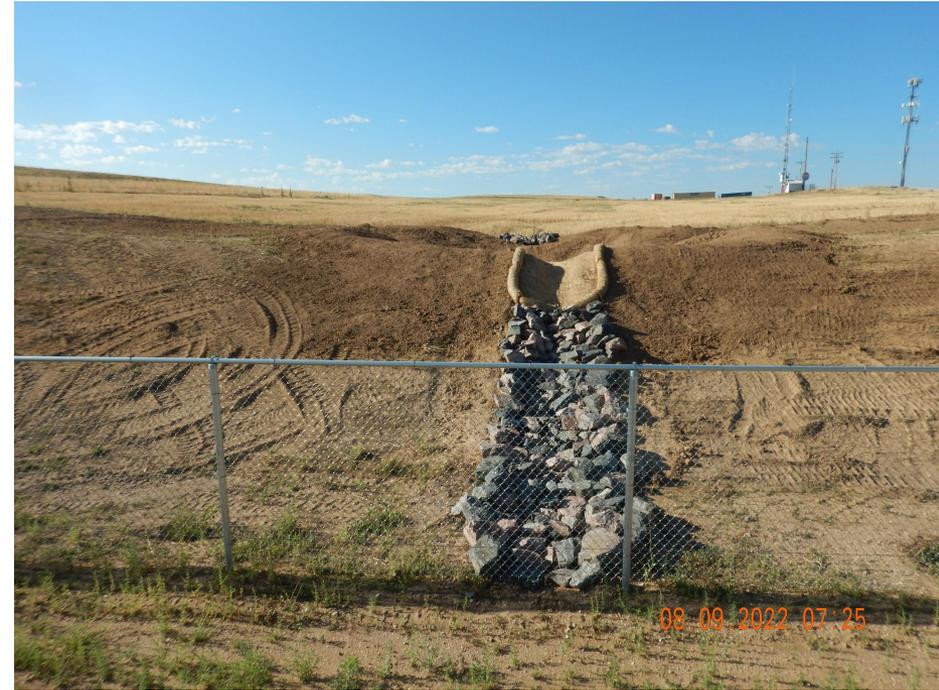
Photo 8. Photo taken from the southern location, facing South. See comments under Photo 2.

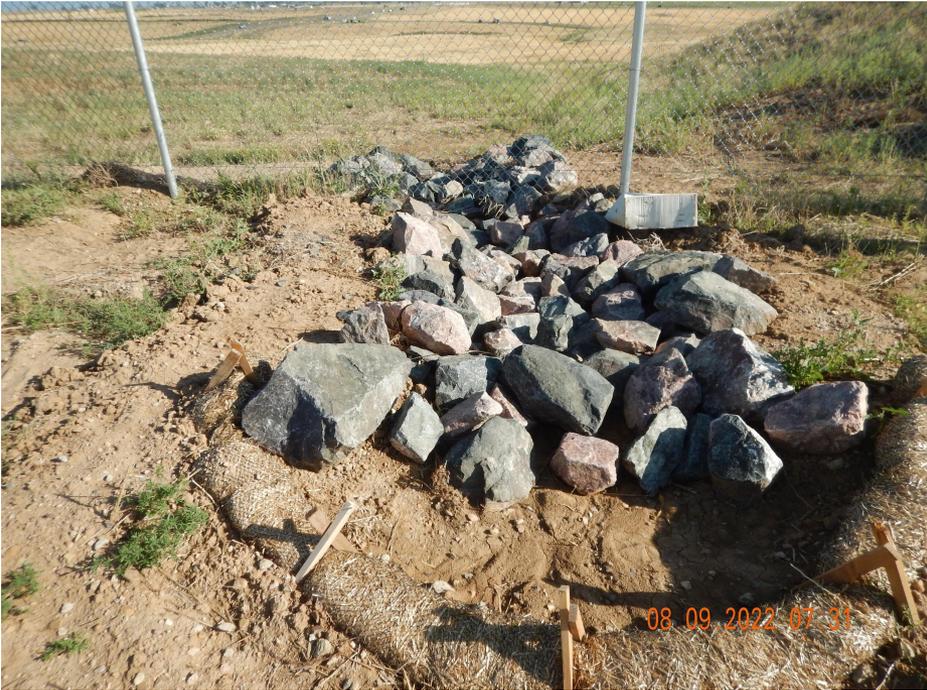
Photo 9. Photo taken from the northeastern well pad, facing North. Operator has installed a stabilized riprap channel.

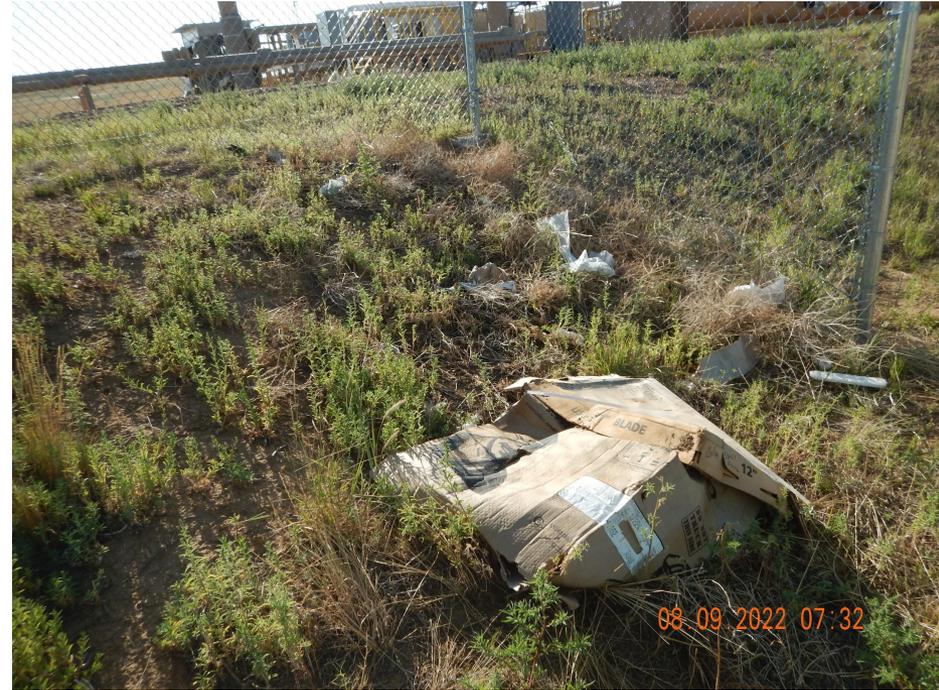
Photo 10. Photo taken from the previous photo illustrates trash within the disturbance area of the location.

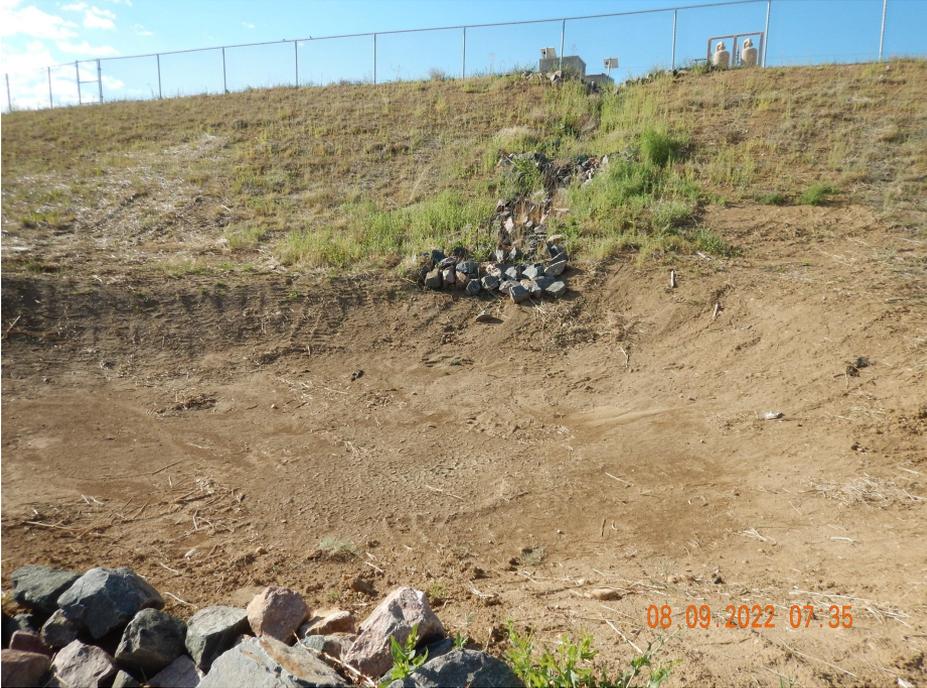
Photo 11. Photo taken from the northern facility pad, facing South. Photo illustrates the current BMPs appear to be in proper functioning condition.

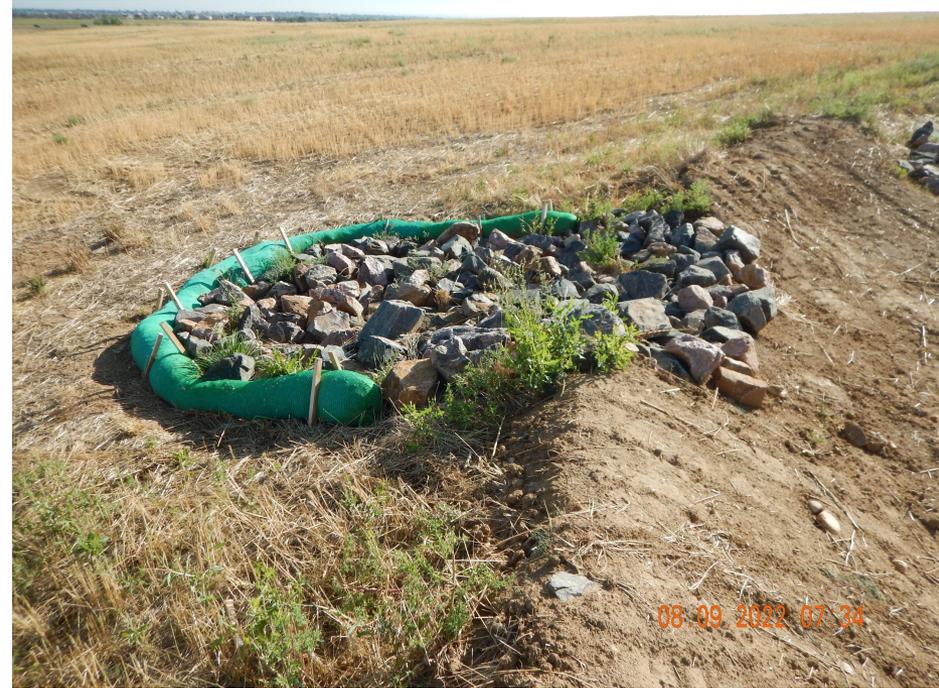
Photo 12. Photo taken from the previous photo illustrates the stabilized outlet of the sediment trap.

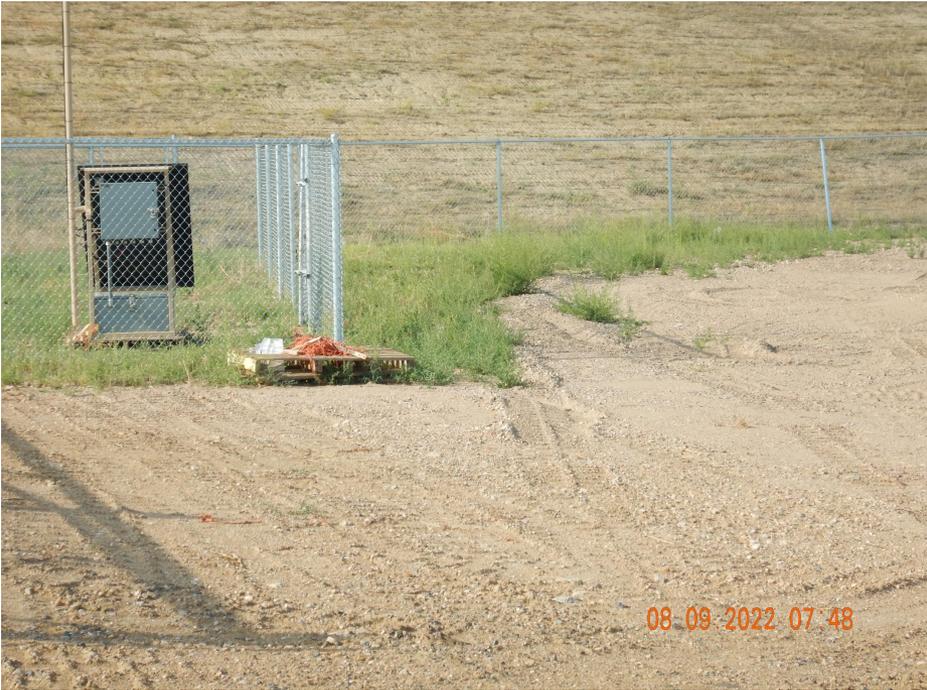
Photo 13. Photo taken from the entrance of location, facing South. Photo illustrates debris/trash.

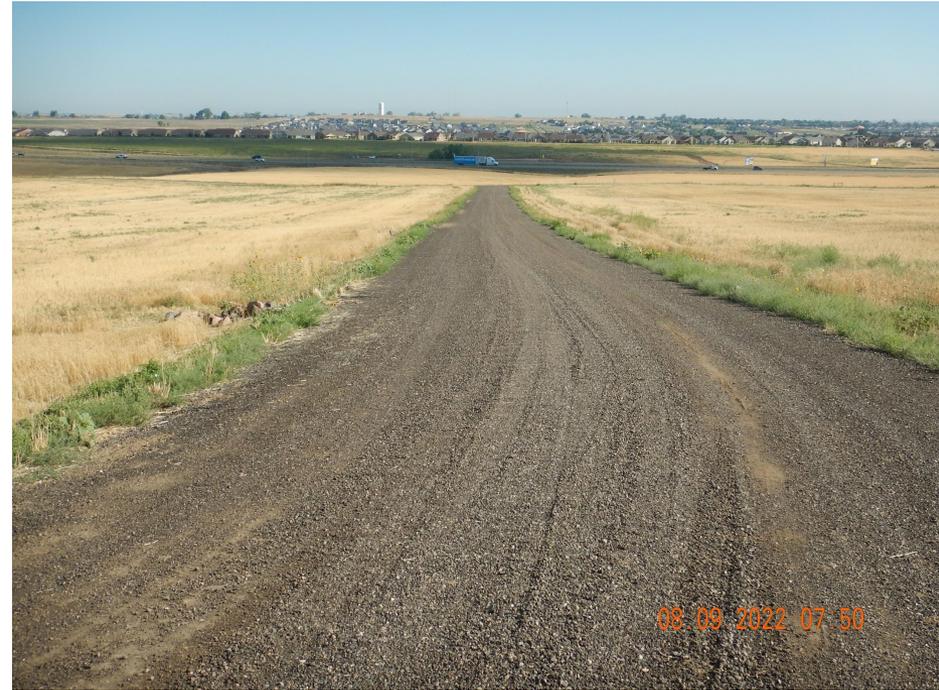
Photo 14. Photo taken along a portion of the main access road, facing North. See comments under Photo 7.
