Construction and Stormwater Inspection

August 10, 2022

Operator: NOBLE ENERGY INC- #100322

Inspection Photos
Location Name:CC31-02 /Pad
Location ID: 460265

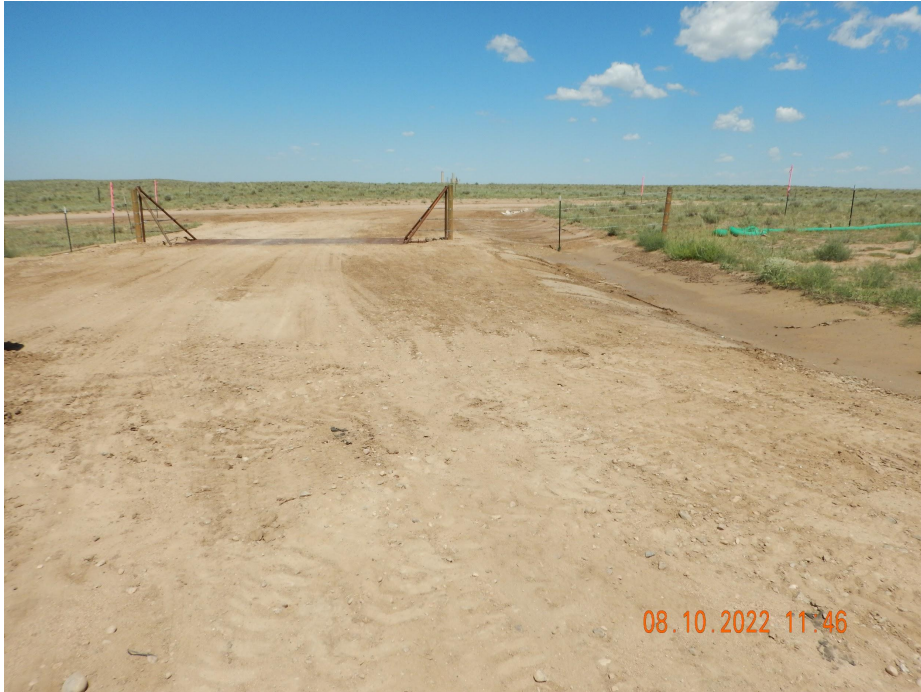
Photo 1. Photo taken from the west entrance of location, facing North. Photo illustrates a cattle guard which would also serve as a VTC device BMP.

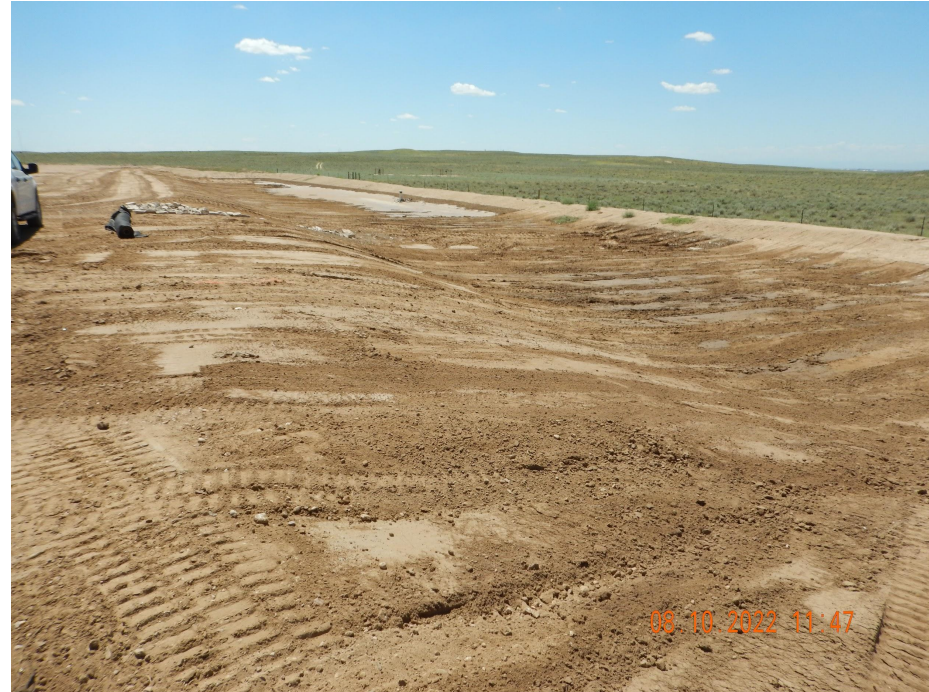
Photo 2. Photo taken from the northwestern location, facing South. Photo illustrates a sediment basin with evidence of stormwater repairs.

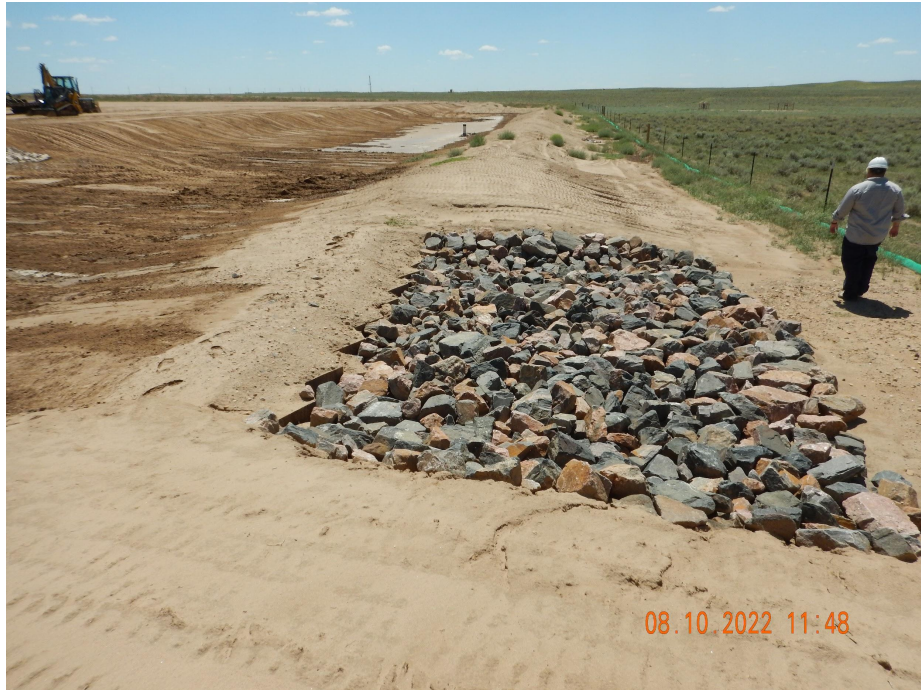
Photo 3. Photo taken from the western location, facing South. Photo illustrates the stabilized outlet of the sediment basin which appears to be in proper functioning condition.

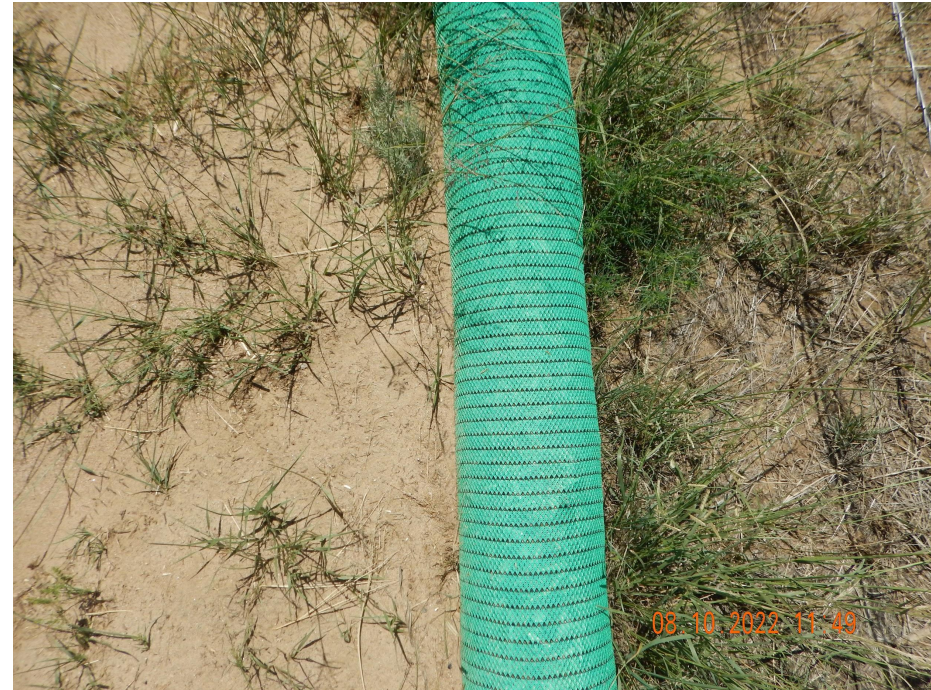
Photo 4. Photo taken along a portion of the western location. Photo illustrates how the filtrex wattle properly worked to keep sediment from leaving location.

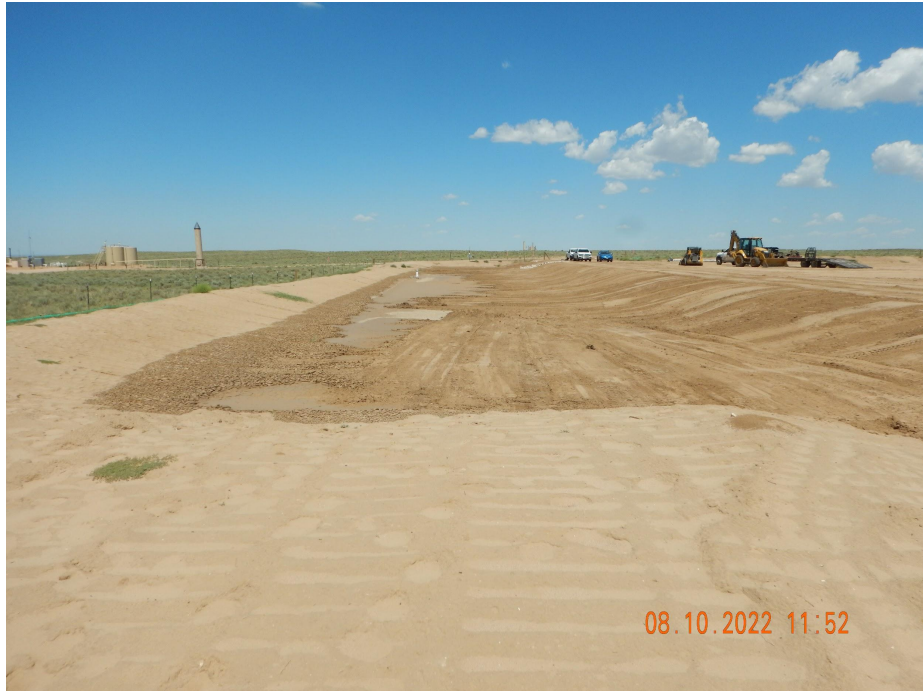
Photo 5. Photo taken from the southwestern location, facing North. See comments under Photo 2.

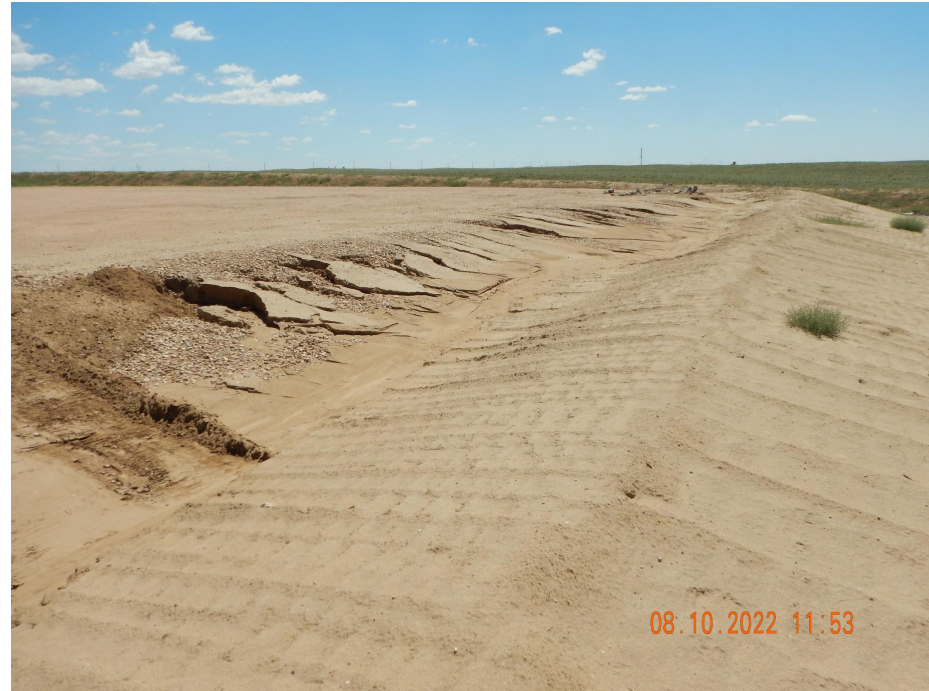
Photo 6. Photo taken from the southwestern location, facing South. Photo illustrates stormwater repairs are in process and in need of maintenance.

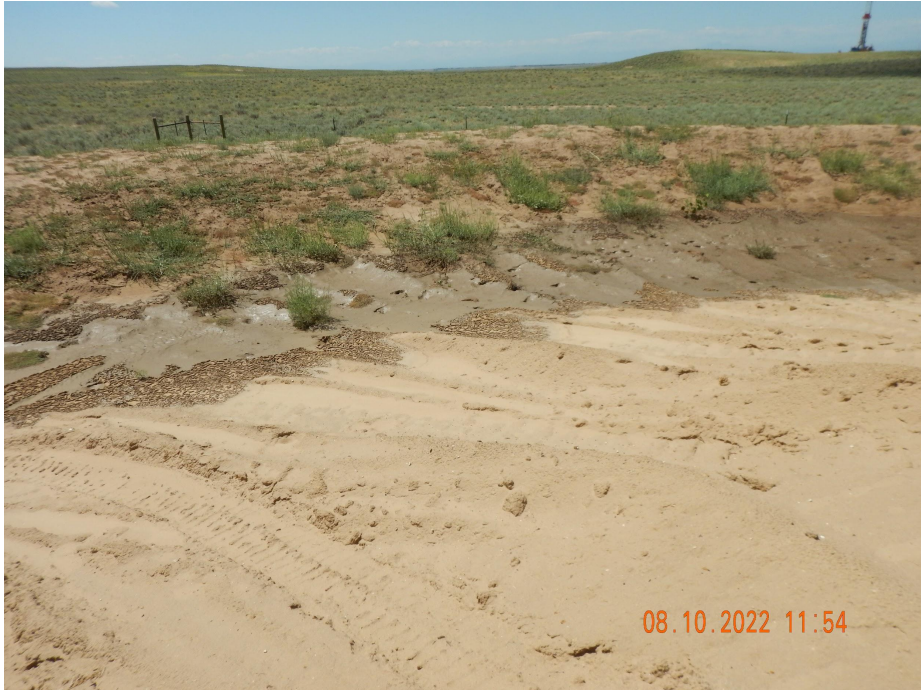
Photo 7. Photo taken from the southwestern location, facing Southwest. Photo illustrates the topsoil stockpile with weed establishment. The temporary BMP (equipment tracking) is no longer in proper functioning condition. Stockpile needs to be stabilized as topsoil is starting to erode into the stormwater ditch.

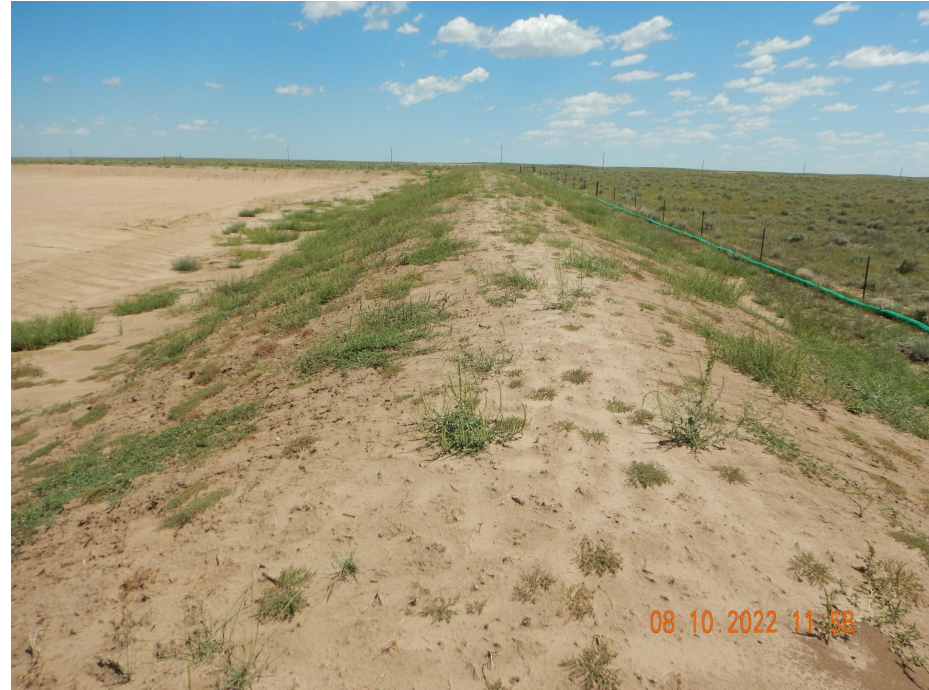
Photo 8. Photo taken from the southern location on top of the topsoil stockpile, facing East. See comments under Photo 7.

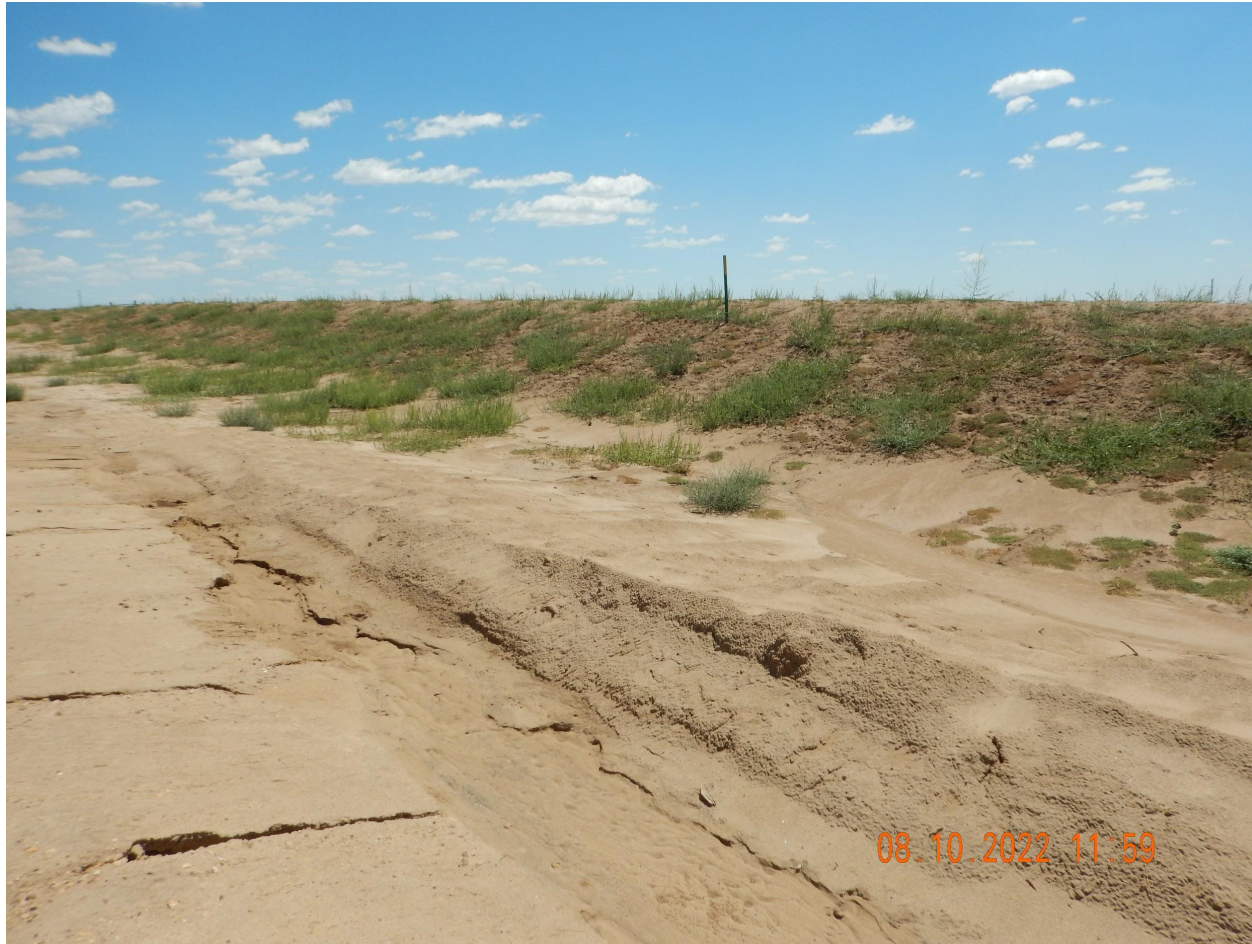
Photo 9. Photo taken from the southern location, facing Southeast. Photo illustrates that the topsoil stockpile needs to be stabilized as topsoil is starting to erode into the stormwater ditch.

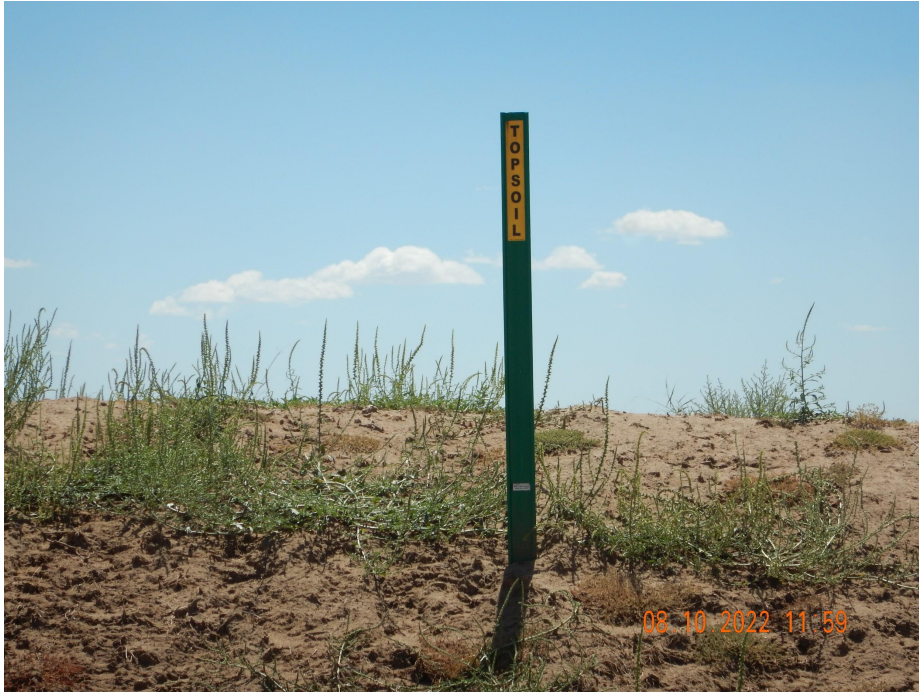
Photo 10. Photo taken of the topsoil stockpile signage.

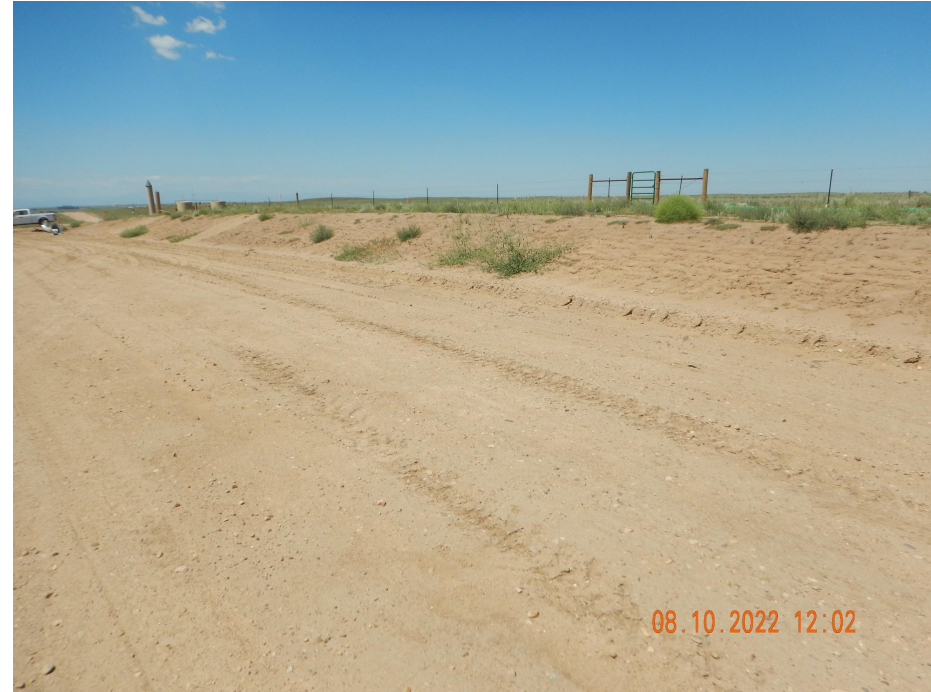
Photo 11. Photo taken from the northern location, facing West. Cut slopes are been temporarily stabilized with equipment tracking.
