Inspection Photos
Morgan A1
Spill ID 481051 (CL) & 482224 (AC)

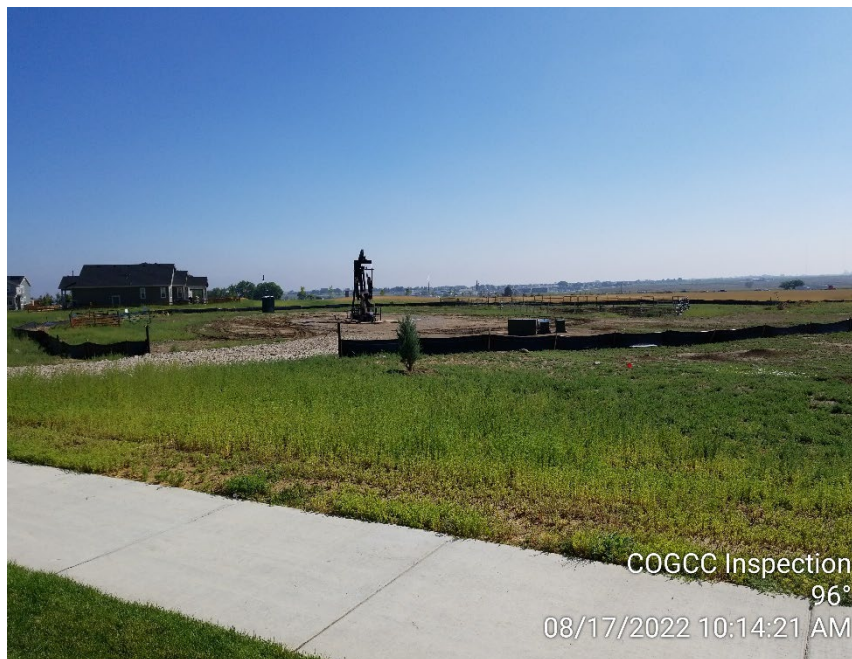
Photo 1 – Location photo.

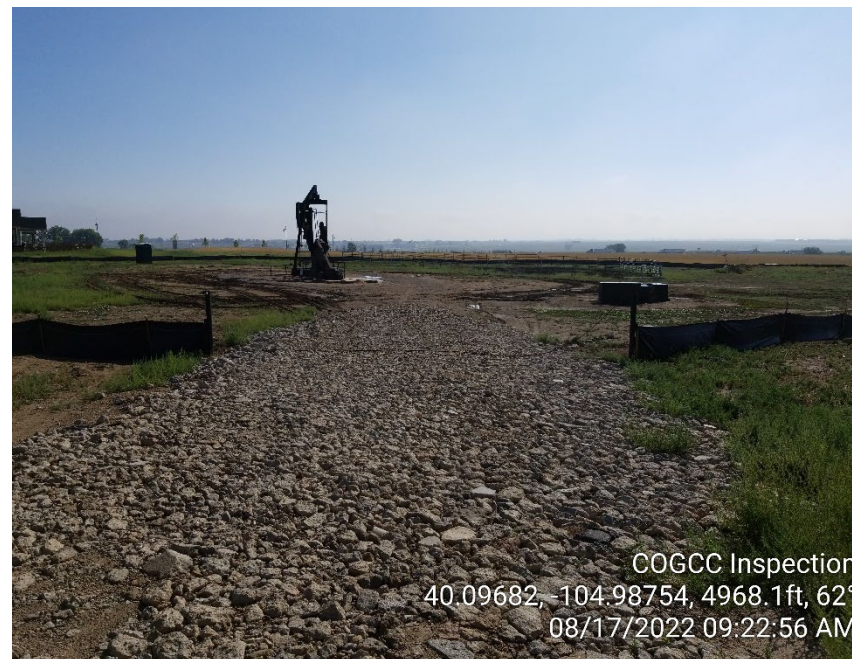
Photo 2 – Access to location unsecured upon COGCC arrival.

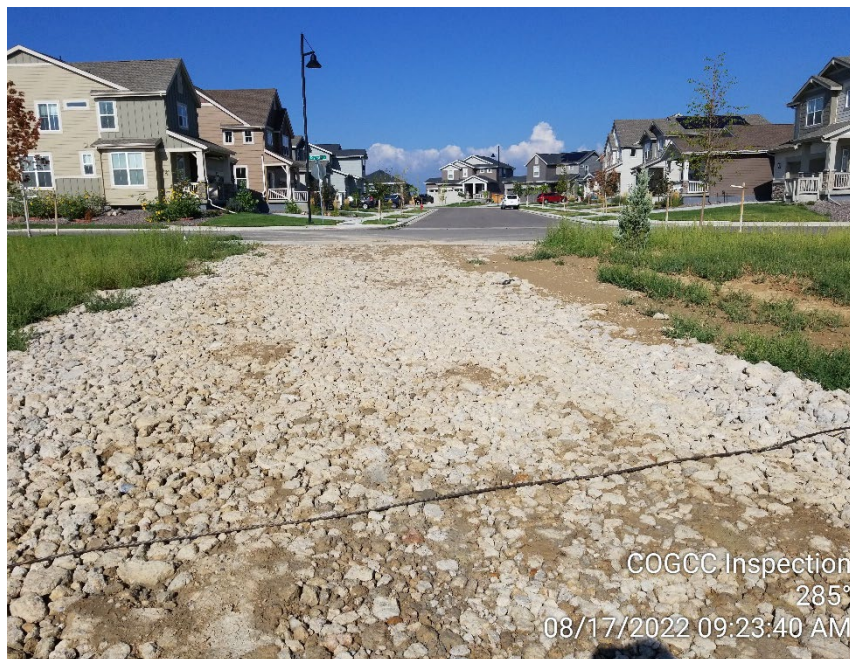
Photo 3 – Dirt being tracked off location onto neighborhood road.

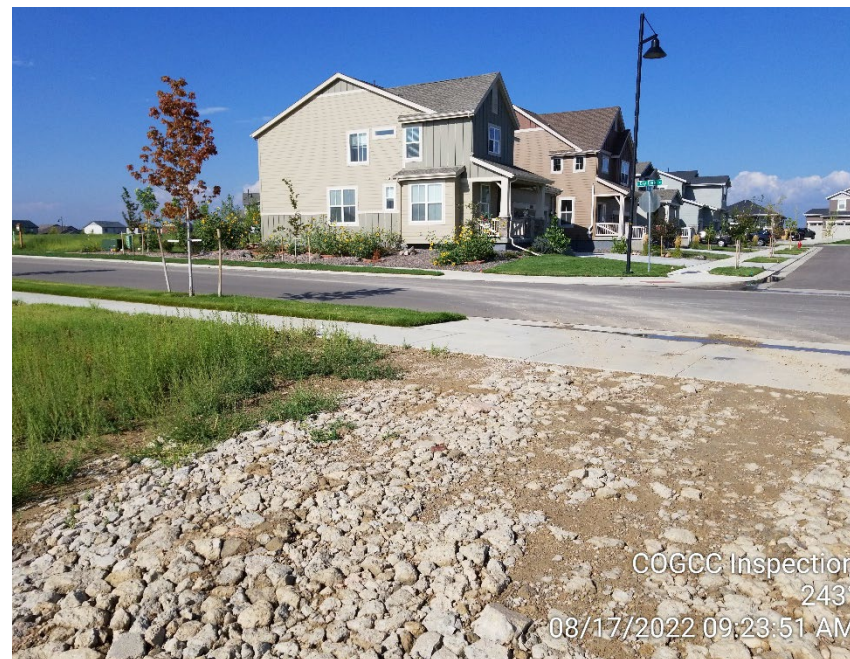
Photo 4 – Dirt being tracked off location onto neighborhood road.

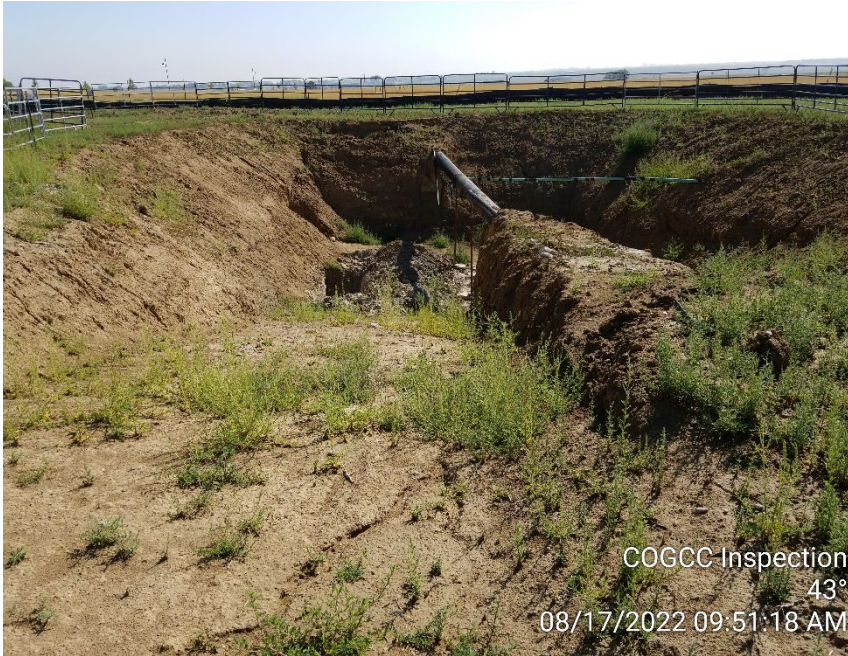
Photo 5 – Open excavation, Spill ID 481051

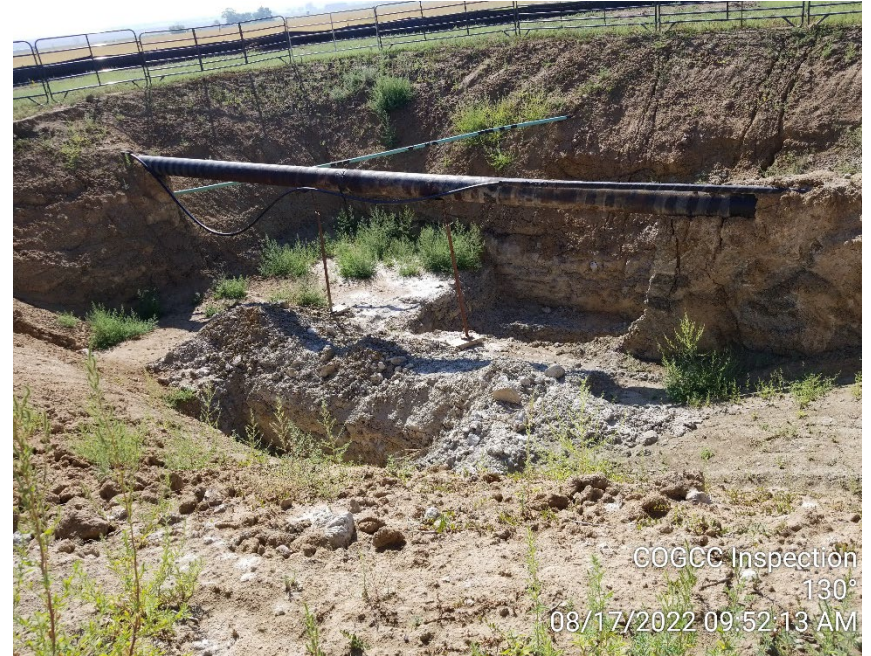
Photo 6 – Open excavation, Spill ID 481051

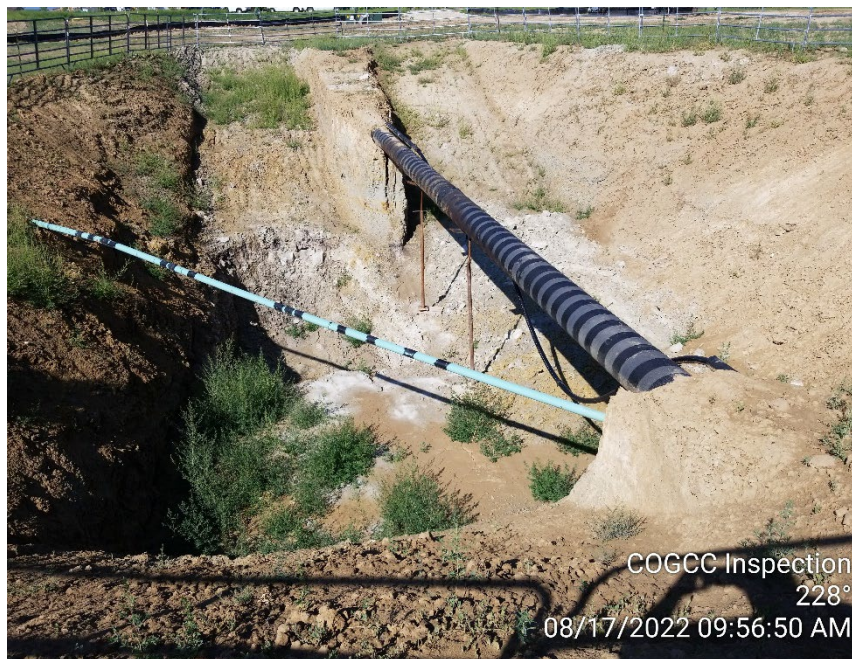
Photo 7 – Open excavation, Spill ID 481051

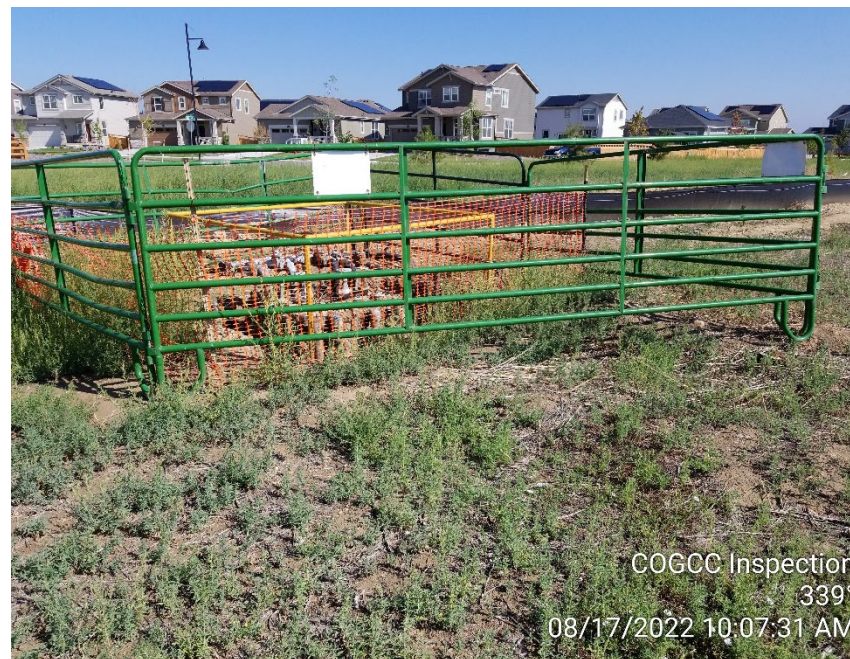
Photo 8 – Open excavation, Spill ID 482224

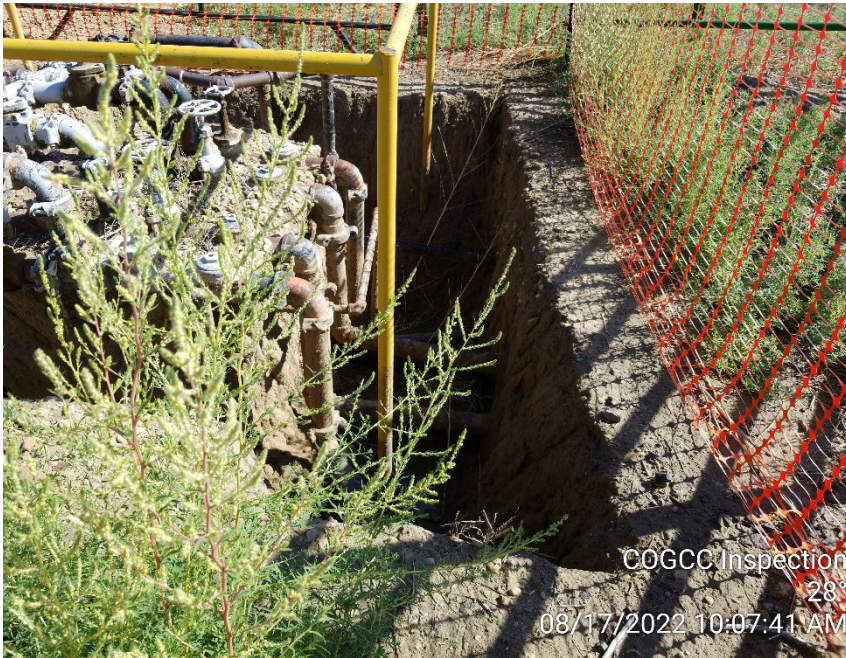
Photo 9 – Open excavation, Spill ID 482224

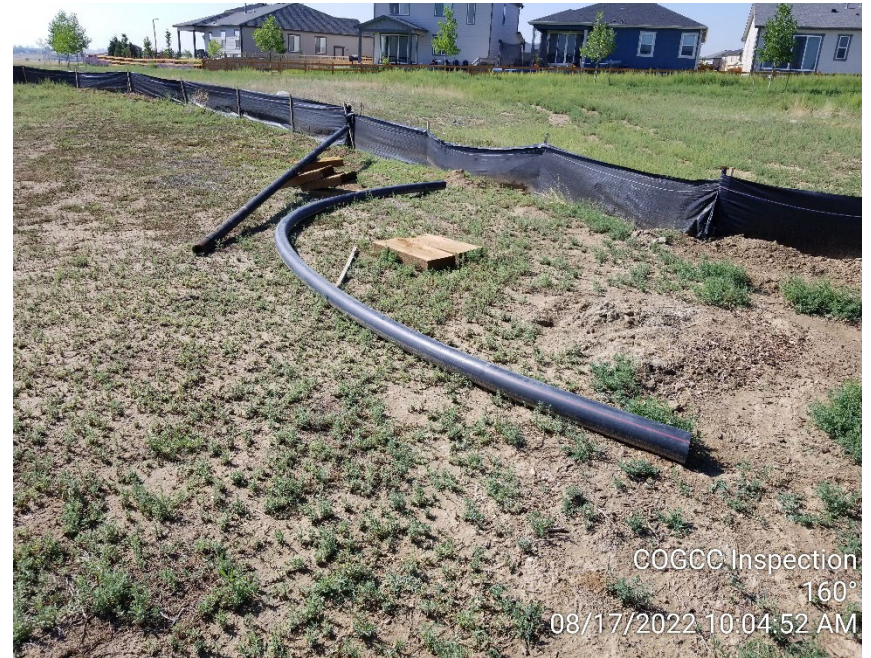
Photo 10 – Trash on location

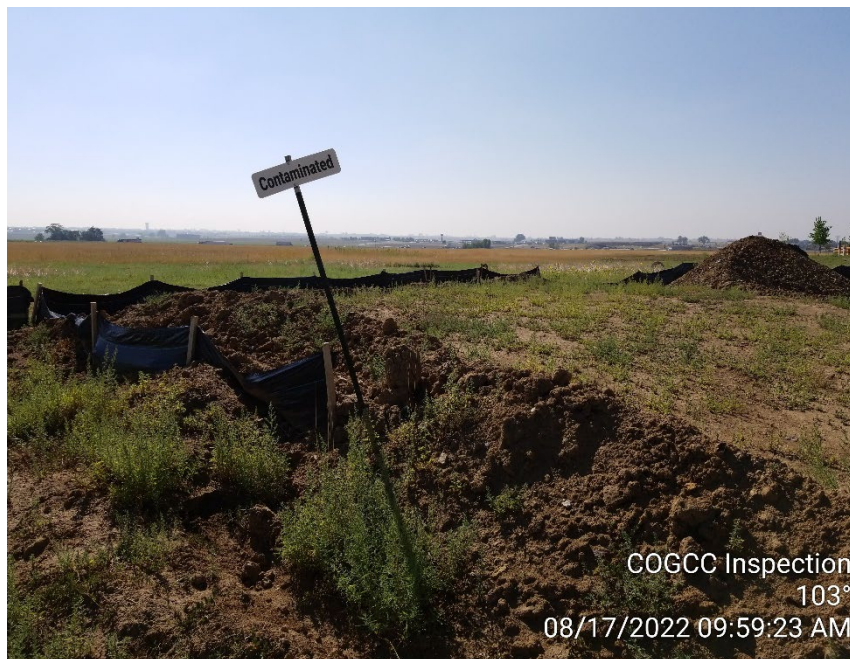
Photo 11 – Soil stockpile with 'Contaminated' sign

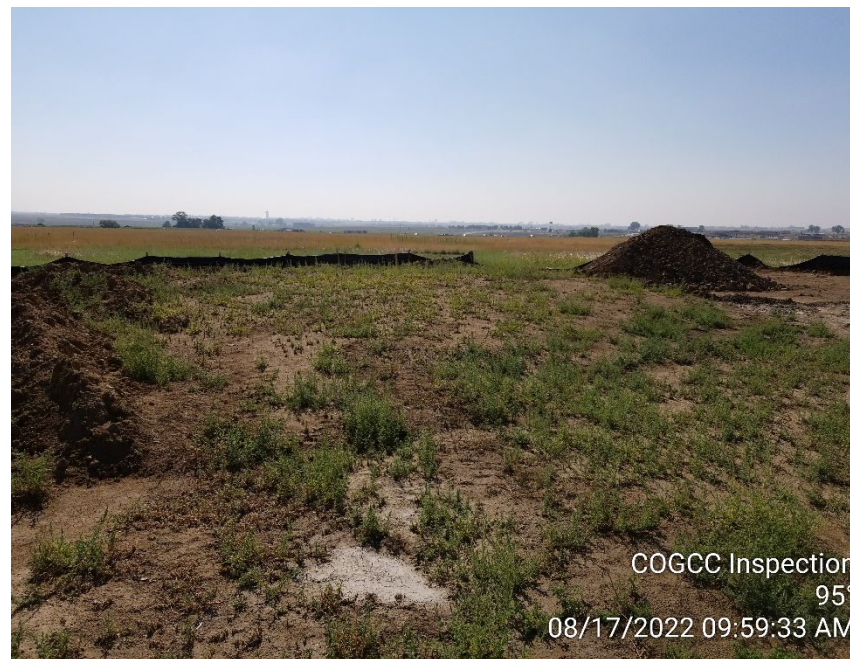
Photo 12 – Soil stockpile area

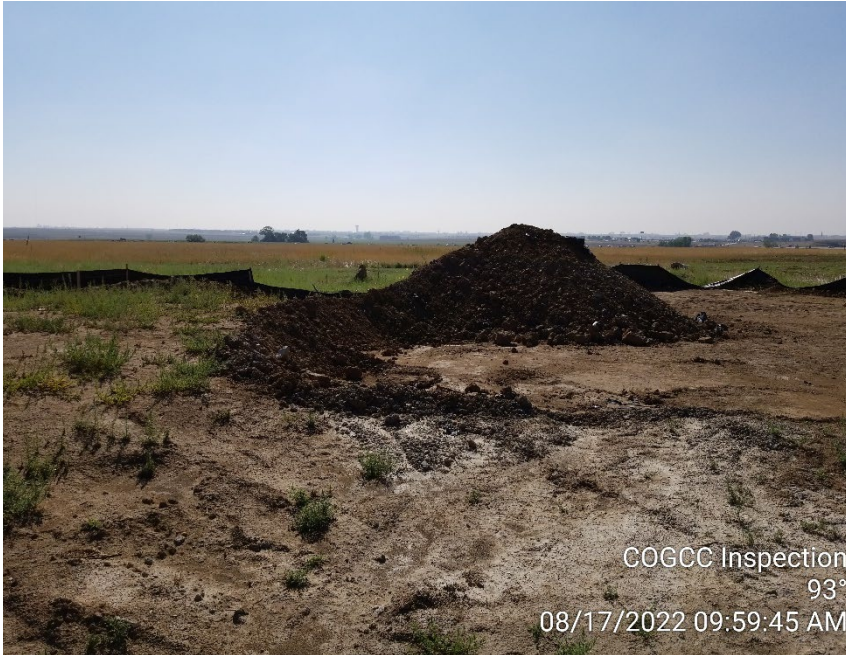
Photo 13 – Soil stockpile

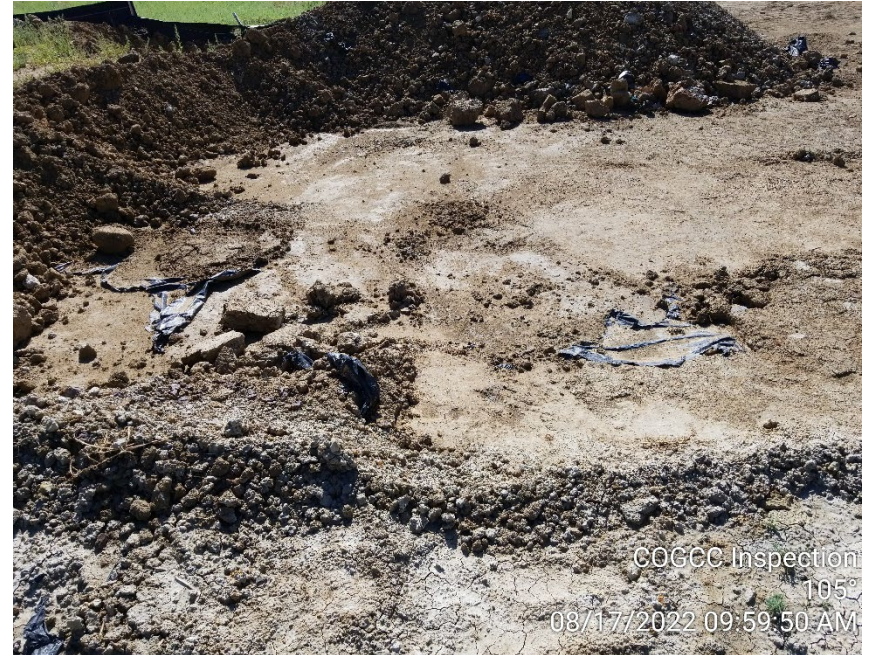
Photo 14 – Ripped lining at soil stockpile

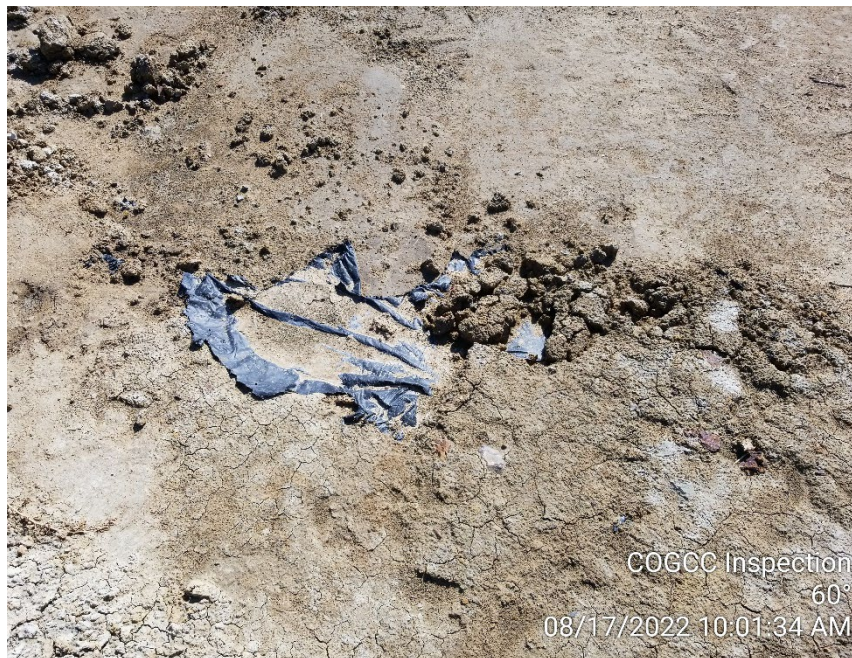
Photo 15 – Ripped lining at soil stockpile

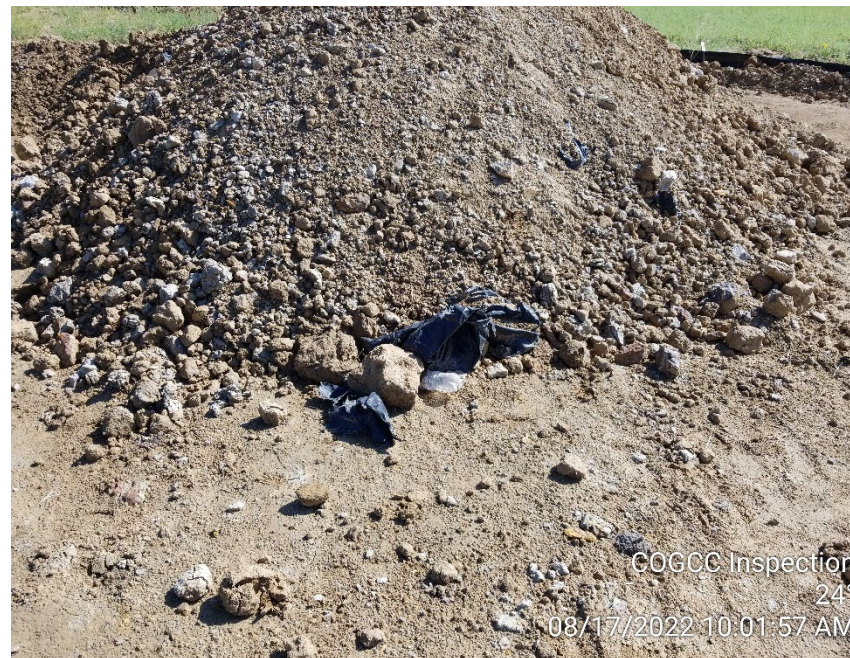
Photo 16 – Soil stockpile with ripped lining and inadequate stormwater BMPs

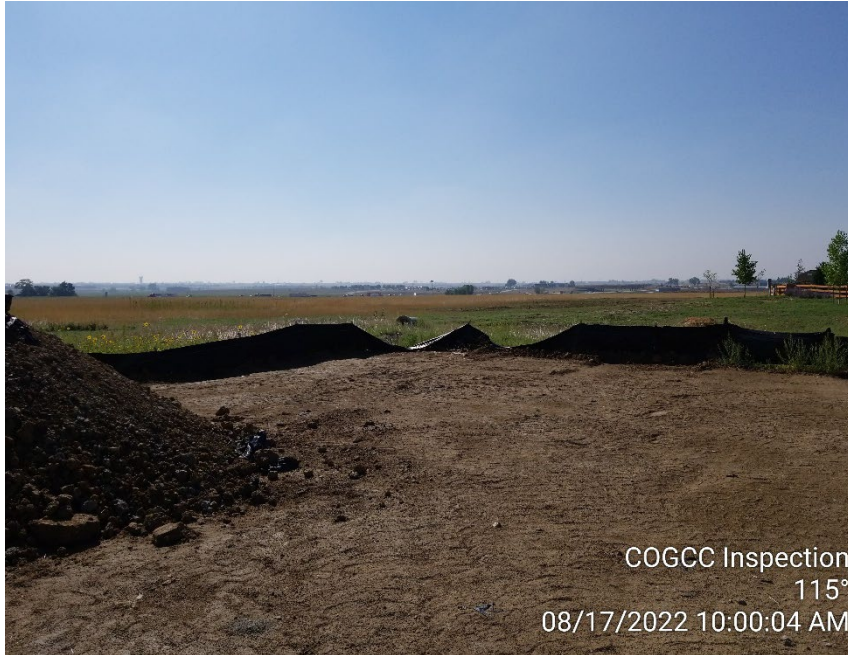
Photo 17 – Downed silt fence

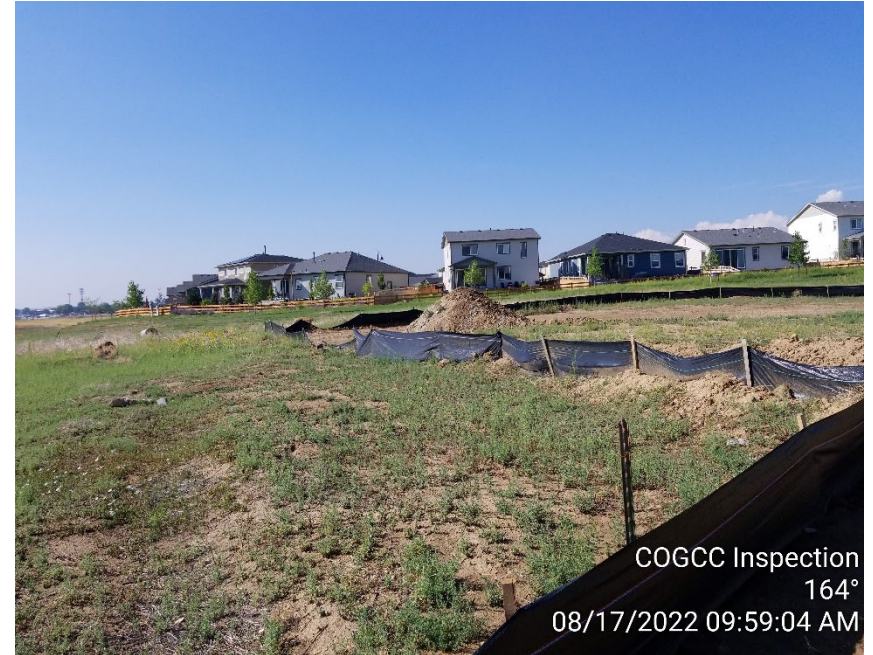
Photo 18 – Downed silt fence

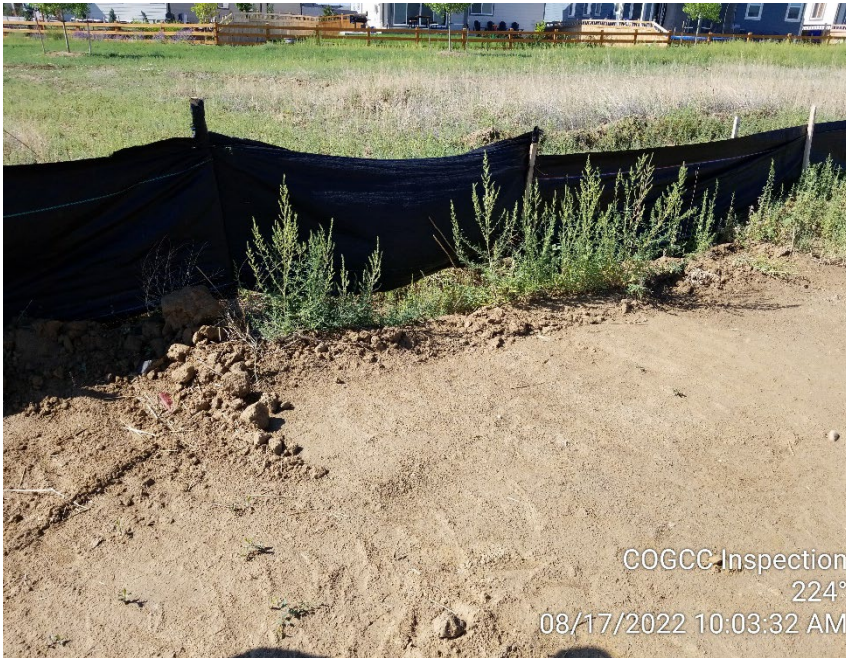
Photo 19 – Improperly installed silt fence

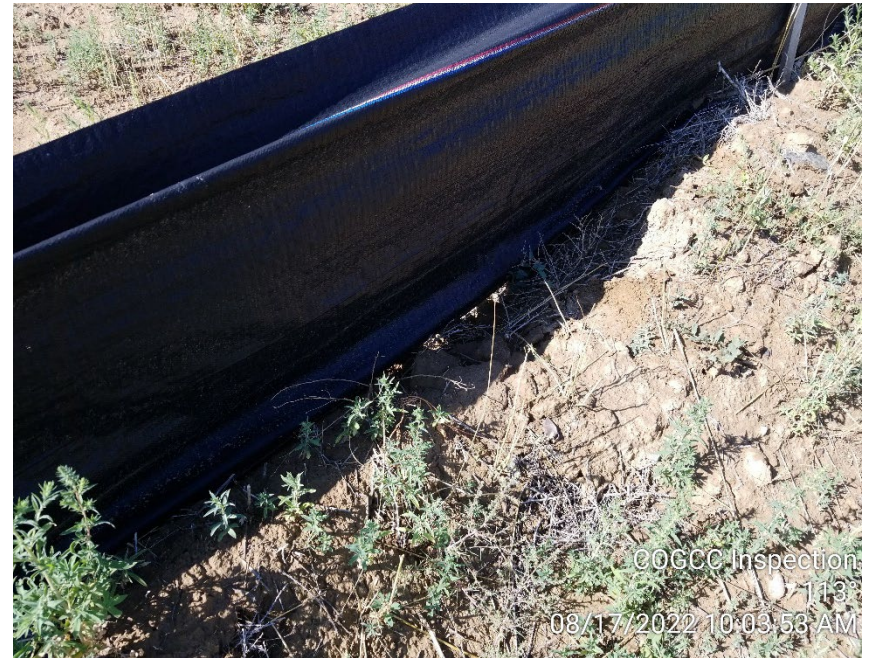
Photo 20 – Improperly installed silt fence

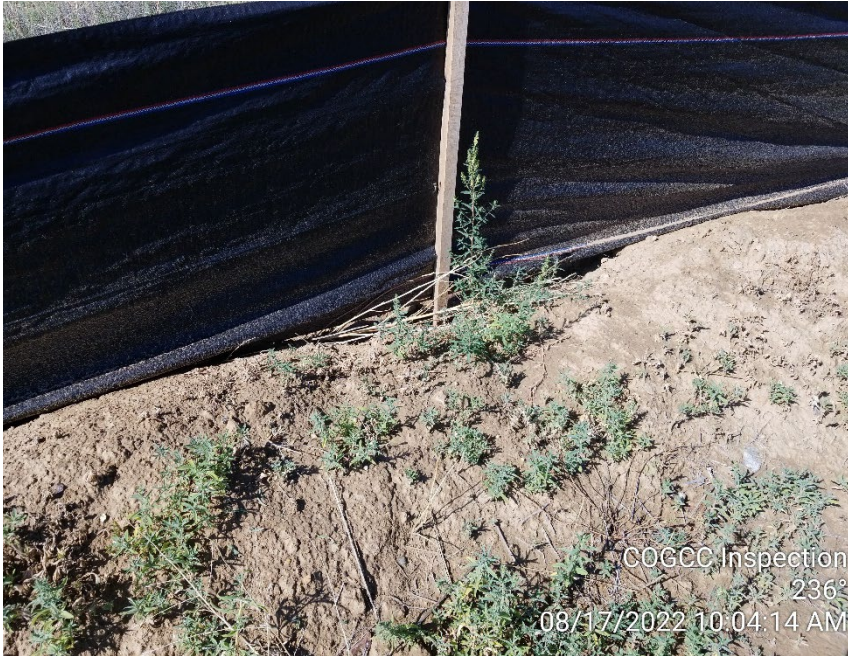
Photo 21 – Improperly installed silt fence

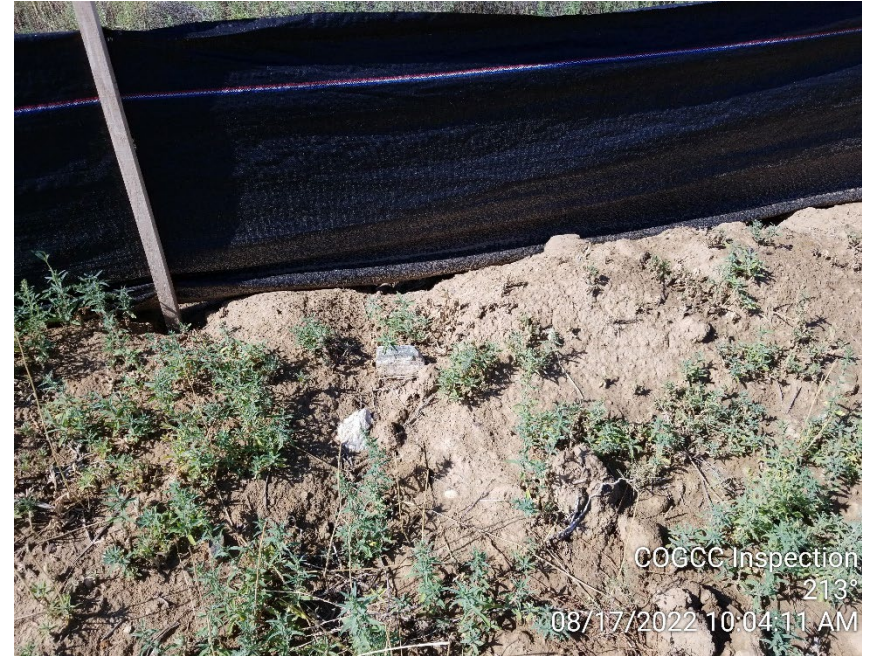
Photo 22 – Improperly installed silt fence

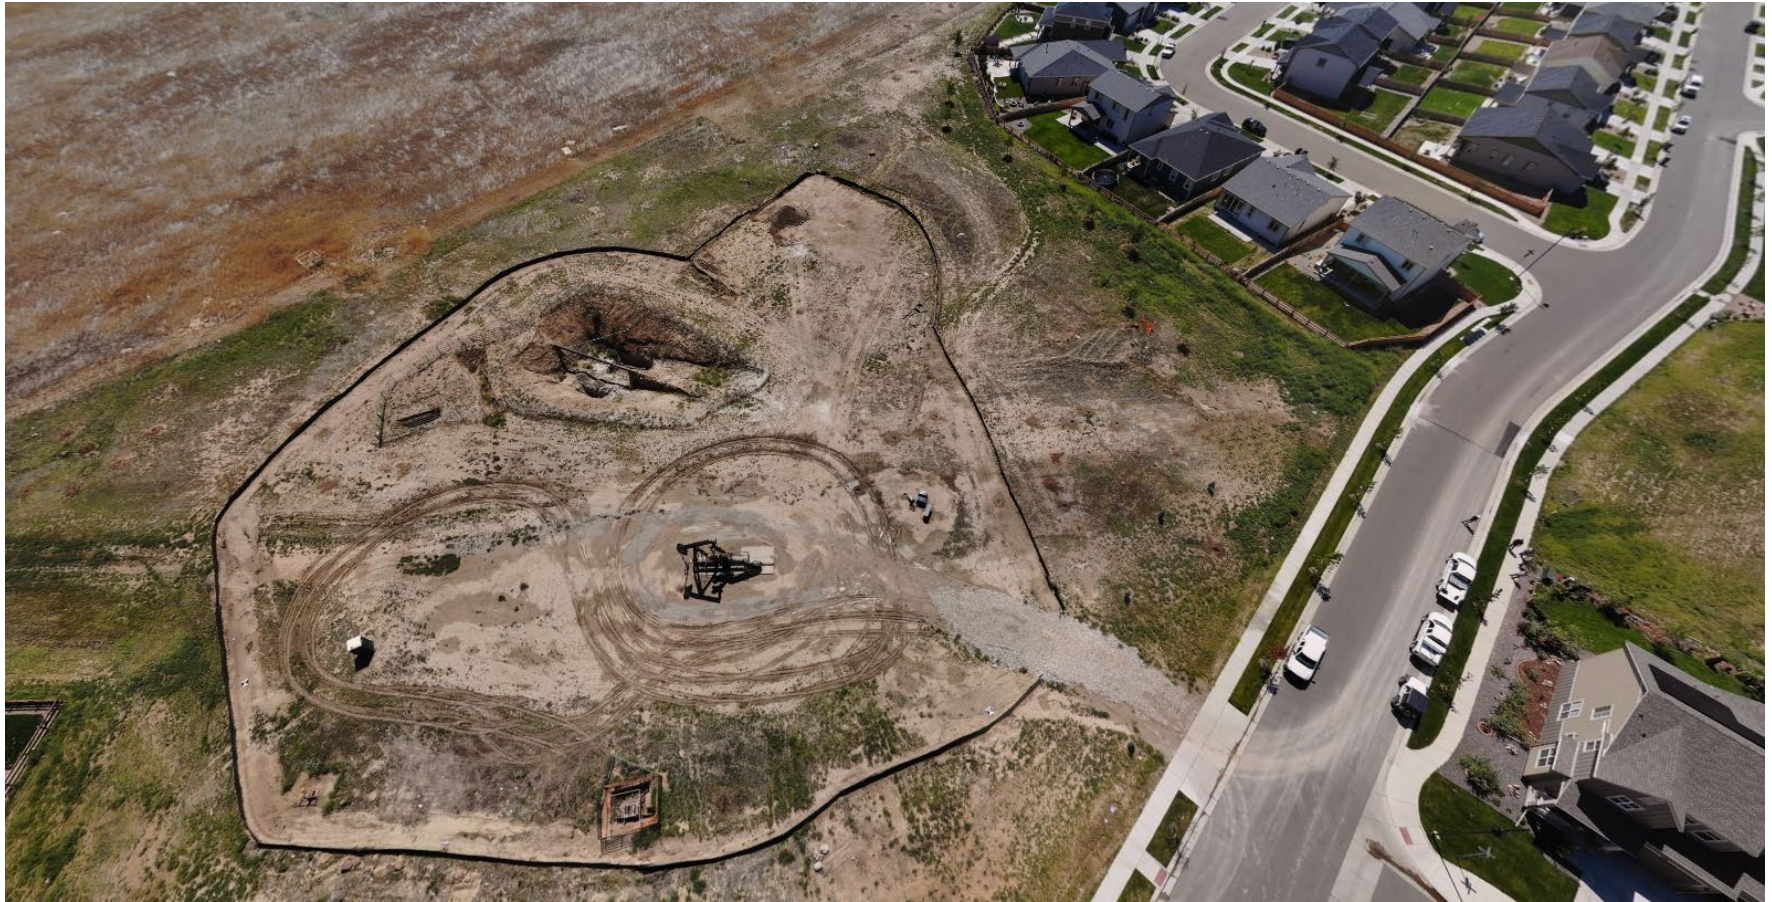
8/17/2022 Drone Imagery – 1.55 Total Acres disturbed
