Inspection Photos
Location Name: Melbon Ranch 3A-17H-M265
Location ID: 428103

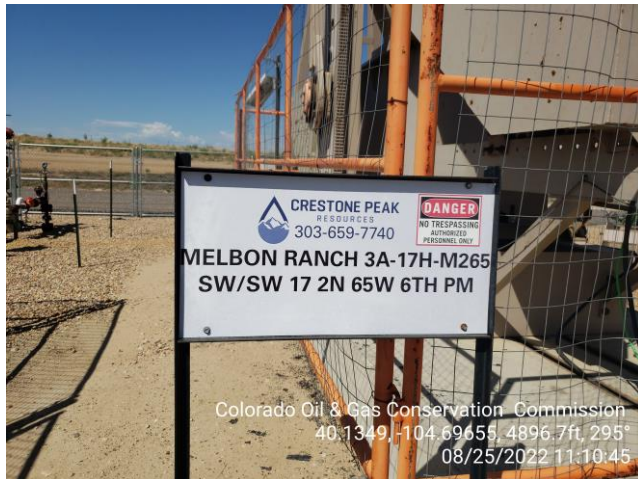
Photo 1 WH sign.

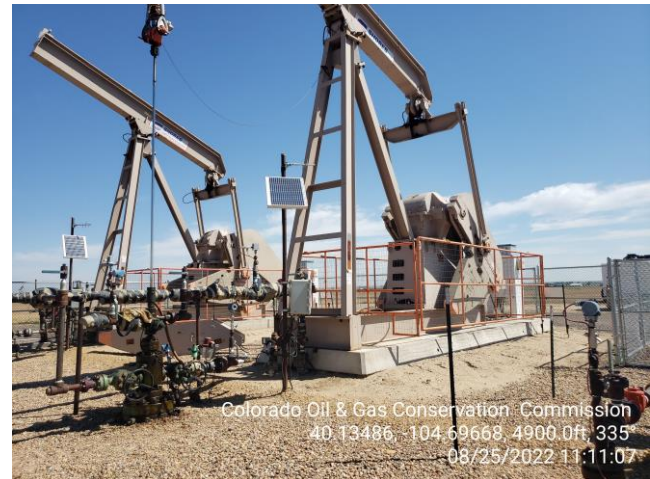
Photo 2 WH

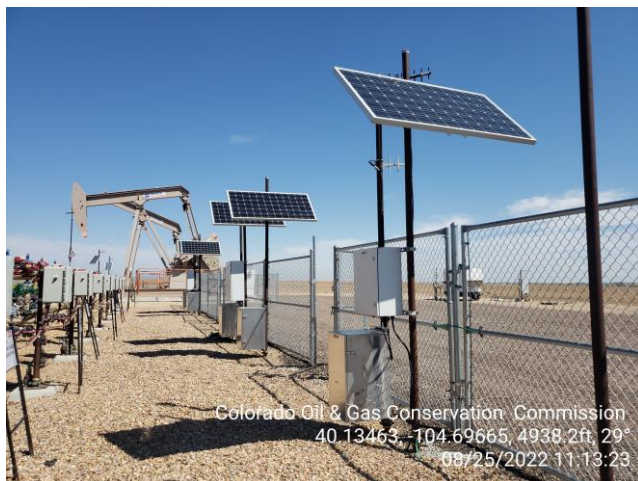
Photo 3 Ancillary equip.

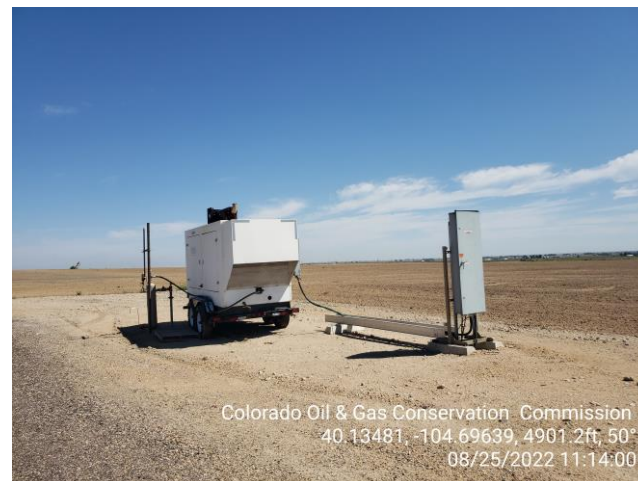
Photo 4 Ancillary equip.

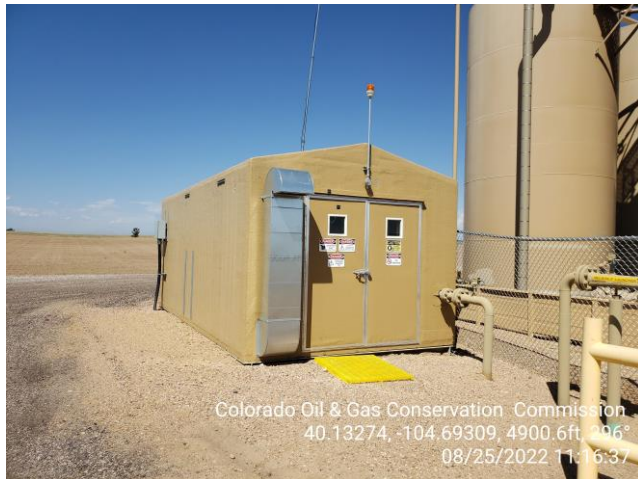
Photo 5 LACT.

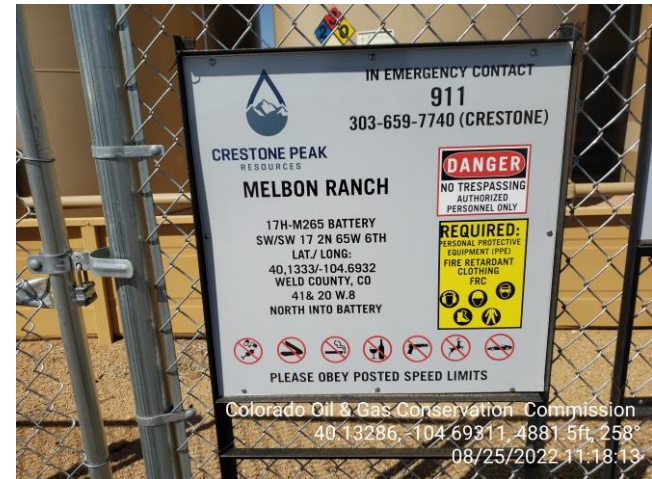
Photo 6 TB sign.

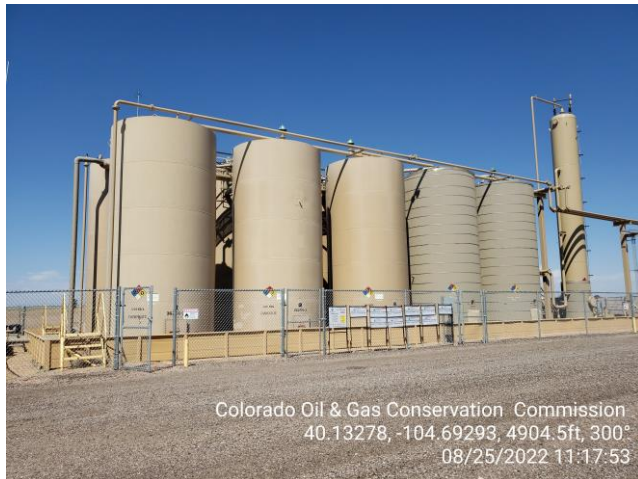
Photo 7 TB.

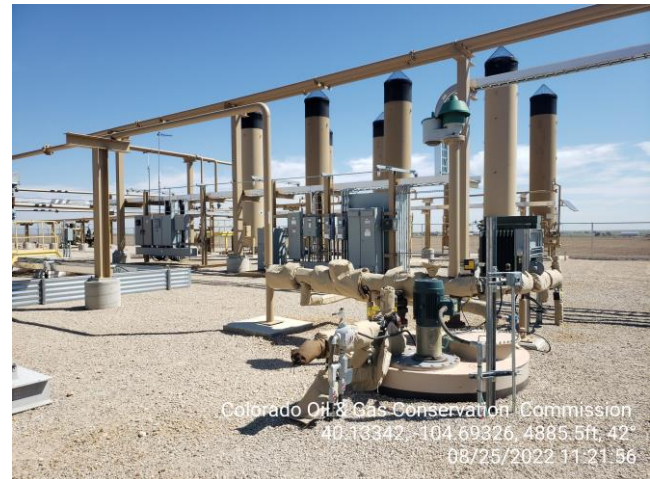
Photo 8 Ancillary equip.

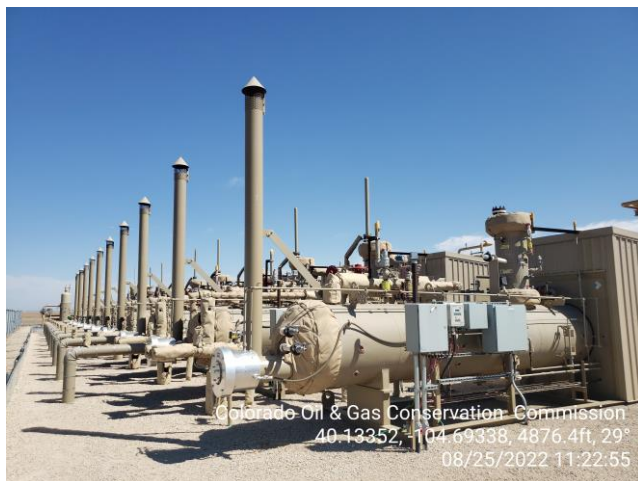
Photo 9 HHS x 12.

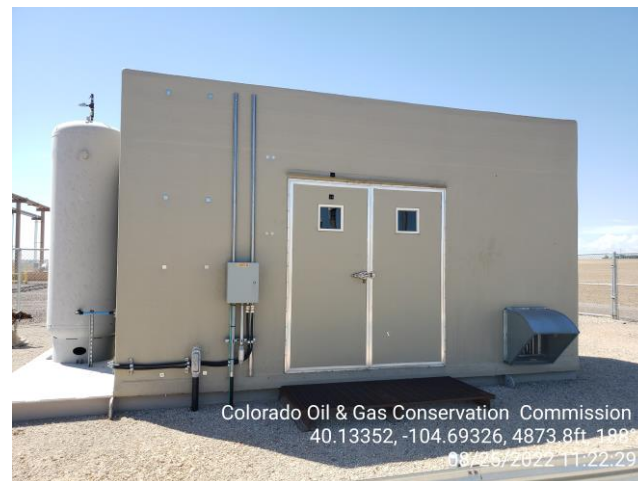
Photo 10 location.

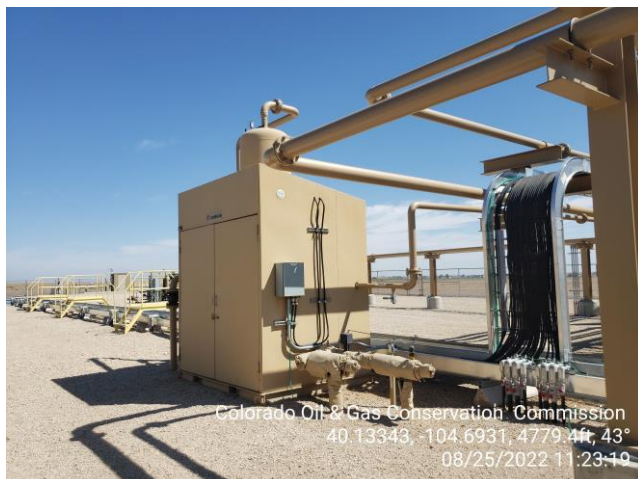
Photo 11 Compressor.

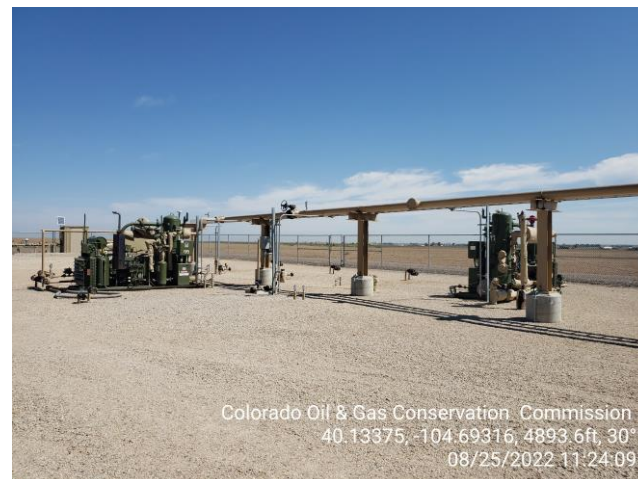
Photo 12 VRU.

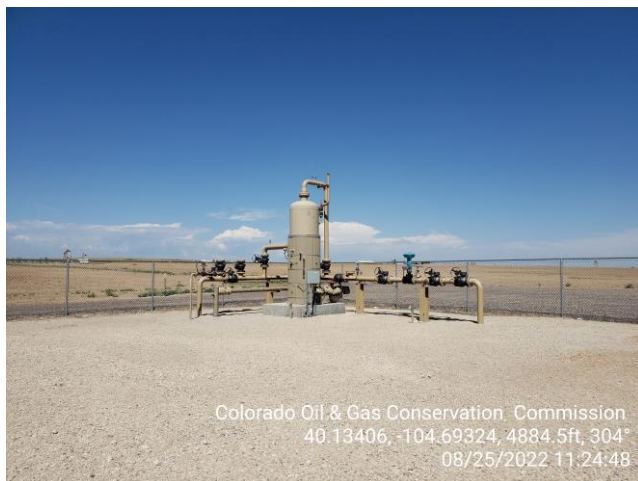
Photo 13 VRT.

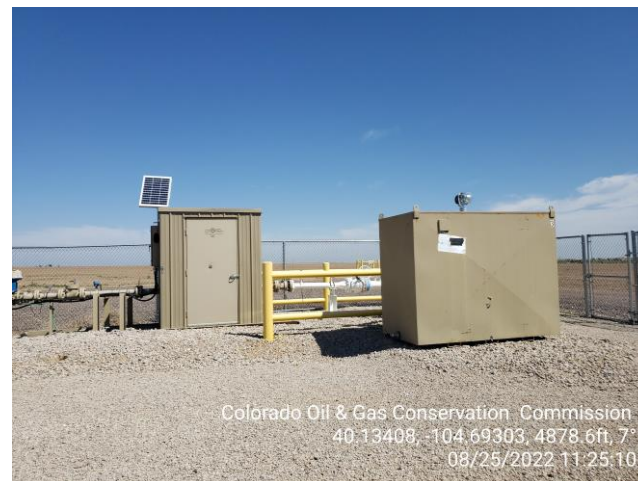
Photo 14 Gas Meter Run Corrosion inhibitor.

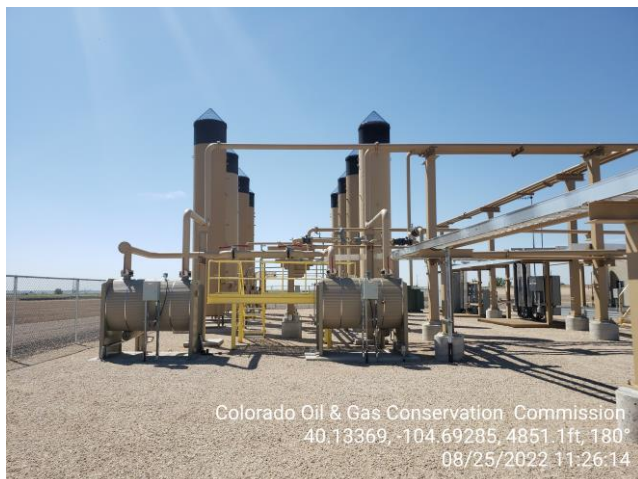
Photo 15 ECDs and water KO.
