Inspection Photos

API: 071-08576

Operator: RED RIVER RANCH HOLDINGS LLC

Inspection Date: 8/25/2022

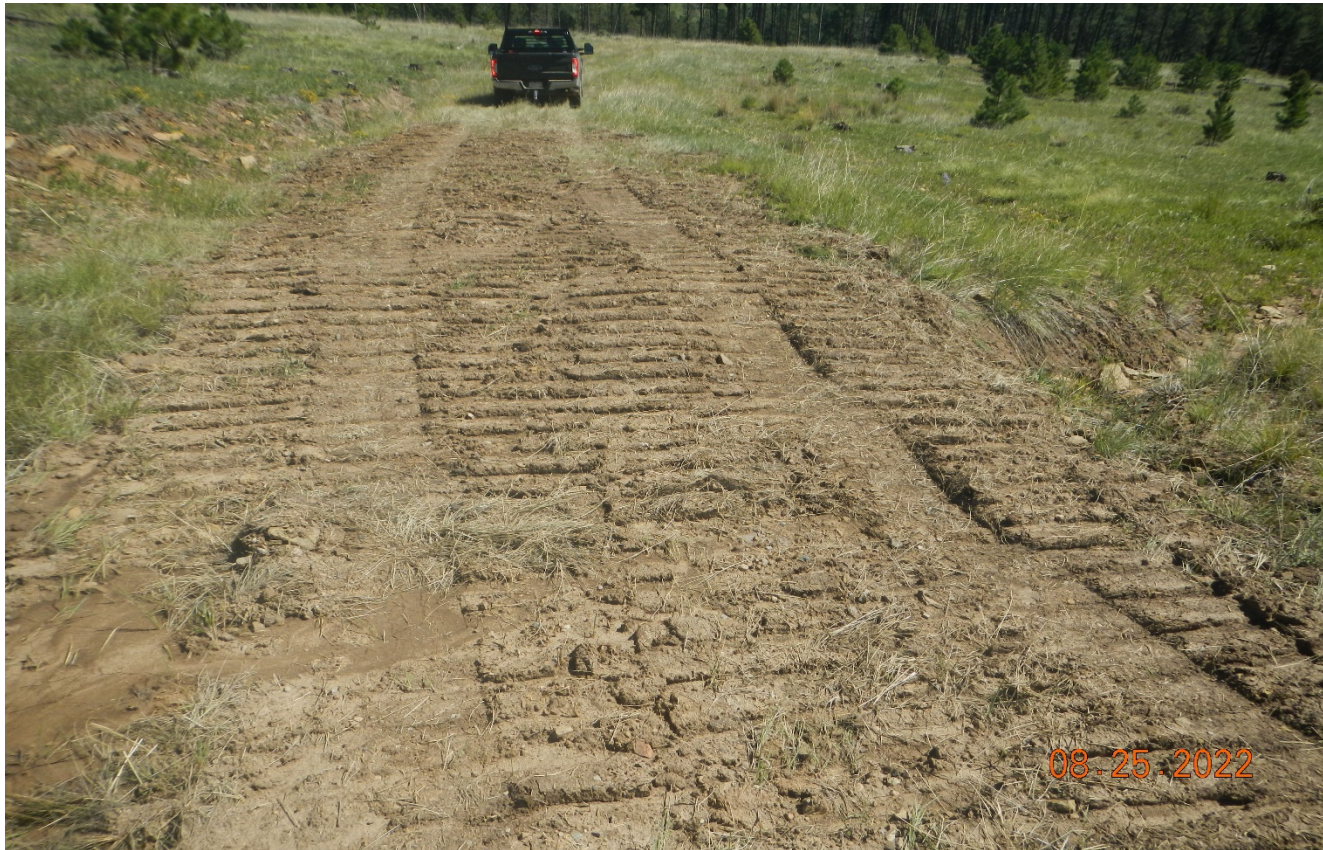
Photo 1. There has been work done to repair erosion at the water bars.

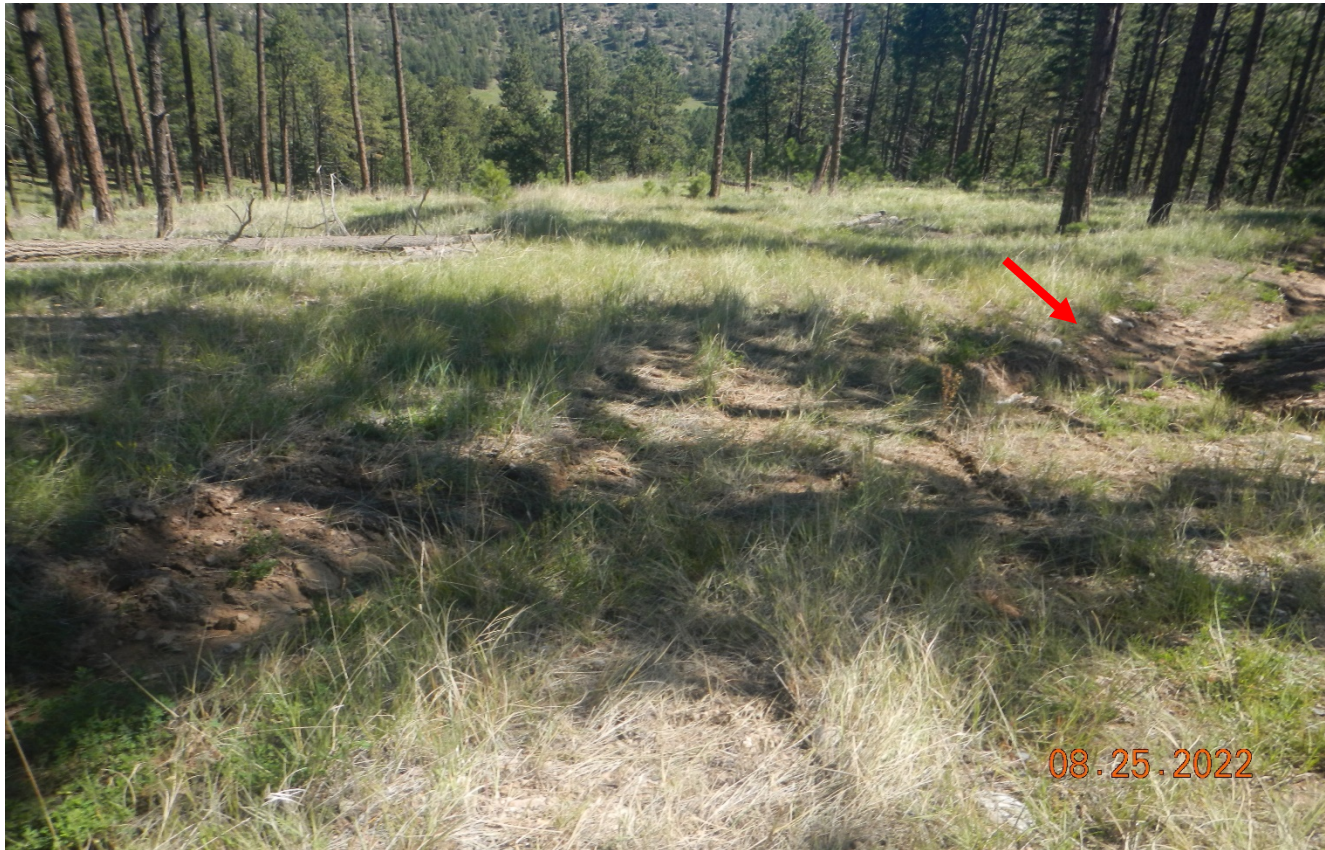
Photo 2. Additional stabilization should be performed at the red arrow where stormwater is diverted toward.

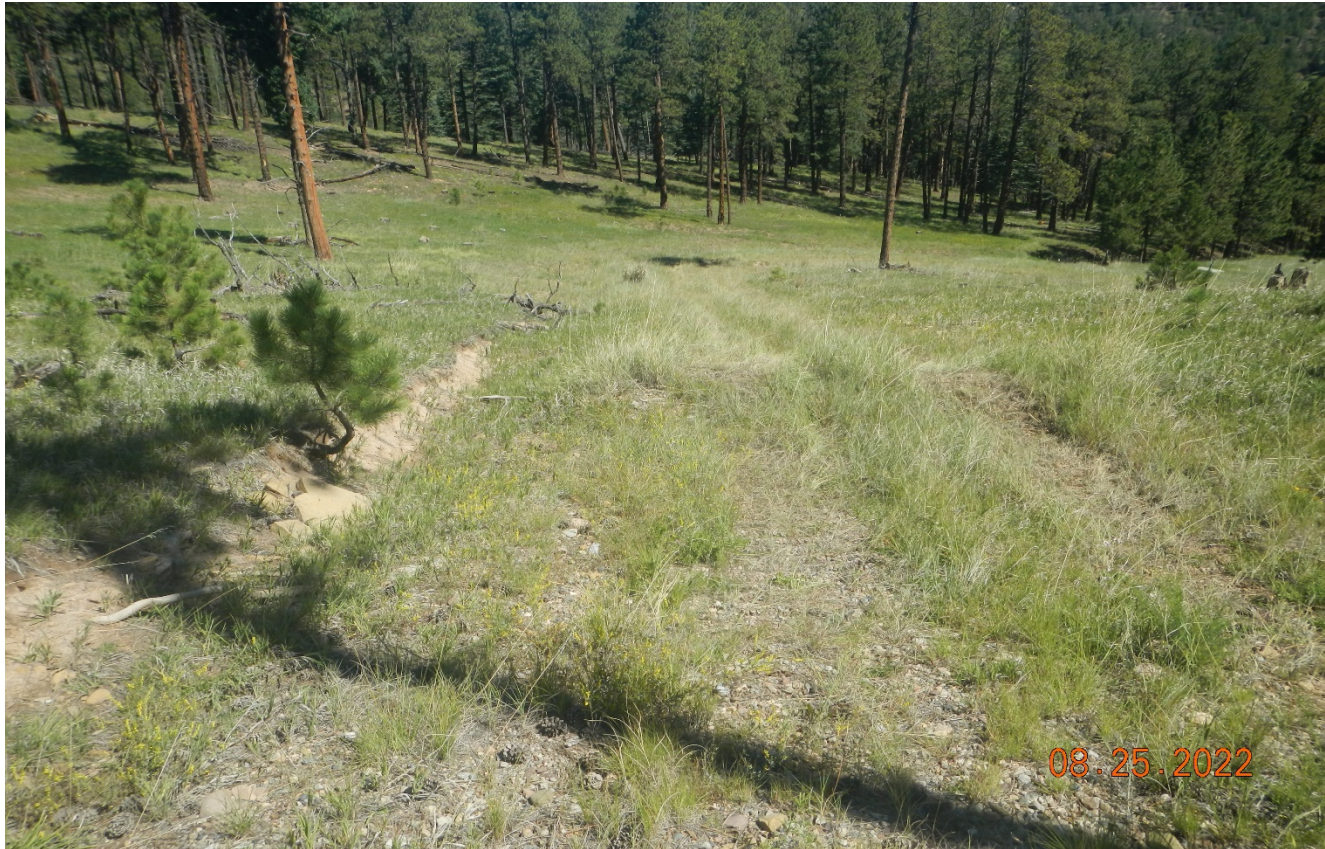
Photo 3. Facing down north along the access road.

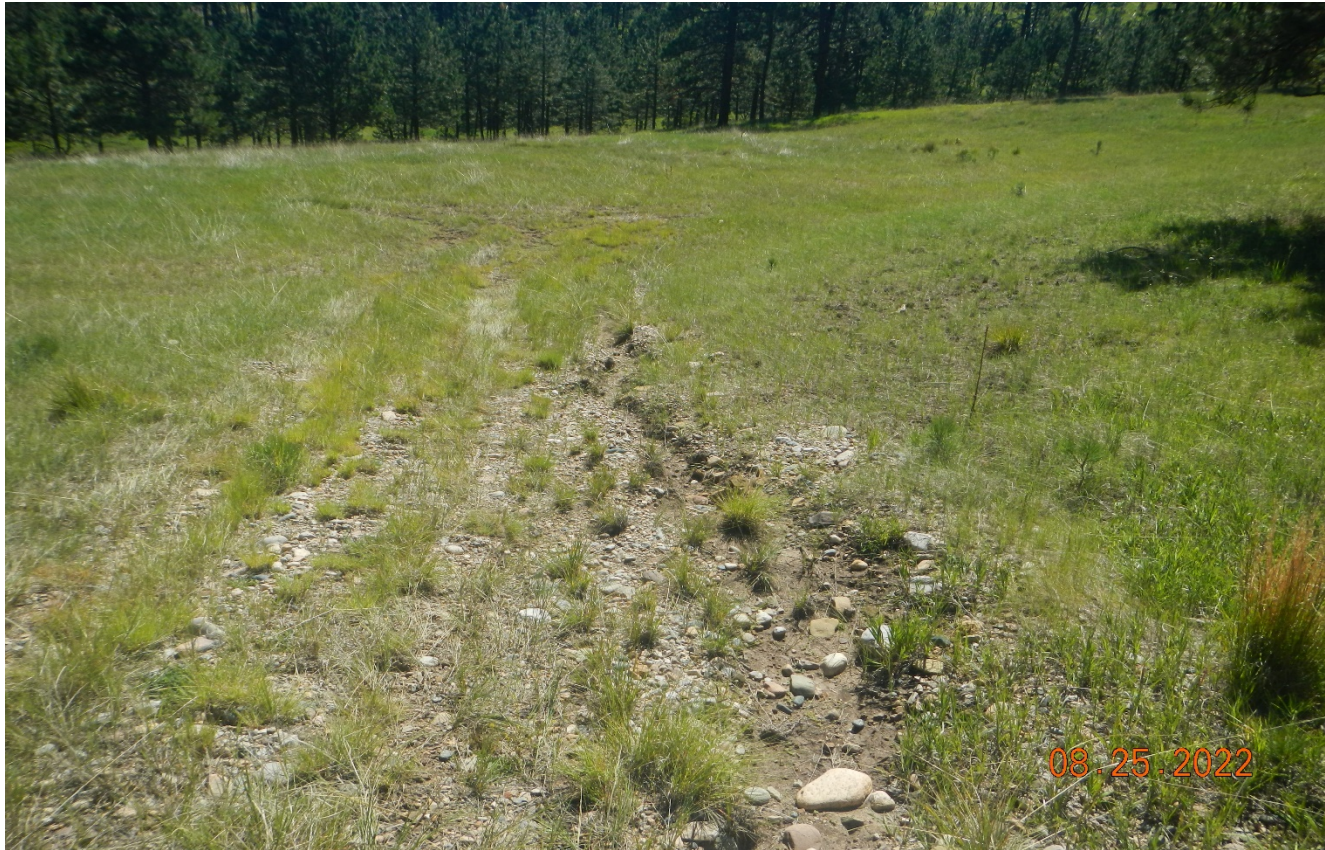
Photo 4. Facing northeast toward the location. There is erosion in this area where stormwater is directed toward the location.

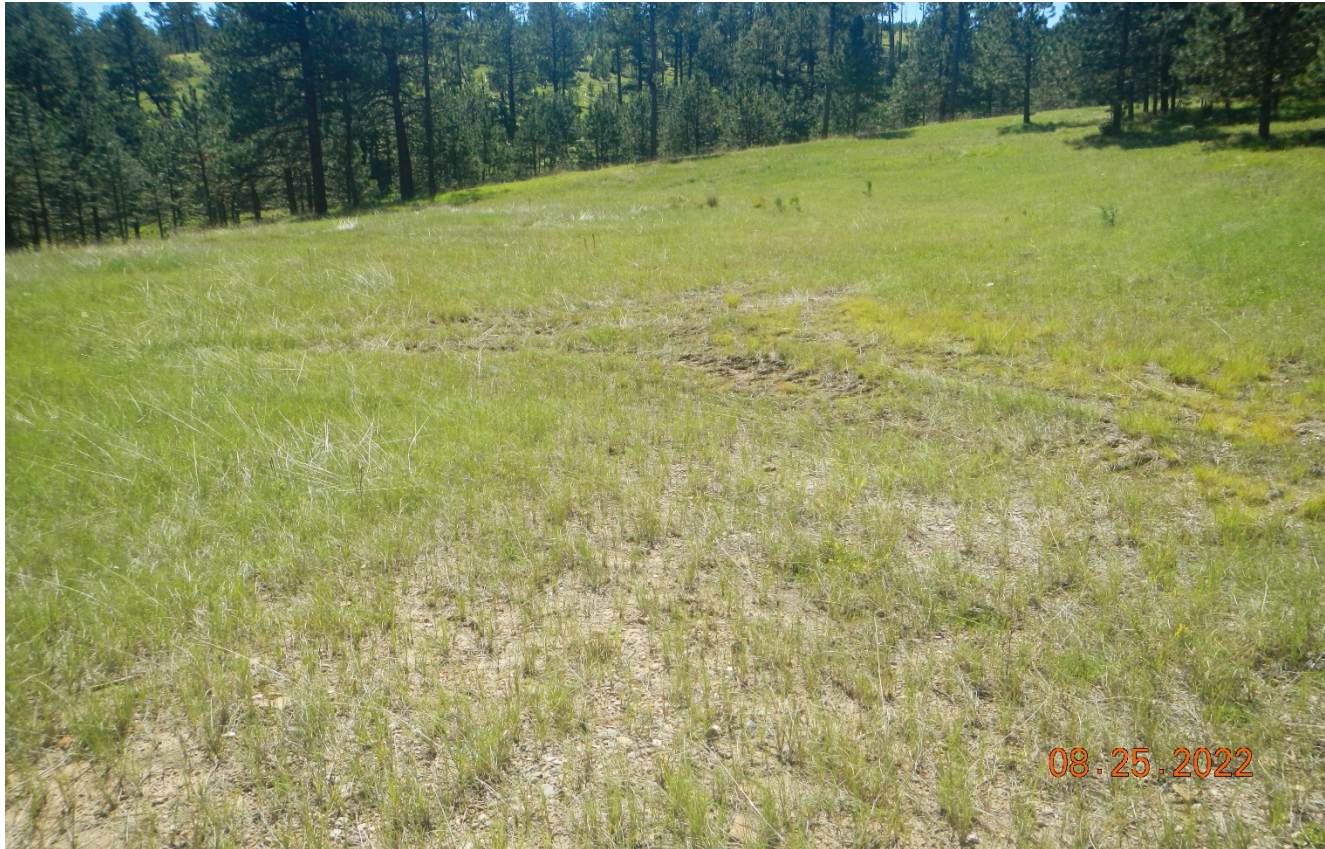
Photo 5. Facing east toward the location. The location is stabilized with native perennial vegetation cover.

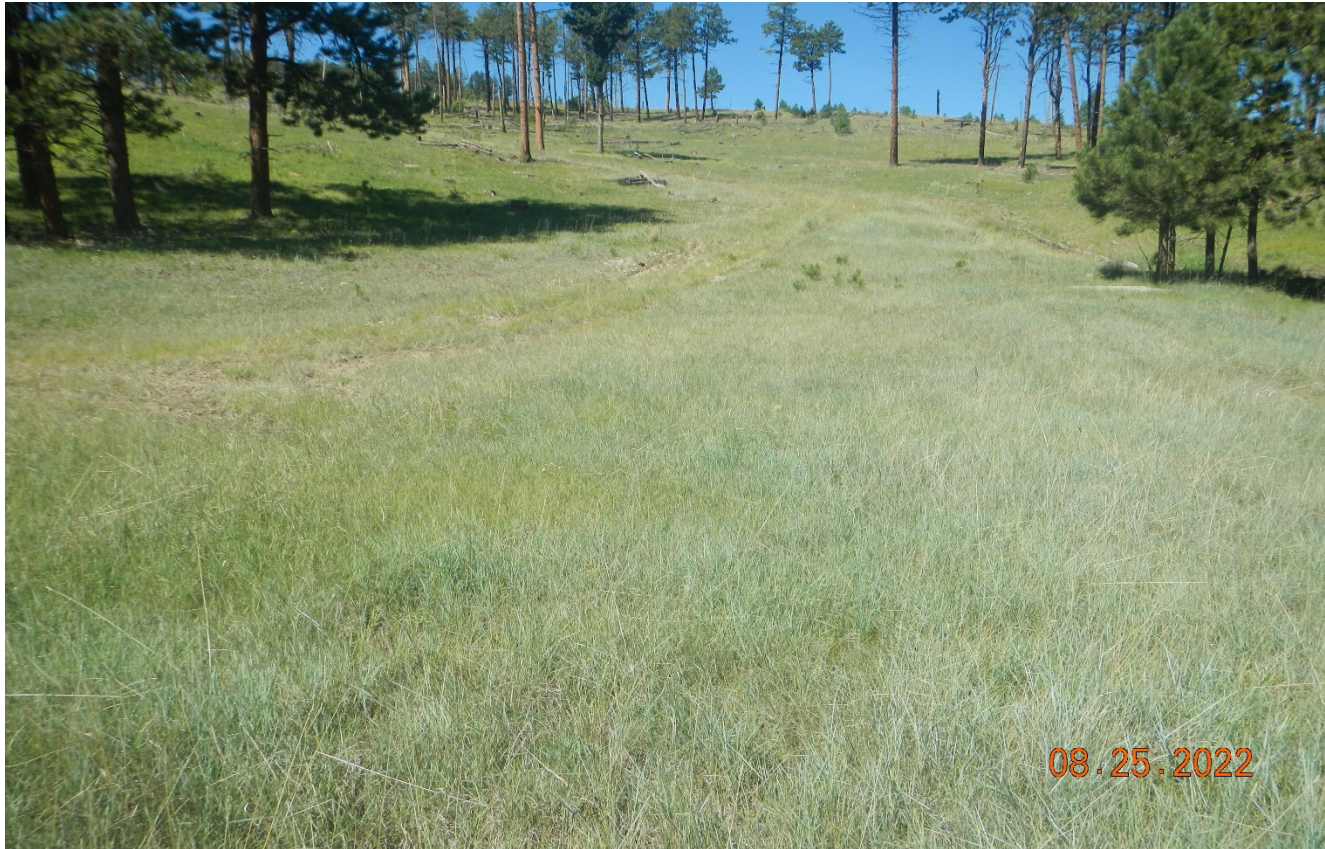
Photo 6. Facing southwest at the location. The location is stabilized with native perennial vegetation cover.
