Inspection Photos

Location Name: MUSTANG RESOURCES LLC MOORE-66S94W /27SENE

Location ID: 323788

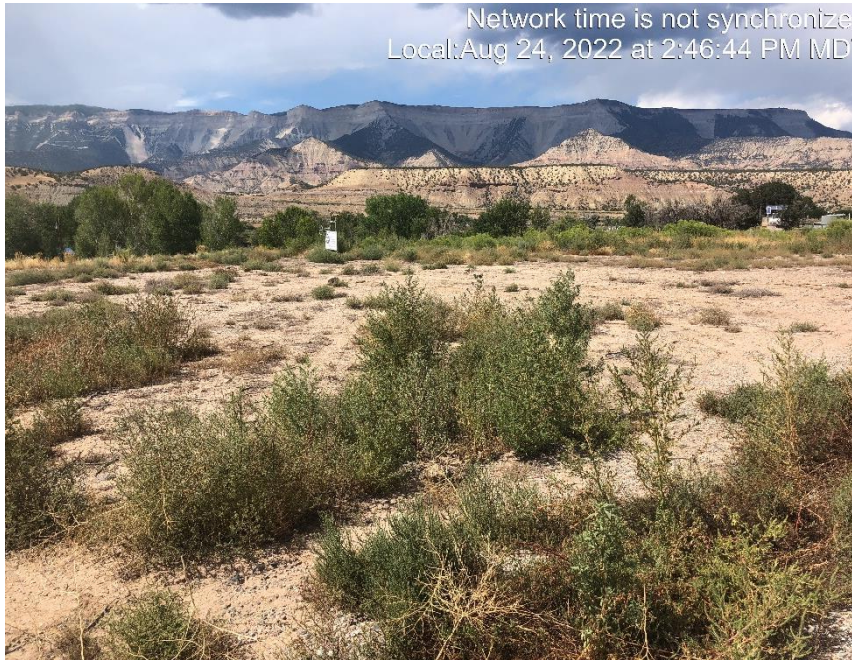
Photo #7572 from entrance to location.

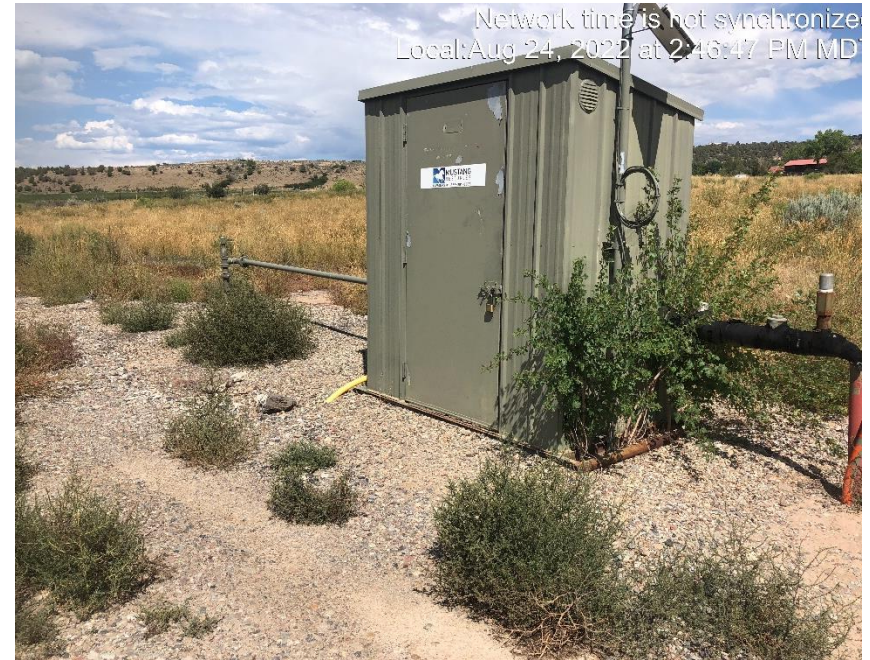
Photo #7573 from entrance to location.

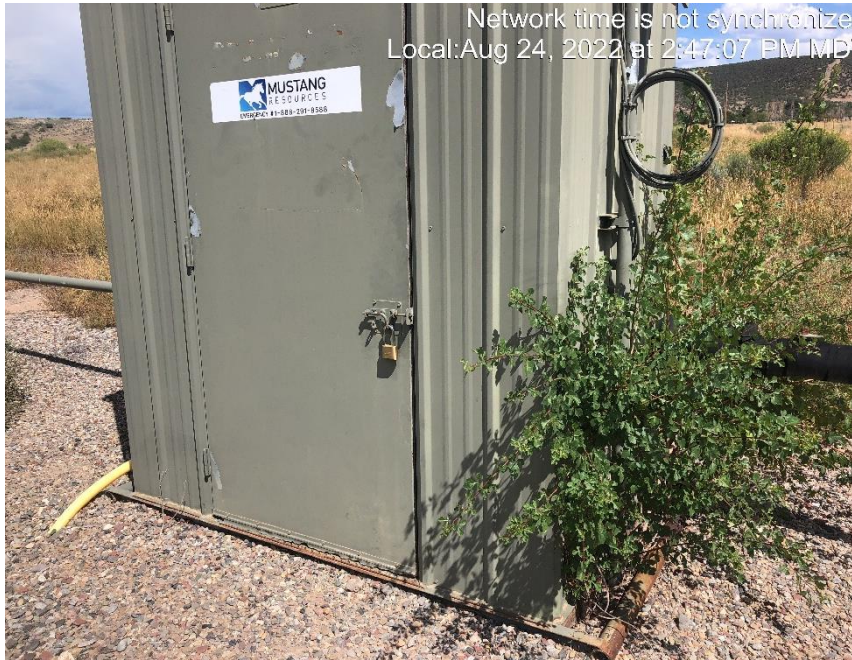
Photo #7574 Multiple places with Undesirable plant species on location.

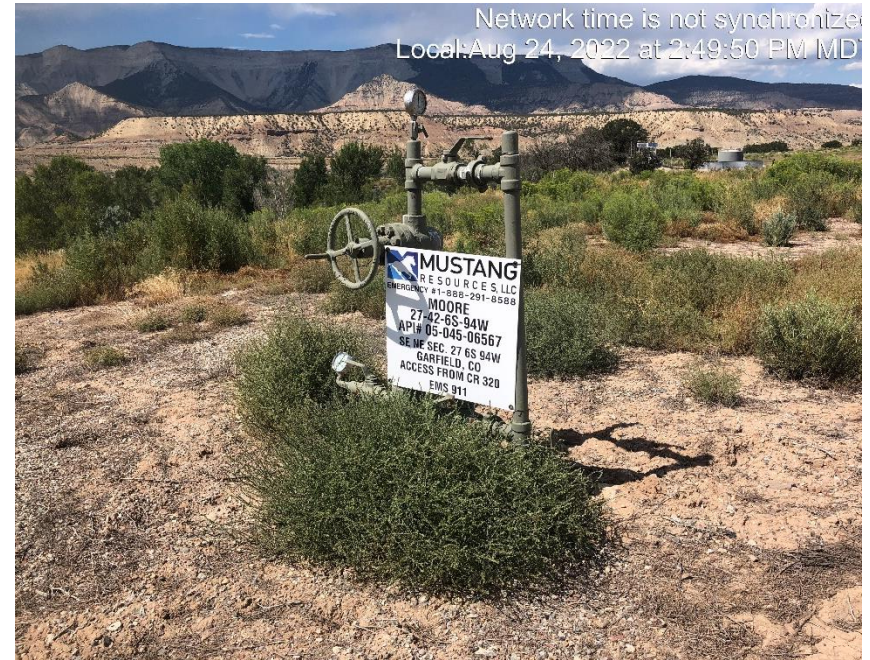
Photo #7576 Multiple places with Undesirable plant species on location.

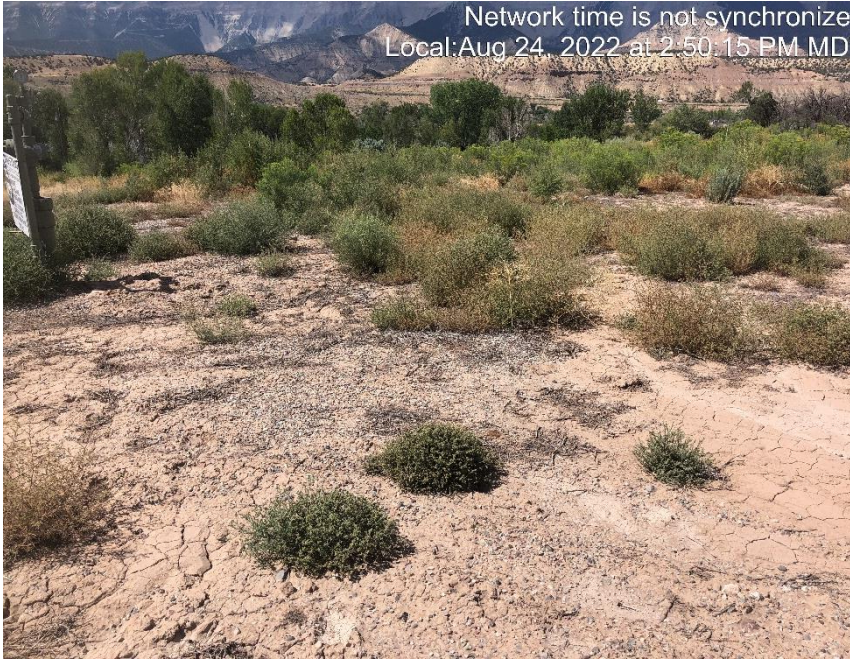
Photo #7577 Multiple places with Undesirable plant species on location.

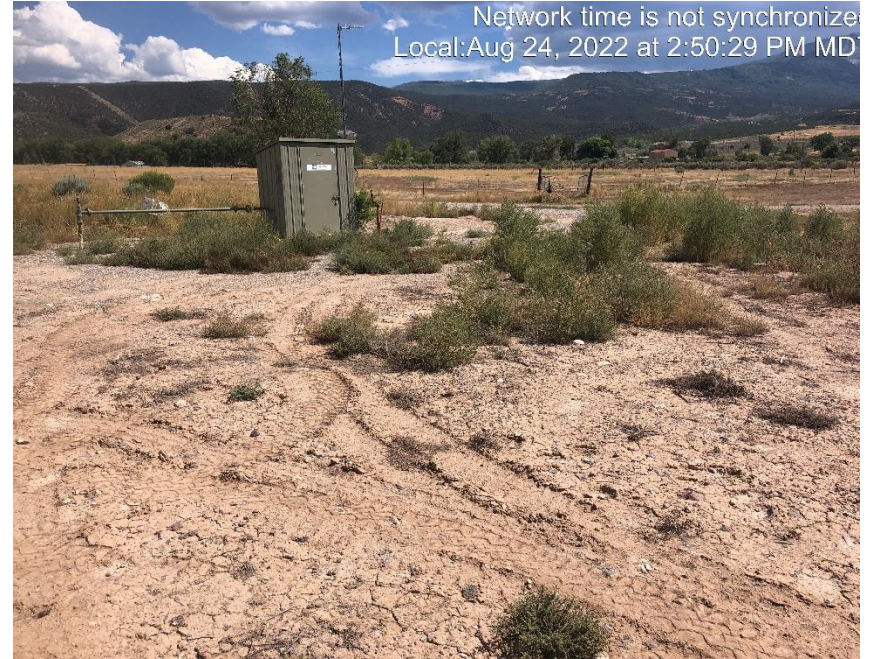
Photo #7578 Multiple places with Undesirable plant species on location.
