Inspection Photos

107-06051

Inspection Date: 8/24/2022

COLORADO
Oil & Gas Conservation
Commission
Department of Natural Resources

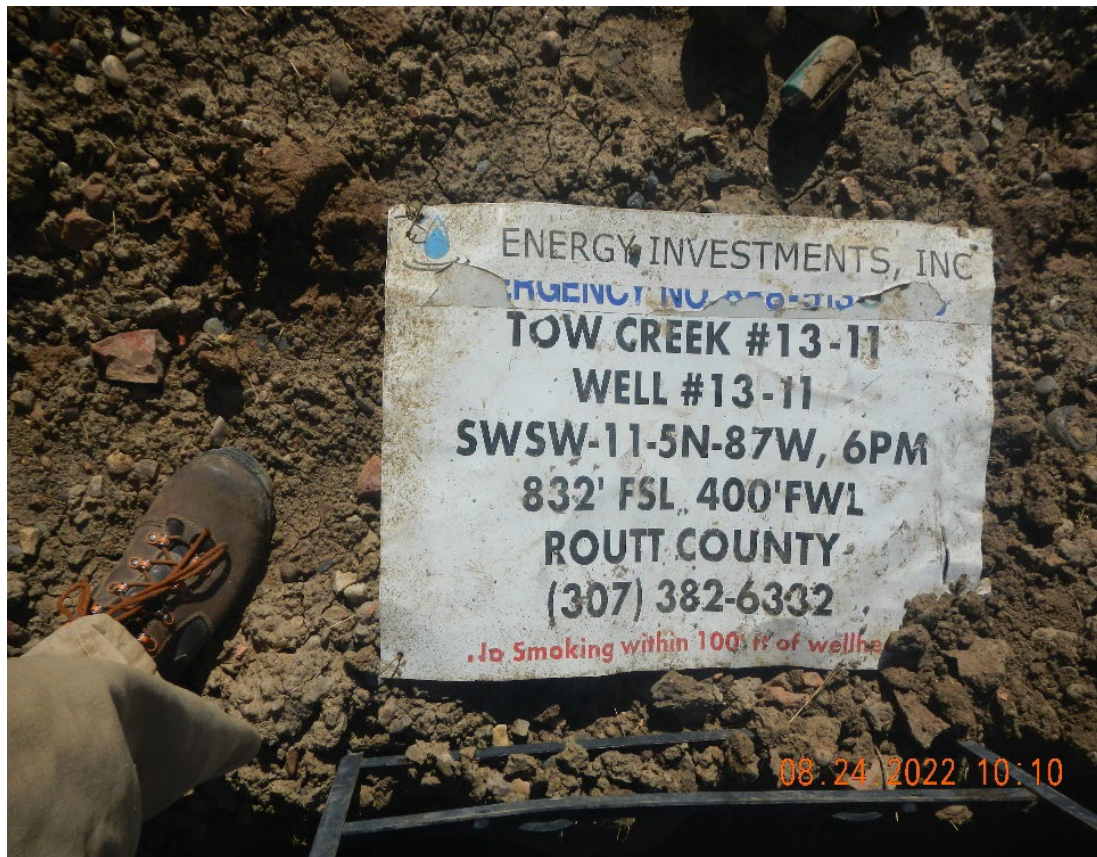
Photo #1 Sign at wellhead.

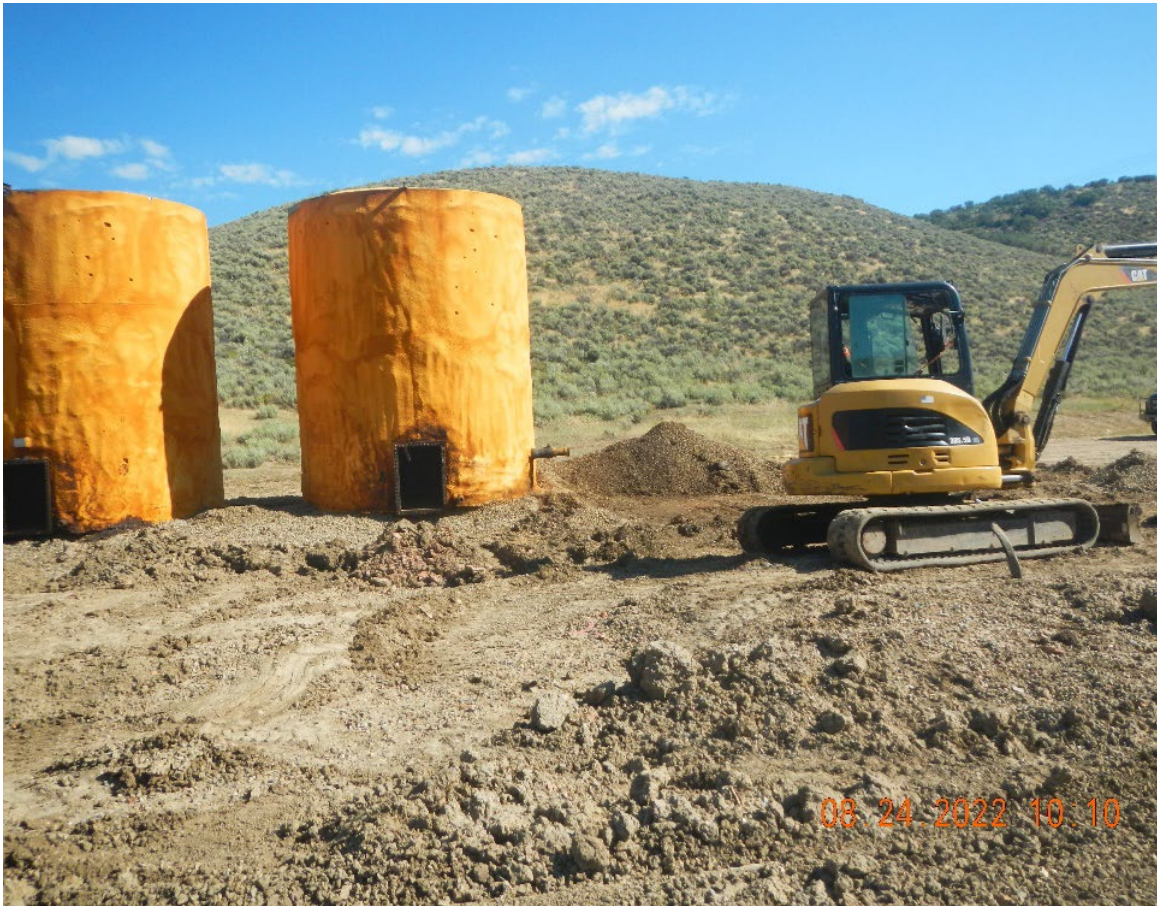
Photo #2 2 AGT in photo are in the same position as when well was producing. The two tanks in photo were the two middle tanks. The eastern and western most tanks were loaded onto a trailer on location. Crews arrived to haul tanks during the day of inspection. It was reported on the Form 27 that the tanks were cleaned on location, no obvious signs of fluid from tanks was observed on location. The tanks were set on gravel and gravel in the tank battery, it was told to COGCC that the gravel was going to be removed. As a part of the investigation, the gravel below the tanks was scraped to dirt to observe the soil below. Soil had a "swampy smell", no hydrocarbon odor was detected.

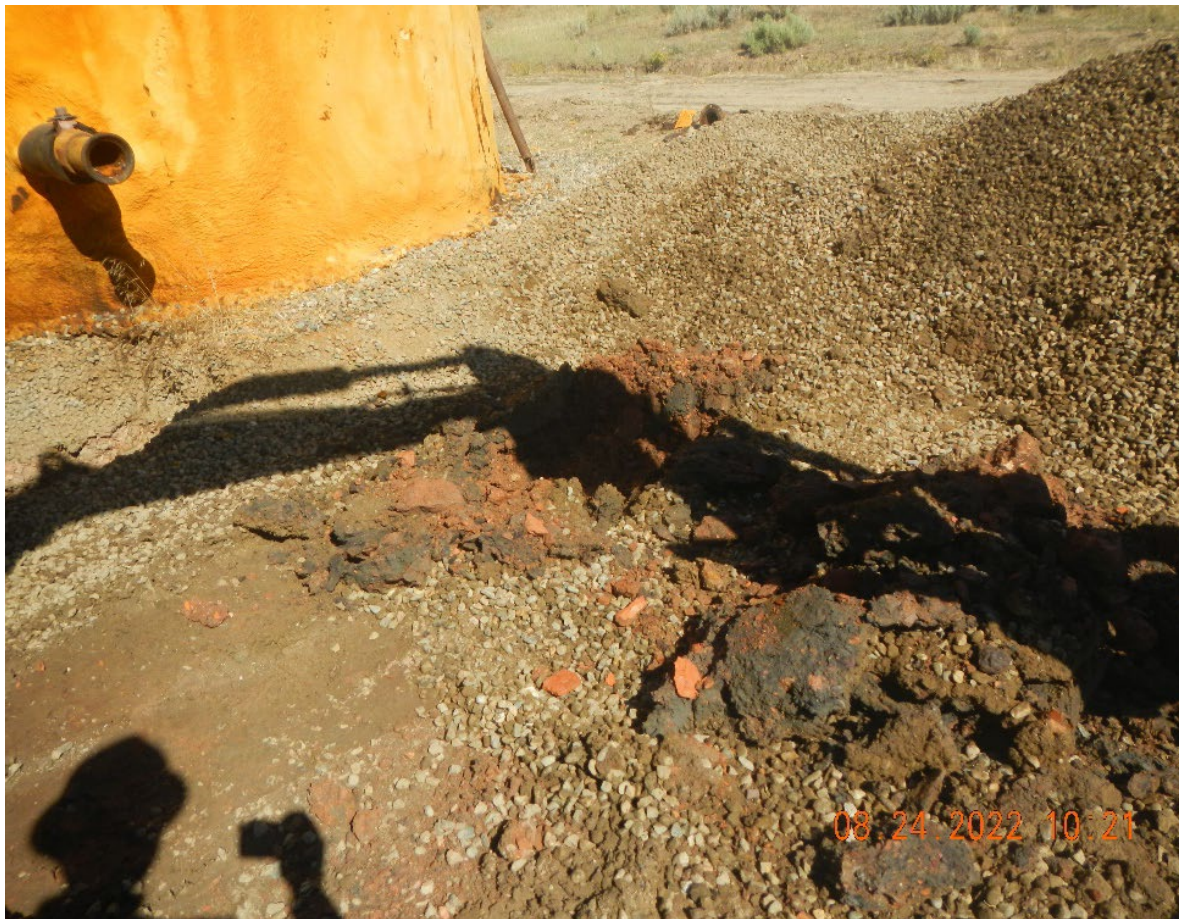
Photo #3 The soil below gravel, and subsurface on the entire pad was medium soft clay with a red claystone below. No hydrocarbon odor was detected.

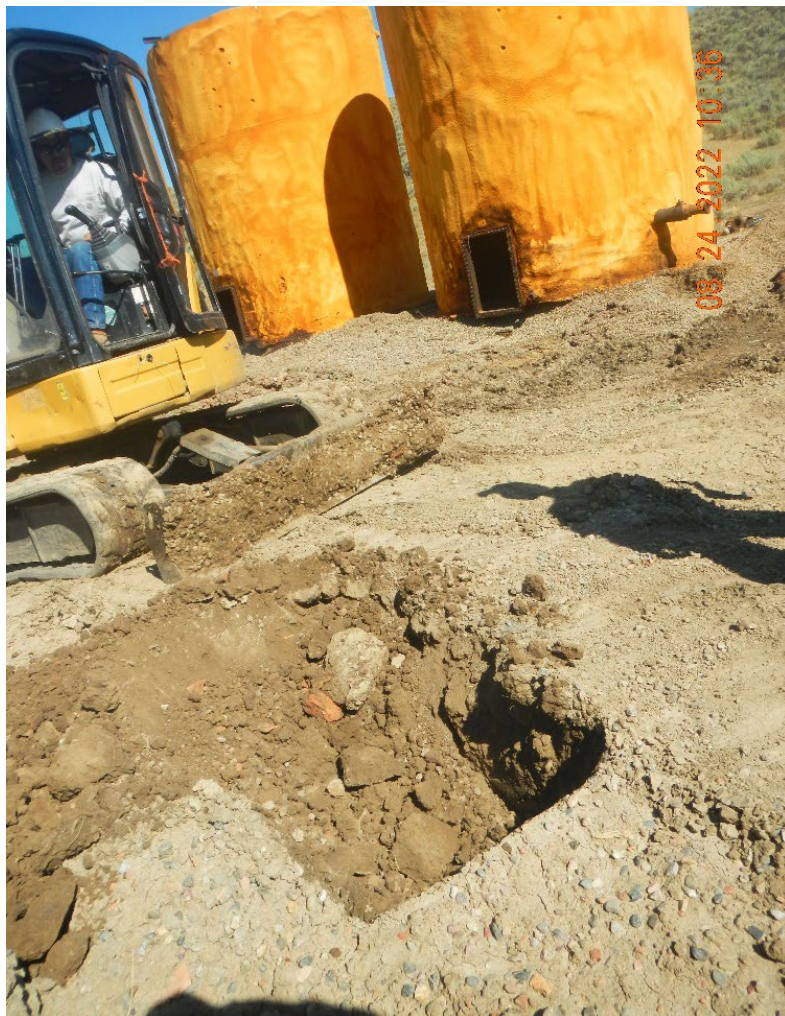
Photo #4 Sample at flowline from wellhead to tank battery. This was the only known flowing on the location. The flowline was removed from the ground.

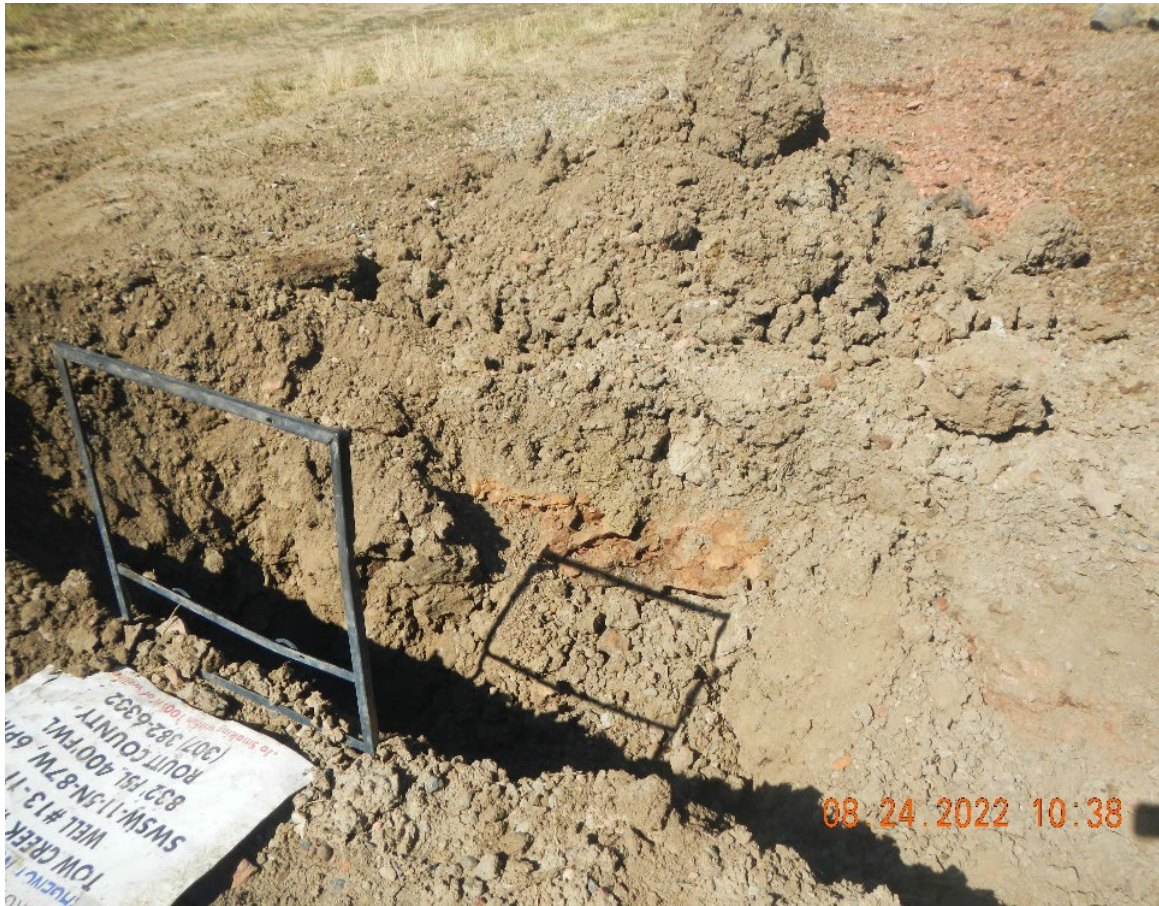
Photo #5 sample at wellhead, approx 6 feet deep. Not soft clay with red claystone below.

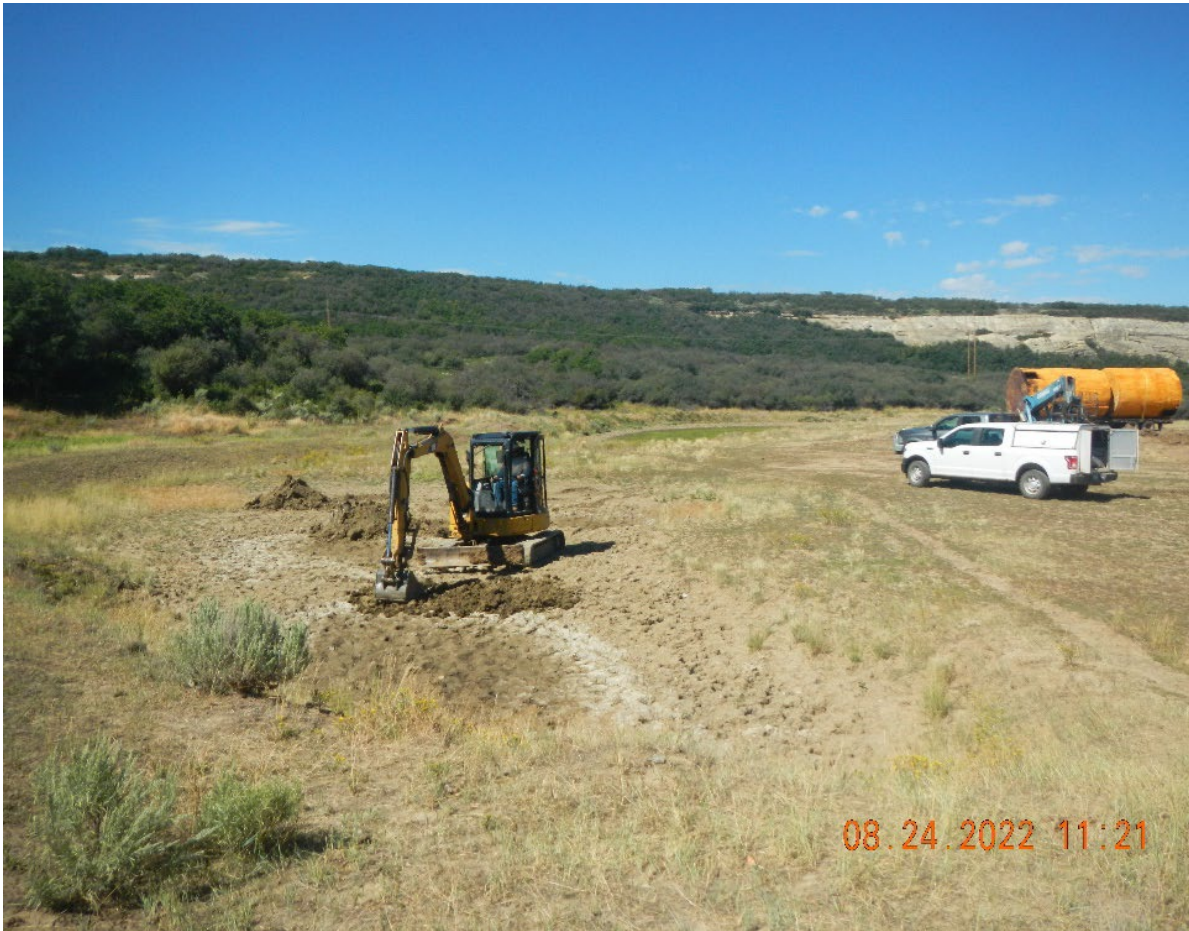
Photo #6 area with excavator was the area with salt staining in aerial photo (google 2019). Three pot holes were dug and observed, no hydrocarbon staining or odor was observed.

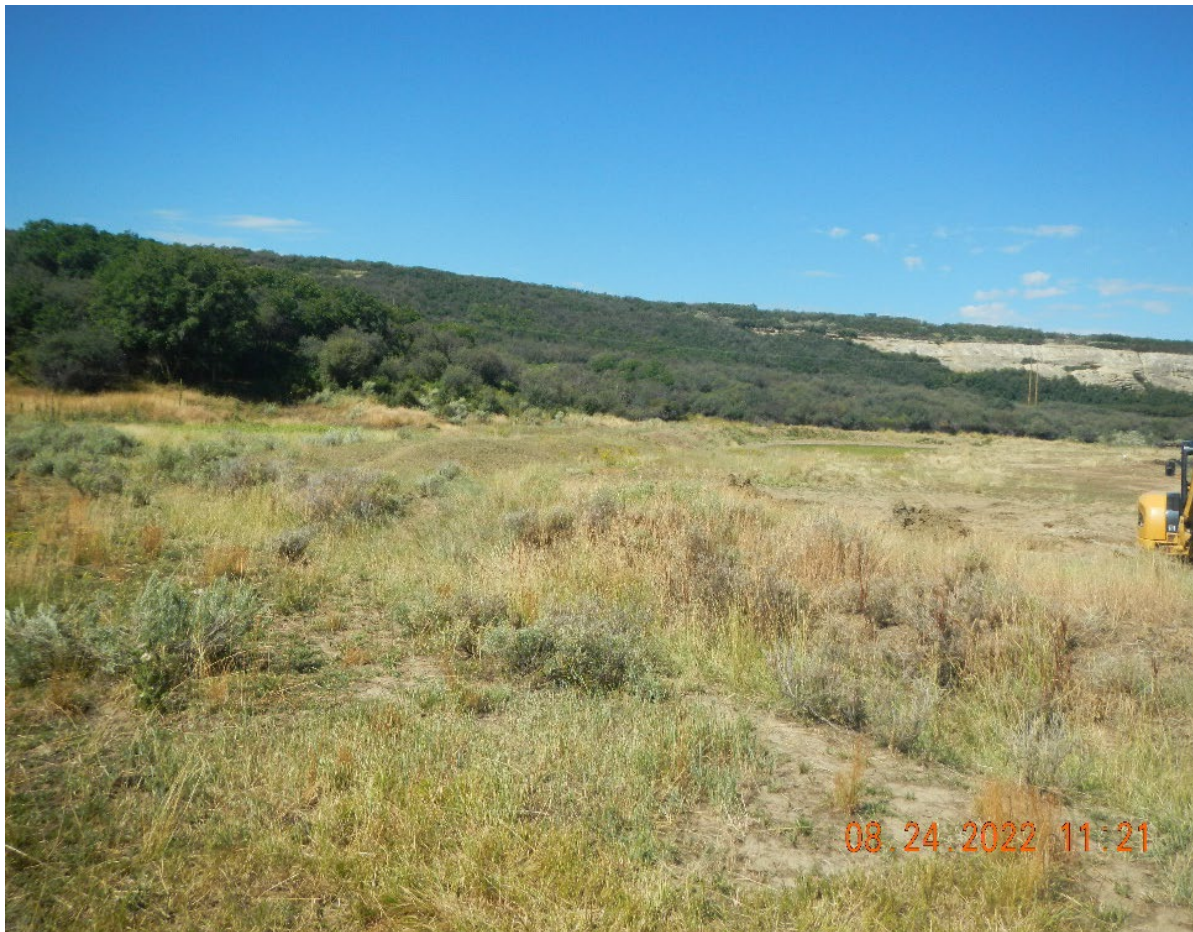
Photo #7 photo was attempting to show the series of surface water diversion berms that exist on the pad. There is a berm that diverts waster coming from the east around the pad into the ponds south of the well pad.

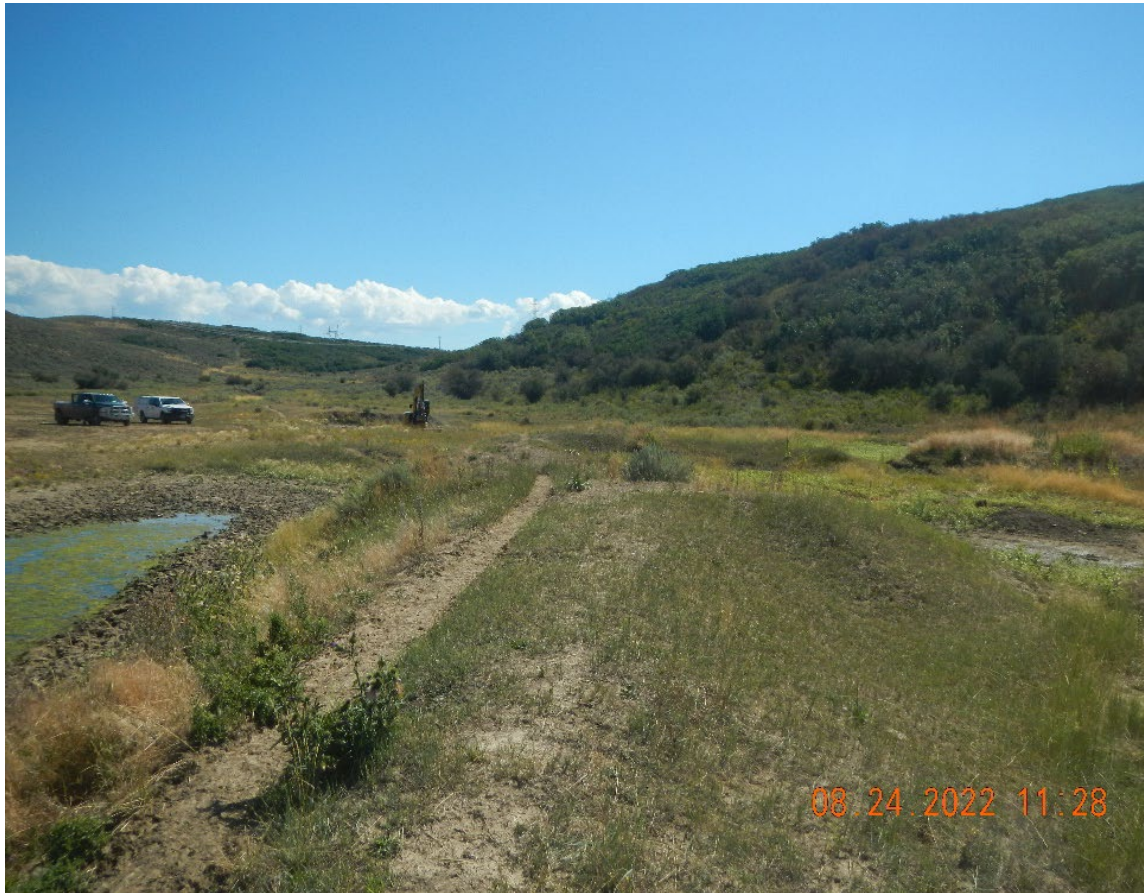
Photo #8 looking east, up grade.

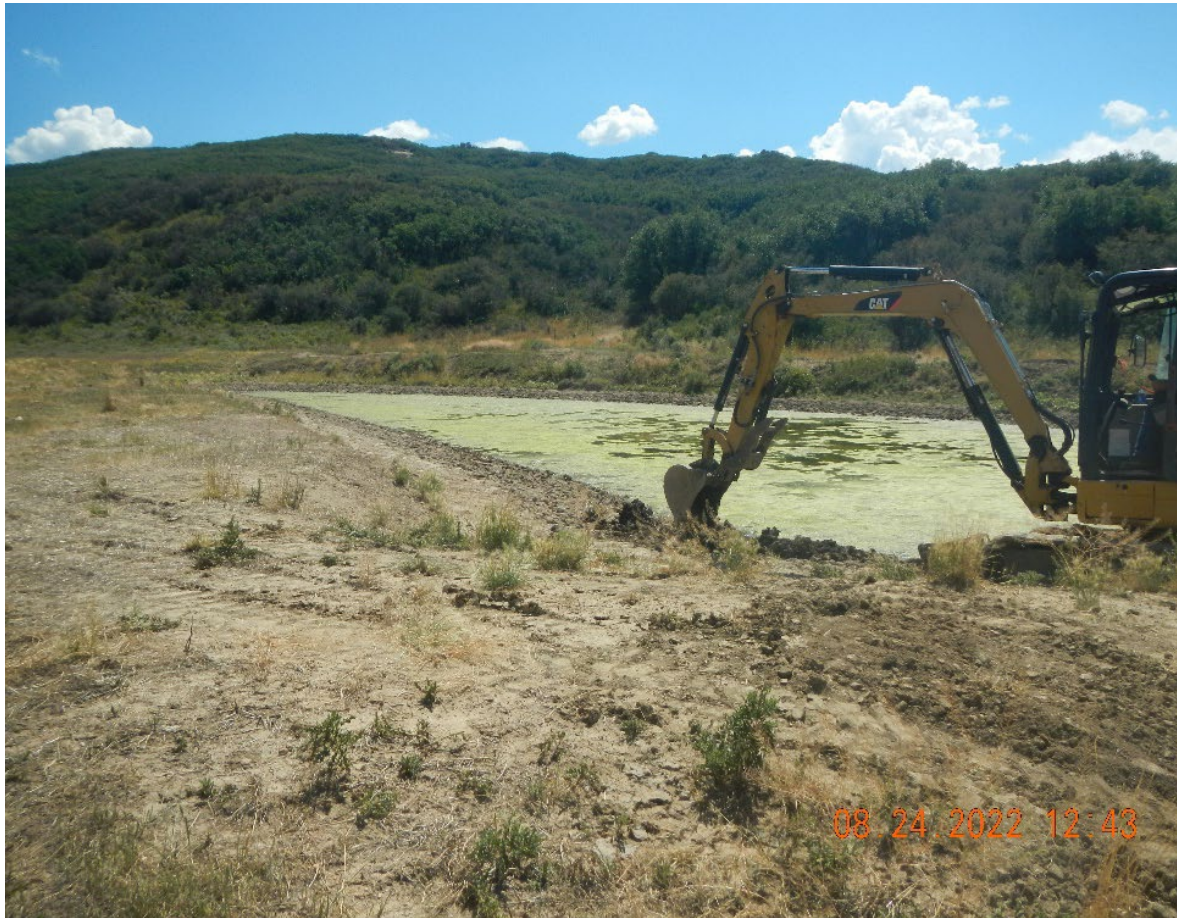
Photo #9 potholing and sampling at the pond near well pad.

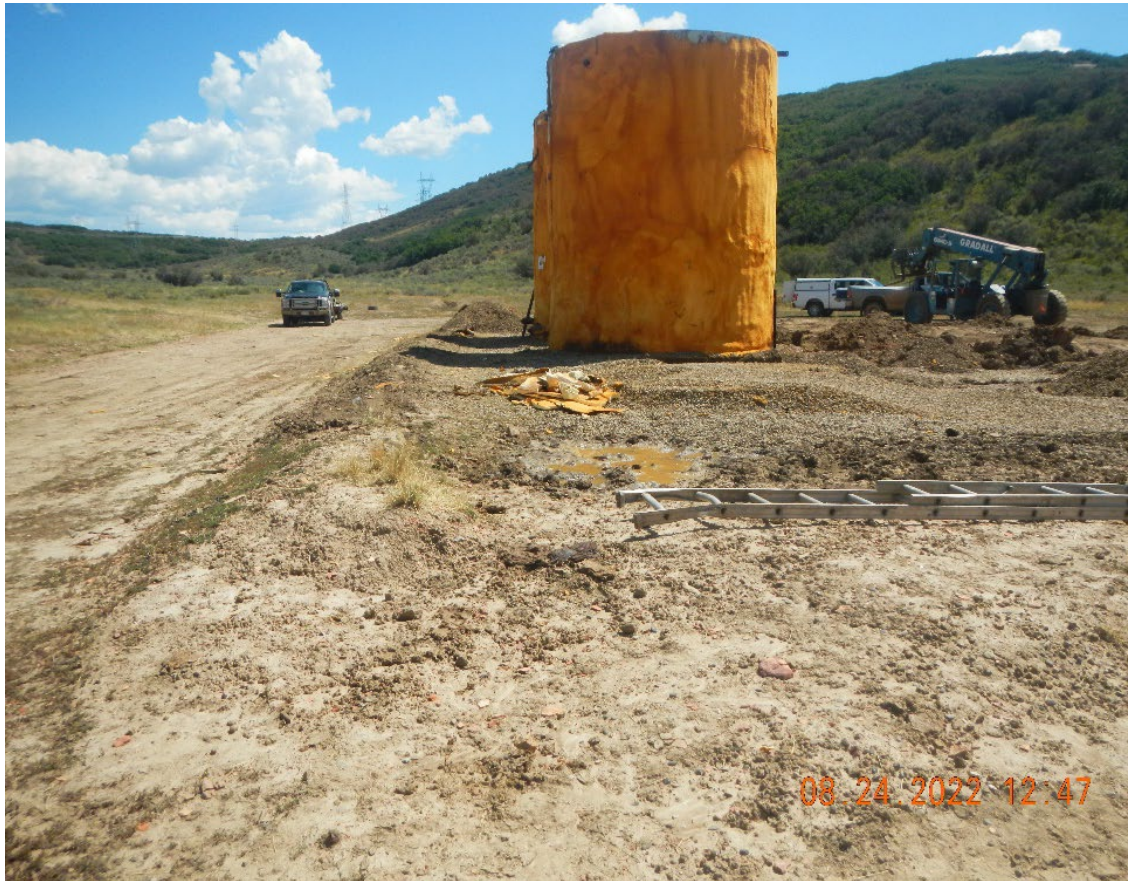
Photo #10 looking east, the western most tank was removed (on trailer on location) gravel seen in photo was pushed to sample the soil below .

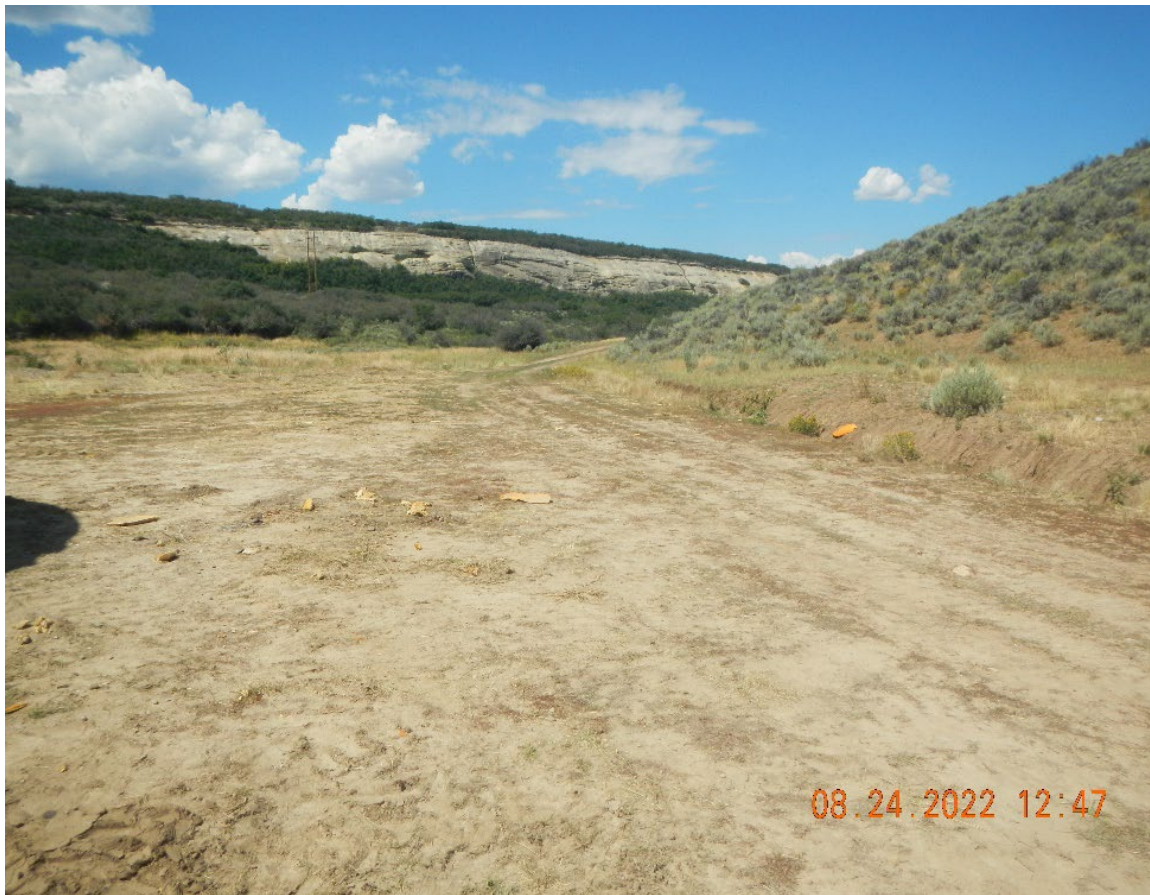
Photo #11 west side of pad, shows foam from tank insulation that was blown around the pad.

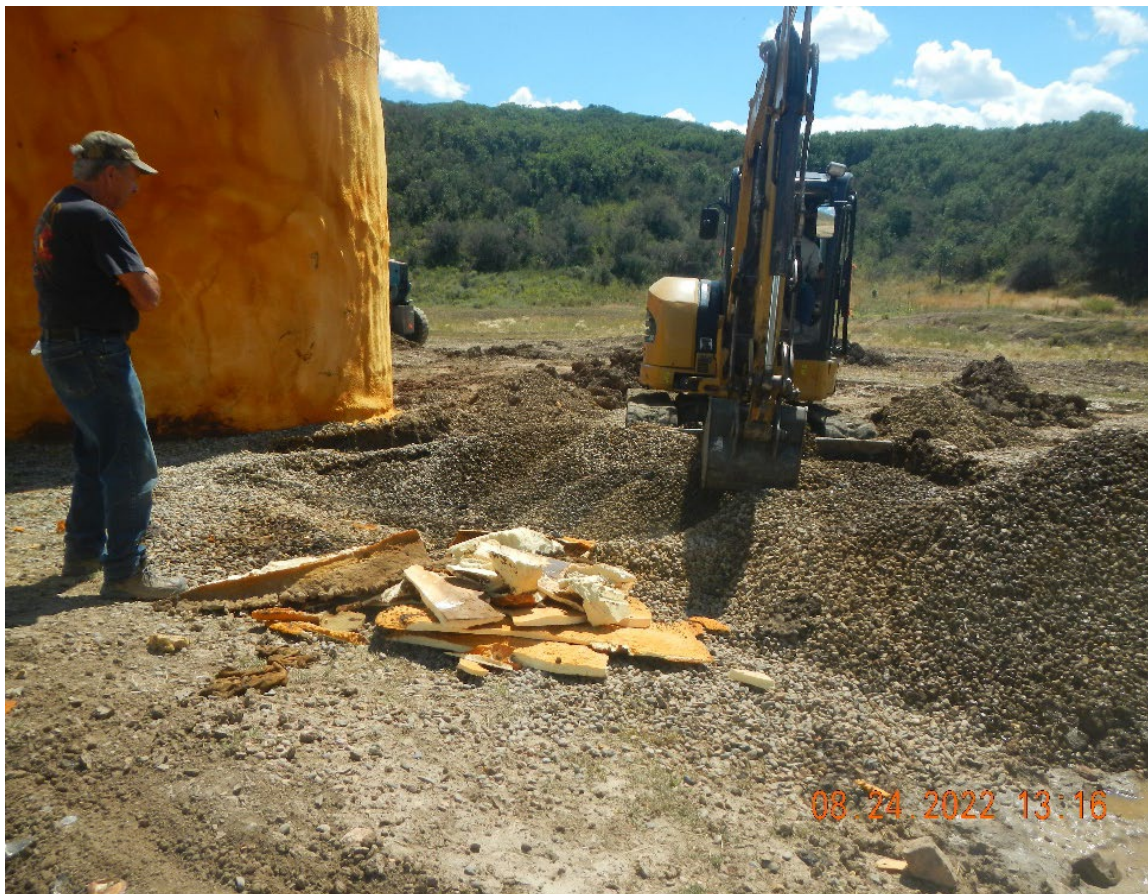
Photo #12 moving gravel to access soil under tank.

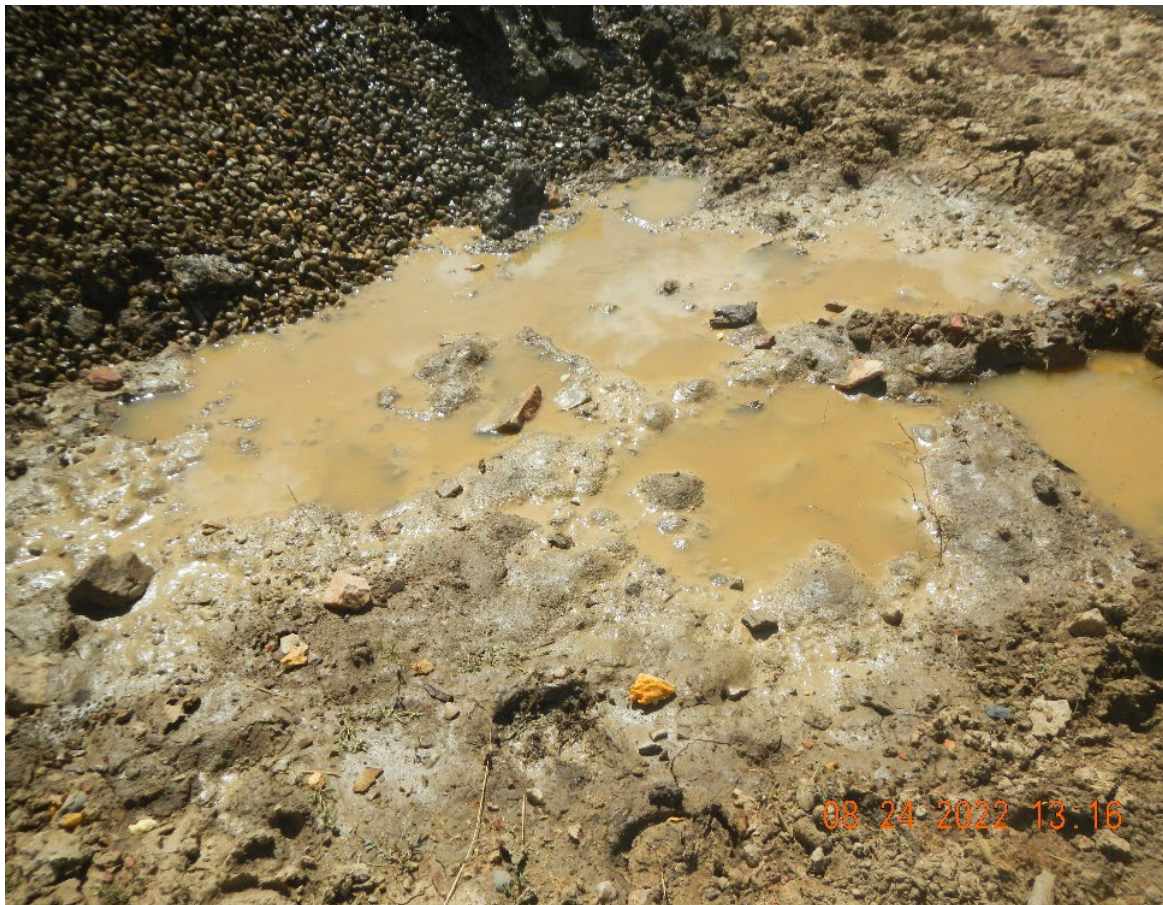
Photo #13 close up of puddle seen in photo 10. no observable sheen on puddles.

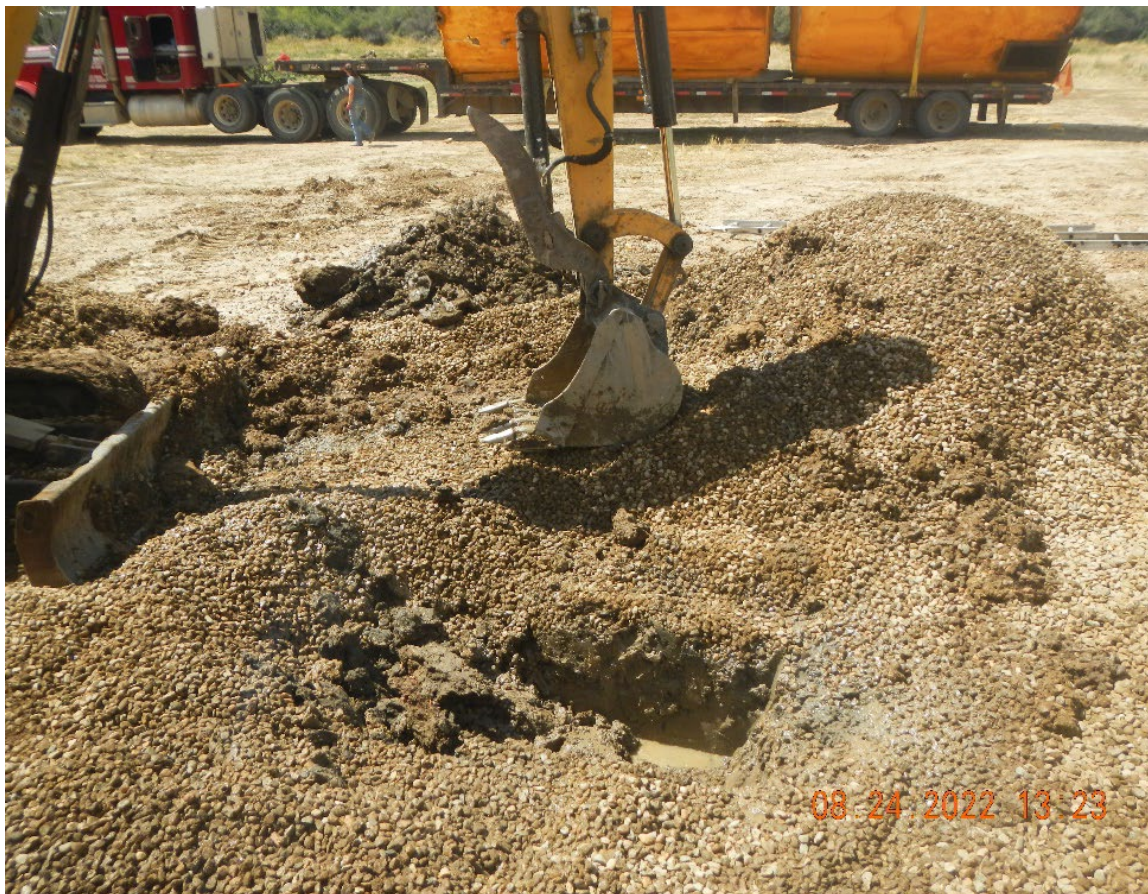
Photo #14 sampling of western most tank, water was in gravel and infiltrated the excavation from the surface.
