Interim Reclamation and Stormwater Inspection

Date: 08/24/2022

Operator: WESTERN OPERATING COMPANY -95620

Location ID: 312291

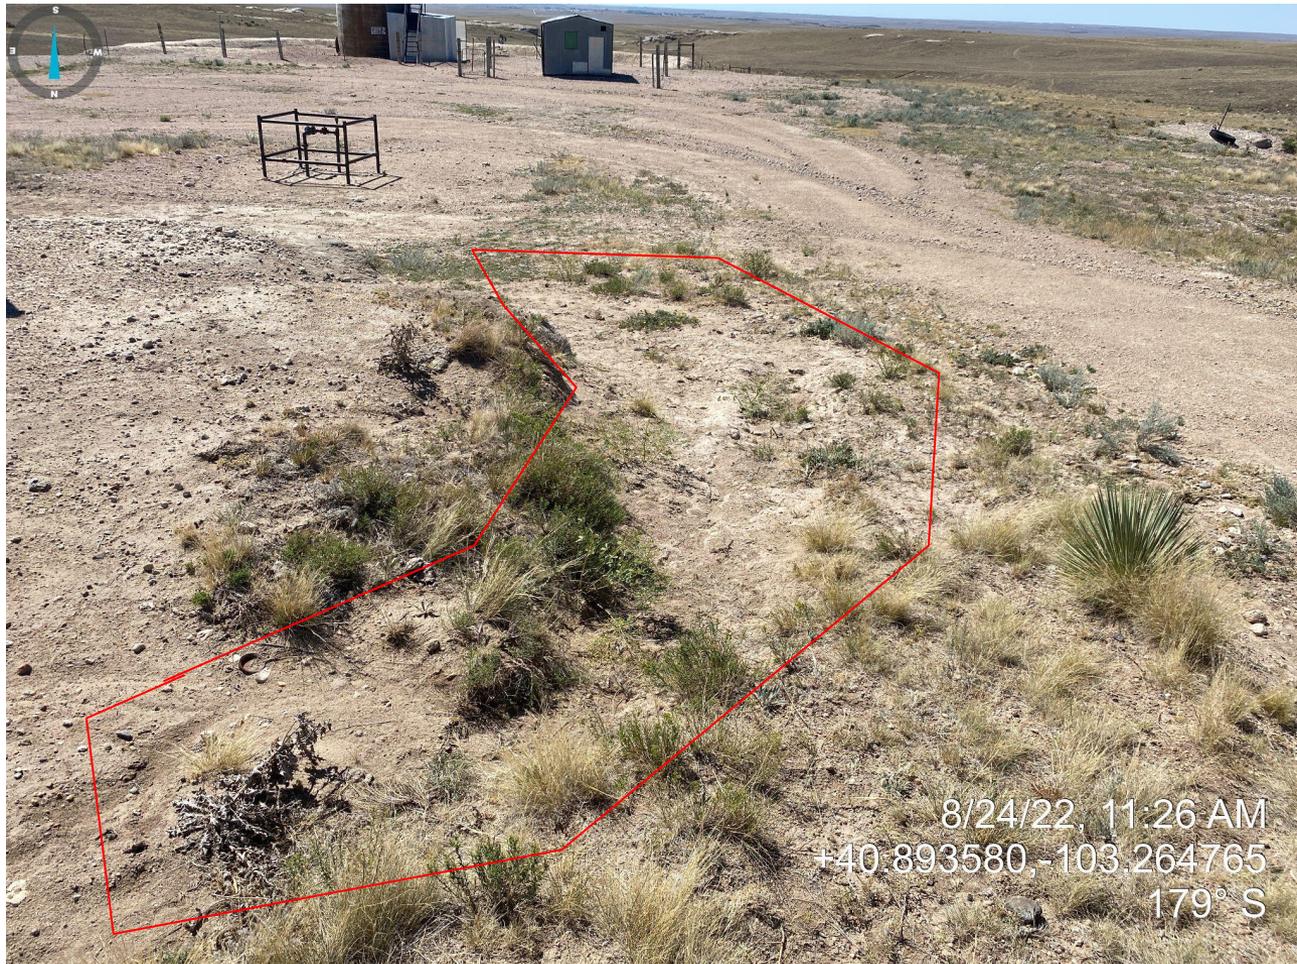
Photo 1. Location photo taken from northern portion, facing south. Photo illustrates gully erosion (outlined in red) on western edge of battery location.

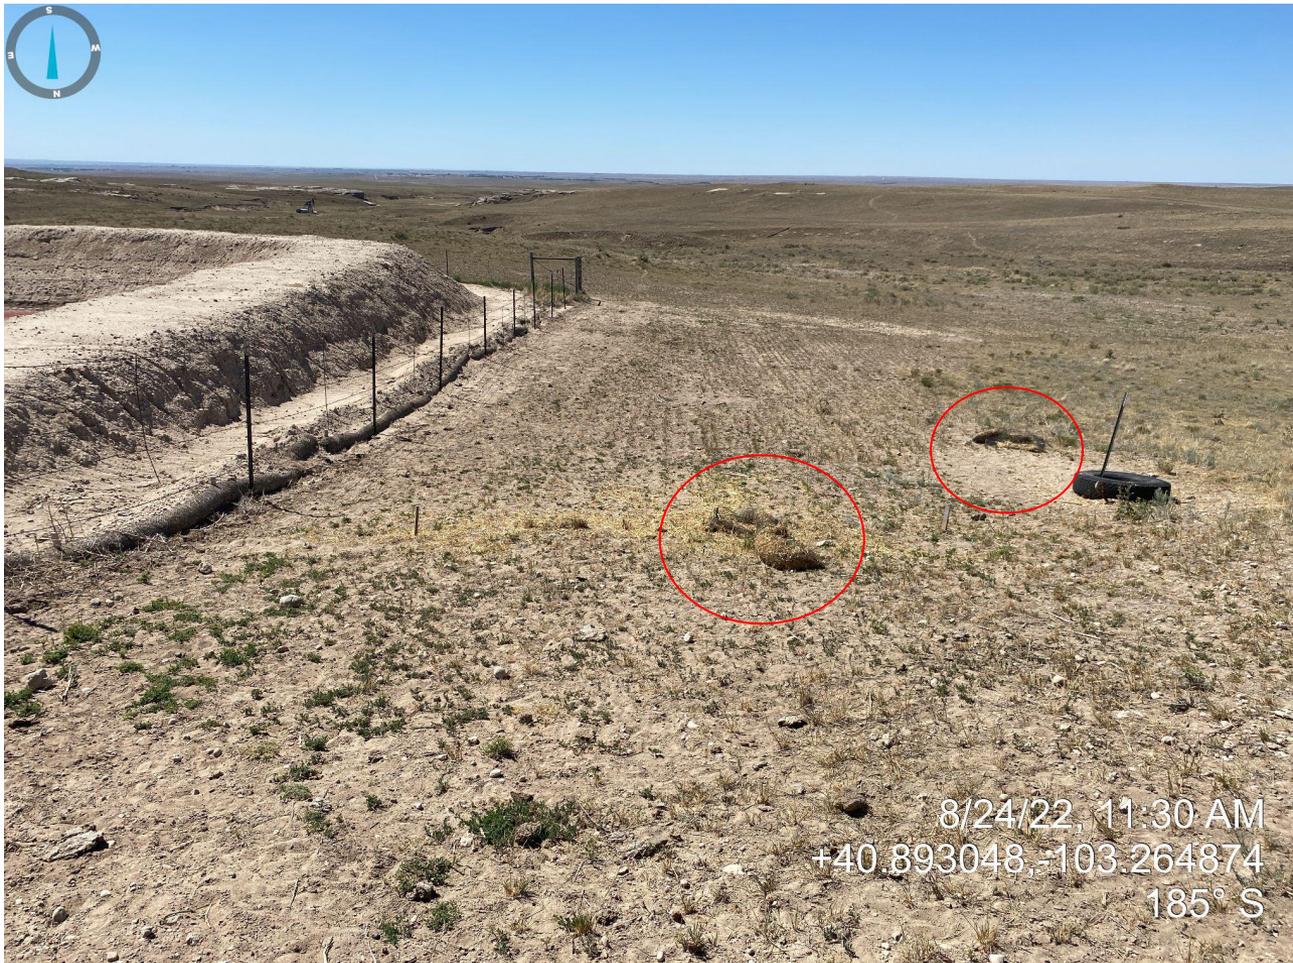
Photo 2. Pit photo taken from northwestern corner, facing south. Photo illustrates non-uniform vegetation cover resulting in bare soil and straw wattle (outlined in red) not properly installed and displaced within affected area; this is now considered debris and needs to be disposed of accordingly.

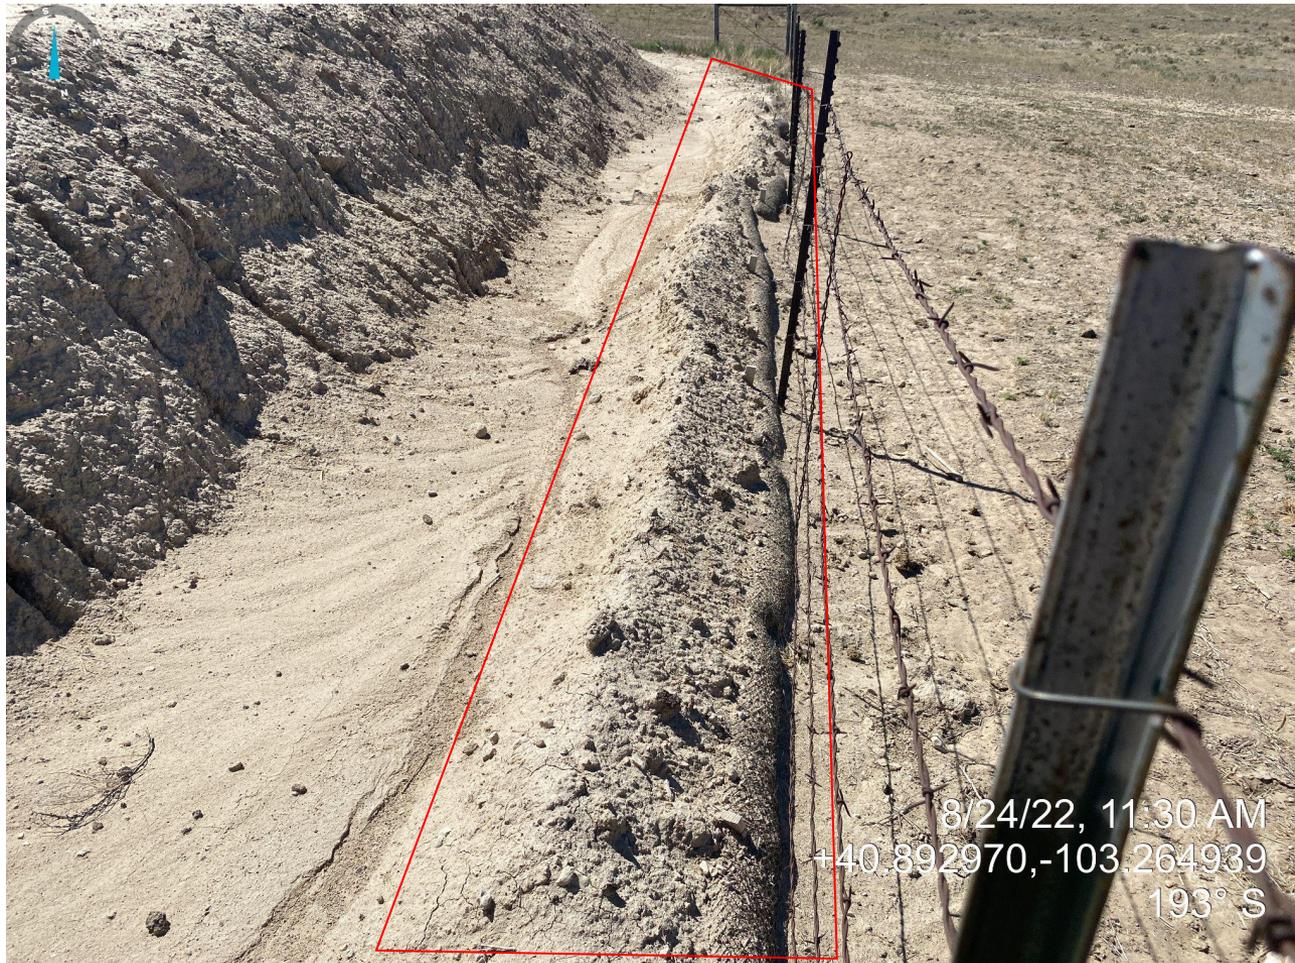
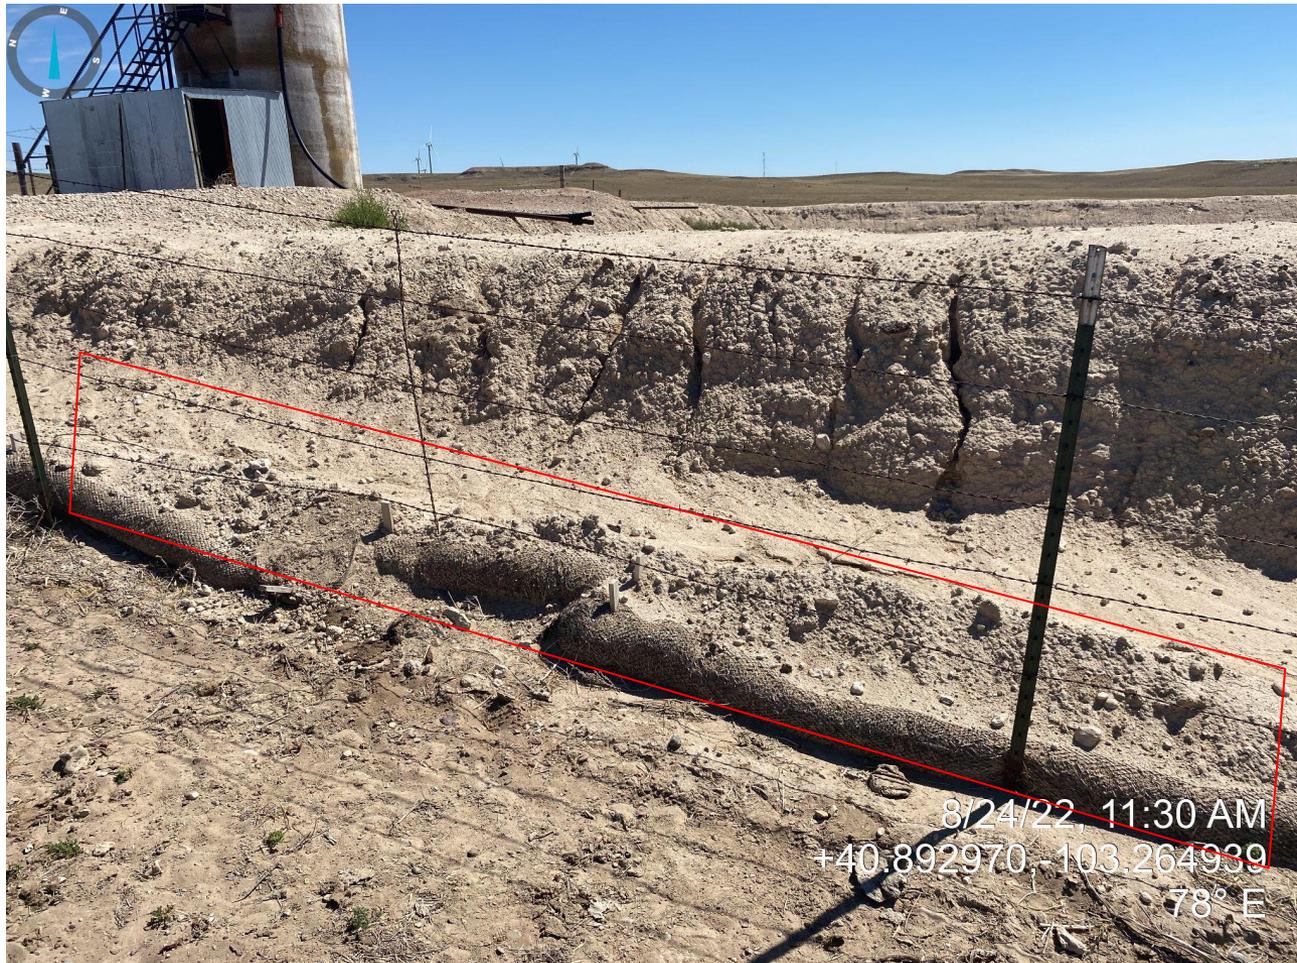
Photo 3. Pit photo taken from western portion, facing south. Photo illustrates straw wattles buried with sediment and are in need of maintenance/replacement to properly capture sediment laden stormwater from exiting location (outlined in red).

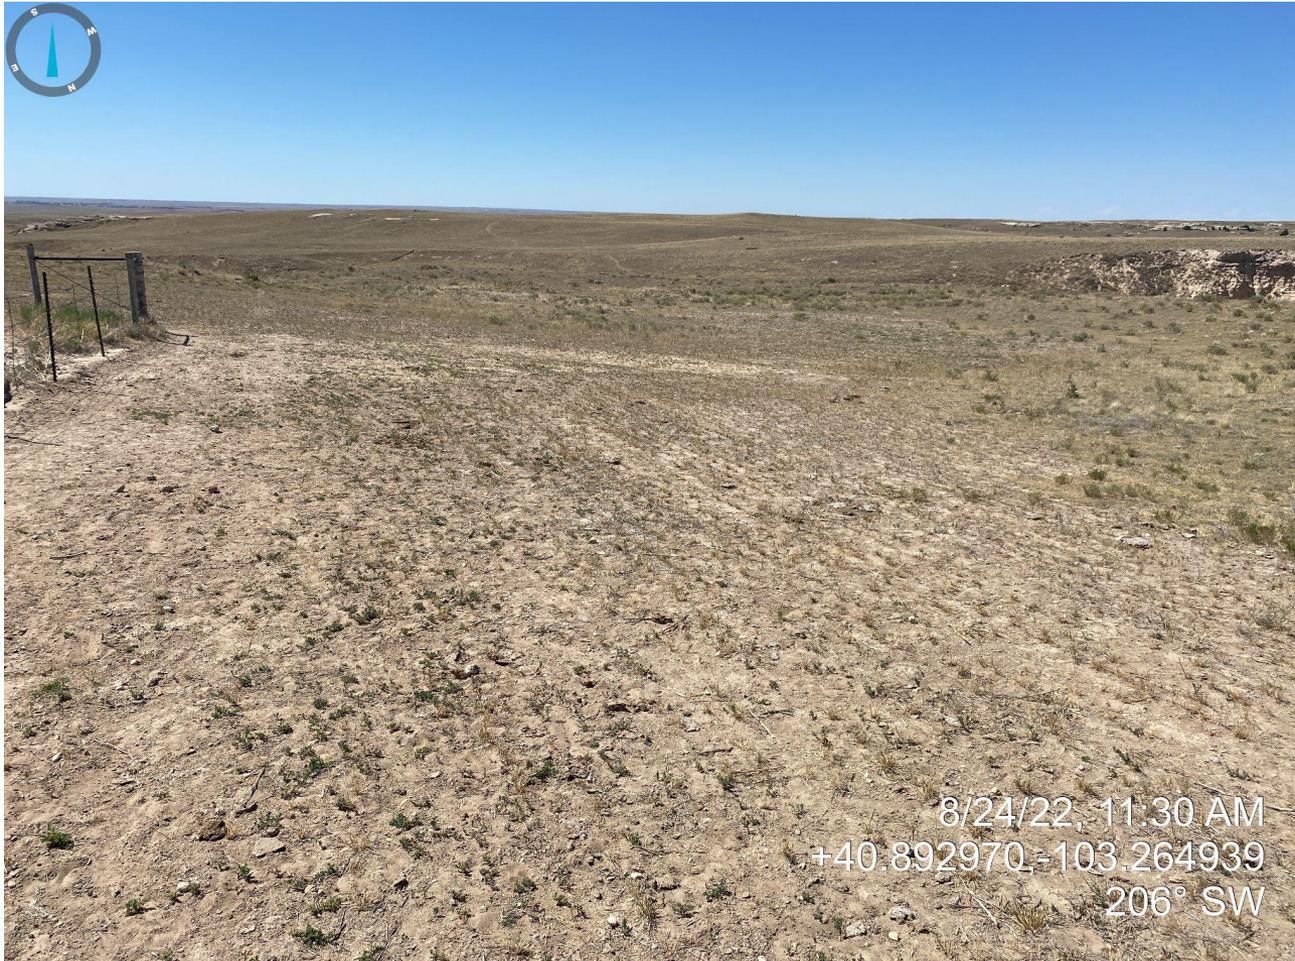
Photo 5. Salt Kill area photo taken from western edge of pit, facing southwest. Photo illustrates non-uniform vegetation cover resulting in bare soil and presence of annual weedy vegetation (e.g. predominantly Kochia).

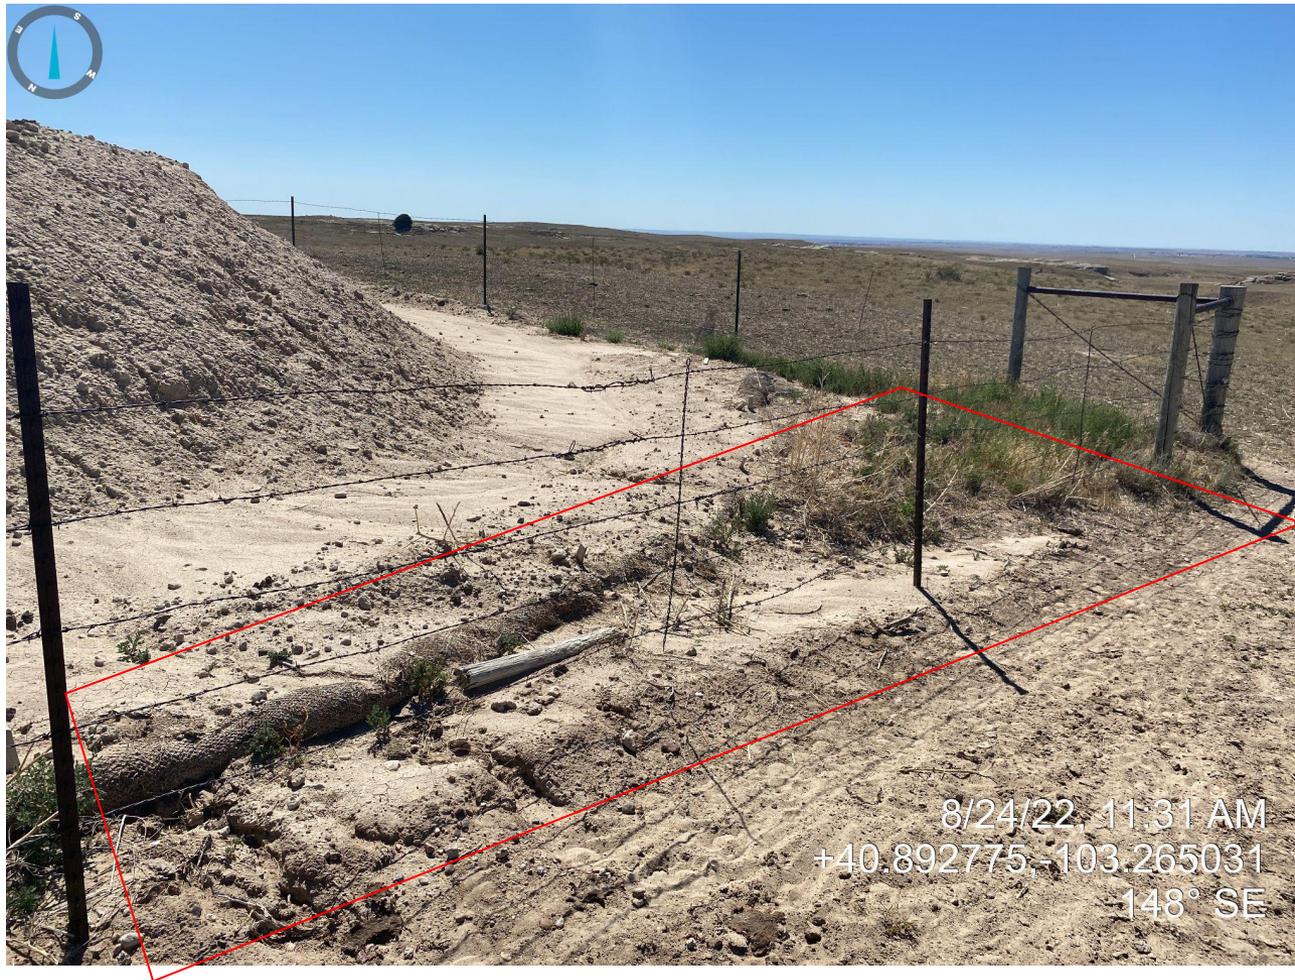
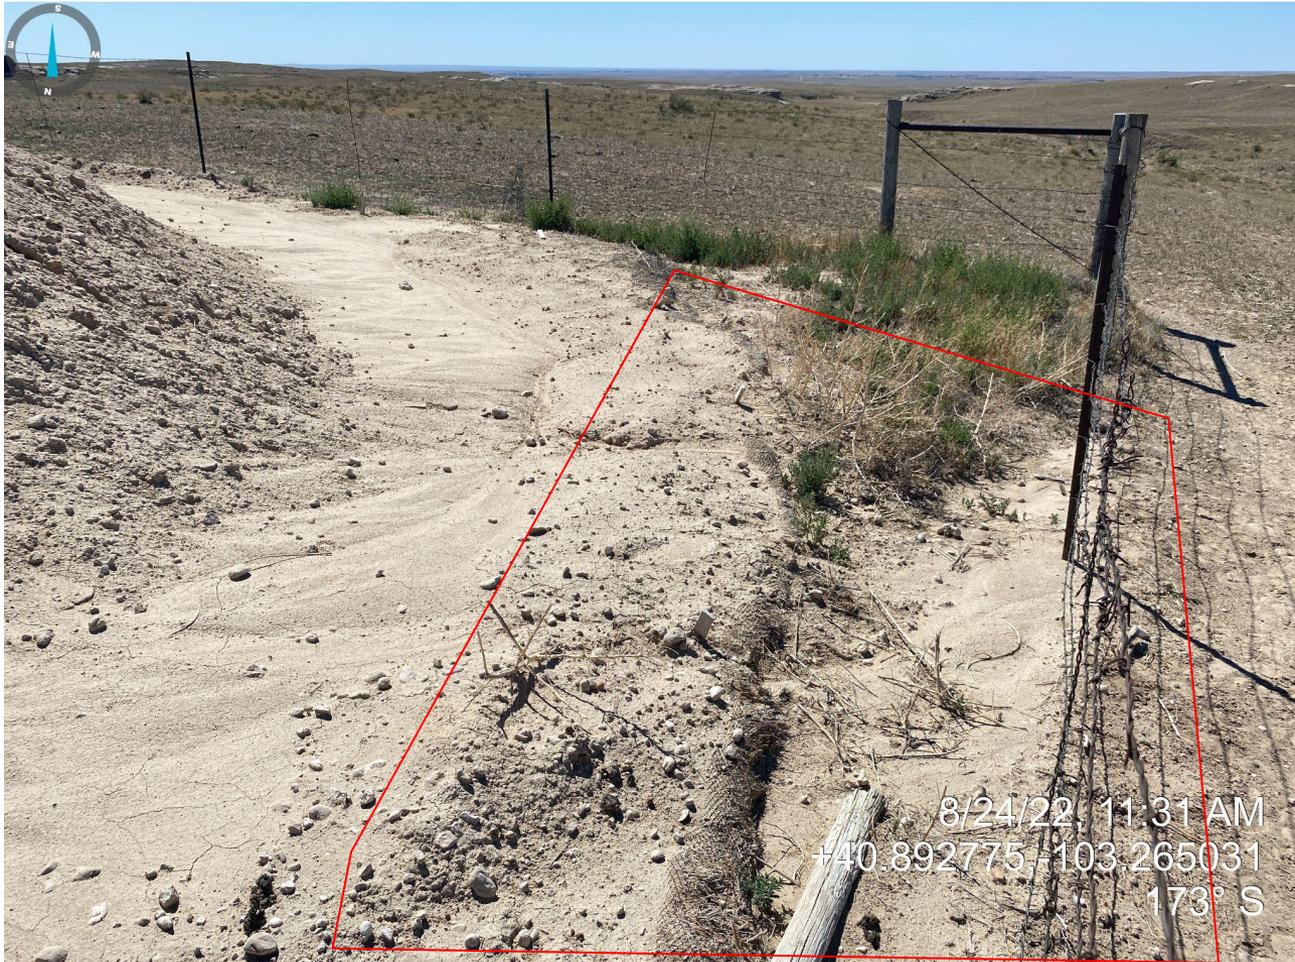
Photo 6. Pit photo taken from southwestern corner, facing southeast. Photo illustrates inadequate stormwater BMPs, straw wattles, that have not been properly maintained causing sediment laden stormwater to leave off location (outlined in red).

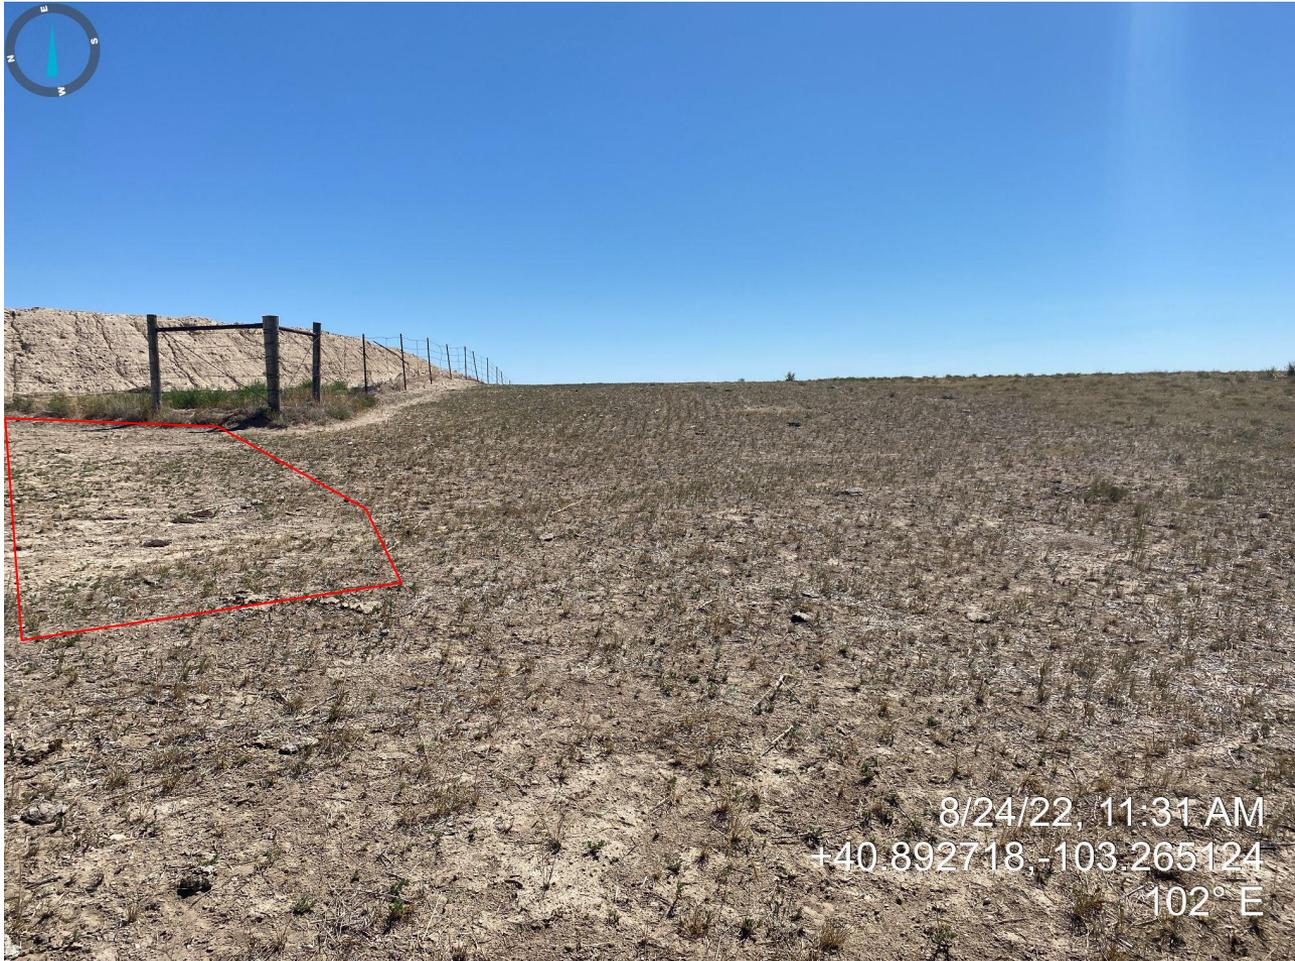
Photo 8. Salt Kill area photo taken from southwestern corner of pit, facing east. Photo illustrates some desirable germination present (e.g. buffalo grass, wheatgrass) and evidence of sediment laden stormwater exiting location (outlined in red).

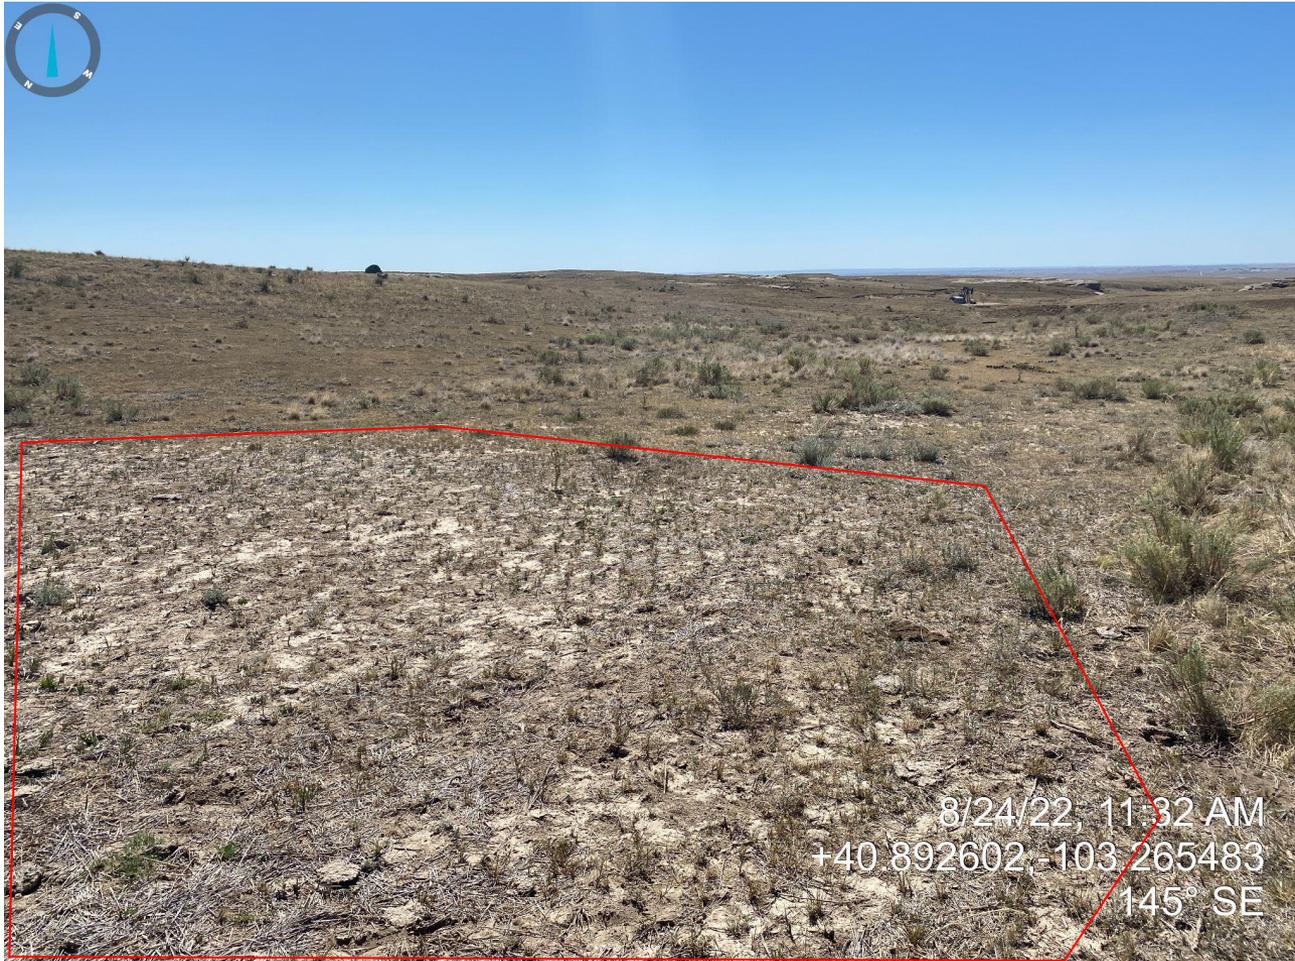
Photo 9. Salt Kill area photo taken from southwestern portion, facing southeast. Photo illustrates desirable revegetation observed within salt kill area.

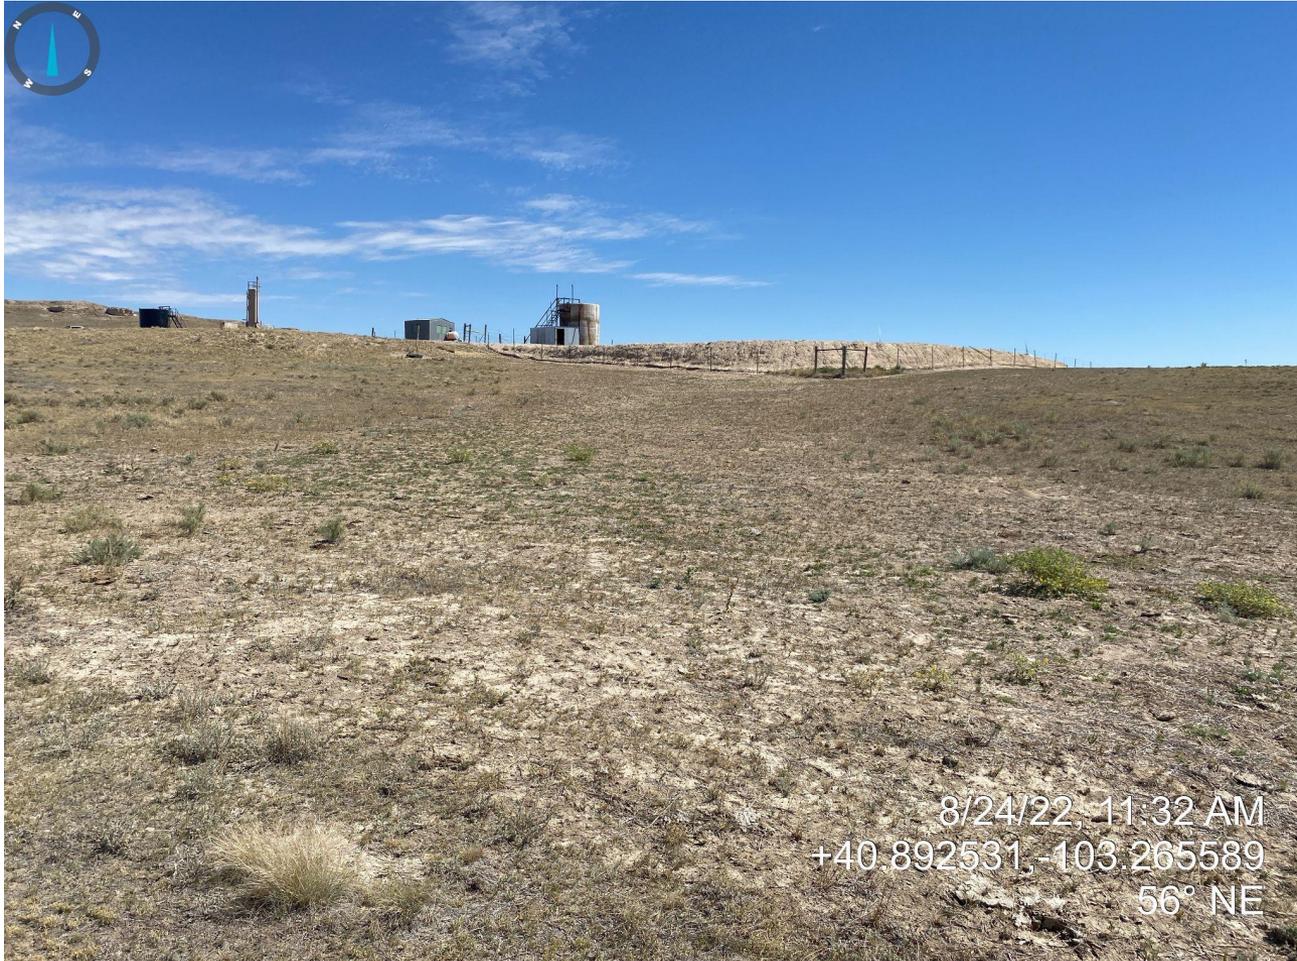
Photo 10. Salt Kill area photo taken from southwestern portion, facing northeast. Photo illustrates non-uniform vegetation cover resulting in bare soil.

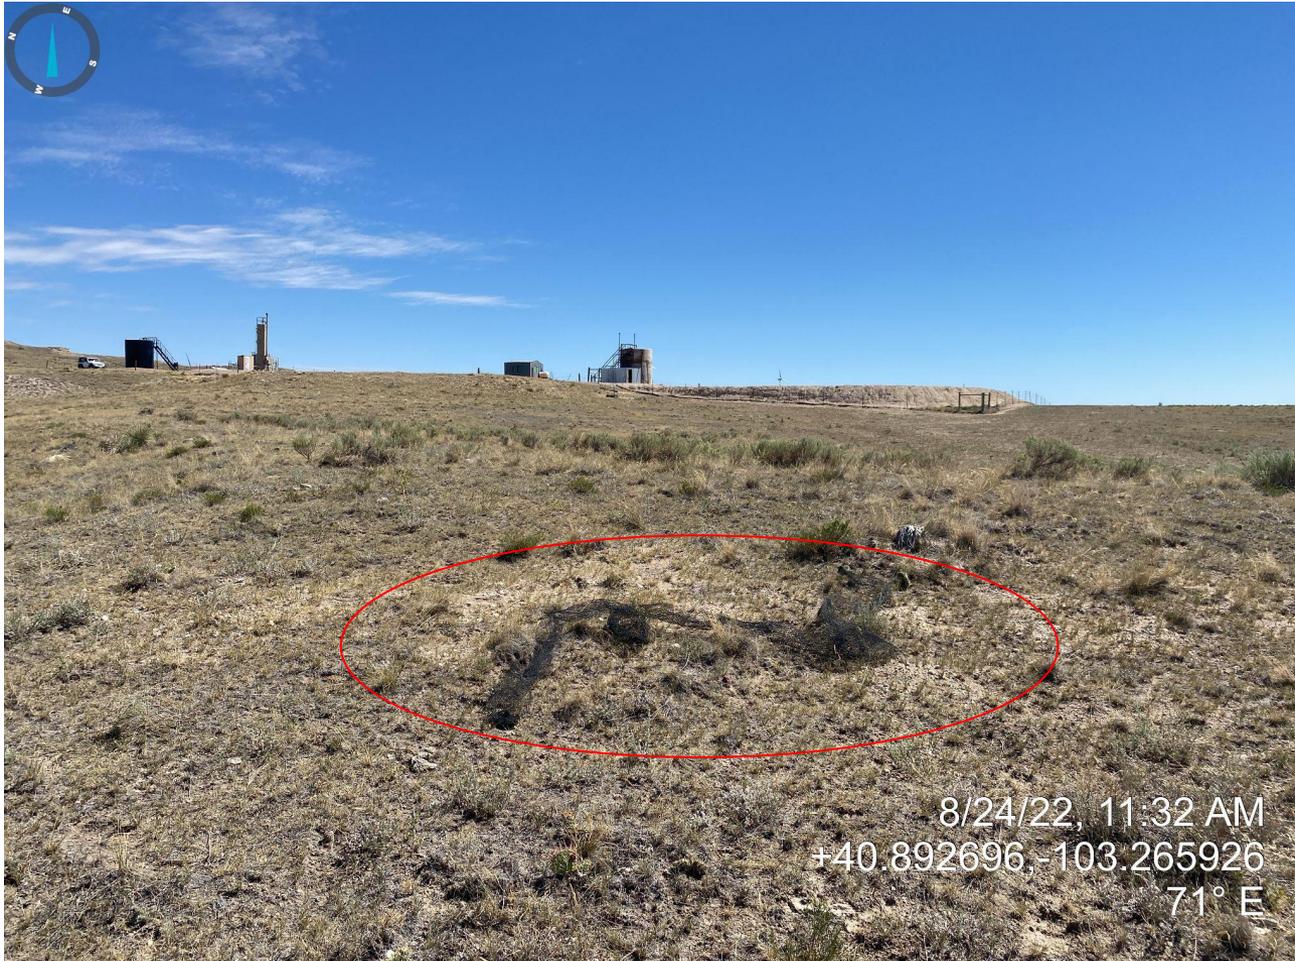
Photo 11. Photo illustrates straw wattle netting off location. Photo taken west of location facing east.

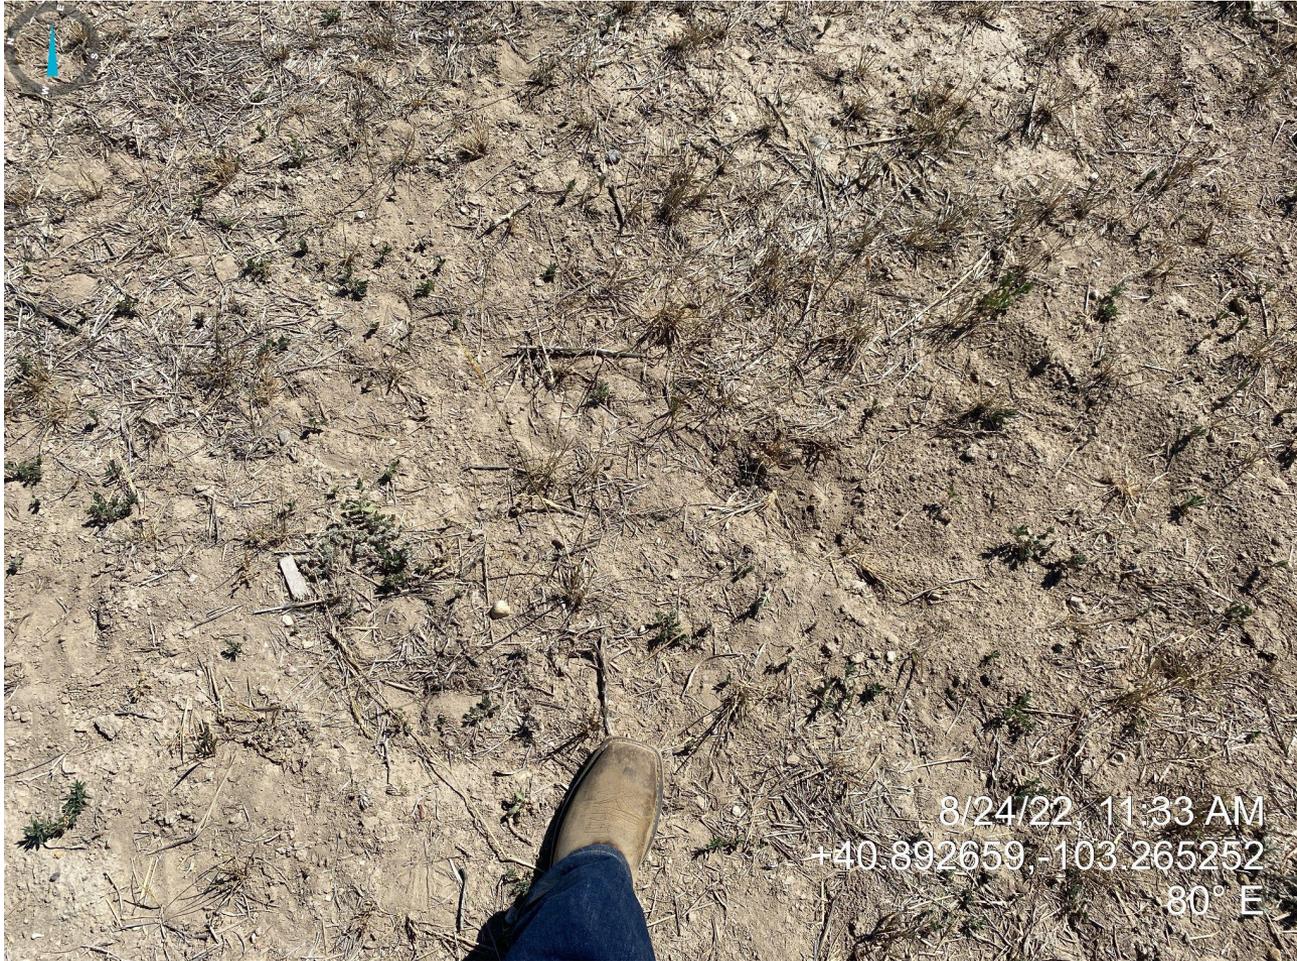
Photo 12. Close up photo of salt kill area germination. Non-uniform vegetation cover resulting in bare soil and undesirable vegetation present (e.g. kochia).

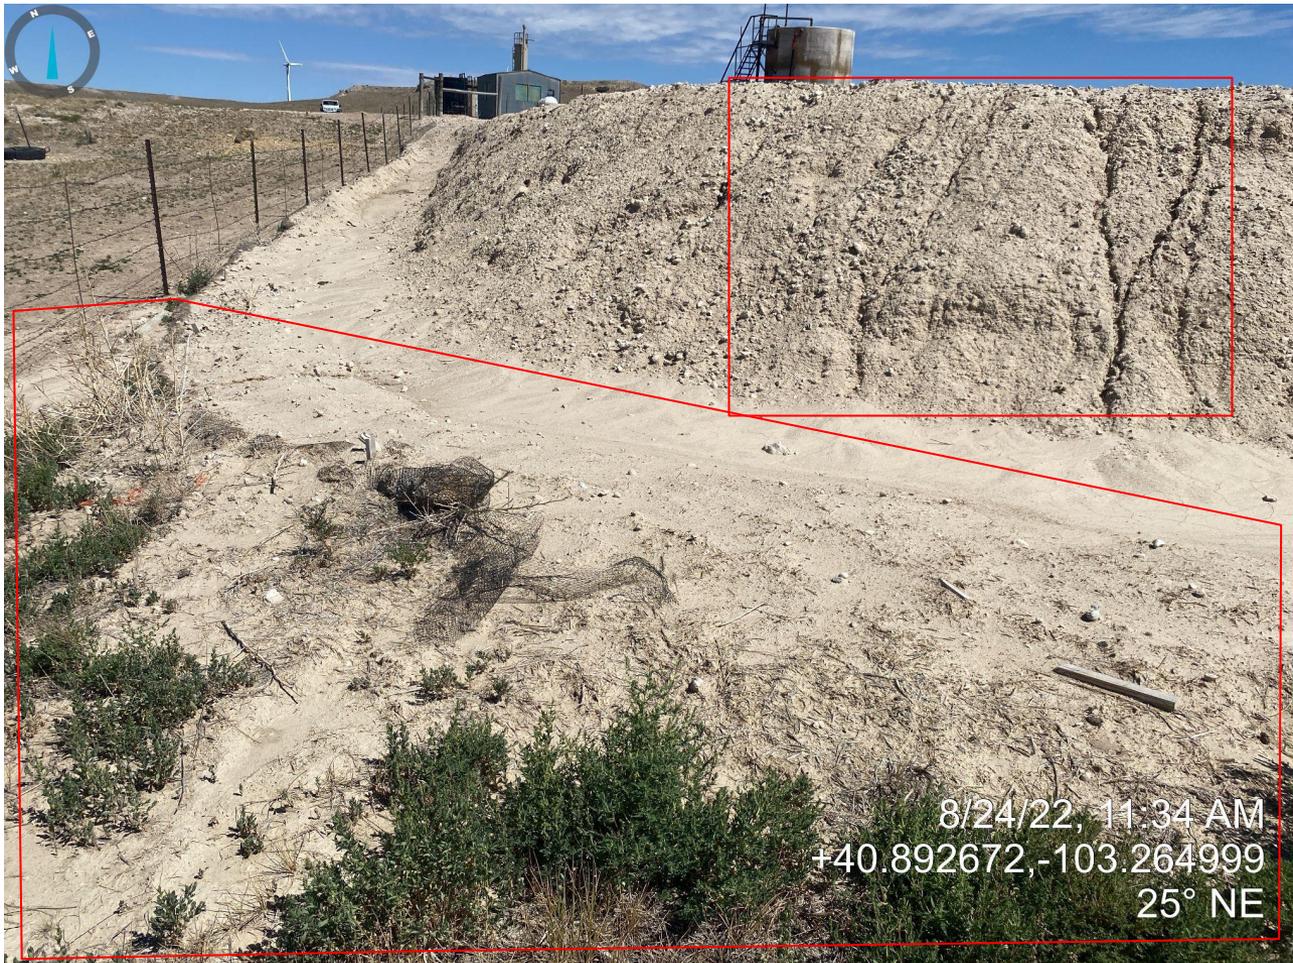
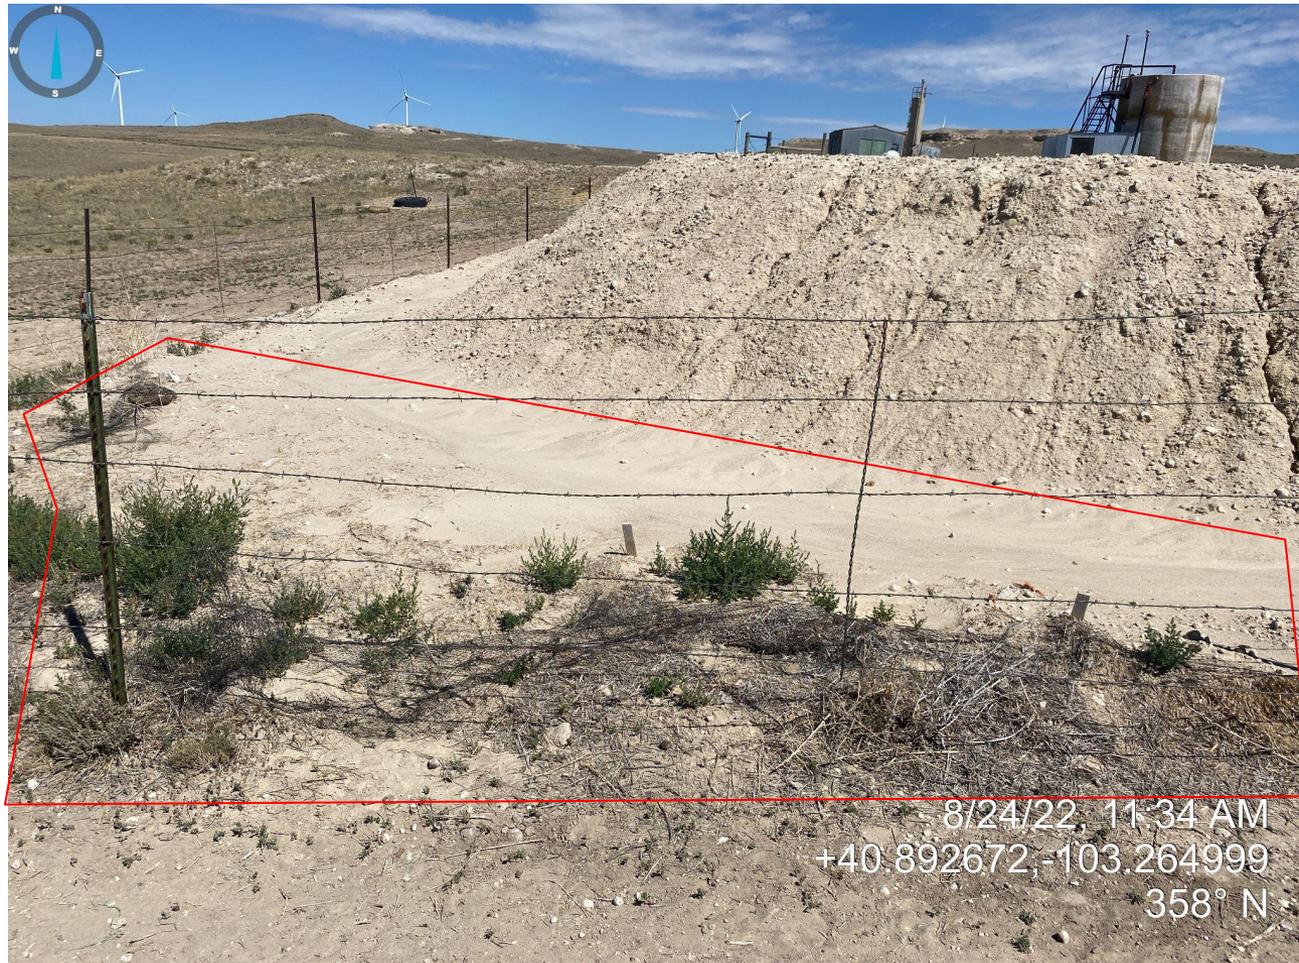
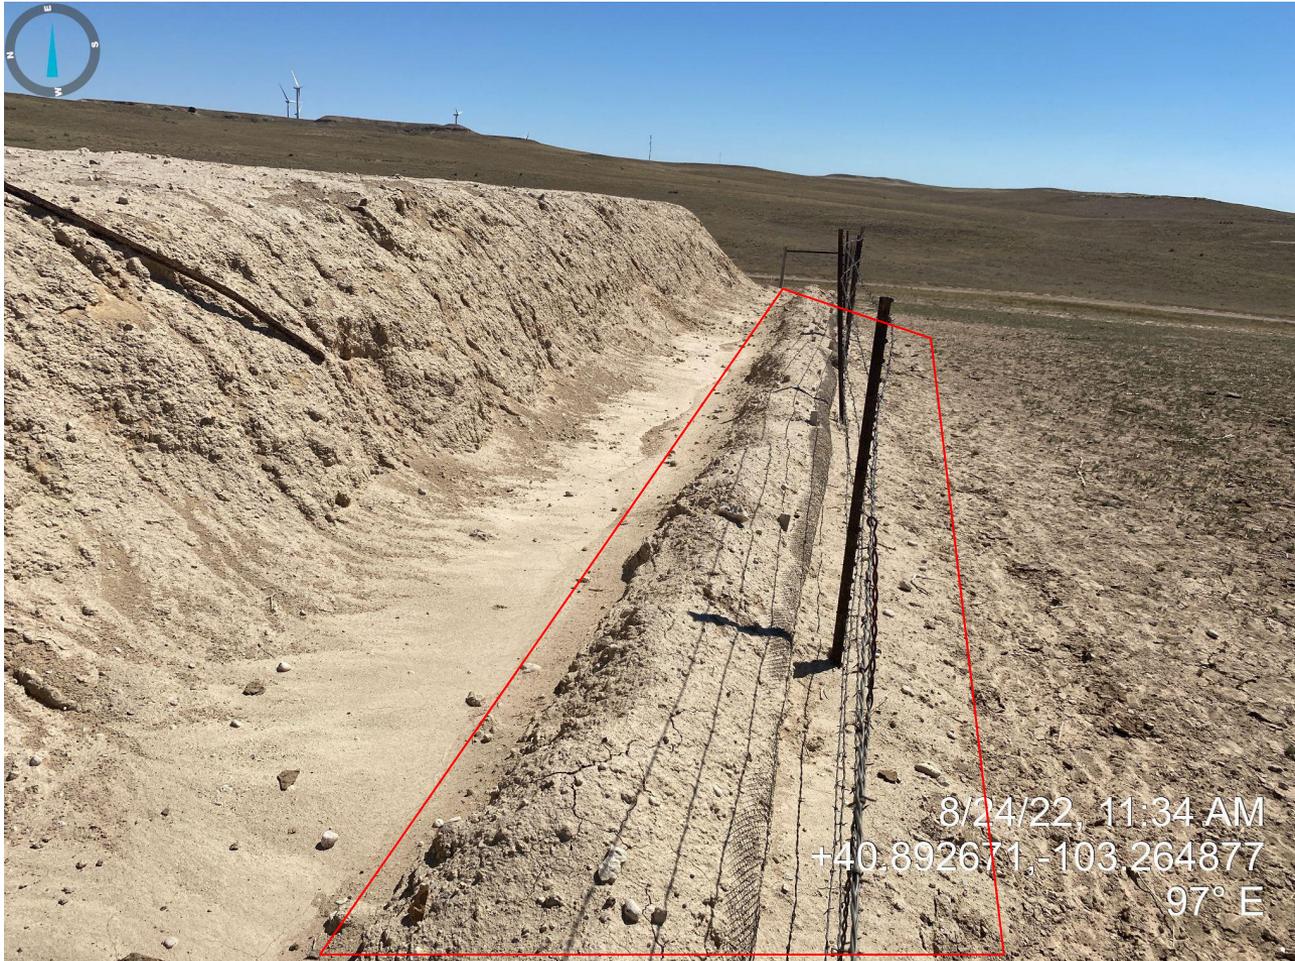
Photo 14. Pit photo taken from southwestern portion, facing northeast. Photo illustrates inadequate stormwater BMPs allowing sediment laden stormwater to exit off location and rill erosion on pit walls (outlined in red).

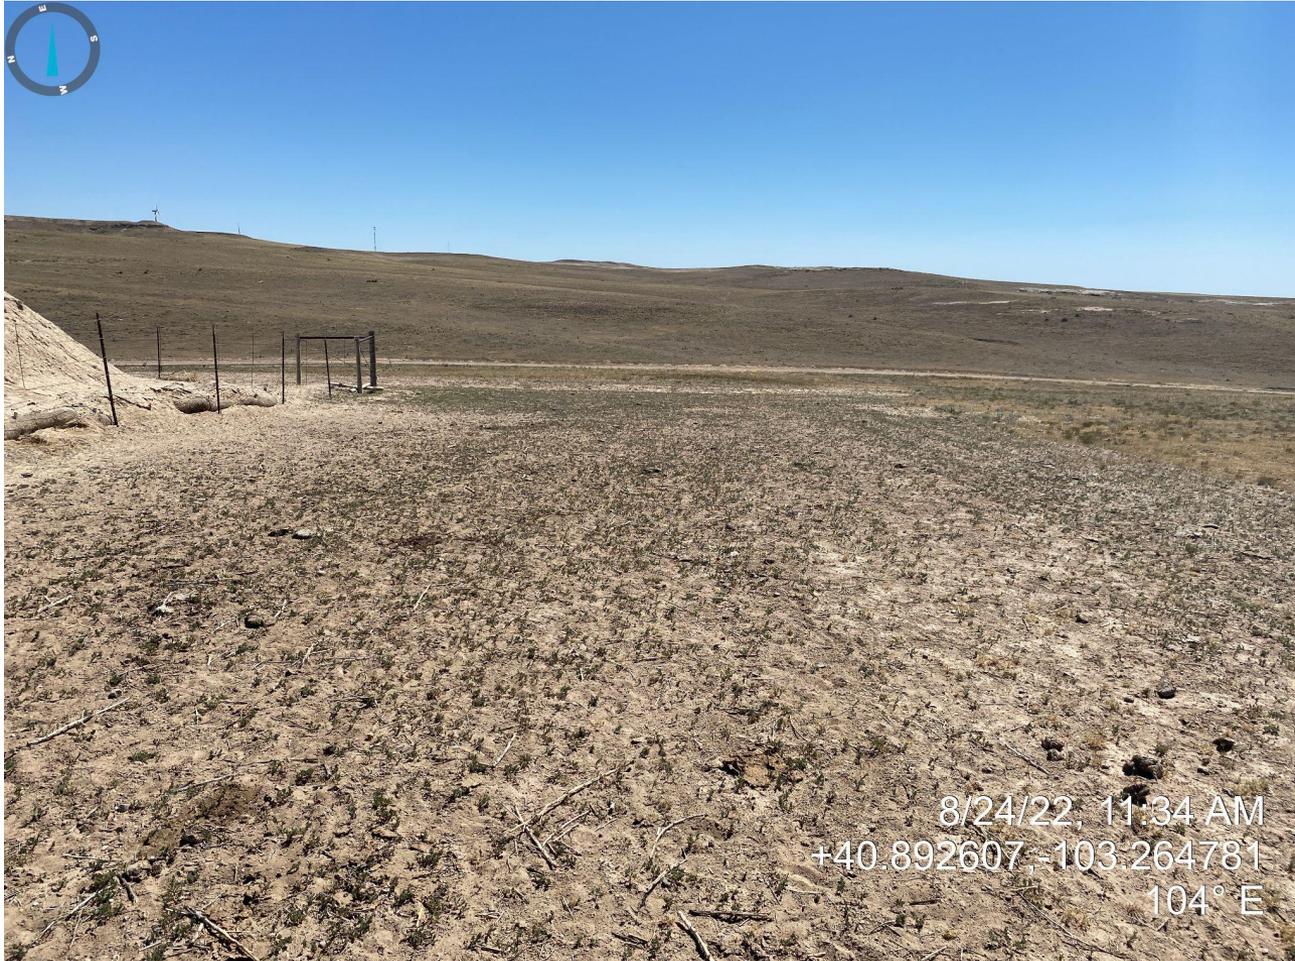
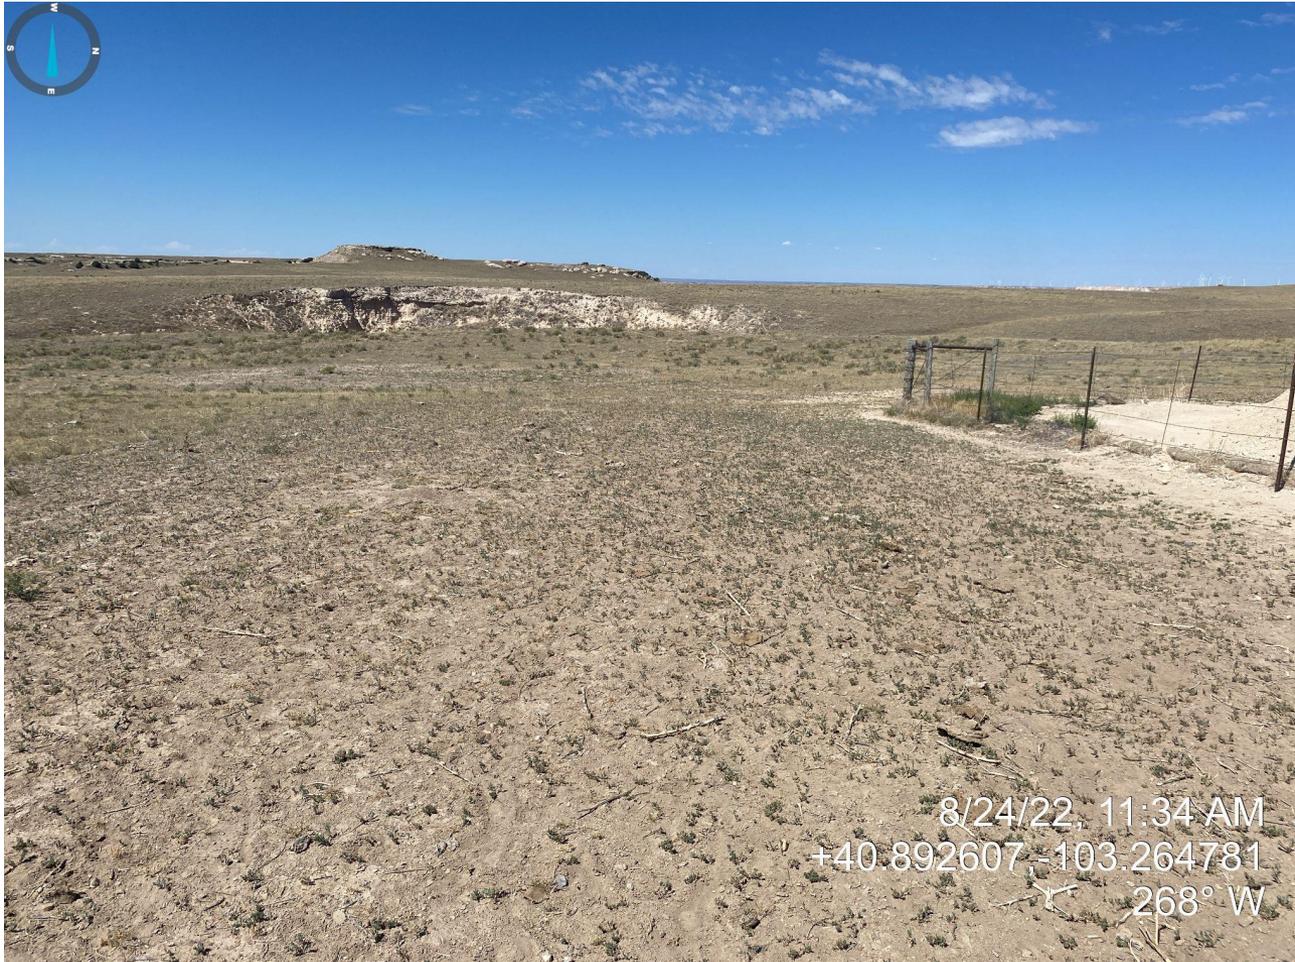
Photo 17. Salt kill area photo taken from southern edge of pit, facing east. Photo illustrates non-uniform vegetation cover resulting in bare soil; additionally, this portion of the reclaimed area is predominantly Kochia.

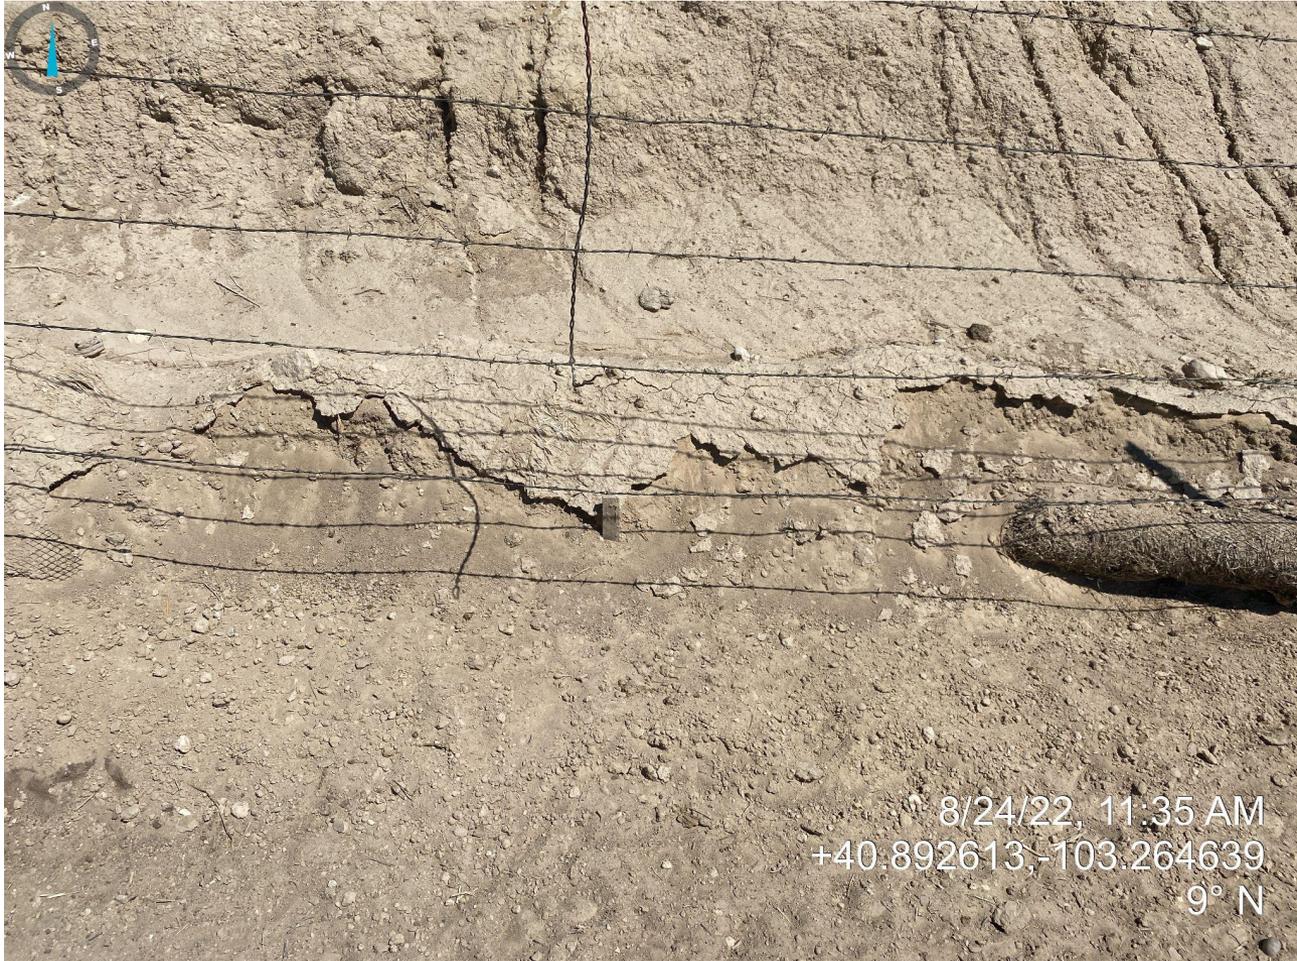
Photo 19. Close up photo illustrates missing straw wattle.
