Interim Reclamation and Stormwater Inspection

Date: 08/24/2022

Operator: WESTERN OPERATING COMPANY -95620

Location ID: 312291

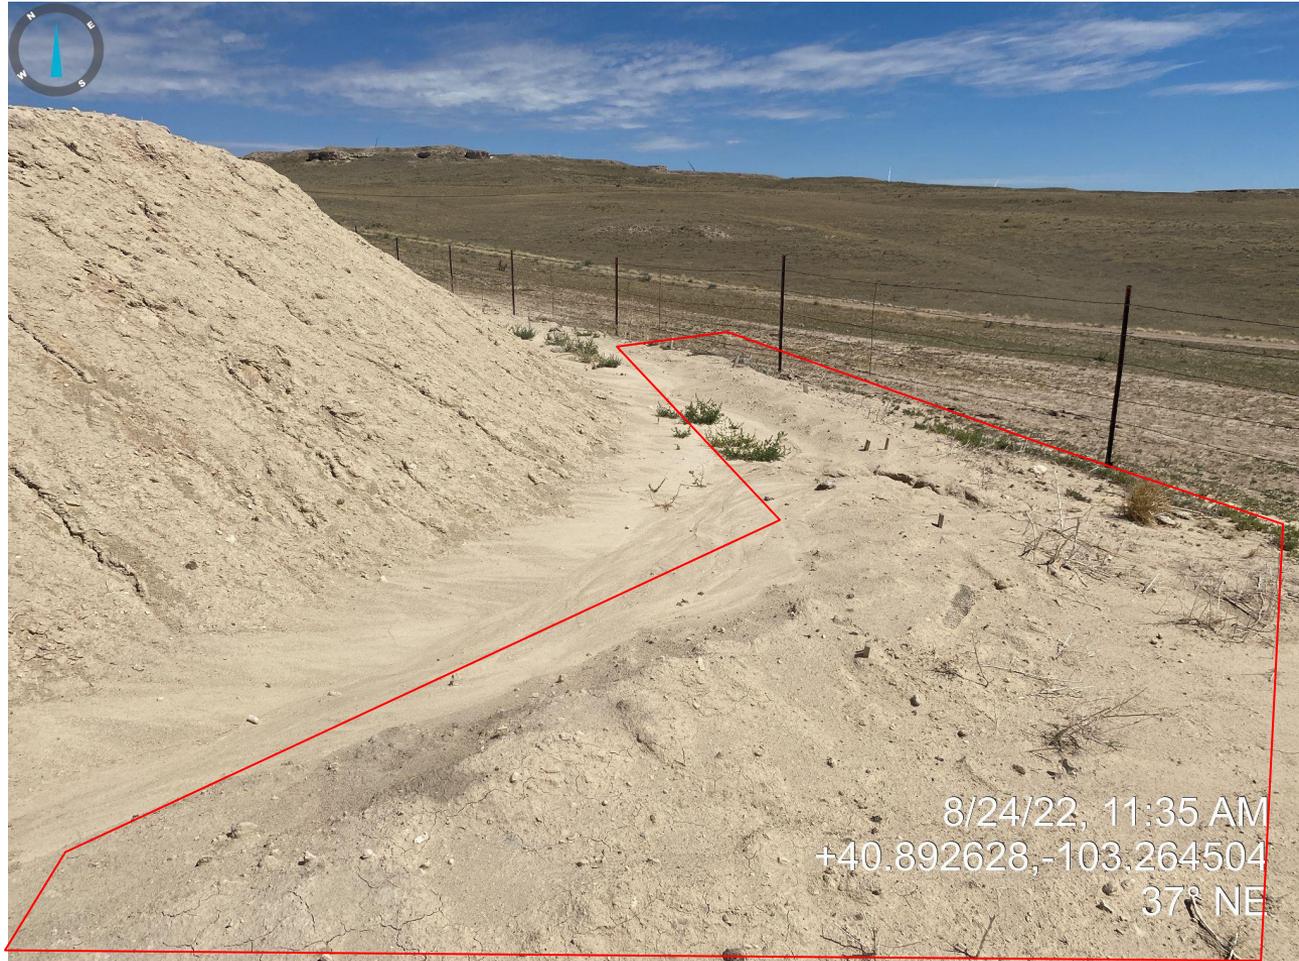
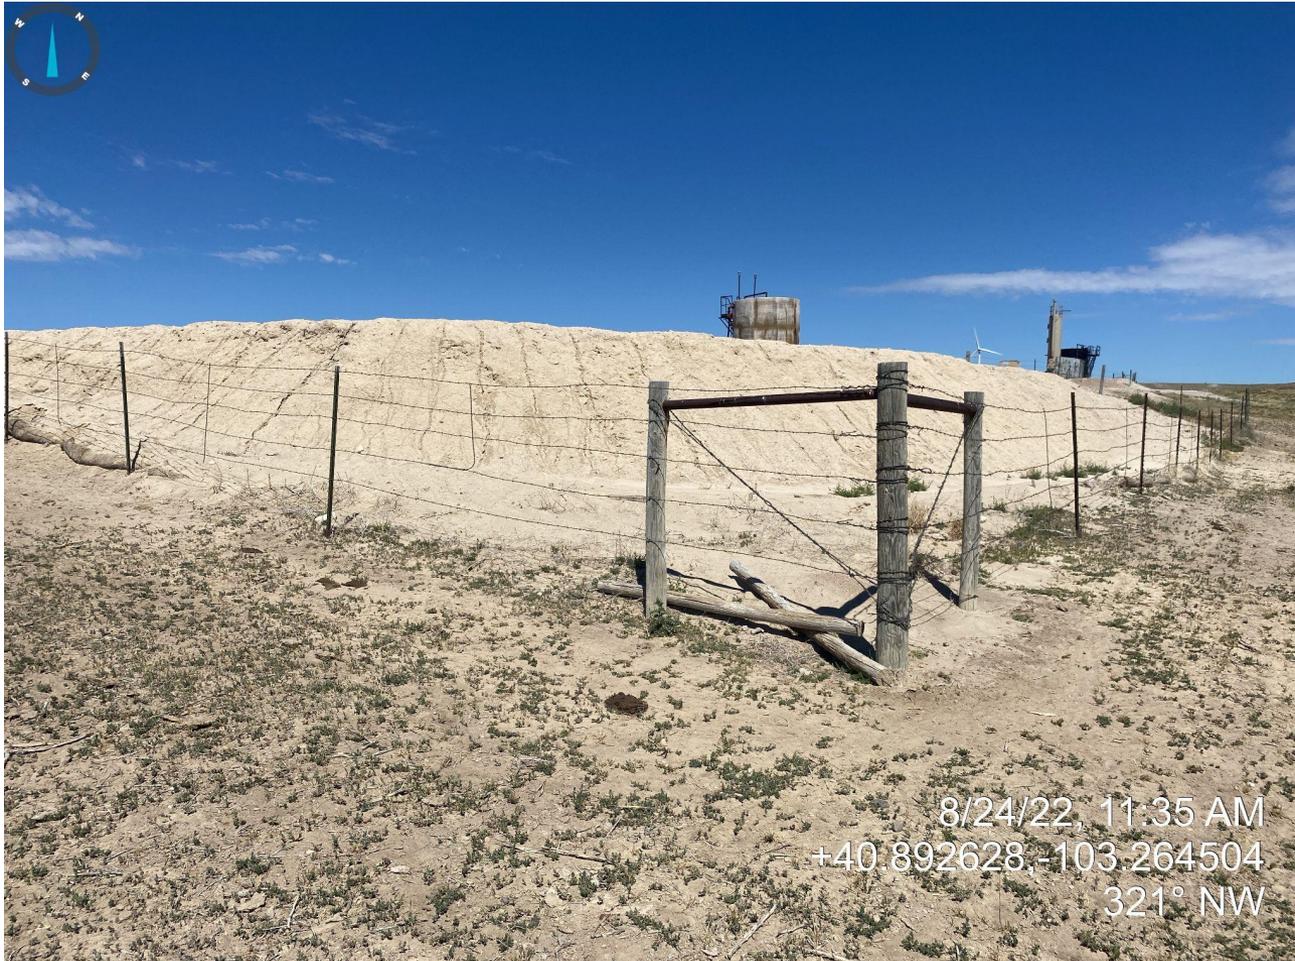
Photo 20. Pit photo taken from southeast corner, facing northeast. Photo illustrates insufficient stormwater BMPs allowing sediment laden stormwater to exit off location (outlined in red).

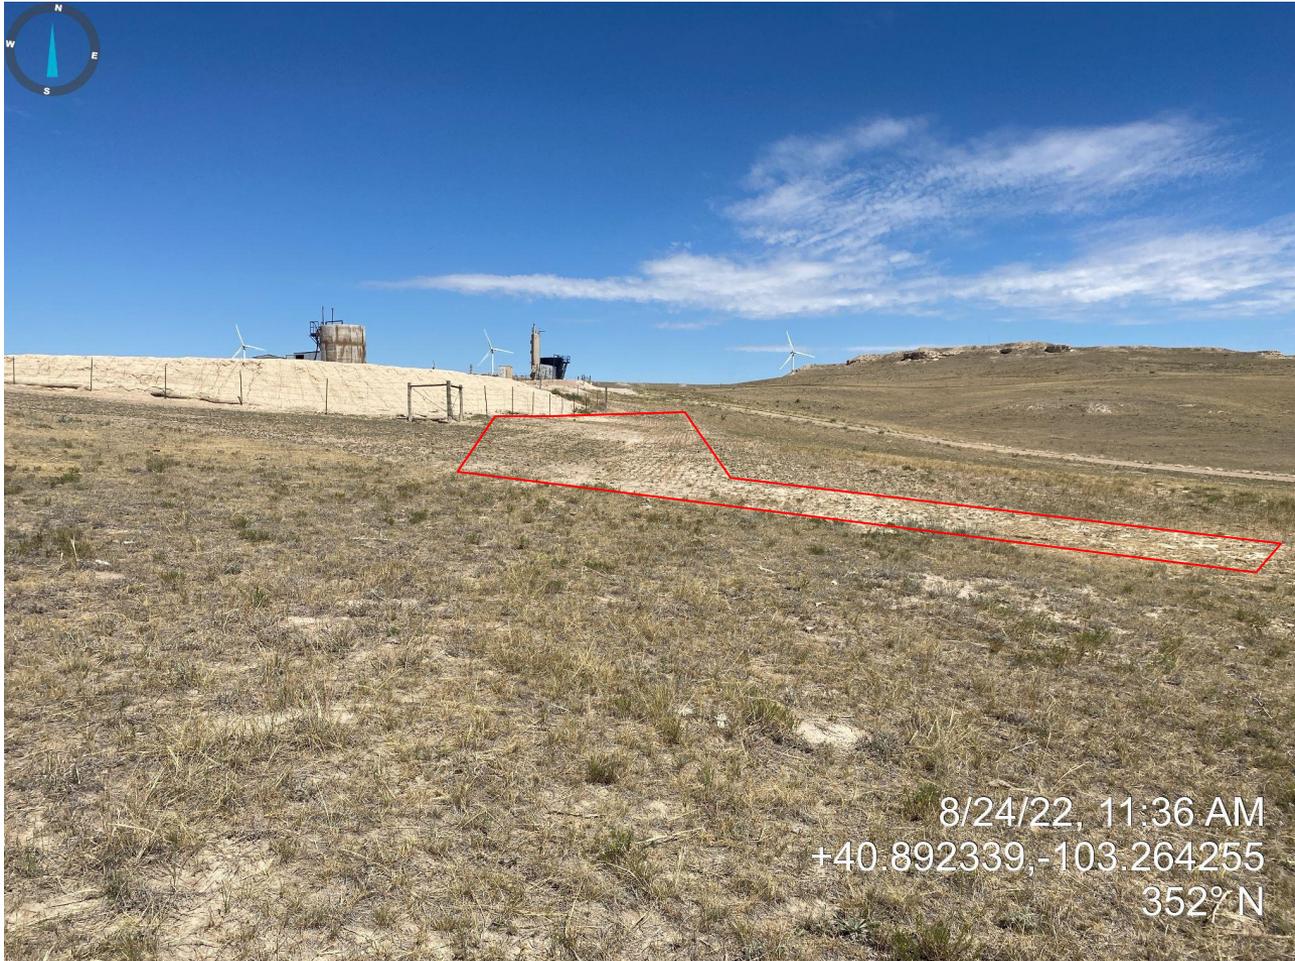
Photo 22. Photo taken southeast of pit, facing north. Photo illustrates areas of non-uniform vegetation cover resulting in bare soil within the salt kill area. (outlined in red).

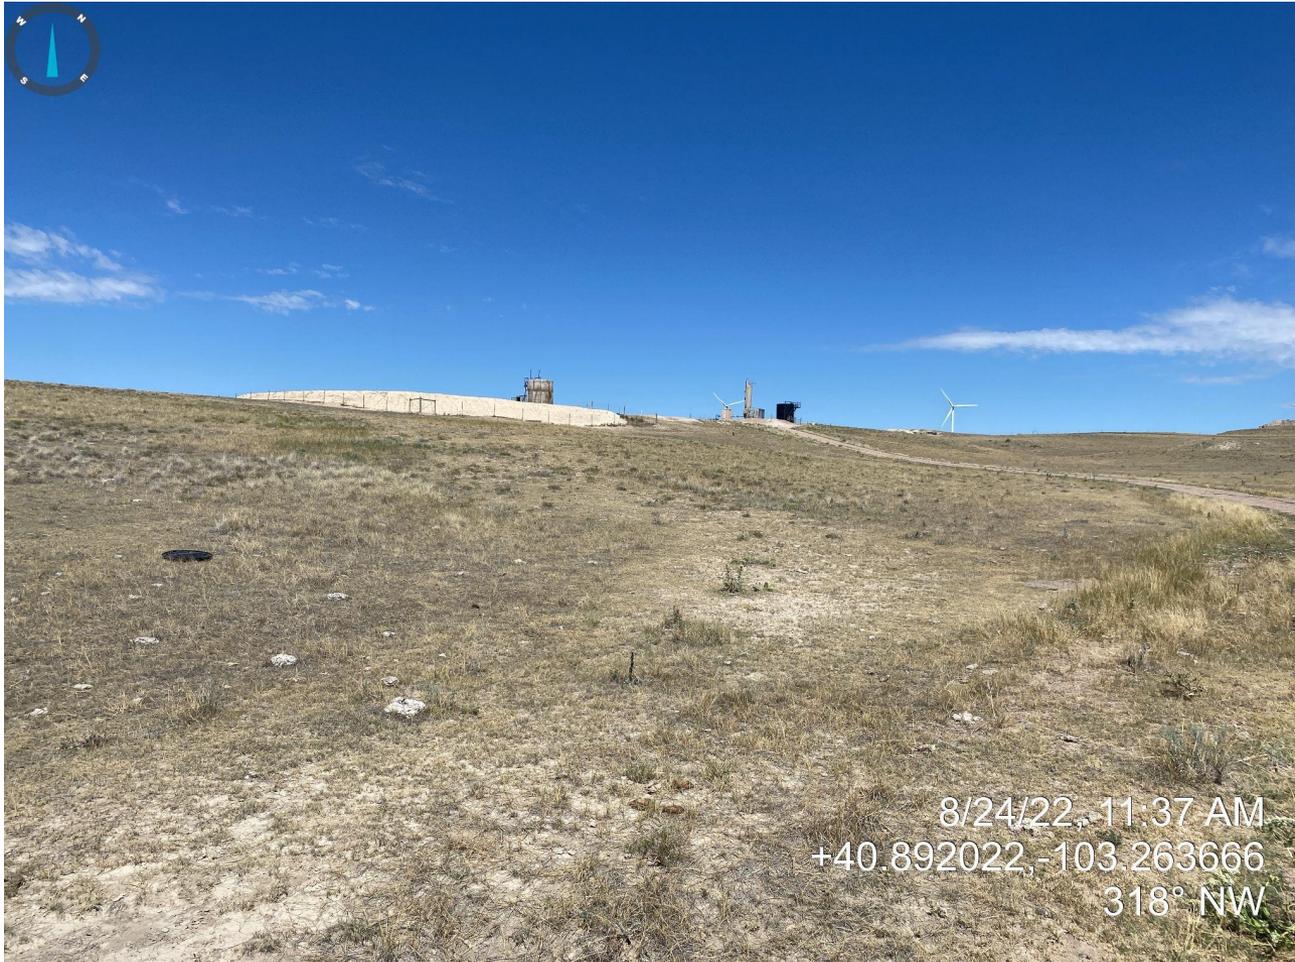
Photo 23. Salt kill area photo taken from access southeast of location, facing northwest. Photo illustrates portions of the reclaimed area have some desirable vegetation and are temporarily stabilized.

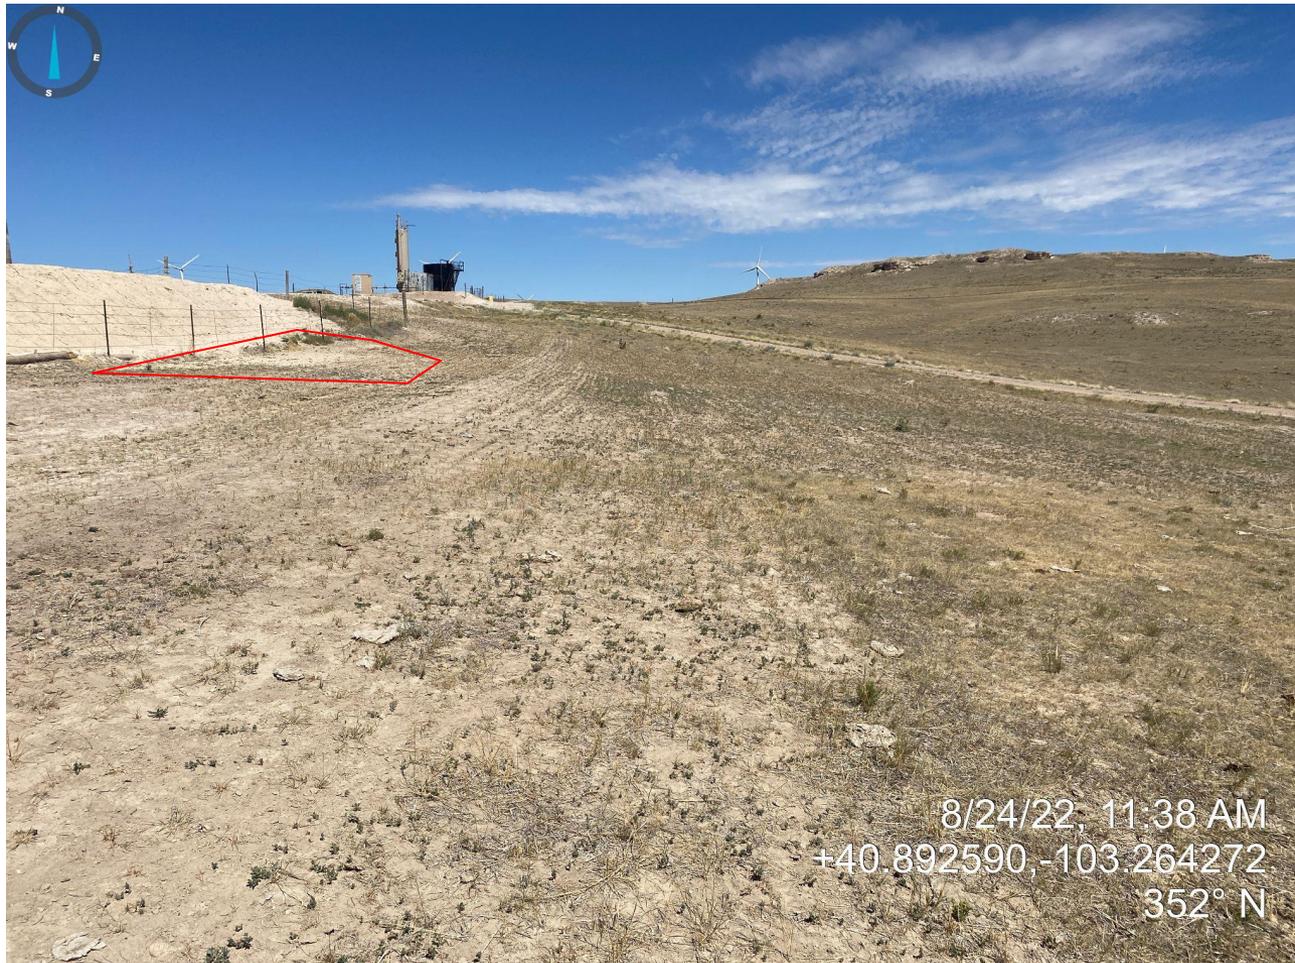
Photo 24. Salt kill area photo taken from southeastern corner of pit, facing north. Photo illustrates offsite sediment transportation (outlined in red), and non-uniform vegetation cover resulting in bare soil. Vegetation is predominantly kochia.

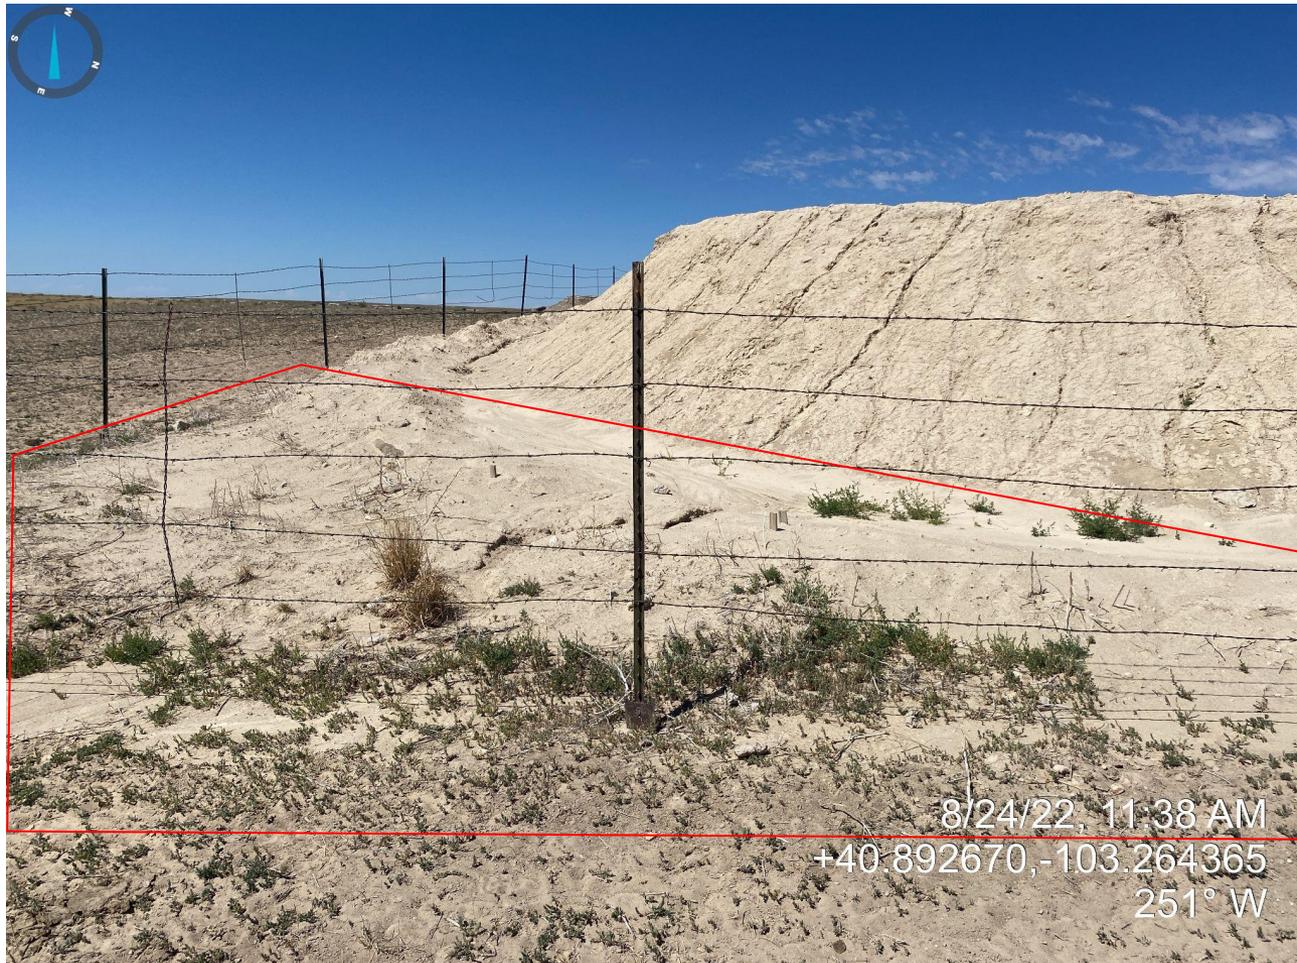
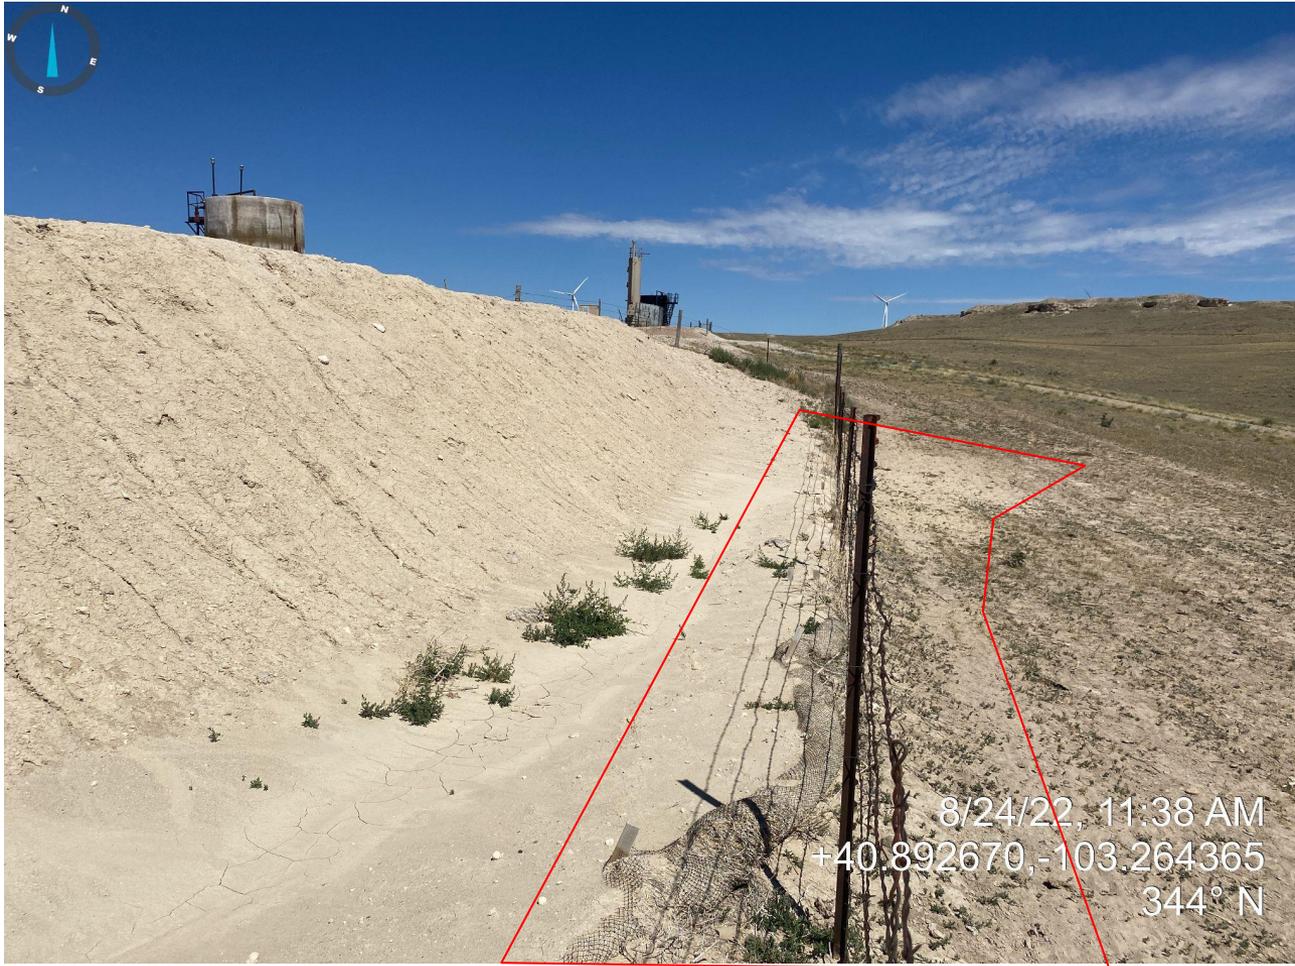
Photo 25. Pit photo taken from southeast corner of pit, facing west. Photo illustrates insufficient stormwater BMPs allowing sediment laden stormwater to exit off location (outlined in red).

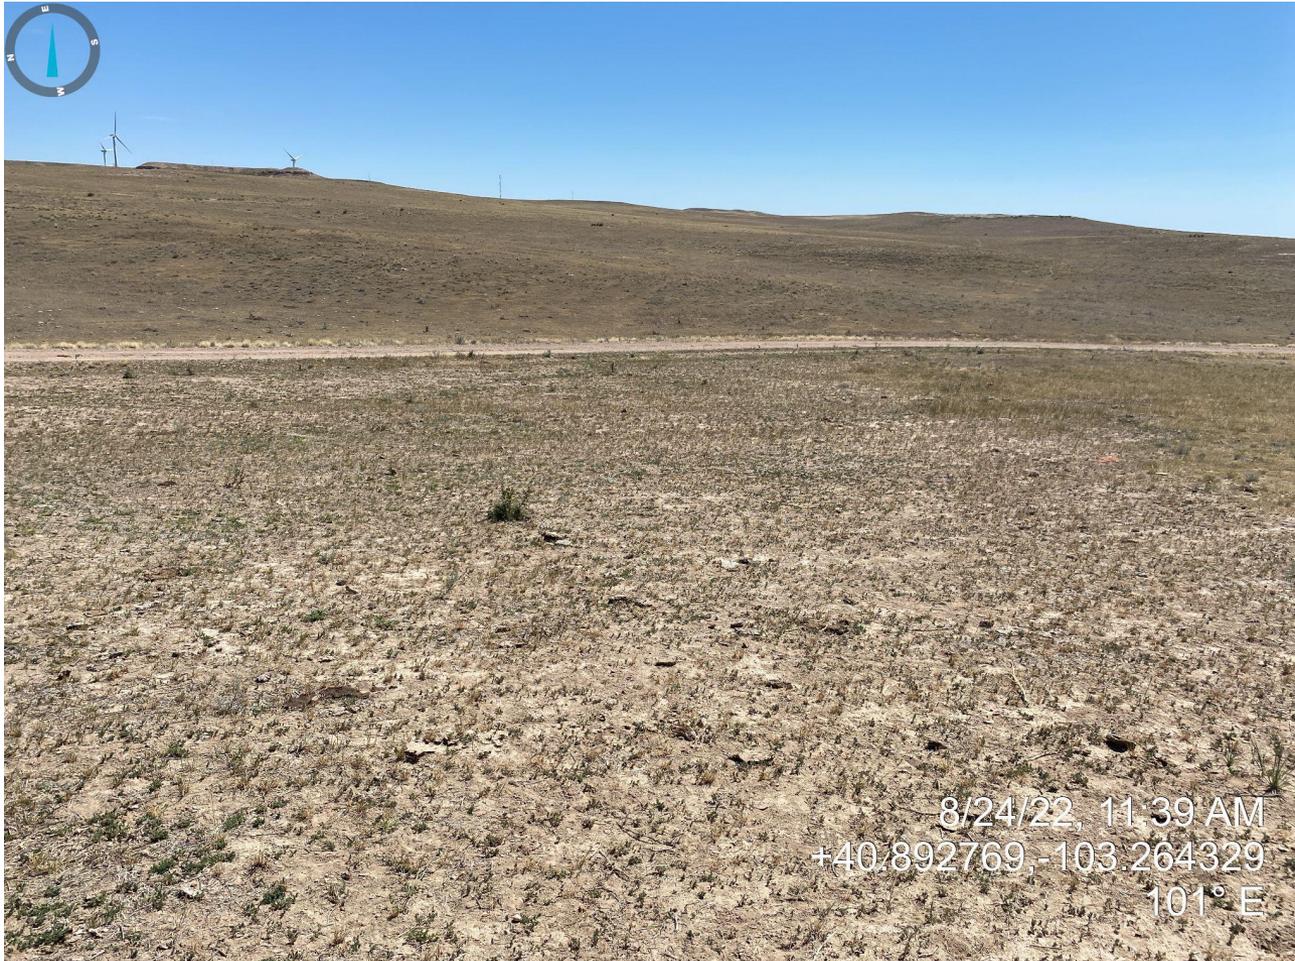
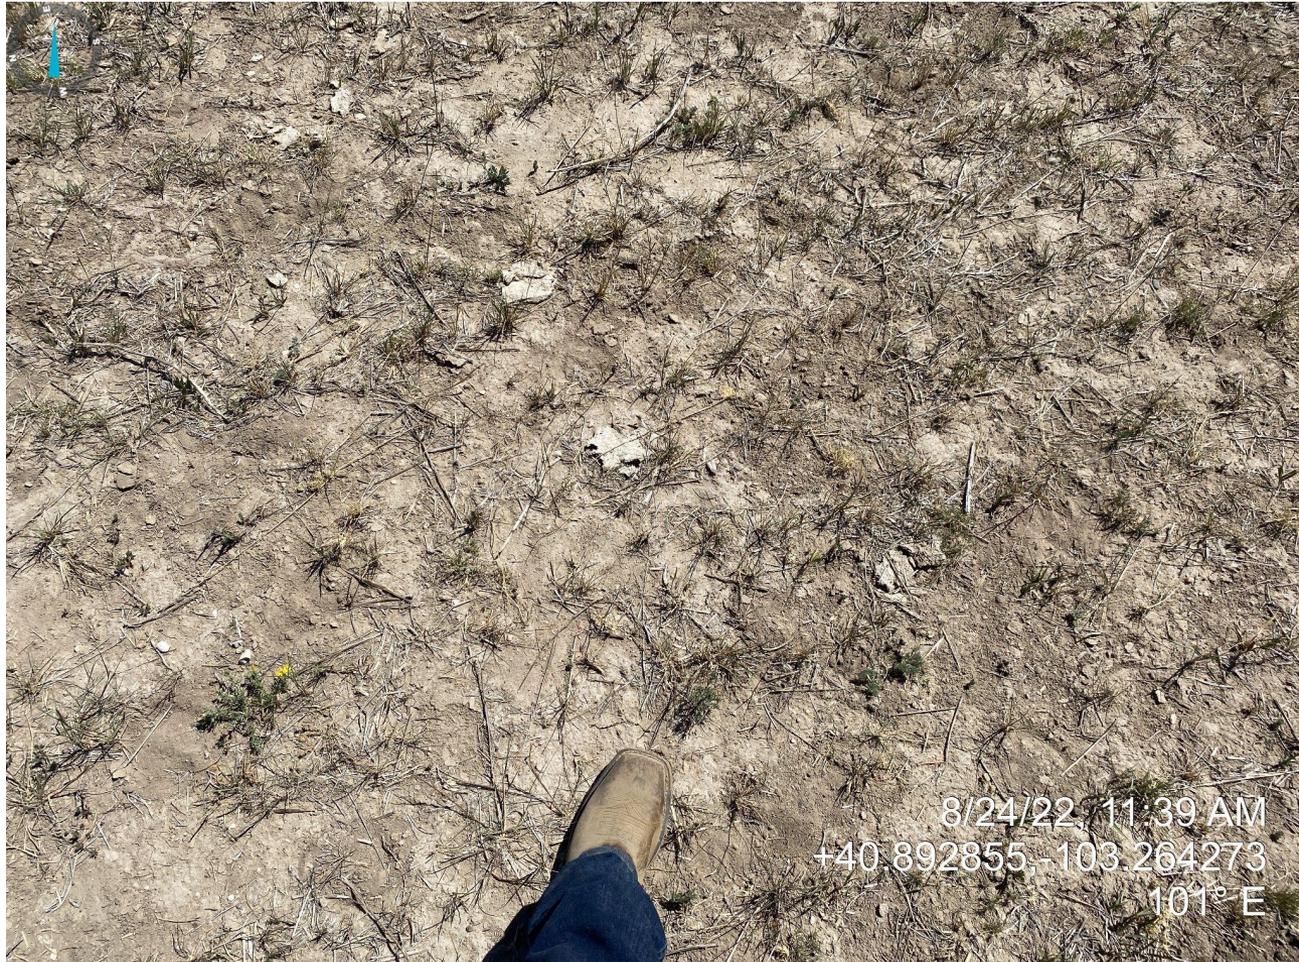
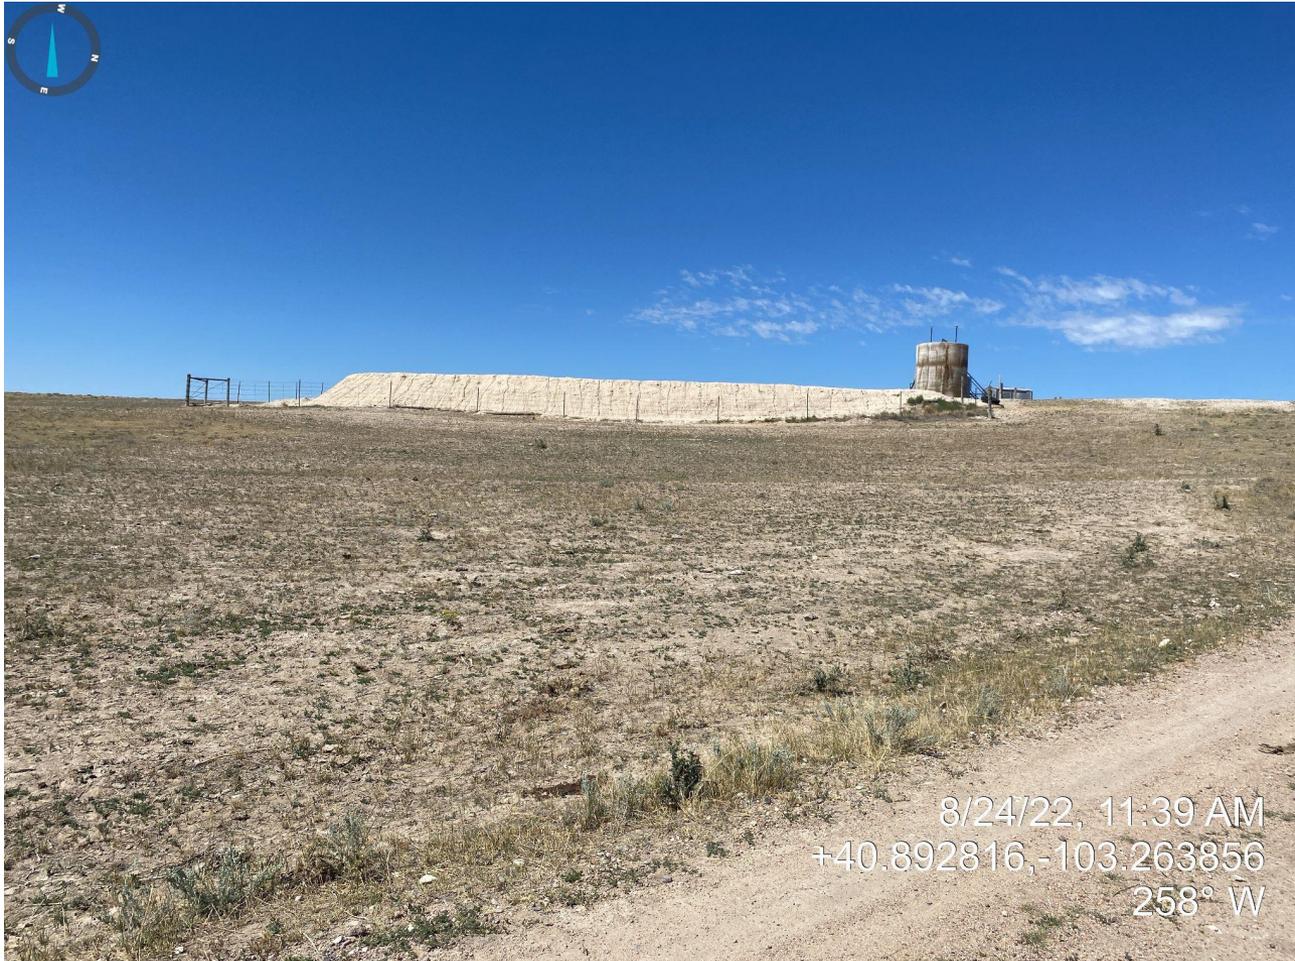
Photo 27. Salt kill area photo taken from center/eastern edge of pit, facing east. Photo illustrates reclaimed area has non-uniform vegetation cover resulting in bare soil and annual weedy vegetation, predominantly kochia.

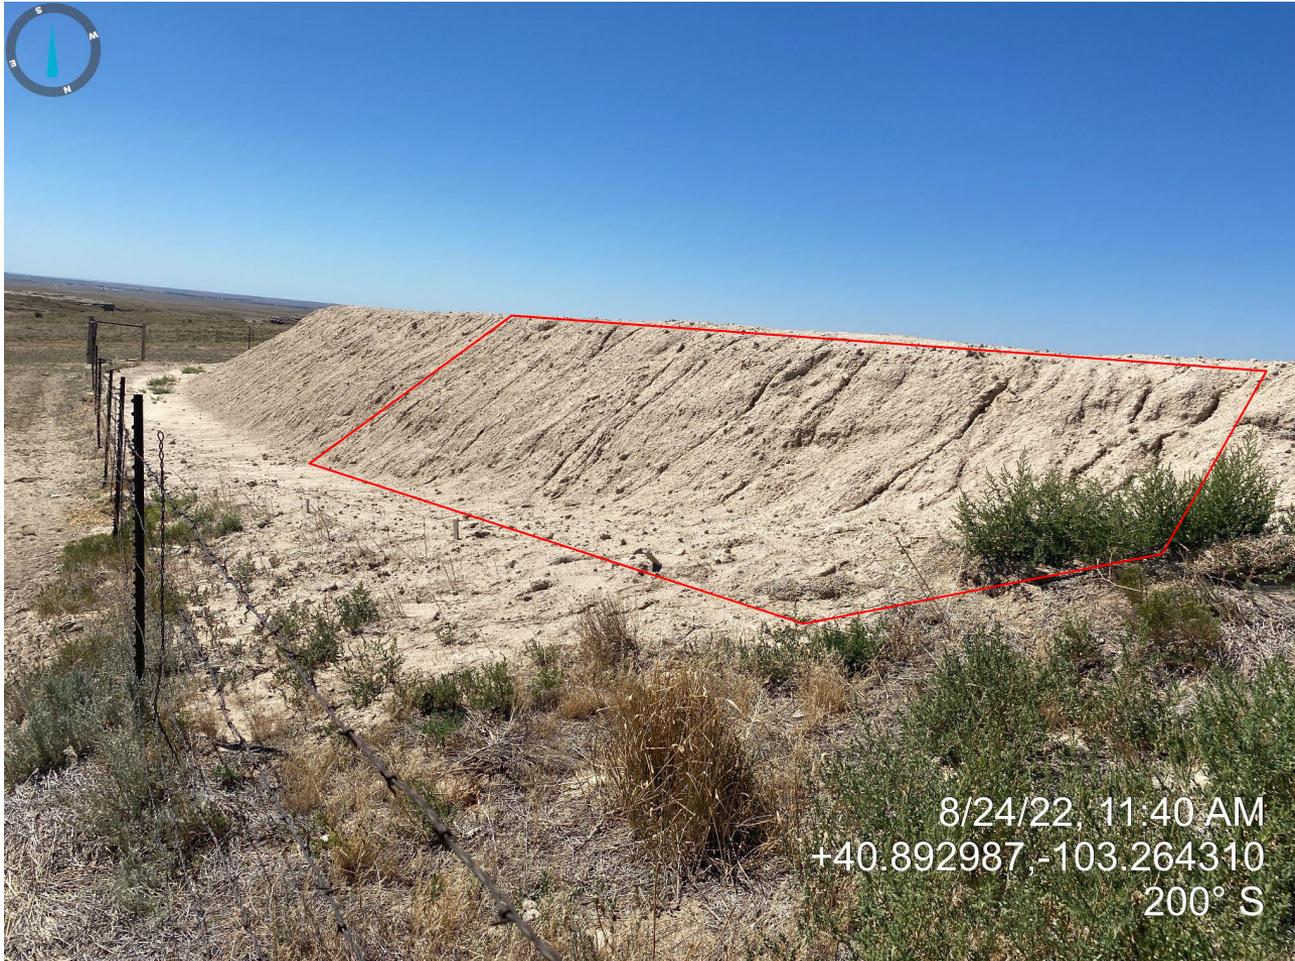
Photo 30. Pit photo taken from northeast corner, facing south. Photo illustrates absence of stormwater BMPs around portions of the pit, resulting in sediment laden stormwater exiting off location. Additionally, it was observed that the pit walls are experiencing rill erosion (outlined in red).

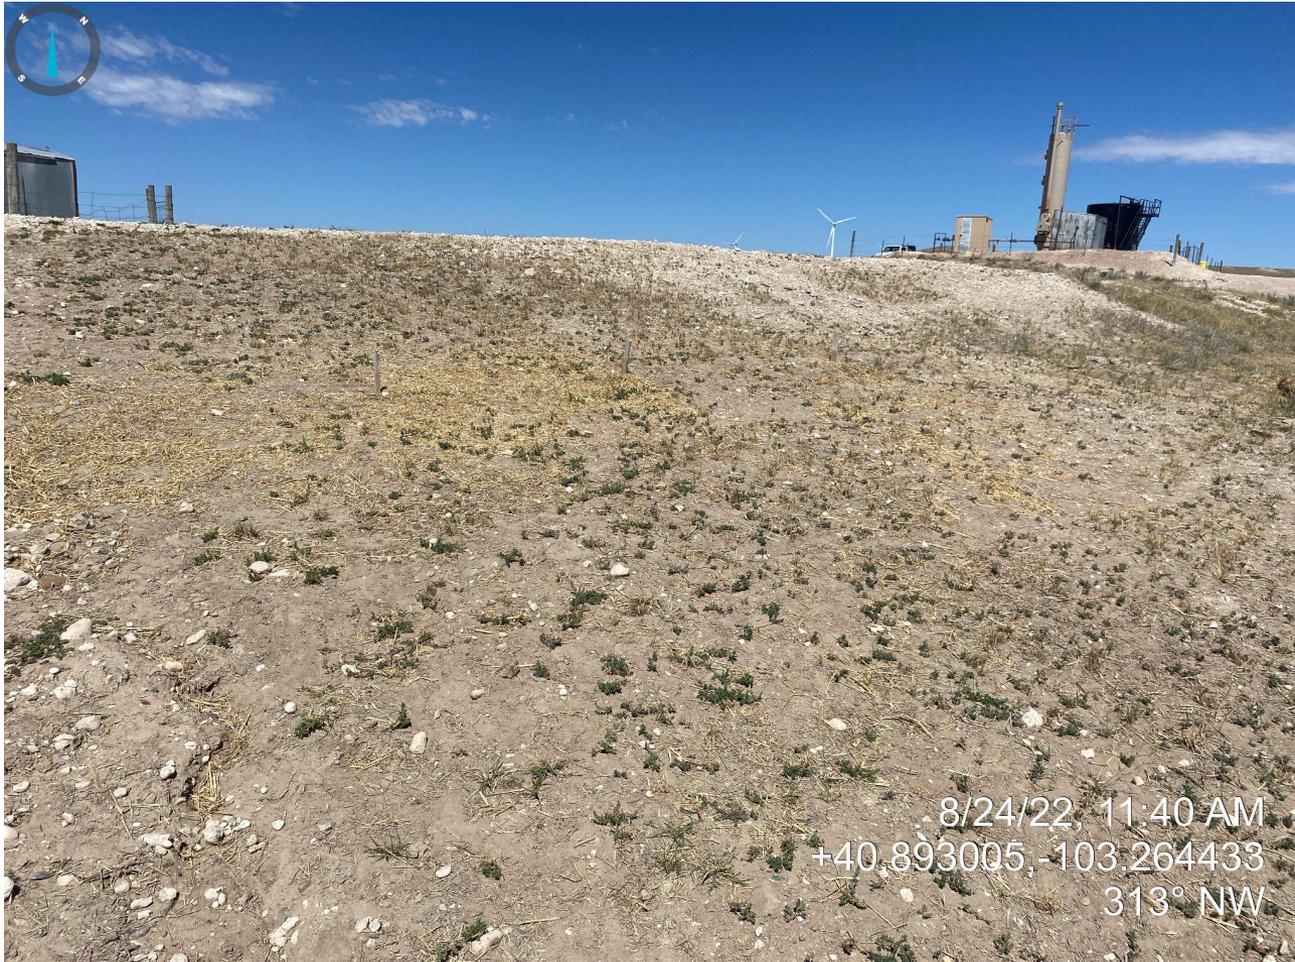
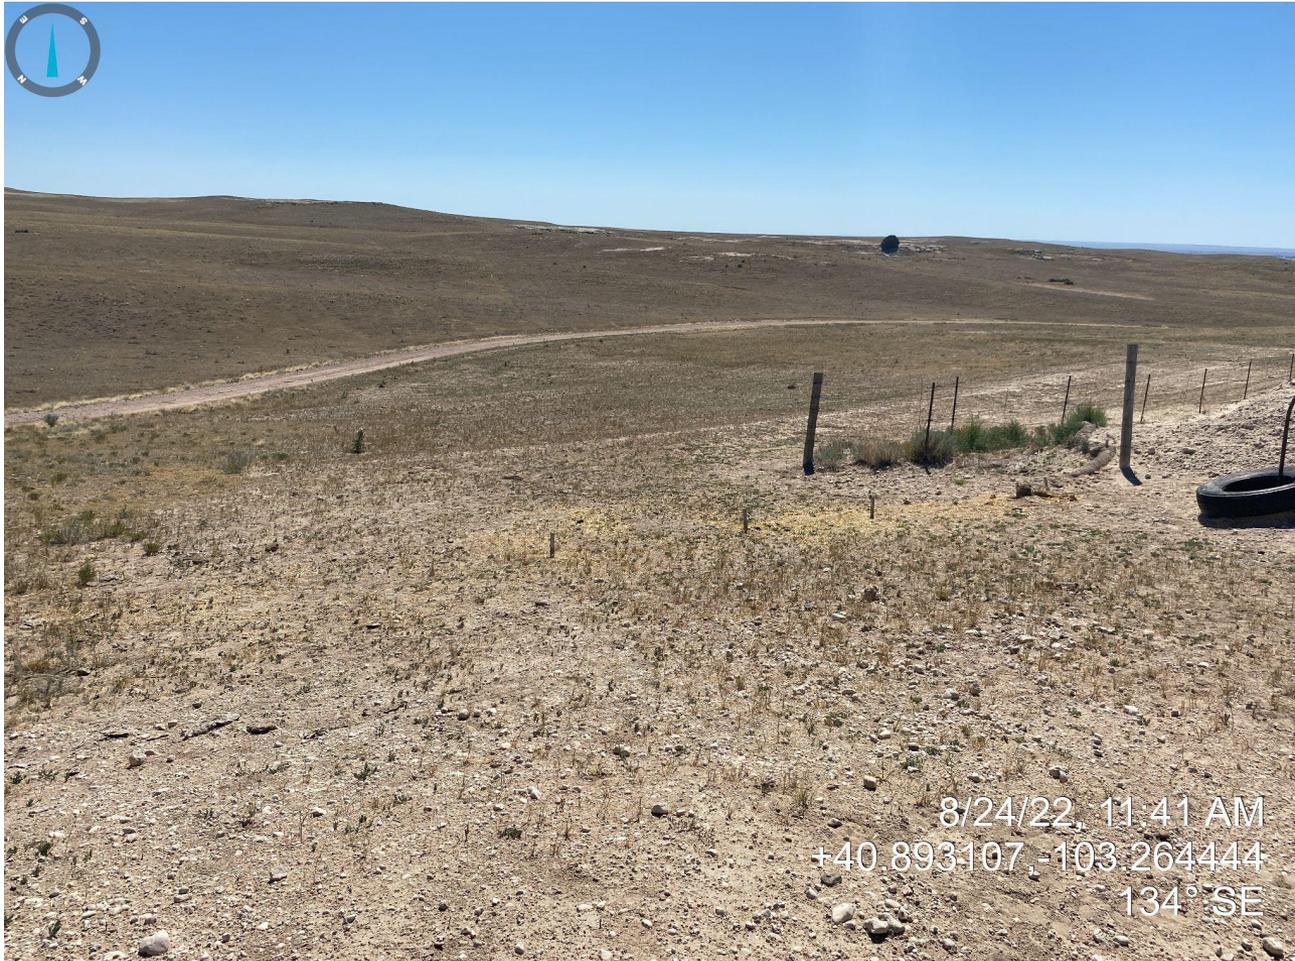
Photo 31. Location photo taken from northeast corner of pit, facing northwest. Photo illustrates slopes have not been stabilized and do not have temporary stormwater BMPs in place. Additionally, it was observed that the slopes do not have uniform vegetation cover resulting in bare soil.

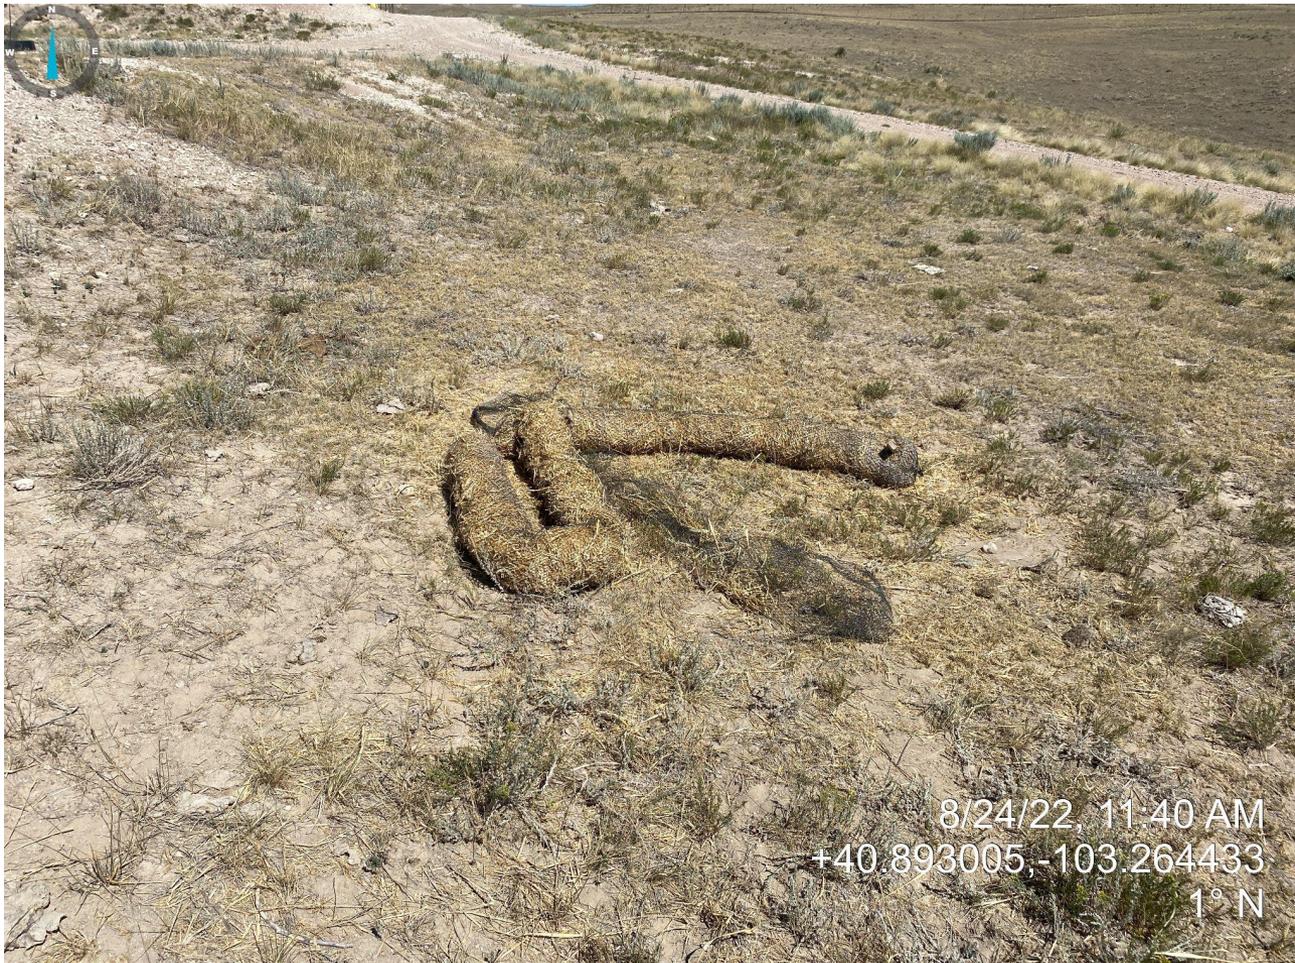
Photo 32. Photo taken northeast of pit corner, facing north. It appears the straw wattles were not installed according to good engineering practices and has moved off location. The wattle is considered debris and needs to be disposed of accordingly.
