Interim Reclamation and Stormwater Inspection

Date: 08/24/2022

Operator: WESTERN OPERATING COMPANY - 95620

Location ID: 312292

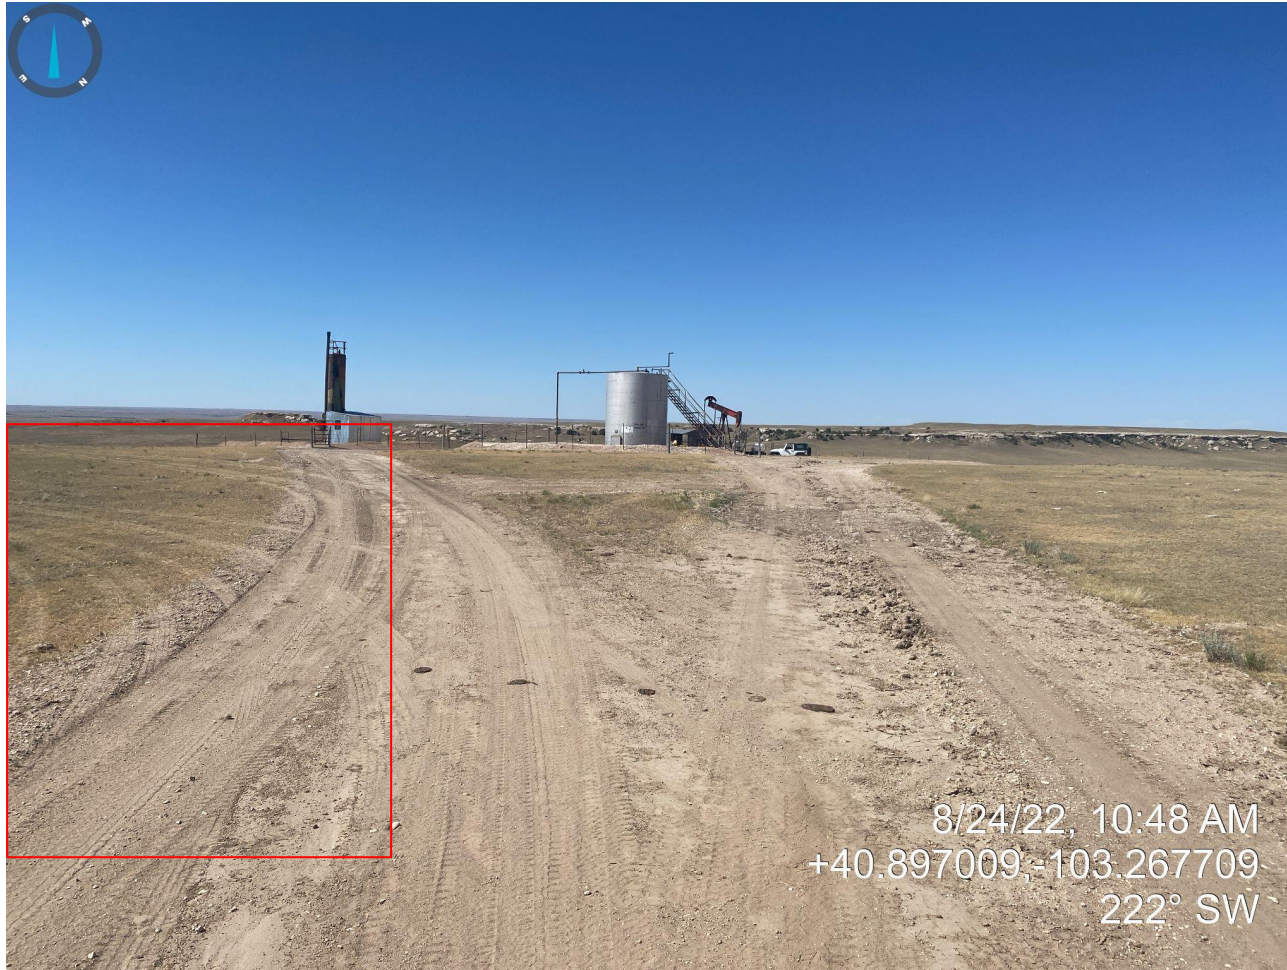
Photo 1. Location photo taken near access road gate/entrance, facing southwest. Photo illustrates vehicle tracking off location.

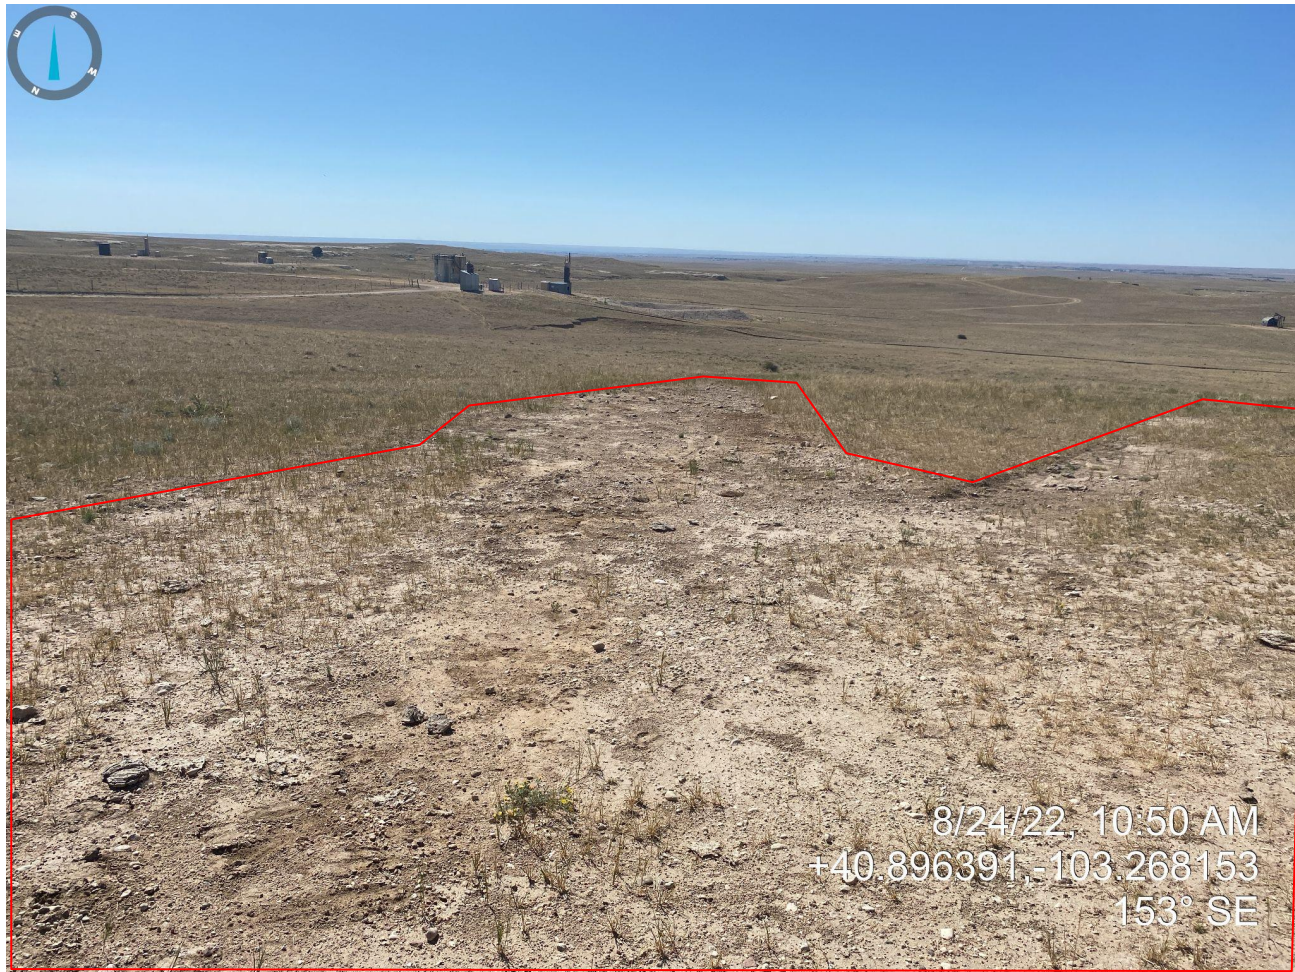
Photo 2. Location photo taken from southeast portion, facing southeast. Red outline illustrates salt kill impact and absence of vegetation cover or temporary stormwater BMPs within affected area.

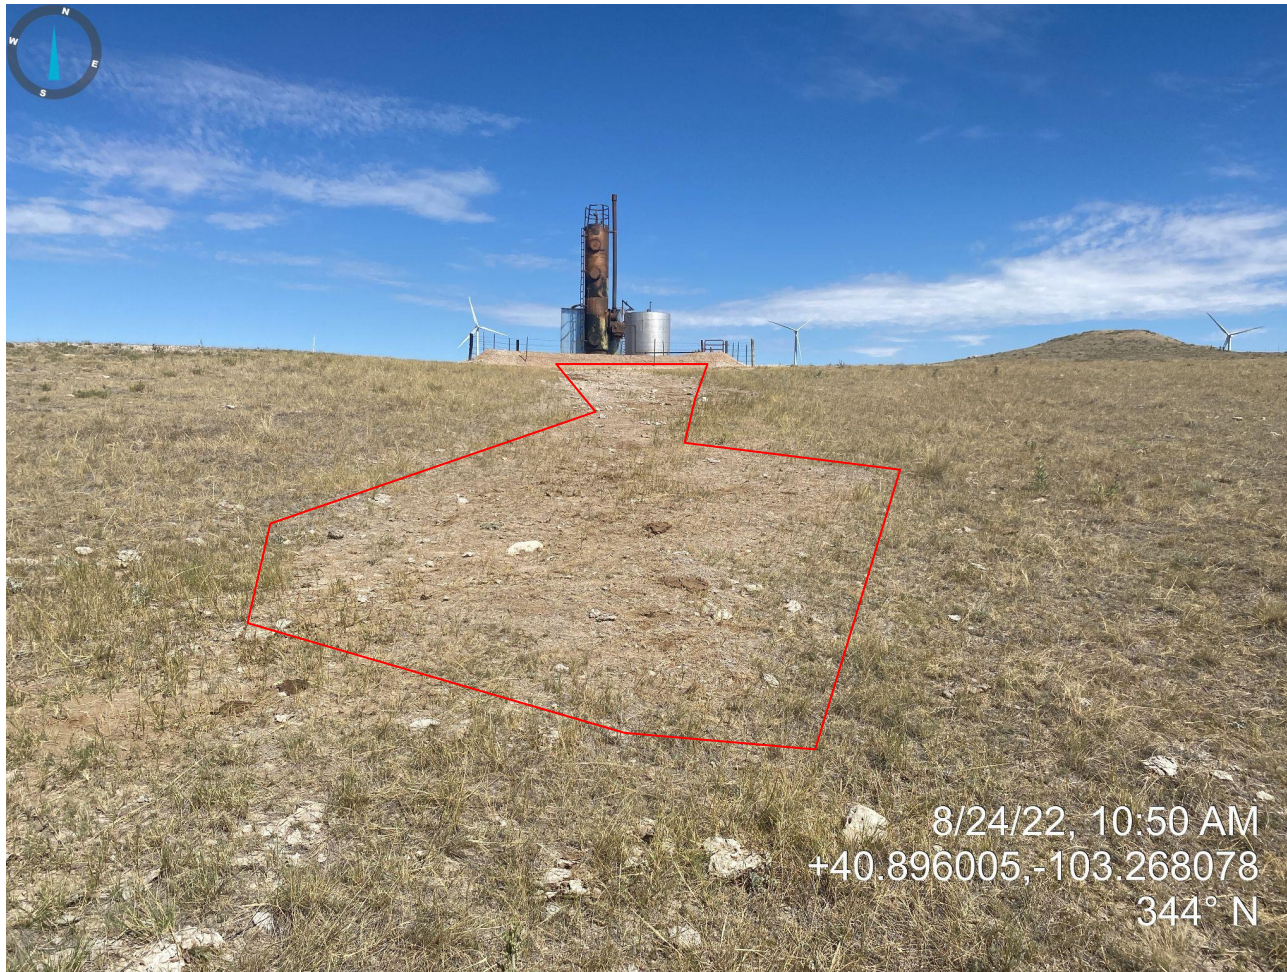
Photo 3. See comments in photo 2.

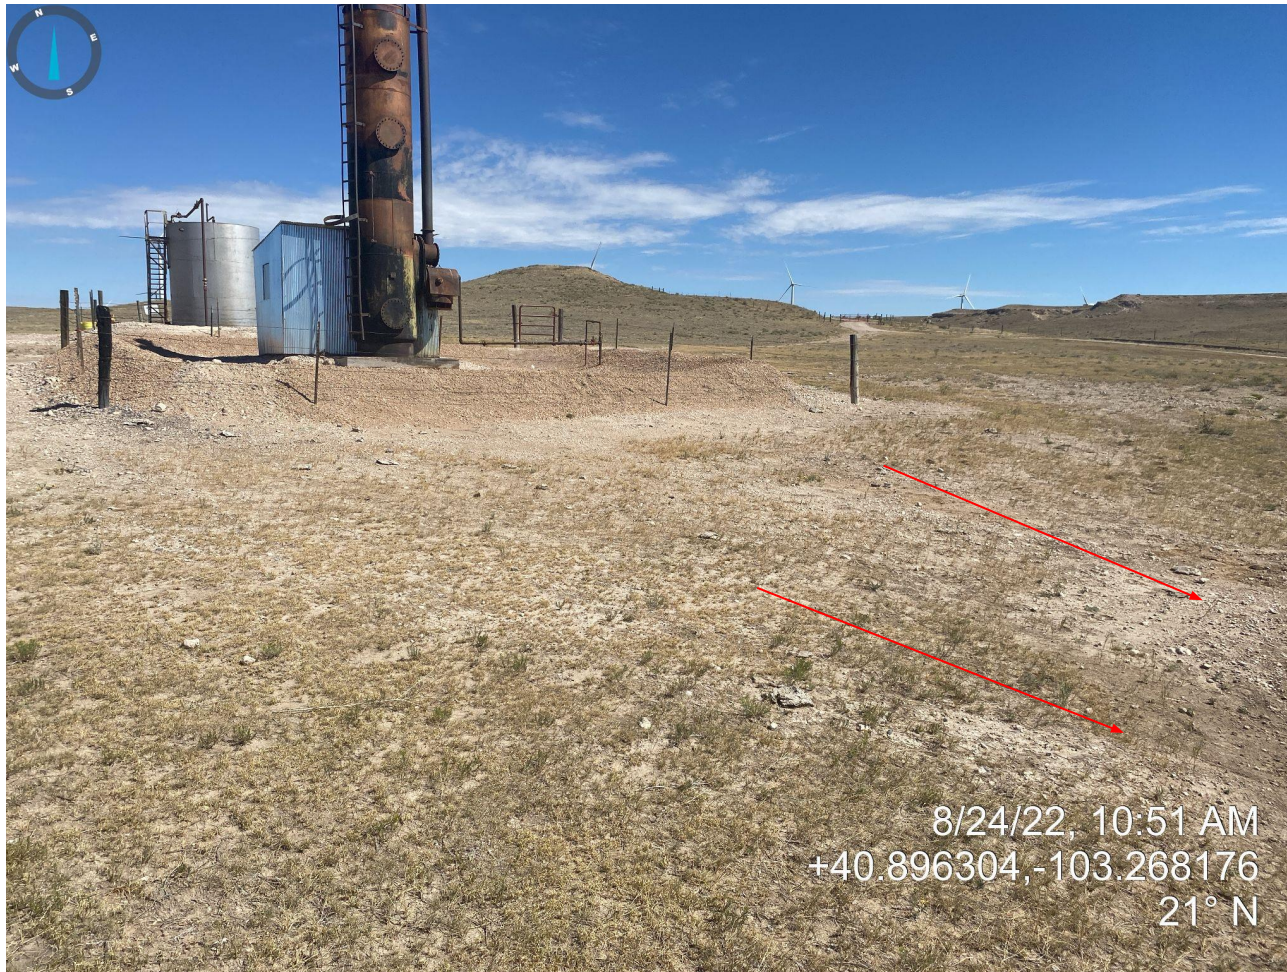
Photo 4. Location photo taking from southeast portion, facing north. Photo illustrates starting point of runoff source, from photo 3, outlined in red.

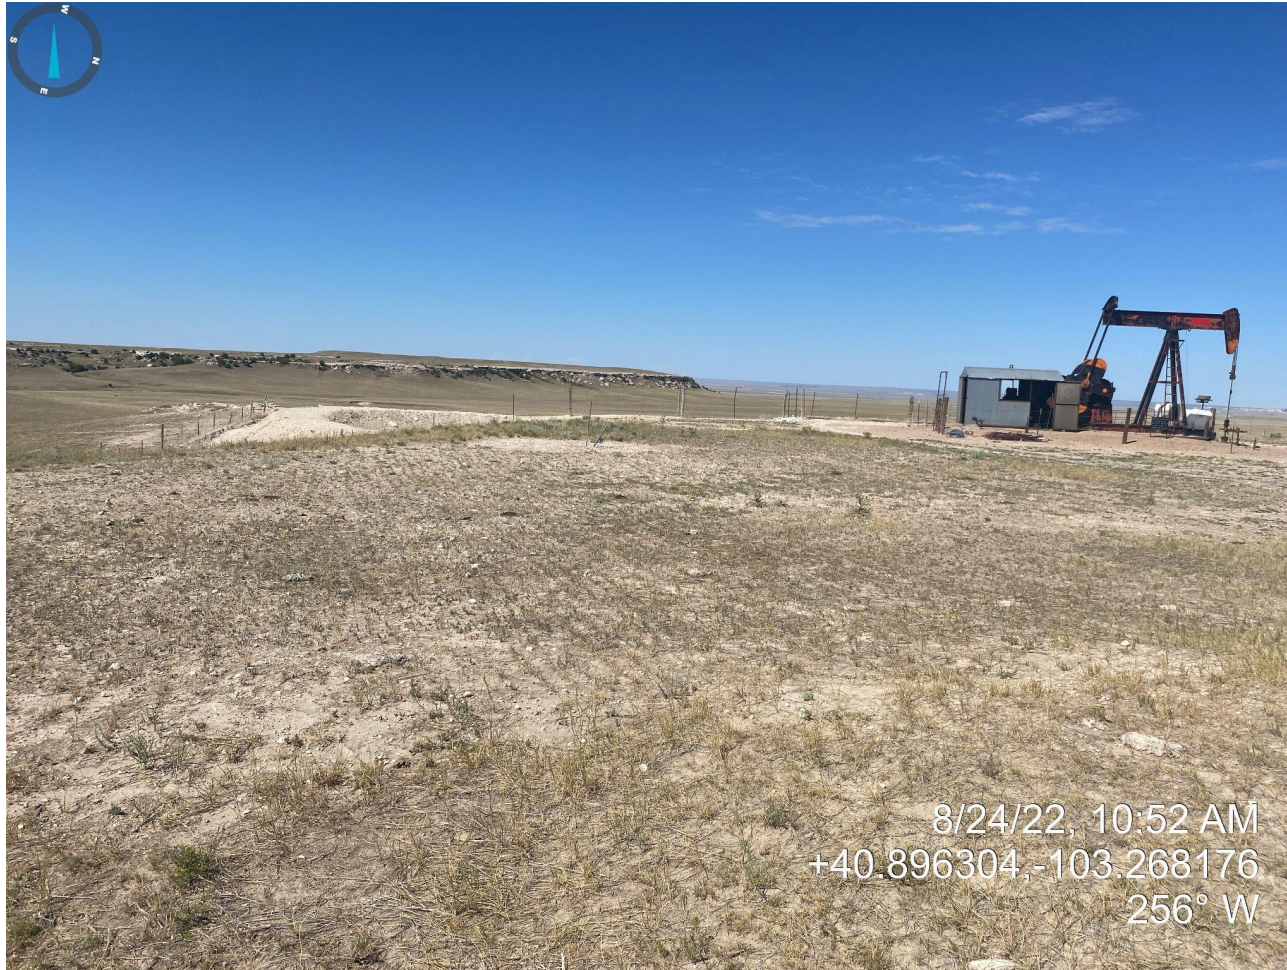
Photo 5. Location photo taken from eastern portion, facing west. Photo illustrates revegetation attempts within affected area.

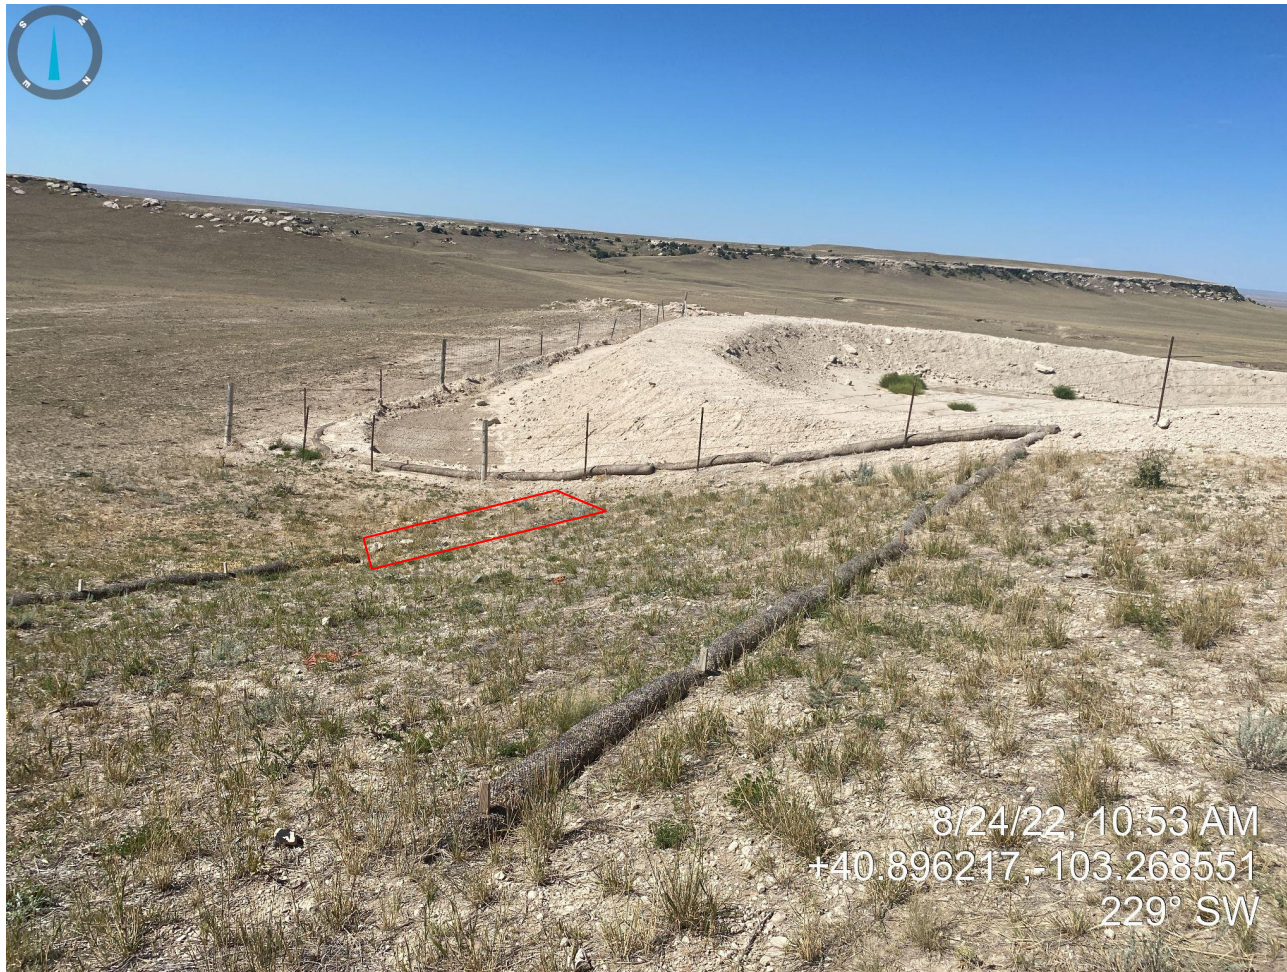
Photo 6. Location photo taken from southeastern portion, facing southwest. Photo illustrates slope is in process of revegetating and temporarily stabilized. Red outline illustrates missing straw wattle.

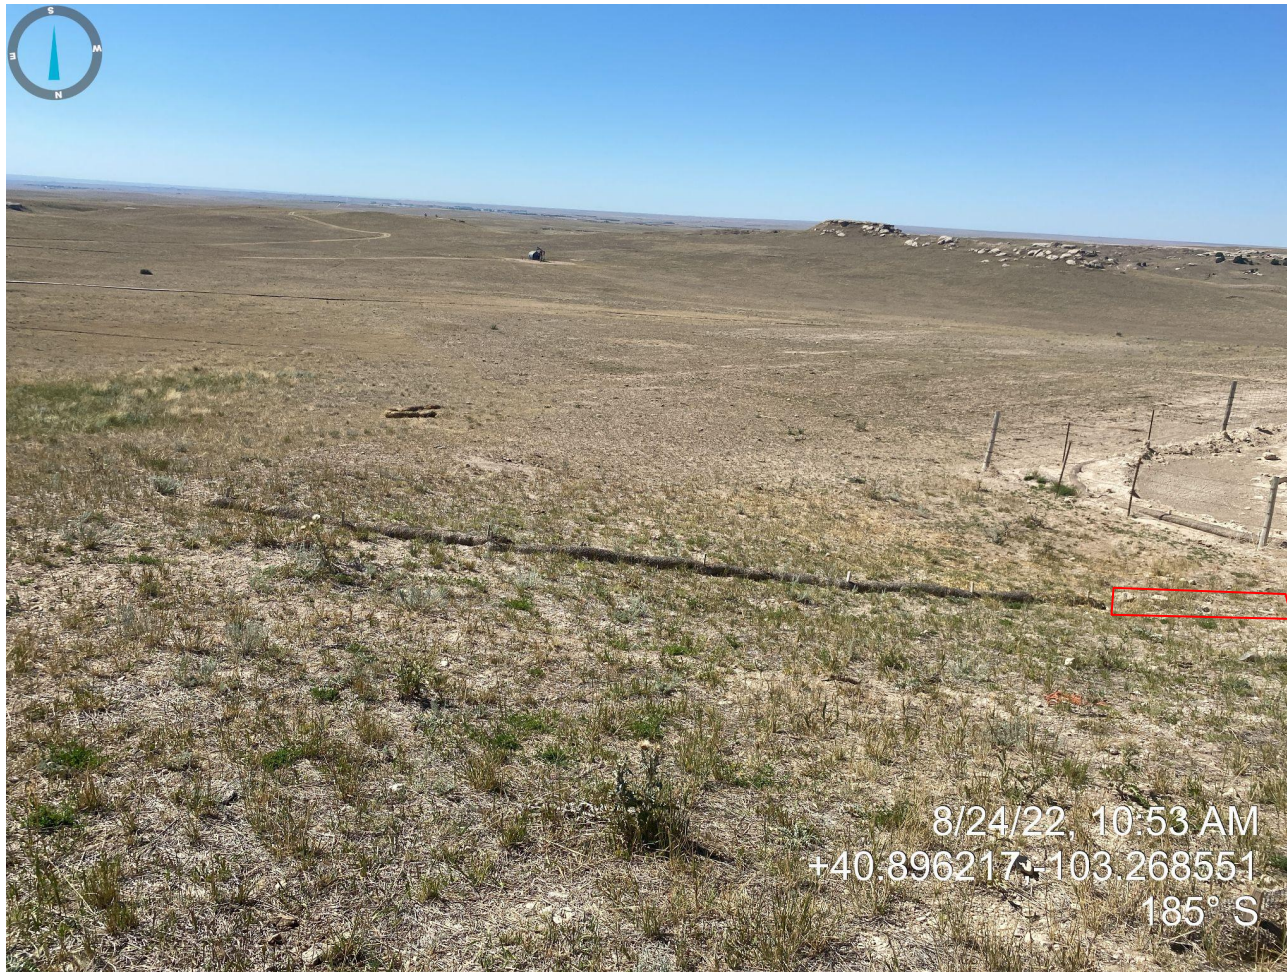
Photo 7. See comments in photo 6.

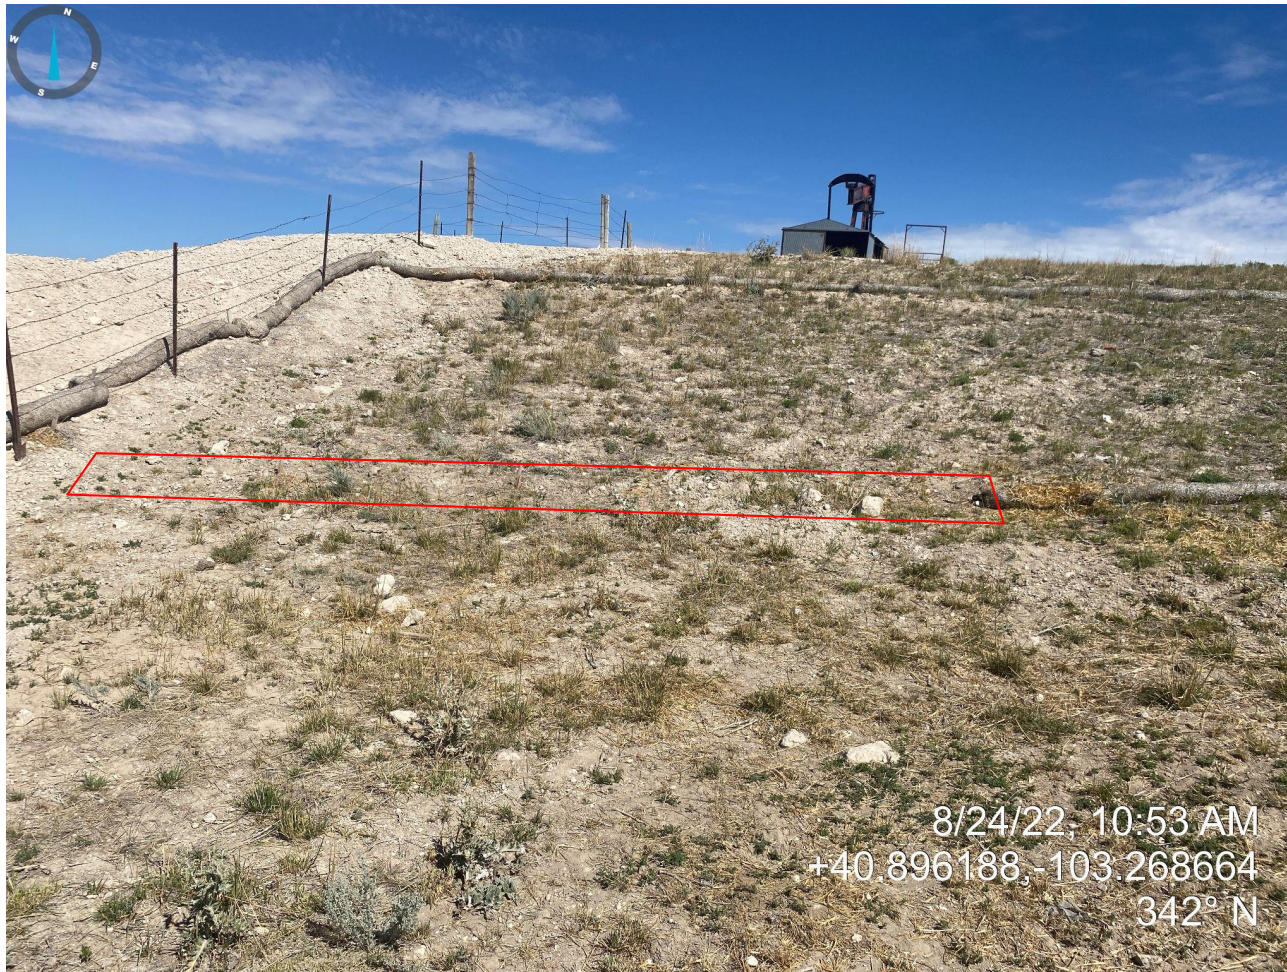
Photo 8. See comments in photo 6.

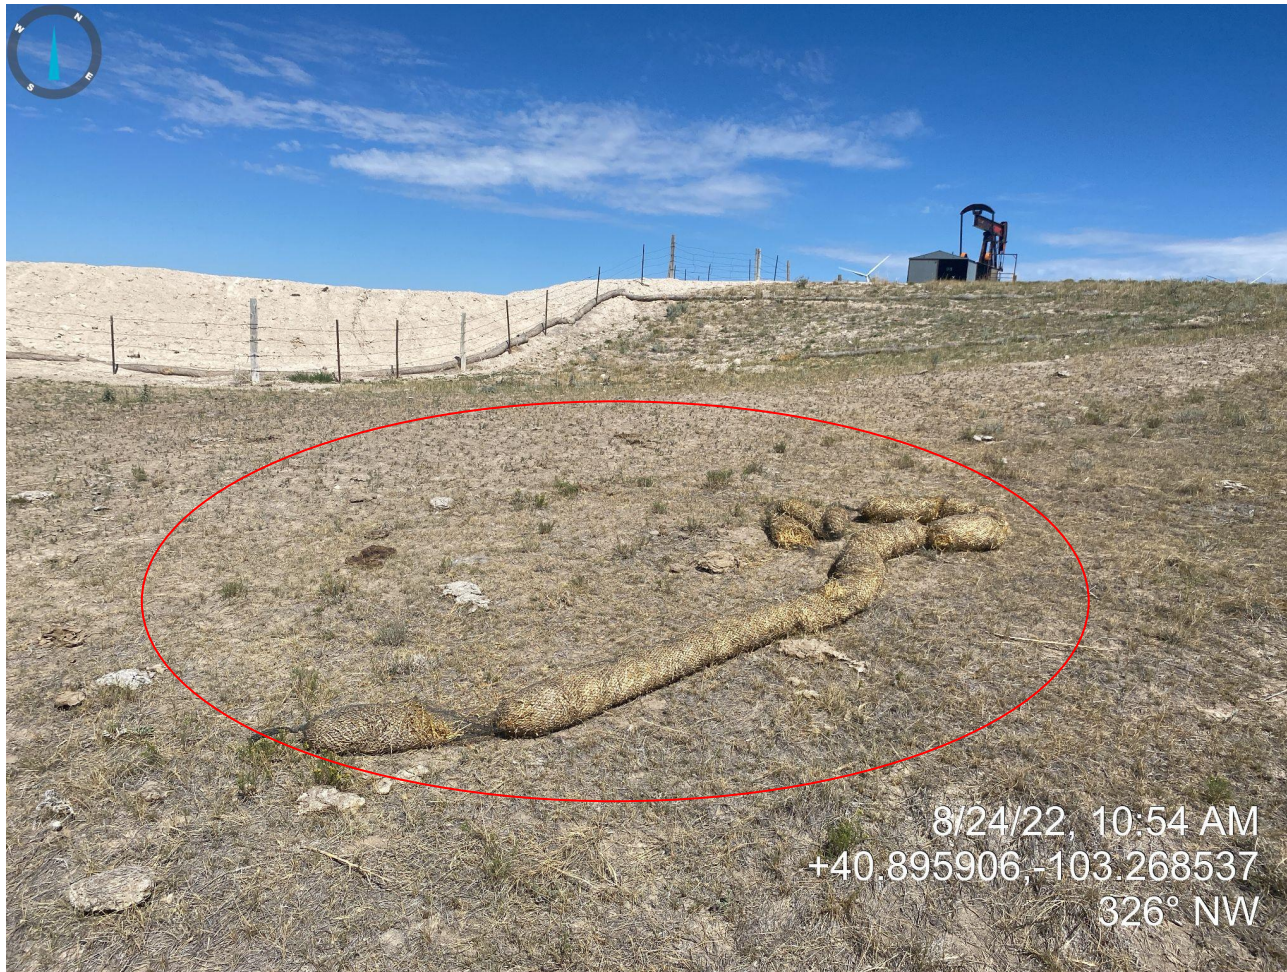
Photo 9. Photo taken southeast of location within salt kill area, facing northwest. Photo illustrates straw wattle was not properly installed and displaced within affected area; this is now considered debris and needs to be disposed of accordingly.

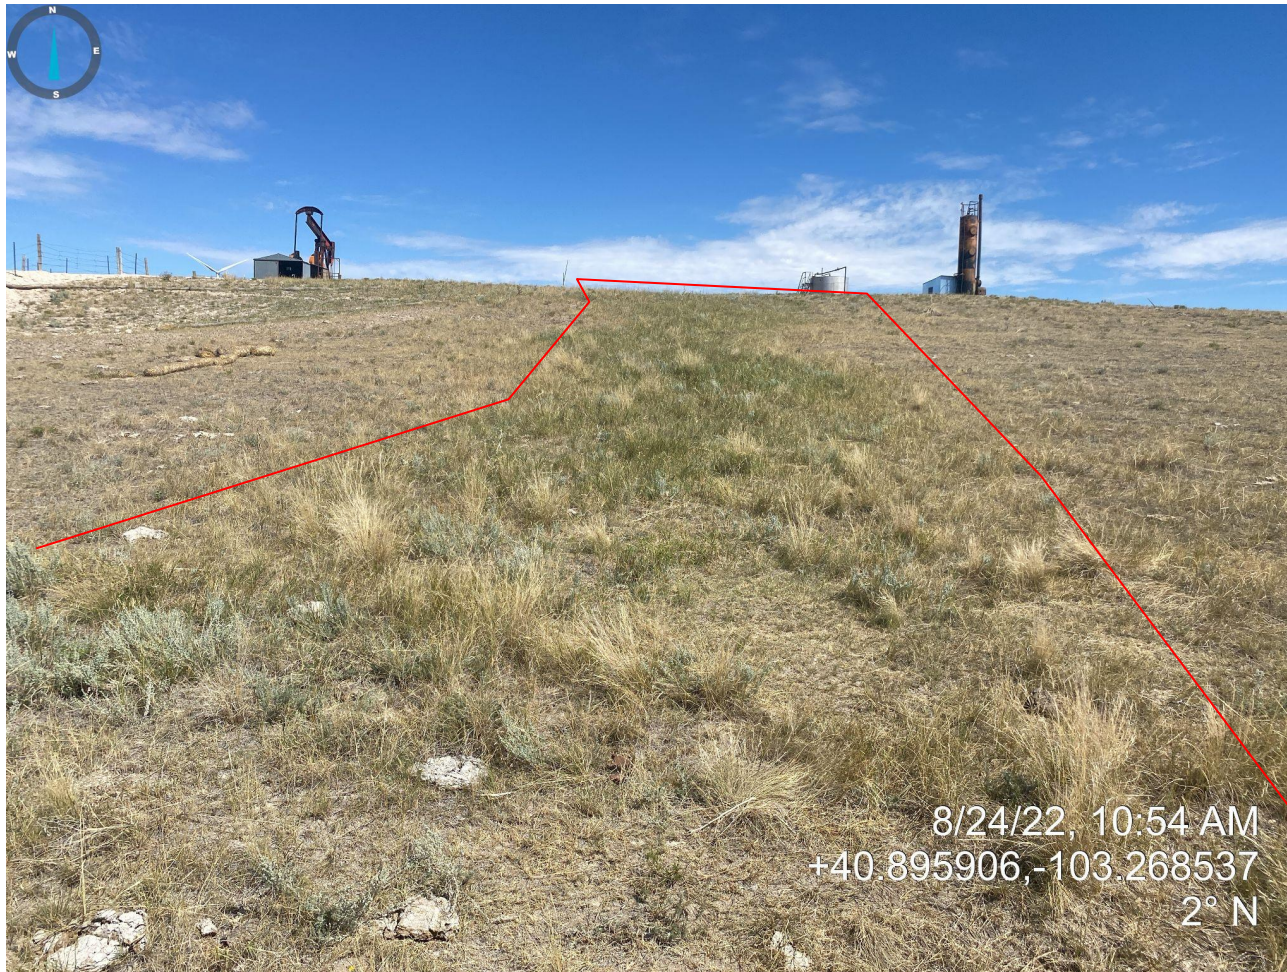
Photo 10. Photo taken adjacent to salt kill area and southeast of location, facing north. Photo illustrates reference area not impact by salt kill, outlined in red.

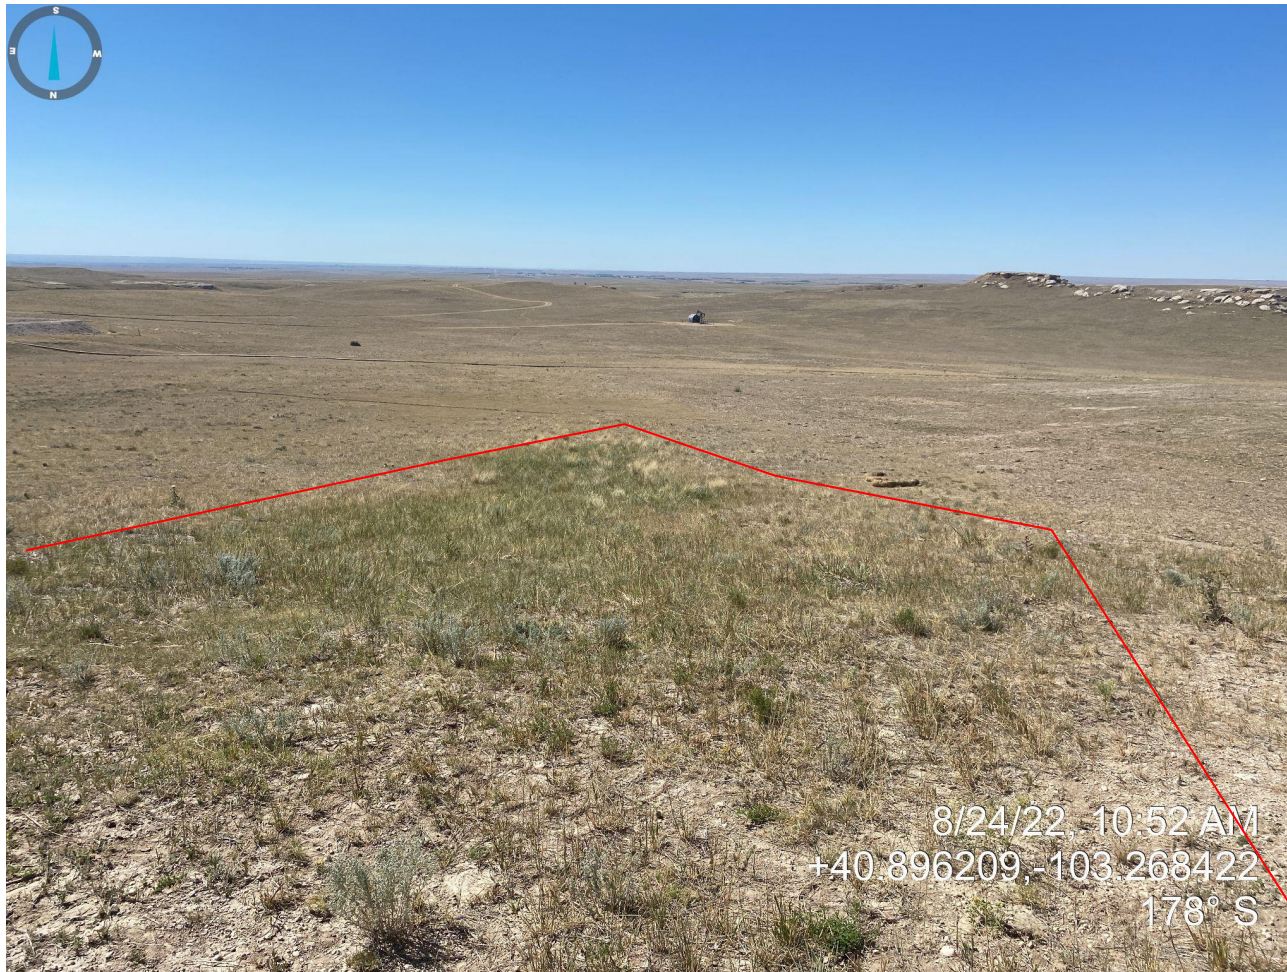
Photo 11. See comments in photo 10.

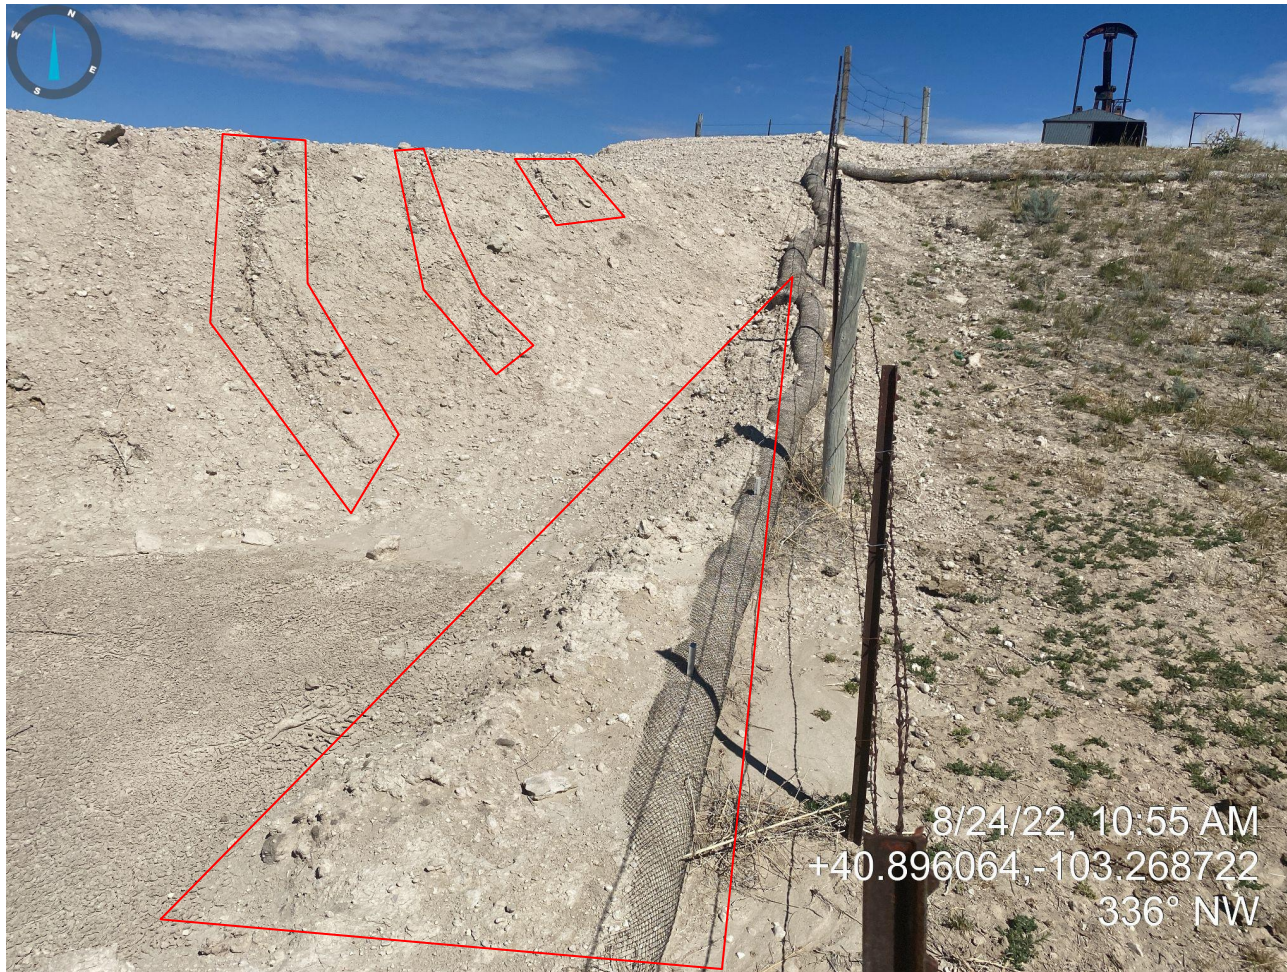
Photo 12. Photo taken east of pit and south of location, facing northwest. Photo illustrates straw wattles buried with sediment and are in need of maintenance/replacement to properly capture sediment laden stormwater from exiting location; pit walls show evidence of rill erosion. Both outlined in red.

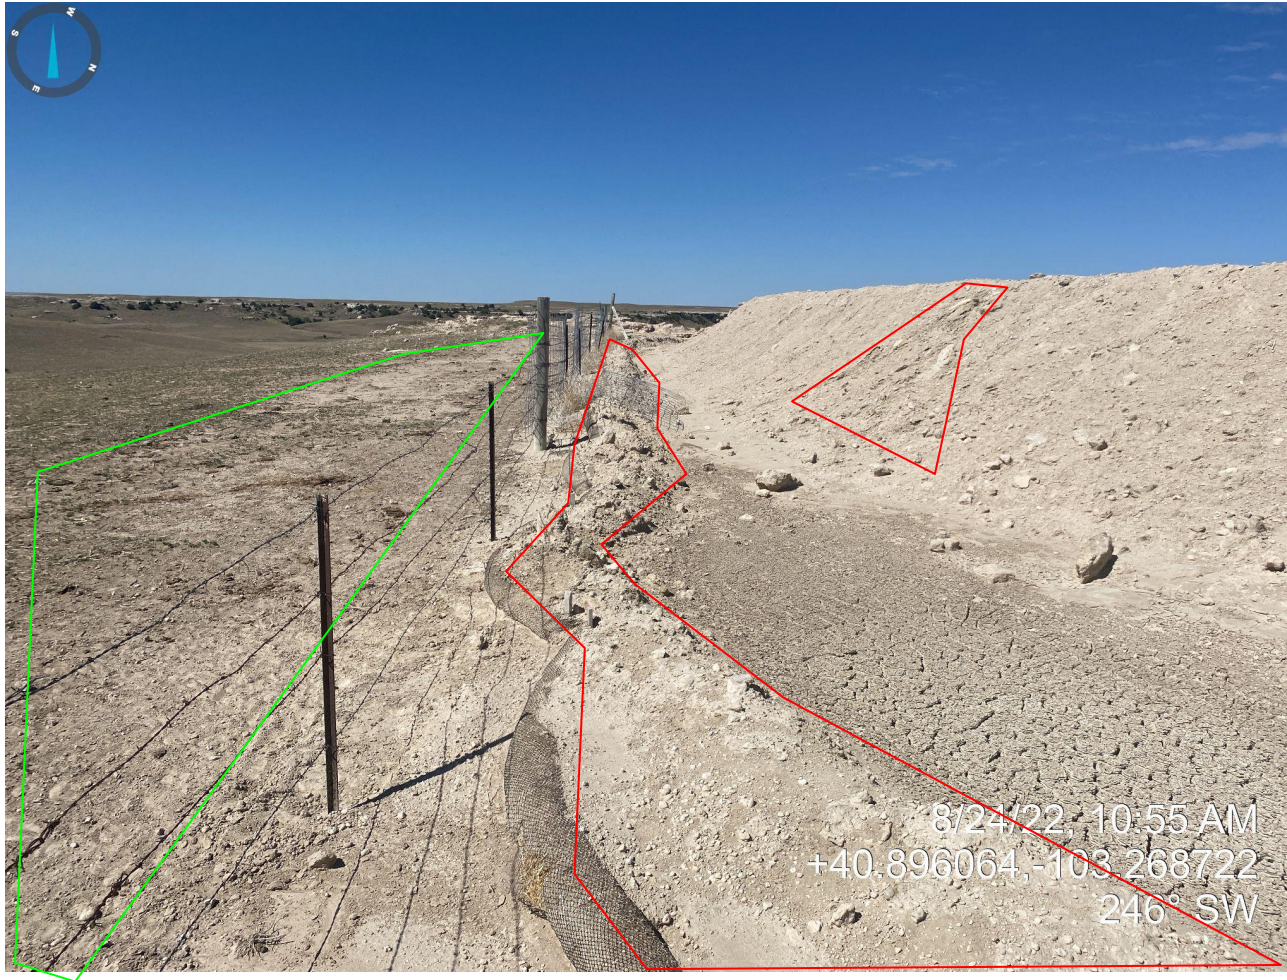
Photo 13. Photo taken from southeast corner of pit, facing southwest. Red outline illustrates sediment buried straw wattles and rill erosion on pit wall. Green highlight illustrates sediment laden stormwater is exiting off location and impacting vegetation establishment.

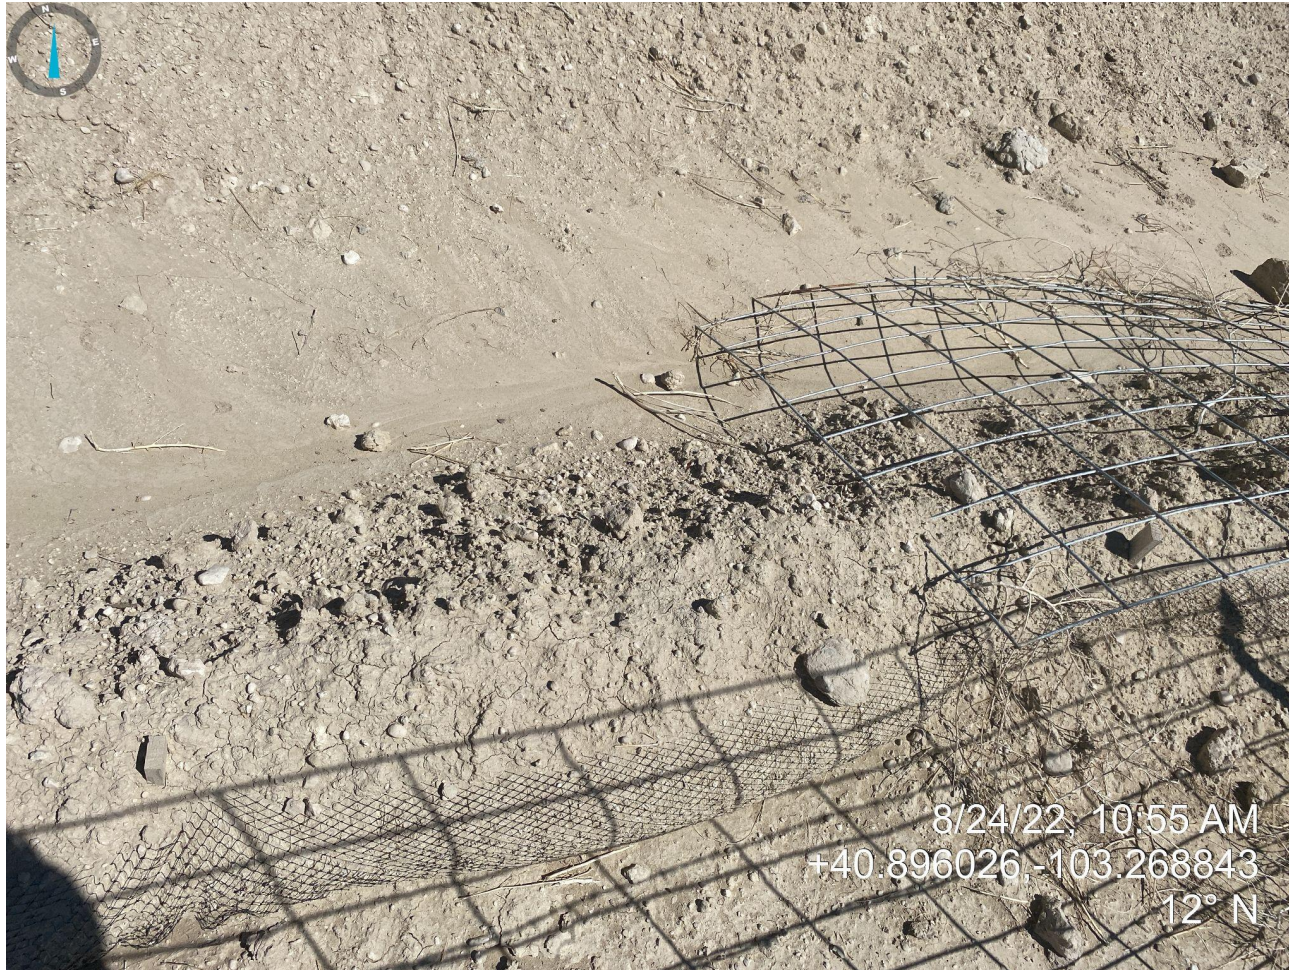
Photo 14. Photo taken from southern portion of pit; close up of buried straw wattles.

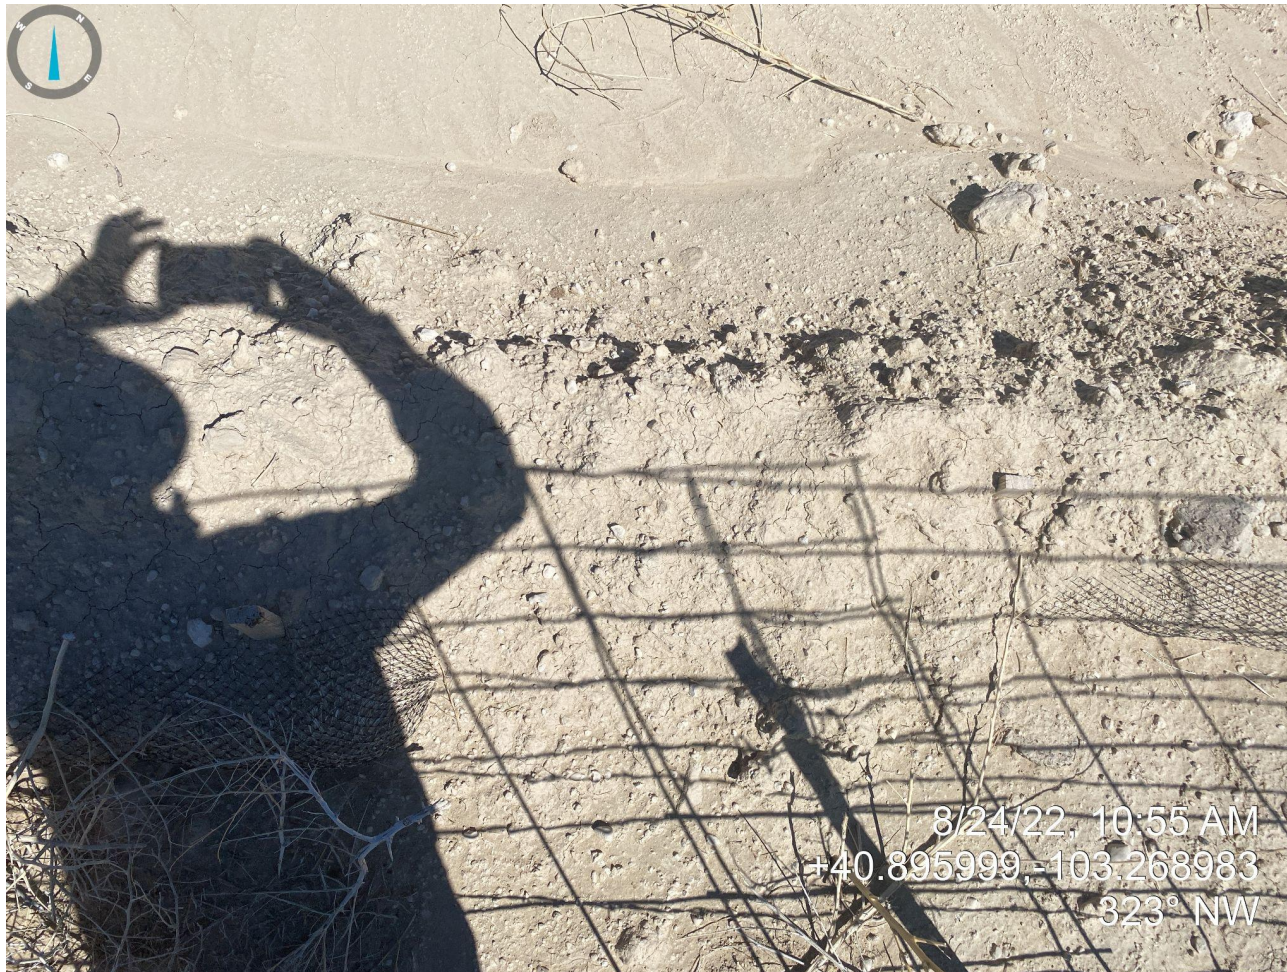
Photo 15. Photo taken from southern portion of pit; close up of inadequate stormwater BMPs. Sediment laden stormwater has buried the straw wattles and is exiting the location.

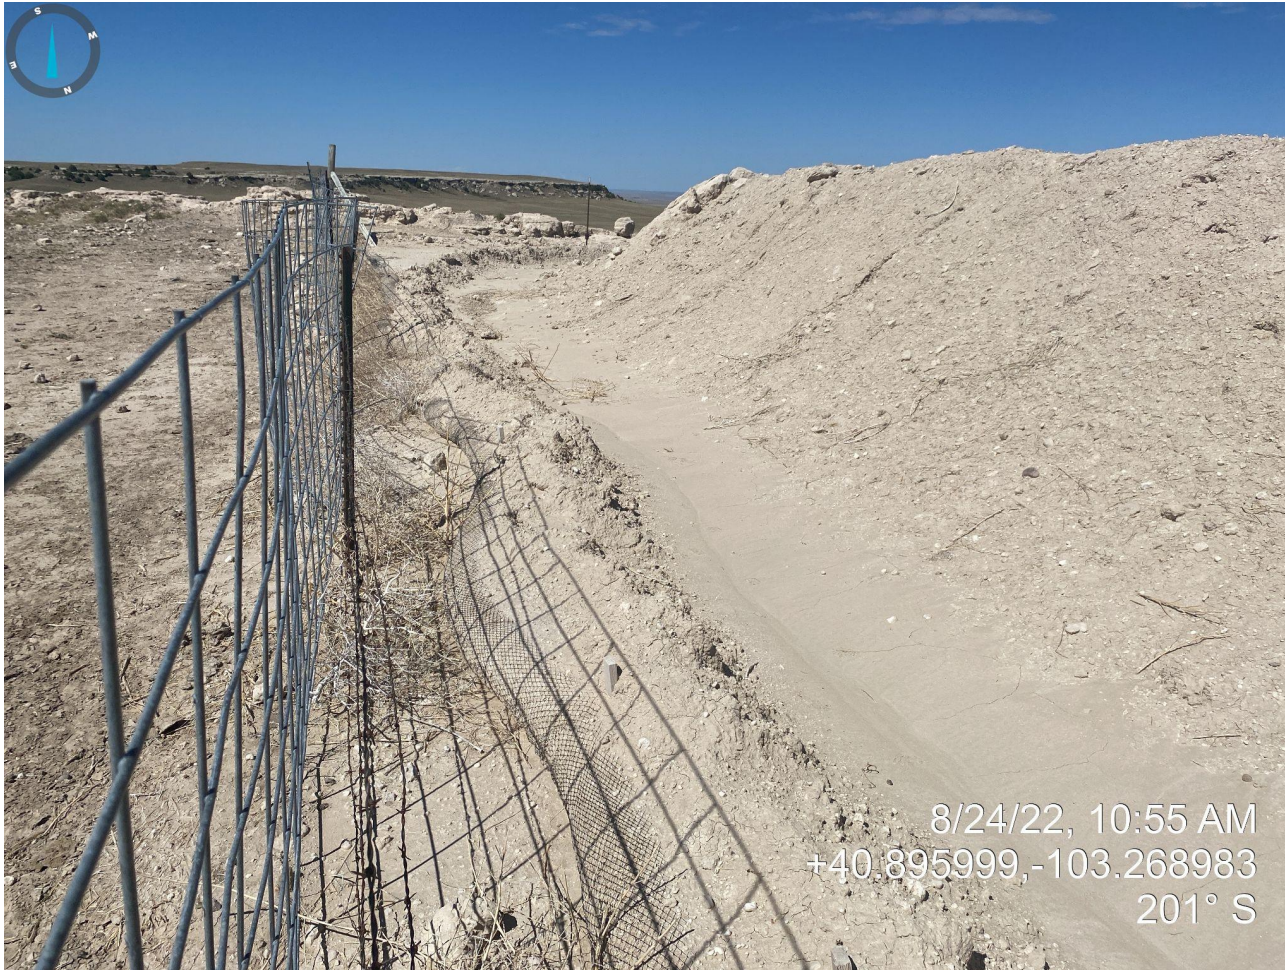
Photo 16. Photo taken from southern center portion of pit, facing west. Photo illustrates stormwater BMPs/straw wattles are buried with sediment and need maintenance/replacement to function properly and keep sediment from exiting location .

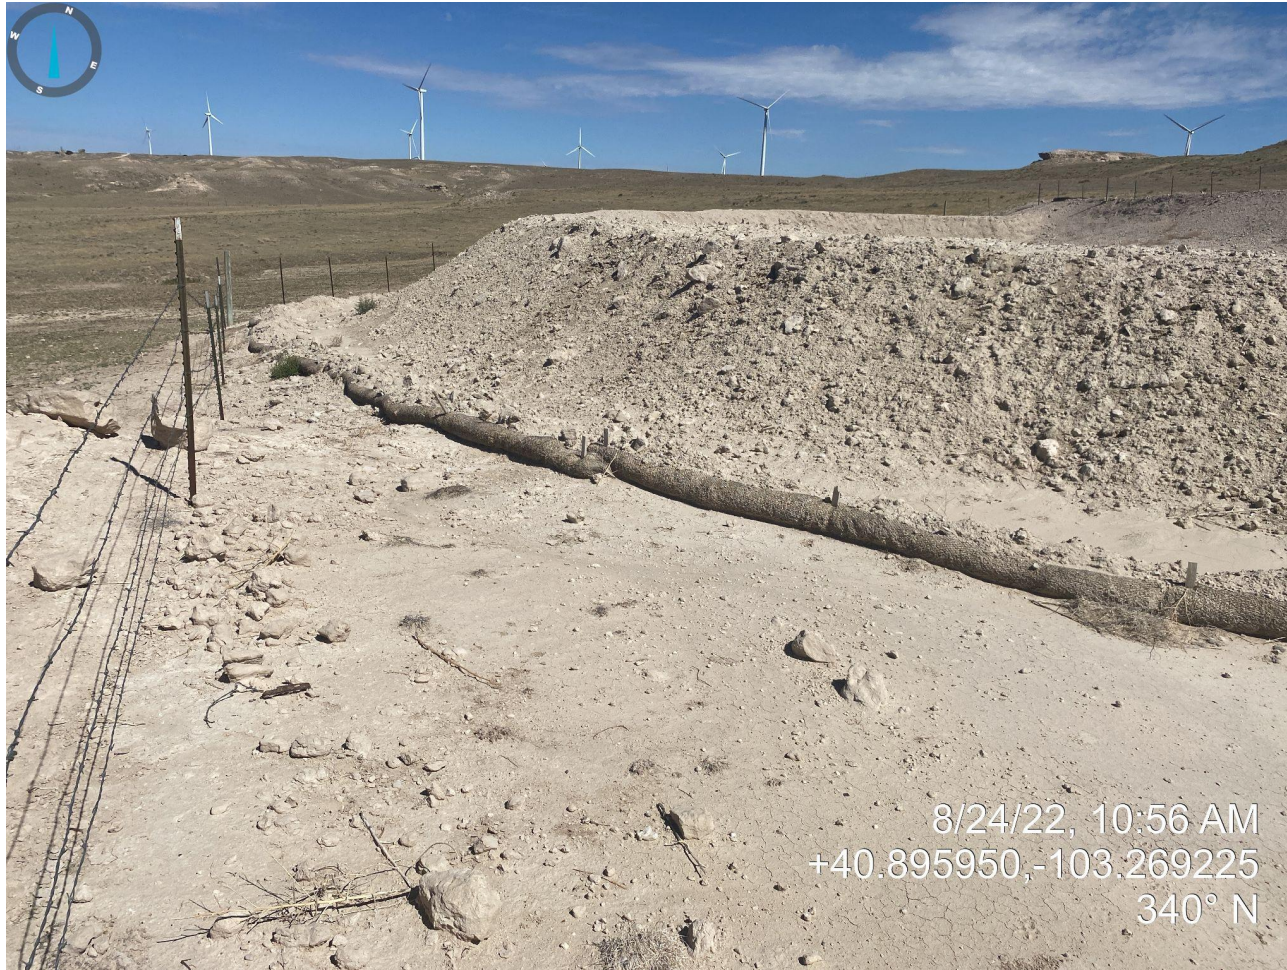
Photo 17. Photo taken from southwestern portion of pit, facing north. See comments in photo 16.

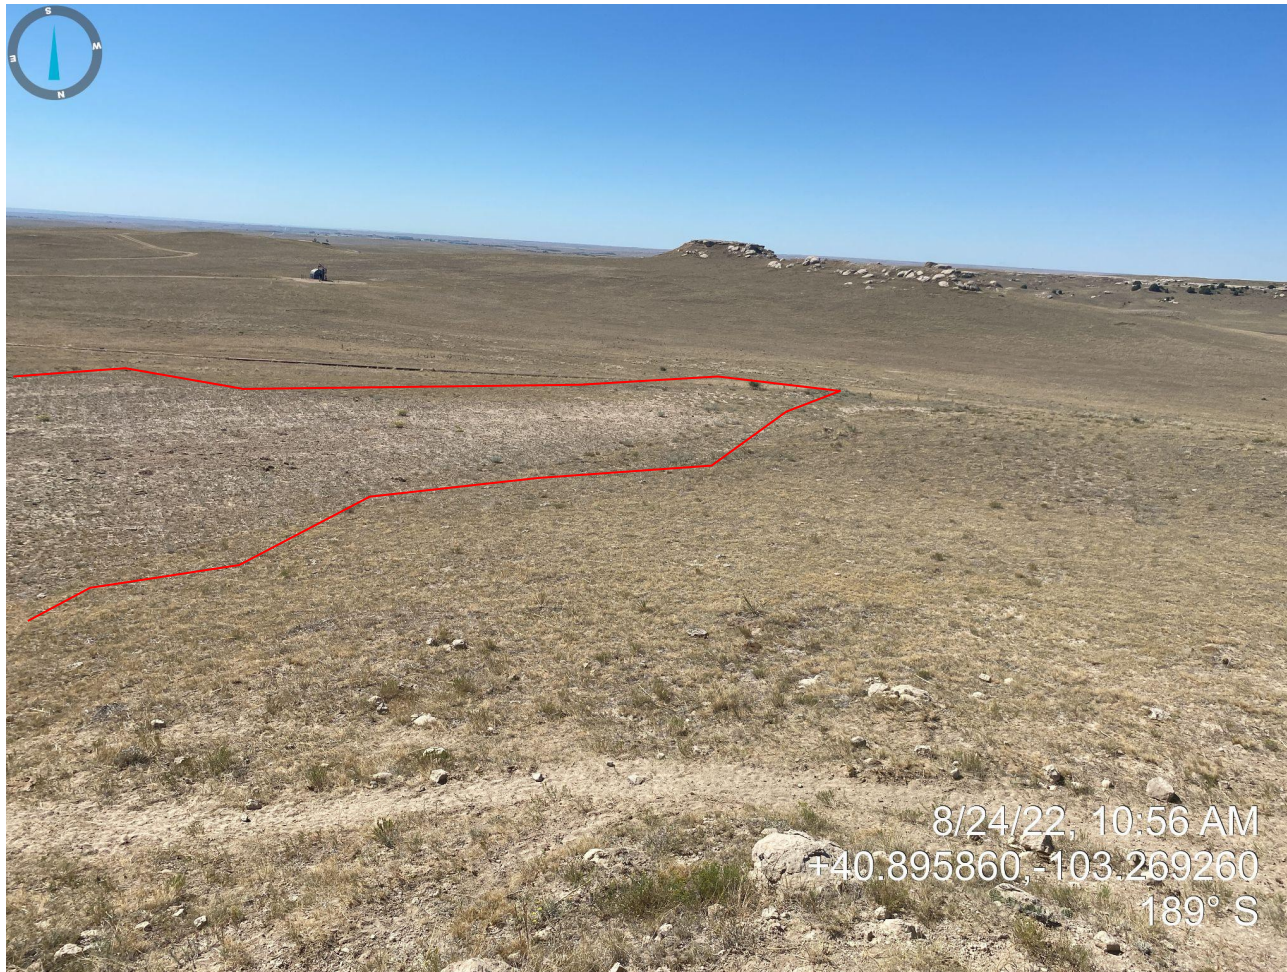
Photo 18. Photo taken of salt kill area from the southwest corner of the pit, facing south. Salt kill area outlined in red.
