Interim Reclamation and Stormwater Inspection

Date: 08/24/2022

Operator: WESTERN OPERATING COMPANY - 95620

Location ID: 312292

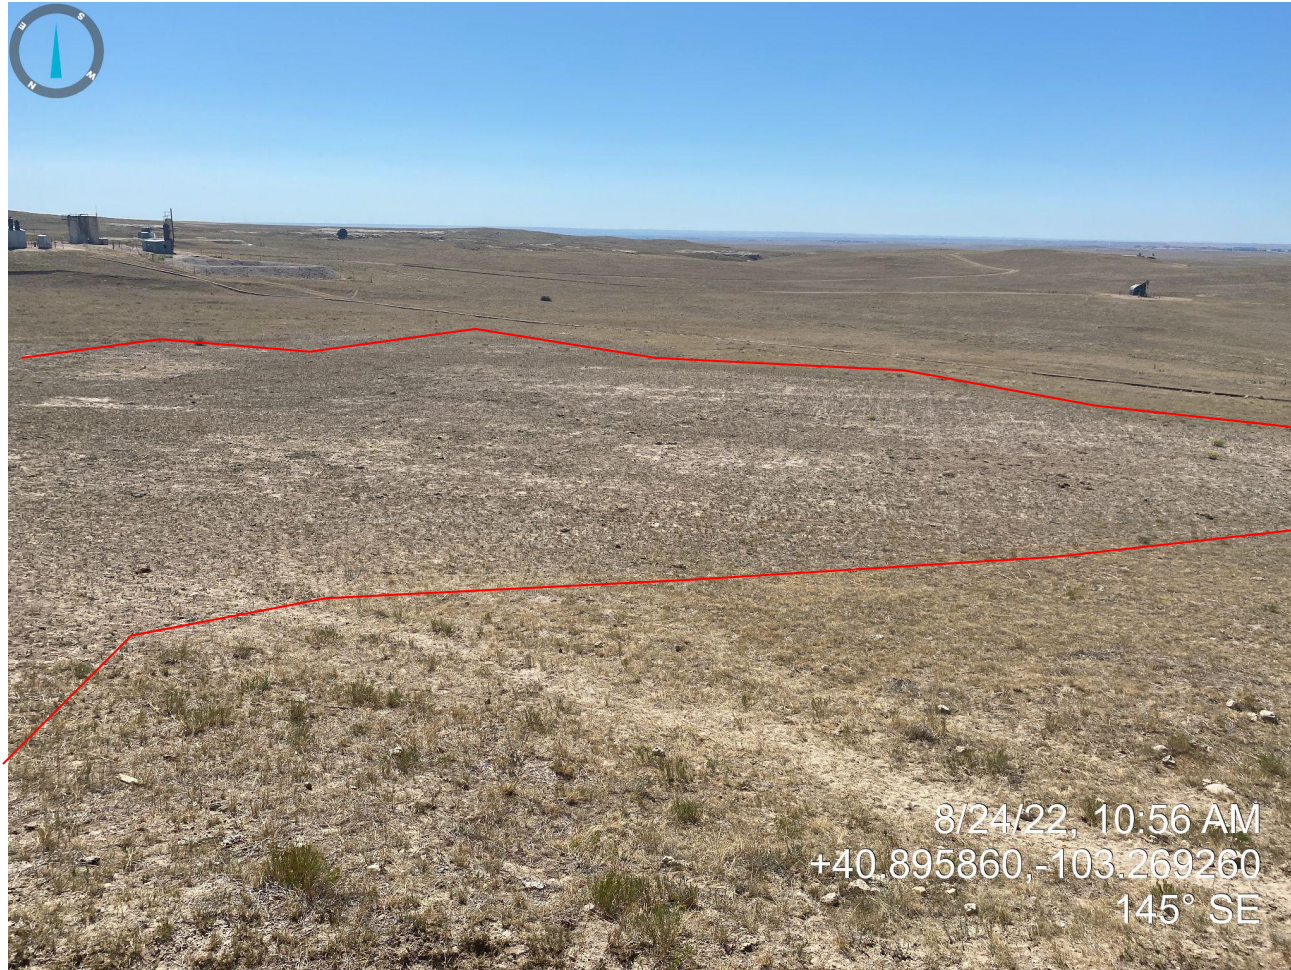
Photo 19. Photo taken of salt kill area from the southwest corner of the pit, facing southeast. Salk kill area outlined in red.

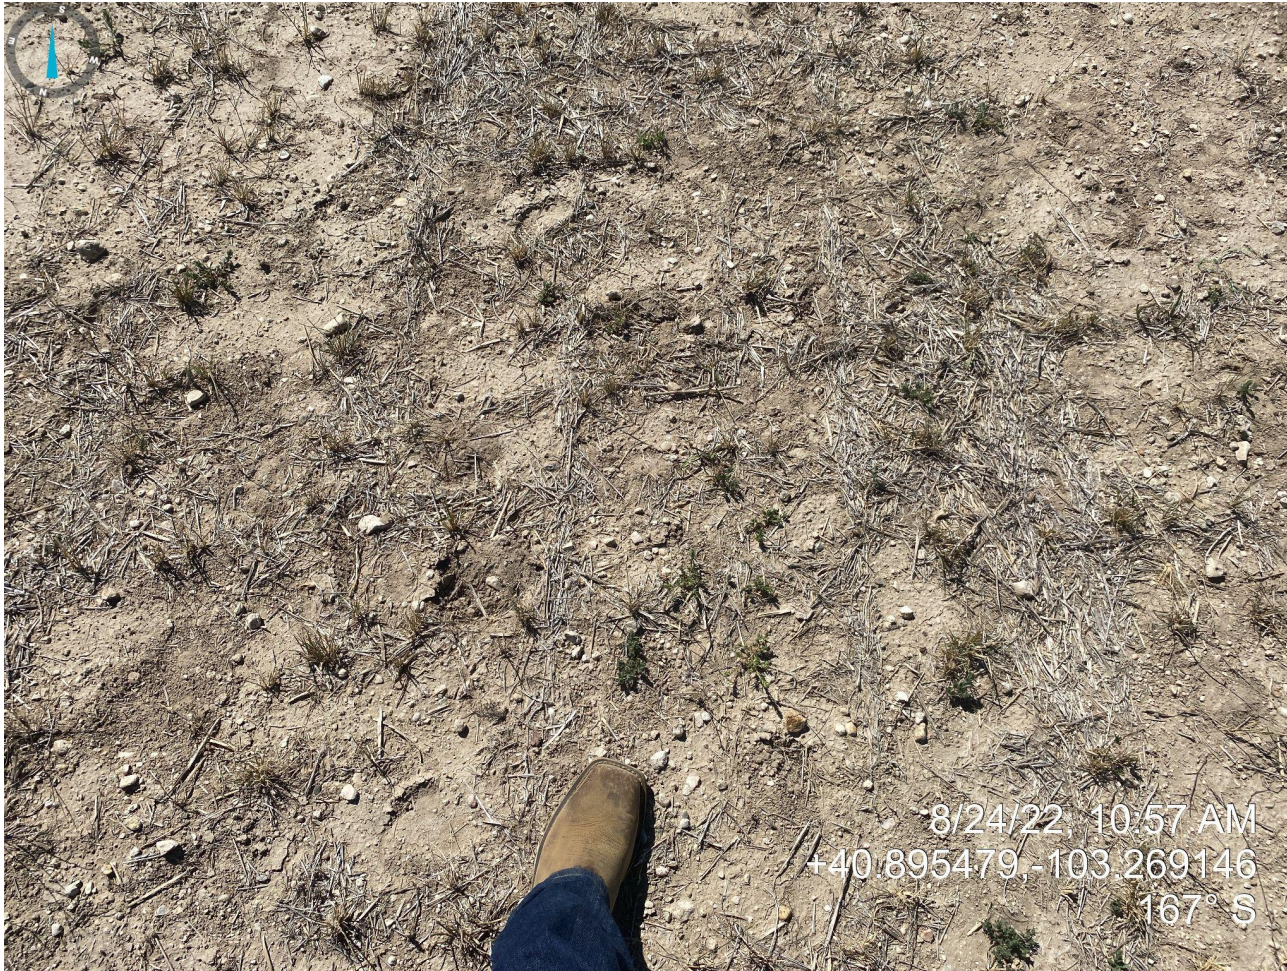
Photo 20. Close up photo within the center portion of the salt kill area. Photo illustrates some desirable vegetation present (buffalo grass, wheatgrass).

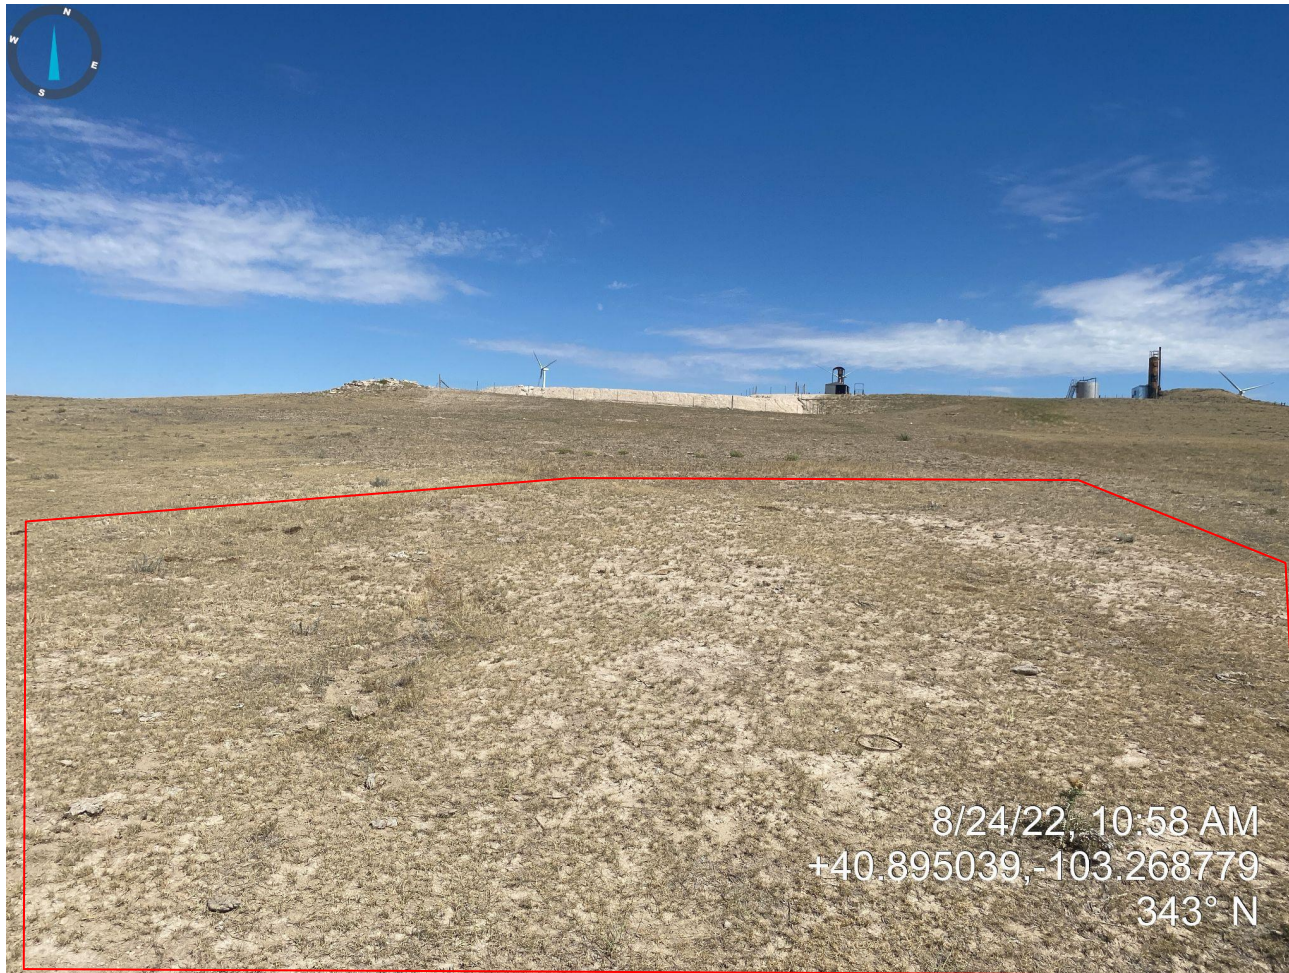
Photo 21. Photo taken from southernmost extent of salt kill, near exposed pipeline, facing north. Photo illustrates some desirable vegetation establishment (predominantly buffalo grass) in foreground, outlined in red.

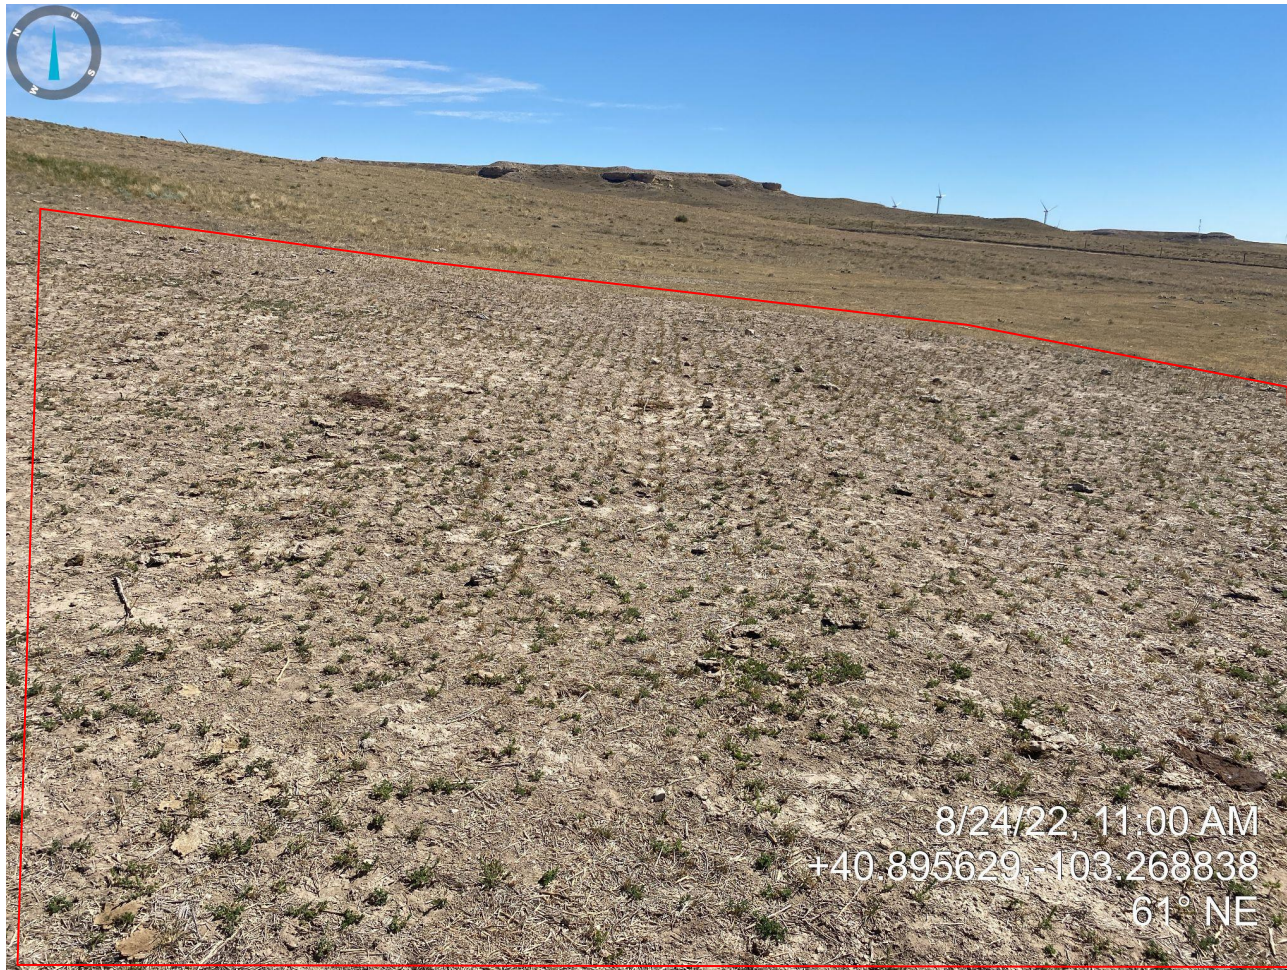
Photo 22. Photo taken from center portion of salt kill, facing northeast. Photo illustrates this portion of the salt kill area has failed to provide uniform vegetation cover resulting in bare soil and annual weedy vegetation, predominantly Kochia.

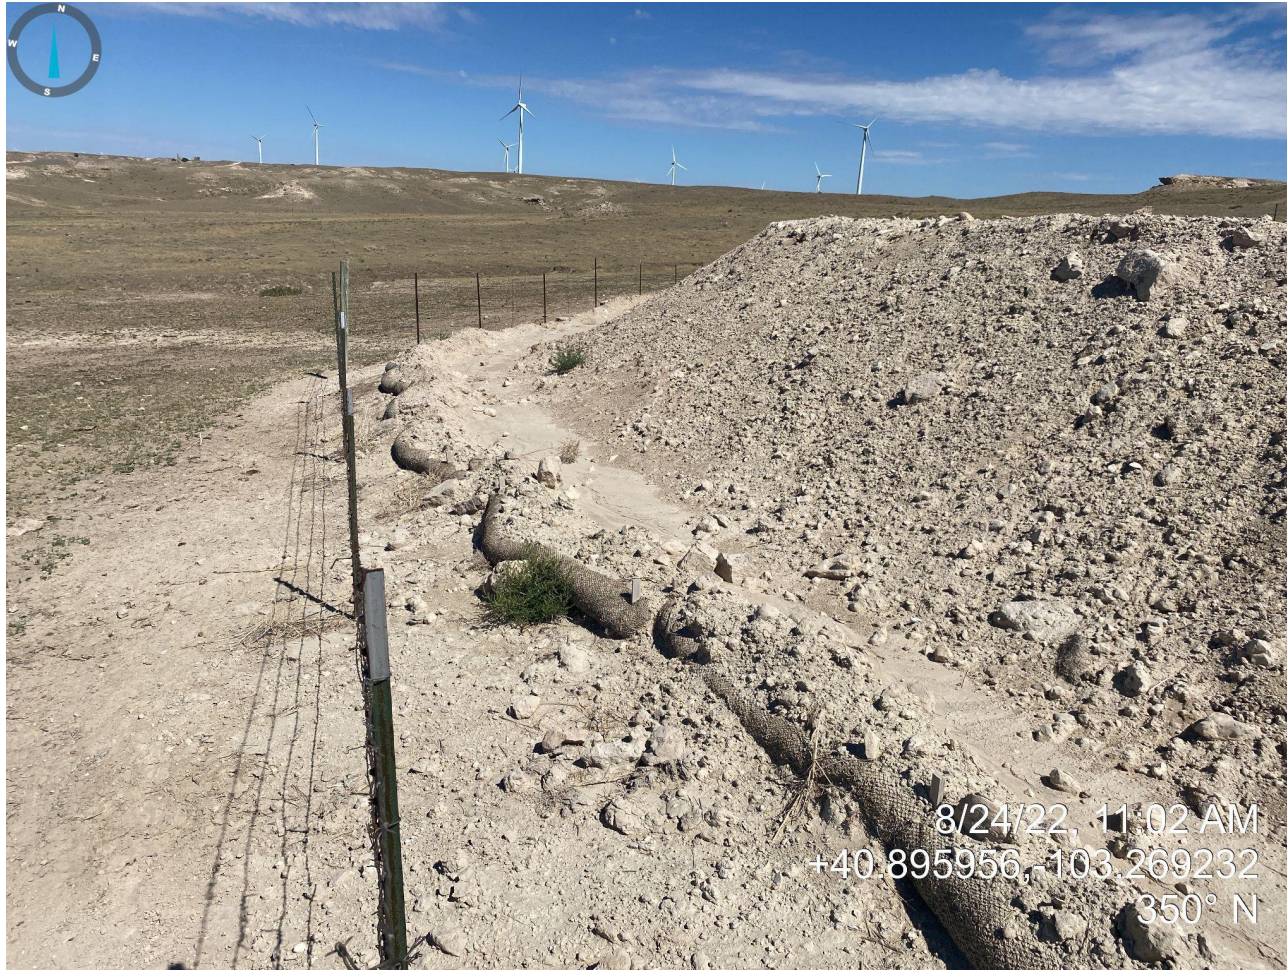
Photo 12. Photo taken east of pit and south of location, facing northwest. Photo illustrates straw wattles buried with sediment and are in need of maintenance/replacement to properly capture sediment laden stormwater from exiting location; pit walls show evidence of rill erosion. Both outlined in red.

Photo 23. Photo taken from westernmost corner of pit, facing north. See comments in photo 12.

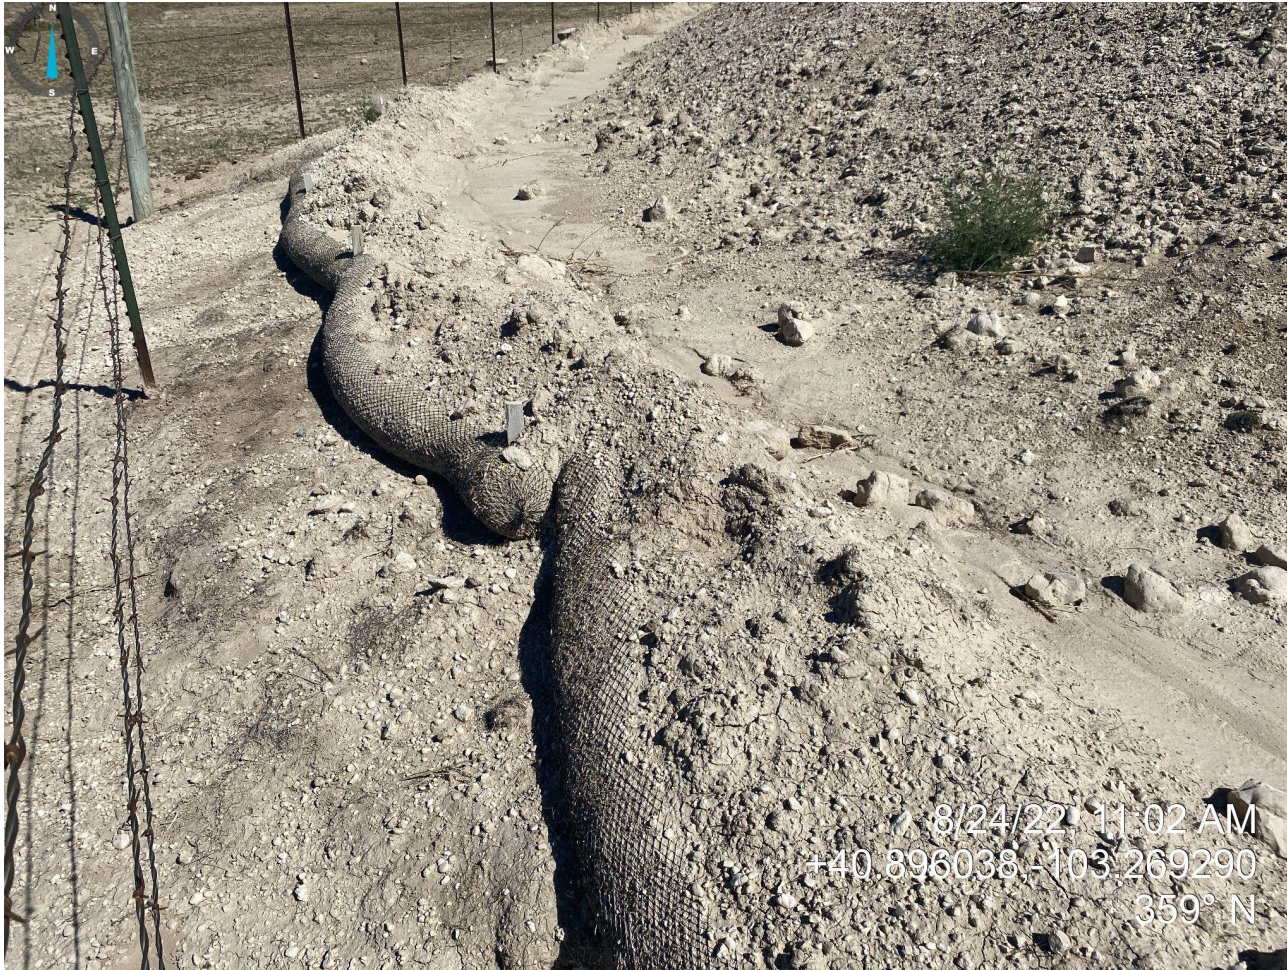
Photo 24. Close up of photo 23. See comments in photo 12.

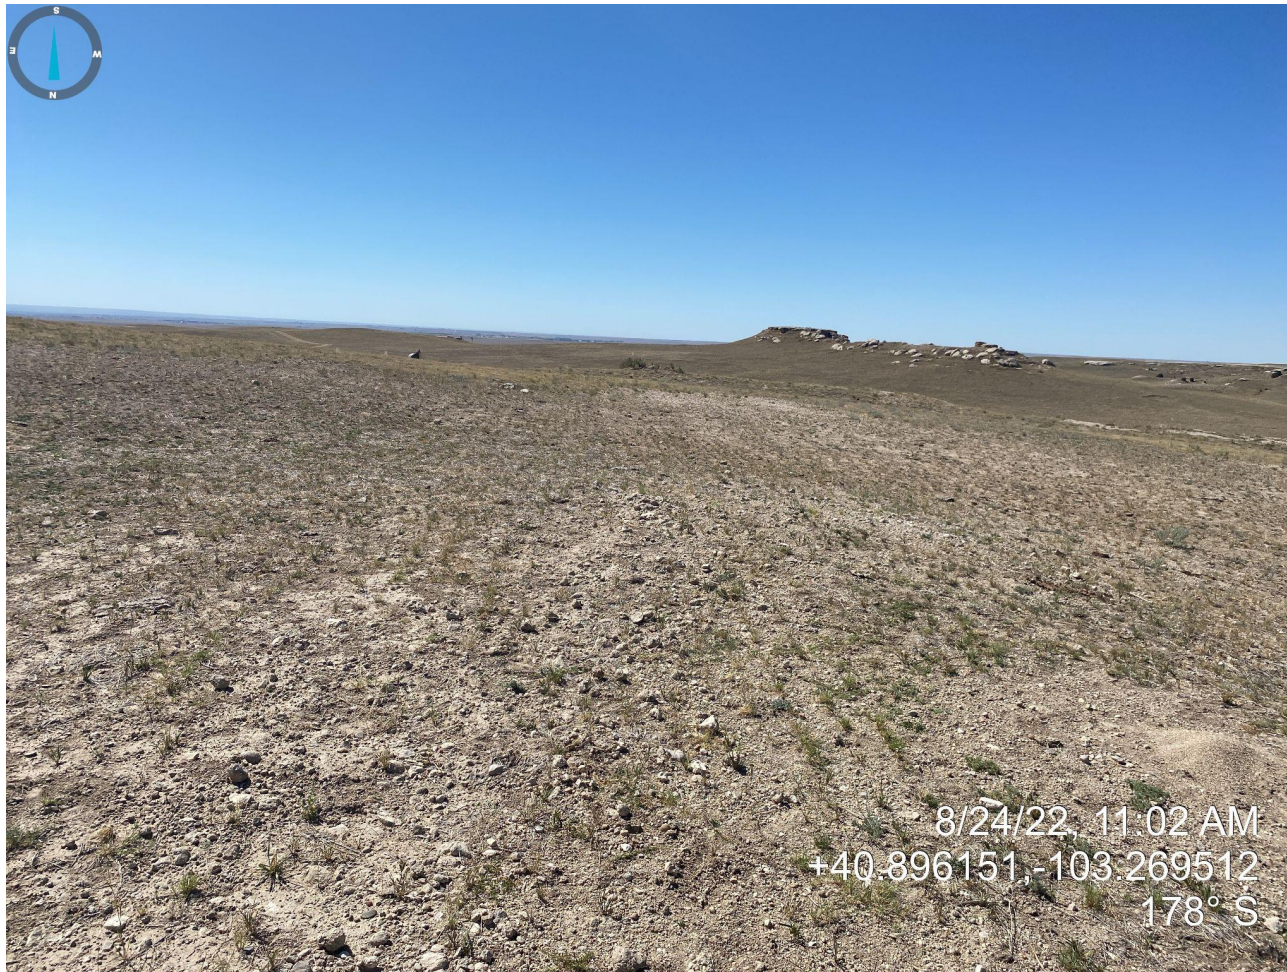
Photo 25. Salt Kill area photo taken west of location, facing south. Photo illustrates this portion of the salt kill area has failed to provide uniform vegetation cover resulting in bare soil.

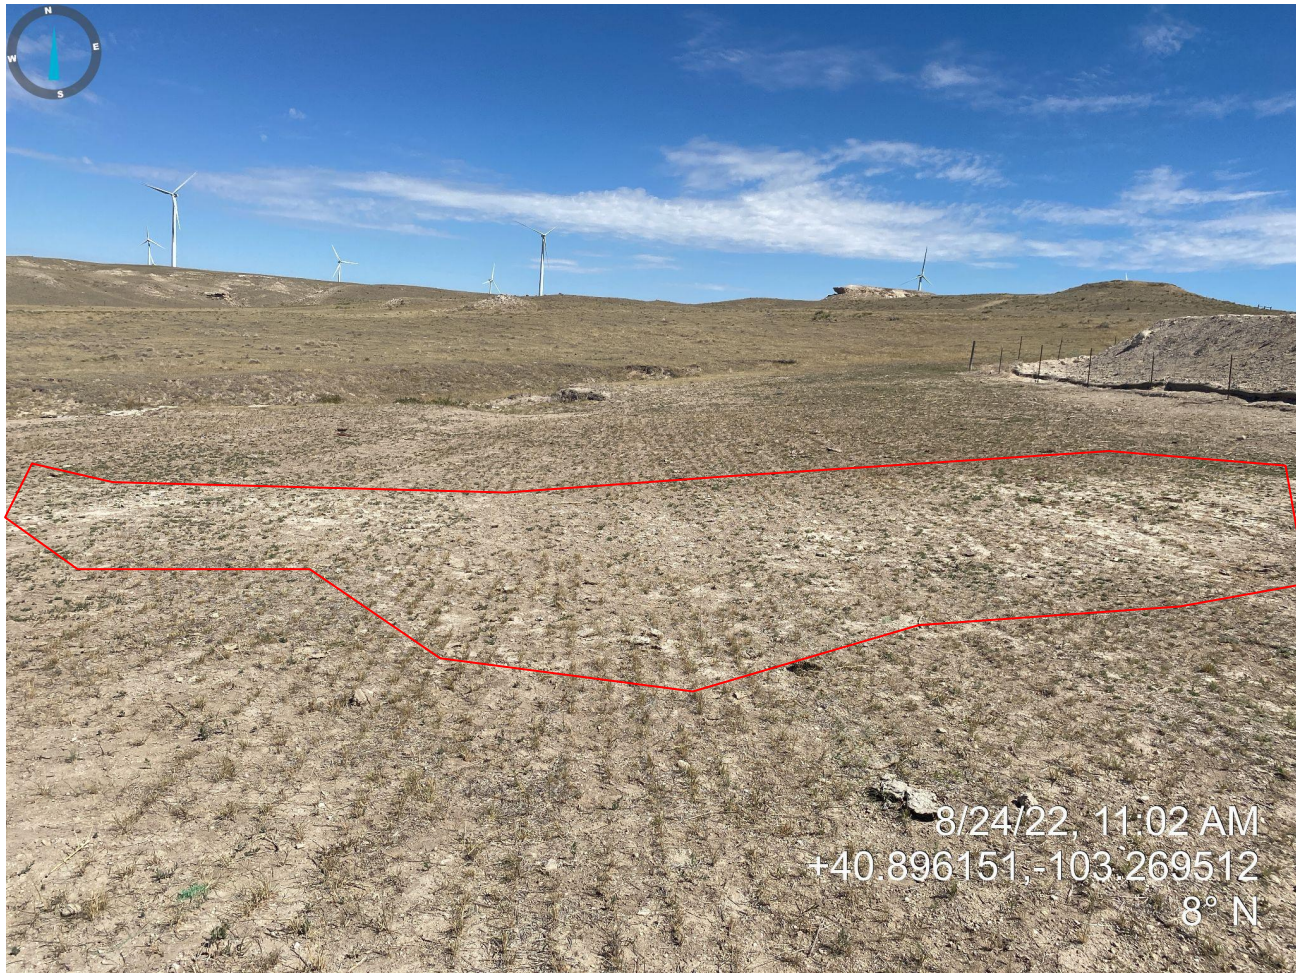
Photo 26. Salt Kill area photo taken west of location, facing north. Photo illustrates this portion of the salt kill area has failed to provide uniform vegetation cover resulting in bare soil. Area outlined in red illustrates recent sediment transport offsite, or soil exceeding Table 915-1 standards, or both.

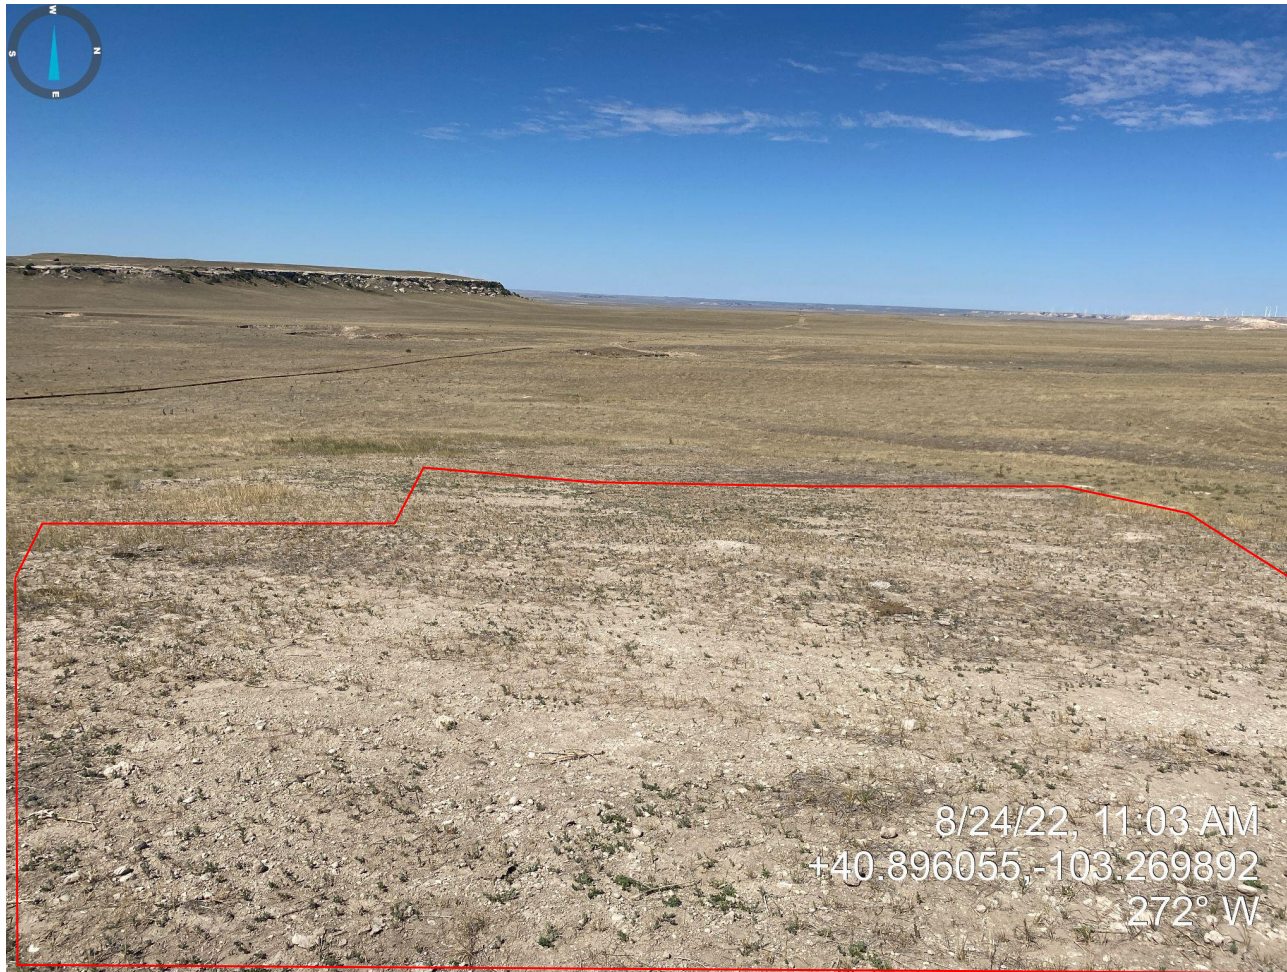
Photo 27. Salt kill area photo taken from western edge of location, facing west. see comments in photo 26.

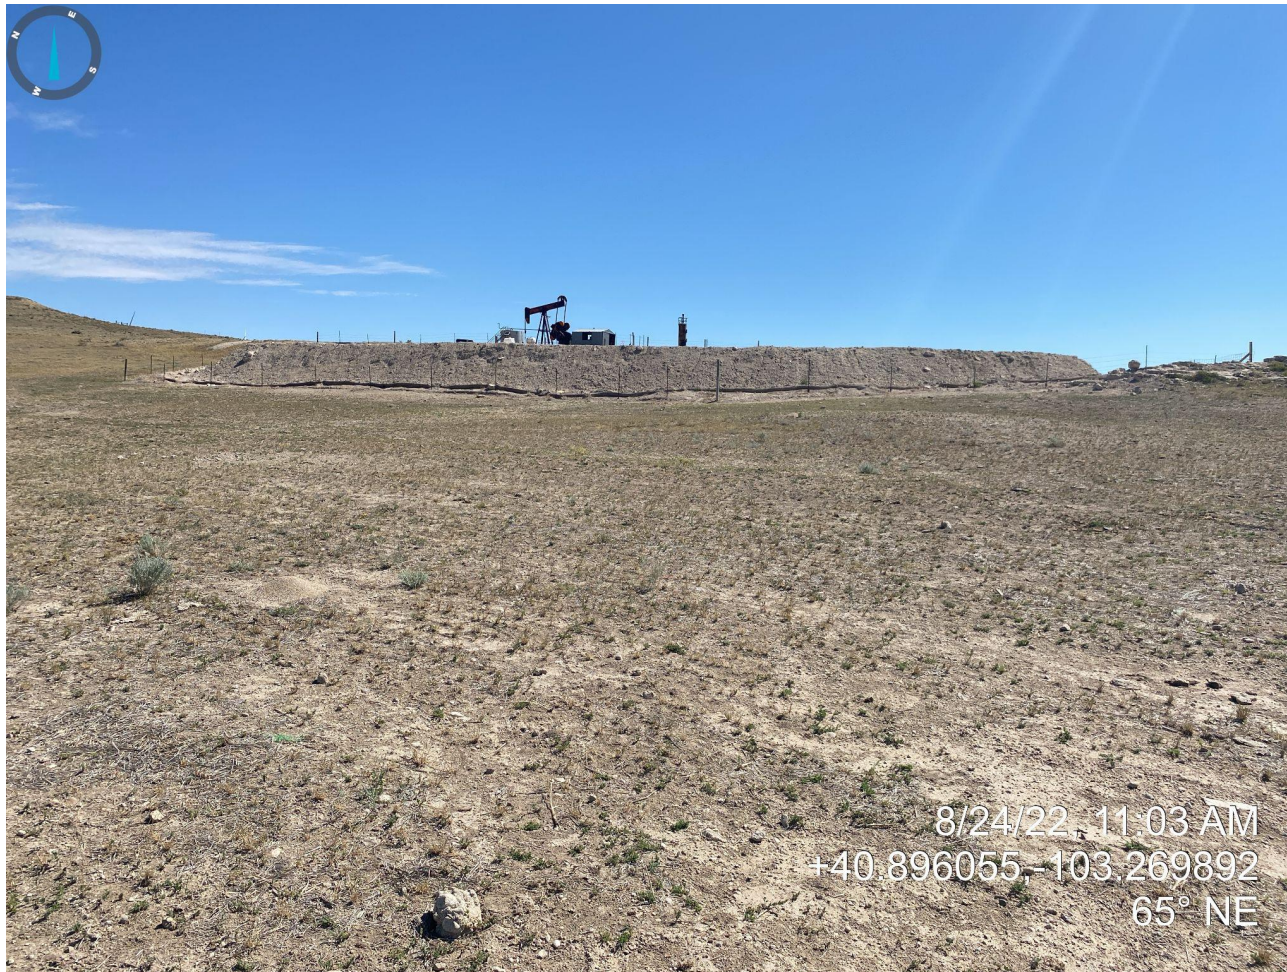
Photo 28. Photo taken from western edge of salt kill area, facing northeast towards location. See comments in photo 26.

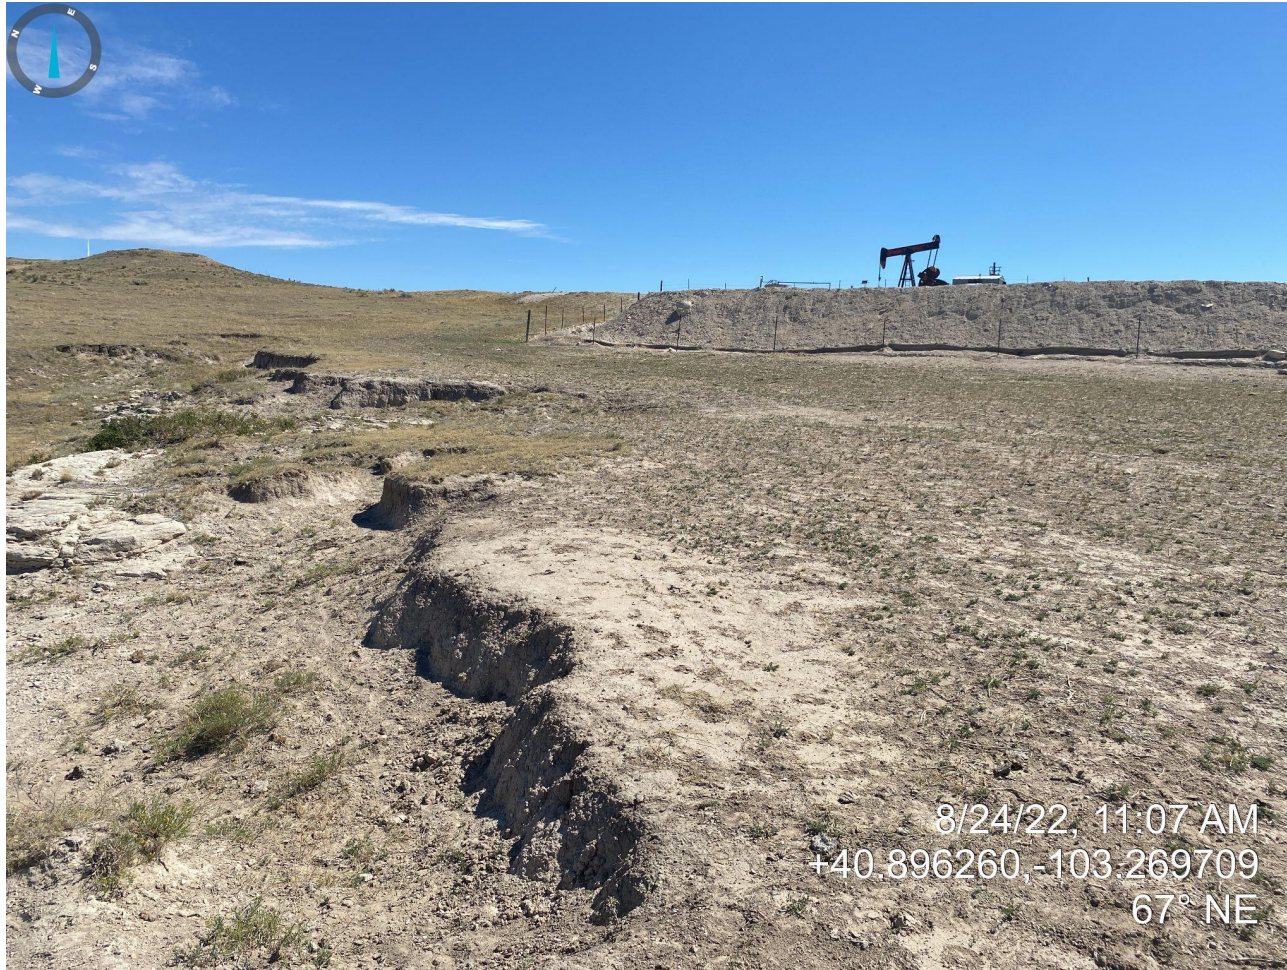
Photo 29. See comments in photo 28.

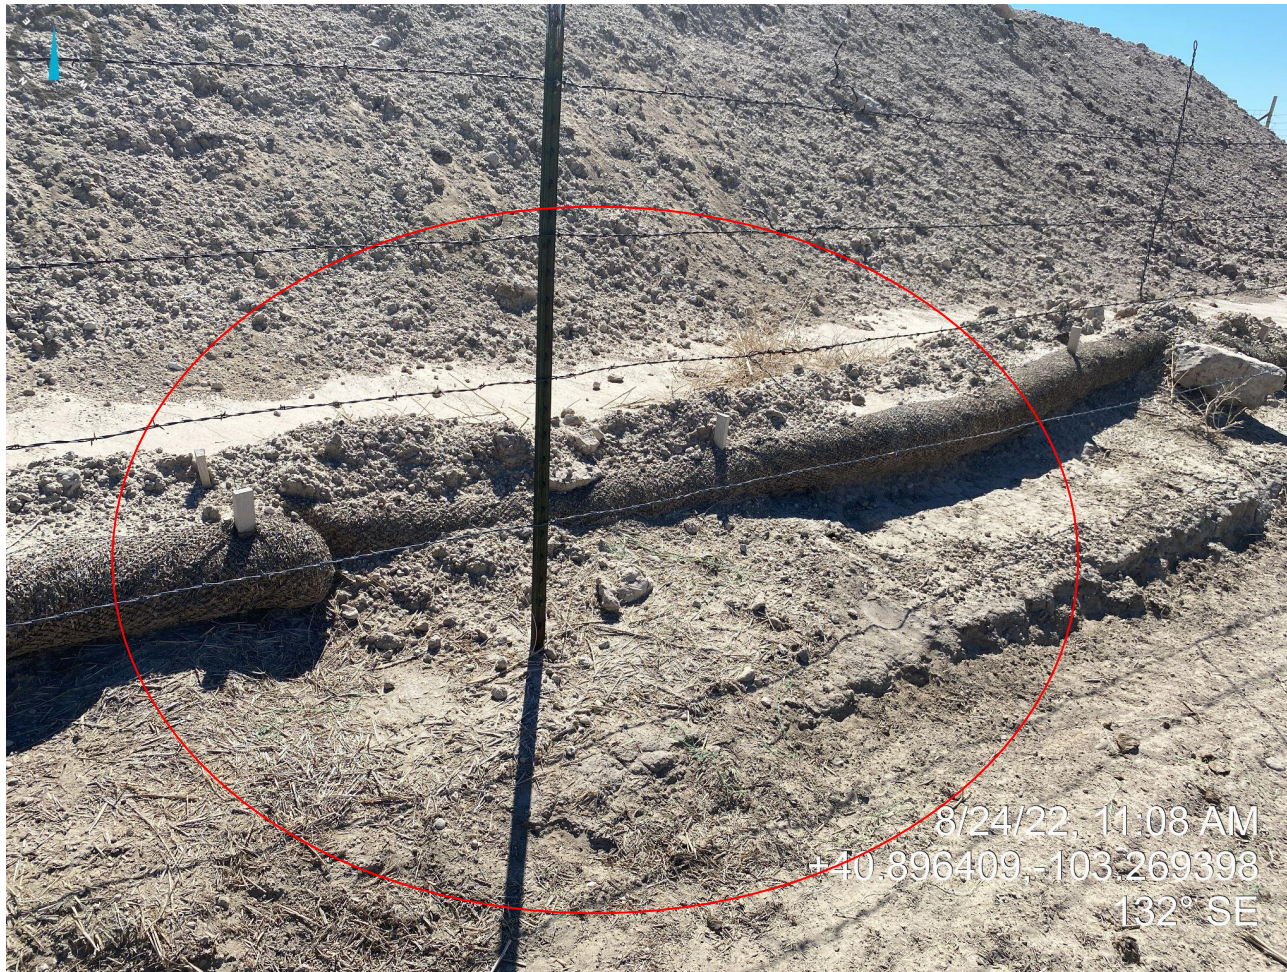
Photo 30. Pit photo taken from western edge, facing southeast. Photo illustrates straw wattles buried and insufficient in keeping sediment laden stormwater from exiting location, outlined in red.

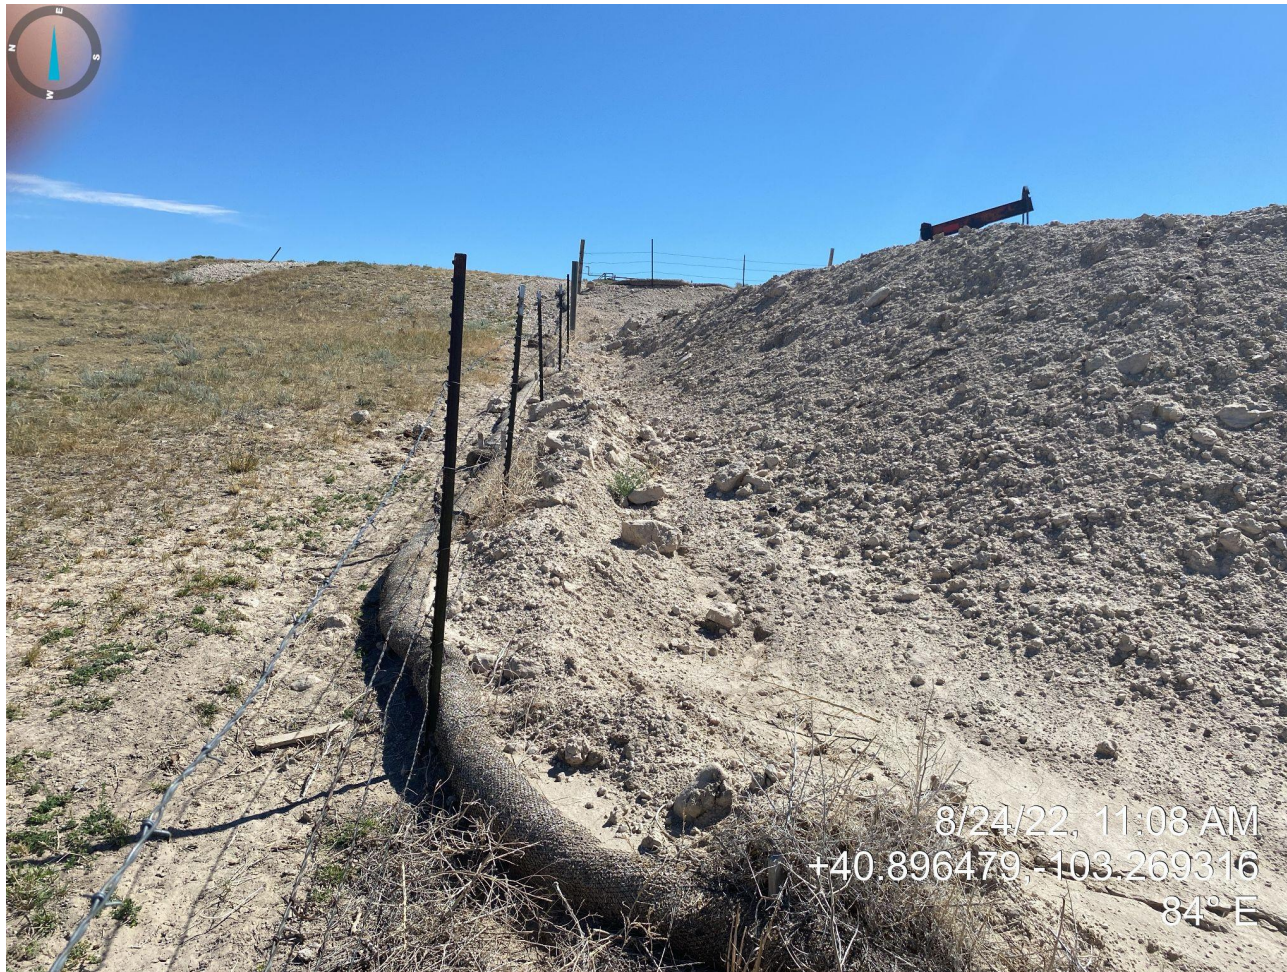
Photo 31. Pit photo taken from northwestern corner, facing east. See comments in photo 12.

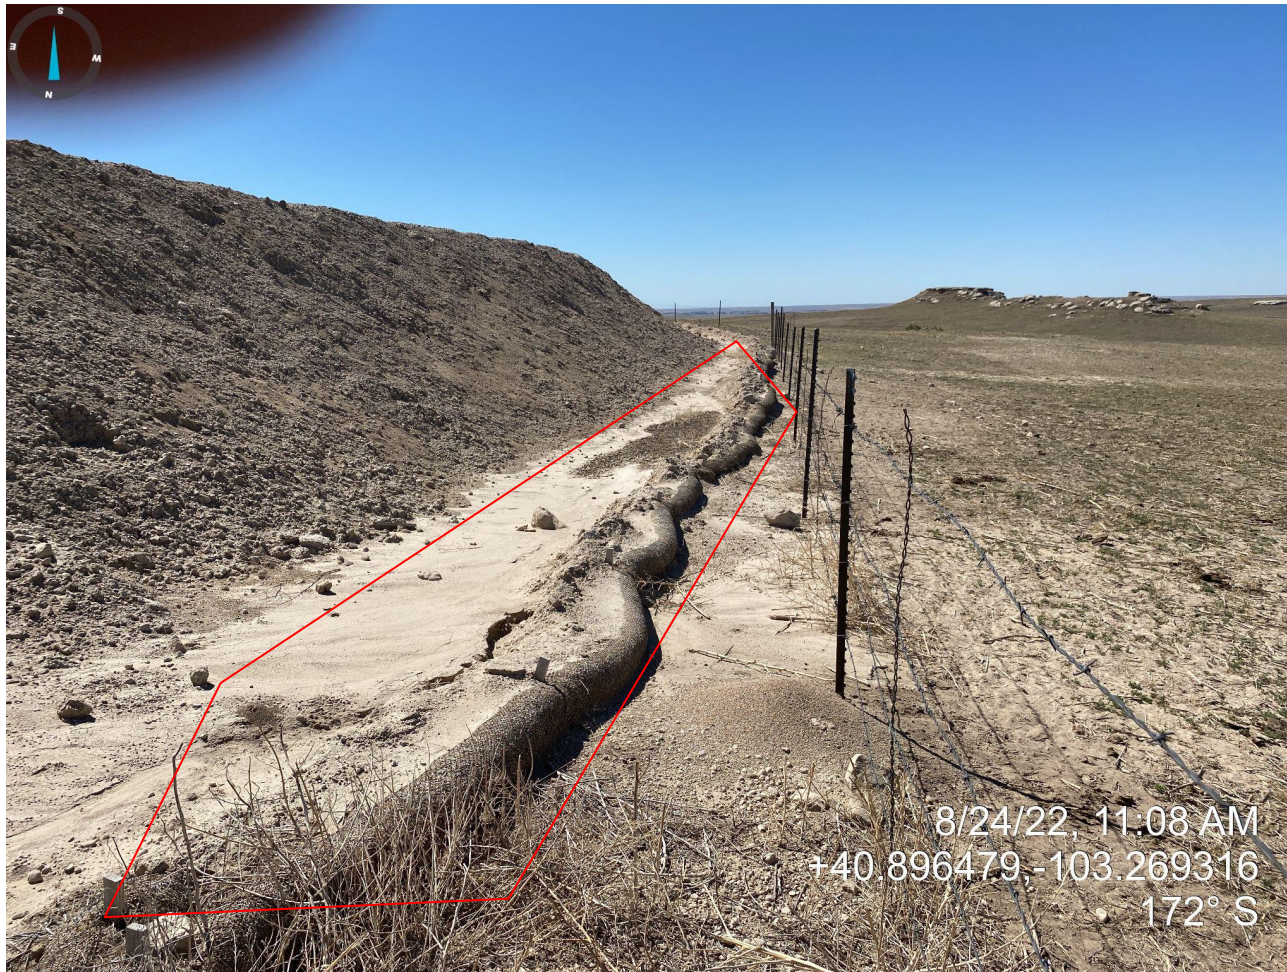
Photo 32. Pit photo taken from northwestern corner, facing south. See comments in photo 12.

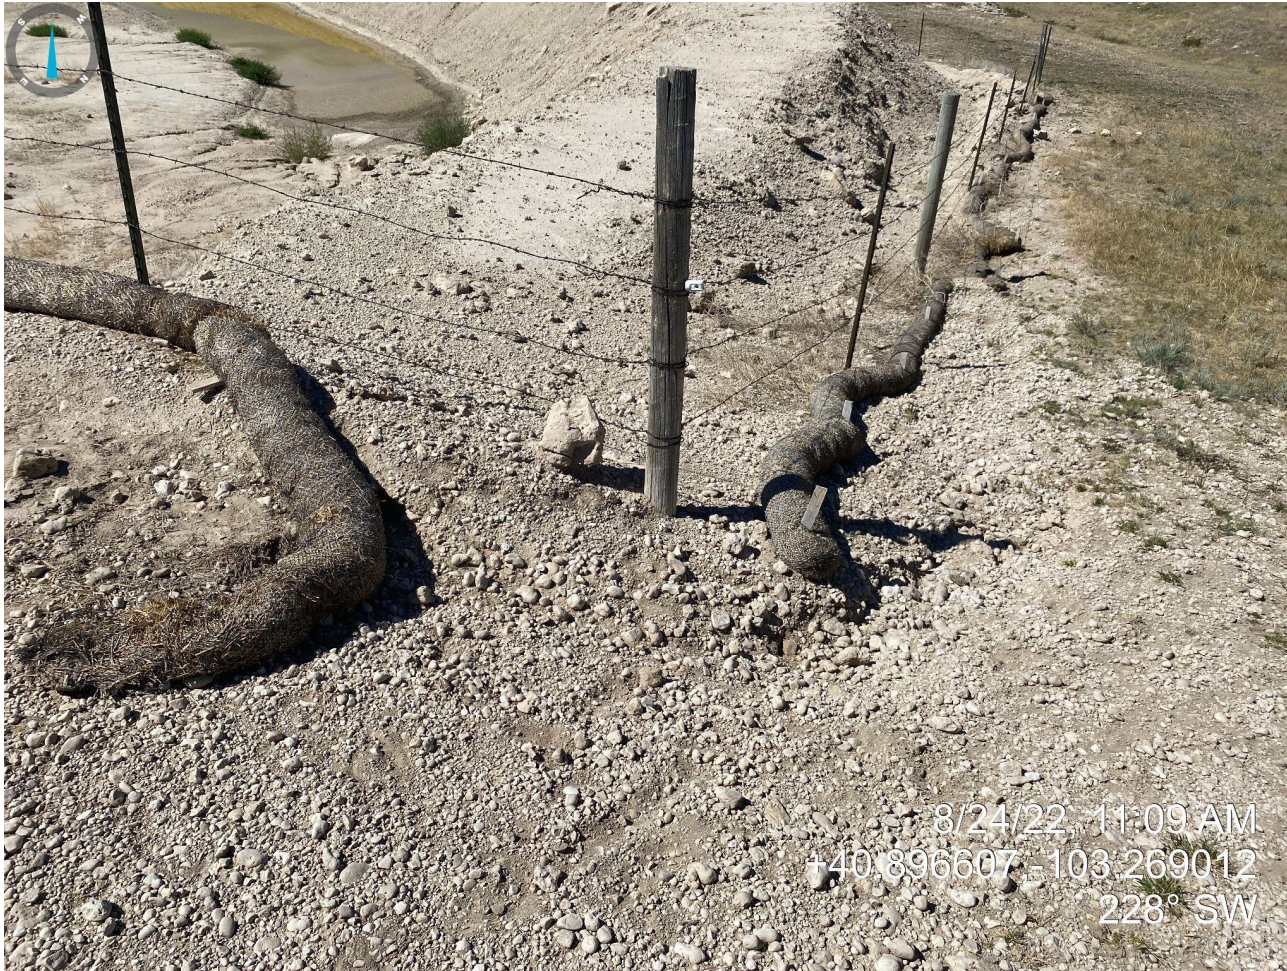
Photo 33. Pit photo taken from northern portion, facing southwest. See comments in photo 12.

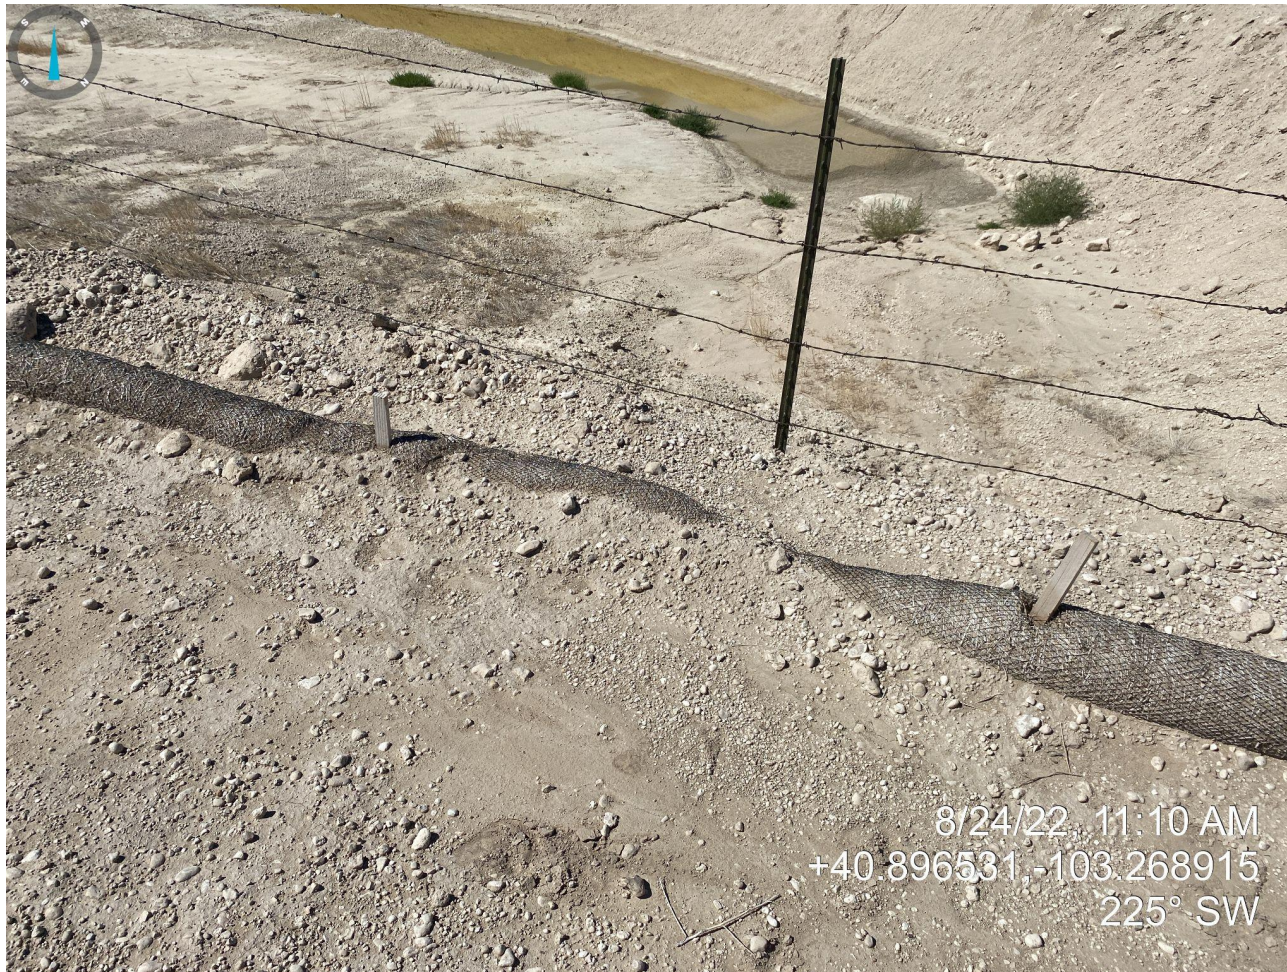
Photo 34. Pit photo taken from northeastern portion, facing southwest. See comments in photo 12.

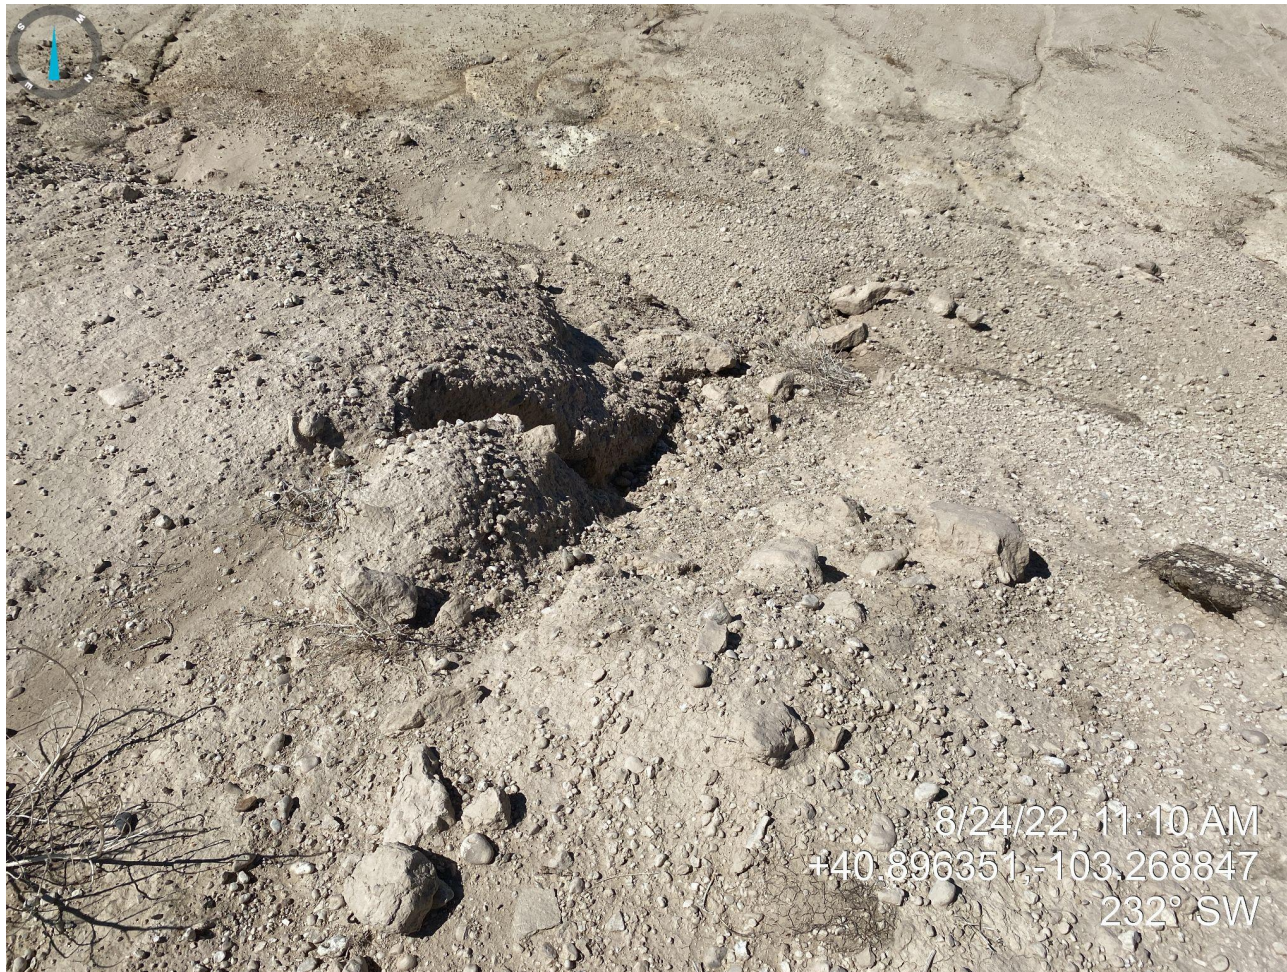
Photo 35. Pit photo taken from northeastern portion, near pump jack, close up. Photo illustrates minor gully erosion on eastern side of pit.

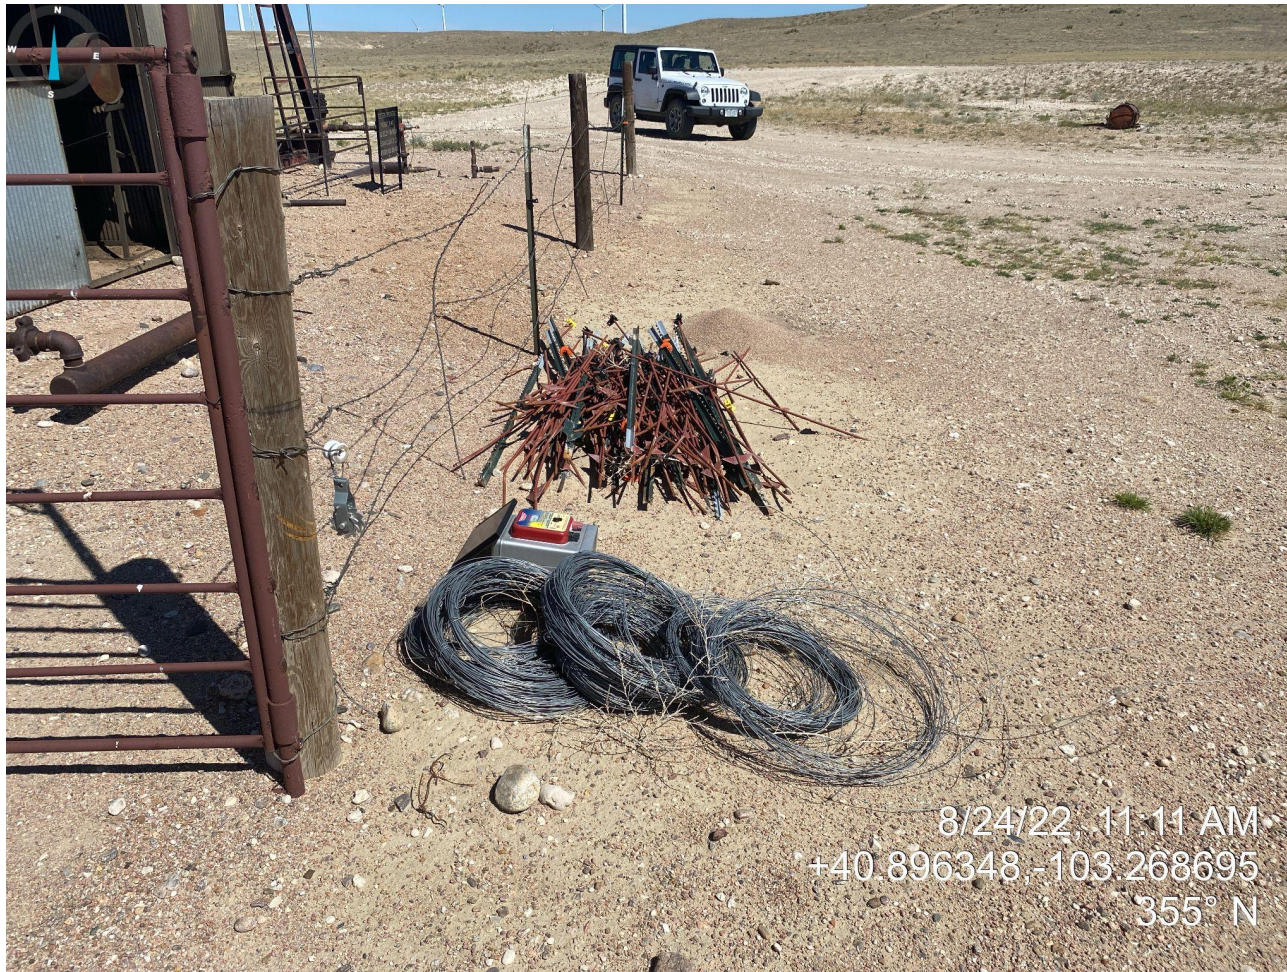
Photo 36. Photo taken near pump jack on southern portion of location, facing north. Photo illustrates fencing material left on site.
